## **RED CHRIS DEVELOPMENT COMPANY LTD.**

### **RED CHRIS TAILINGS FACILITY**

## **2014 DAM SAFETY INSPECTION REPORT**

PROJECT NO.: 0866001.14.7  
DATE: November 24, 2014  
DOCUMENT NO.: 0866001.14.002

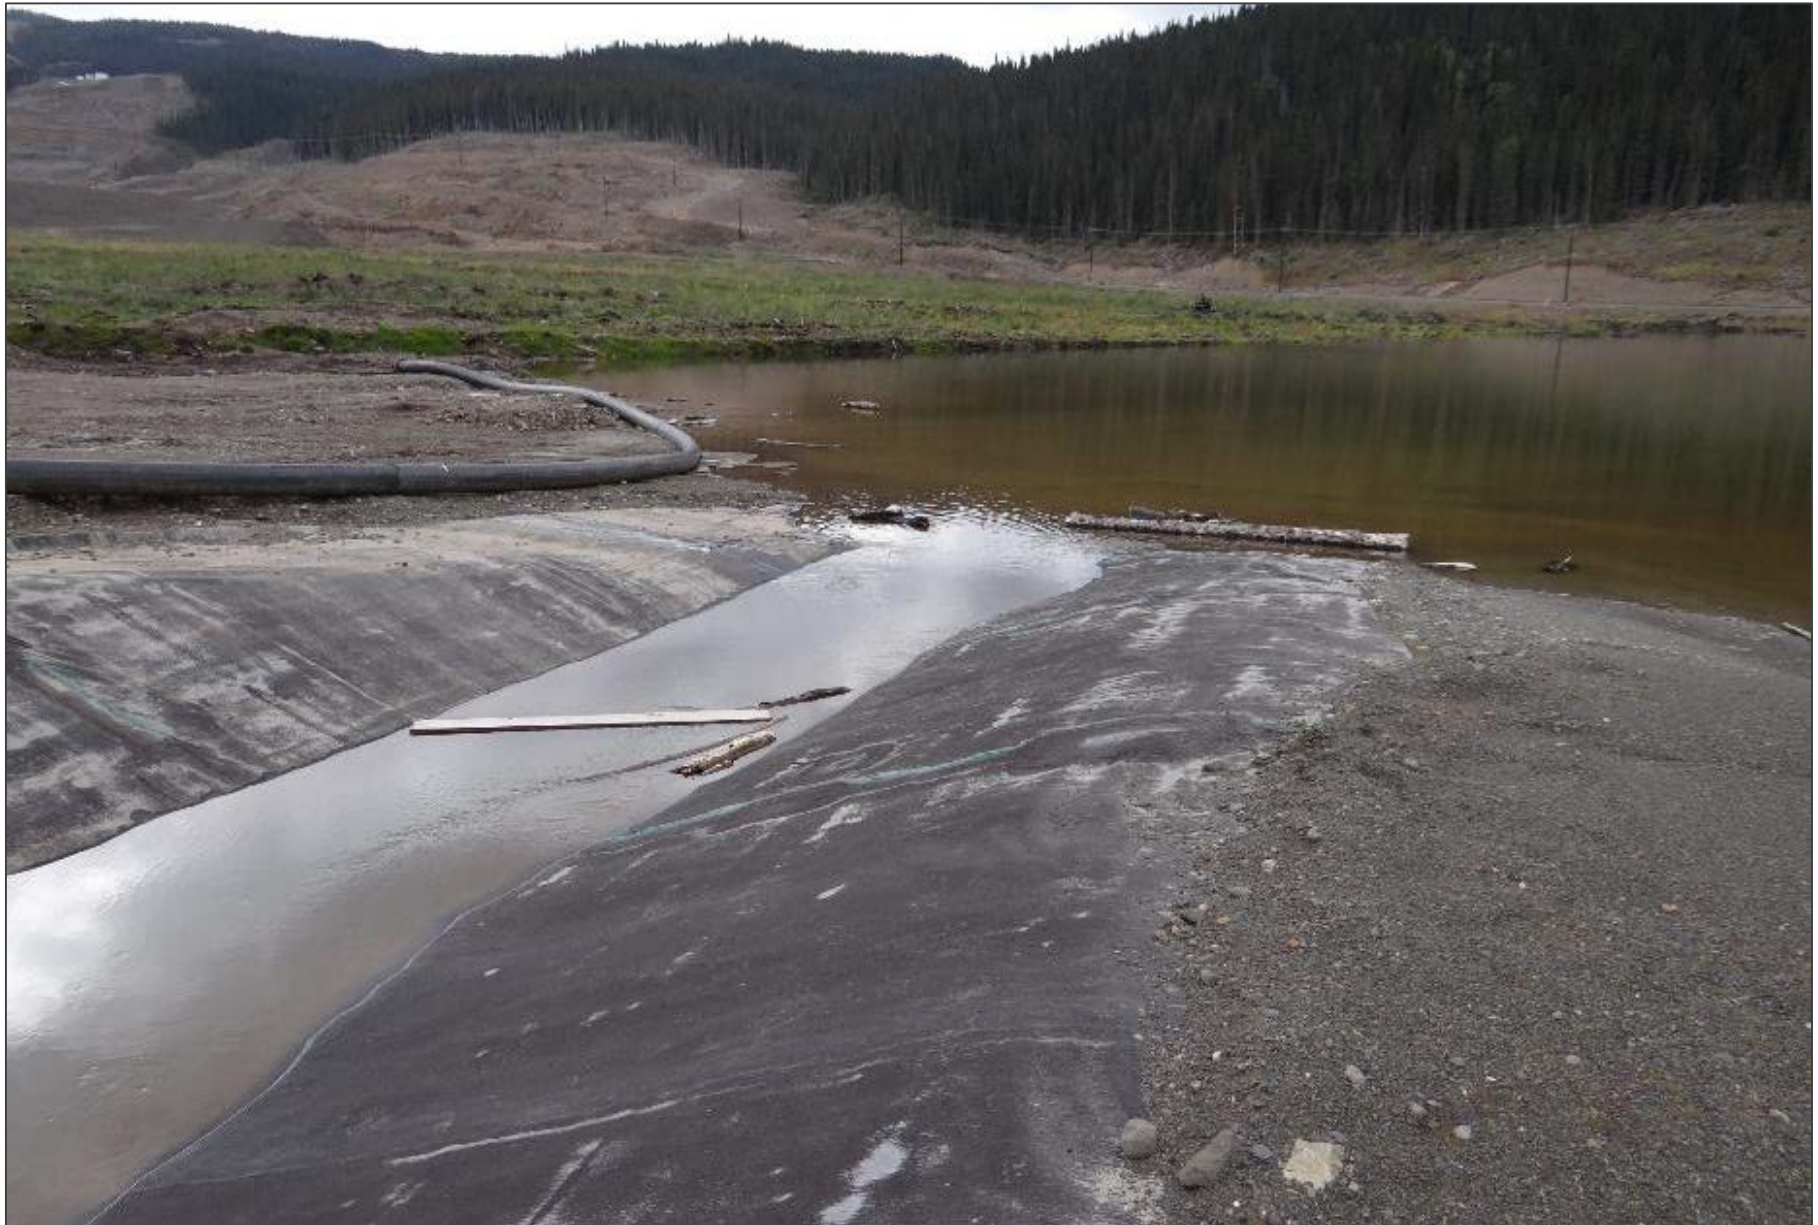
**Inlet to the bituminous geomembrane-lined open channel spillway from the NRD reservoir. Note floating wood debris in the reservoir and in the channel. This material needs to be cleared.**

- There was some floating debris in the pond and within the spillway channel itself. Such debris should be removed.
- There were no indications of flow occurring below the bituminous geomembrane – such conditions if present could potentially lead to undermining and eventual tearing of the geomembrane.
- Some cobbles were noted at the crest of the geomembrane liner slopes (see Photo 52). Such stones should be removed.
- An armored outlet has yet to be constructed at the downstream termination of the geomembrane. As a result, scour is occurring and is undermining the geomembrane. The outlet should be constructed, and the scour and undermining that has occurred, should be repaired.

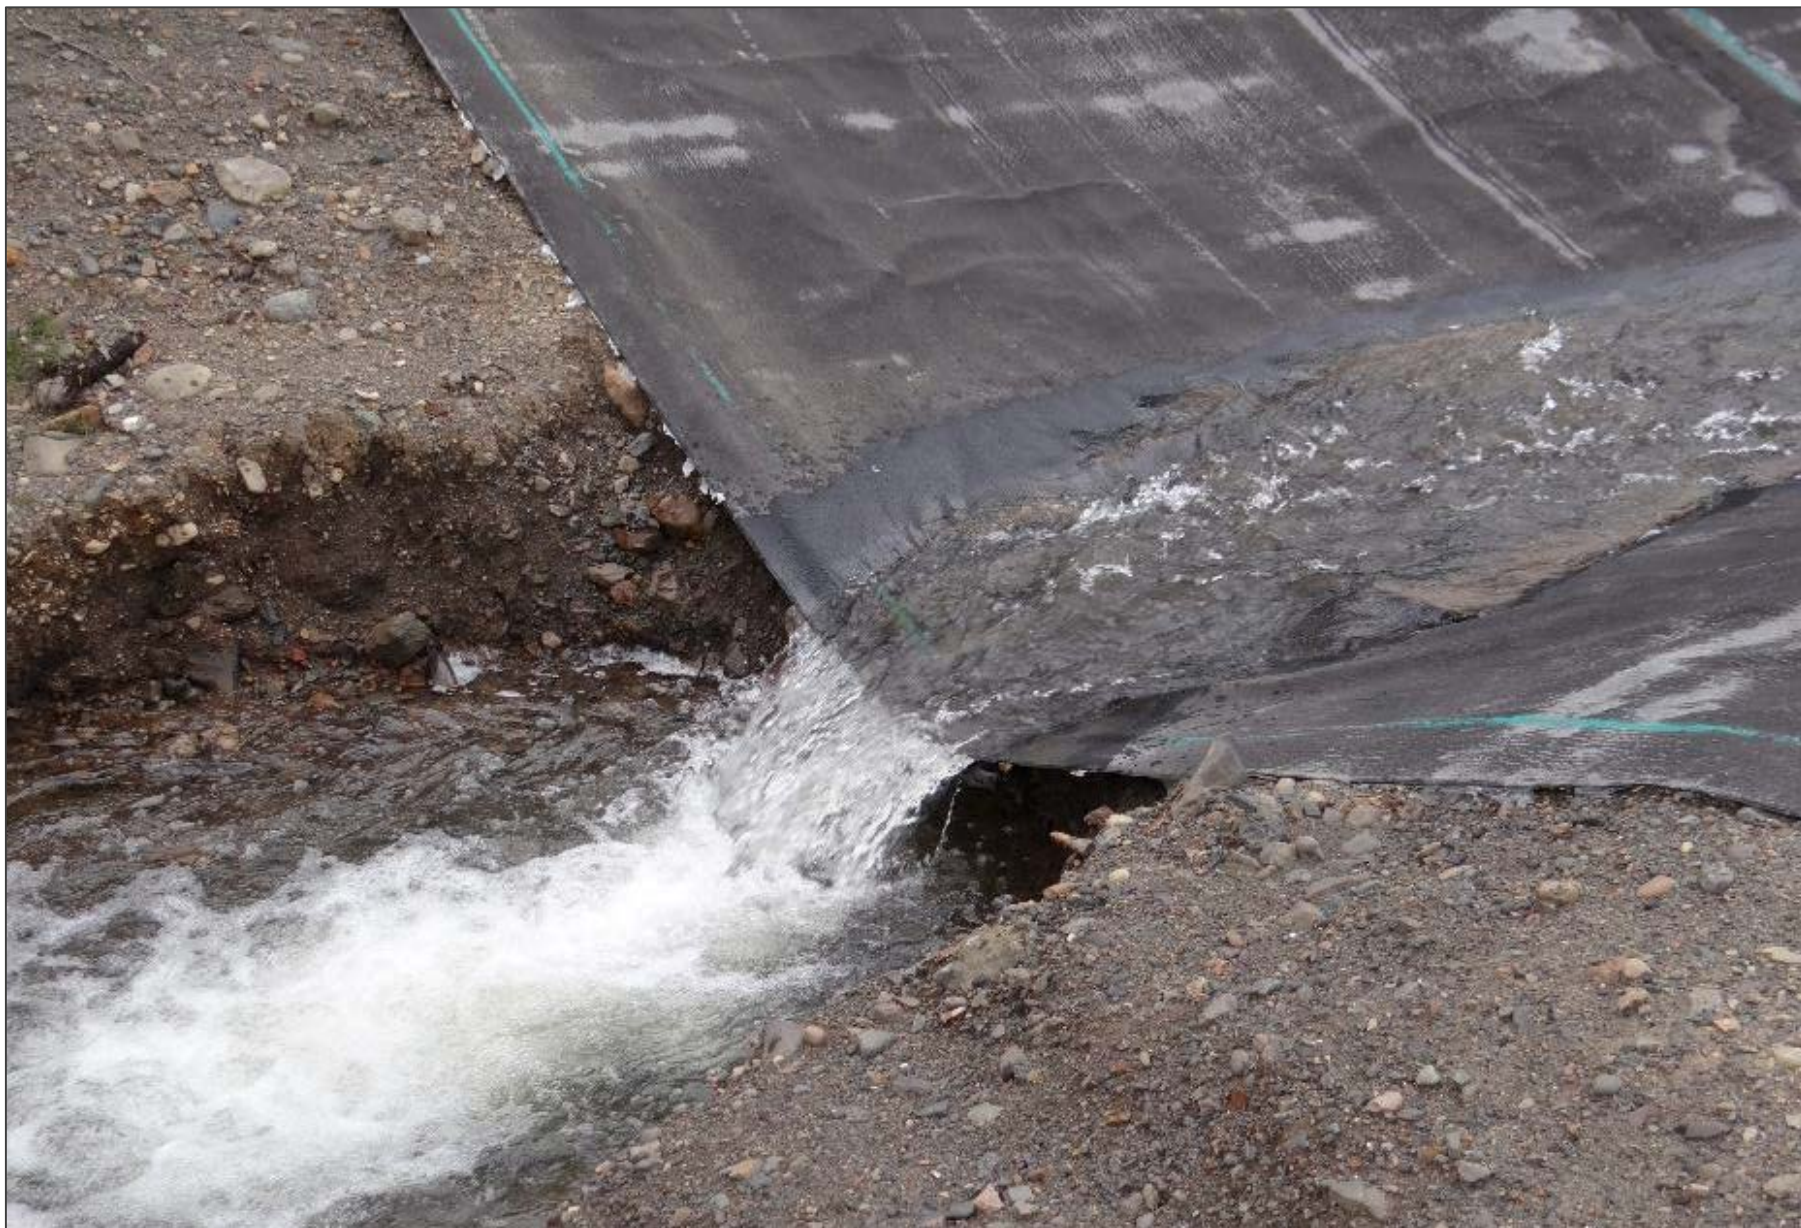
**Outlet of the NRD spillway channel. The channel outfall and outlet structure has not yet been constructed, with the result that there is scour occurring and the geomembrane is being undermined. These works need to be completed and the existing scour repaired.**

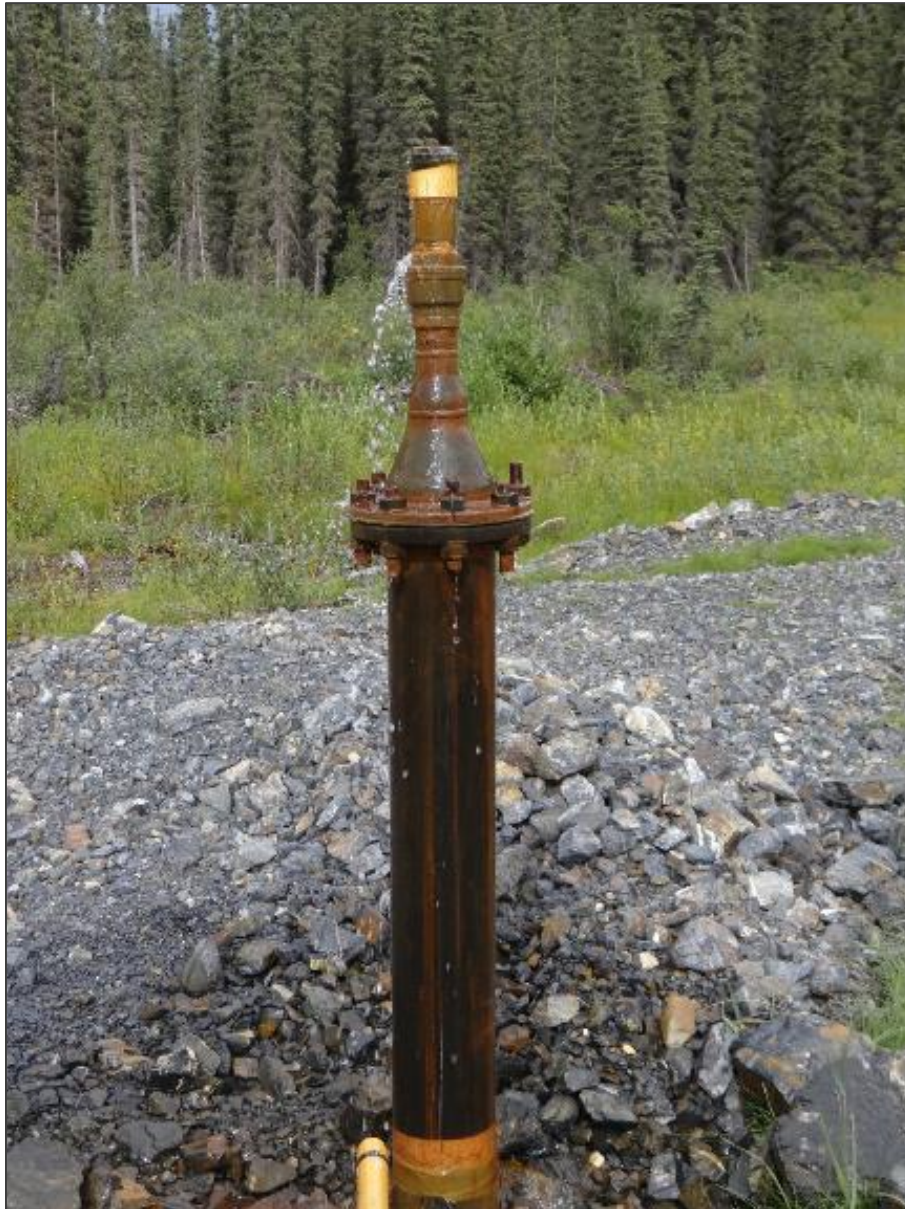
**Groundwater monitoring well MW13-4S downstream of the NRD, indicating artesian conditions. Pressure gauges should be installed on all artesian wells so that shut-in pressures can be recorded.**

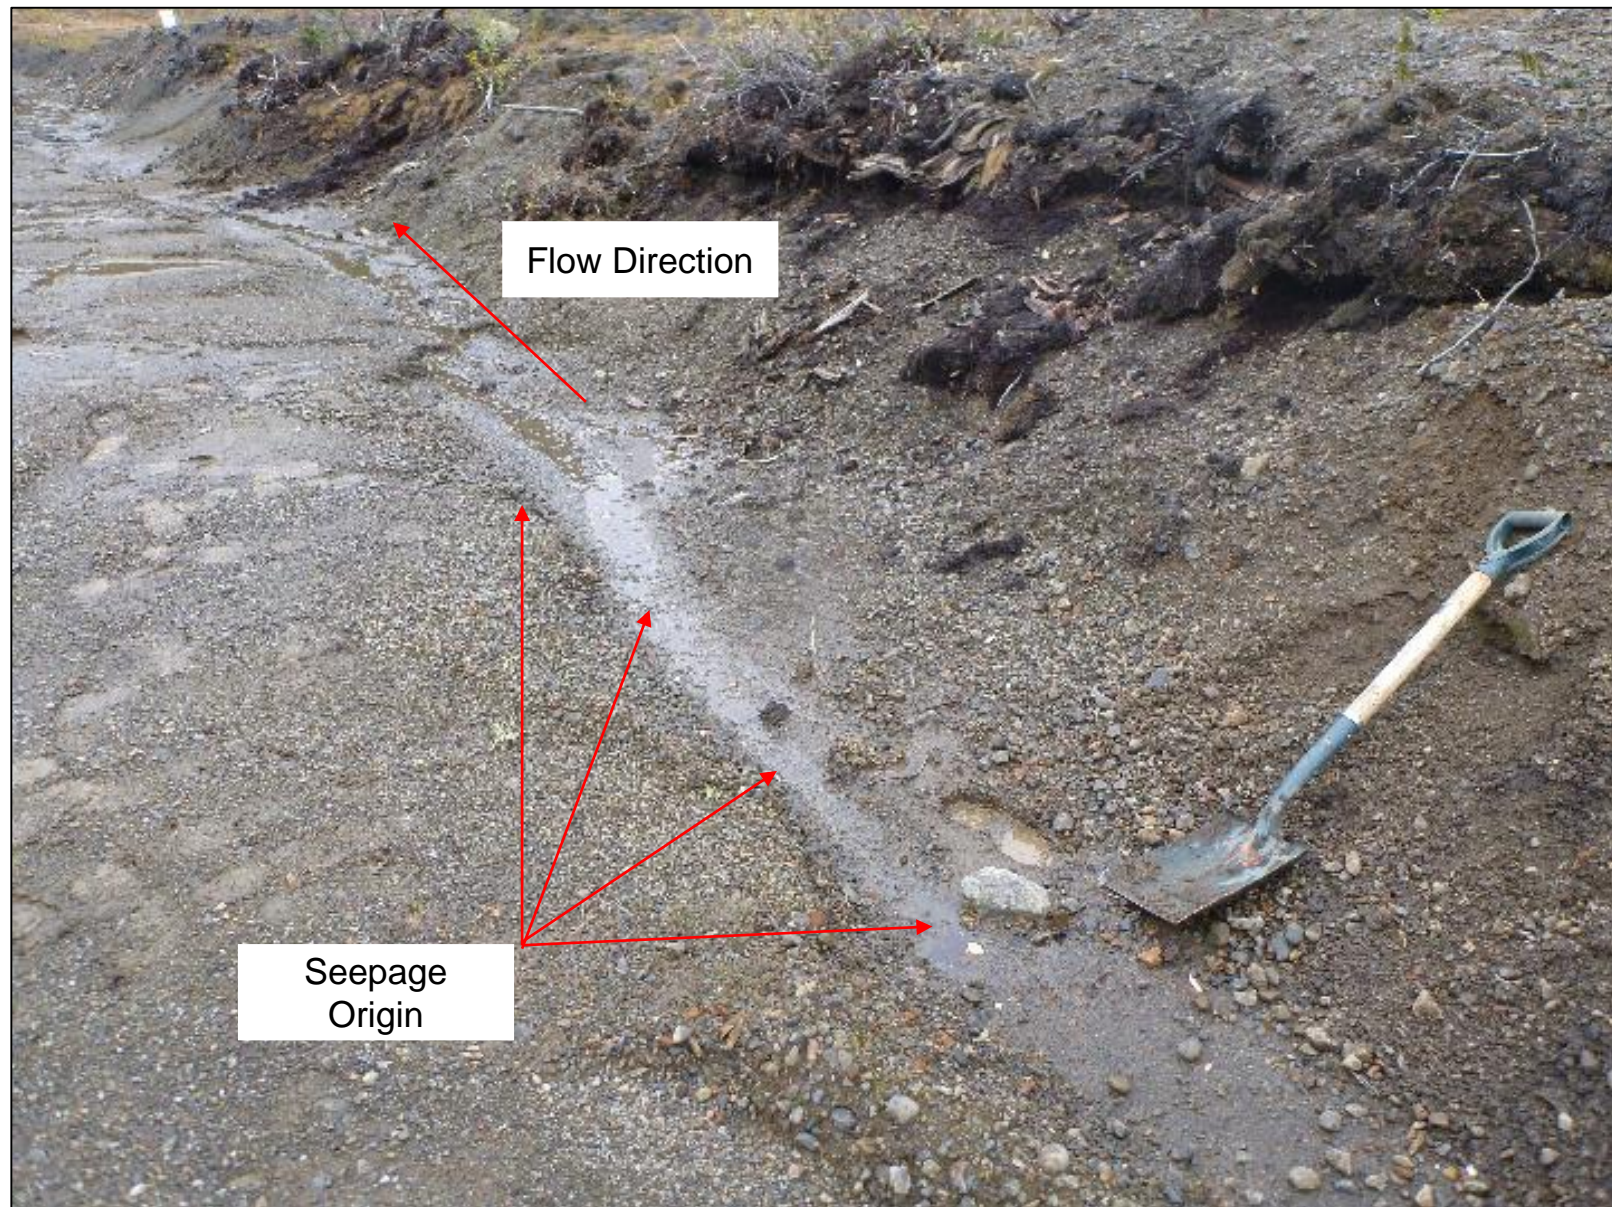
**Chainage 0+050: Water seen flowing through small natural ditch. Water not observed up slope (east) of this point. Water is clear. Looking west parallel to North Reclaim Dam alignment.**

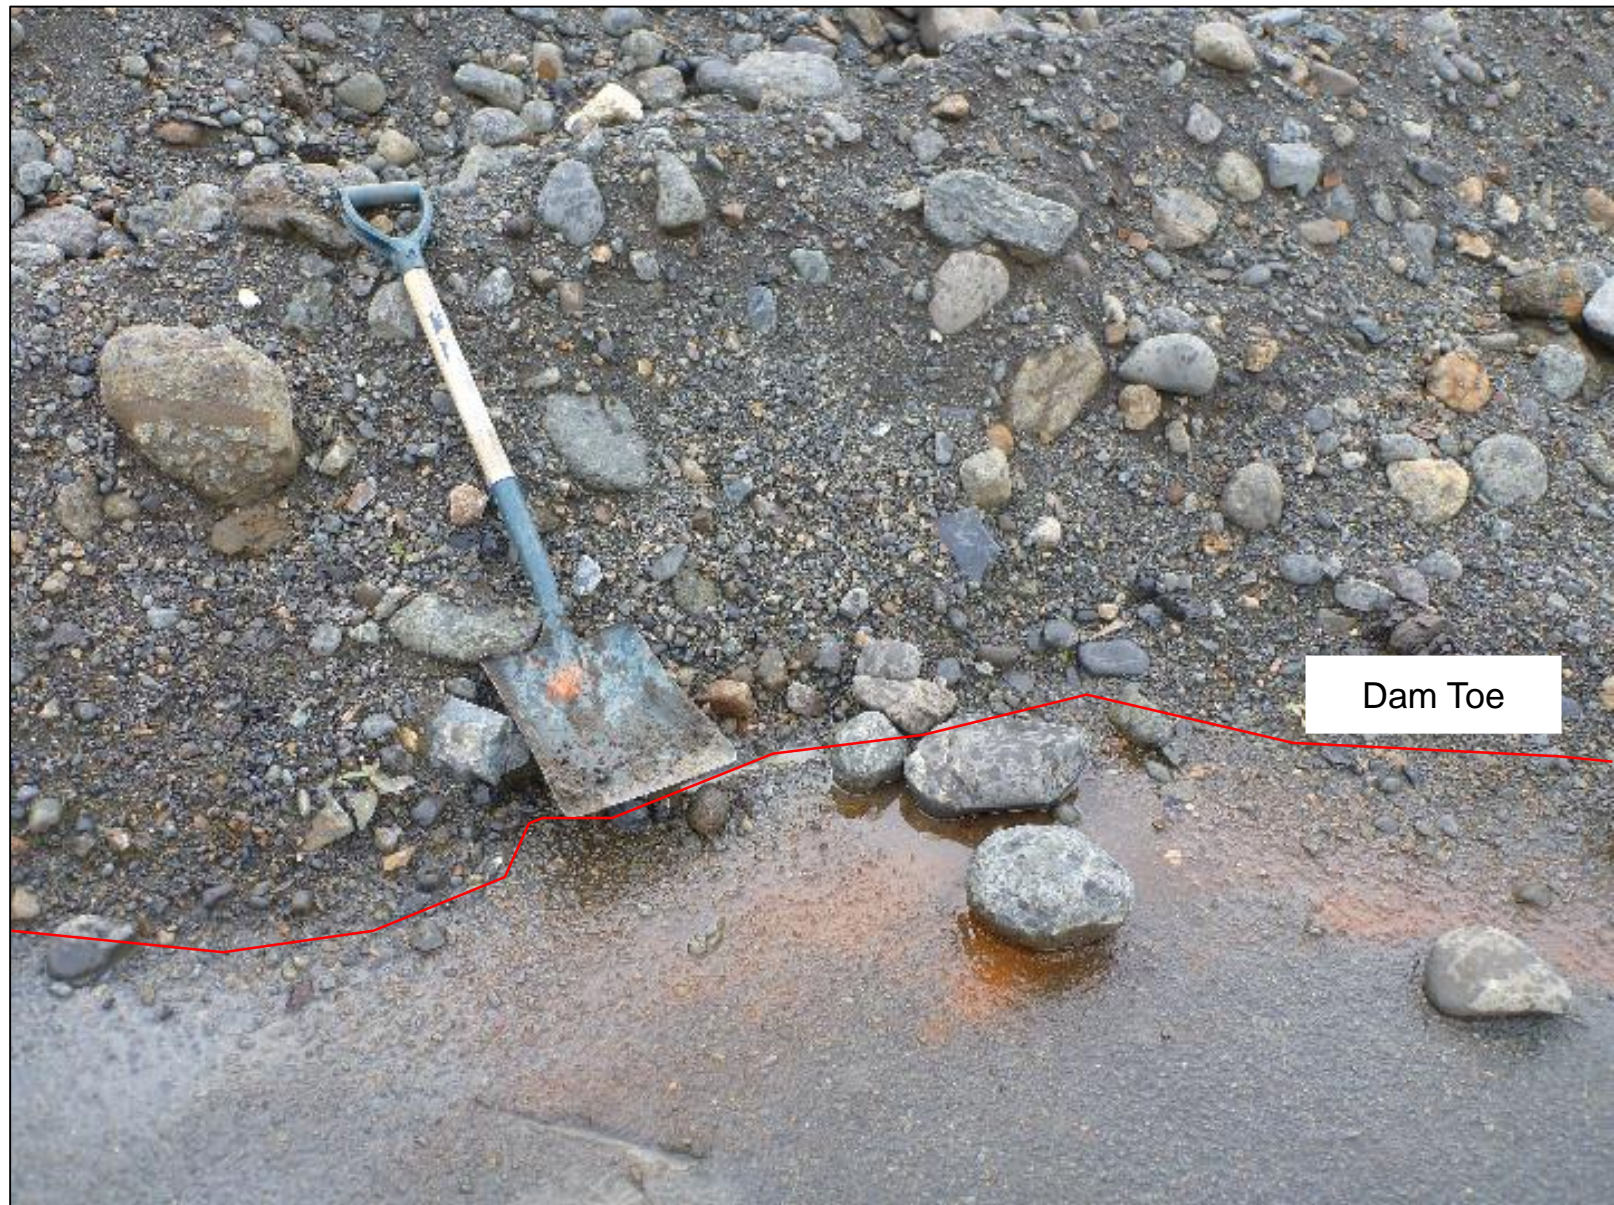
**Chainage 0+080: Water observed trickling from dam toe. Orange staining in location of seepage.**

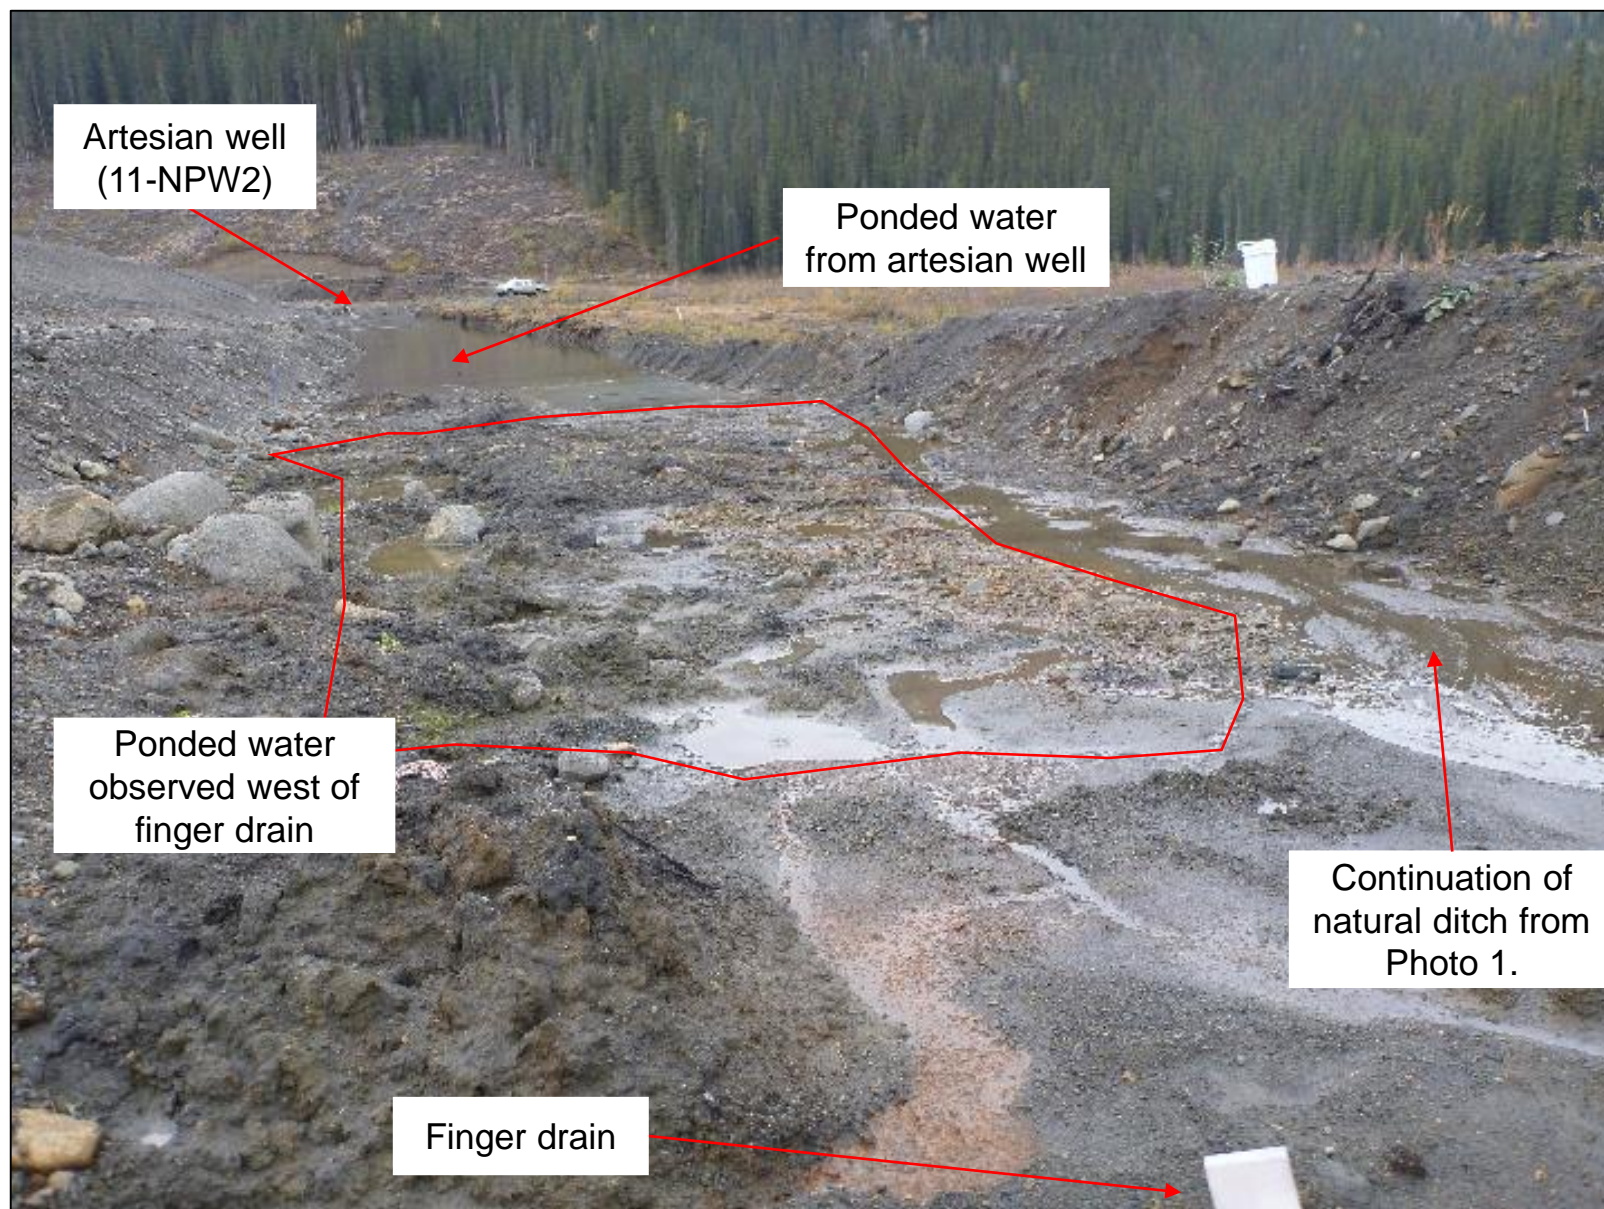
Chainage 0+085: Seepage is clear west of artesian well. Seepage observed at dam toe, though flowing water was not observed. Orange staining in location of seepage. Photo taken west of finger drain, looking west.

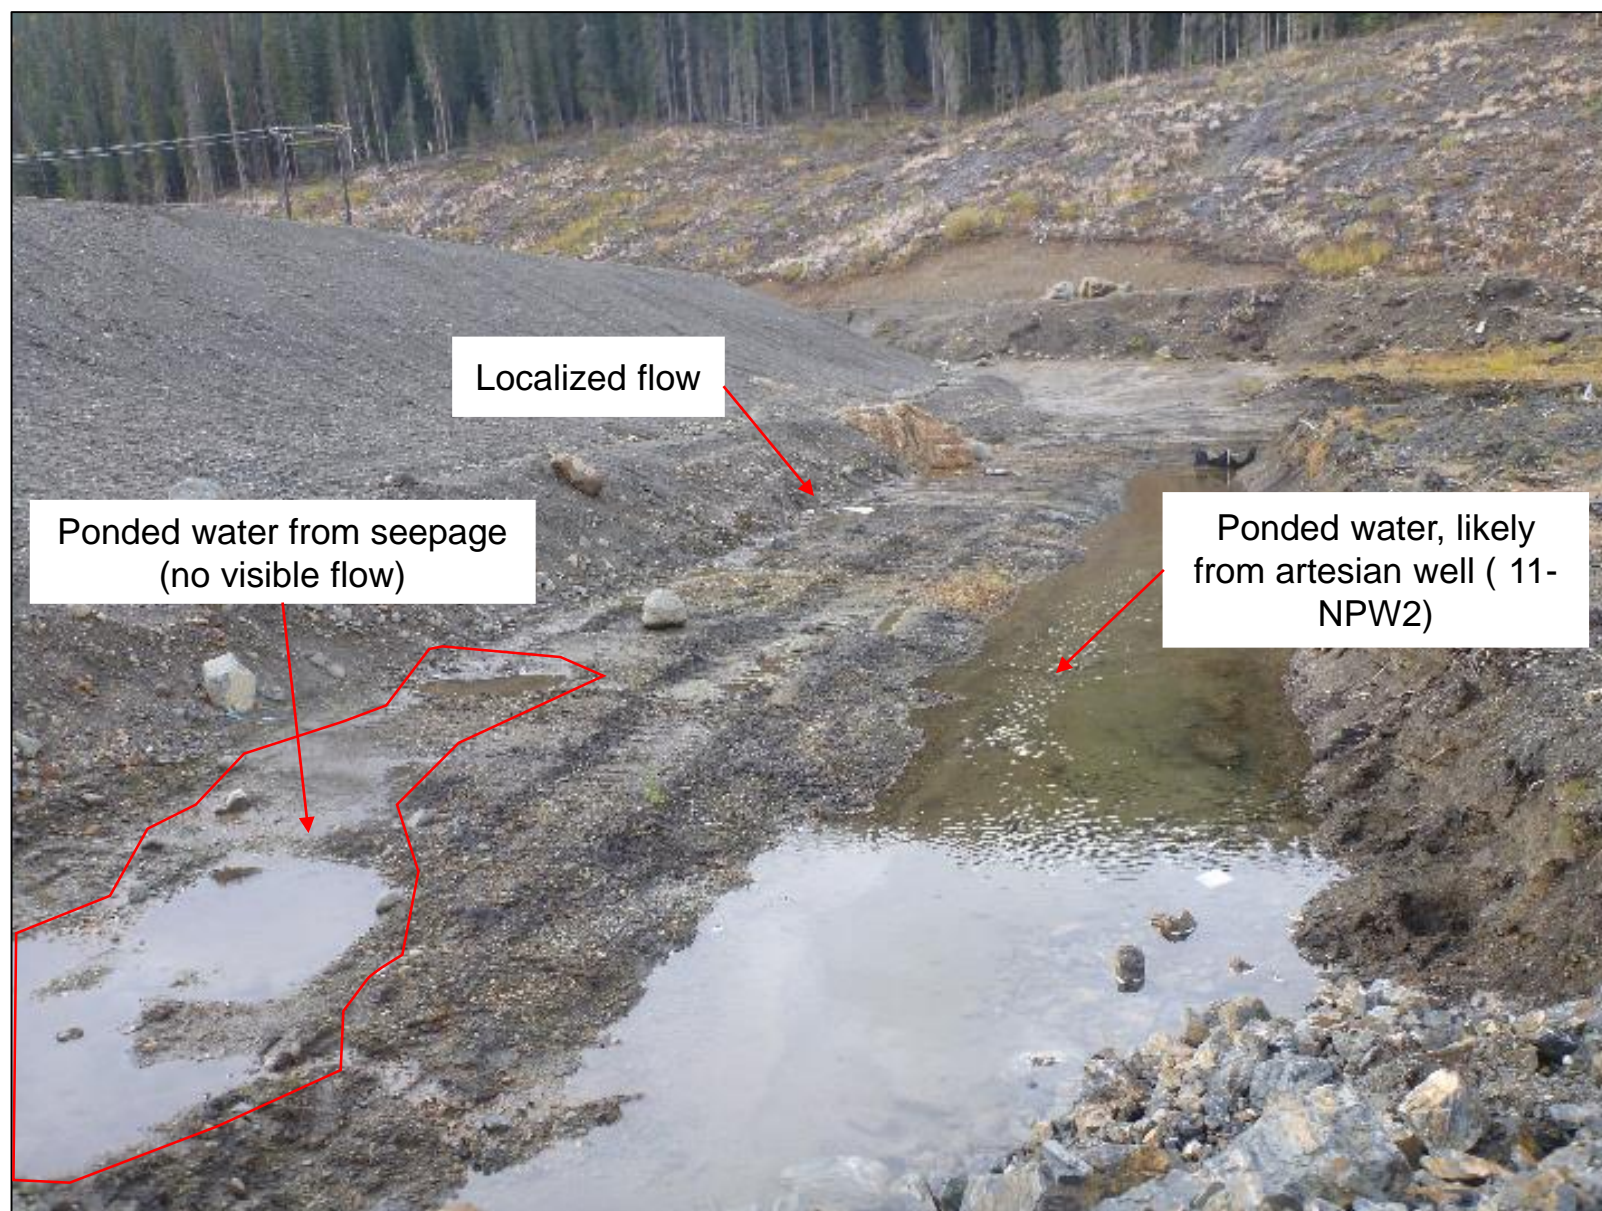
Chainage 0+250: Localized flow (~0.25 L/min) and ponded water was observed at dam toe though water flowing into pond was not observed. Photo taken west of artesian well (11-NPW2), looking west.

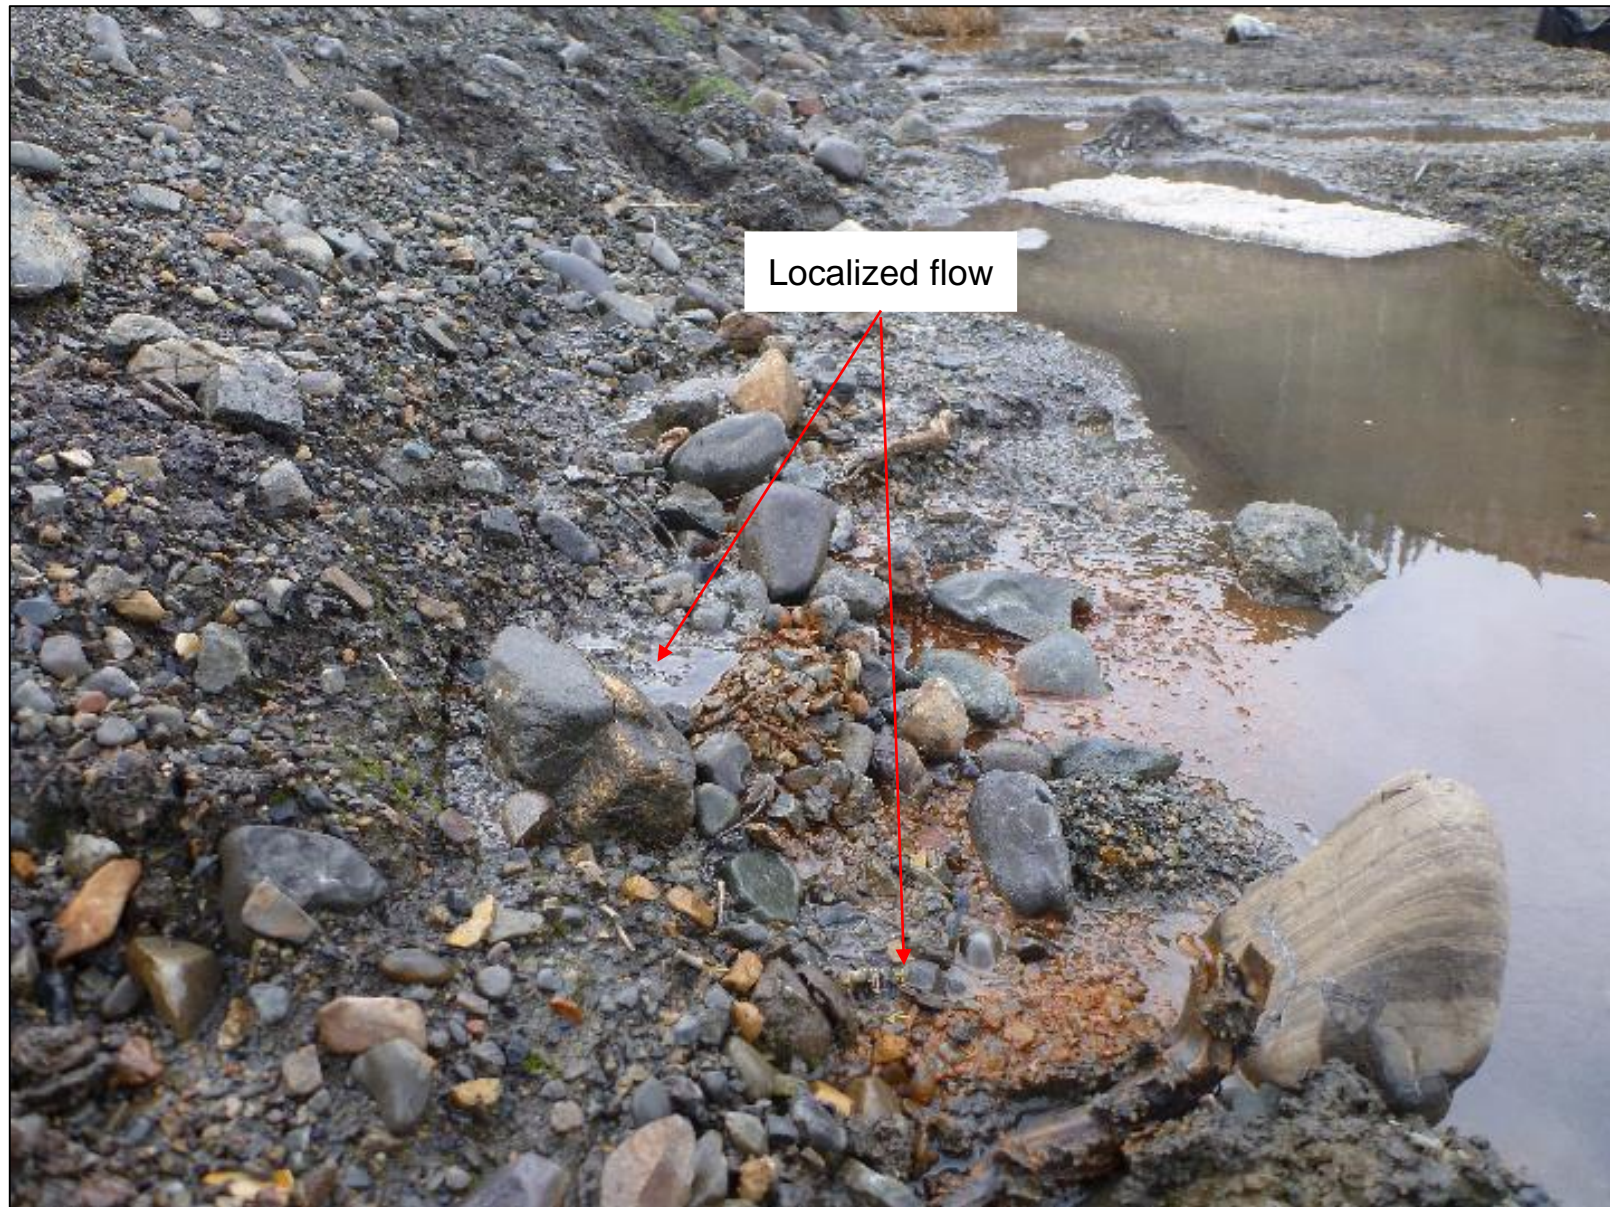
Chainage 0+250: Localized flow (~0.25 L/min), noted in Photo 4. Looking west.

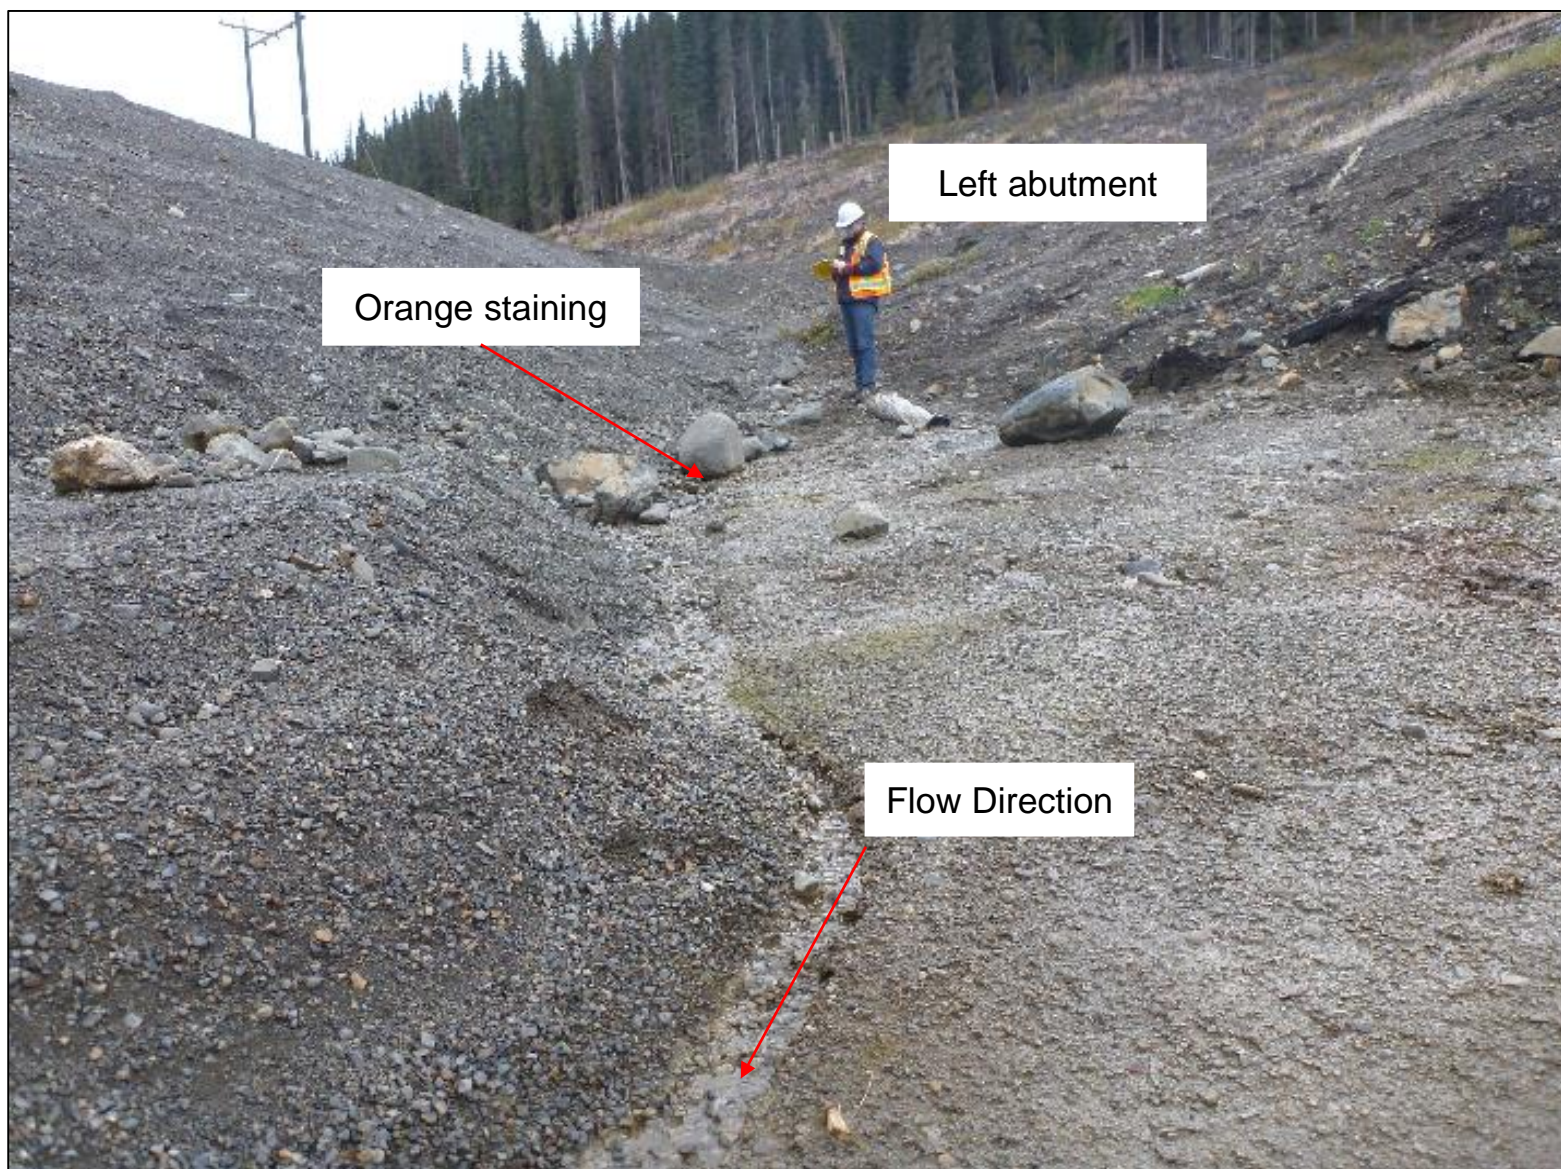
**Chainage 0+290: Seepage originating from left abutment, visibly flowing along toe for approximately 50 m. Likely some seepage contribution from toe. Water is clear. Seepage elsewhere not visibly flowing but soil is damp nearby. Orange staining in location of seepage. Looking west.**

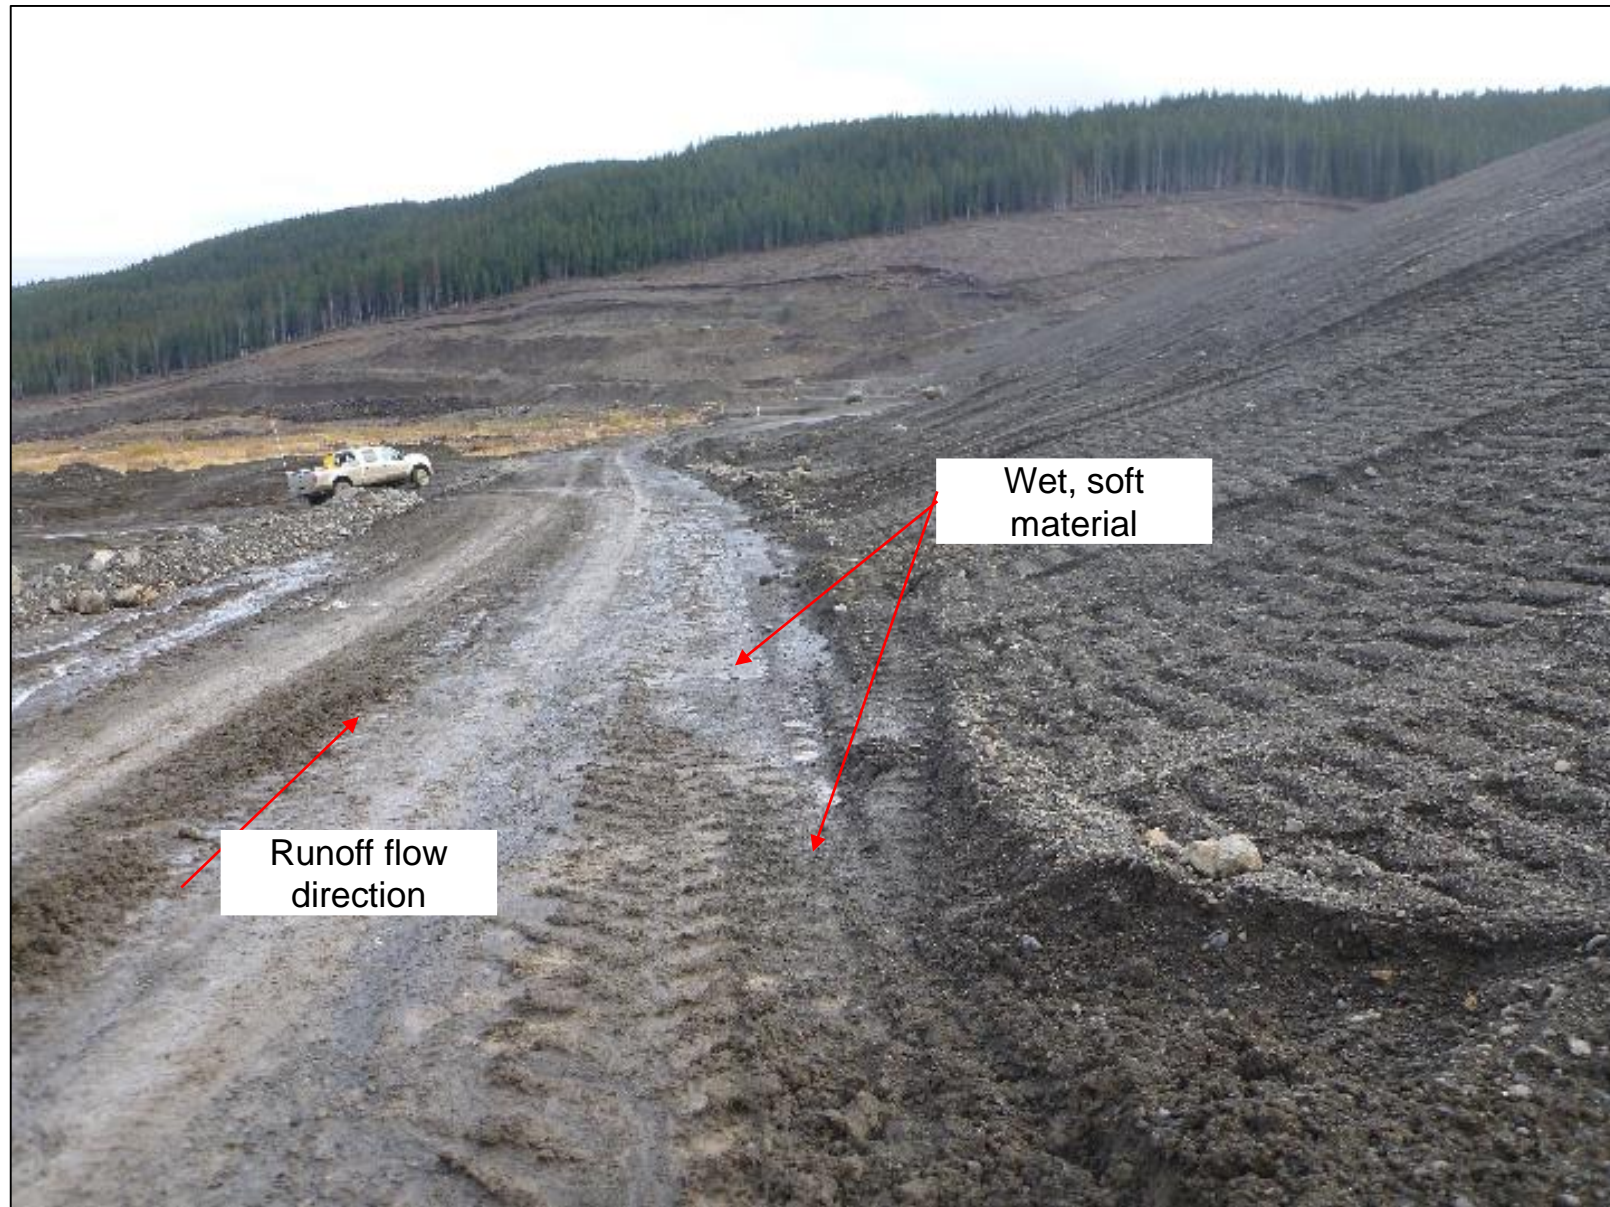
Chainage 0+472: Wet, soft material and ponding water observed at toe of dam. Runoff from access road observed on left (north).

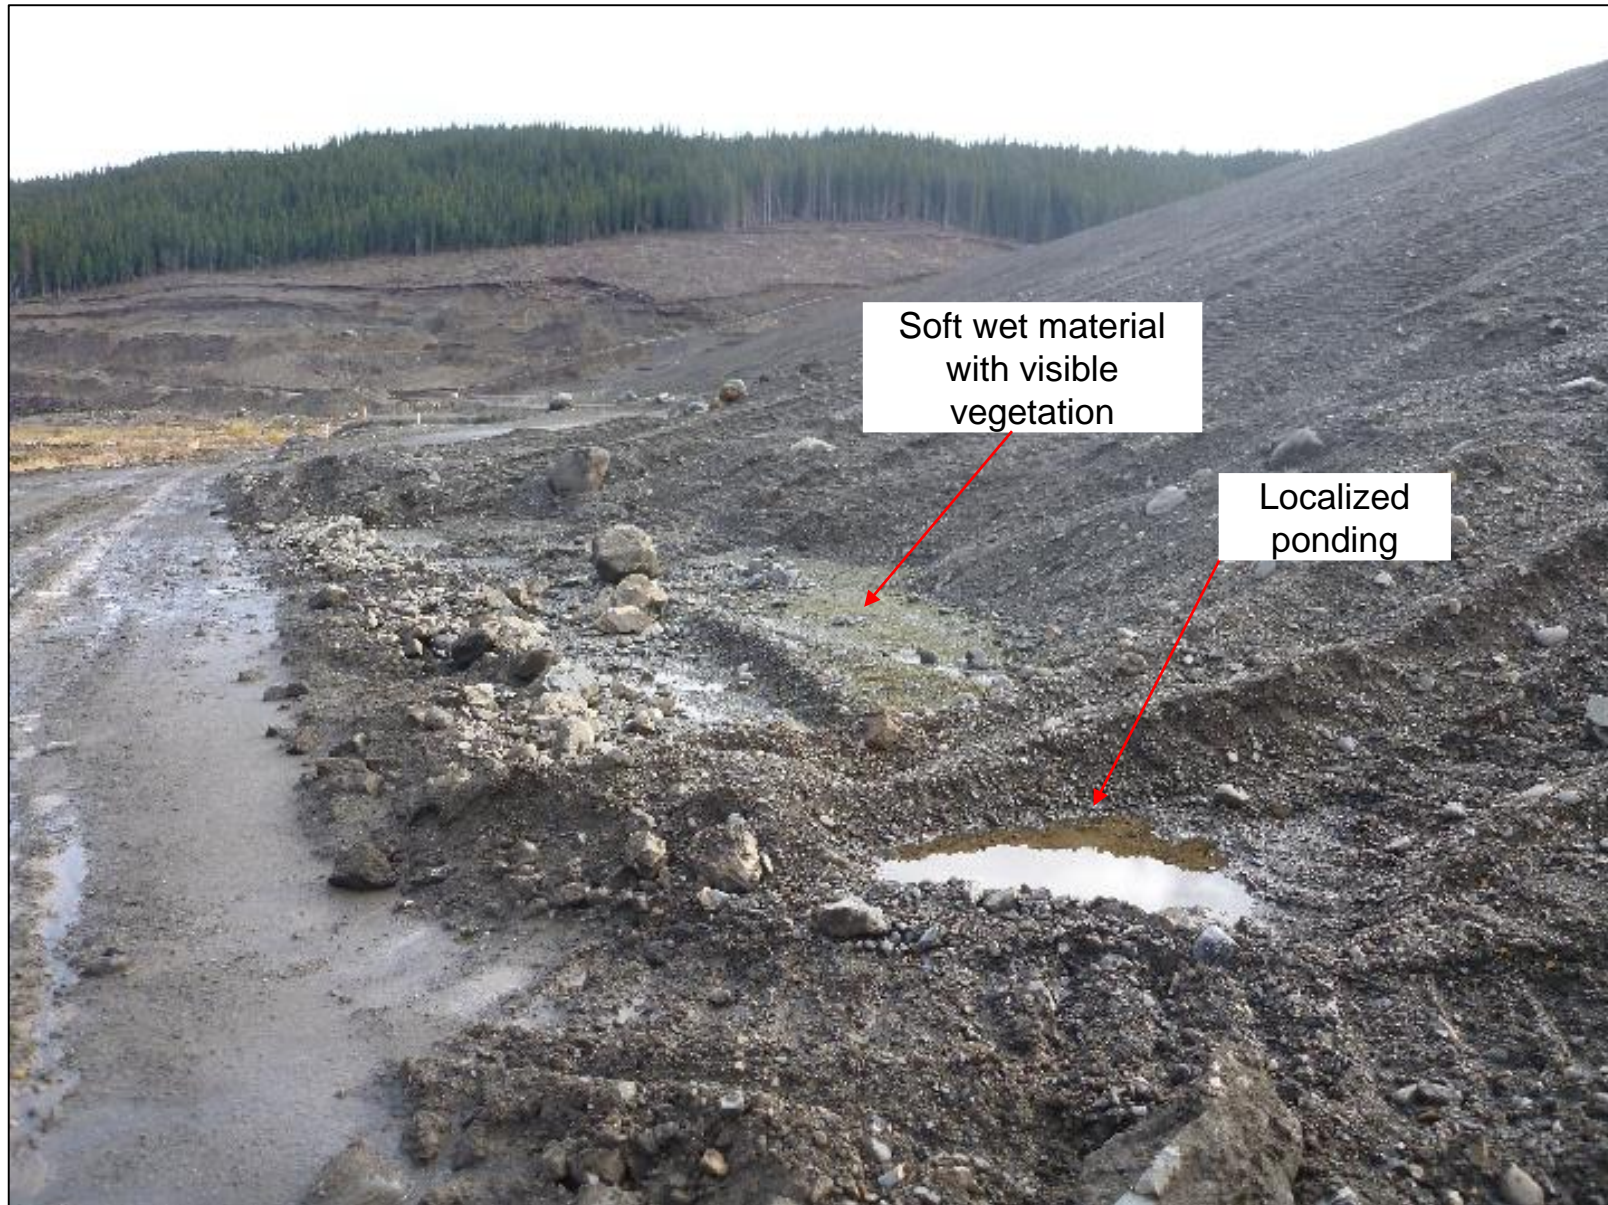
Chainage 0+470: Localized ponding and wet material at toe of NSD. No flowing water observed. Looking east.
