## **RED CHRIS DEVELOPMENT COMPANY LTD.**

### **RED CHRIS TAILINGS FACILITY**

## **2014 DAM SAFETY INSPECTION REPORT**

PROJECT NO.: 0866001.14.7  
DATE: November 24, 2014  
DOCUMENT NO.: 0866001.14.002

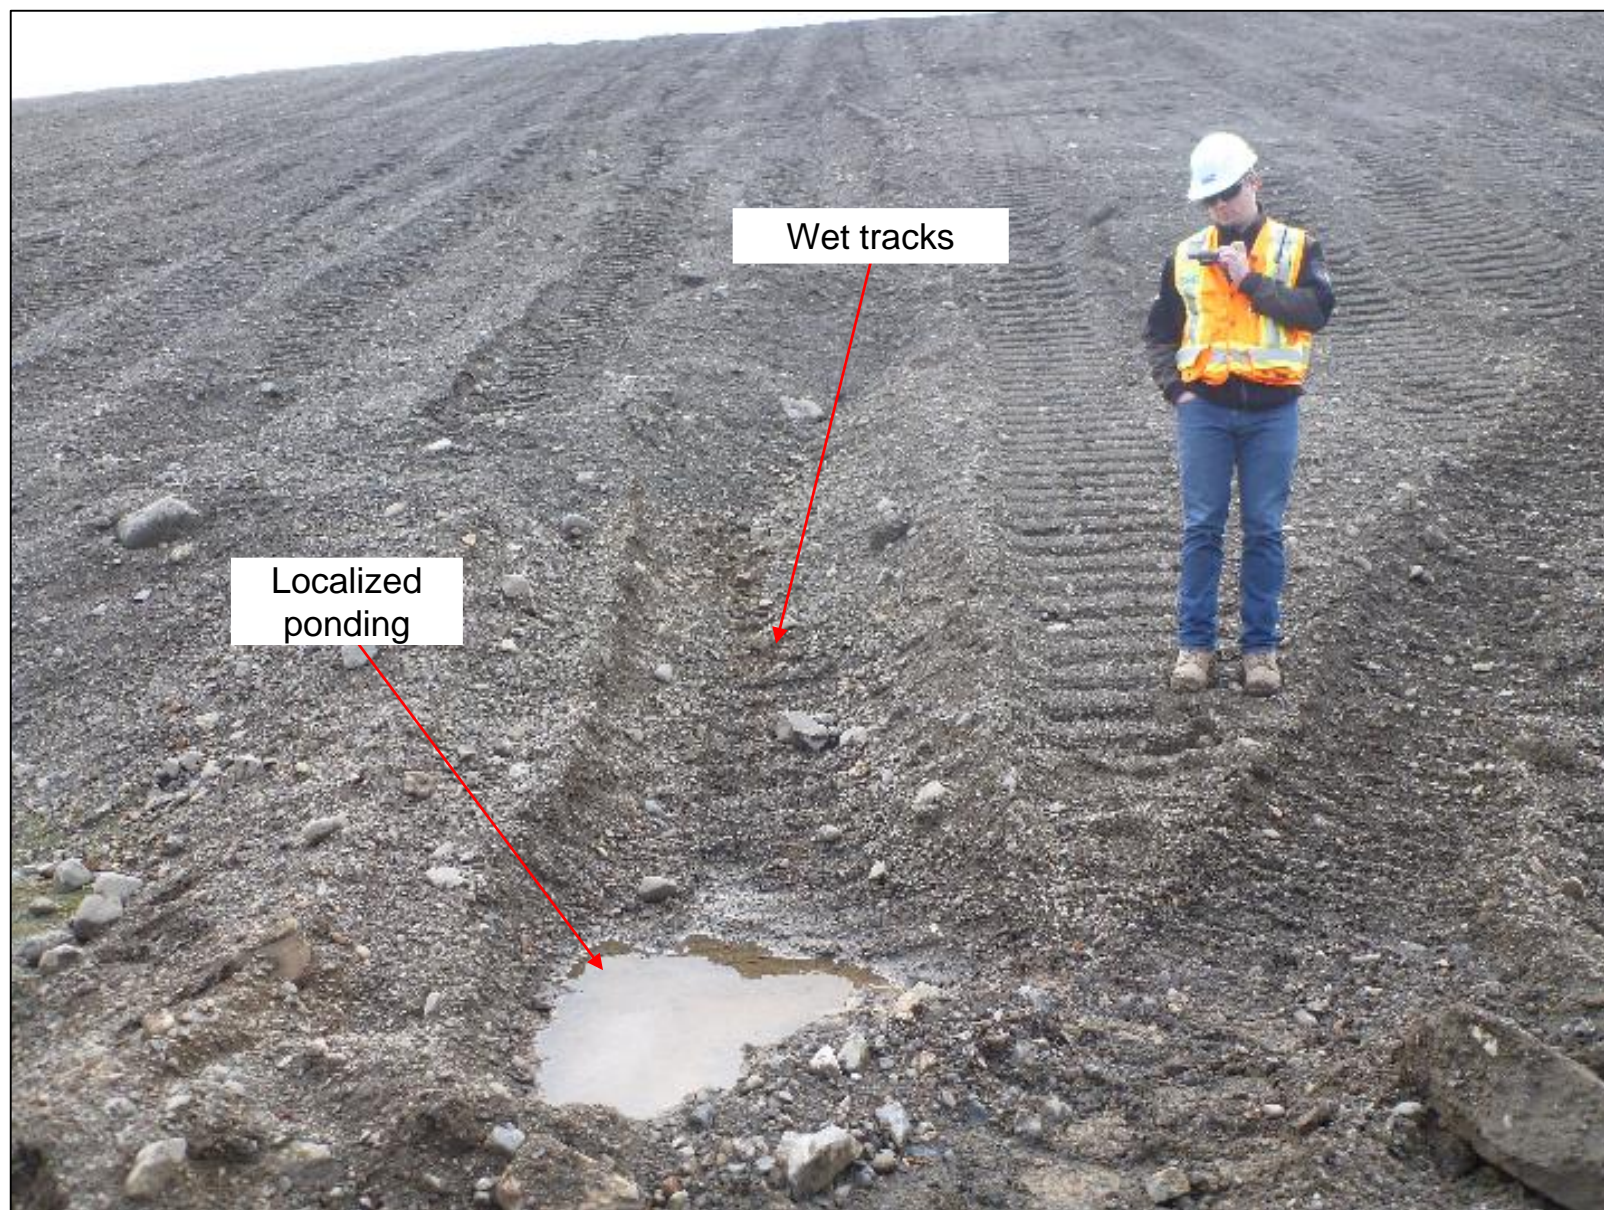
Chainage 0+470: Localized ponding (noted in Photo 2) with visibly wet track marks above. Track mark appeared wetter than others in the area. No flowing water visible. Photo taken at dam toe, looking south.

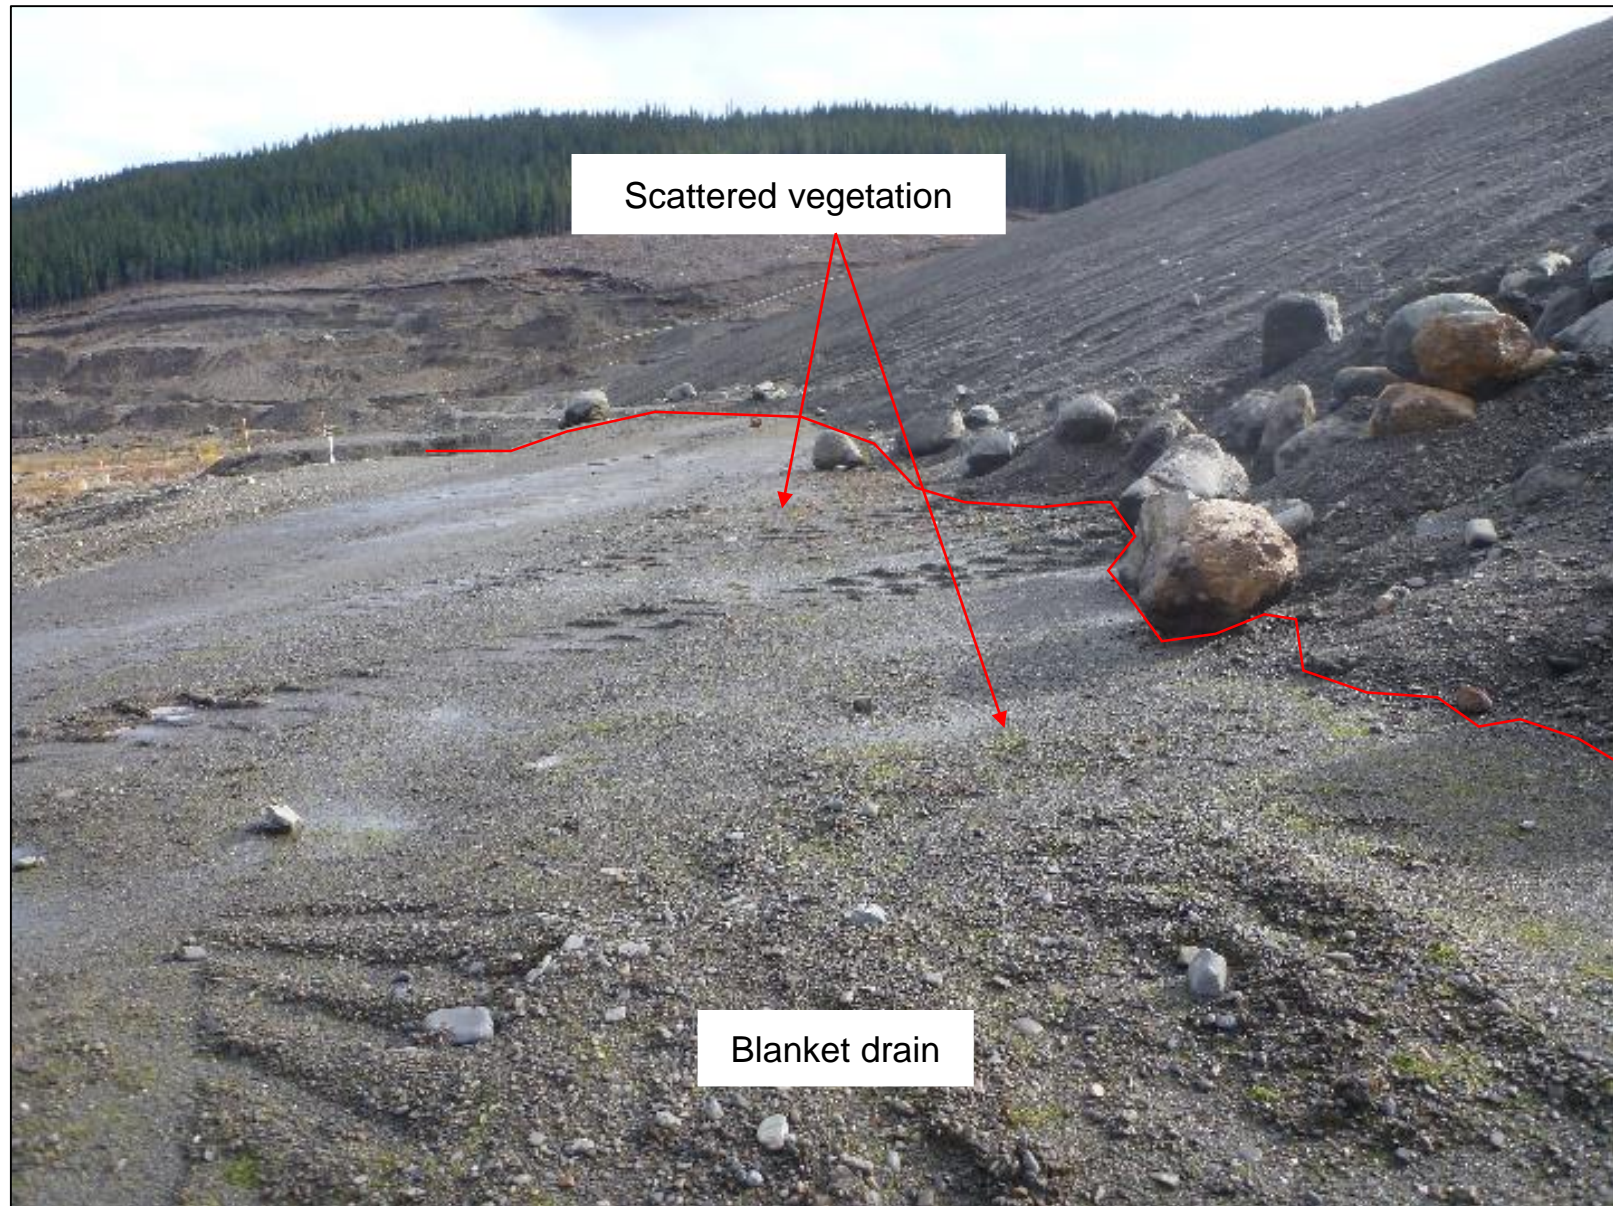
**Chainage 0+420: Blanket drain that extends beyond downstream toe appears wet on surface. Small vegetation visible. No flowing water observed. Looking east.**

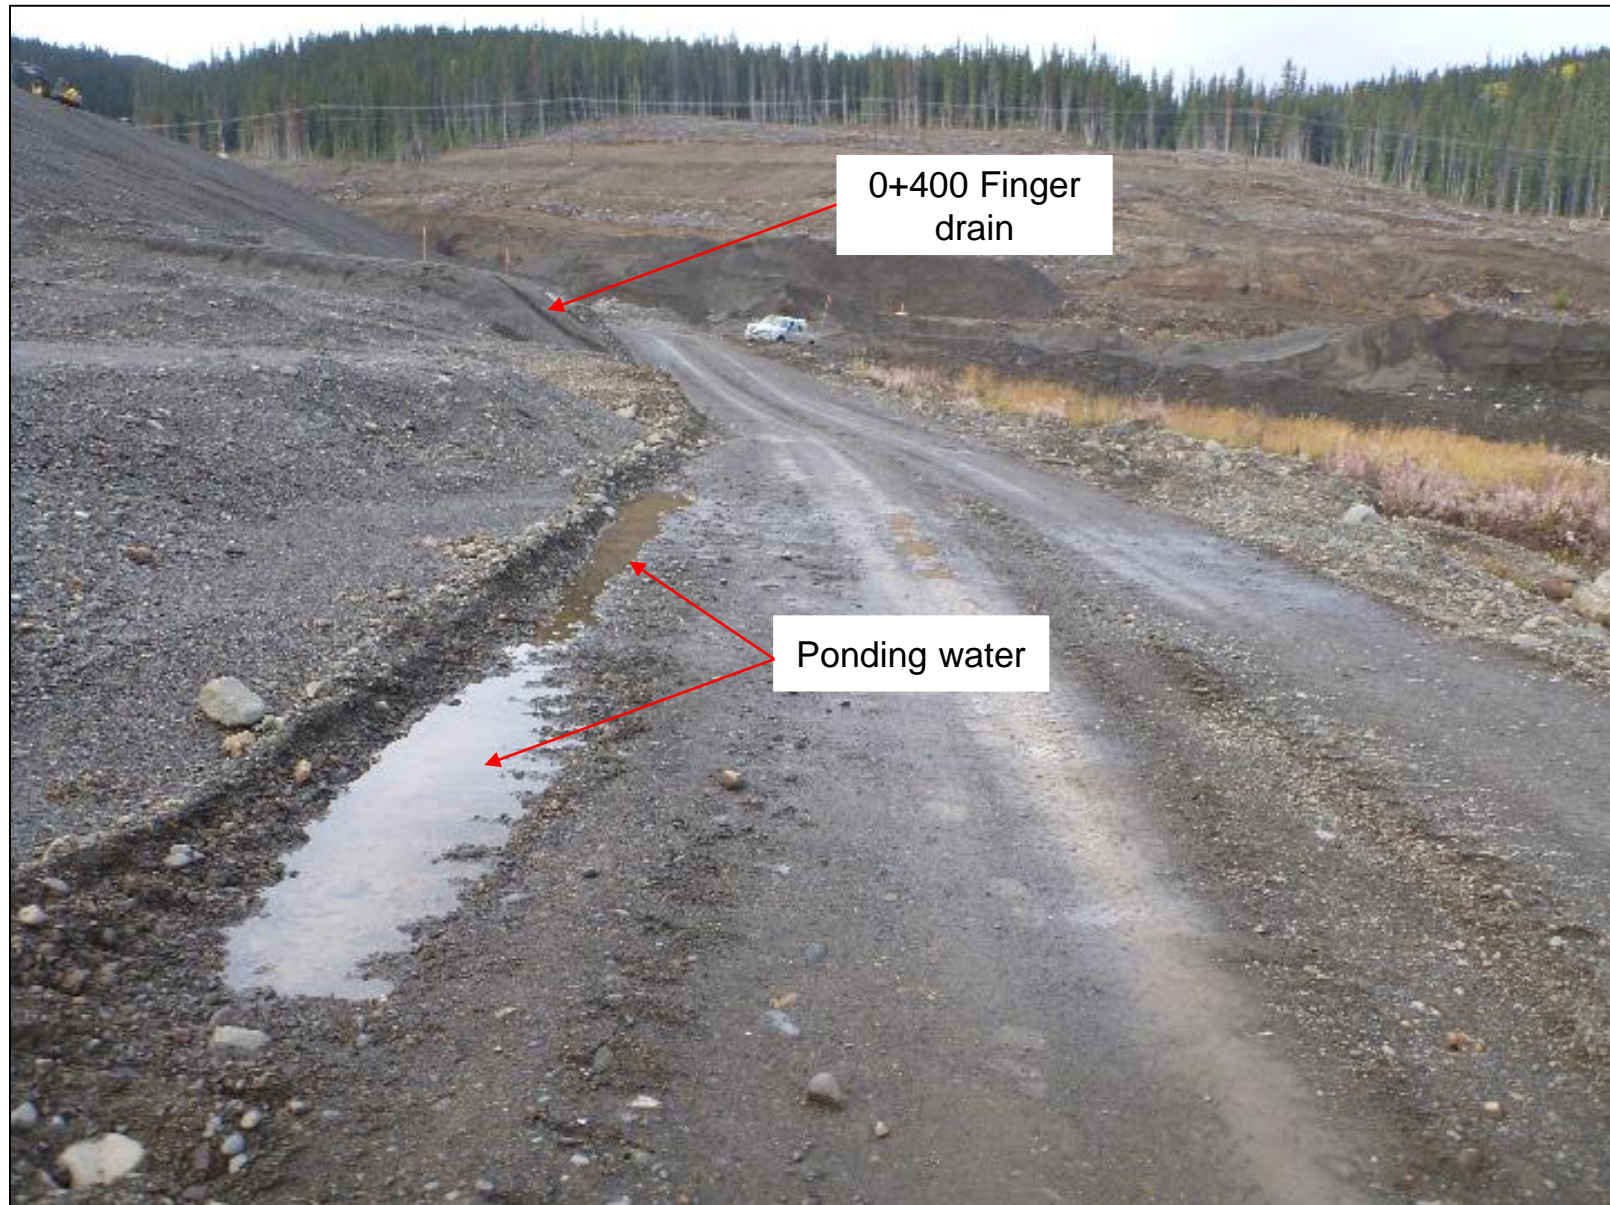
**Chainage 0+390: Ponding water at toe of NSD east of finger drain. Extends approximately 8 m along toe. No flowing water observed. Looking west.**

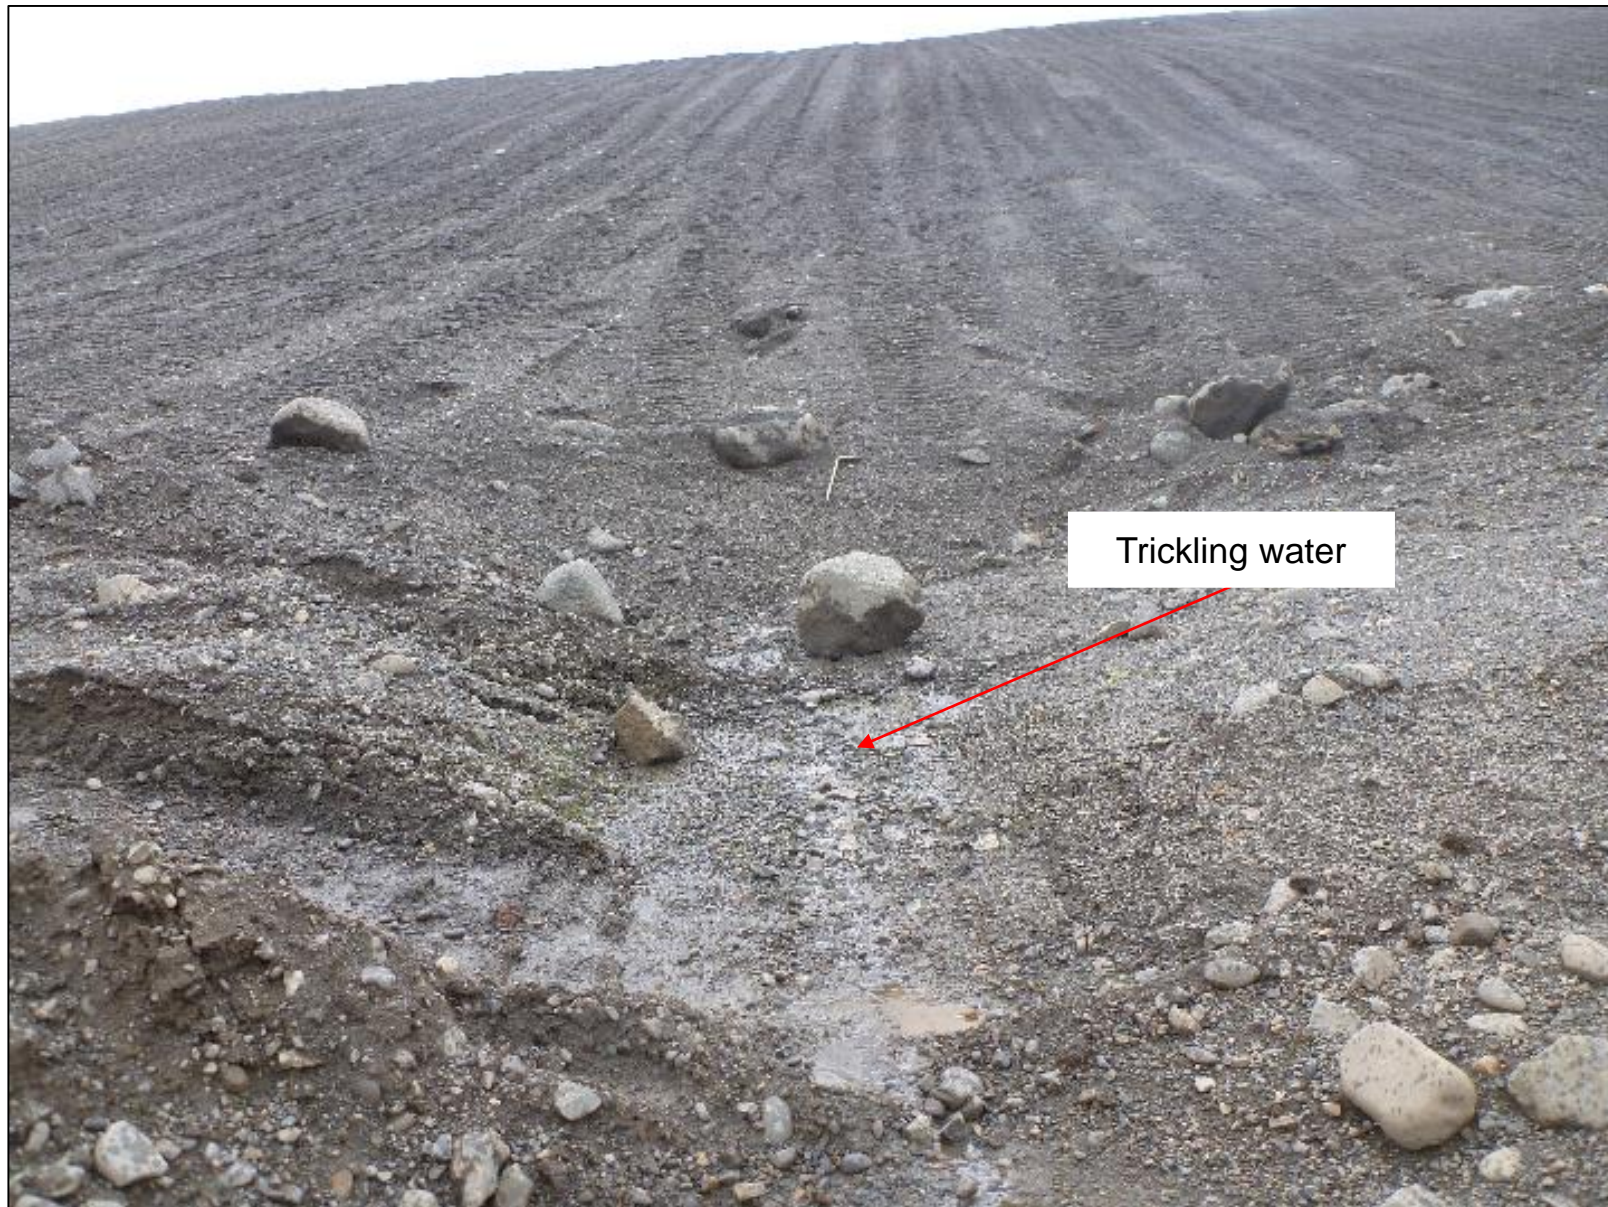
**Chainage 0+215: Trickling water noted on the blanket drain; this location is a low point on the downstream toe and blanket drain near where a natural creek flowed before dam construction. Looking south from NSD toe.**

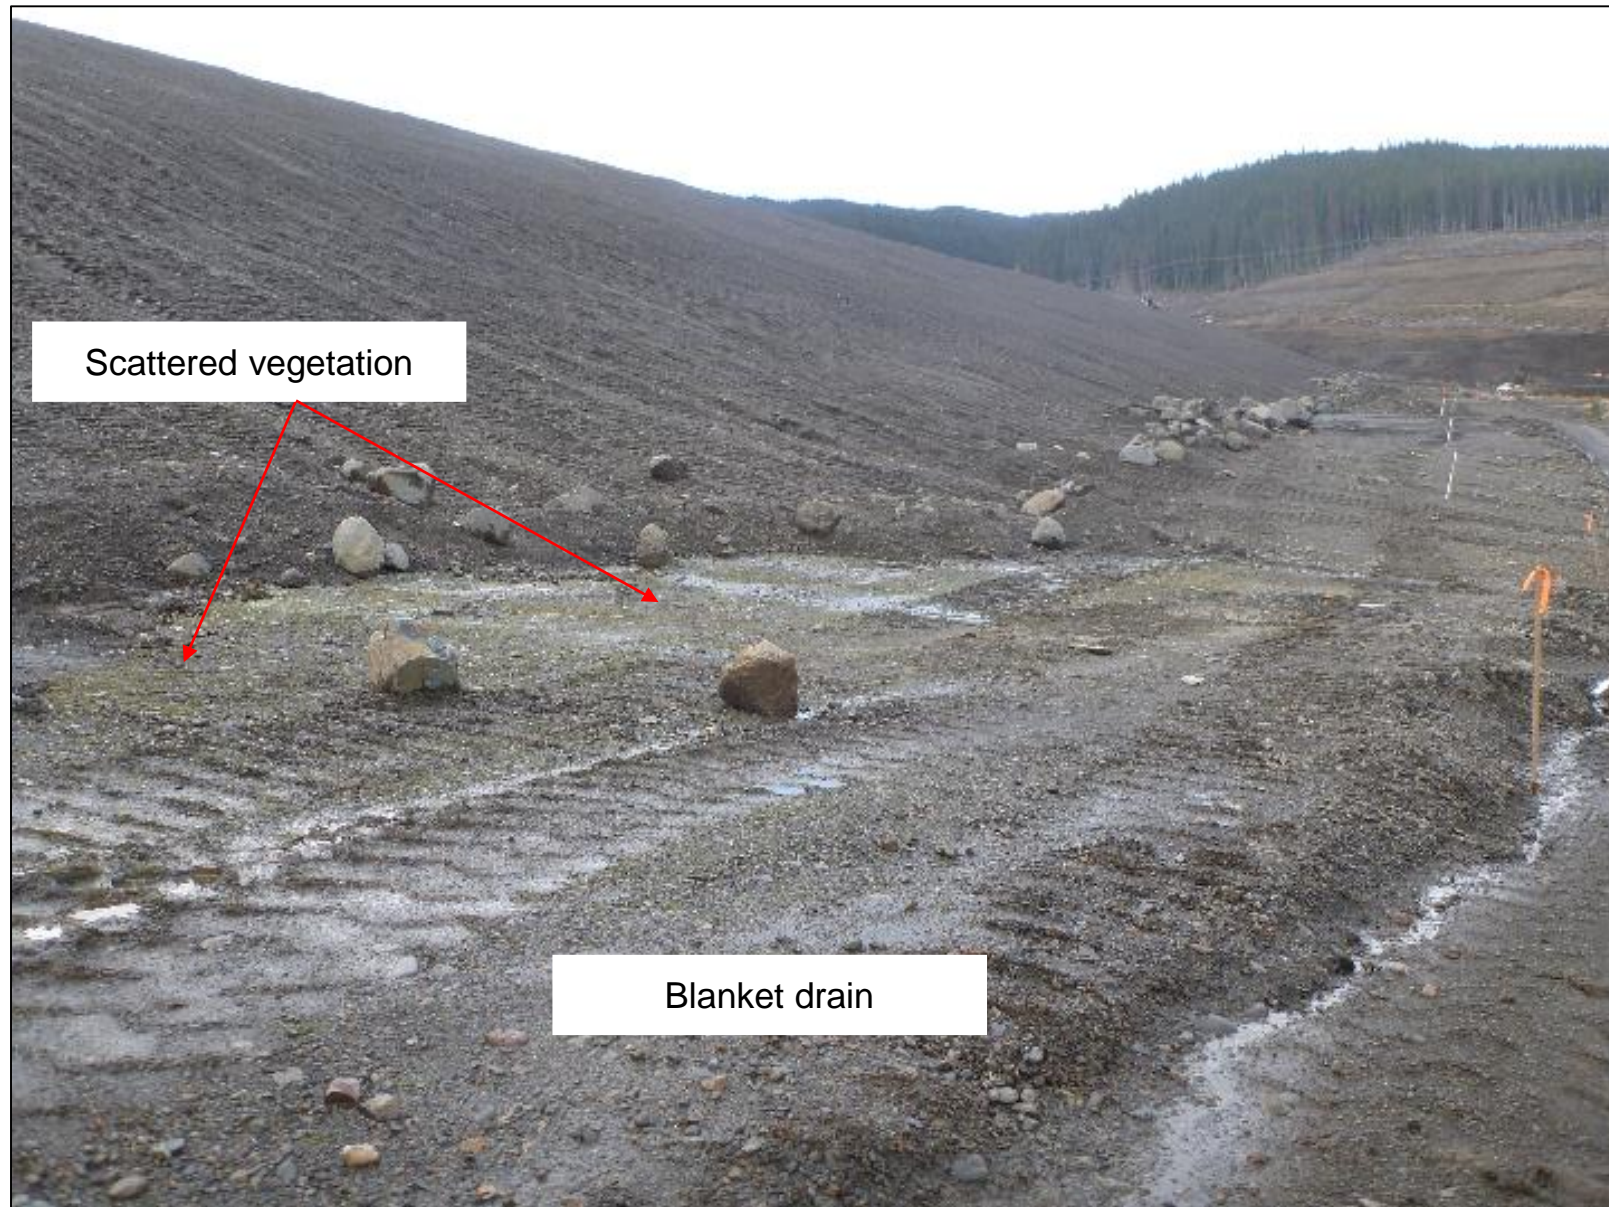
Chainage 0+200: Wet at surface where blanket drain extends beyond downstream slope. Thin layer of vegetation noted on drain surface. Looking west.

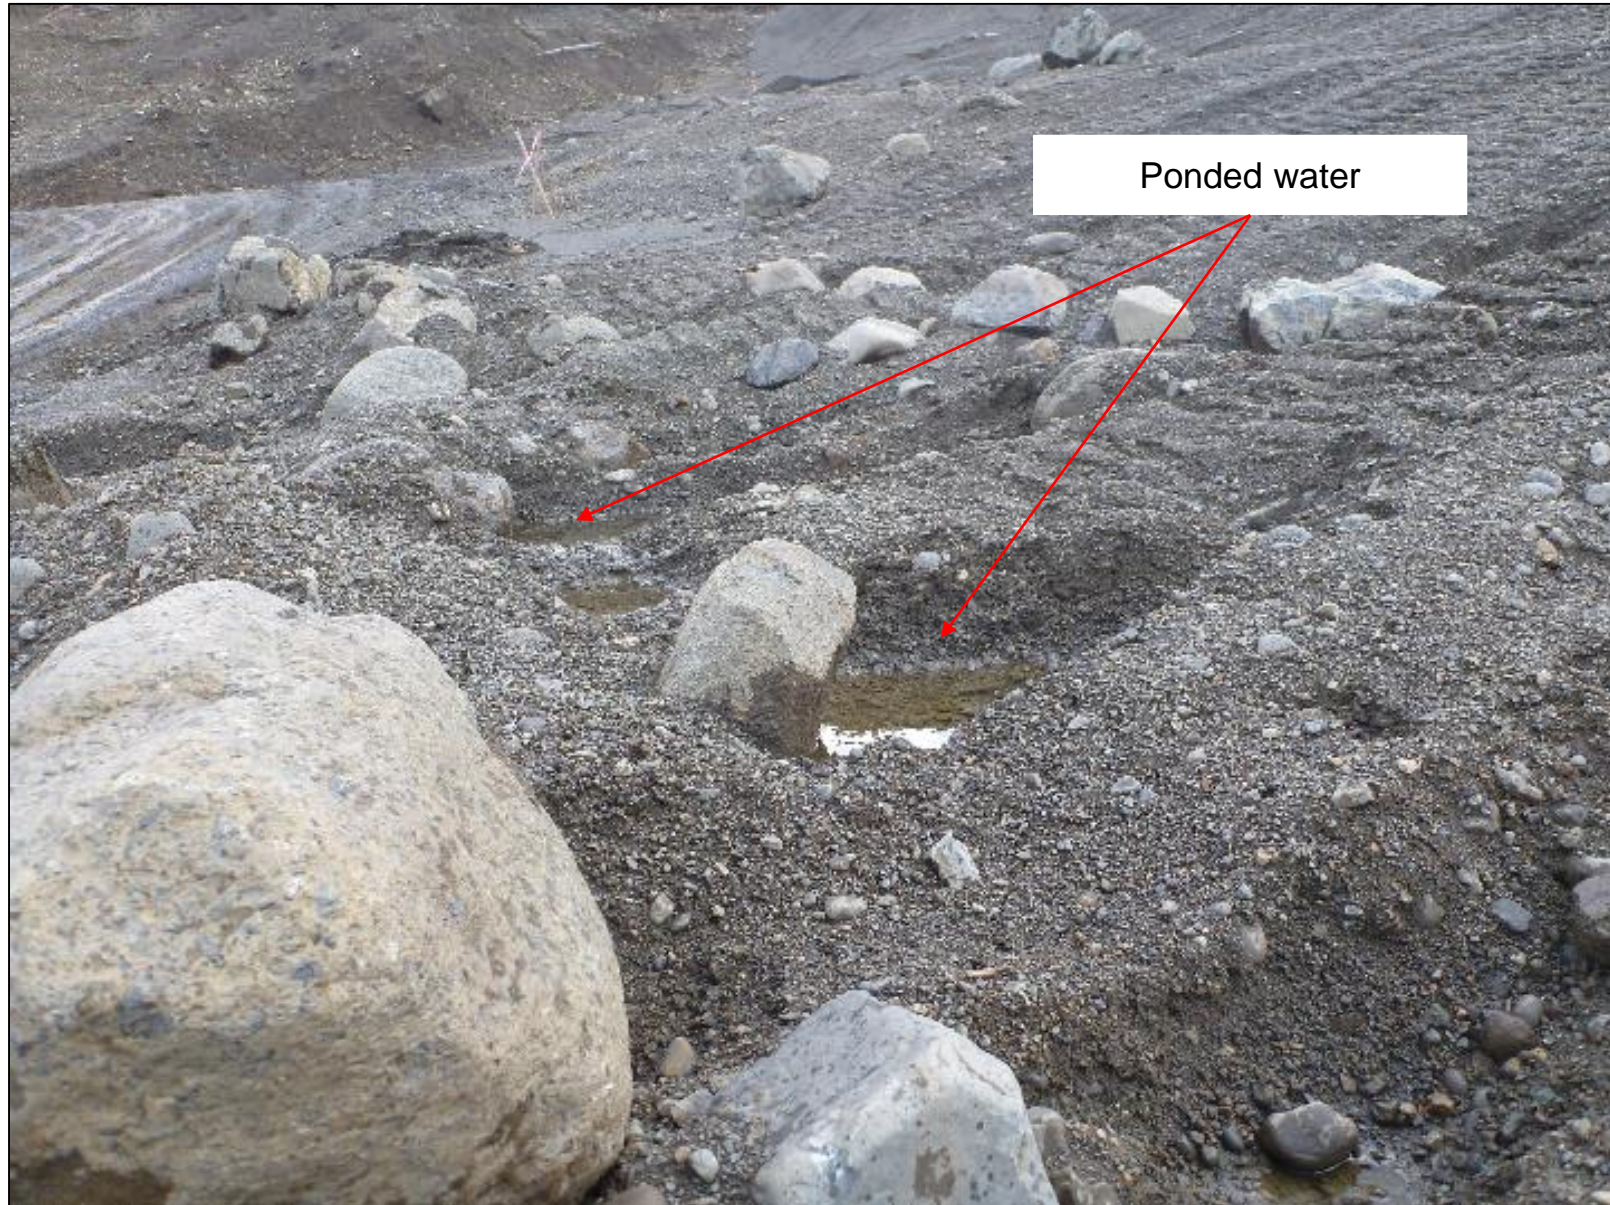
**Chainage 0+195: Ponded water observed in depressions caused by side cast rocks from the 1118 Bench above. Looking east.**

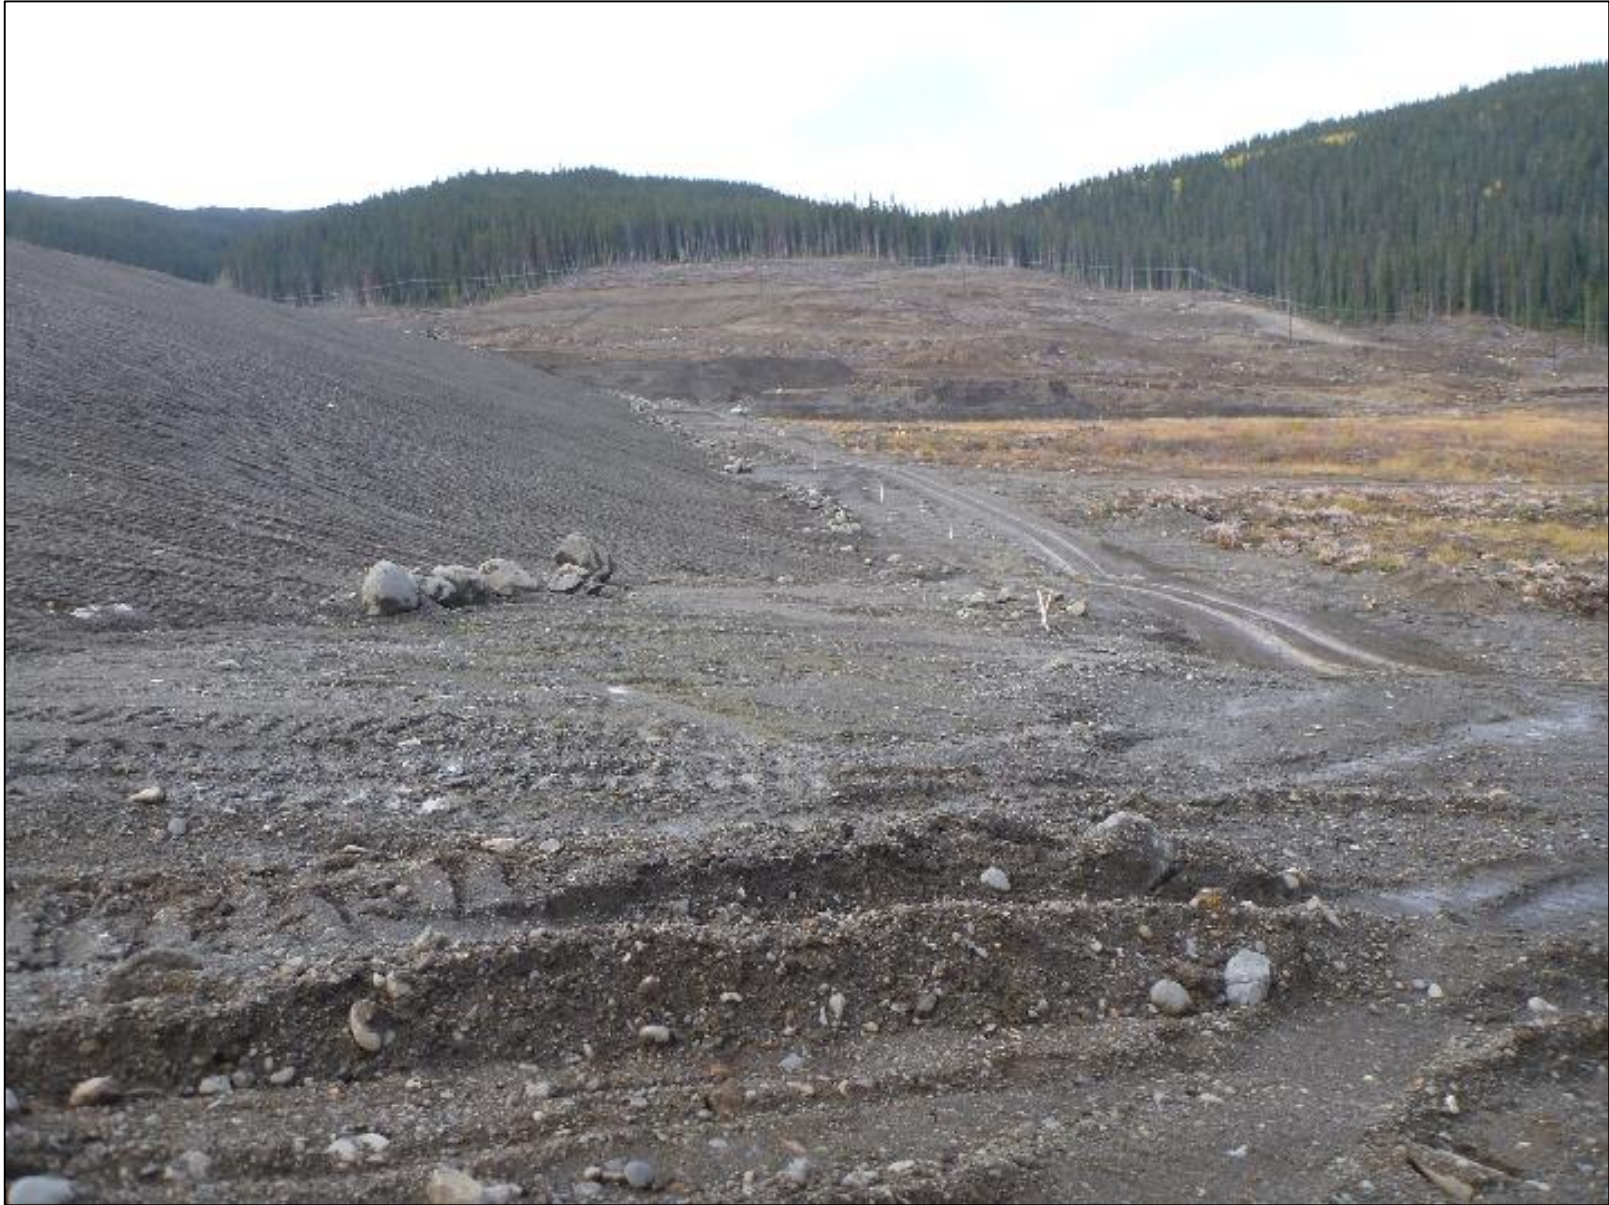
**Chainage 0+135: No seepage noted at elevations higher than this point. Ponding water observed in ruts. Looking west.**
