**PITEAU ASSOCIATES**  
GEOTECHNICAL AND  
HYDROGEOLOGICAL CONSULTANTS

Re: 2014 Tailings Dam and Impoundment Dam Safety Inspection, Samatosum Mine, Barriere, BC

FIRST QUANTUM MINERALS LTD.  
SAMATOSUM MINESITE  
2014 DAM SAFETY INSPECTION

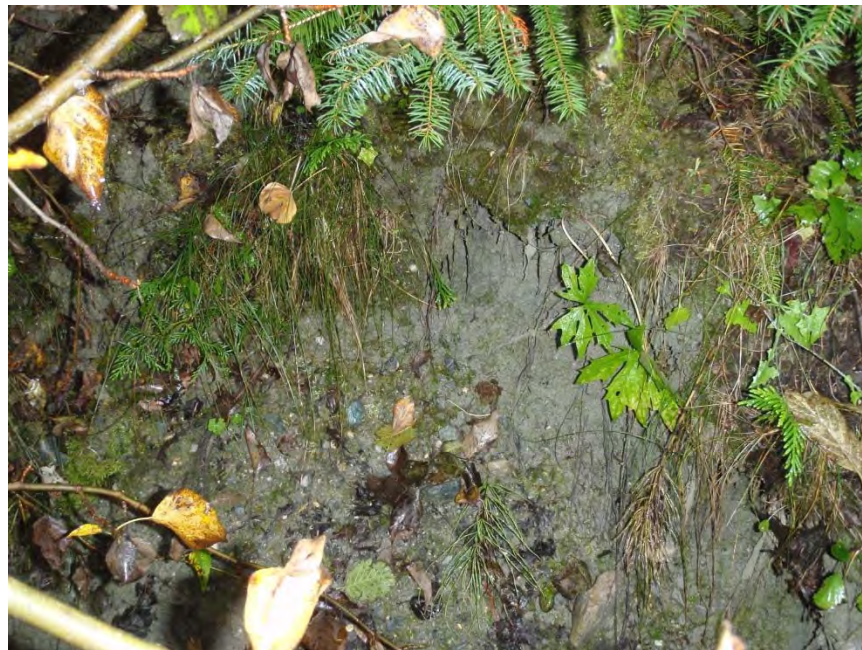
Photos 2, 3 and 4 show various views of the rediversion works. Based on our observations, it appears that the rediversion structure continues to function as designed. As noted in previous inspection reports, erosion of the stilling basin at the rediversion has occurred where a small ephemeral stream enters. As can be seen in Photo 2, dense morainal soil exposed in this area continues to erode slowly. No remedial action or maintenance of the rediversion works is considered necessary at this time.

**Photo 2.** View of minor erosion on left side of stilling basin at redirection where ephemeral stream enters. No work warranted at this time.

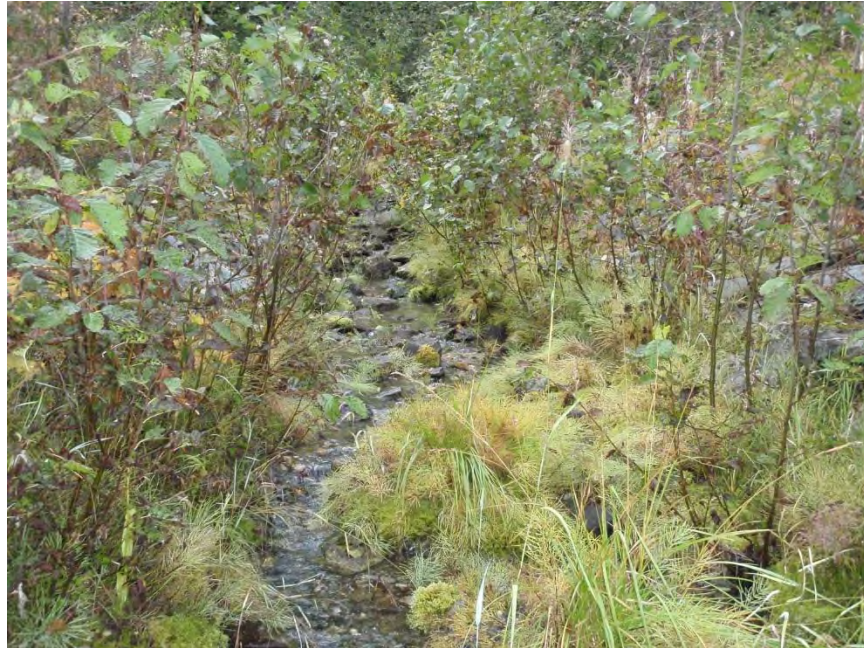
**Photo 3.** View of Diversion Segment I and main creek looking upstream from rediversion. Note alder saplings starting to encroach on channel. We understand that channels are periodically cleared of saplings as part of the routine maintenance program at Samatosum. While clearing of these saplings does not appear warranted at this time, their growth should be monitored and they should be removed before they pose a concern for development of debris jams.

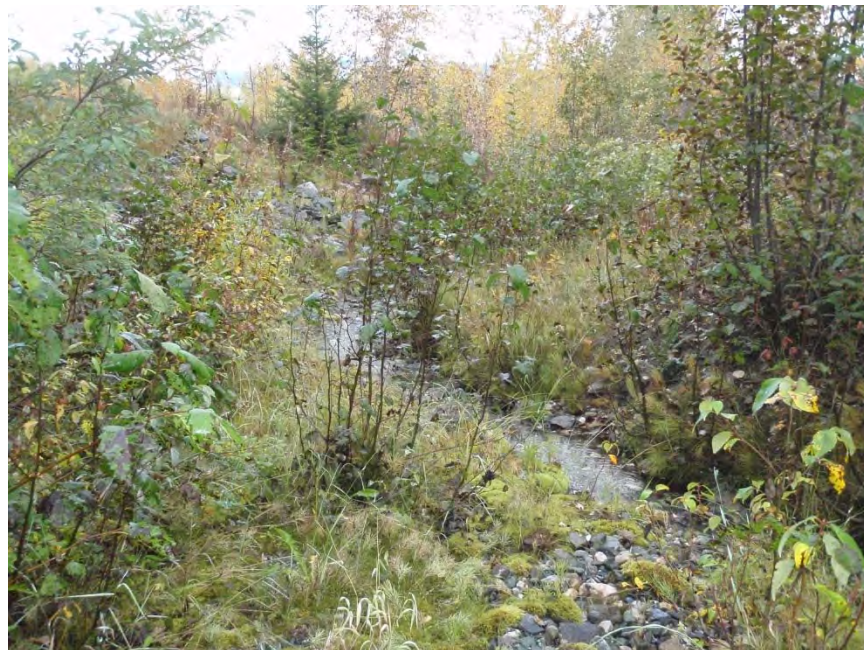
**Photo 4.** View looking downstream toward junction of diversion and rediversion. Again saplings are noted in this area, but removal of them does not appear warranted at this time.

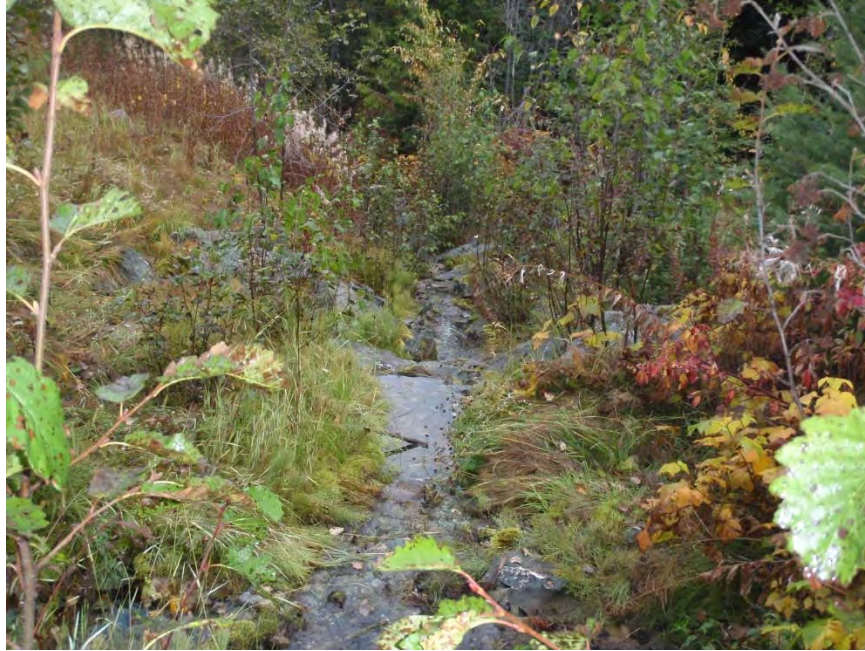
Below the redirection, the armoured portion of the redirected channel is in good condition and shows no signs of erosion or excessive accumulation of vegetation (see Photos 5 and 6).

**Photo 5.** View looking down rediversion from just above first weir below junction of diversion and rediversion.

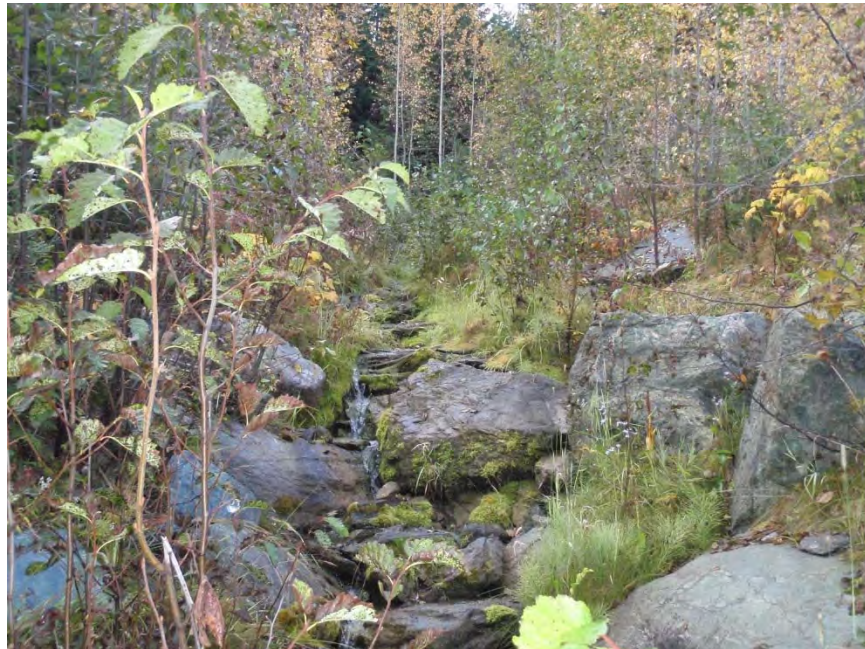
**Photo 6.** View looking upstream at armoured portion of rediverted channel.

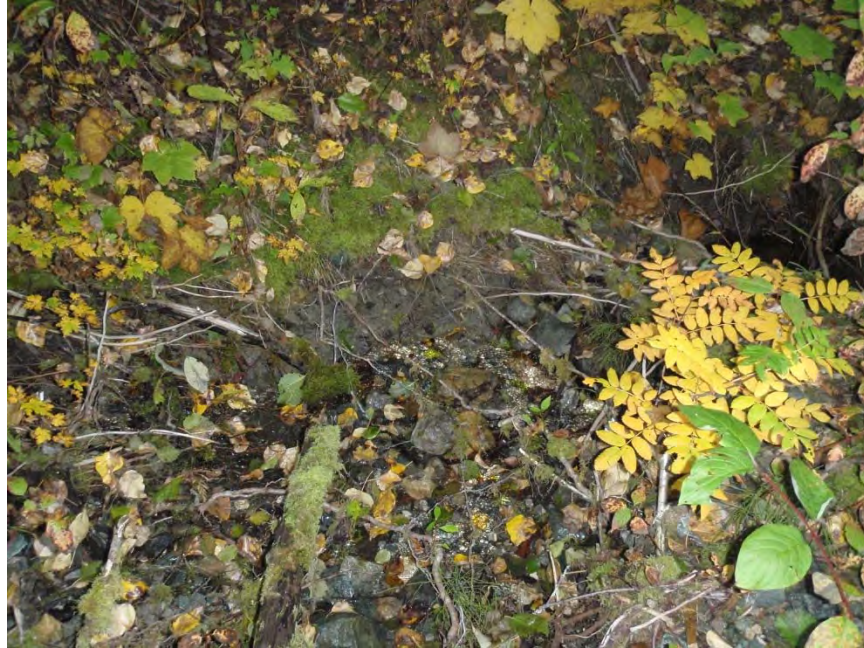
As noted during previous inspections, an area of minor channel bank erosion is located on the redirected channel approximately 25m upstream of the point where it discharges into a small embayment in the tailings impoundment (see Photo 7). At this location the left channel bank is approximately 0.8m high and appears to be stabilizing, as evidenced by vegetation growth on the exposed mineral soil.

**Photo 7.** View of minor erosion on bank of rediverted channel upstream of point where it discharges into impoundment.

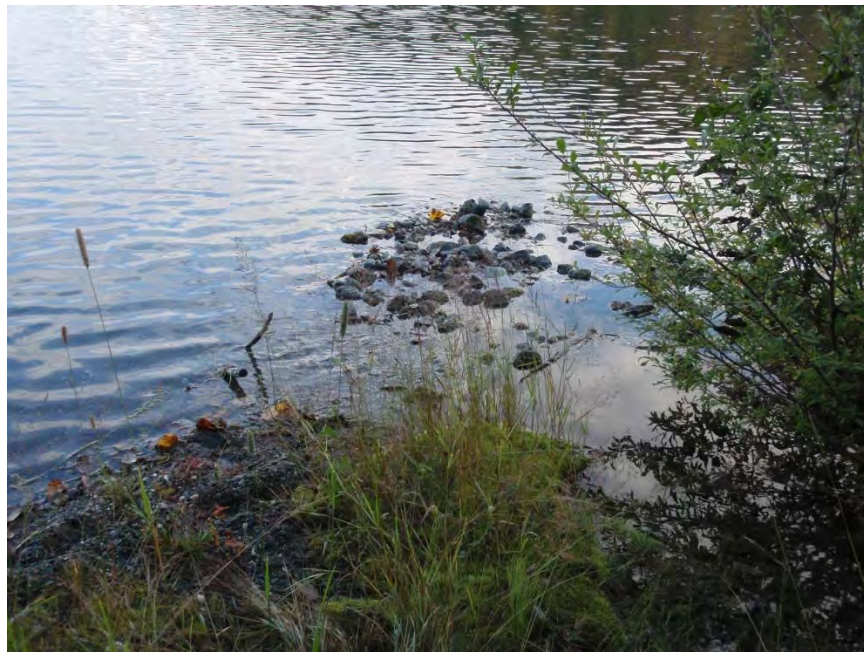
As can be seen in Photo 8 and as noted during previous inspections, a gravel deposit has developed on the bottom of the impoundment where eroded gravel from the diversion channel banks has been deposited. No channel meandering or scouring of the shoreline or submerged tailings has occurred during the current reporting period. No significant changes were noted relative to our September 2012 inspection. No remedial action or maintenance is considered necessary at this time.

**Photo 8.** View of point where rediverted channel discharges into impoundment. Note gravel deposited in impoundment, likely from erosion of the channel banks upstream. No significant change since previous inspection.

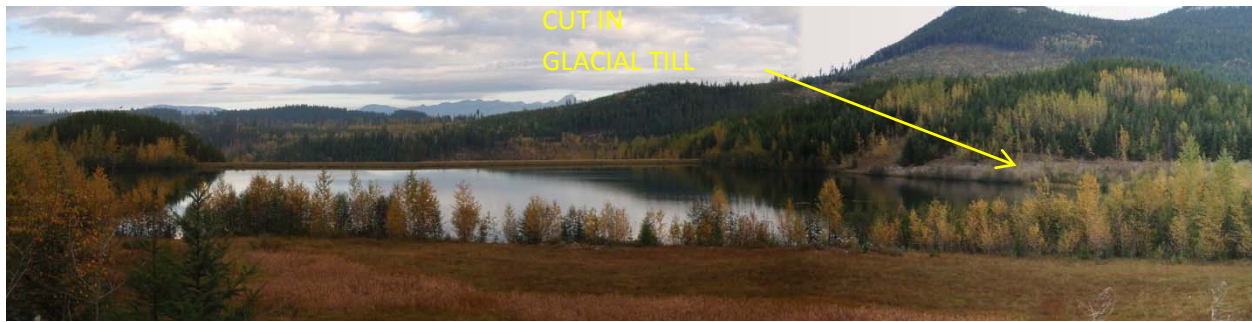
Visible on the right in Photo 9, is an area of exposed glacial till on the northwest shore of the impoundment that corresponds to an old road cut. No evidence of significant slumping or major erosional scars is visible, but minor erosional rills are evident. No remedial work is considered warranted in this area.

**Photo 9.** View of tailings storage facility from the point where redirection discharges into impoundment. Note exposed glacial till on the northwest shore on the right side of the photo. No evidence of instability or significant erosion. No work warranted at this time.

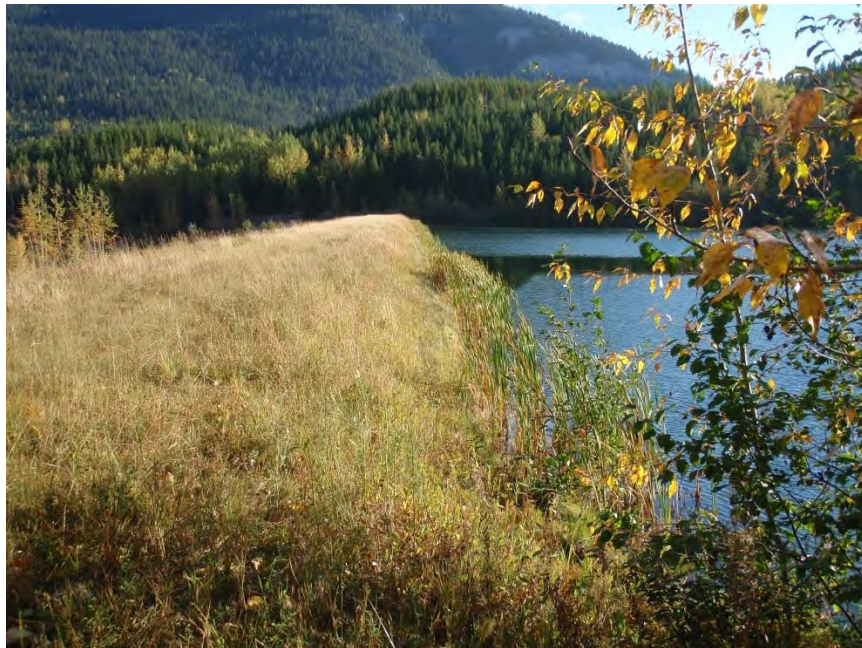
As can be seen in Photo 10, vegetation, primarily grasses, is well established on the upstream face of the embankment. Vegetation, primarily grasses and clover, also appears to be well established on the crest and downstream face of the embankment, and continues to be effective in preventing surface erosion (see Photos 11 and 12). Small shrubs up to about 0.7m high are also becoming established on the downstream face of the embankment, and also aid in stabilizing the surficial soils and preventing erosion. However, trees growing on the embankment are not desirable due to the potential for windfall and subsequent erosion when the trees mature. Trees growing on the embankment

As noted during previous inspections, sections of the upstream face of the tailings dam have been undercut at the waterline by wave erosion. In these areas, as much as 40 cm of undercutting was measured at the time of the inspection. While the rushes and sedges previously planted along the upstream face at the waterline (see Photo 10) significantly reduce the potential for wave erosion, it is recommended that the amount of undercutting be monitored to confirm that the problem is not worsening. To this end, we understand that Samatosum has established two monitoring points along the upstream face where undercutting is monitored. However, it is recommended that three or four more monitoring points be added to the two existing ones and these should be marked in the field where reliable measurements of the amount of undercutting can be made on a periodic basis, such that any increase in the rate of erosion over time can be identified.

**Photo 10.** View of upstream face of tailings dam. Eroded and undercut portion at waterline shows no significant change since the last inspection. Note cattails planted along the waterline to help reduce wave action erosion of the upstream face.

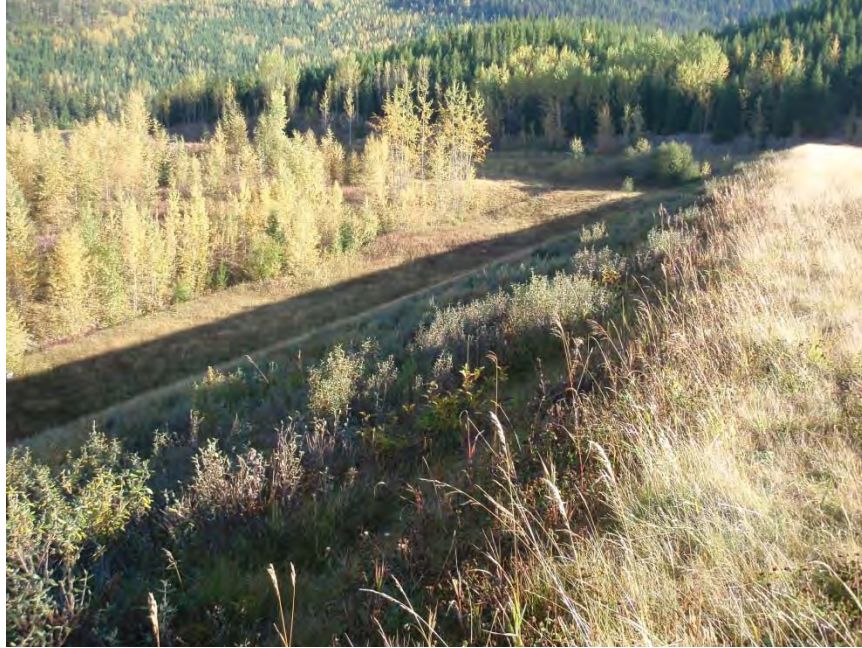
**Photo 11.** View looking along downstream crest and downstream face from the left abutment towards the right abutment. Note the Buffalo Berry bushes on the face. As noted during past inspections, these shrubs pose a limited risk and do not impede the ability to conduct a visual inspection of the dam. No work warranted.

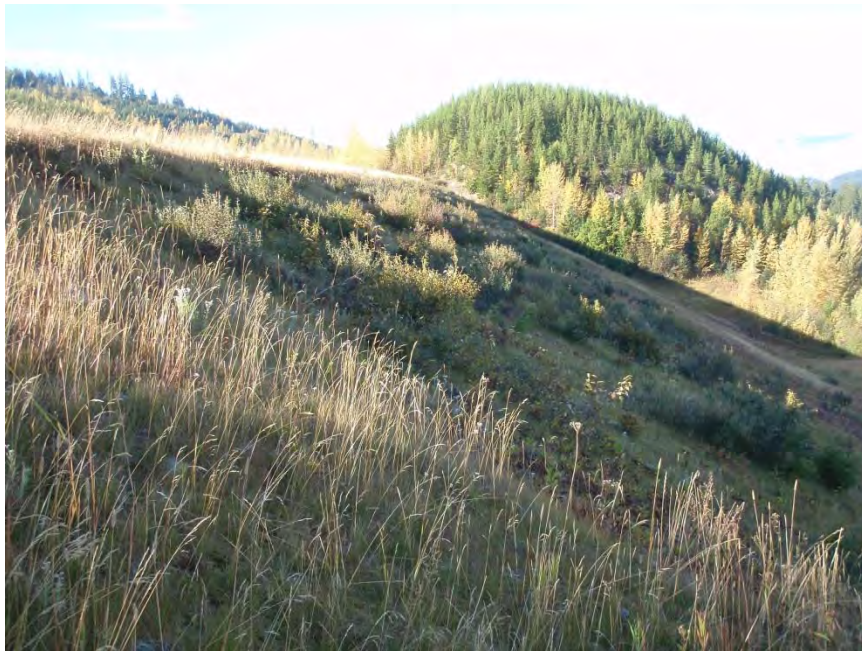
**Photo 12.** View looking along downstream face of tailings dam from the right abutment.

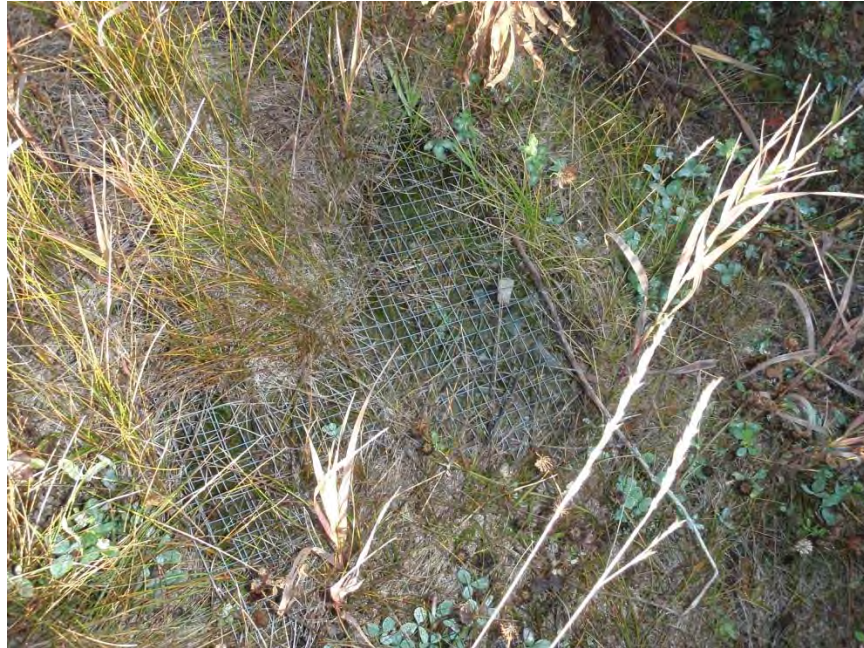
Several gopher holes were evident in the downstream face at the time of the inspection. Based on the number of active gopher burrows, the gopher population appears to be somewhat lower than noted during previous inspections. The burrows at the downstream toe of the dam are concentrated in the drainage blanket, and are presumably above the zone of saturation. Based on an inspection of several of the burrows conducted by Samatosum in April 2004 and June 2006, we understand that burrow run lengths are up to about 3.5m and extend only as deep as 0.7m below the surface of the embankment face. The effect of the burrows on the stability of the dam is presently considered to be negligible. However, continued burrowing near the waterline on the upstream face could increase the risk of local piping and erosion. As per the action plan noted in the 2006 Geotechnical Site Inspection report, the installation of a galvanized mesh on the upstream and downstream faces has been completed to help restrict gopher activity in these areas (see Photo 13).

**Photo 13.** View of a portion of the galvanized mesh placed on upstream and downstream crest to help prevent gophers from burrowing into dam.

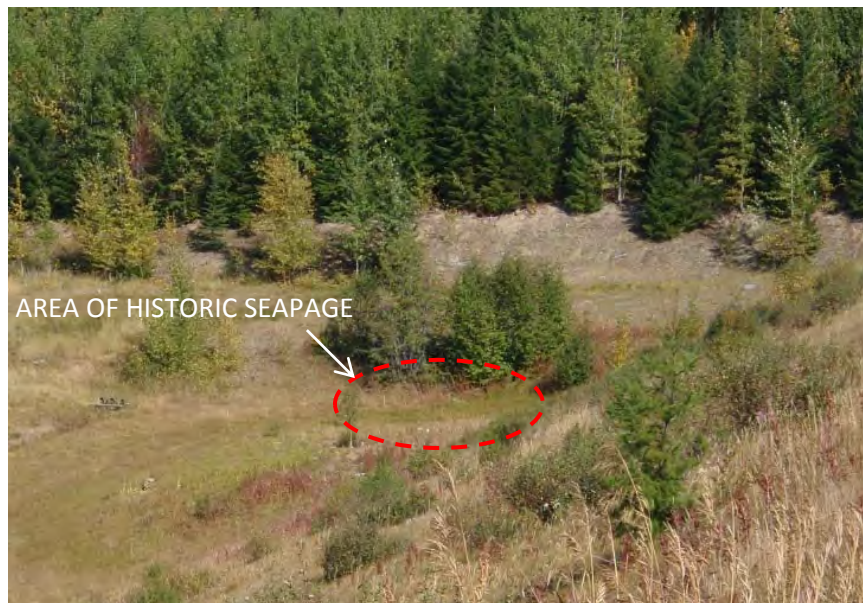
As in past years, soft/wet conditions were noted in the vicinity of rutting on the right abutment (Photo 14). Similarly, greener vegetation is evident on the left abutment and in the low area below the downstream toe of the main embankment (see Photo 15). Minor surface seepage and ponding of water in this area was noted during the inspection. The quantity of water discharging from the toe drain is very minor and within the range of design predictions. No indicators of potential instability, such as seepage above the toe or tension cracks, were noted on the downstream face of the embankment.

**Photo 14.** View of area of historic seepage and rutting on right abutment. No work warranted.

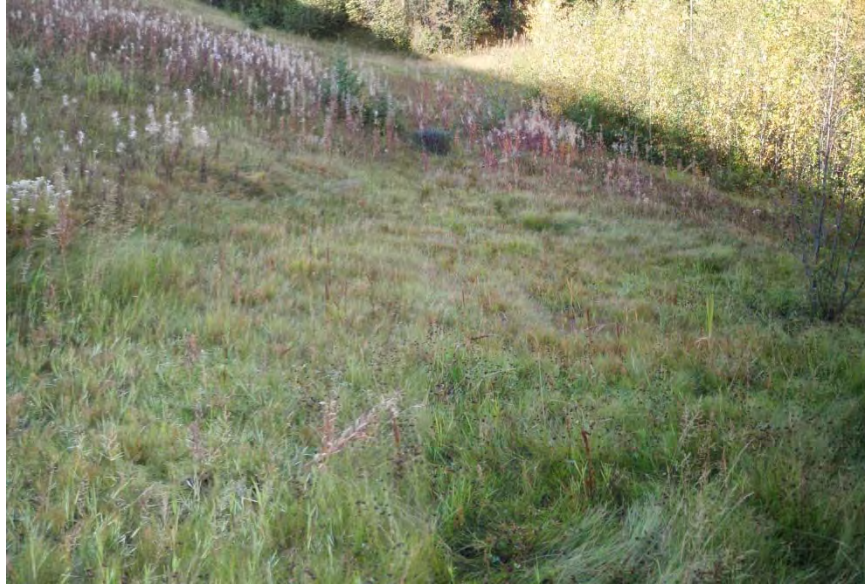
**Photo 15.** View of historic seepage zone at toe of tailings dam in vicinity of drainage blanket. Spongy ground and minor ponded water was noted at surface in this area. No work warranted.

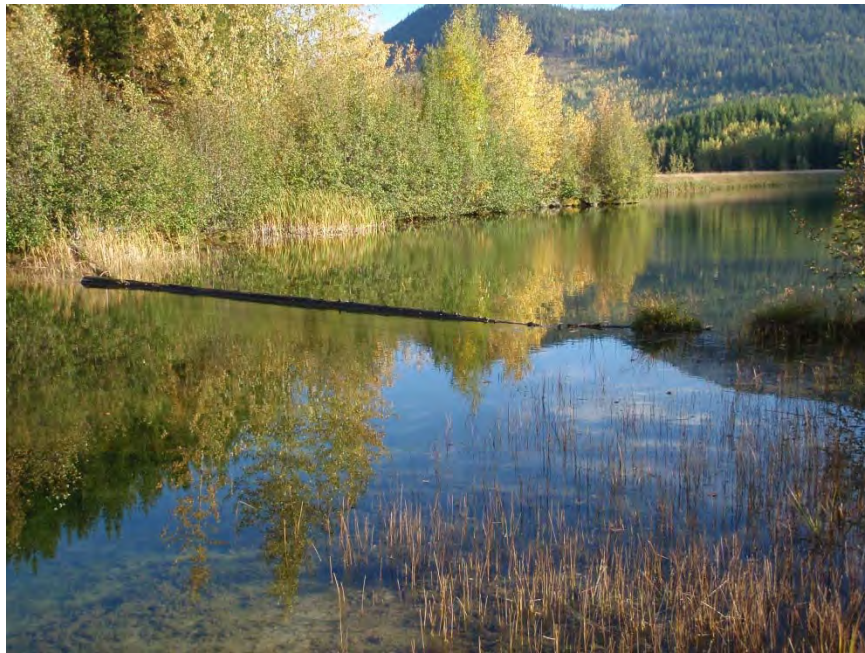
The approach channel, saddle dyke and spillway, which comprise the outlet spillway, are illustrated in Photos 16, 17 and 18. No erosion has been observed along the saddle dyke, and vegetation on the face of the dyke is well established. The log boom anchored across the entrance to the approach channel to prevent floating debris from blocking the spillway remains in place (see Photo 16) and appears to be in good condition. A minor amount of water was discharging over the spillway weir at the time of the inspection (see Photo 18).

**Photo 16.** View of log boom at entrance to approach channel.

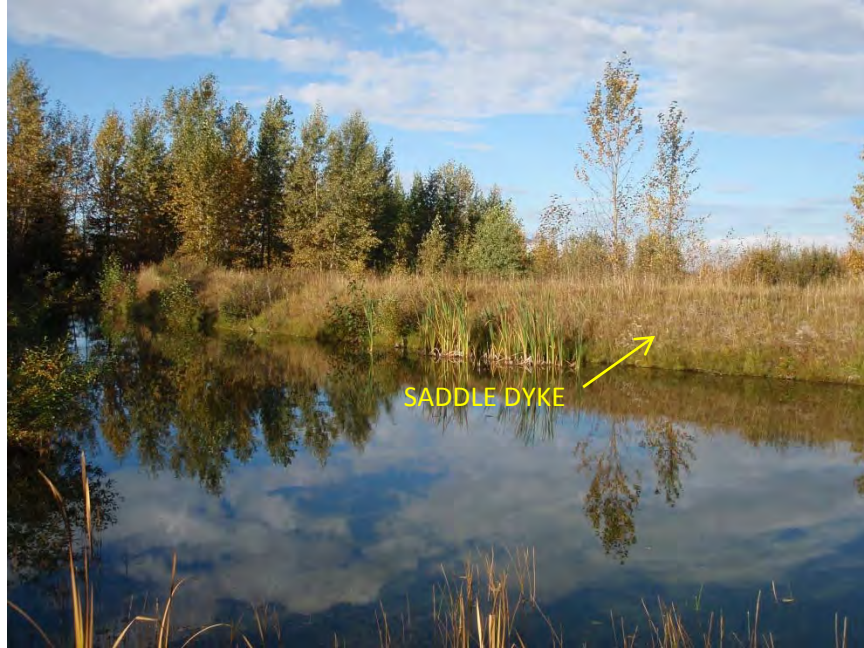
**Photo 17.** View of approach channel from just downstream of inlet and log boom. Note well vegetated upstream face of Saddle Dyke.

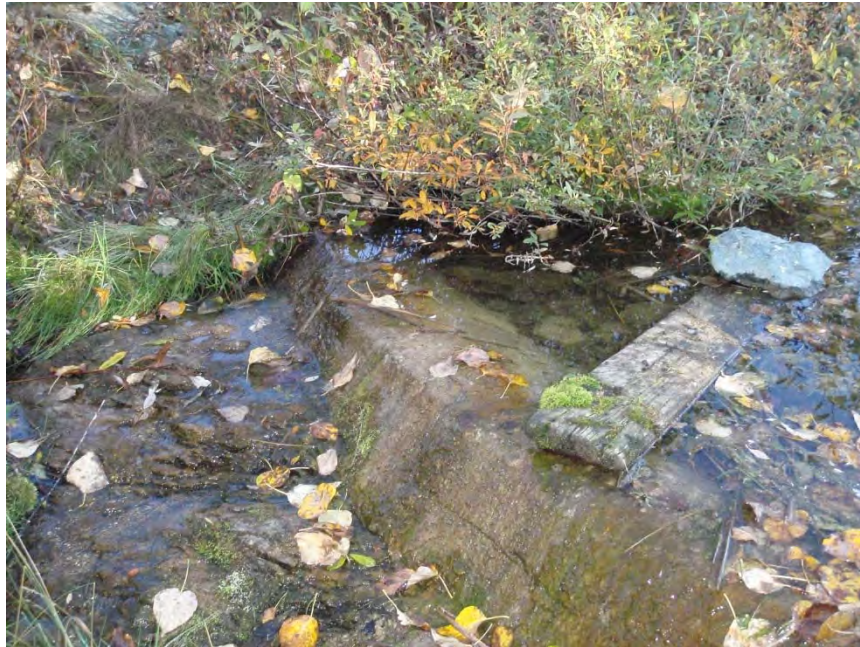
**Photo 18.** View of spillway weir. Note the water flowing over the crest of the weir.

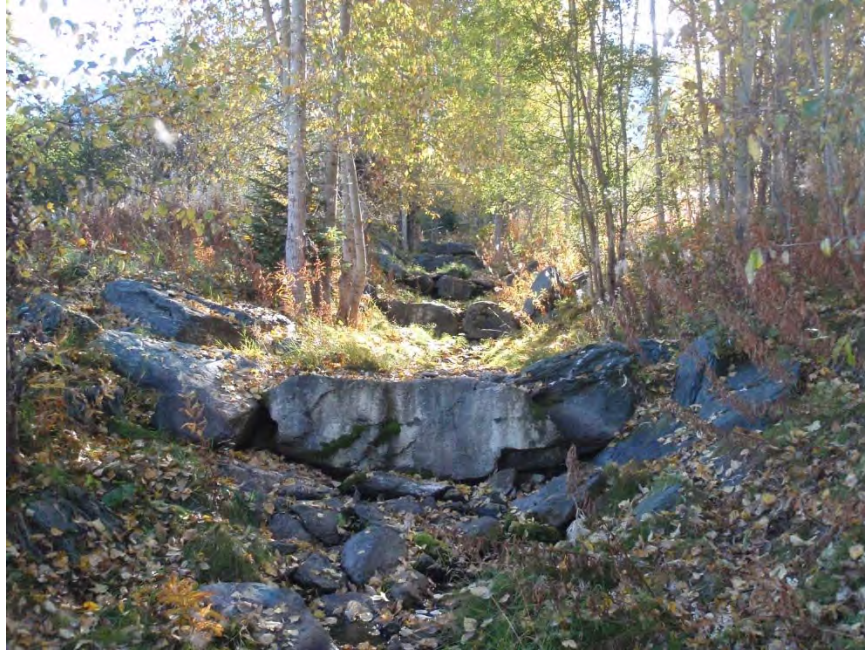
**Photo 19.** View looking up Segment VII about 100m below the spillway. Note the cleared channel.

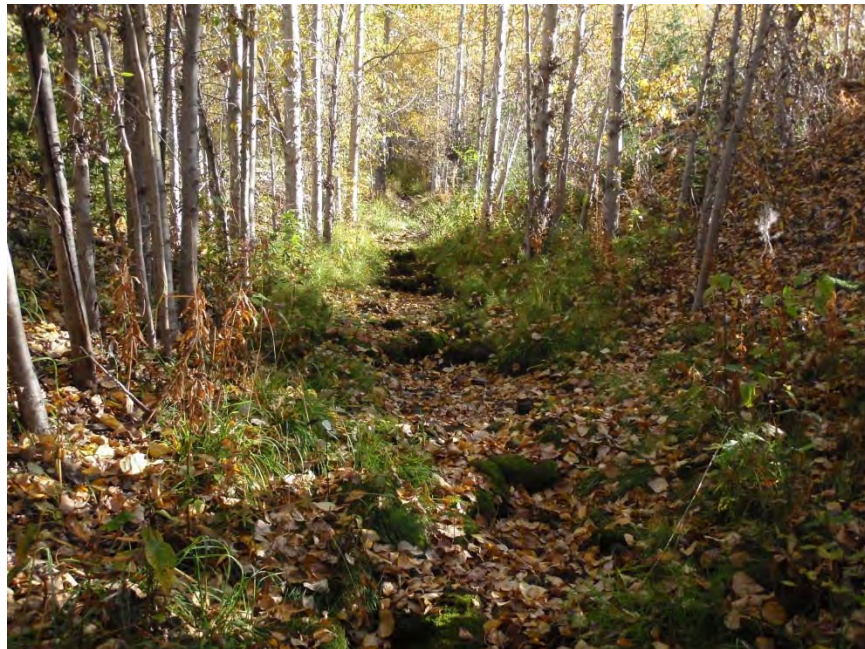
**Photo 20.** View looking up the lower portion of Segment IX just above the turning pond.

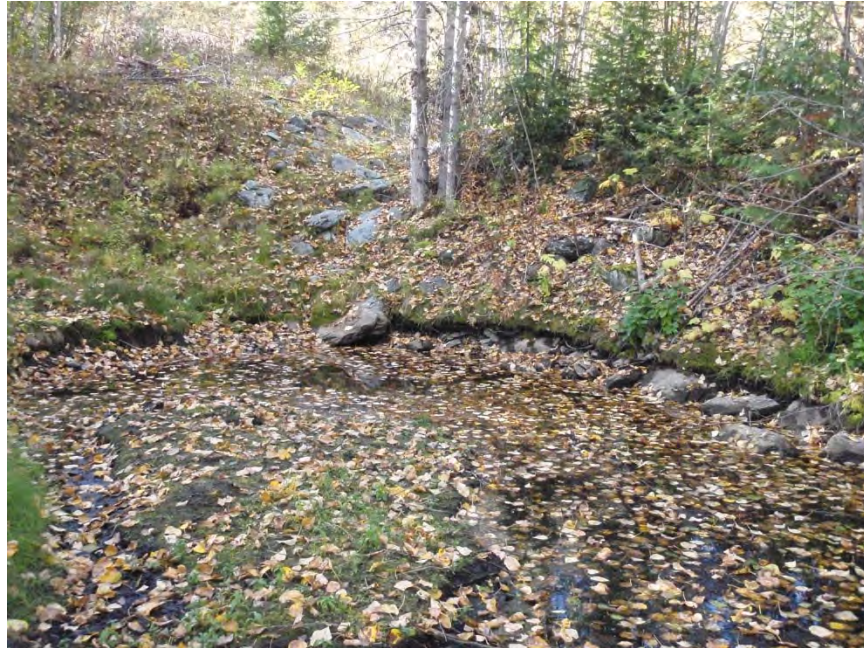
The stilling basin/turning pond structure at the junction of Segments IX and X (Photo 21) and the stilling basin/culvert at the downstream end of Segment X (Photo 25) were both in relatively good condition at the time of the inspection. However, as can be seen in Photo 25, alder saplings are beginning to become established in the stilling basing at the inlet to the culvert under Johnson Lake Road and should be removed to help prevent debris buildup that could restrict flow into the culvert inlet.

**Photo 21.** View of the turning pond at the junction of Segments IX and X.

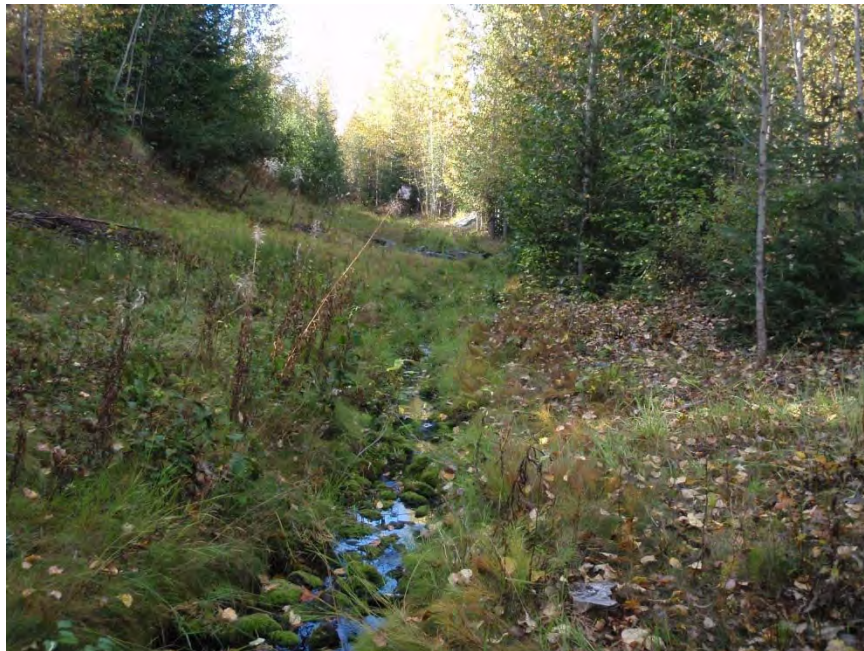
**Photo 22.** View looking up Segment X immediately upstream of the section of eroded slope that was previously pulled back. Note the open channel, which has been recently cleared of saplings.

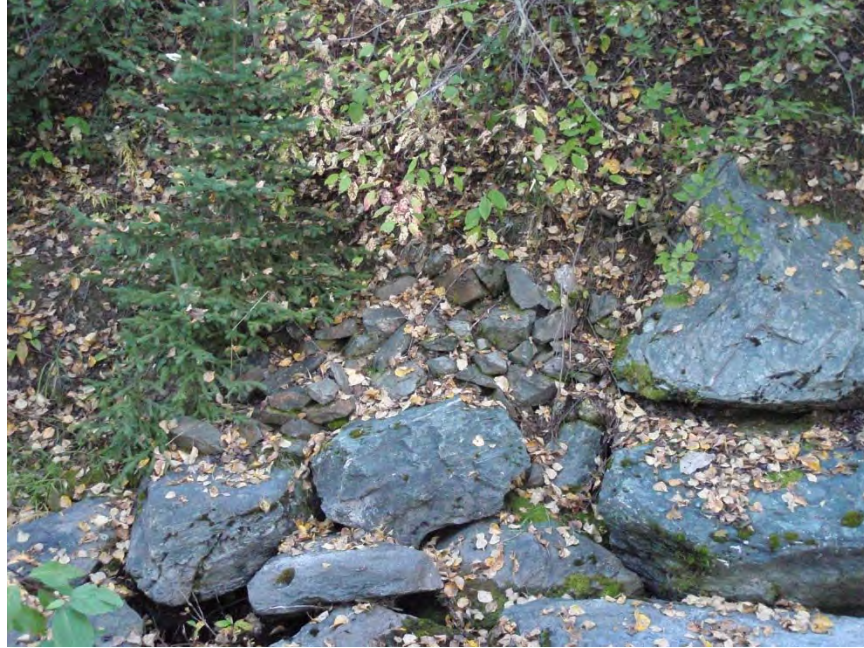
Previously repaired areas of erosion in the riprap armoured sections of the lower portion of Segment X show no evidence of further erosion (see Photo 23).

**Photo 23.** View of hand placed armour on right bank of Segment X. No erosion evident at any of the three locations of hand-placed armour.

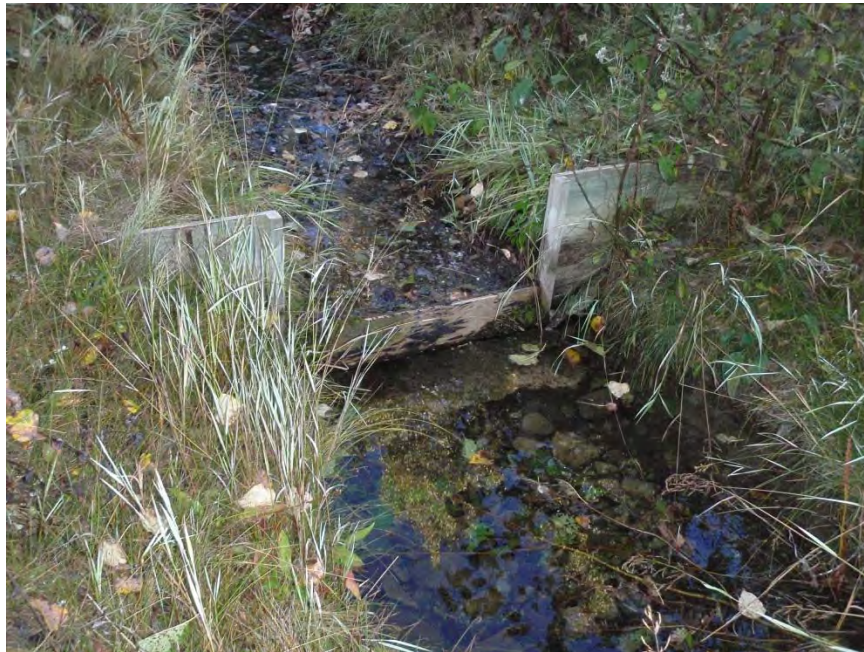
Photos 19 to 24 illustrate the current condition of the diversion channel downstream from the abandonment spillway. No significant changes to the diversion channel were apparent since our September 2012 inspection. As part of the ongoing maintenance program, Samatosum continues to remove saplings and significant accumulations of vegetation from channel side slopes (see Photos 19 and 20) to maintain flow capacity. Minor erosion, noted during the 2012 inspection, immediately downstream of the wooden weir located just upstream of the downstream end of Segment X (see Photo 24) does not appear to have changed significantly. The eroded portion of channel shown in Photo 24 should be armoured to help prevent future erosion.

**Photo 24.** View of area of minor channel erosion in lower Segment X, immediately below the concrete and wooden weir located just upstream of the inlet of the culvert under Johnson Lake Road. Eroded channel banks should be armoured to help prevent future erosion. Water currently flows under weir. Weir should be relocated or repaired, as required.

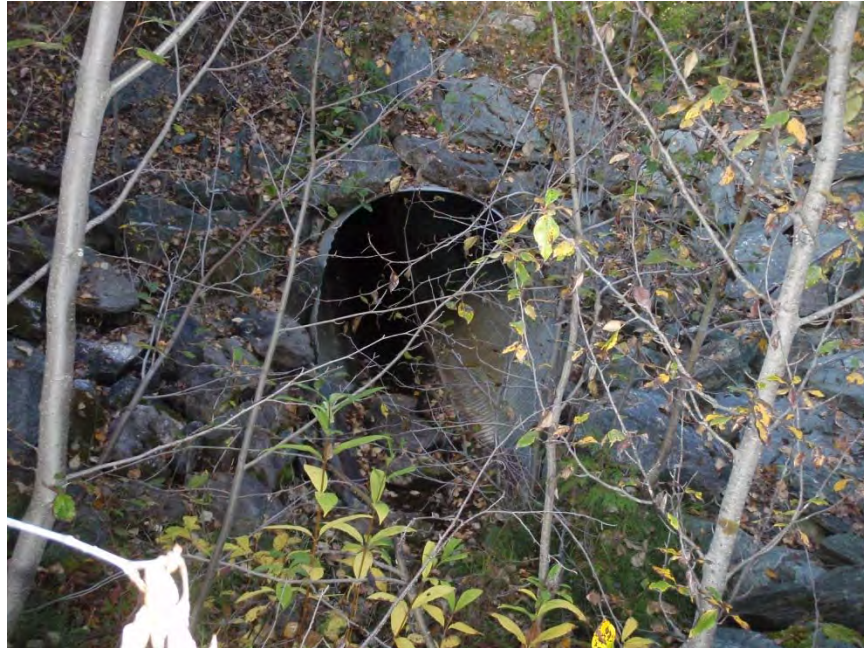
**Photo 25.** View of the inlet to the culvert under Johnson Lake Road at the bottom of Segment X. Alder saplings are becoming established and should be removed to prevent a buildup of debris.

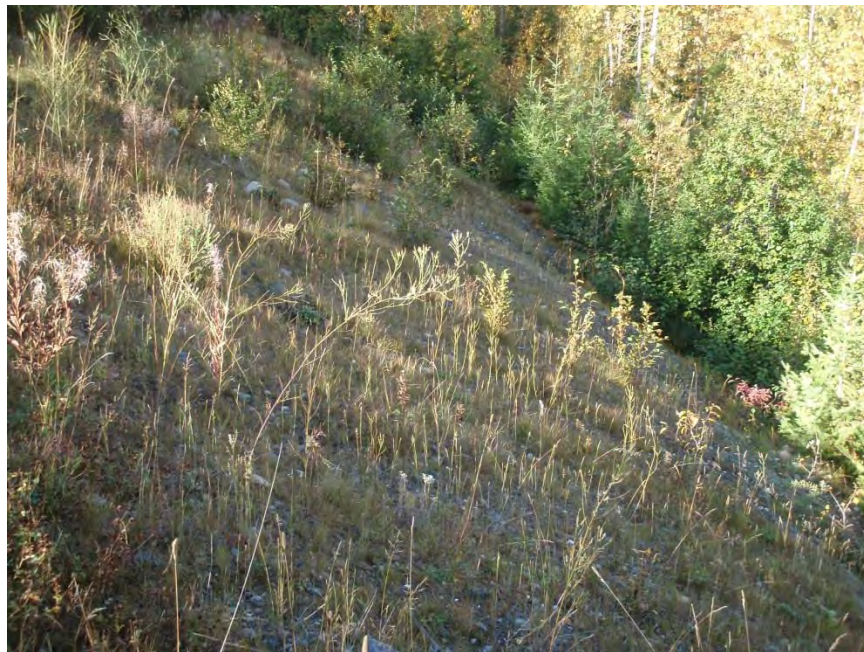
As can be seen in Photo 26, the pulled pack (i.e., resloped) area of previously reported instability above the middle section of Segment X continues to perform well. No evidence of further instability or erosion of this area was noted at the time of the inspection and no remedial action or additional slope stabilization appears warranted at this time.

**Photo 26.** View of portion of resloped area of slope instability noted during previous inspections. Pulled back slope is performing well.

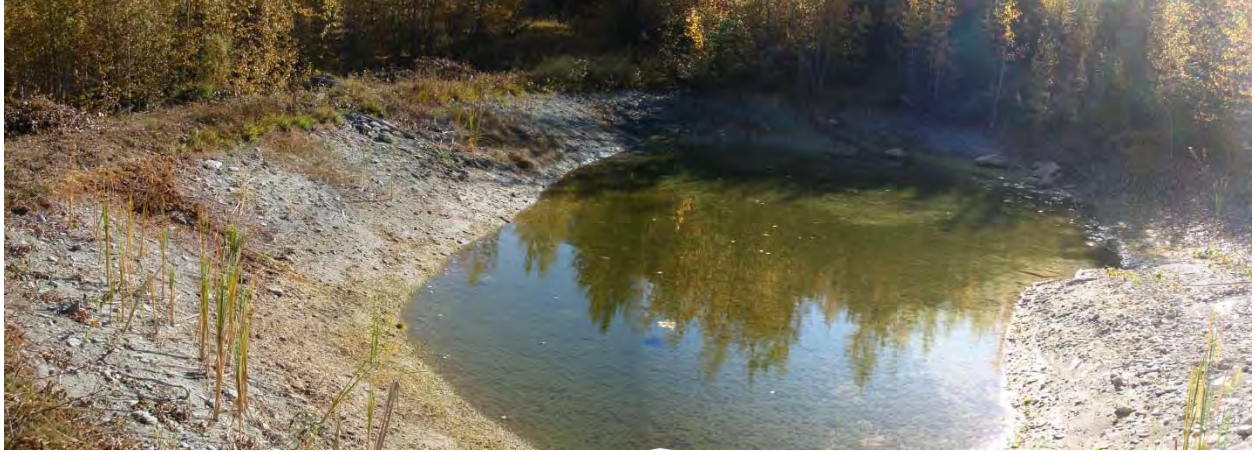
As illustrated in Photo 27, there appeared to be up to about 1m of water in the plant site sedimentation pond at the time of the inspection. The dyke that forms the pond appears stable and is covered with vegetation, including grasses, alder and cottonwood saplings. Interior slopes of the pond are covered with typical wetland vegetation. We understand that small flows discharge through the rockfill spillway during the freshet. No erosion or undermining of the spillway armouring was noted at the time of our inspection. Saplings should be removed from the crest of the dyke to facilitate visual inspections.

**Photo 27.** View of plant site sedimentation pond. No significant change since last inspection, except vegetation on dyke has been removed.

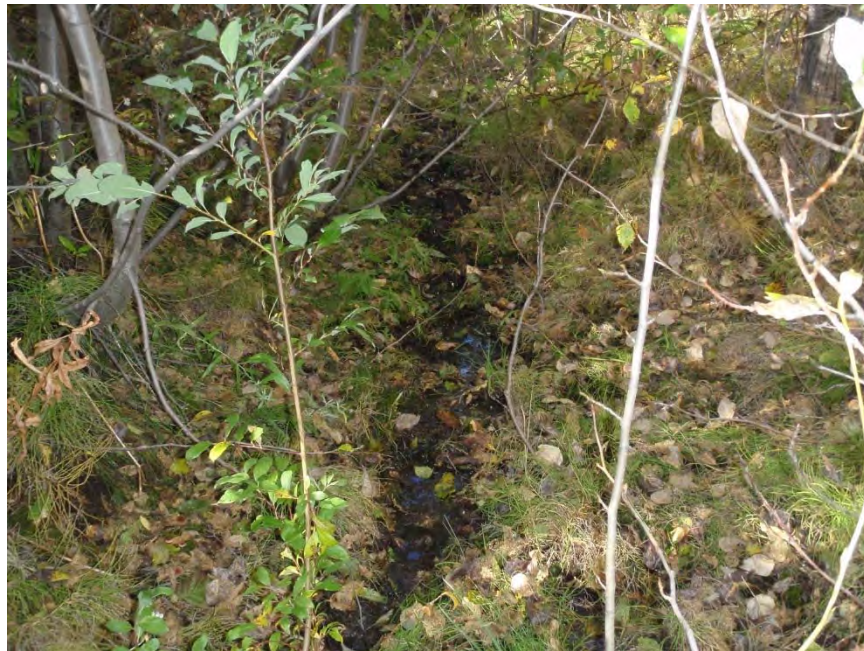
As directed by MEM, the collection ditches below the dam were regraded near their confluence in October 2000, to prevent ponding of water in a low lying area. At the time of the inspection, minor ponding was noted in the remaining portion of the seepage collection ditch (see Photo 28). No remedial work or maintenance is required at this time.

**Photo 28.** View of ponded water in seepage collection ditch below toe of tailings dam.

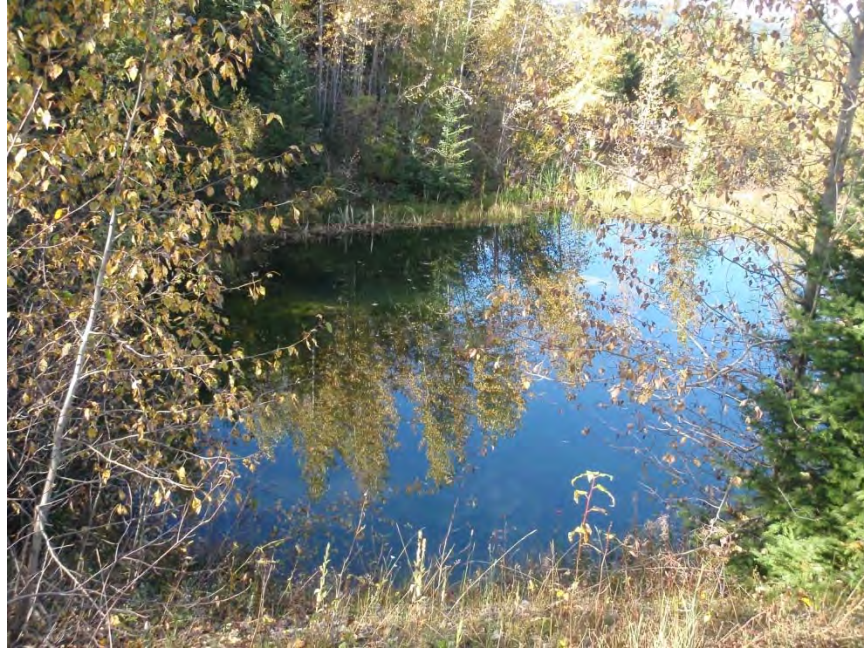
Consistent with previous inspections, the baffle in the centre of the pond is submerged under about 0.5m of water (see Photo 29), but the freeboard on the dyke is approximately 1m, which is considered to be adequate. Given the limited inflows and the lack of suspended sediment in the inflow, the submerged baffle is not considered to be a significant concern.

**Photo 29.** View of the water quality pond. Baffles are submerged.

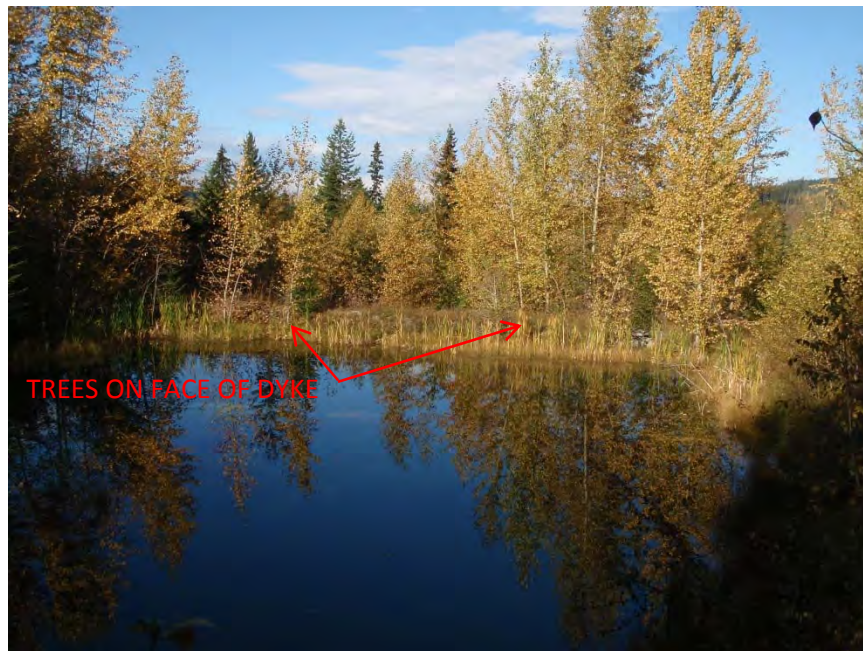
slopes. As can be seen in Photo 30, a few cottonwood trees have become established on the upstream face of the dyke near the waterline. While these trees will likely need to be removed in the future, they do not appear to represent a significant hazard at the present time. No remedial work or maintenance is required at this time.

**Photo 30.** View of the water quality pond dyke. Note large saplings near waterline on upstream face of dyke that pose limited hazard to dyke stability and do not impede visual inspection. Removal of saplings not warranted at this time.
