KLONDIKE SILVER - SILVANA MINE

2014 Annual Dam Safety Inspection

Reference Number: 1406428-007-R-Rev0-2000

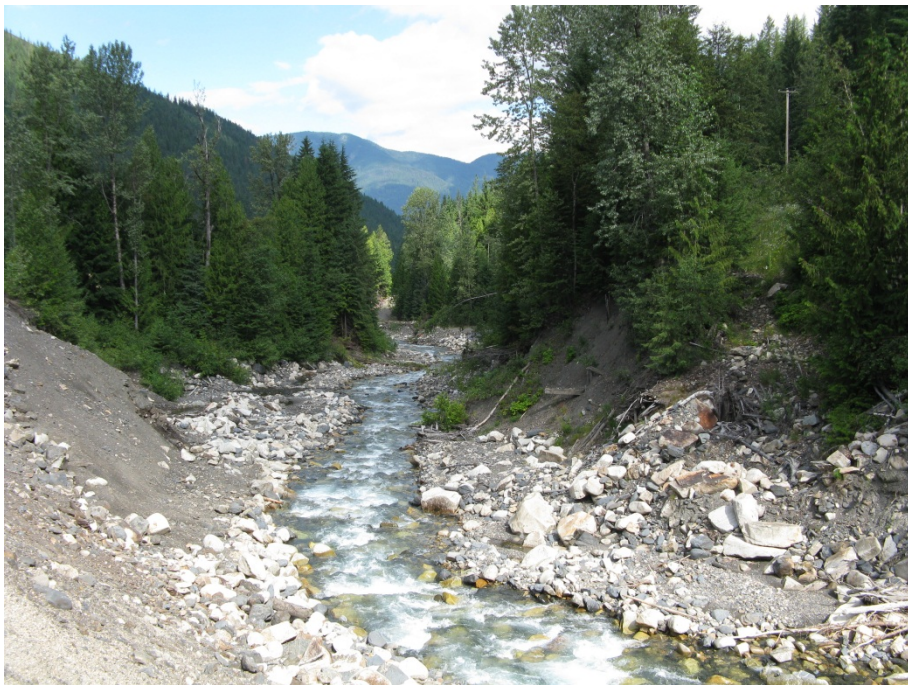
Photograph 1: Looking Downstream towards Pond 1 TMF Dam - in trees on left

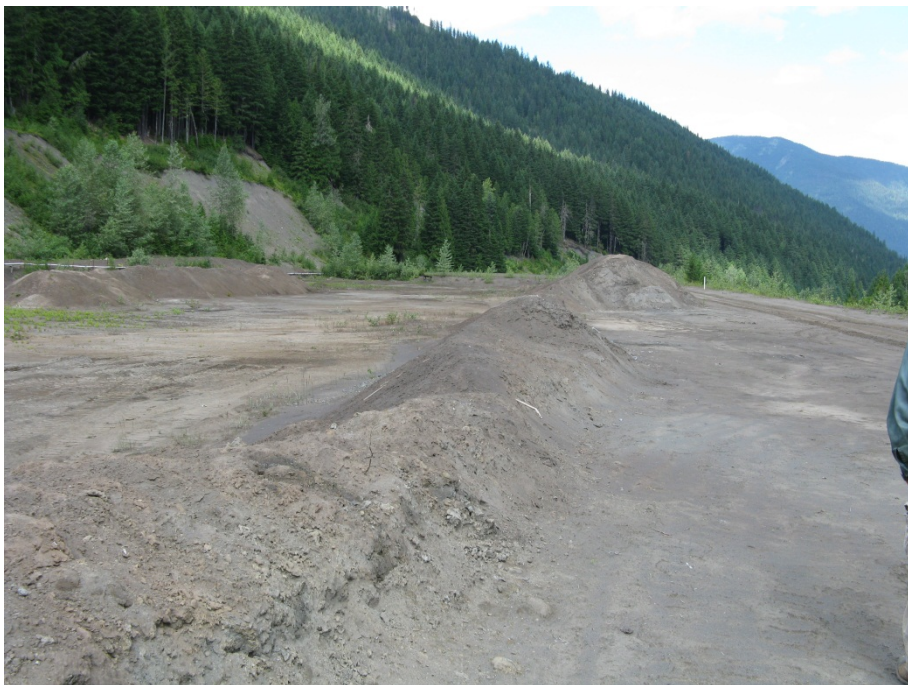
Photograph 2: Pond 1 – stockpile tailings on left

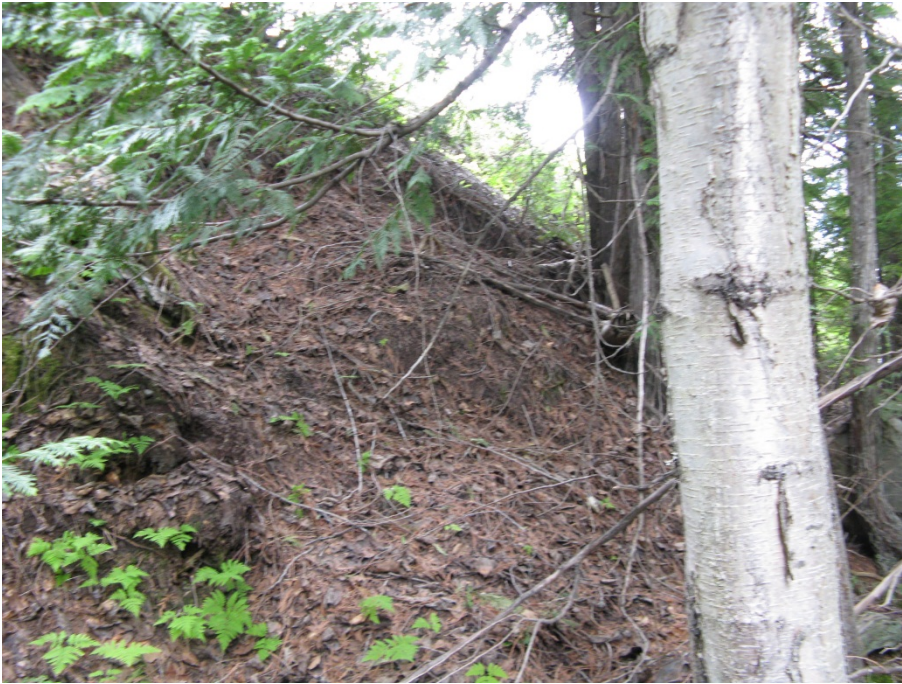
Photograph 3: Downstream slope Pond 1 from toe area – tree covered

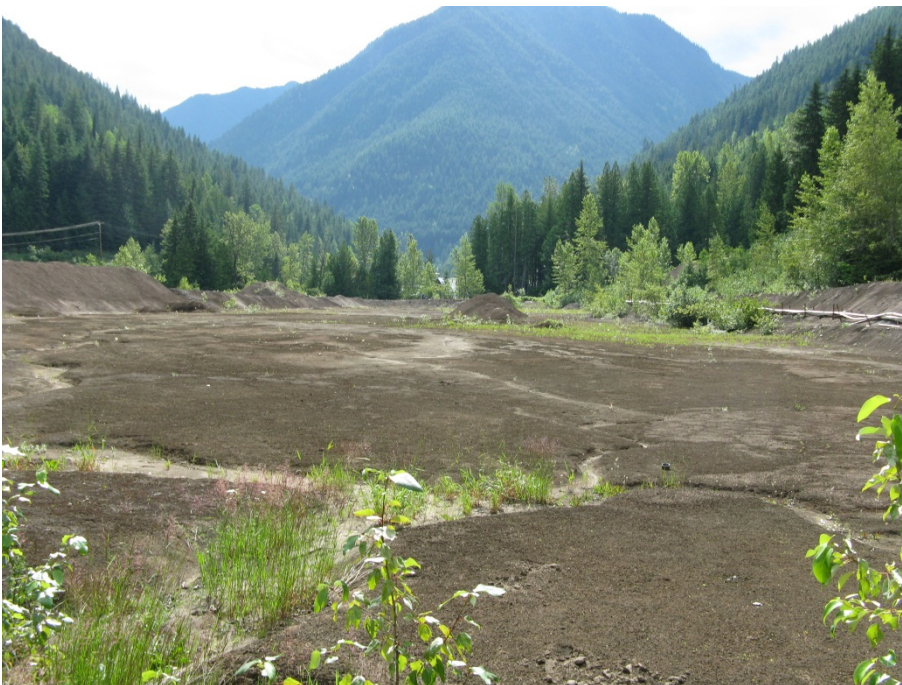
Photograph 4: Pond 1 from downstream end looking back to mill

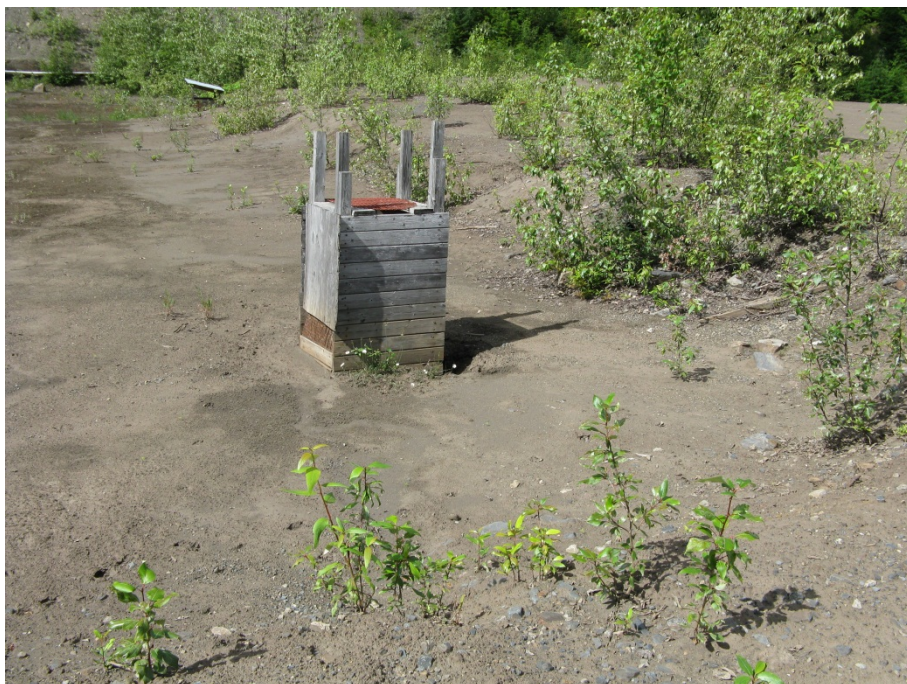
Photograph 5: Pond 1 decant

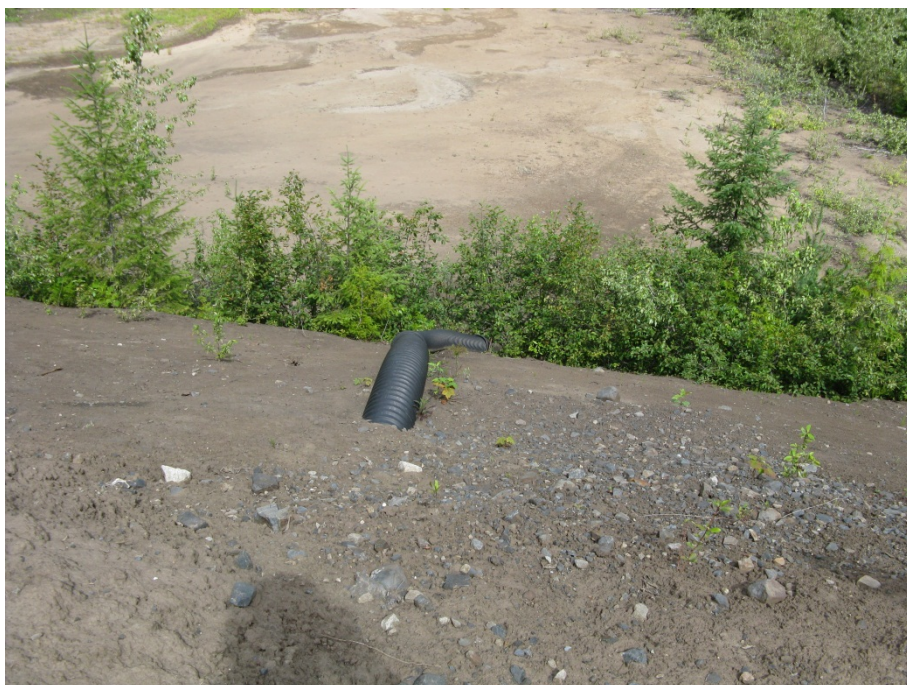
Photograph 6: Downstream Face of Pond 1 – Pond 1 overflow pipe on slope to Pond 2

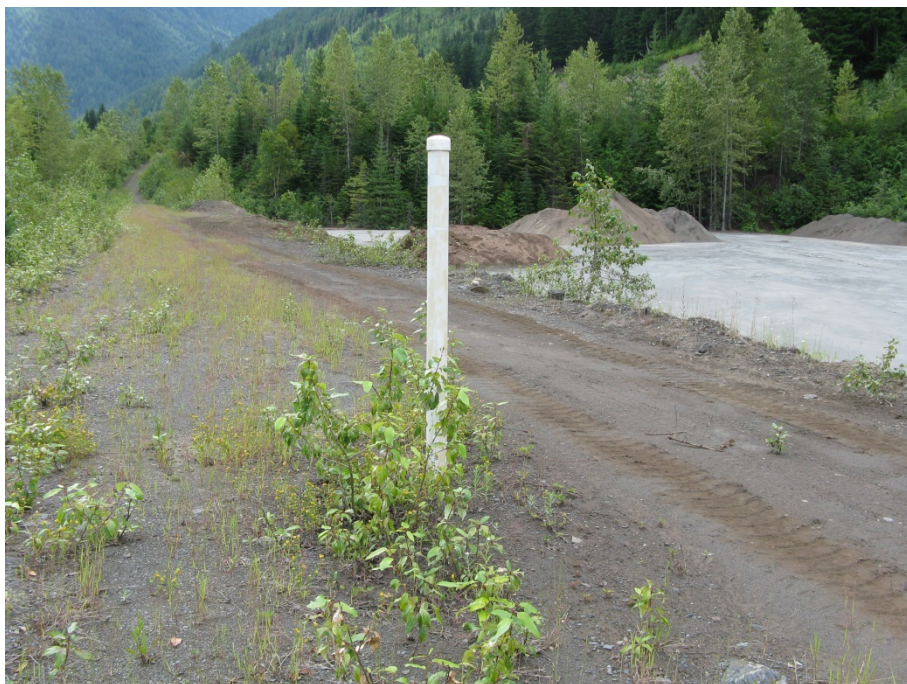
Photograph 7: Dam Pond 3 – piezometer in foreground

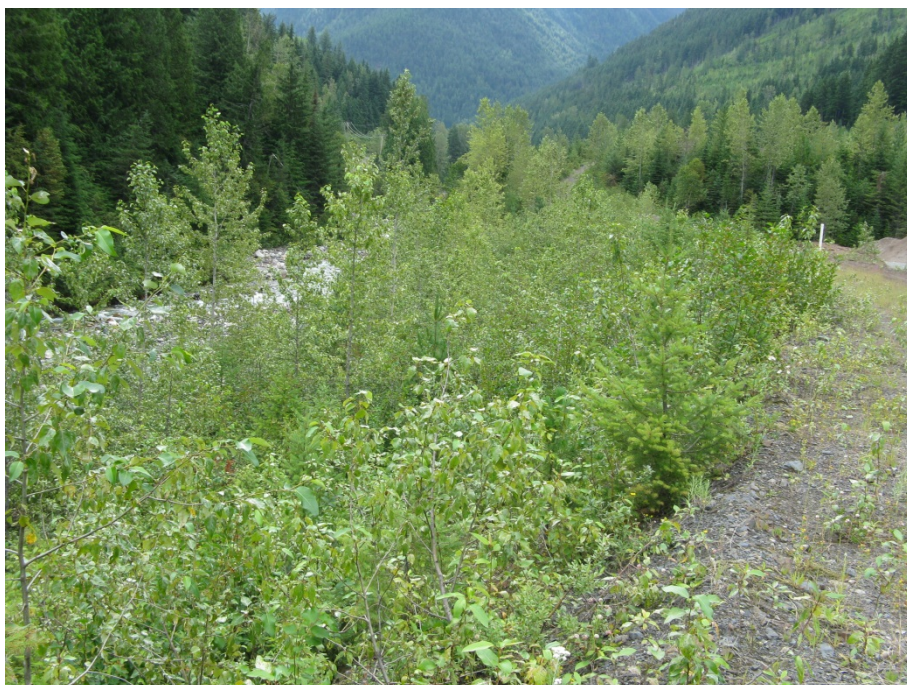
Photograph 8: Downstream Face of Pond 3 Dam – creek on left

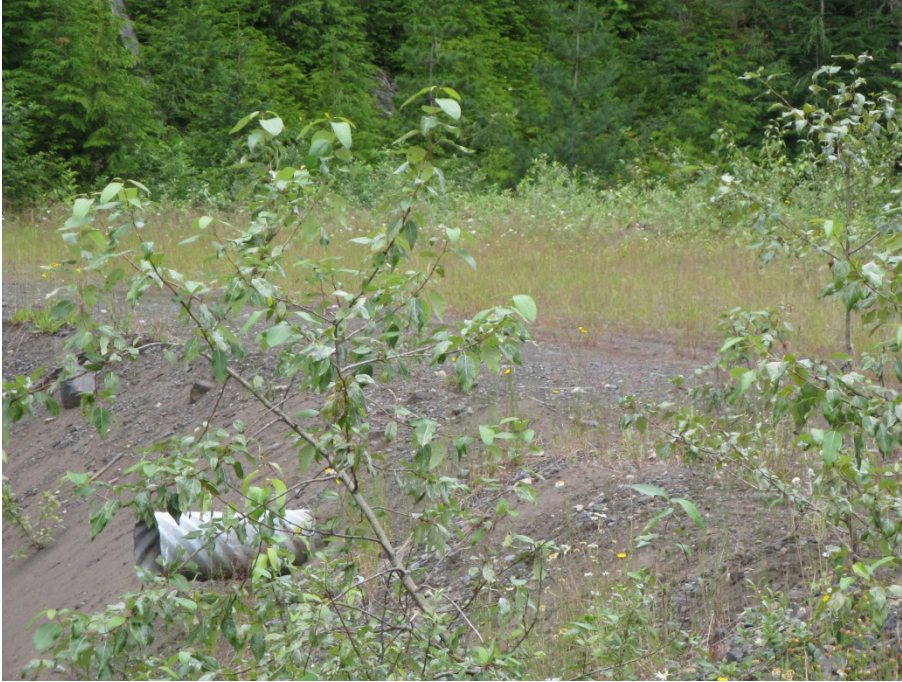
Photograph 9: Downstream Face Pond 3 Dam – over flow pipe

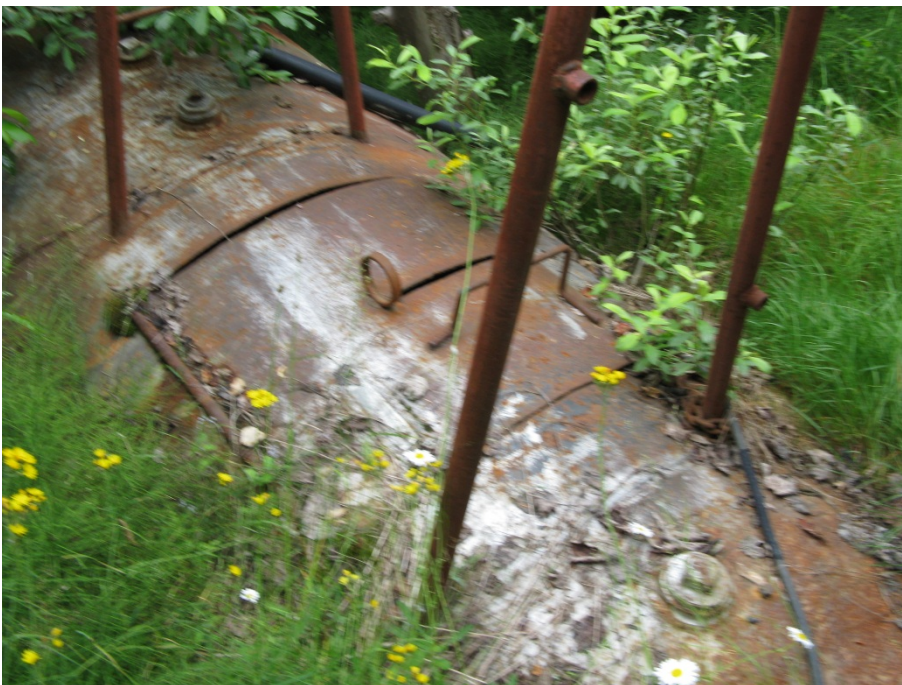
Photograph 10: Return water tank below Pond 3

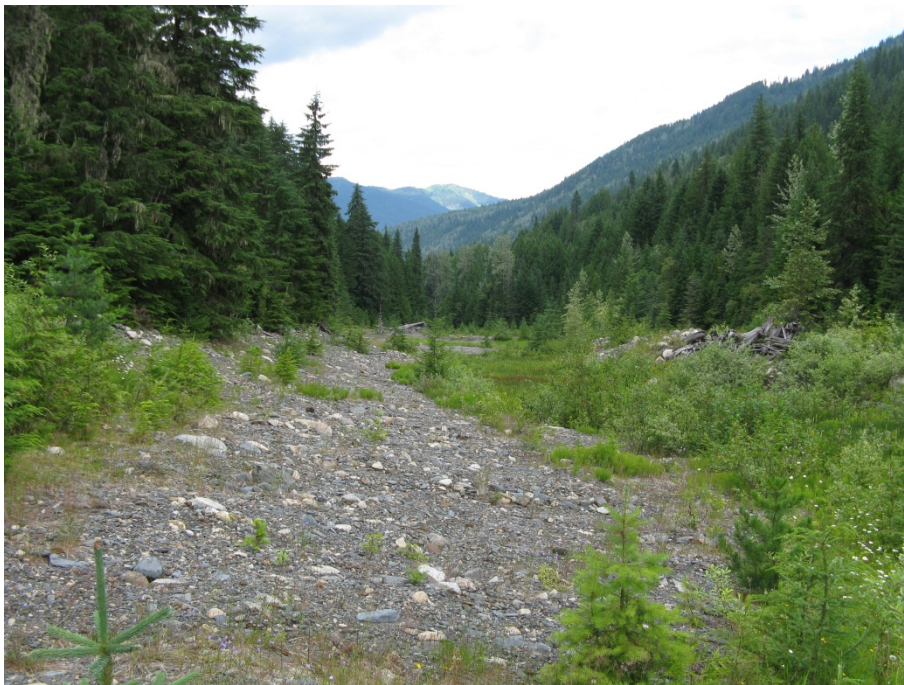
Photograph 11: Downstream area below Pond 3

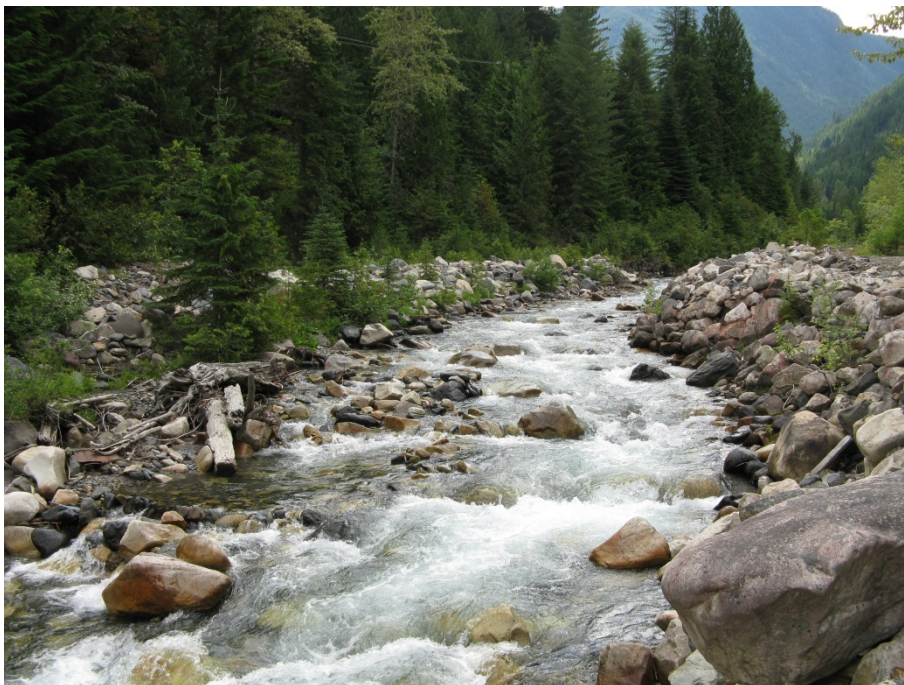
Photograph 12: Creek adjacent to Pond 3 dam – 8 m wide bench to toe of dam
