INDEPENDENT REVIEW OF 2014 DAM SAFETY INSPECTION REPORT

Snip Mine Tailings Dams

Submitted to:
Barrick Gold Inc.
PO Box 788
Penticton, BC
V2A 6Y7

Reference Number: 1412161-004-R-Rev1-4000

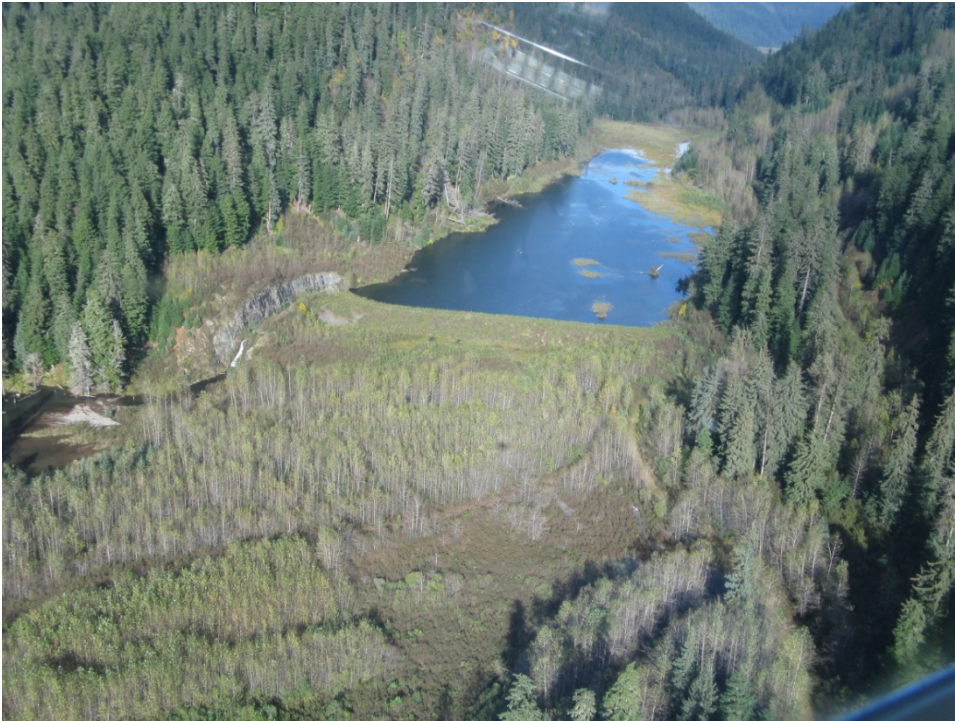
Snip Mine was an underground operation, located some 320 km northwest of Smithers in northwest British Columbia. The mine was located in the mountainous terrain of the coastal mountains. The tailings facility layout is shown in Photograph 1.

Photograph 1: Site Overview - Dyke 1 In Foreground, October 1, 2014

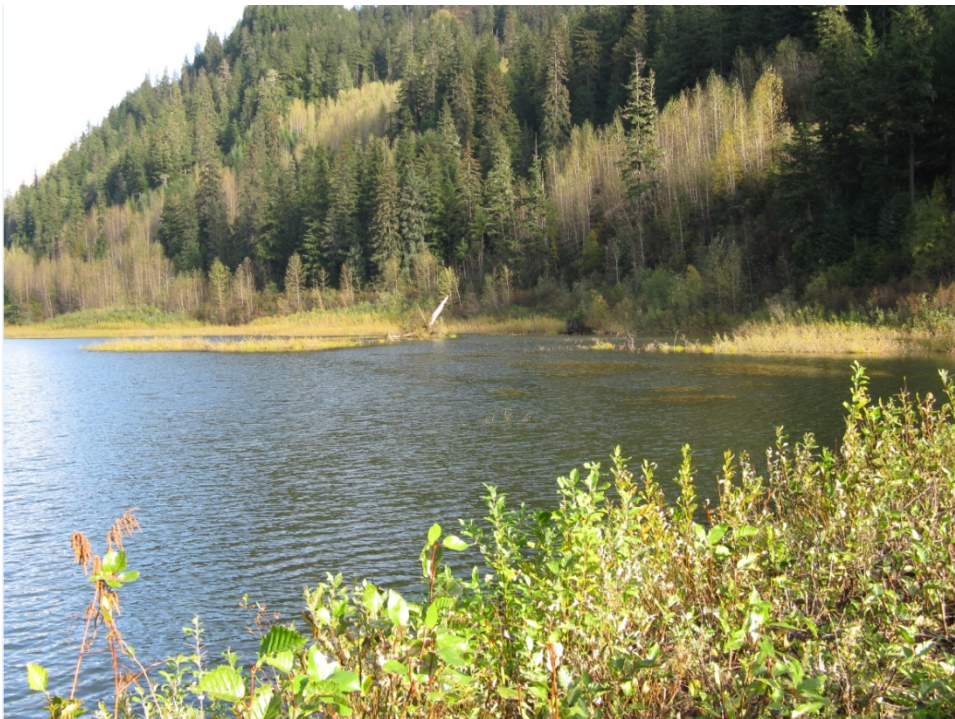
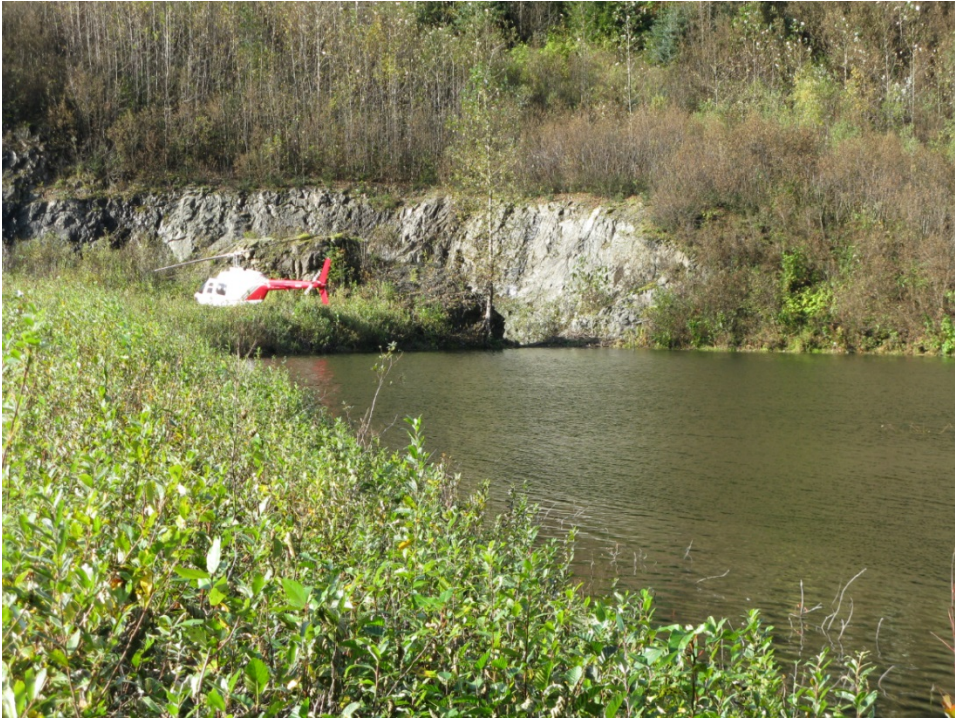
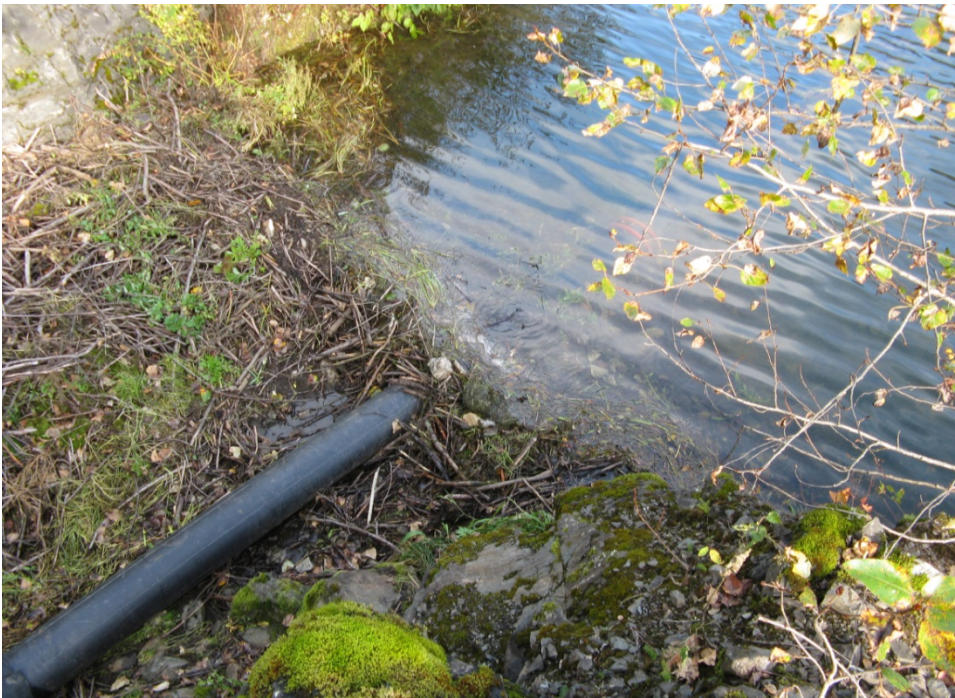
- The spillway channel at Dyke 1 is clear of vegetation, but a beaver has built a small dam at the inlet to the spillway. The pipe installed to bypass the beaver dam is working well. The spillway should be cleared and the beaver activity monitored and managed (see Photographs 2, 3, and 4 in Appendix A).

Photograph 2: Beaver Lodge In Pond Near Dyke 1, October 1, 2014

Photograph 3: Spillway Inlet, October 1, 2014

Photograph 4: Beaver Dam in Spillway with bypass pipe in center of spillway, October 1, 2014

- Barrick should continue to monitor and manage the beaver activity in the spillway to enable safe passage of any flood event from the Snip Tailings Storage Facility.
- The vegetation on Dykes 1 and 3 should be cleared on a more regular basis to enable clear view of the dams and future inspections.
- The monitoring instrumentation at the facility should be reviewed and, if needed, maintenance should be completed (Piezometer DH90-07).
- A Dam Safety Review should be completed in 2023.

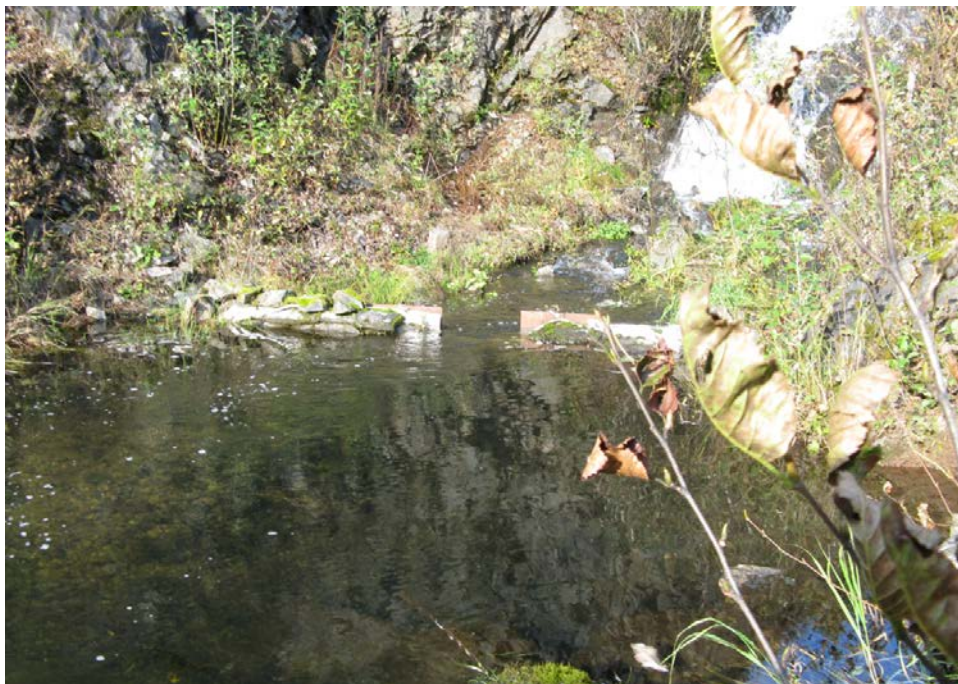
- The monitoring weir downstream of Dyke 1 is flooded. If the conditions downstream do not change in early 2015 and the weir is required for on-going monitoring, the back water condition should be investigated so the weir will operate as required (see Photograph 5 in Appendix A).

Photograph 5: Weir Downstream of Dyke 1, October 1, 2014

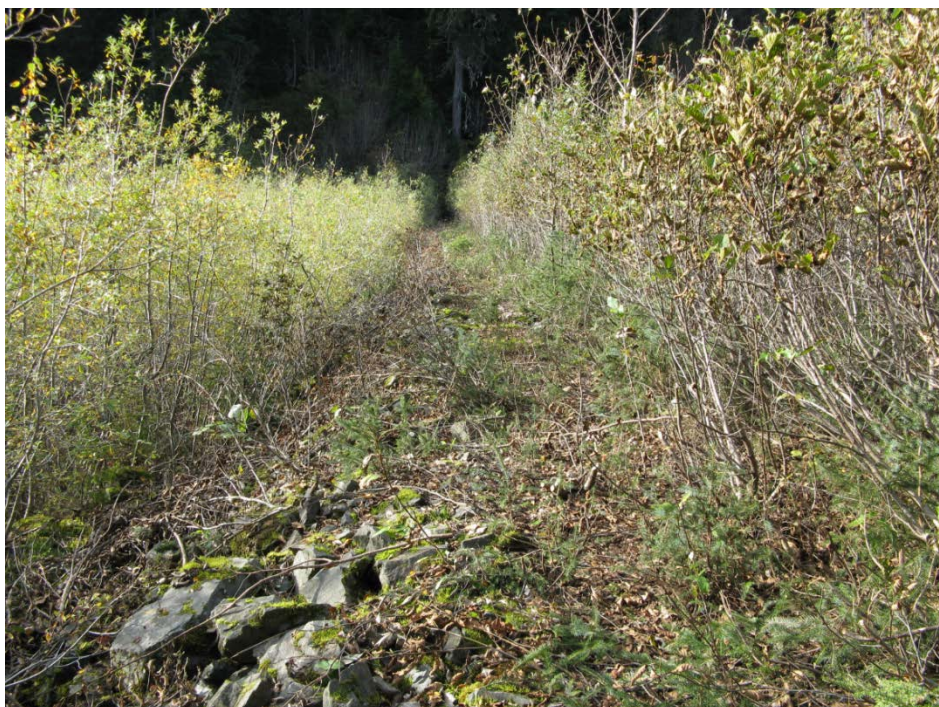
- The upstream slope, crest, and downstream slope of Dyke 3 should be cleared to allow improved regular inspections when water quality samples are collected on a quarterly basis. The clearing completed on Dyke 3 for the October 1, 2014, inspection was a good start (see Photograph 6 in Appendix A).

Photograph 6: Dyke 3 Dam Crest – Partially Cleared, October 1, 2014
