**BARRICK GOLD INC.
SNIP TAILINGS STORAGE FACILITY**

2014 DAM SAFETY INSPECTION

VA101-2/17-1
Rev 0
November 28, 2014

**2014 DAM SAFETY INSPECTION
VA101-2/17-1**

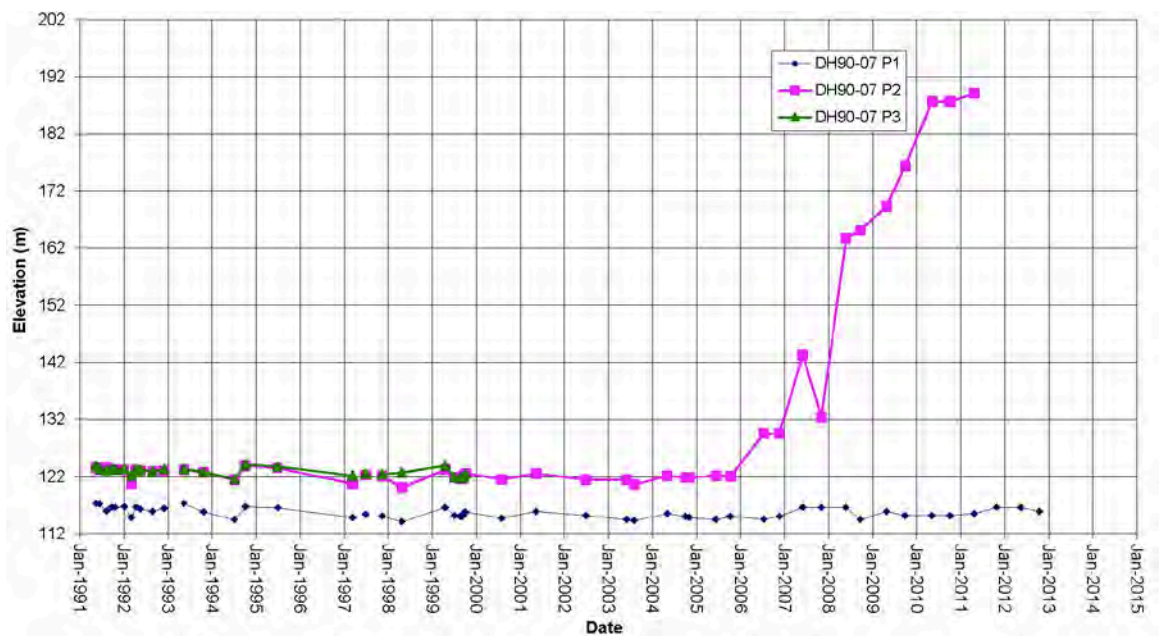
Figure 4.6 Dyke 3 Piezometers DH90-07

The piezometer DH90-07 P2 readings were generally stable between installation in 1991 to late 2005. Since 2005 the readings have steadily increased, the most recent reading suggests pore water pressures approximately 50 m above existing ground level. This is clearly not accurate and the readings from DH90-07 P2 are erroneously high. The potential causes should be investigated and the piezometer flagged as having suspect data.

The maintenance of piezometers should continue as on ongoing activity and it is recommended that performance of Piezometer DH90-07 P2 be assess based on the manufactures recommended trouble shooting guide. The piezometer should either be repaired of removed from service.

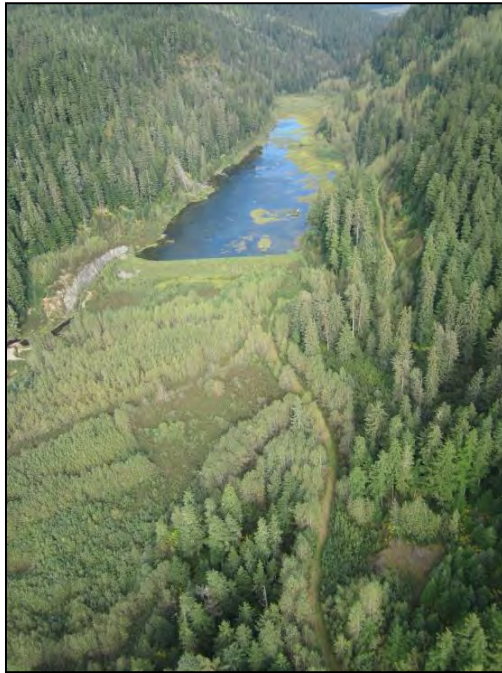
- The Dykes 1 and 3 were in good condition and did not present any noticeable indications of deformation or erosion.
- The vegetation on the crest, upstream and downstream slope of Dyke 1 has been trimmed to leave dense low ground cover. Heavy vegetation cover is present on the stability berm (Photo 1).

PHOTO 1 – Dyke 1 - Overview from downstream.

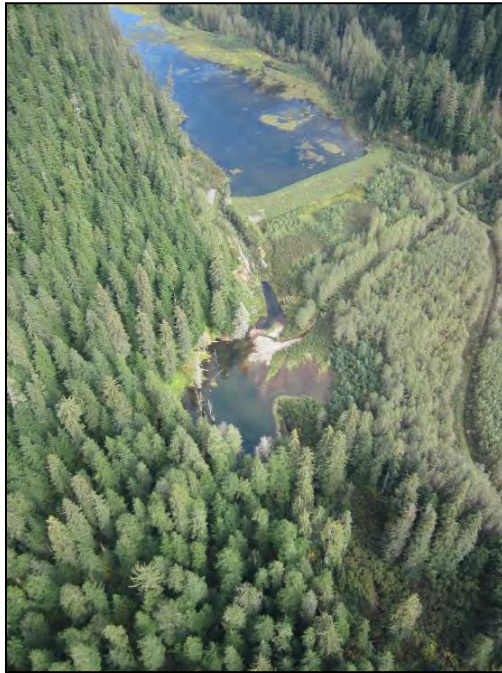
- The spillway was noted to be in good condition and discharging water into Sky Creek, a beaver dam below the spillway near the confluence with Sky Creek has resulted in a pond submerging the monitoring weir (Photo 3).

PHOTO 3 – Dyke 1 – Overview from the West.

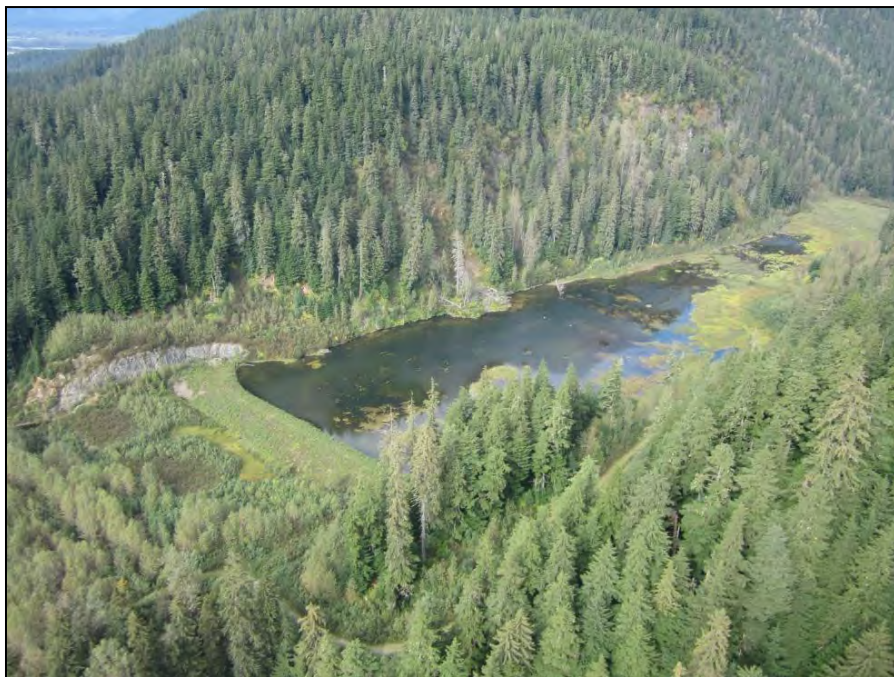
- A shallow water pond covers approximately 60% of the tailings basin area in the southwest side of the facility and is in contact with Dyke 1 (Photo 4). The extent of the pond was similar to that observed in 2013.

- No new slides were observed in the impoundment side slopes, which are generally heavily vegetated (Photo 4).
- A beaver lodge is observed in the water pond, no beavers were observed (Photos 20 and 21).

PHOTO 4 – Dyke 1 – Overview from the East.

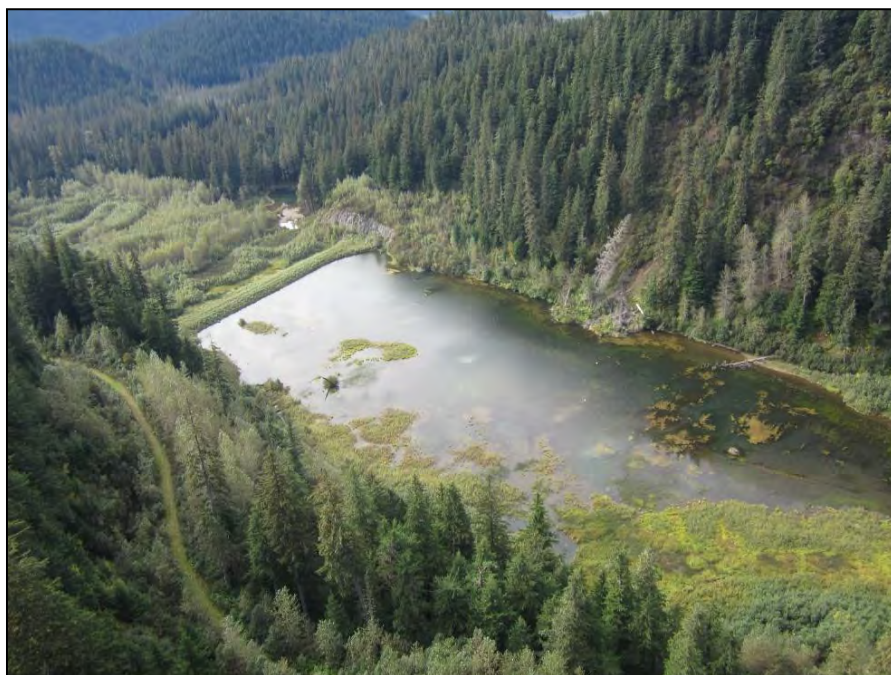
- The TSF has approximately 2 m of freeboard.
- No activity was observed in the small slide noted on the north slope of the tailings basin, approximately 100 m upstream of Dyke 1. The slide is now generally covered by a well-established vegetation (Photo 5).

- The slough on the north slope of the tailings basin, approximately 100 m upstream of Dyke 1, was similar to that observed in previous inspections (Photo 5).

- There was no apparent change in the condition of the slough immediately upstream of the spillway entrance, this slough is now covered in dense vegetation (Photo 5).

PHOTO 5 – Dyke 1 & Impoundment – Overview.

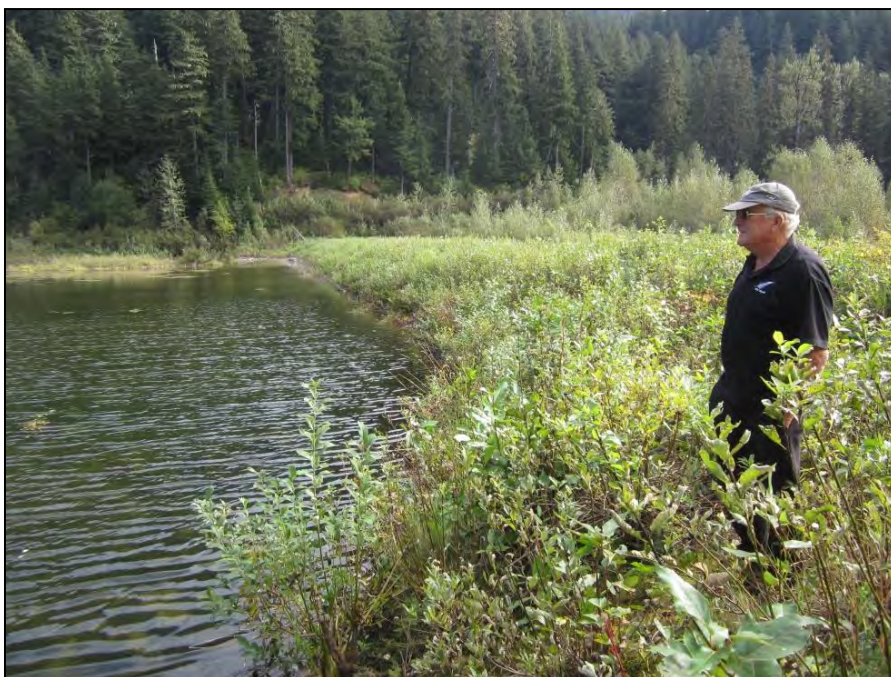
- The dyke appeared to be in good condition with no cracking, bulging, deformation or erosion observed.
- The vegetation on the crest, upstream and downstream slopes of the dyke was trimmed 2013 prior to the DSR inspection. The vegetation during the site inspection formed a well-established low (300 mm to 600 mm high) ground cover (Photo 6). Ongoing clearance of vegetation from the dam crest and slopes to the stability berm will be required.
- The upstream face of the dyke was in contact with the pond over the full length of the dyke (Photos 5, 6 and 7).
- The riprap on the upstream face of the dyke was in satisfactory condition with well-established vegetation to the pond edge (Photo 6 and 7).

- No erosion was noted along the length of the crest (Photos 6 and 7).
- The decommissioned outlet decant was in good condition, with no erosion, cracking or deformations observed at the inlet (Photos 7 and 8). The approximate route of the decant pipe was inspected and no signs of ground distress noted. The outlet of the decommissioned decant is not visible.

PHOTO 6 – Dyke 1 – Upstream face from the North West.

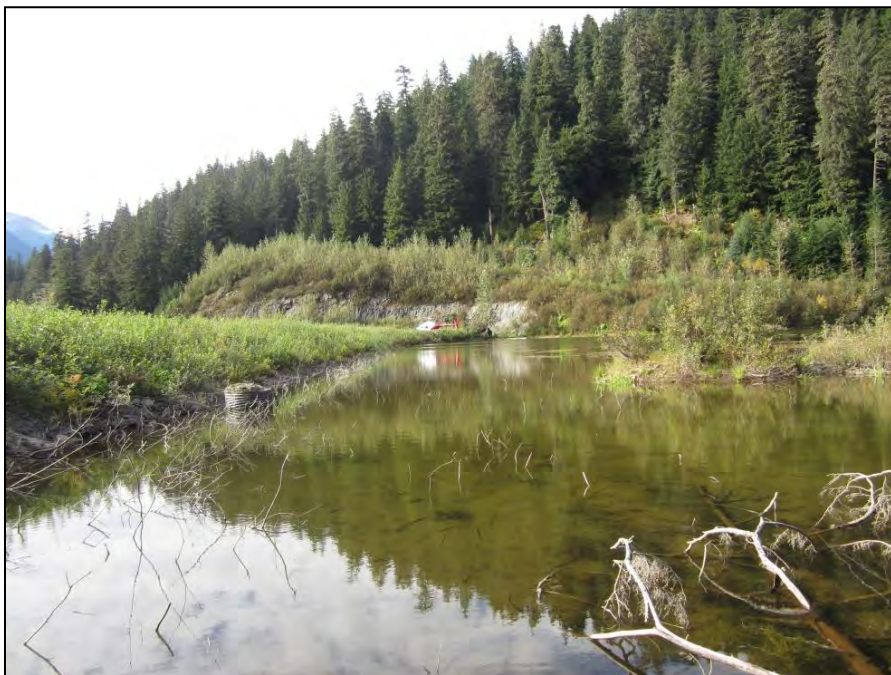
PHOTO 7 – Dyke 1 – Upstream face from the South East.

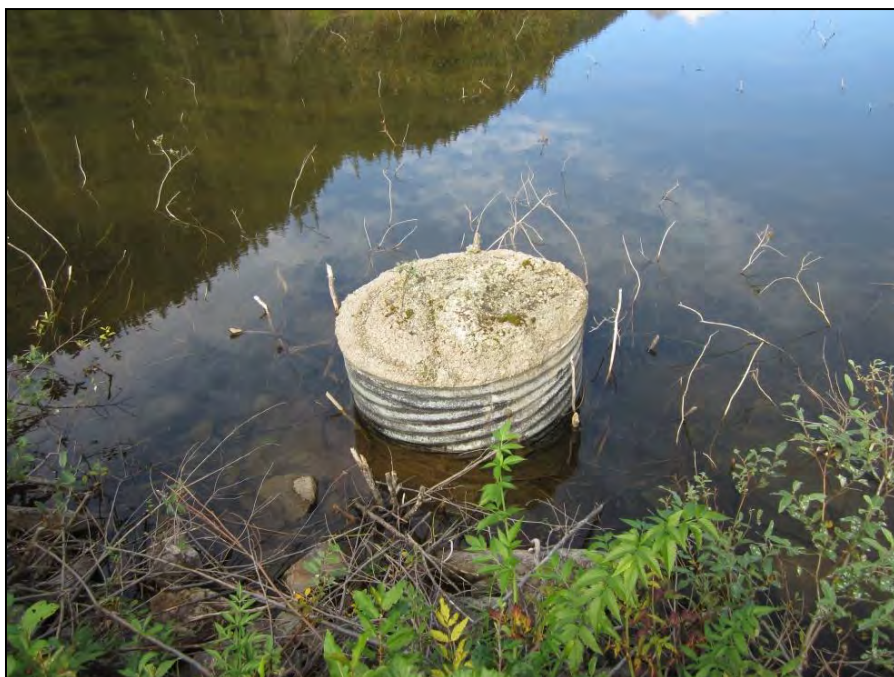
PHOTO 8 – Dyke 1 – Decommissioned decant inlet.

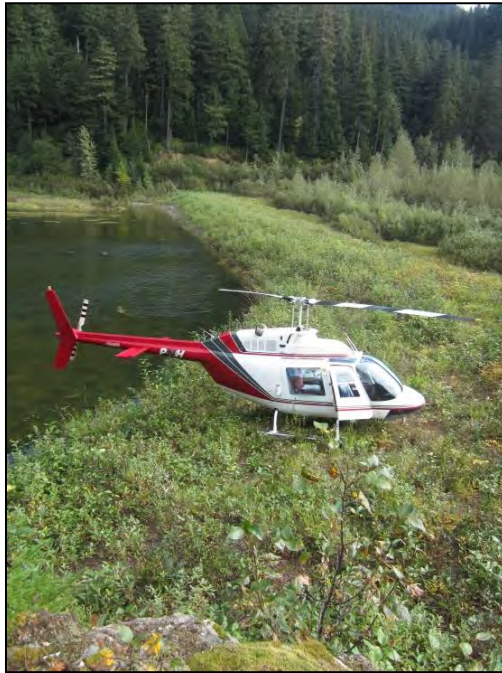
- No cracks, depressions or soft spots were noted on the crest of Dyke 1; the dyke was in good condition along its length (Photo 9).
- Vegetation on the downstream face of Dyke 1 is low (approx. 1 m high), well established and very dense. Accessing and traversing the downstream face of the dyke is difficult and visibility of the ground is limited (Photos 10 and 11).

PHOTO 9 – Dyke 1 – Dam crest.

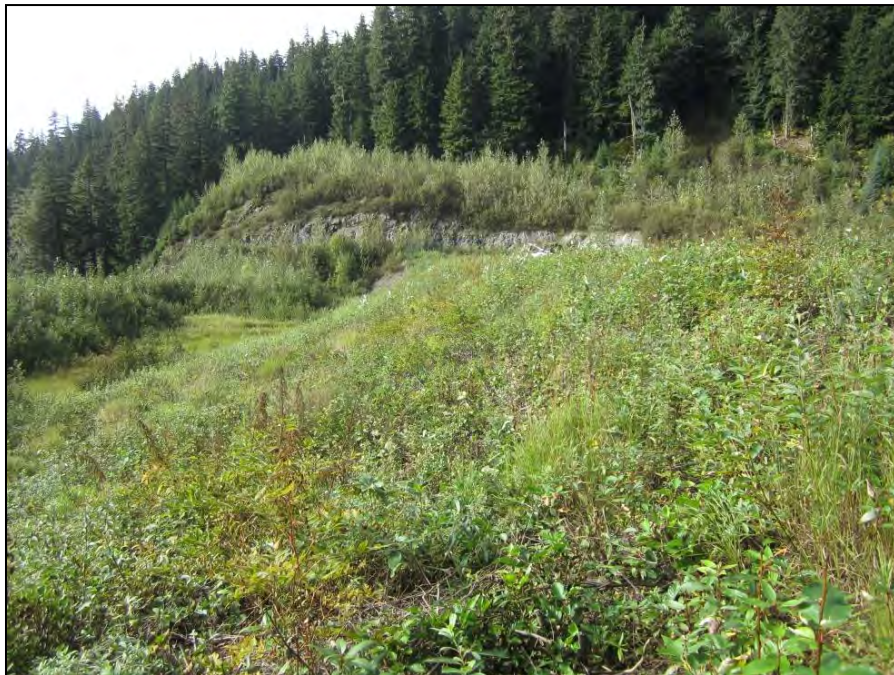
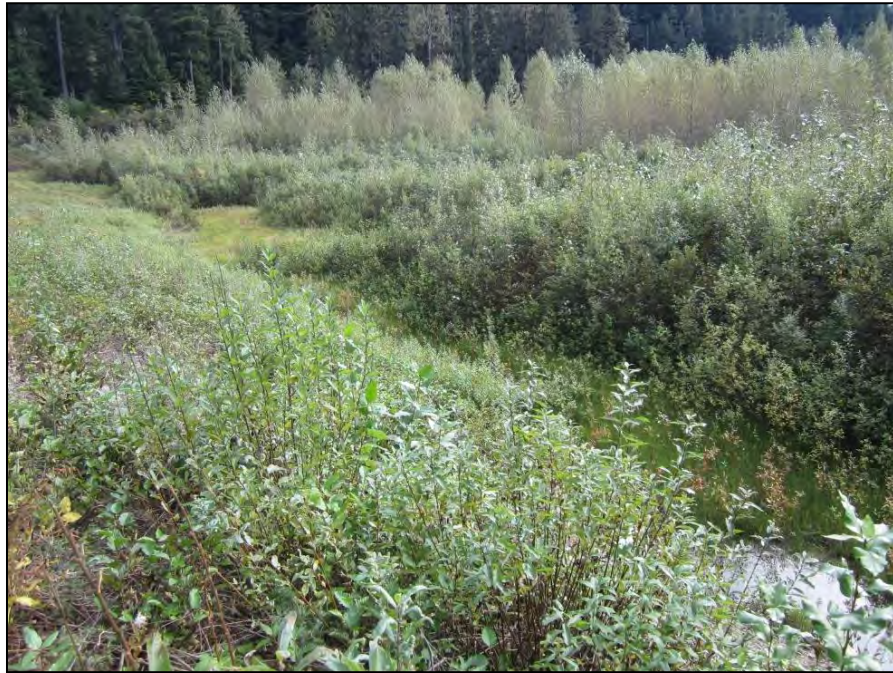
PHOTO 10 – Dyke 1 – Downstream face of the dam from the South East.

PHOTO 11 – Dyke 1 – Downstream face of the dam from the North East.

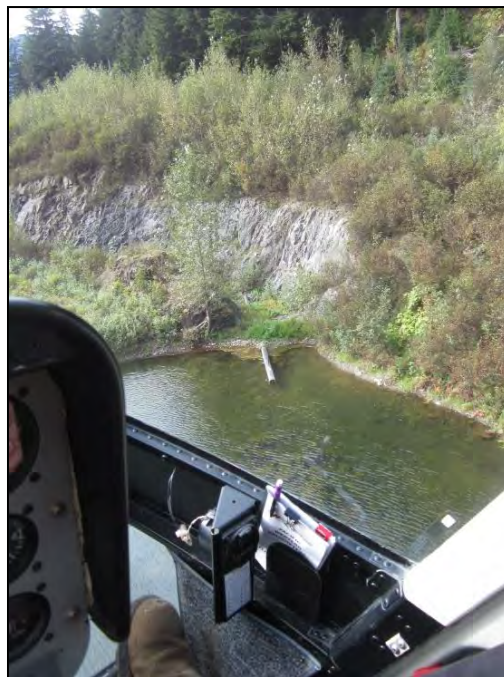
- The spillway inlet (Photo 12) and outlet (Photo 13) were found to be in fair condition with a generally clear unobstructed passage.
- The spillway inlet includes material (mostly branches) placed at the entrance by beavers. This material has been partially cleared (Photos 12, 14 and 16).

PHOTO 12 – Spillway entrance (Dyke 1 North East abutment).

5.0	SPILLWAY		
(a)	Inlet		
	- Obstructions	F	Some waddy debris from beaver activity and and vegetation becoming established, recommend this is removed.
	- Slough Above Inlet	S	Unchanged from previous inspections, dense well established vegetation

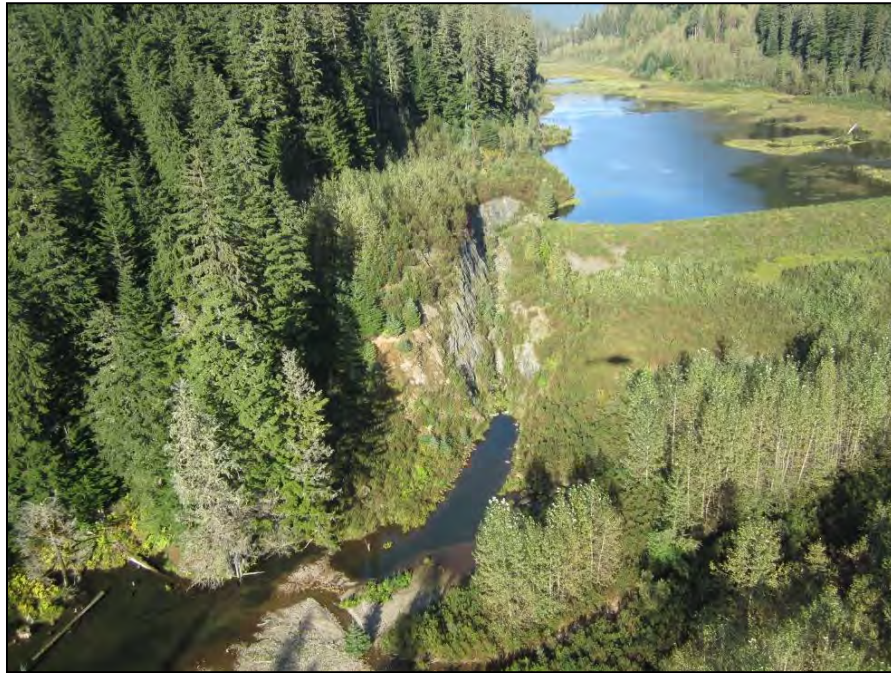
PHOTO 13 – Spillway Outlet (Dyke 1 North East abutment).

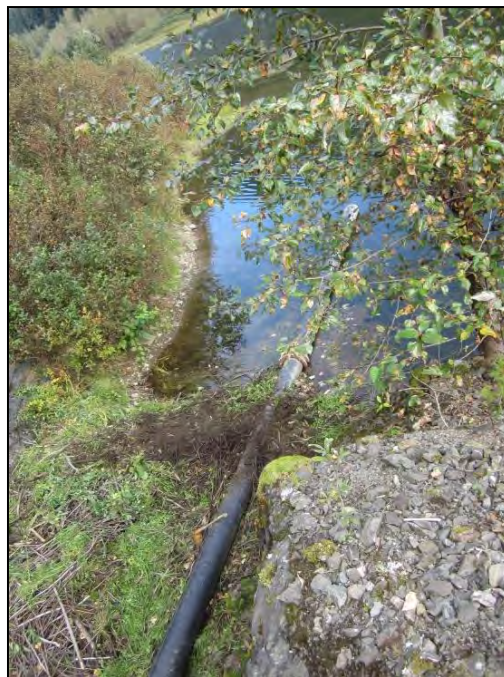
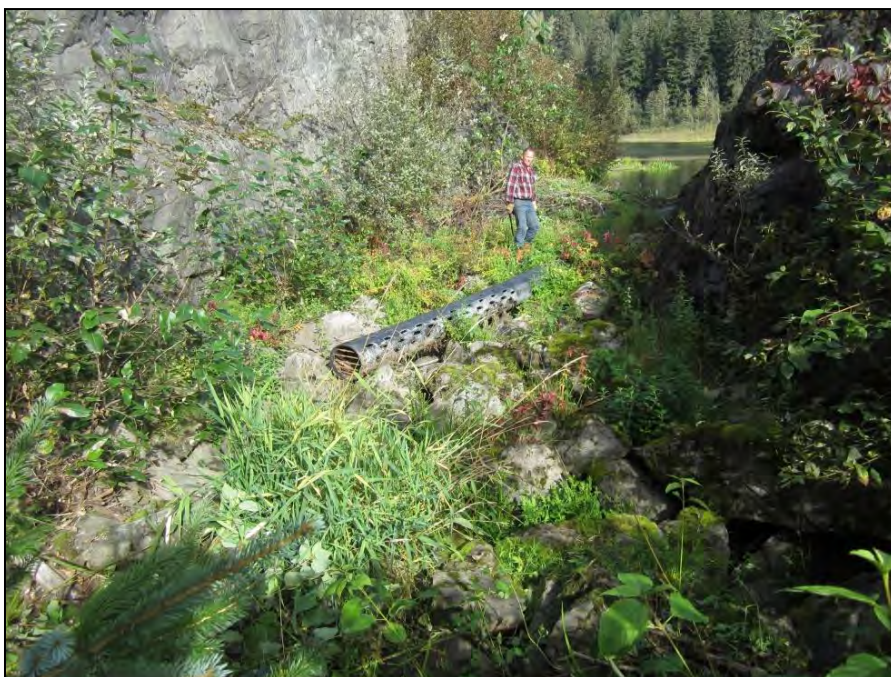
PHOTO 14 – Spillway entrance – site fabricated beaver protection pipe.

PHOTO 16 – Spillway - Side slopes and beaver protection pipe outlet.

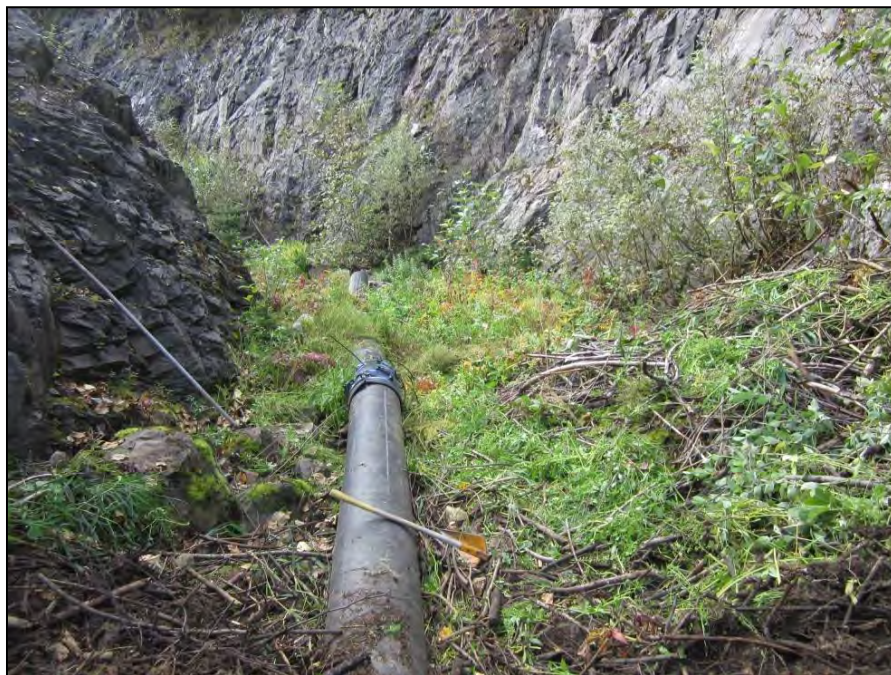
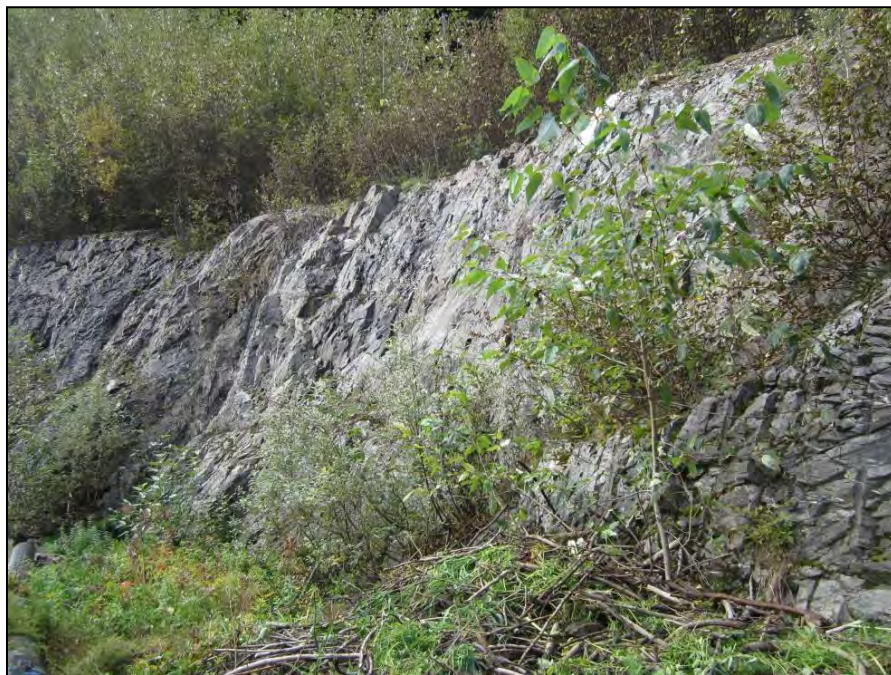
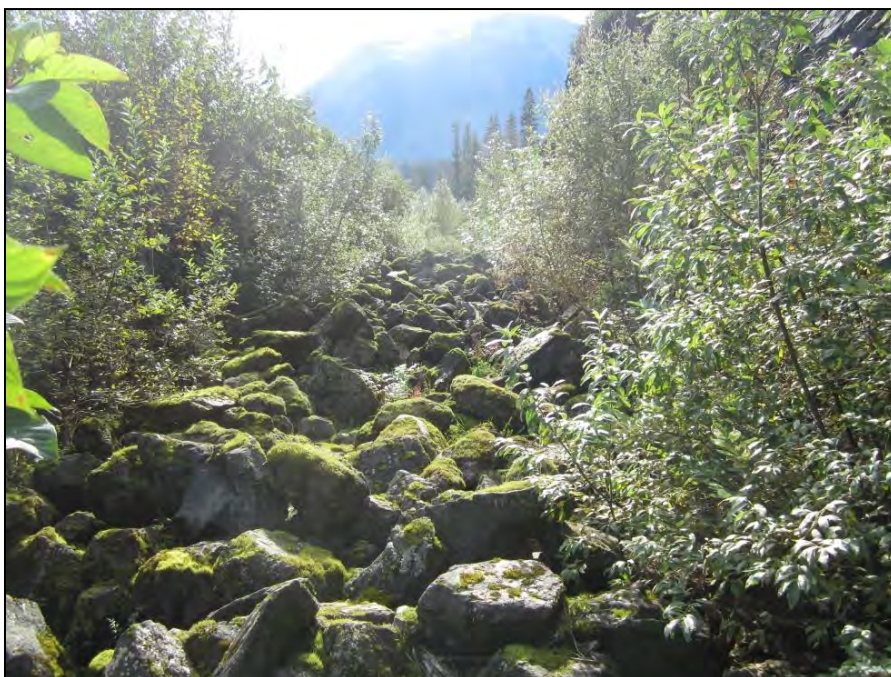
- The spillway side slopes channel are in fair to good condition with minor obstructions or impediments to the flow due to brush becoming established at discrete locations on the walls of the channel (Photos 15 to 18). The riprap on the floor of the spillway was generally clean once past the immediate entrance to the spillway.

PHOTO 15 – Spillway - Side slopes and beaver protection pipe.

PHOTO 17 – Spillway – rock cut side slopes.

PHOTO 18 – Spillway channel.

(b)	Excavated Channel		
	- Rock Cut	S	Isolated vegetaion in banks, recommend this is removed
	- Obstructions	F	Isolated clumps of vegetation, recommend it is removed

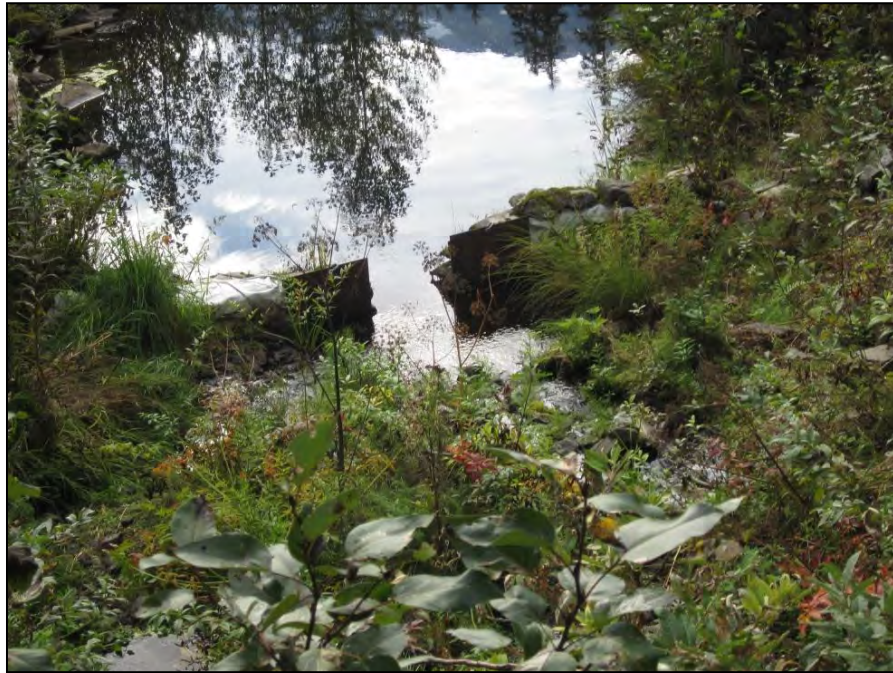
- The outlet of the spillway into Sky Creek was in fair to good condition with some discrete brush becoming established.
- A beaver dam has been built downstream of the spillway outlet resulting in ponded water submerging the weir located below the spillway outlet (Photo 19). The beaver dam is approximately 50 m downstream of the spillway exit and has no impact on the security of the facility (Photo 19).

PHOTO 19 – Spillway – weir at base of the outlet (note weir is flooded due to downstream beaver dam).

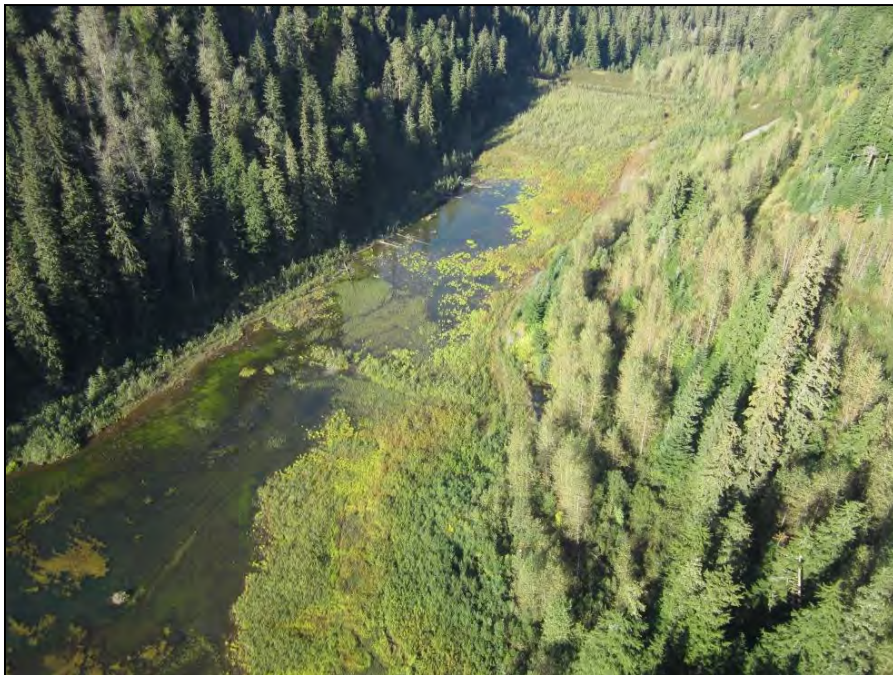
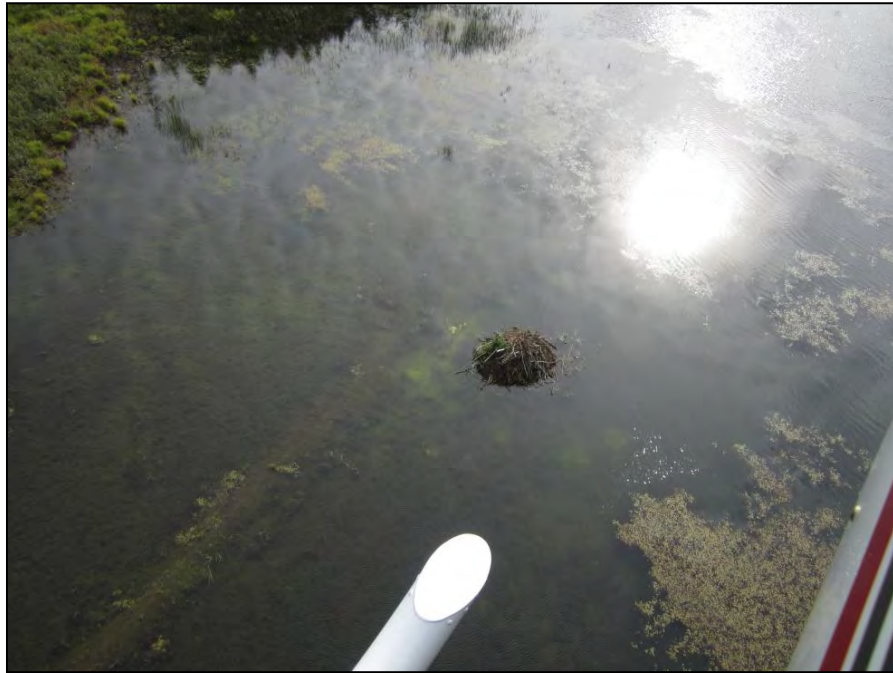
PHOTO 20 – Impoundment limit and Dyke 3 (note beaver lodge in lower left corner, see photo 21 for detail).

PHOTO 21 – Beaver lodge in impoundment pond.

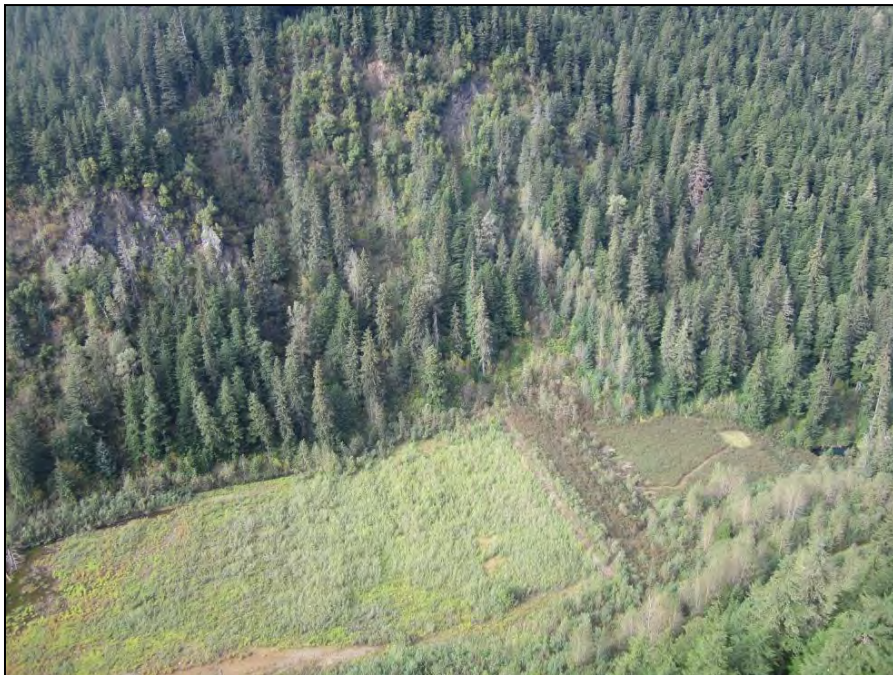
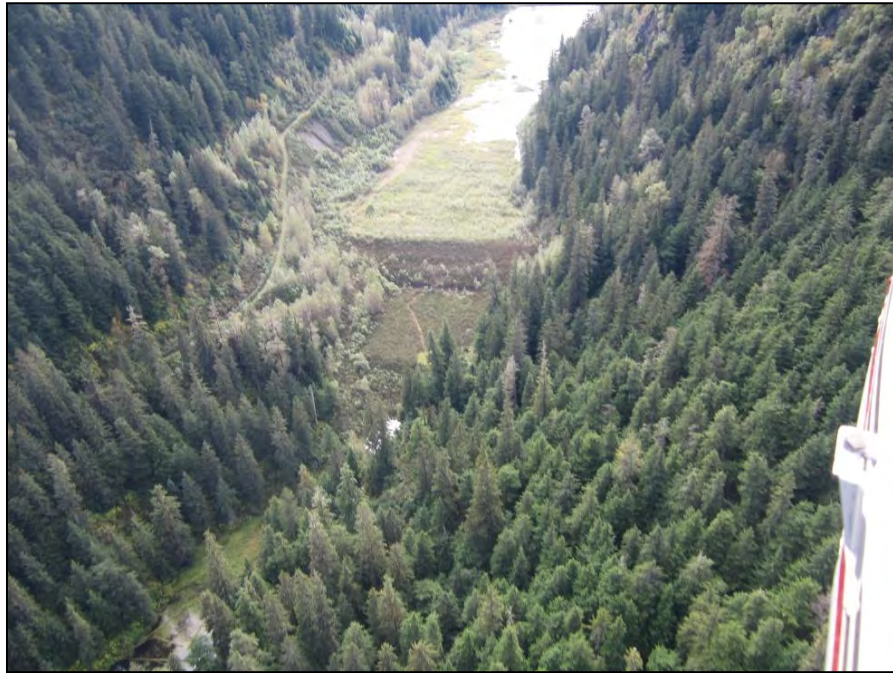
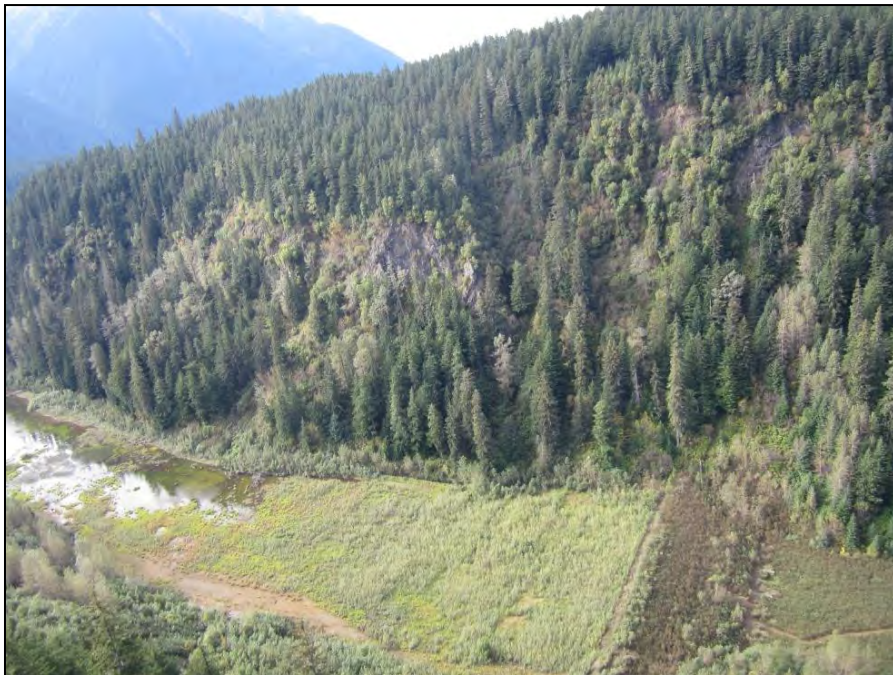
- The north and south abutments to the dyke were in good condition with no new slope instability features noted (Photo 22 to 24).
- A small road fill instability noted in previous inspections approximately 100 m upstream of the dyke is unchanged from previous inspections (Photo 25) and poses no threat to TSF stability.

- No surface water was ponded against the upstream face of Dyke 3 (Photos 22 to 24).
- Very thick vegetation growth, approximately 3 m high, was present on Dyke 3, including the dyke crest, downstream slope, closure stability berm. The vegetation growth made progress difficult and limited visibility to a few meters (Photos 28 and 29). A thorough visual inspection of Dyke 3 was not possible. The clearing of this vegetation from the upstream rip rap to the crest of the stability berm is recommended.

PHOTO 22 – Dyke 3 – Upstream overview from South East.

PHOTO 23 – Dyke 3 – Downstream overview from North East.

PHOTO 24 – Dyke 3 West Abutment and Impoundment - Overview.

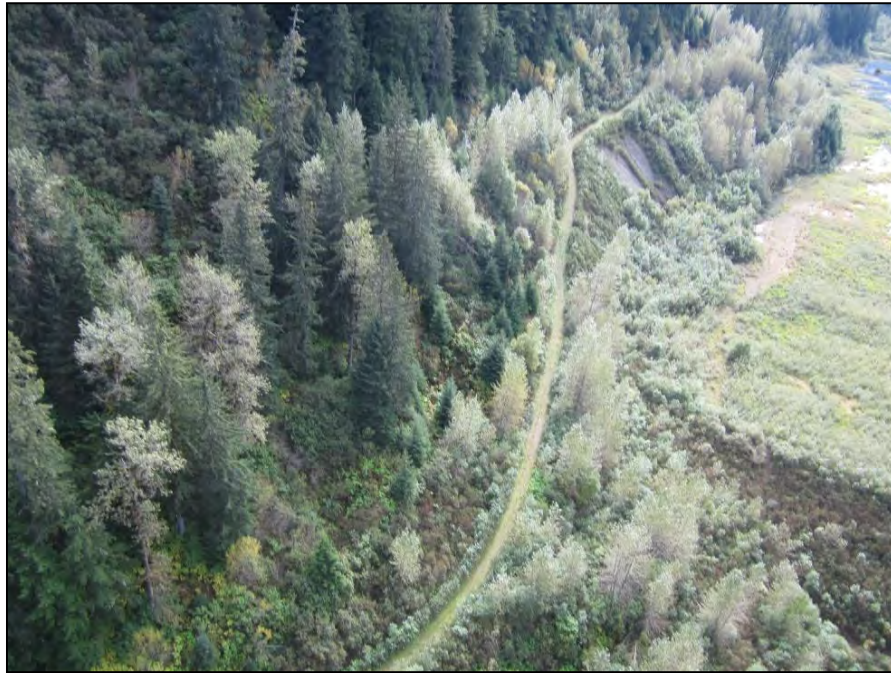
PHOTO 25 – Dyke 3 – East Abutment Overview.

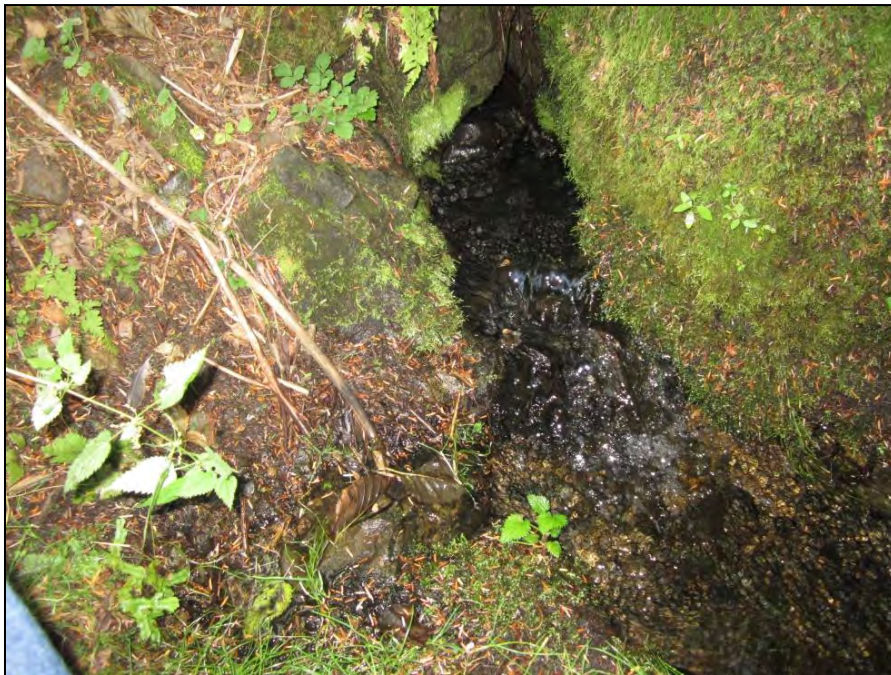
PHOTO 30 – Dyke 3 seepage – clear estimated flow rate 1 to 1.5 l/sec.
