November 21, 2014

CONFIDENTIAL
FILE: V15103110-01Cassiar Gold Corporation
China Minerals Mining Corporation
Suite 1100 – 1111 Melville Street
Vancouver, BC V6E 3V6**ISSUED FOR USE**

Subject: Report on Dam Safety Inspection
Tailings Storage Facility – Cassiar Gold Mine
near Jade City, BC

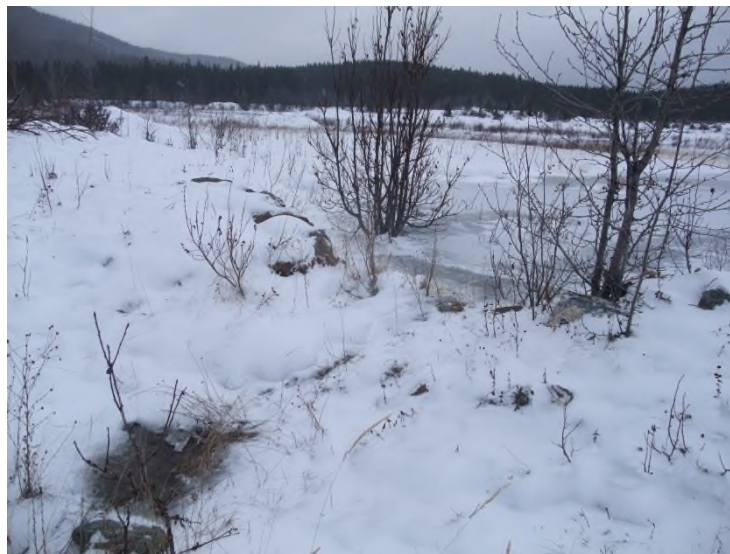
There was a small volume of ponded water within TSF 1 hydraulically connected to a small riprap lined spillway (estimated dimensions 6 m top, 1 m base, 1.5 m high) at the east end of the facility. There was minimal flow (estimated < 2 L/s) flowing at the time of the inspection – see Photos 1 and 2. Knight Piesold estimated the spillway capacity to be about 5 m³/s which is in excess of the 1-in-200 year 24-hour storm precipitation of 53 mm.

Photo 1: Upstream view of spillway inlet at TSF 1 (October 28/14)

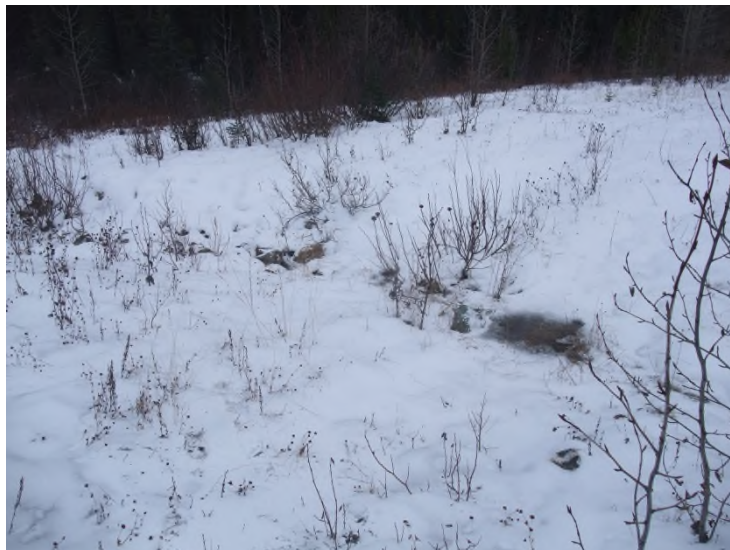
The site is presently in care and maintenance, with no regular monitoring or water sampling being completed. There is a small trickle (estimated < 2 L/s) through the spillway from TSF 1. Only water is being discharged – no tailings were observed in the discharge.

Photo 2: Downstream view of spillway from TSF 1 (October 28/14)

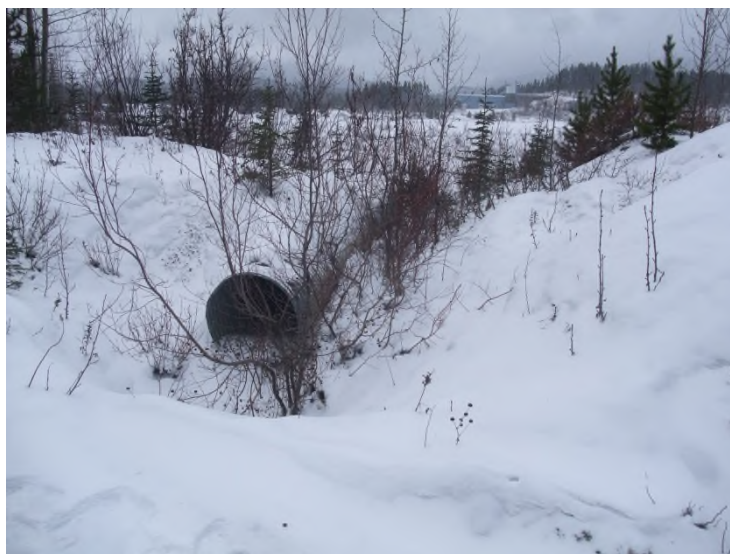
The south end of TSF 1 contained an incomplete culvert installation (see Figure 2 and Photo 3) probably for water management purposes. As this end of the pond is a couple metres higher than the existing spillway, it will likely never convey water. It is recommended that this partially installed culvert be removed and the embankment closed off and repaired at abandonment.

Photo 3: Incomplete culvert installation at south end of TSF 1 (October 28/14)

1. The emergency spillway at the south end of TSF 1 is incomplete and the culvert materials are on site. It looks as though construction was started and then abandoned. The elevation of TSF base at this corner (976 m) is about two metres above the limits of ponded water (and the invert of the spillway at 974 m) so will likely not see water in the current operating condition. As noted in the 2009 inspection, this should be closed off and repaired during closure and reclamation activities.

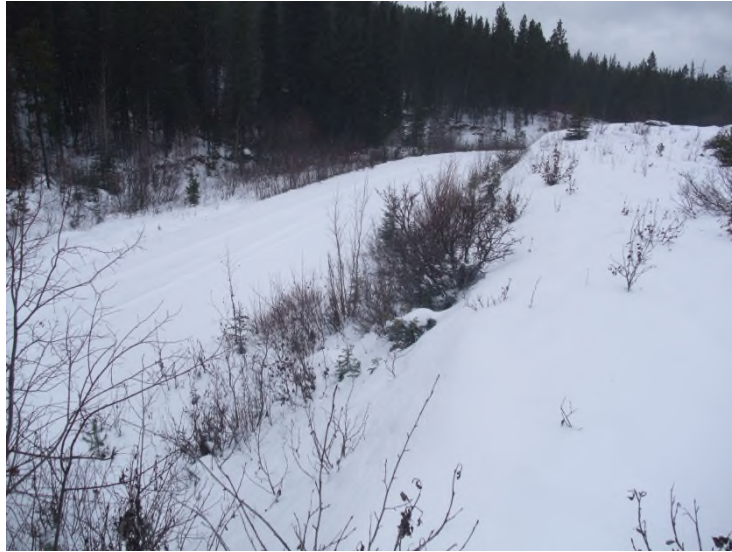
One oversteep section was noted on the west side of TSF 1, next to the road to the mine. This oversteep section was previously noted in the Knight Piesold report, and should be flattened or stabilized with a toe berm if TSF 1 is to impound significant volumes of water in the future.

Photo 4: Oversteep section of berm along west side of TSF 1 (October 28/14)

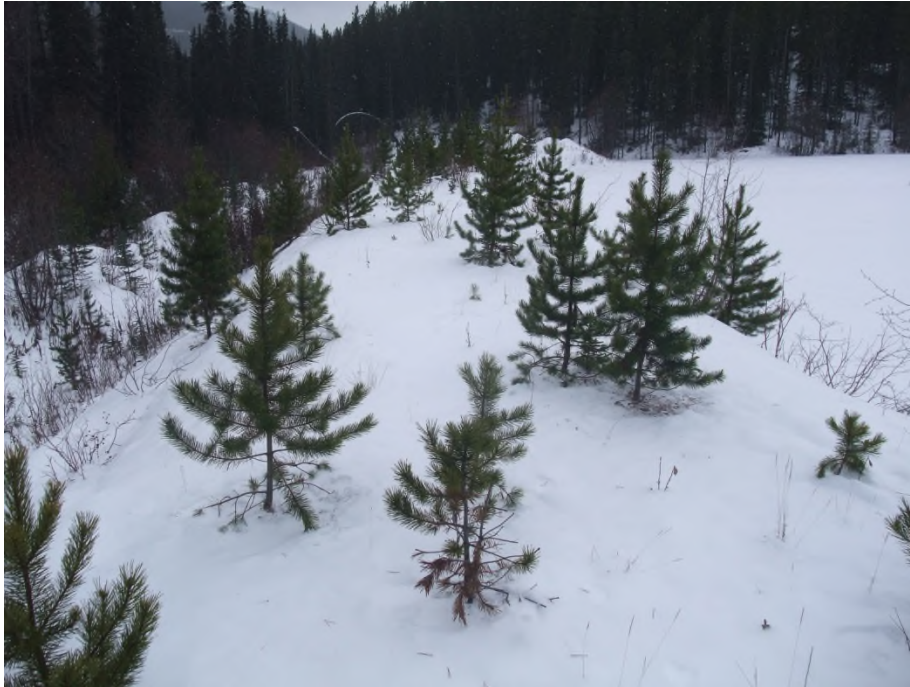
Significant pine tree growth was noted on one section of the berm (see Photo 5) – with some trees up to 100 mm butt diameter. These should be cut down and have their root bulbs pulled out to minimize the potential for future seepage paths, should the facility become operational again. Some minor earthfill and compaction will be required after removal of some of the larger trees.

Photo 5: Pine tree growth on crest of south leg, Phase 1 and 2 berm of TSF 2 (October 28/14)

2. Assuming that the tailings storage facilities will be used again in the future, remove woody vegetation on the crests and the top 3 m of sideslopes on both TSF 1 and TSF 2, ensuring that the roots are pulled out with heavy equipment. Re-compact the surface after root removal to fill in the depressions. Roots are potential conduits for uncontrolled seepage, and vegetation growth generally inhibits visual inspection. Some earthfill and compaction may be required for some of the larger trees, particularly on TSF 2.
