Wolverine Mine 2014 Tailings Facility Annual Inspection

Submitted to:
Wolverine Coal Partnership

Project Number: 341-8

Date:
November 4, 2014

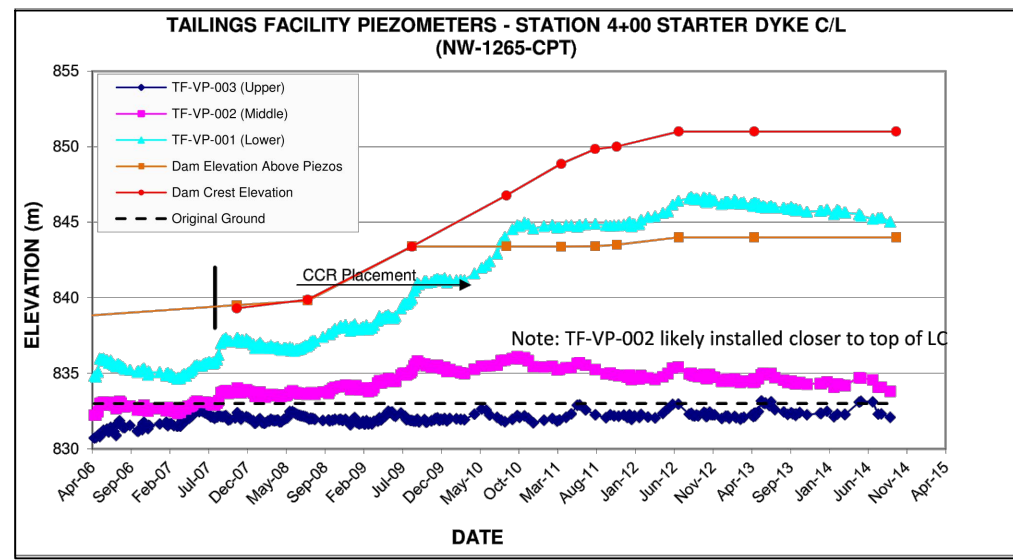
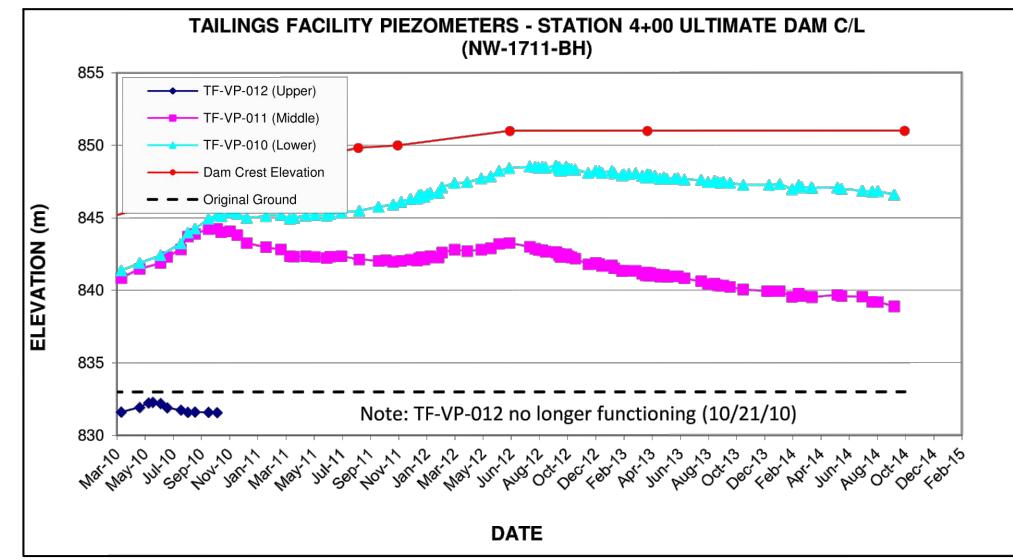
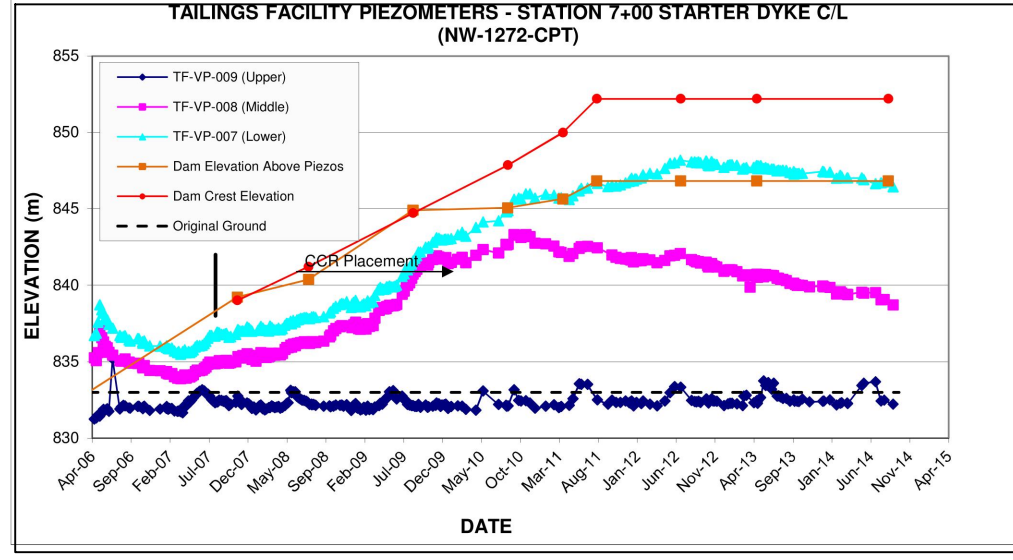
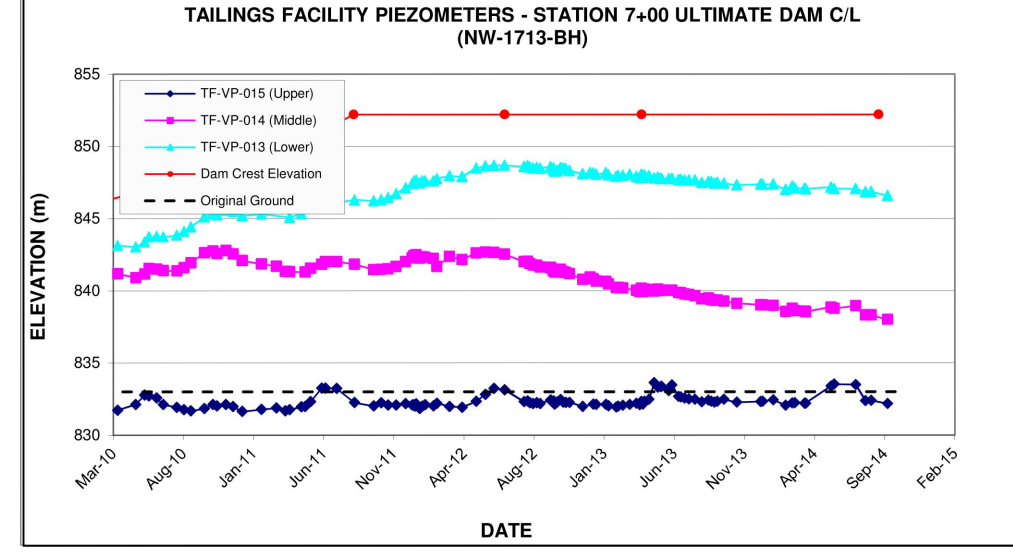
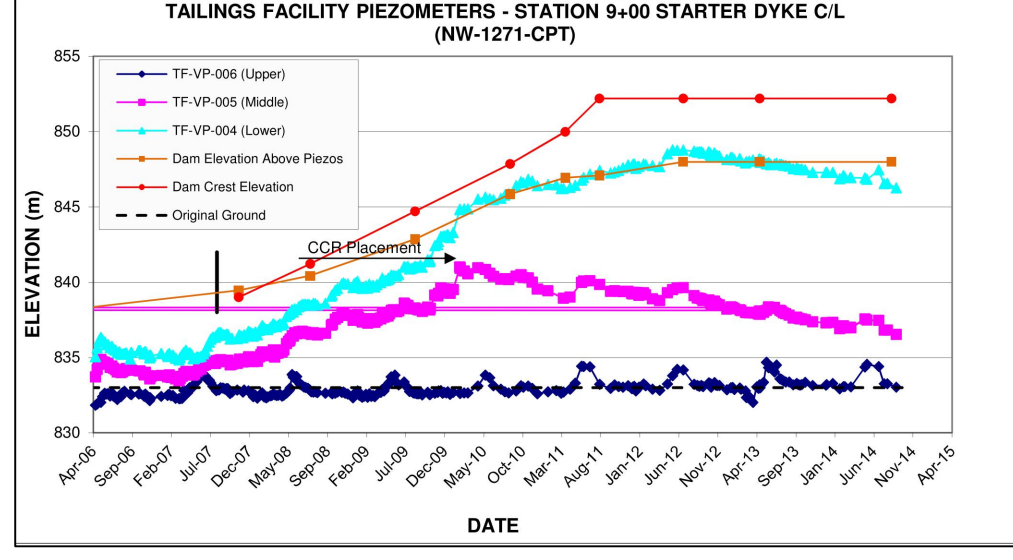
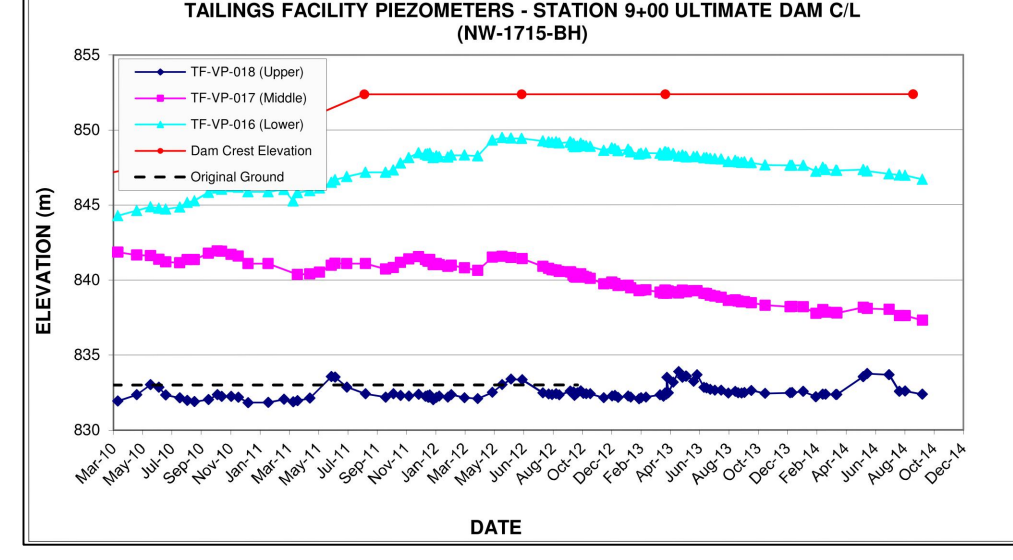
WOLVERINE COAL PARTNERSHIP WOLVERINE PROJECT		
	FIGURE 1 TAILINGS FACILITY FOUNDATION PIEZOMETER DATA		
SCALE: AS SHOWN DATE: 2014-10-16 CO-ORD. SYS.: UTM NAD83-10 DRWN BY: SC DSGN BY: GL REVD BY: GL APPD BY: SE	PROJECT NO.: 341-8	FIG. NO.: 1	REV.: 0

- The piezometers in the bouldery gravel unit (labeled as Upper) are providing an indication of the shallow groundwater table beneath the tailings dam with the exception of TF-VP-012 which is no longer functional. The Upper piezometers vary between elevations of 832m and 833m and show an annual rise (1 to 2m) during May and June corresponding with the spring freshet. The groundwater level is about 8 to 9m below the pond water elevation (840.8m on August 14, 2014) indicating that the upper clay unit and upstream blanket continue to act as seepage barriers between the tailings pond and the underlying natural groundwater regime.
- The piezometers in the lower clay unit (labeled as Middle and Lower) clearly indicated a response to loading from the starter dyke in mid-2006 and subsequent CCR placement

which began in mid-2007. Since CCR placement ended mid-2012, the Middle and Lower piezometers have shown continued pore pressure dissipation (i.e. post-construction). The Middle piezometers are installed about 5m below the top of the lower clay unit and are currently showing an average $b\text{-bar}^1$ of approximately 0.17. The Lower piezometers are installed about 20m below the top of the lower clay unit and are currently showing an average $b\text{-bar}$ of approximately 0.42. The Lower piezometers are showing higher response to dam raising than the Middle piezometers because the upwards drainage path is longer which delays consolidation.

- The Lower piezometers installed initially beneath the starter dyke (TF-VP-001, -004, -007) in the lower clay unit are measuring a piezometric surface that is averaging about 0.6m higher elevation than that of the current dam elevation above the piezometers. This is more than likely the three-dimensional effects of loading due to placement of CCR on the downstream side of the tailings dam where the fill placement is higher than immediately above the piezometer nest. The Lower piezometers are deeper than the Middle piezometers and are showing a more delayed dissipation in pore pressures due to a longer flow path.

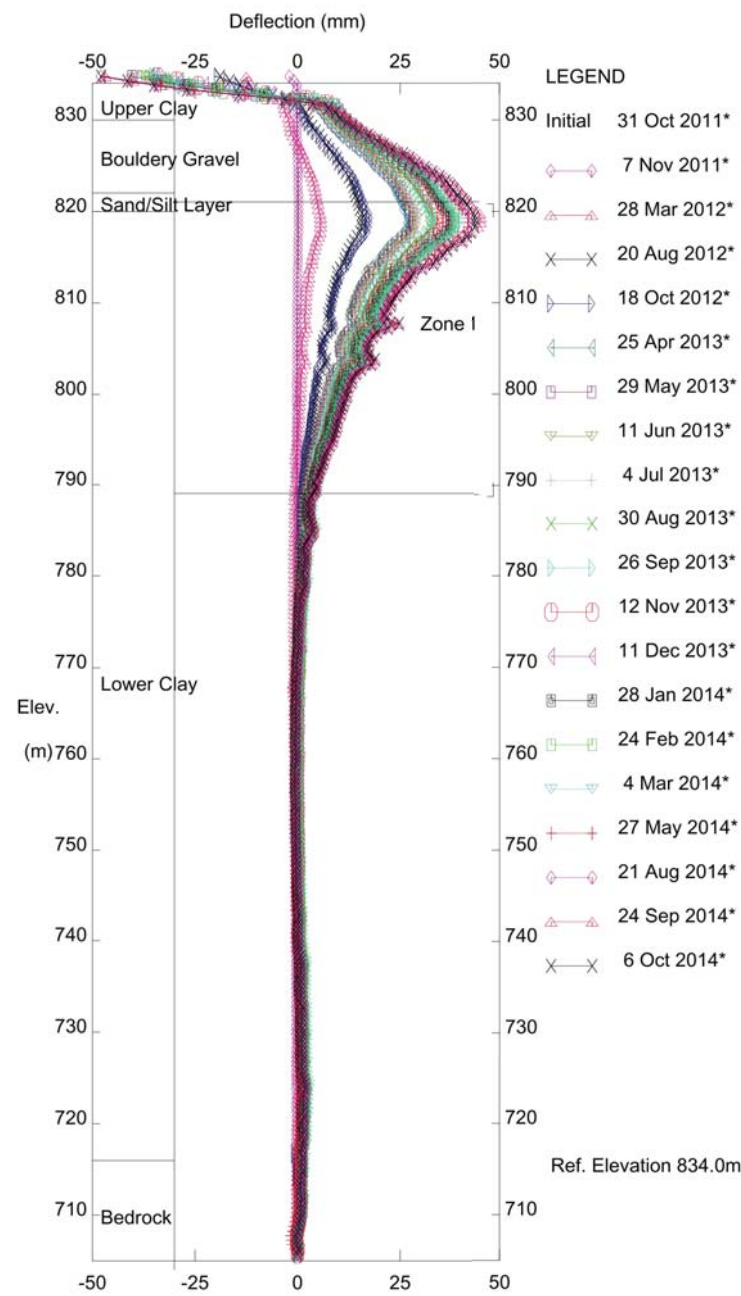
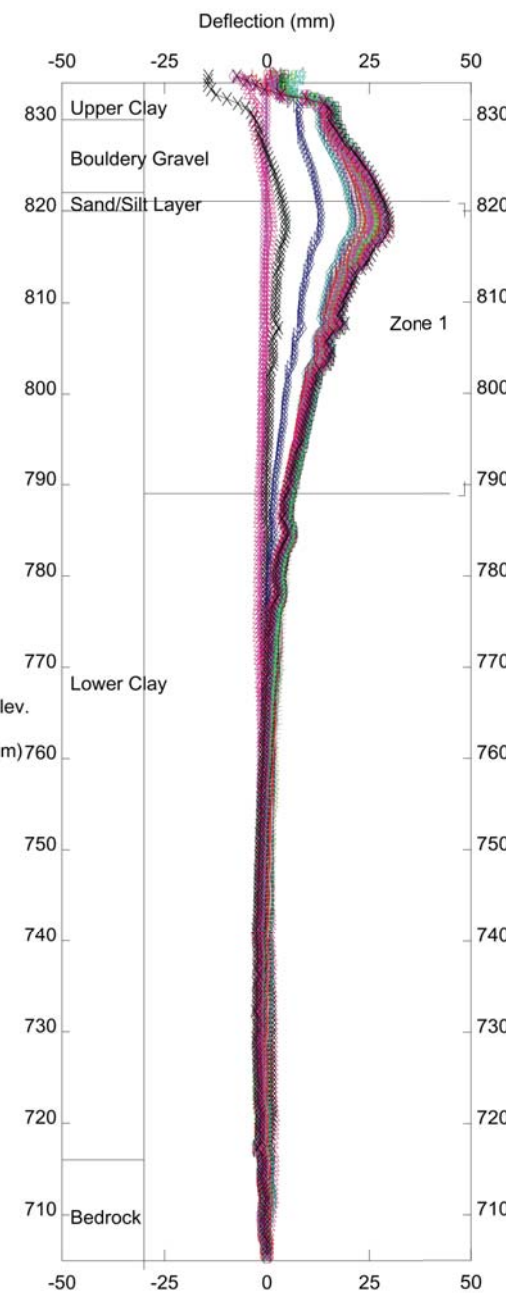
Cumulative Deflection
 Direction A
 Perpendicular to Dam Crest Tailings Facility, Inclinator TF-SI-002

Inclinometers TF-SI-002, TF-SI-004 and TF-SI-005 showed continuous movement throughout the year. TF-SI-002 and TF-SI-004 have shown a reduced rate of movement in 2014 (compared to 2013). TF-SI-005 indicates a slight increase in the rate of movement since the last annual inspection. There has been no significant movement detected in TF-SI-006.

The movement observed in these slope inclinometers is an expected response due to undrained loading of the dam fill on the underlying lower clay unit. Shear stresses produced by the undrained loading are contributing to lateral straining as observed at the top of the lower clay unit. As consolidation continues and the excess pore pressure in the clay dissipates, more of the load is transferred to the soil skeleton and lateral strains should reduce over time (provided there are no further dam raises). Based on the data observed to date, it appears that the slope inclinometers TF-SI-002 and TF-SI-005 are beginning to show signs of a reduced rate of displacement.

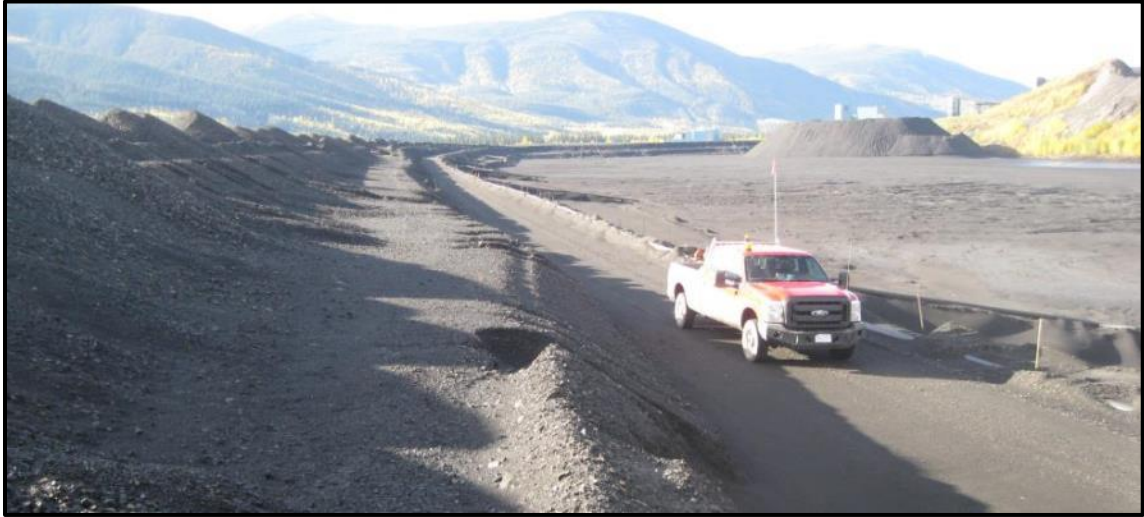
There were no signs of cracking or instability observed and the upstream slope was in good condition (Photo 1). There were some minor erosional gullies along parts of the slope. Visual inspections should continue (particularly after heavy rainfall) along the upstream slope to ensure that the minor gullies do not develop further and propagate back into the crest.

Photo 1: Upstream slope of the main embankment (looking southwest).

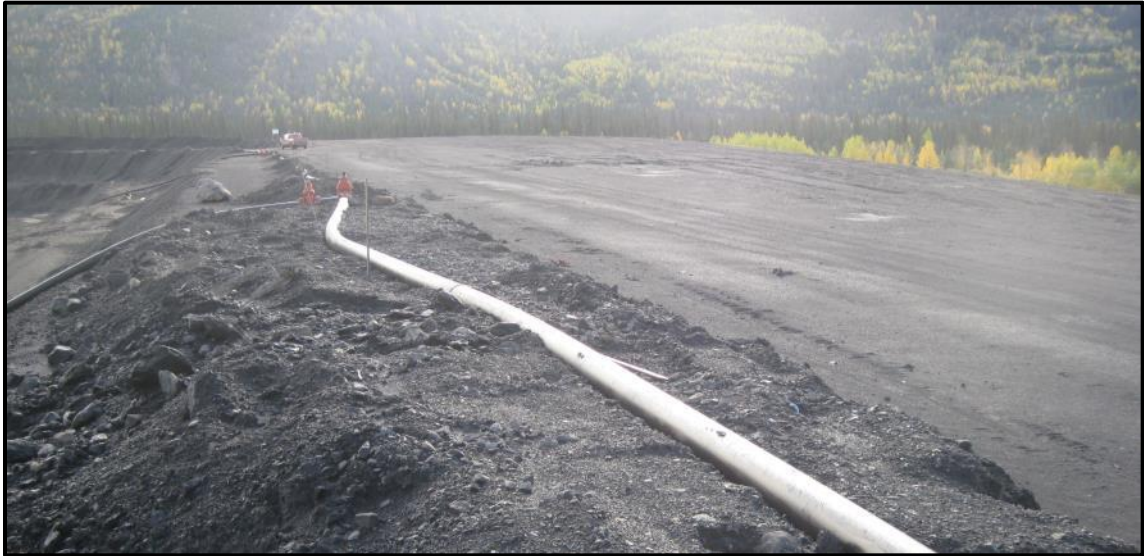
There were no signs of cracking or instability observed (Photos 2 to 5). During operations, the crest area is used as a running surface for haul trucks to access the fill placement areas and is non-vegetated. There were no signs of ponded water or significant depressions at the time of the inspection.

Photo 2: Crest area of the south embankment (looking east).

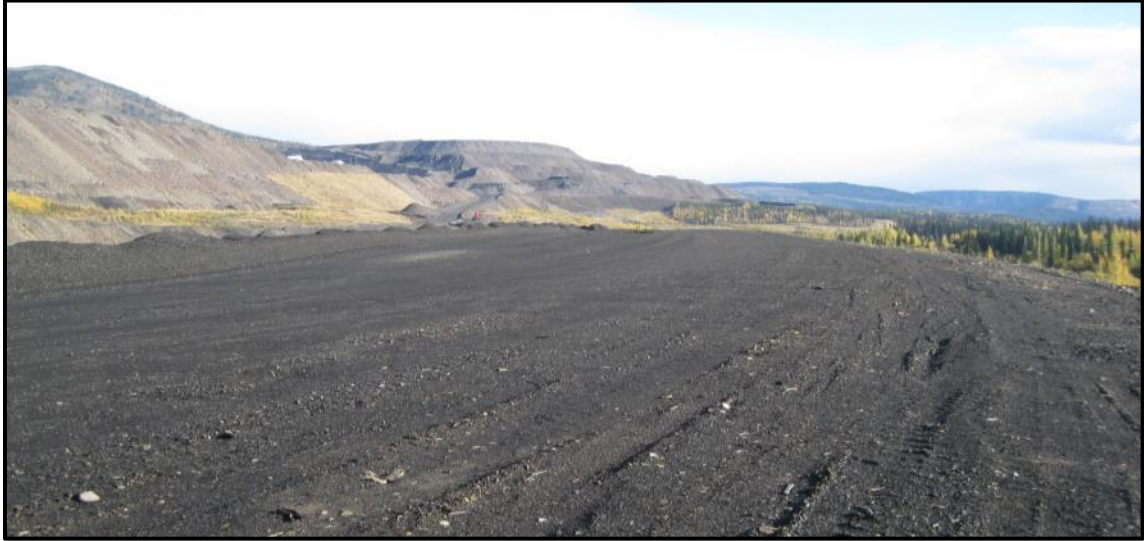
Photo 3: Crest area of the main embankment (looking northeast).

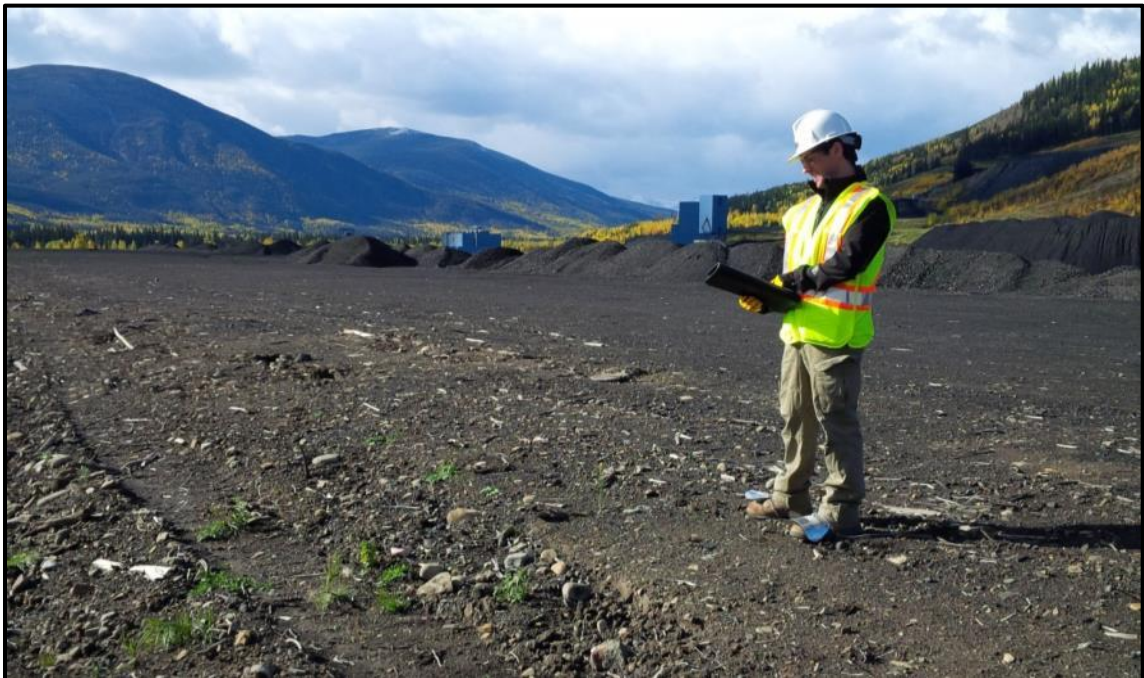
Photo 4: Crest area of the main embankment (looking southwest).

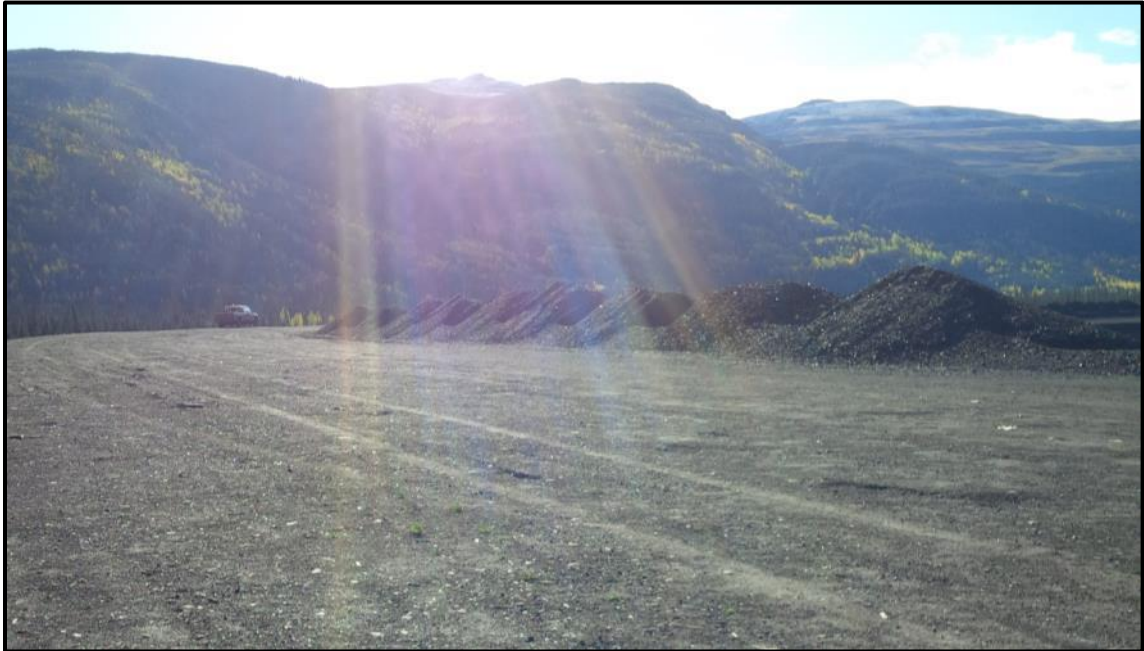
Photo 5: Crest area of the northern embankment (looking southeast).

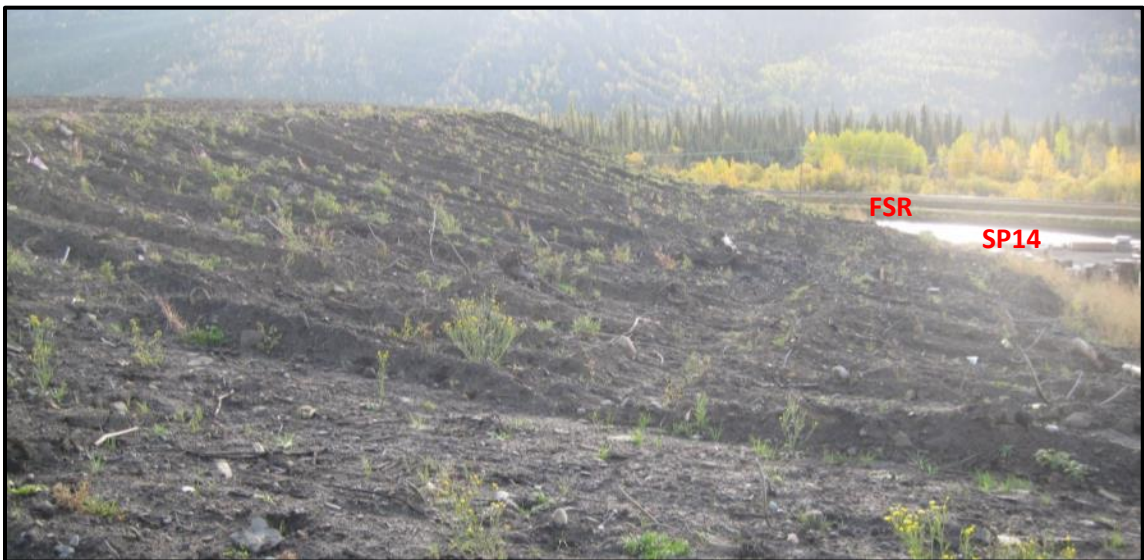
There were no signs of cracking or instability observed. Placement of reclamation material has continued up most of the slope face since the last annual inspection (See Photos 6 to 8). This will help prevent the establishment of erosional gullies in the long term. Vegetation established on the northeastern slope has prevented the continuation of minor erosional gullies upslope (Photo 9). Erosional gullies observed on the northern abutment during the last annual inspection have since been remediated.

Photo 6: Reclamation material placed on the southern embankment downstream slope (looking east).

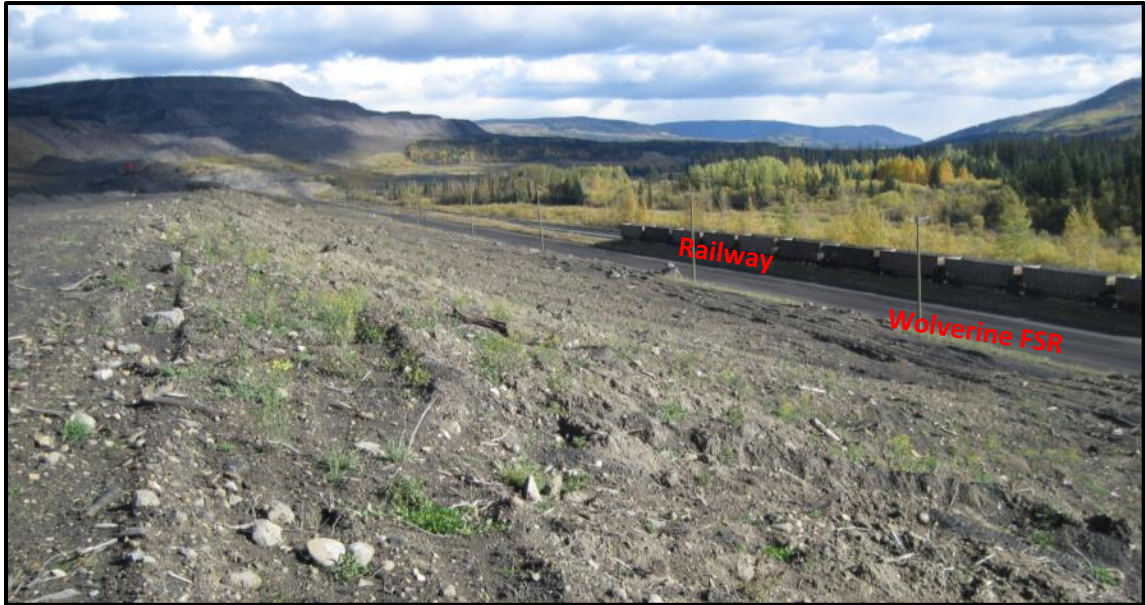
Photo 7: Reclamation on the main embankment downstream slope (looking northeast)

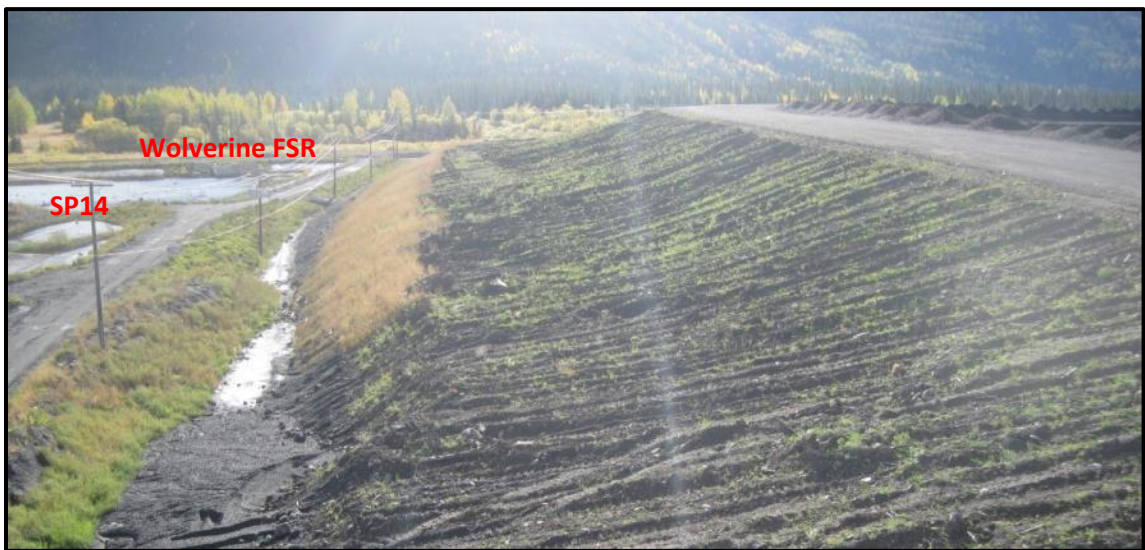
Photo 8: Reclamation on the northeastern embankment downstream slope (looking southeast)

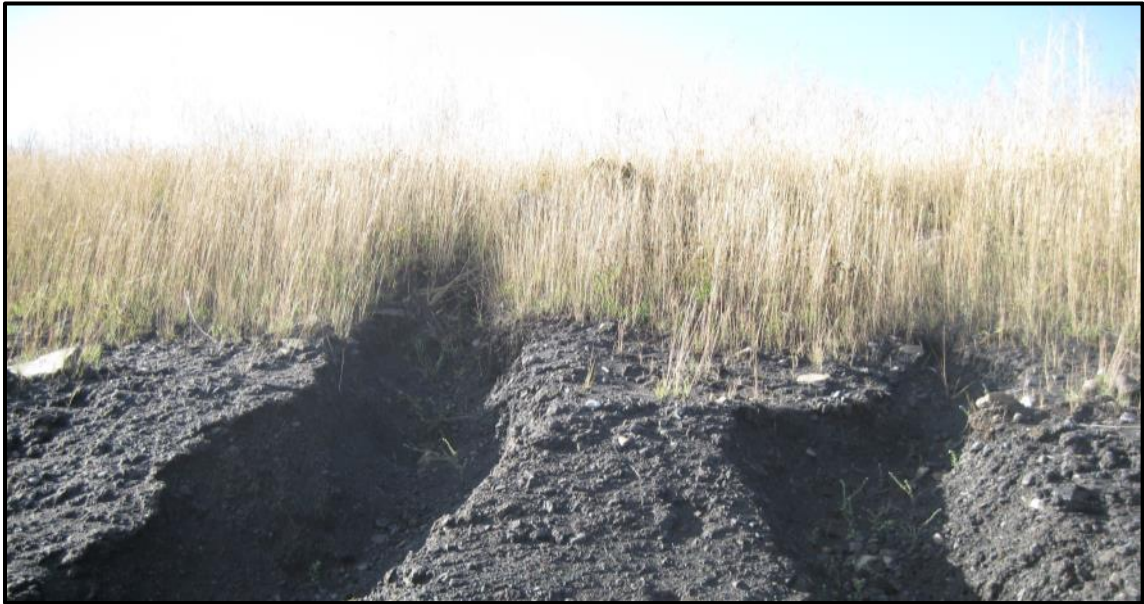
Photo 9: Reclamation on the northeastern embankment downstream slope. Further erosion has been minimized due to the presence of established vegetation.

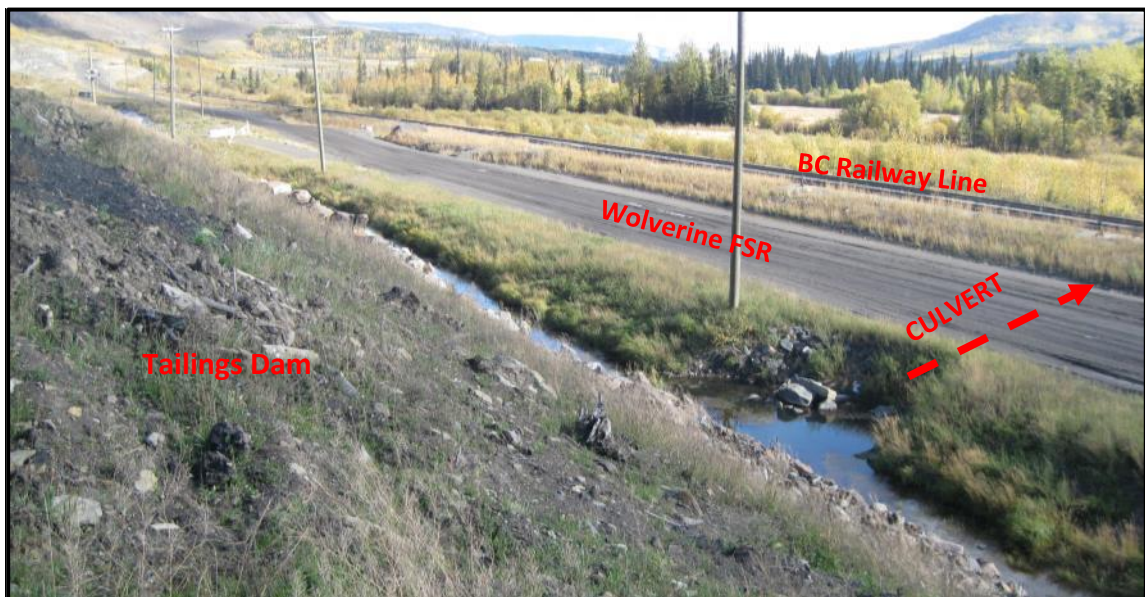
The downstream toe drain ditch (Photos 10 to 12) is functioning as per design intentions and visibly clean water was observed flowing into the ditch. Culverts installed to allow water to discharge from the ditch into the Wolverine River were blocked off in 2012 due to environmental release restrictions. WCP recently obtained a conditional approval from the Ministry of Environment (in a letter dated September 25, 2014) to re-establish flow through the culverts. At the time of the inspection, water in the ditch was being pumped into an adjacent

settling pond (SP-12). Approximately 30 cm depth of water was ponding in the ditch at the northeastern corner (Photo 10), with the remainder of the ditch relatively dry (Photo 11). Site personnel have since reported that the culverts (Photos 10 and 12) have been unplugged (on October 3) and flow is now conveyed directly into the natural floodplain channels which drain into the Wolverine River.

Photo 10: Toe drain ditch at approx. Station 3+00 (looking northeast). Water ponding between approx. Stations 3+00 and 4+50 due to plugged culverts at time of inspection. Culverts have since been opened up.

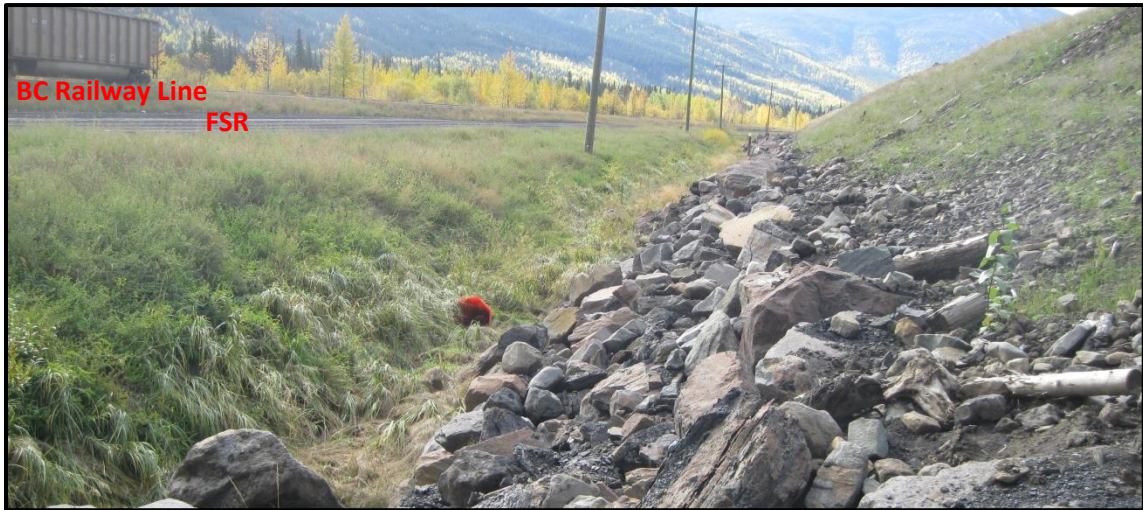
Photo 11: Toe drain ditch between Stations 4+00 and 5+00 (looking south). Ditch is generally dry from this point heading south.

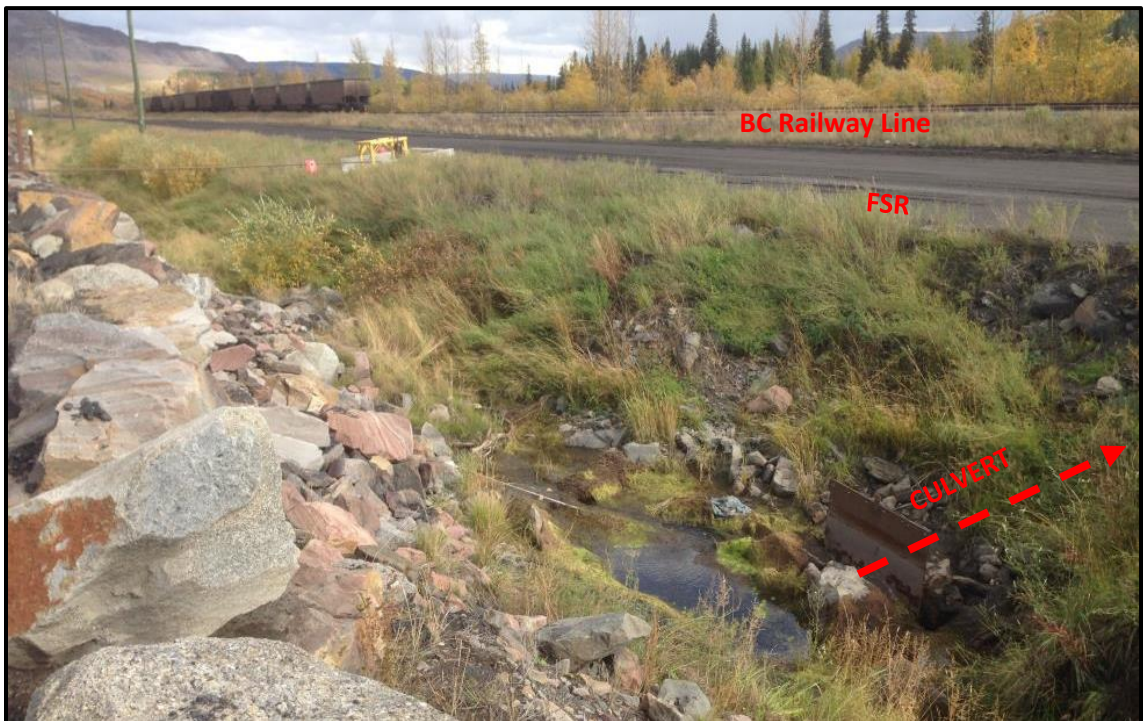
Photo 12: Toe drain ditch at approx. Station 7+00 (looking northeast). Minor flow (< 0.5 l/s, clear) observed coming from the toe drain and directly into the culvert.

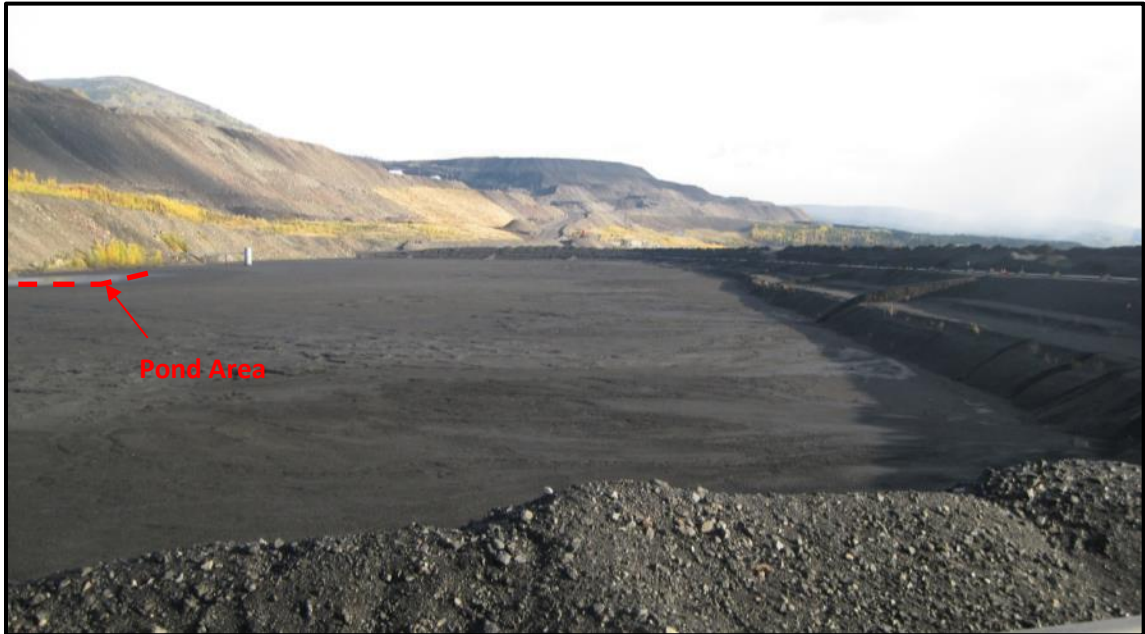
The water level in the tailings facility was visibly low at the time of the inspection and the impoundment was mostly covered by beach (see Photo 13). Drawing 1 shows the approximate pond extent based on the August 2014 ground survey information. The tailings pond was approximately 840.8m based on the August 2014 survey. Regular water level measurements of the tailings pond should be taken to maintain a record over time.

Photo 13: Tailings beach with edge of pond on far left (looking north).

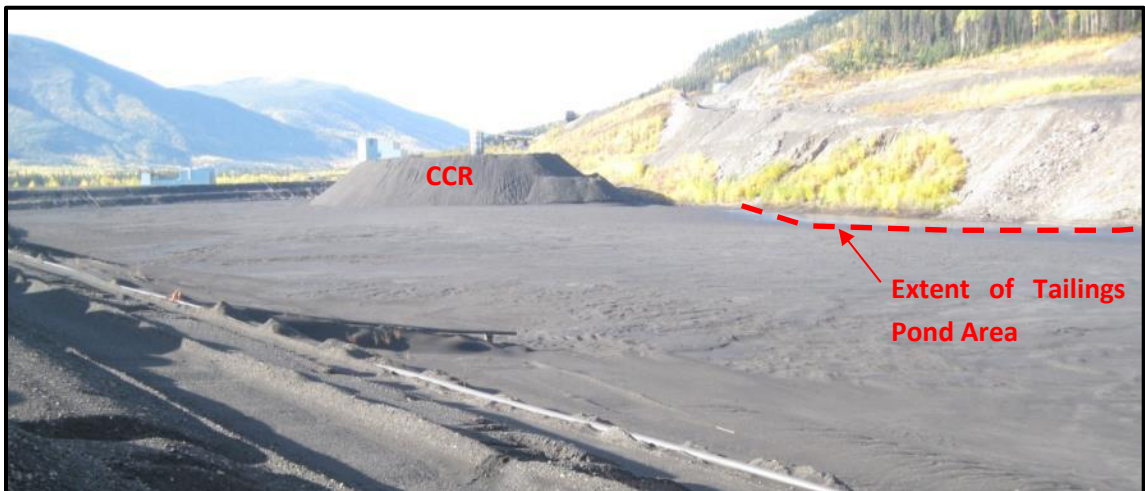
The temporary winter CCR stockpile (Photo 14), as illustrated in Drawing 1, is about 8m larger than originally envisioned at an elevation just over 860m. Design guidelines were provided to WCP personnel in December 2013. These design guidelines were as follows:

Norwest understands from discussions with site personnel that the winter CCR stockpile is used whenever temperatures are below -15°C. The cold temperatures make it difficult to meet the lift compaction specifications in the permanent CCR stockpile. Efforts should be made as soon as possible to reduce the current height of the stockpile to 852m.

Photo 14: Winter CCR Temporary Stockpile (looking southwest) with tailings pond on right side.

6. Downstream toe ditch buttress construction (priority – 3 to 6 months). Norwest are currently completing the buttress design.
7. Reduce height of Winter CCR Stockpile (priority – 3 to 6 months). The stockpile should be reduced to the maximum recommended elevation of 852m.
