December 1, 2014

Project #: 341-8

Subject: Wolverine Tailings Facility – 2014 Annual DSI Supplemental Information (Rev 1)

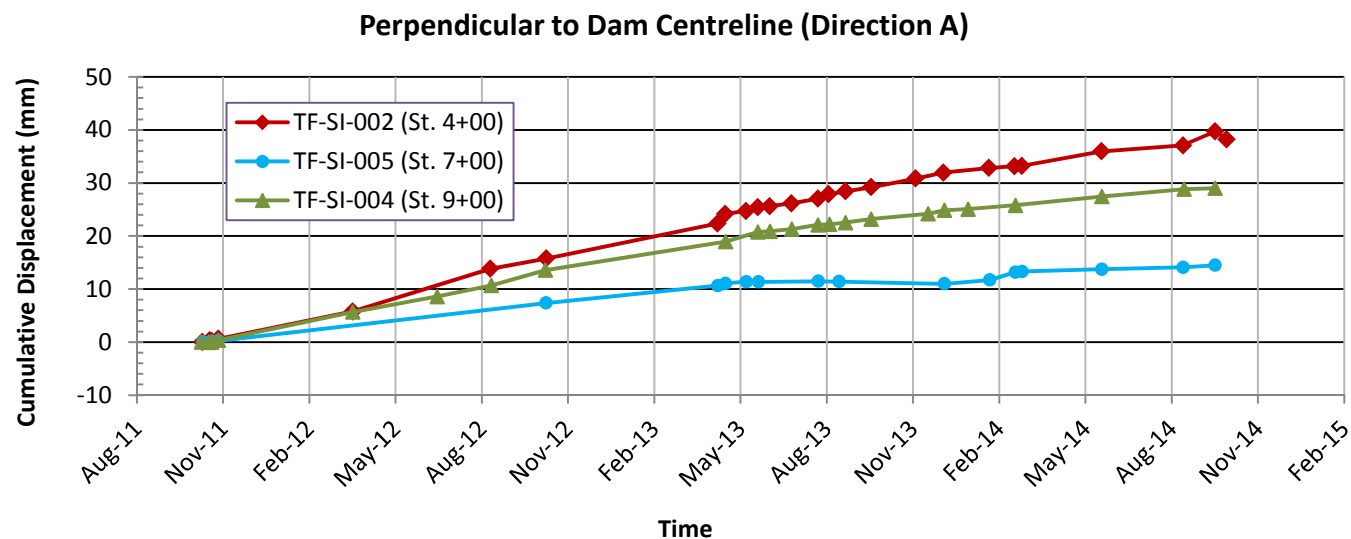
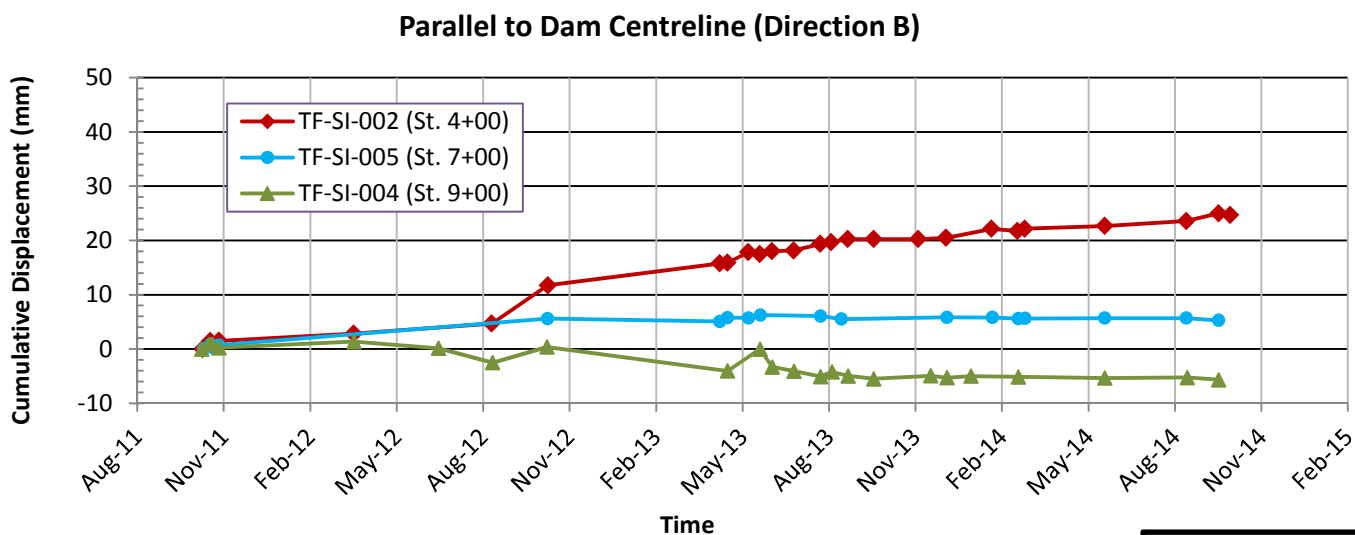
Norwest currently review time-displacement plots during quarterly monitoring data review and as part of the annual inspections. Time-displacement for zones of interest within slope inclinometers TF-SI-002, -004 and -005 are presented in Figure 1 (see enclosed). This data is also summarized in Table 3.1 of the 2014 DSI report.

1. Data for TF-SI-006 has not been shown as there is no significant movement in this slope inclinometer to date.

#7 – Inclusion and review of time displacement plots	Time-displacement data for 2014 included in Figure 1 (enclosed). Time-displacement data also to be included in future annual dam inspection reports.

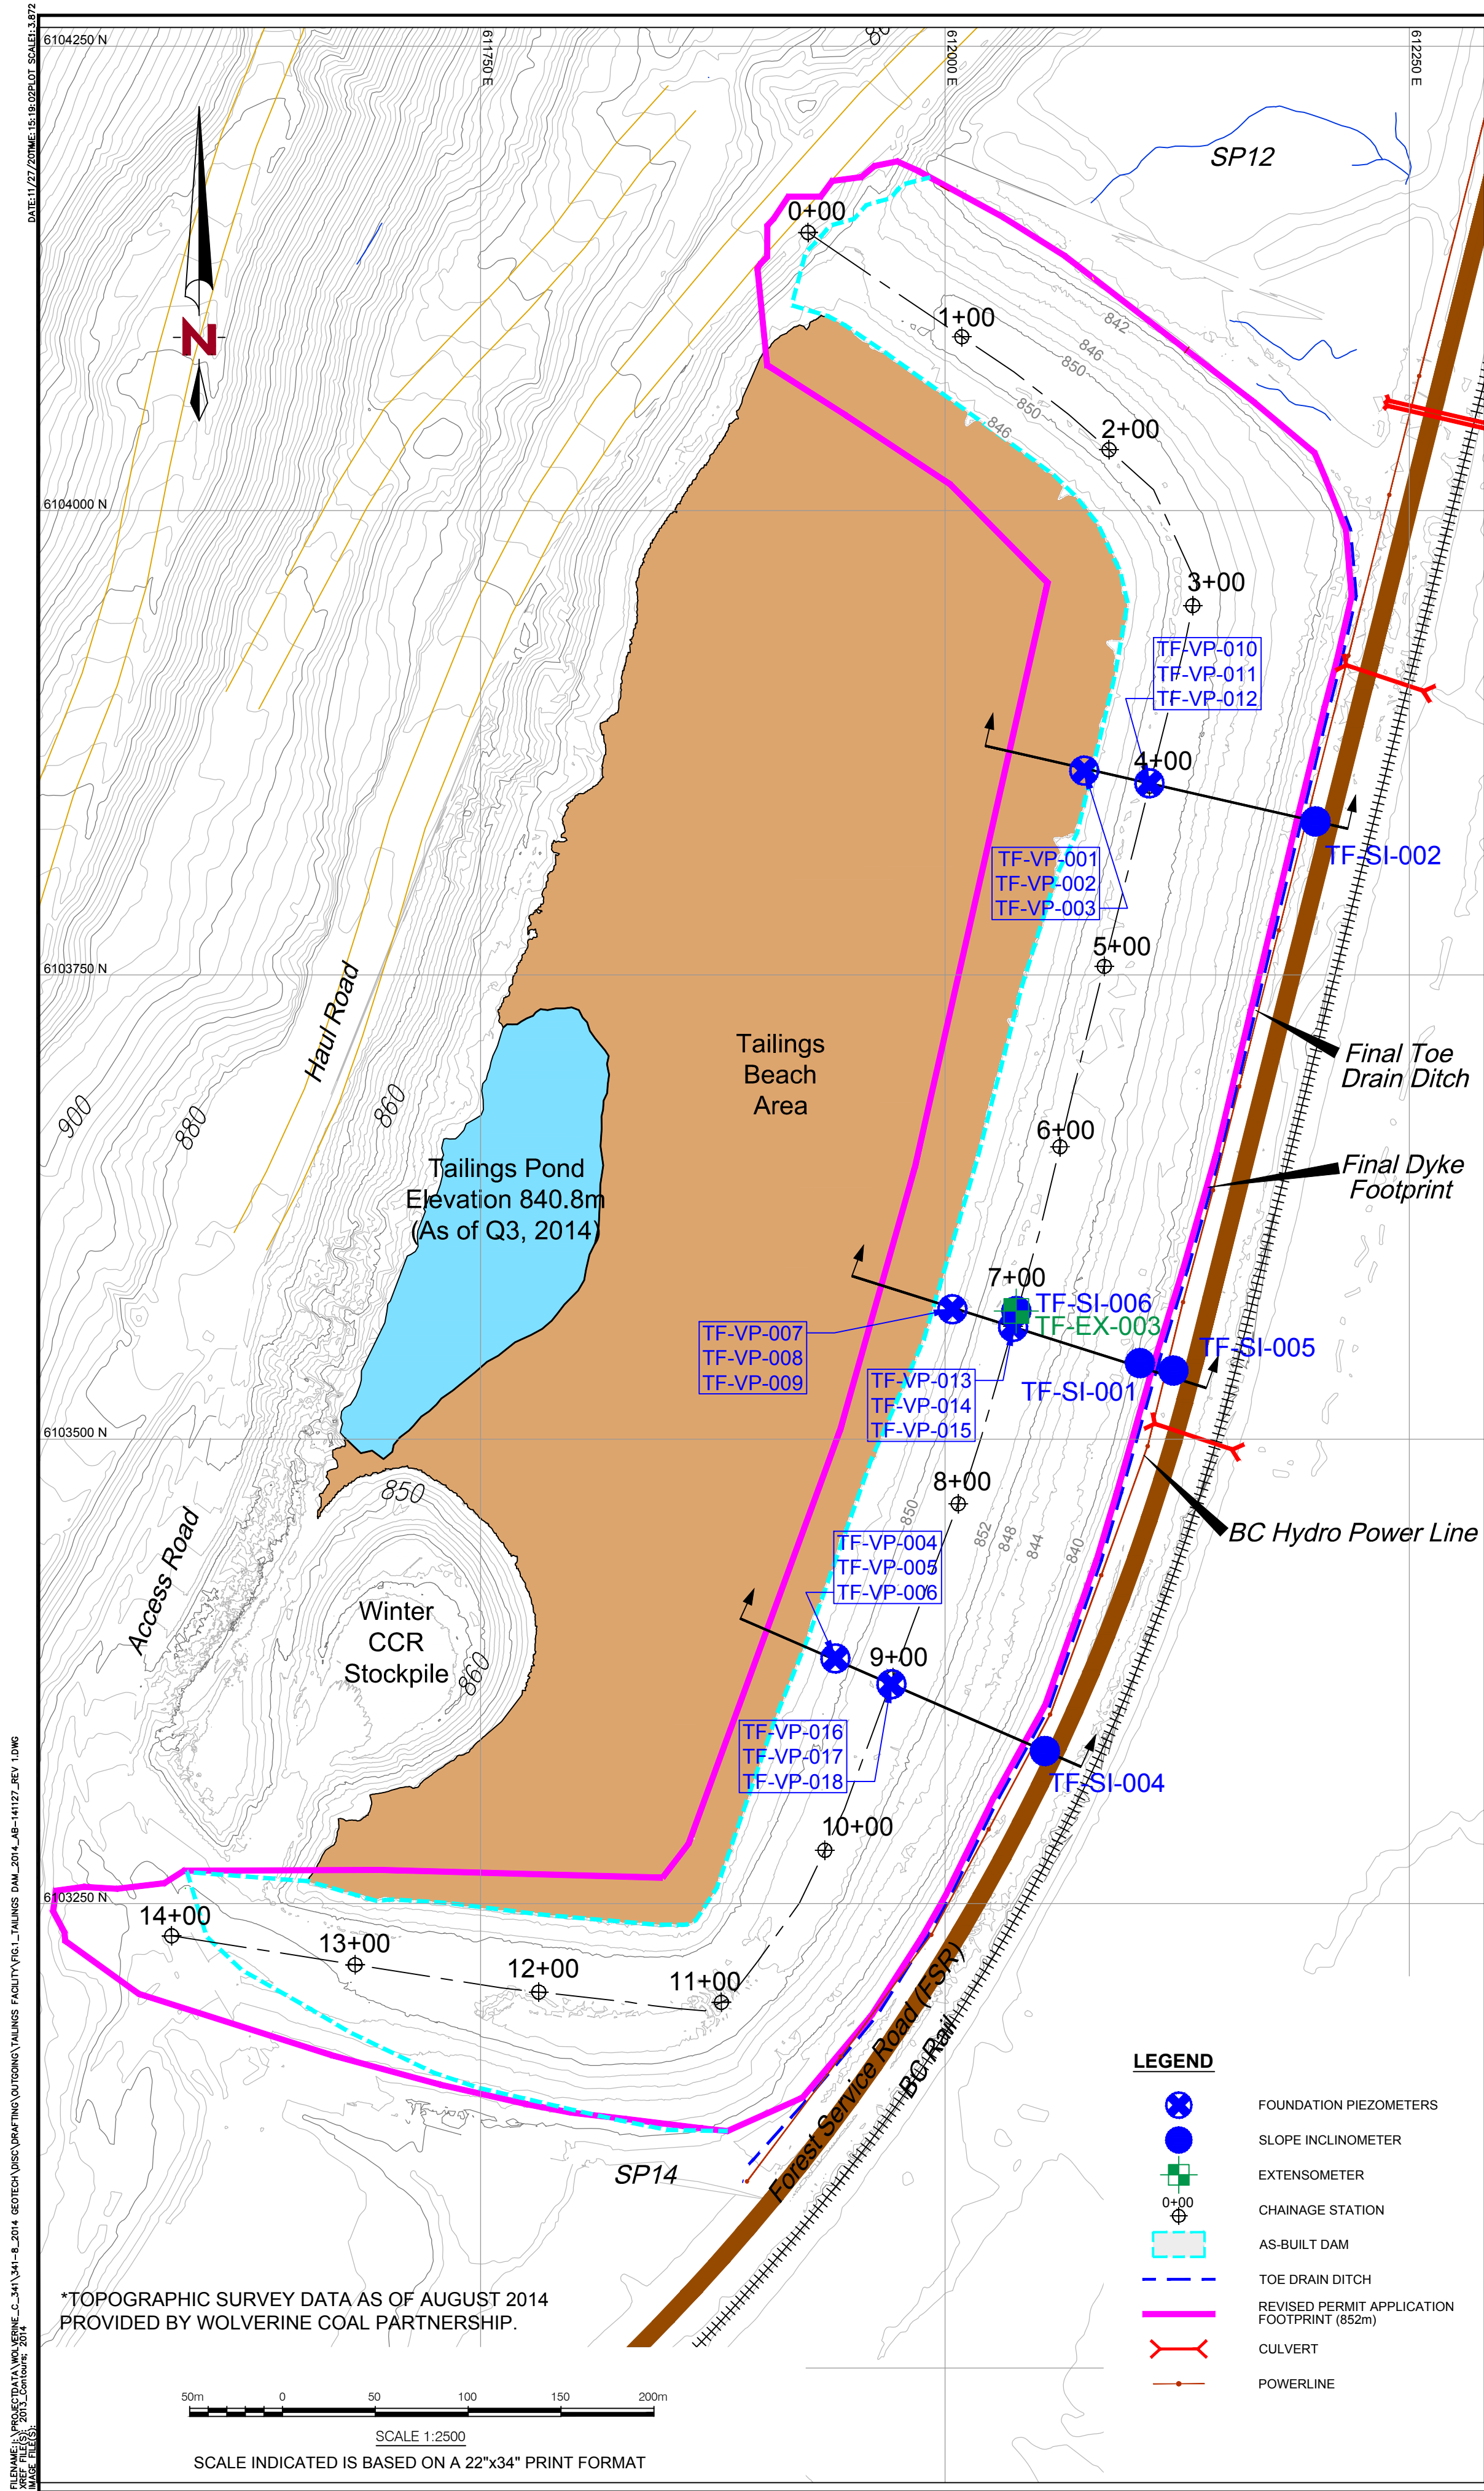
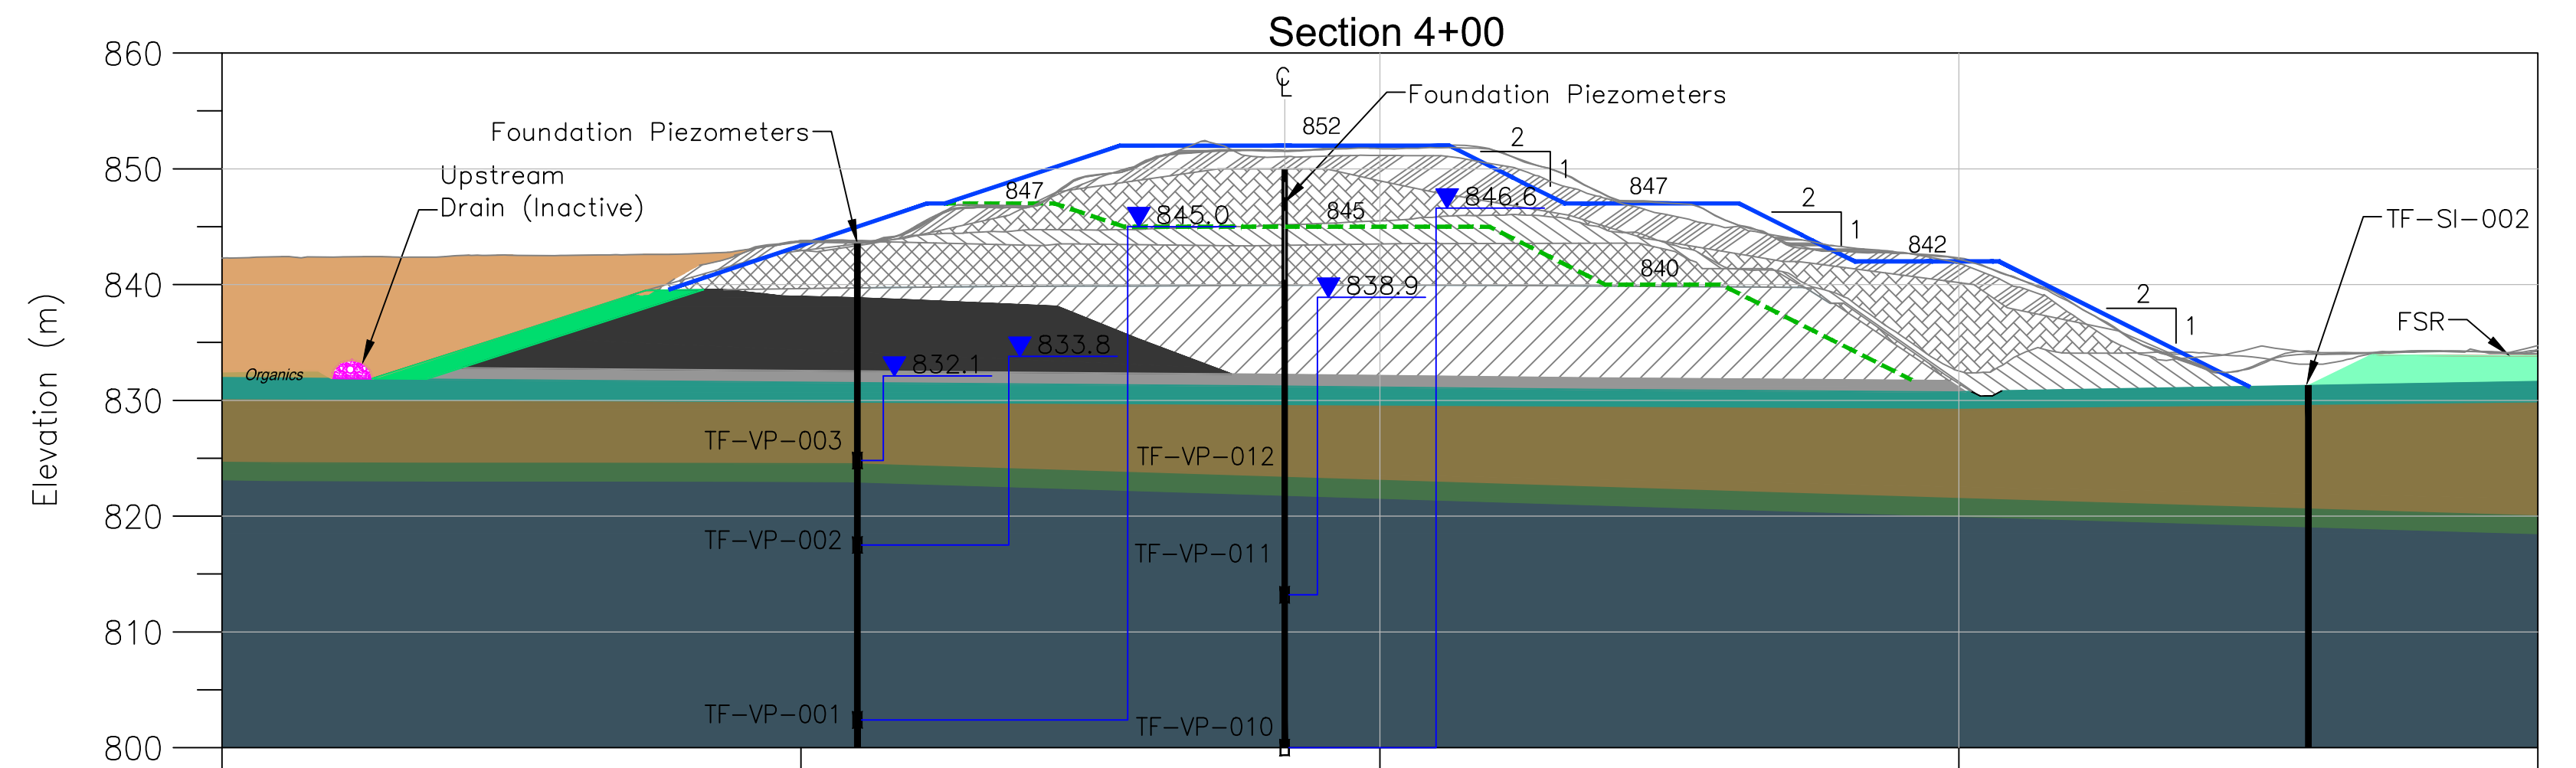
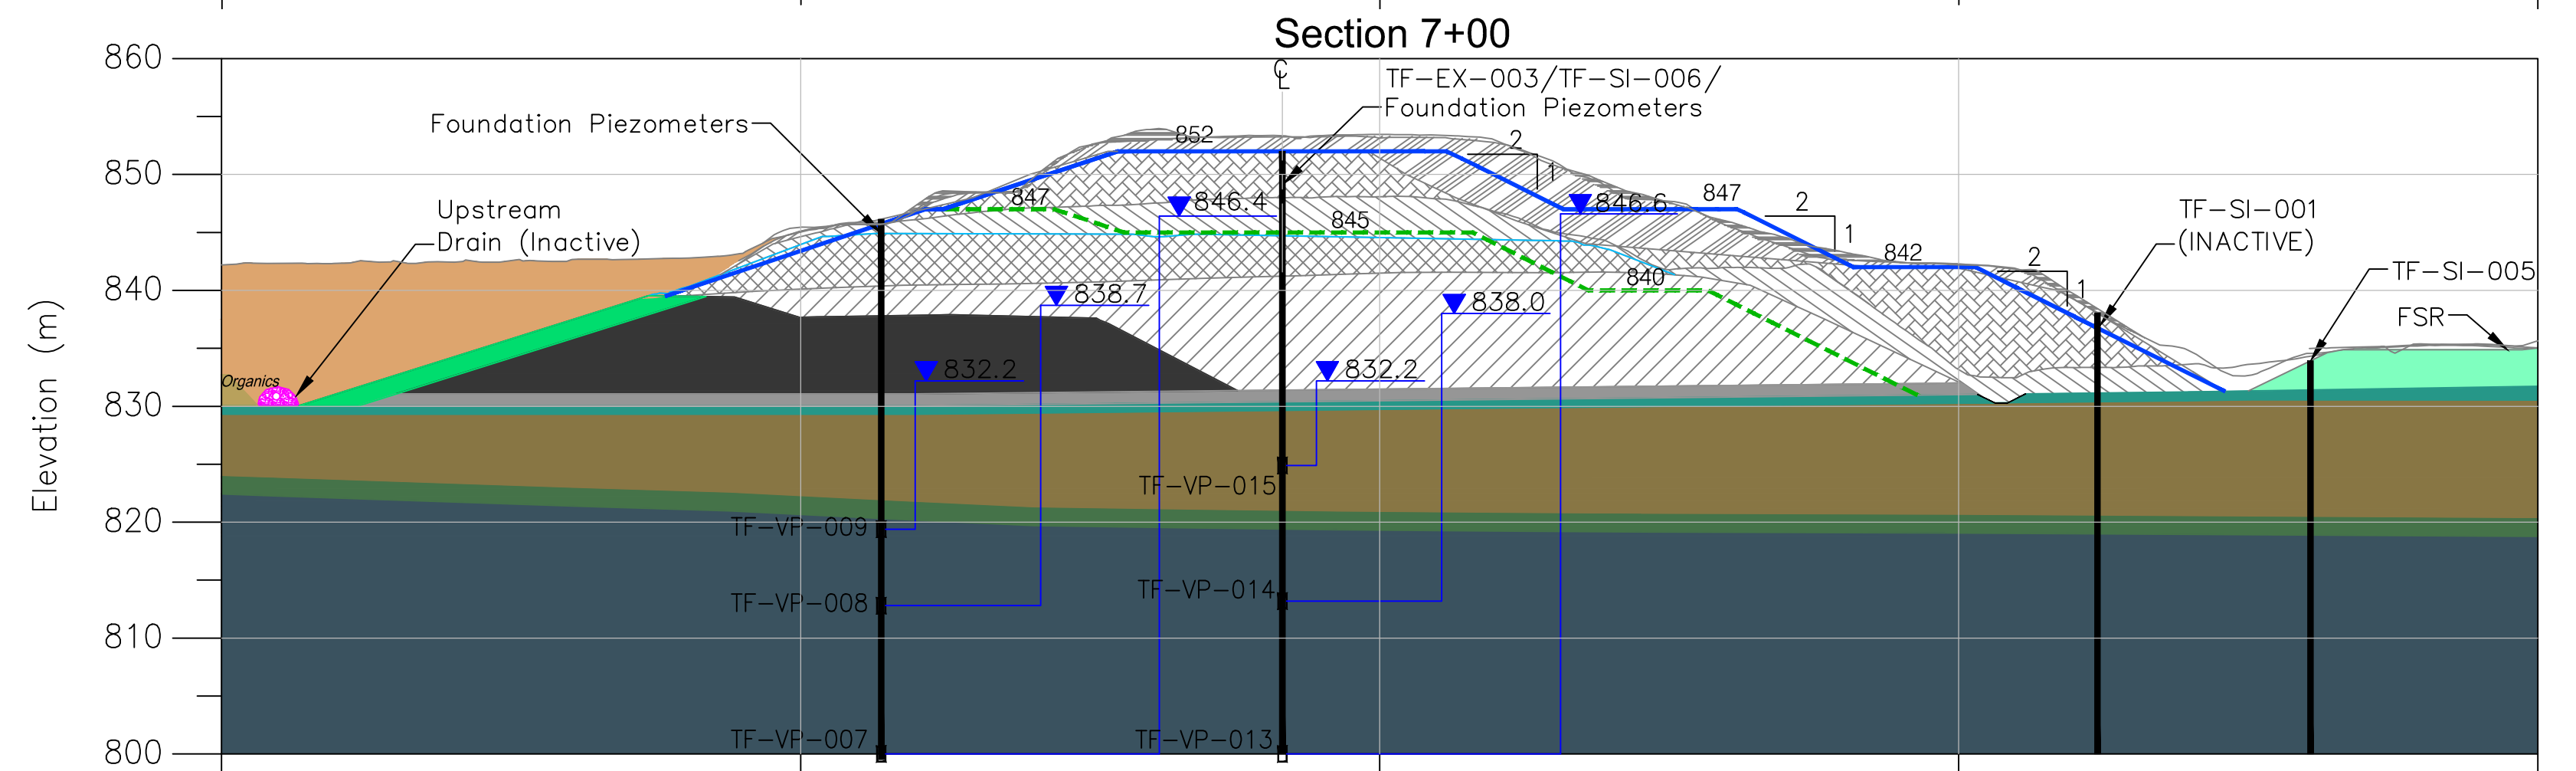
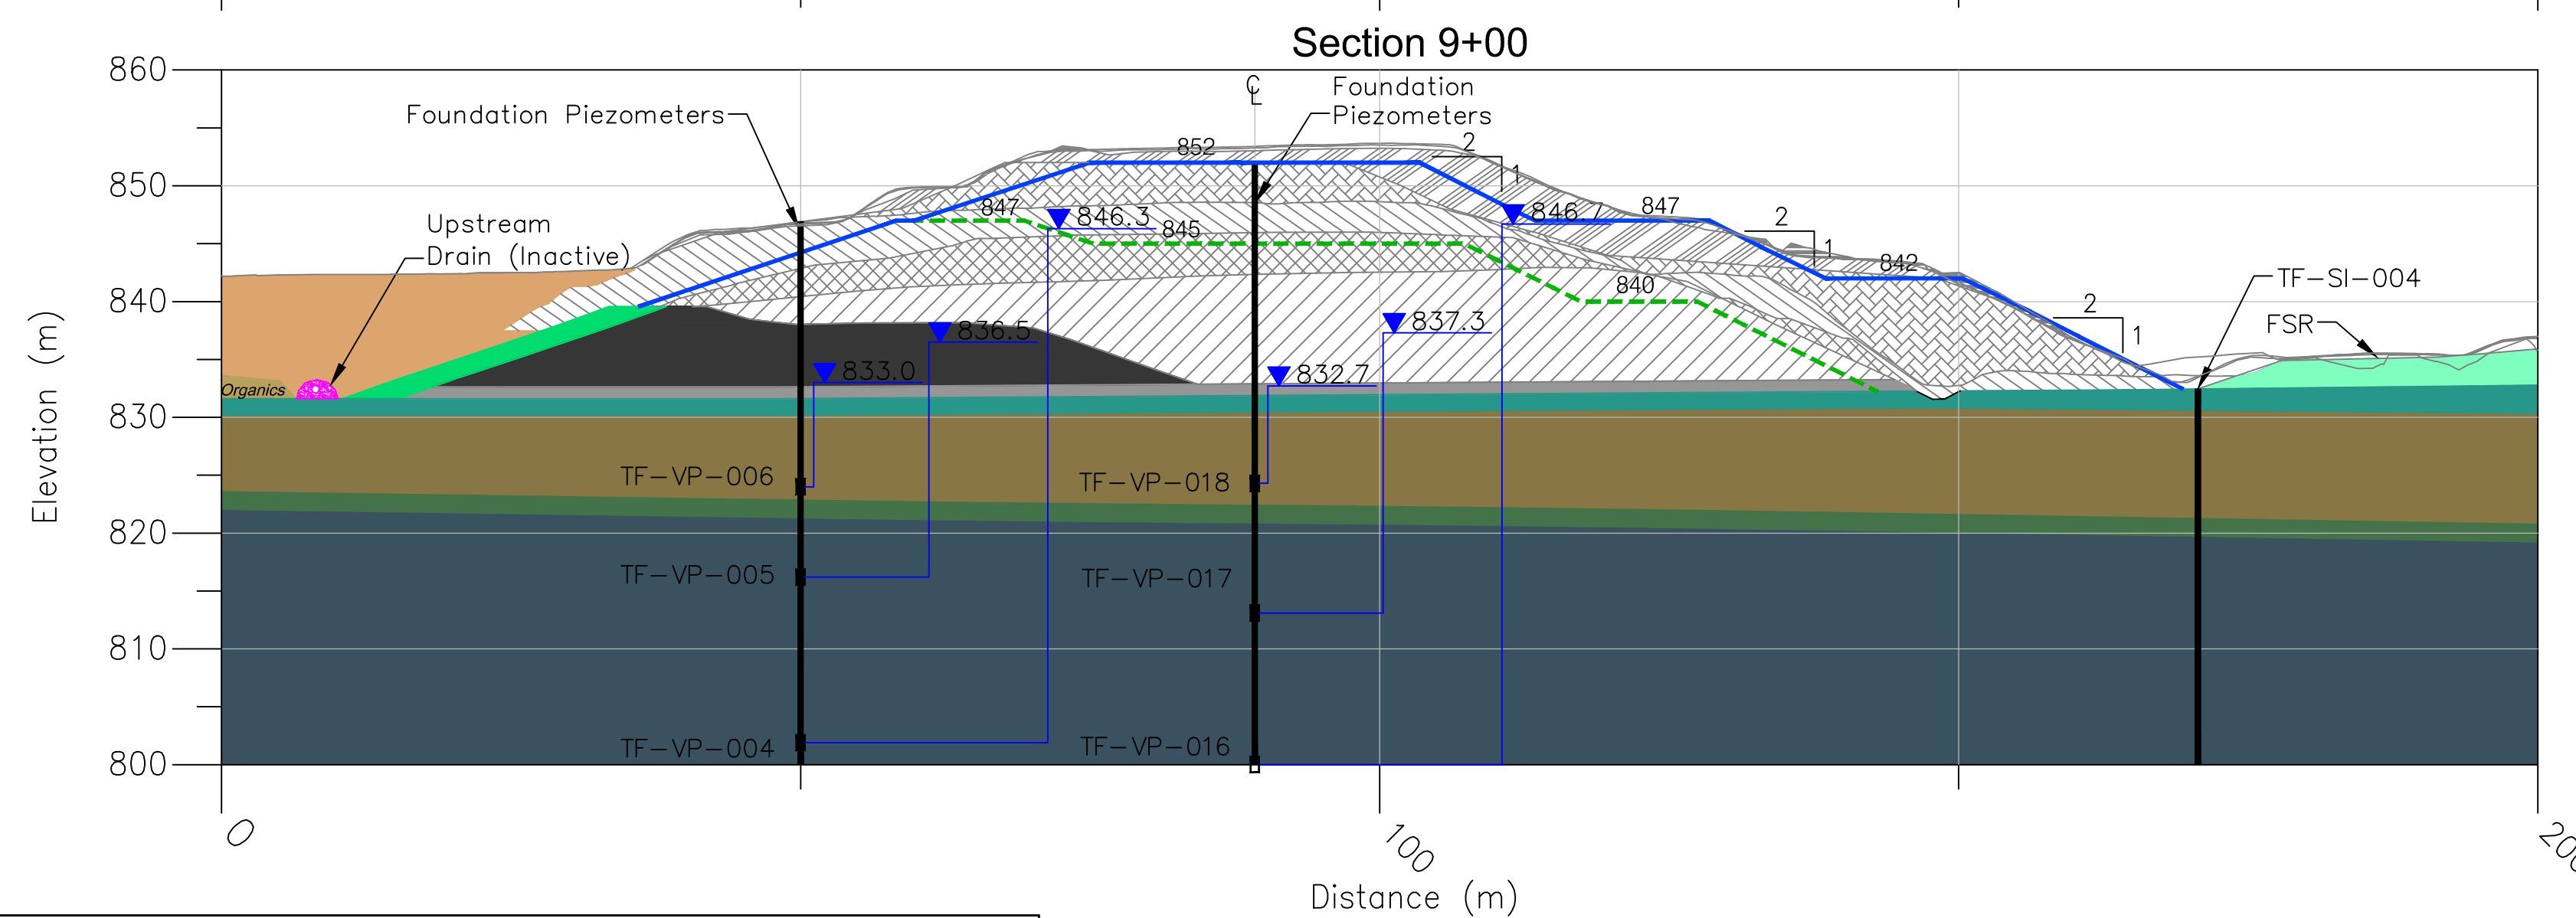
DRAWING 1

There has been no placement of CCR on the tailings dam since the 2011/2012 construction season, and therefore construction records have not been included in the DSI. A revision of Drawing 1 (presented in the DSI) is enclosed to clarify that CCR material has not been placed on the tailings embankment since 2012. Any changes to the embankments since 2012 are attributed to embankment slope reclamation activities.

#4 – Construction Records	CCR was not placed in 2014 and no construction records were generated. This has been clarified on revised Drawing 1 (enclosed).
