November 28, 2014

ISSUED FOR USE  
FILE: W14103527-01

**Subject:** Report on Dam Safety Inspection  
Tailings Storage Facilities – Yellowjacket Gold Mine  
near Atlin, BC

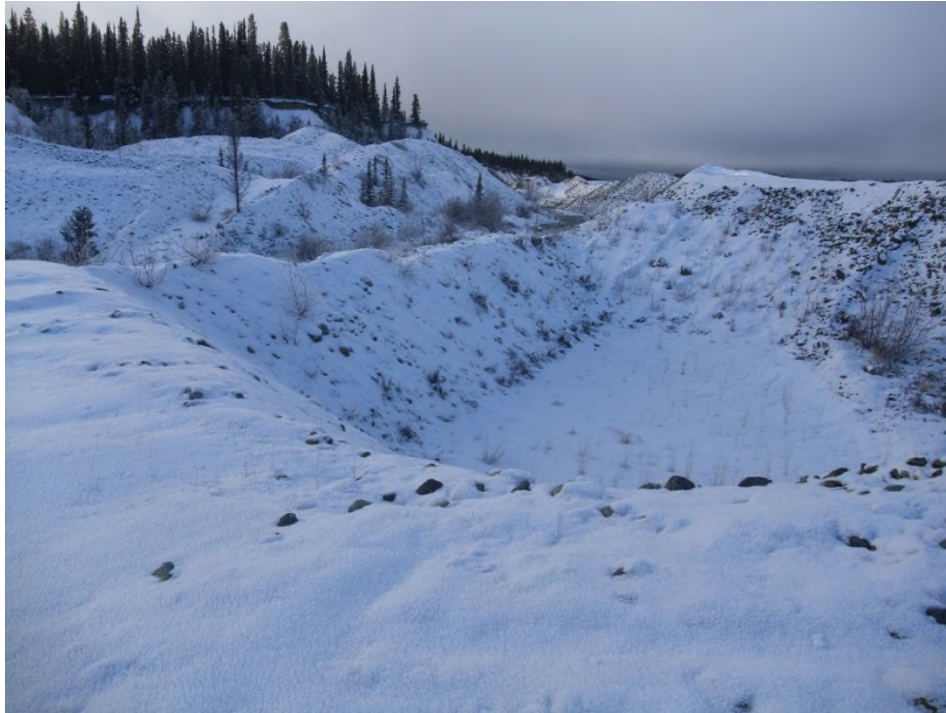
There was no ponded water in either of TSF 1 or TSF 2. Lloyd Brown estimated that there was about 1.5 m to 2.0 m of tailings in TSF 2, and an unknown (but significantly smaller) volume in TSF 1. Interior and exterior sideslopes were stable at about 1.5:1 (horizontal to vertical).

Photo 1: View of TSF 1 from berm of TSF 2 with Pine Creek in background (November 14/14)

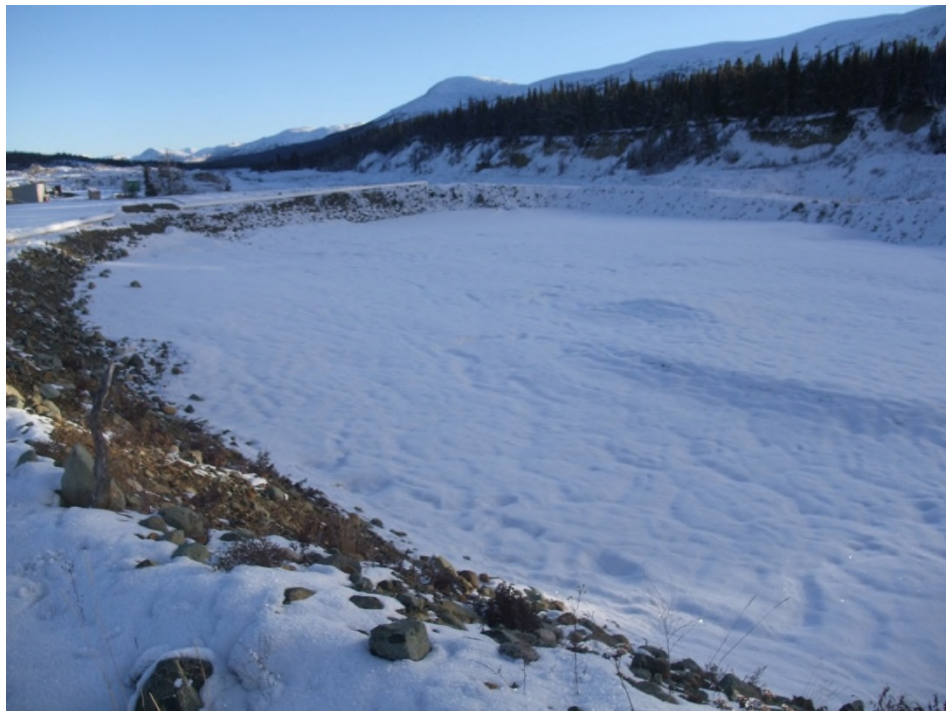
Photo 2: View of TSF 2 looking towards open pit in background behind berm (November 14/14)

There was at least 2.5 m of freeboard in TSF 1 and 1.5 m in TSF 2; the toes of the berms were away from and armoured against erosion protection from Pine Creek; there was no inflow of water to either TSF 1 or TSF 2 (other than rainfall and snowmelt); and there were no outlets or overflow spillways from either pond.

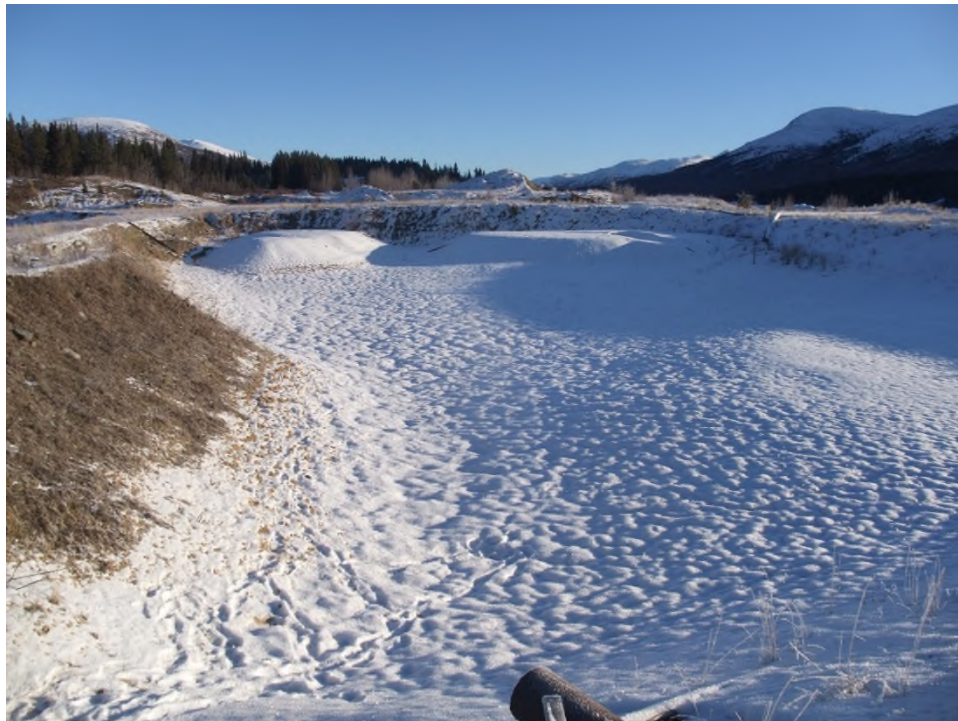
This pond was noted to be dry and stable at the time of the inspection. There were two small piles of tailings noted at the north end of the structure, and some tailings on the base. The main use of this facility appears to have been for the temporary storage of water pumped from the open pit, providing time for solids to settle out before decanting back to Pine Creek through a 300 mm steel pipe.

There was a small (~300 mm diameter) steel pipe outlet set at a freeboard of about 1.5 m in TSF 3, discharging through a wooden box control structure on the other side of the berm.

Photo 3: View of TSF 3 showing tailings piles at far end and on base of pond, as well as the 300 mm steel pipe decant at bottom of photo (November 14/14)

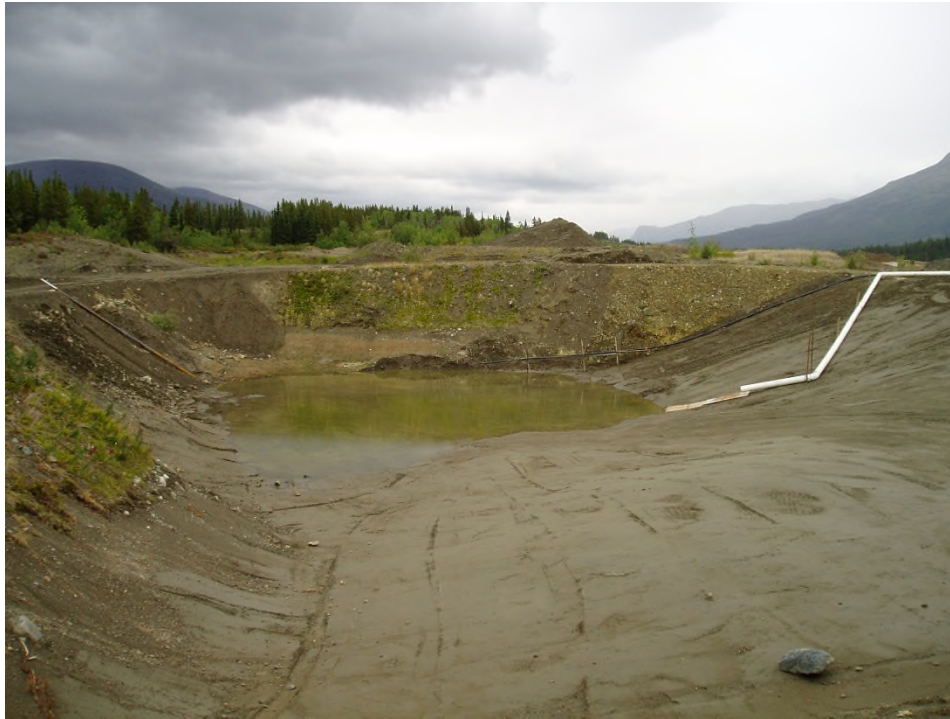
The narrowest crest width observed was about 3 m, with the average closer to 6 m. The majority of the retaining berm appeared to be constructed of glacial till on a granular (gravel and cobbles) base. Interior and exterior sideslopes averaged approximately 1.5:1. A photo taken shortly after construction was provided (see Photo 4) confirming that the base of the facility is lined with till.

Photo 4: View of TSF 3 shortly after construction showing black tailings line, white water line, and base lined with glacial till (unknown date – photo provided by others)
