KGHM AJAX MINING INC. AFTON TAILINGS STORAGE FACILITY

REPORT ON 2014 ANNUAL INSPECTION

VA101-246/39-1
Rev 0
October 1, 2014

AFTON TAILINGS STORAGE FACILITY REPORT ON 2014 ANNUAL INSPECTION VA101-246/39-1

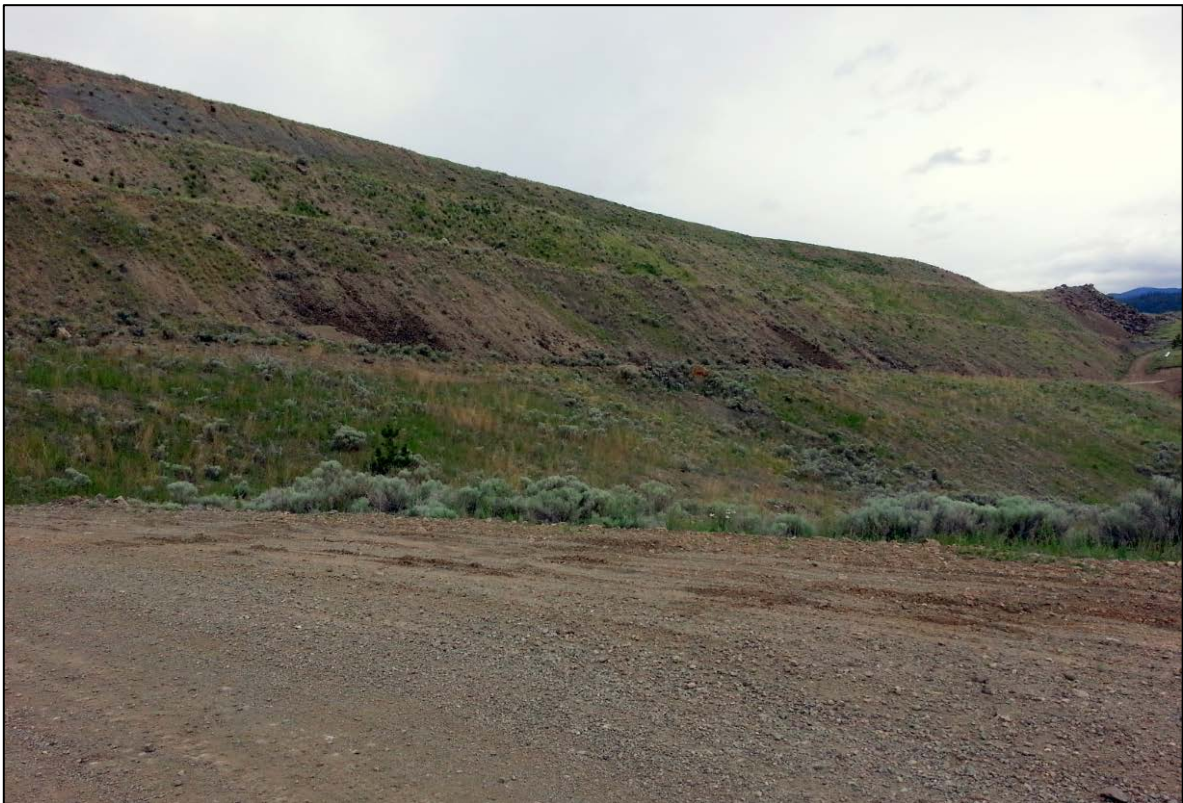
Figure 2.2 View Looking South along the West Dam

No signs of distress were identified on the West Dam and it was considered to be in good condition at the time of the site visit. The dam slopes were approximately planar and there was no evidence of cracking, bulging or slumping in the fill materials. The dam crest appeared to be relatively level with no signs of differential settlement or distress. There was no evidence of animal burrowing nor were there any visible signs of seepage through the dam. Some minor erosion paths were noticed on the downstream side of the dam however they do not impact dam safety and are not considered to be a deficiency requiring action.

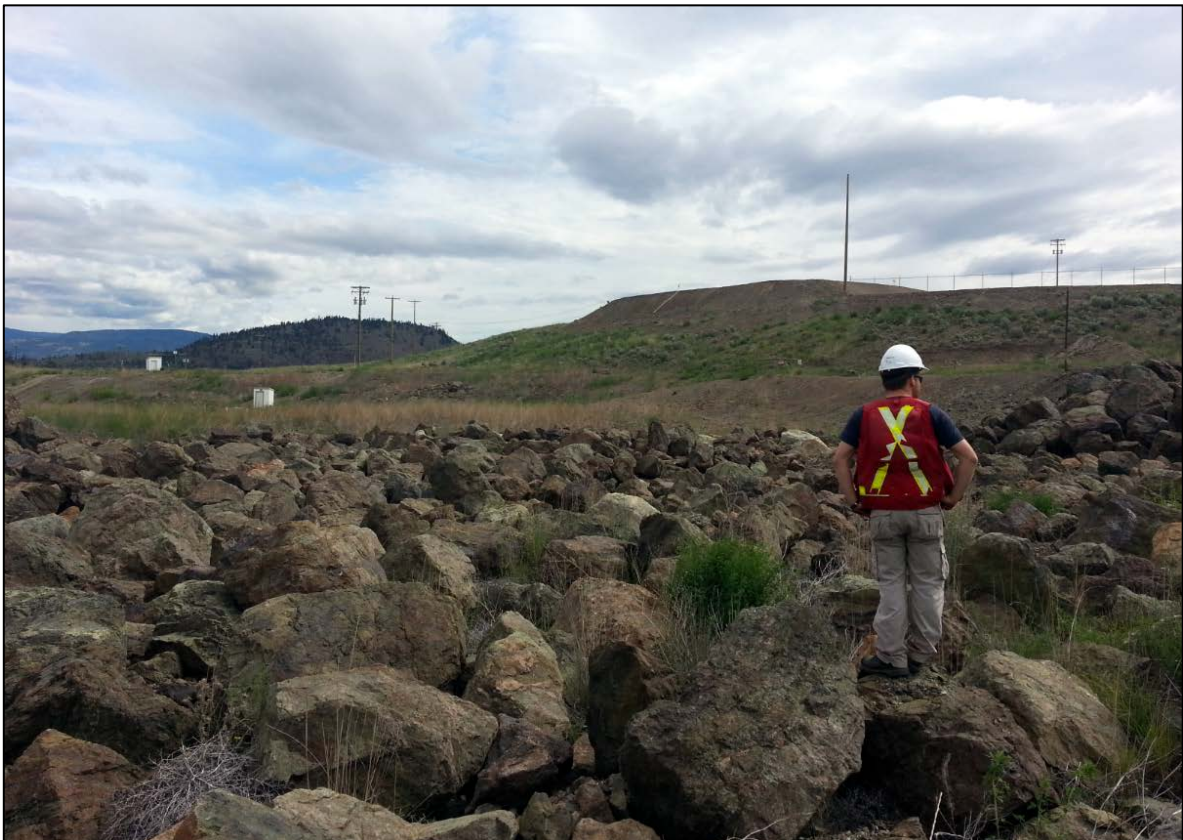
Figure 3.1 Looking (East) Down the Spillway at the East Dam

The Spillway is lined with large rip rap where it exits the TSF at the East Dam, as shown on Figure 3.1. The outlet at the East Dam appeared to be in good condition and there were no visible concerns. The condition of the Spillway between the outlet at the East Dam and the KGHM/New Gold property gate is unknown, as this section was not accessed during the inspection.

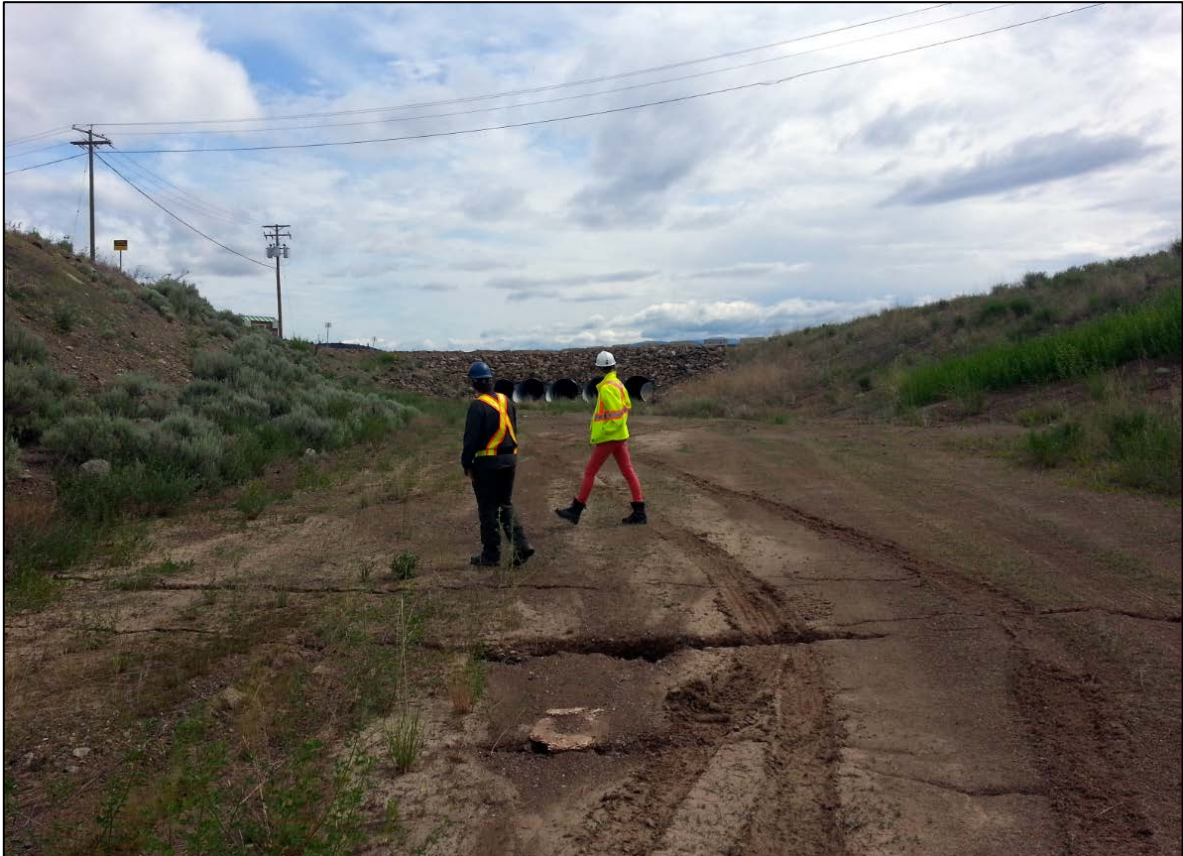
Figure 3.2 Observing the Cracks in the Spillway Upstream of the Road Crossing

Further downstream, cracks were observed in the Spillway channel, approximately 50 m to 100 m downstream from the gate separating the KGHM and New Gold properties at the East Dam. The cracks run roughly perpendicular to the Spillway and in some cases are large, visible for substantial distances across the New Gold property. These cracks were discussed with New Gold personnel and were confirmed by New Gold to be the result of subsidence caused by the block-cave mining operation. Subsidence is discussed further in Section 4.

The subsidence cracks that were noticed in the Spillway channel in June 2014, two years after production at the New Afton Mine began, are potentially significant. Considering the direction of mining and the mine life ahead, it is anticipated that increased subsidence cracking and settlement will occur, extending further into the area of the Spillway, East Dam, and Afton TSF as a whole as the mine advances.

Thorough assessments of the interaction between the underground mine and the Afton TSF must be completed to demonstrate that dam safety and underground mine safety are not compromised by ongoing mining activities. The assessments should consider all failure mechanisms that could occur as well as risk reduction measures that can and should be implemented.

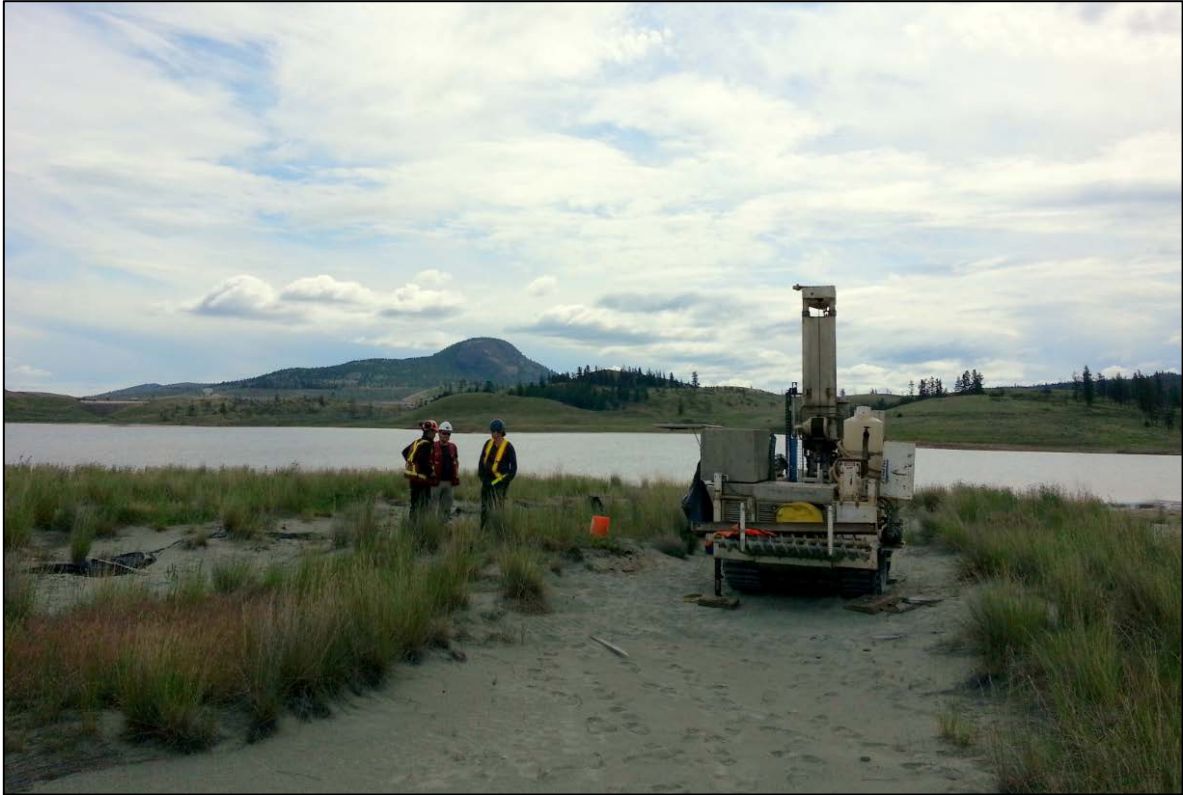
Figure 4.1 2014 New Gold Piezometer Installation Drilling Program near the West Dam

The New Gold piezometer data should be obtained and routinely monitored by KGHM, as it will provide good information on water pressures and water levels in the tailings deposit. KGHM should

obtain the locations and depths of all New Gold piezometers, and any that may be relevant to dam safety should be added to the Operations, Maintenance, and Surveillance (OMS) manual in the ERP.

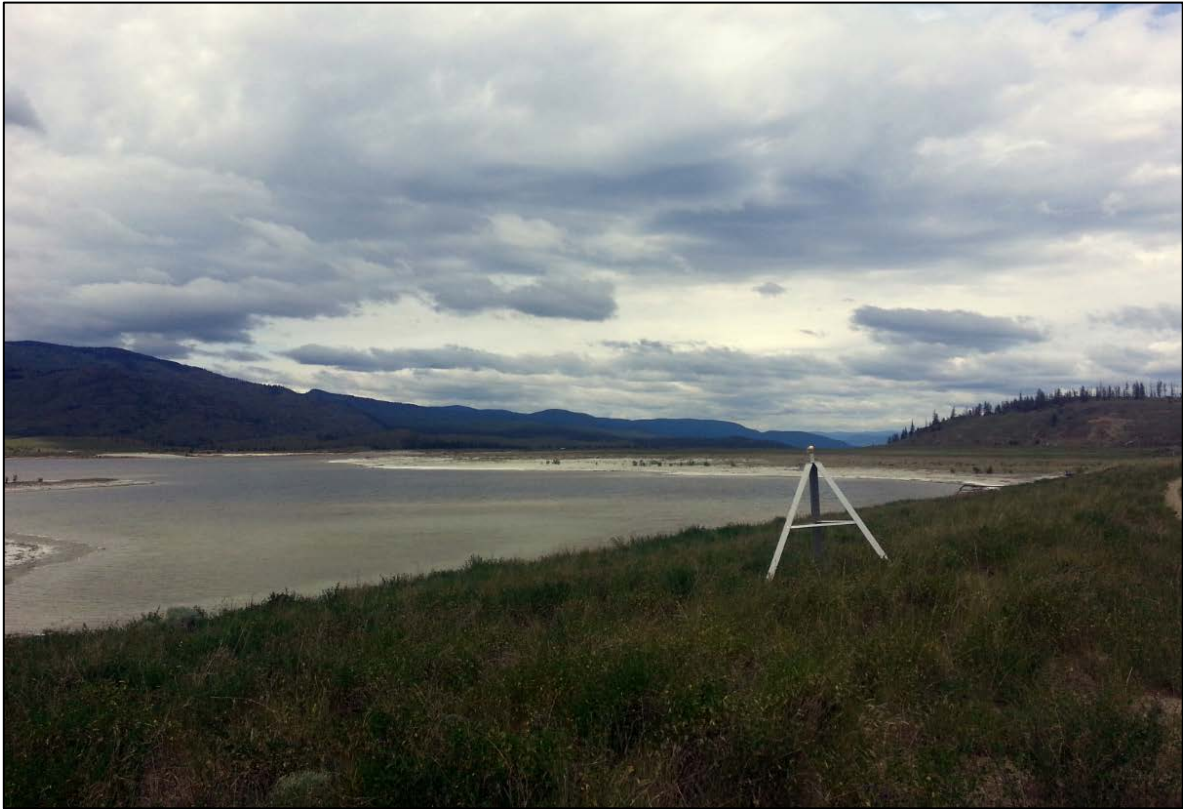
Figure 4.2 Surface Monitoring on the East Dam

Surface monitoring equipment was observed along the East Dam during both the 2014 annual inspection and the 2013 DSR site visit (Figure 3.2). This New Gold instrumentation currently consists of prisms along the East Dam, the waste rock dump buttressing the East Dam, and the Spillway.

A presentation of the data collected to date for the East Dam and Spillway Channel was provided by New Gold for the annual inspection, and it is included in Appendix B. The data shows vertical settlement in the East Dam of less than 0.05 m, and settlement in the Spillway channel of up to 0.7 m over the past year. The locations of the prisms and their individual settlement data can be reviewed in Appendix B. This instrumentation should be monitored closely and routinely by New Gold and KGHM going forward.

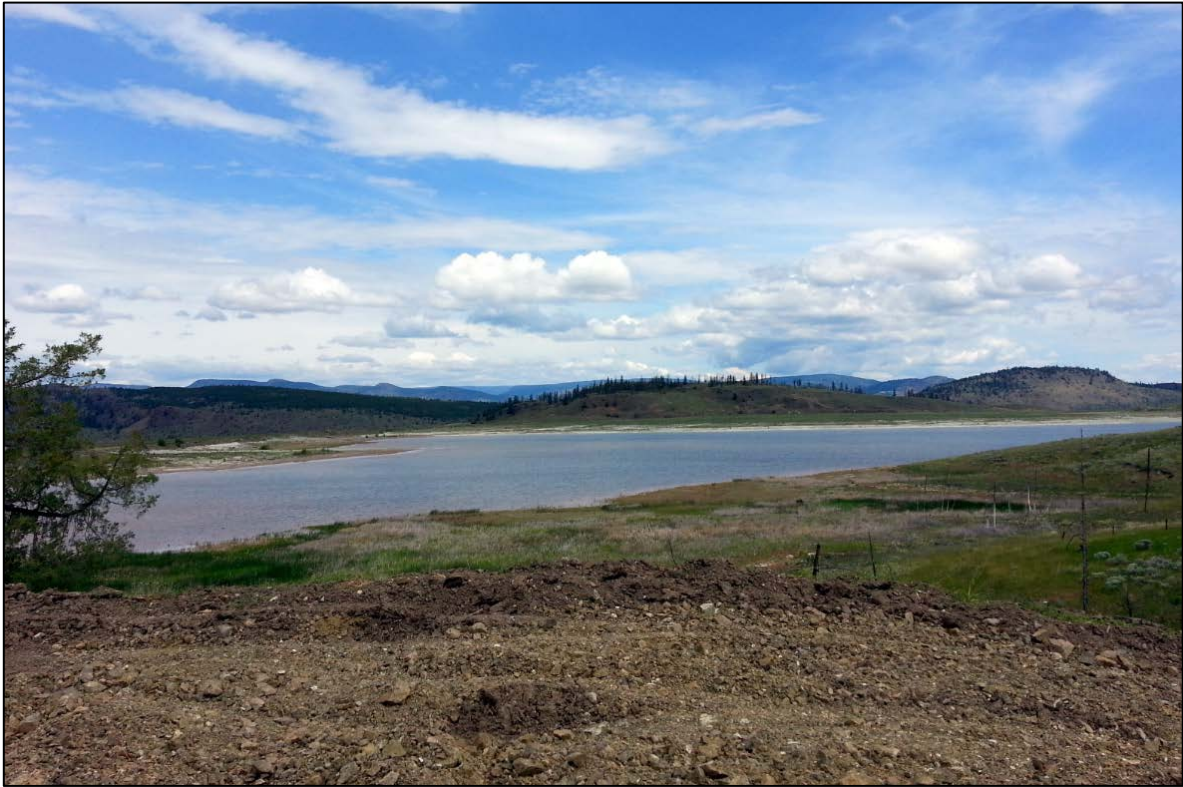
Figure 5.1 View of the TSF Pond from the West Diversion Dam

The pond at the time of the 2014 annual inspection is shown on Figure 5.1. To determine the pond level, on-site KP personnel took a series of GPS readings at various points along the water's edge between June 11th and 17th, and these points were plotted onto the 0.5 m topography. All of the points fell between 699.5 m and 700.0 m and were generally closer to the 700.0 m contour.

The 0.5 m rise in the tailings pond in the year between the 2013 DSR and the 2014 annual inspection can be attributed to the Alkali Creek Diversion Channel construction program. For approximately 3 months (late March until late June, 2014), the diversion channel flow was diverted from the West Diversion Dam into the TSF to facilitate construction downstream, as shown on Figure 5.2. The depth-area-capacity curve for the TSF surface shows a storage capacity of approximately 245,000 m³ between the 699.5 m and the 700.0 m contours, and this volume aligns very well with the estimated flow rates in the diversion for the three months during construction. The Alkali Creek Diversion Channel is discussed further in Section 7.

The tailings pond is at a normal level and has over 4 m of freeboard up to the Spillway Channel outlet. Although this is acceptable from a freeboard point of view, and a larger pond does benefit KGHM in terms of dust control efforts, lowering the pond will displace water away from the East Dam and will reduce the risk of water and tailings ingress to the underground mine should a crack extend into the TSF in the future. For this reason it is recommended that the pond be pumped out or otherwise displaced away from the East Dam.

3. Dewater or otherwise displace the tailings pond away from the East Dam to reduce the risk of water and tailings ingress to the underground mine should a subsidence crack extend into the TSF in the future.

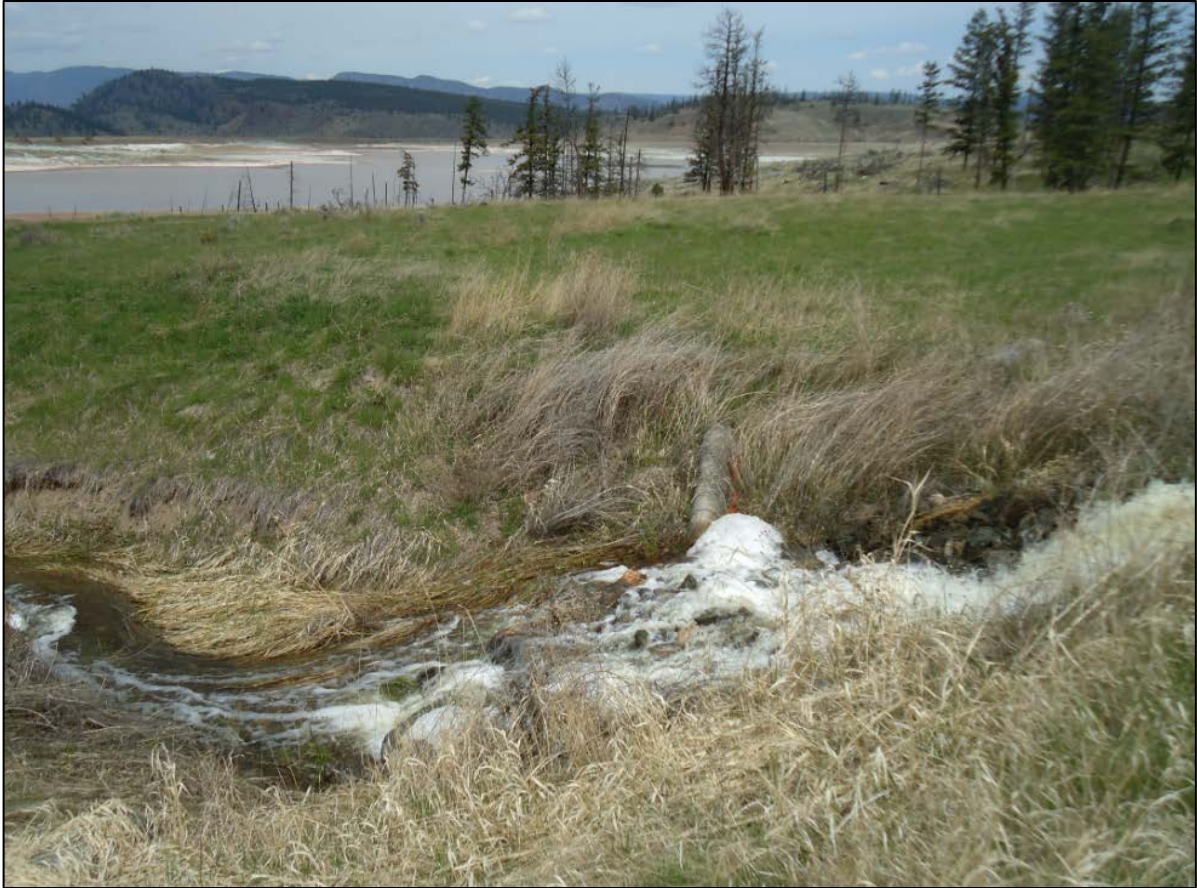
Figure 5.2 Diversion of Alkali Creek into the TSF

- In the spring of 2014, Alkali Creek was diverted into the TSF during construction of the Alkali Creek Diversion Channel as described in Section 7.4.

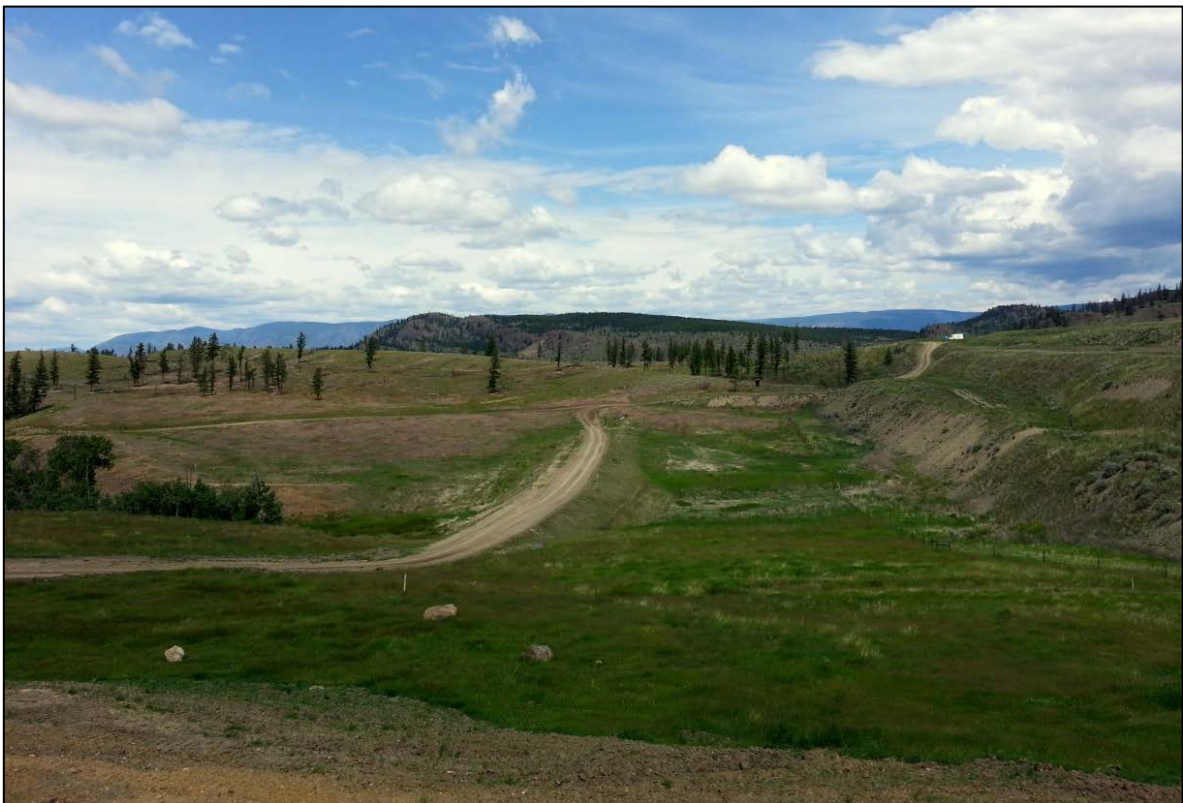
Figure 6.1 Southwest Seepage Pond

The Southwest Seepage Pond Dam is shown on Figure 6.1. The pond has a very small upstream catchment area and primarily collects surface runoff from the downstream face of the West Dam and a small area on the south abutment. The impounded area upstream of the dam is typically dry, as was the case during the site visit.

A breach of the Alkali Creek Diversion Channel upstream during a storm in May 2011 led to the Southwest Seepage Pond being filled and subsequently overtopped. A portion of the impounding embankment was eroded during this event. KGHM repaired the dam in September, 2013; the quality assurance report is referenced in Section 1.5. The Southwest Seepage Pond Dam is in good condition.

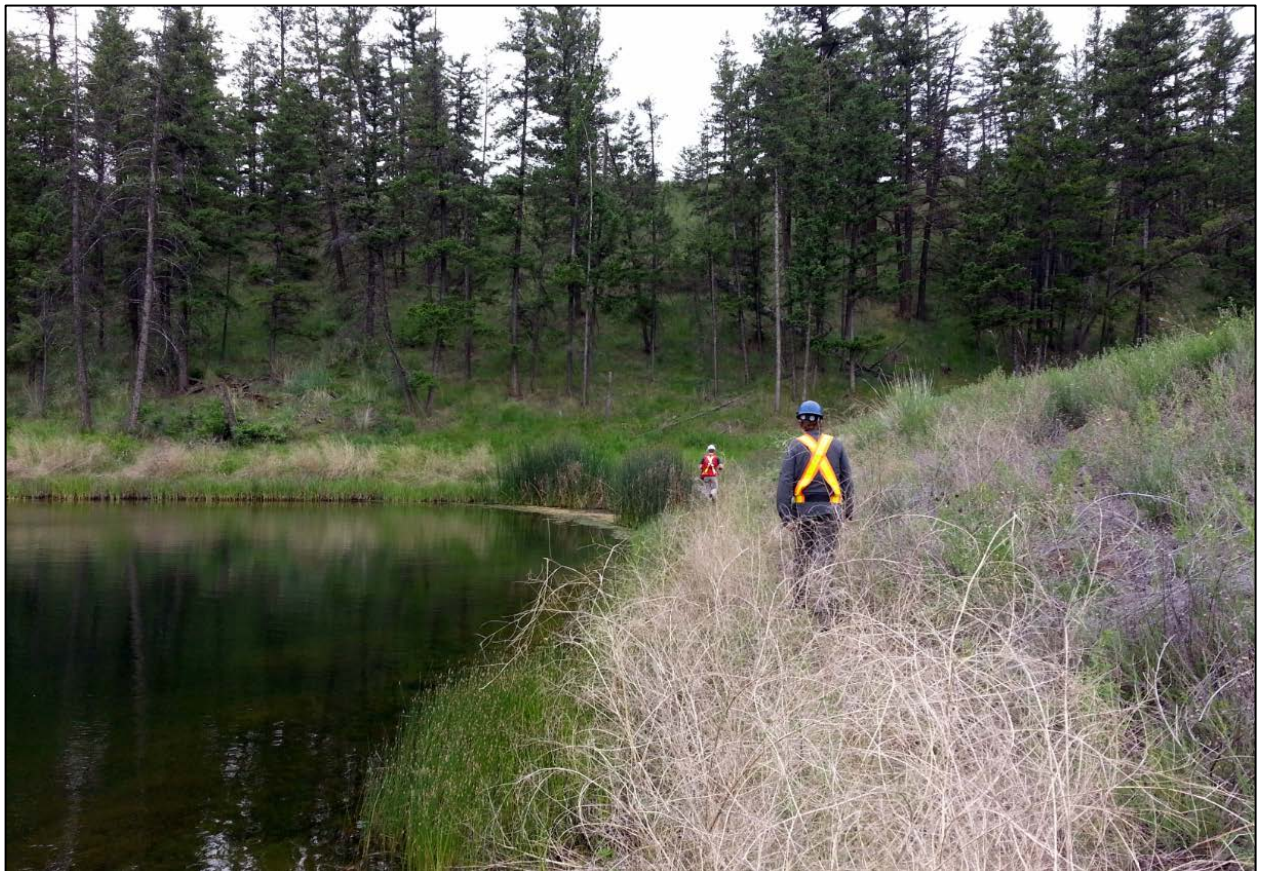
Figure 6.2 Northwest Seepage Pond Dam, Looking South

The Northwest Seepage Pond had an estimated freeboard of 2 m up to the dam crest and the dam appeared to be in good condition during the site visit. At the time of the visit, the outlet culvert was blocked by plywood, debris, and vegetation.

In September 2014, KGHM personnel removed the material that was blocking the outlet culvert to restore its intended function and capacity. It is recommended that this outlet remains permanently unblocked in the future.

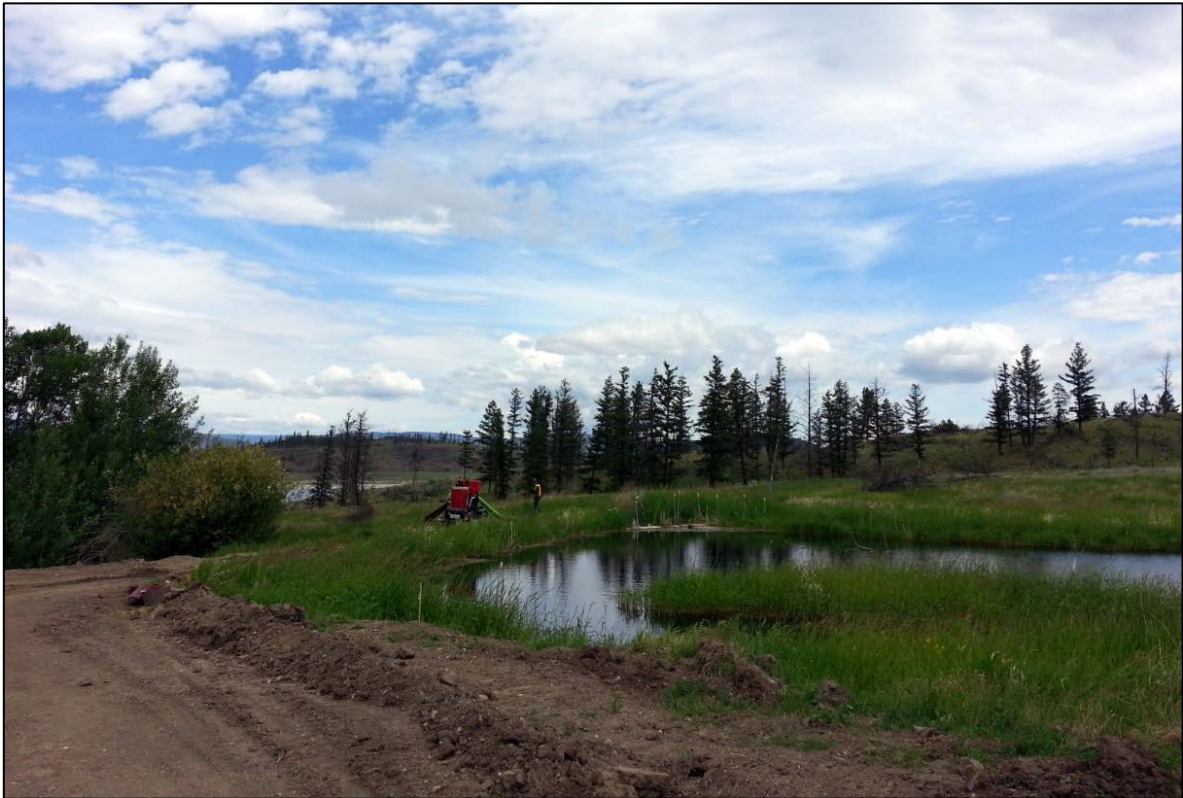
Figure 7.2 West Diversion Dam at the Start of the Alkali Creek Diversion Channel

The West Diversion Dam appeared to be in good condition at the time of the site visit and there were no signs of distress in the dam. On site personnel confirmed that the West Diversion Dam was not altered or otherwise impacted during the construction works for the Alkali Creek Diversion Channel. It was noted, however, that the outlet elevation for the channel is now lower than it has been historically, and this will result in a lower equilibrium water level in the slough.

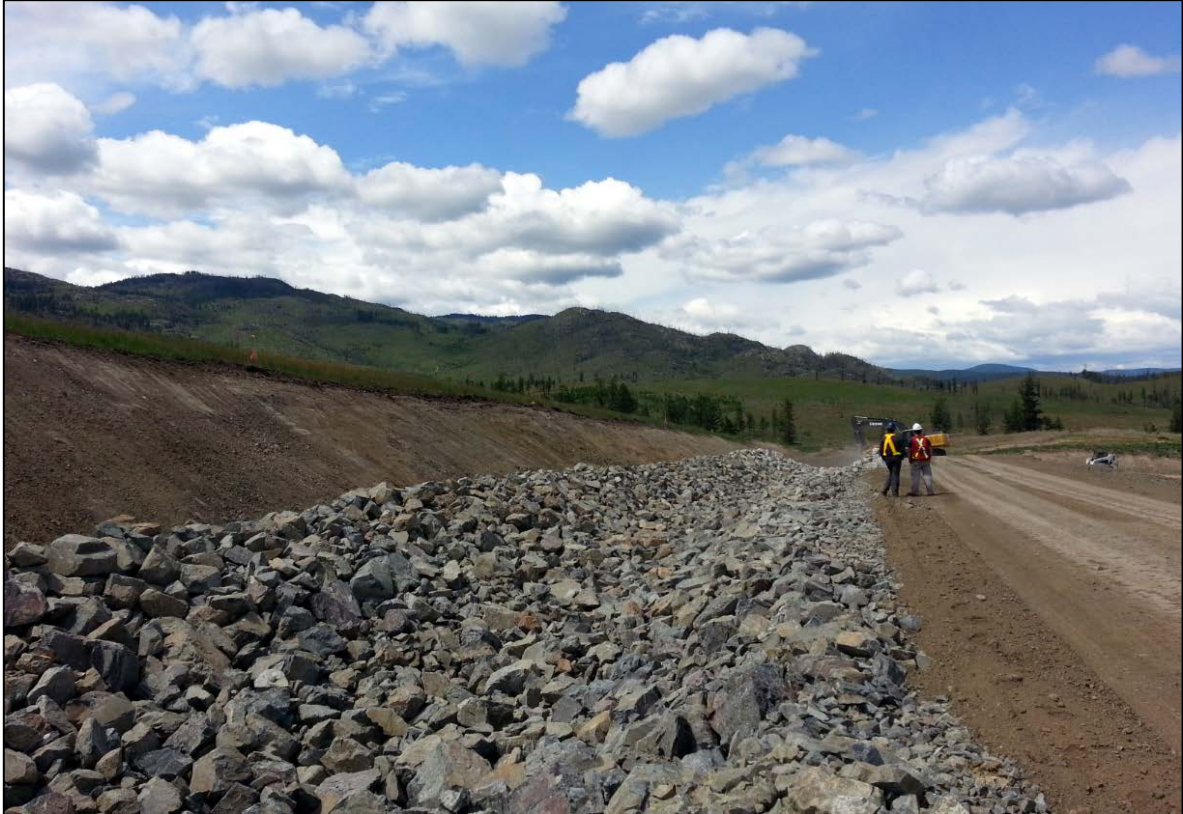
Figure 7.3 View Looking Downstream Along the Alkali Creek Diversion Channel

The construction program was nearing completion at the time of the site visit, and was completed approximately two weeks later in late June, 2014. The channel has been designed and constructed to safely pass inflows up to 4.4 m³/s, the estimated 1 in 200 year flood event. The construction quality assurance report is referenced in Section 1.5, and a photograph taken during the site visit is shown on Figure 7.3.

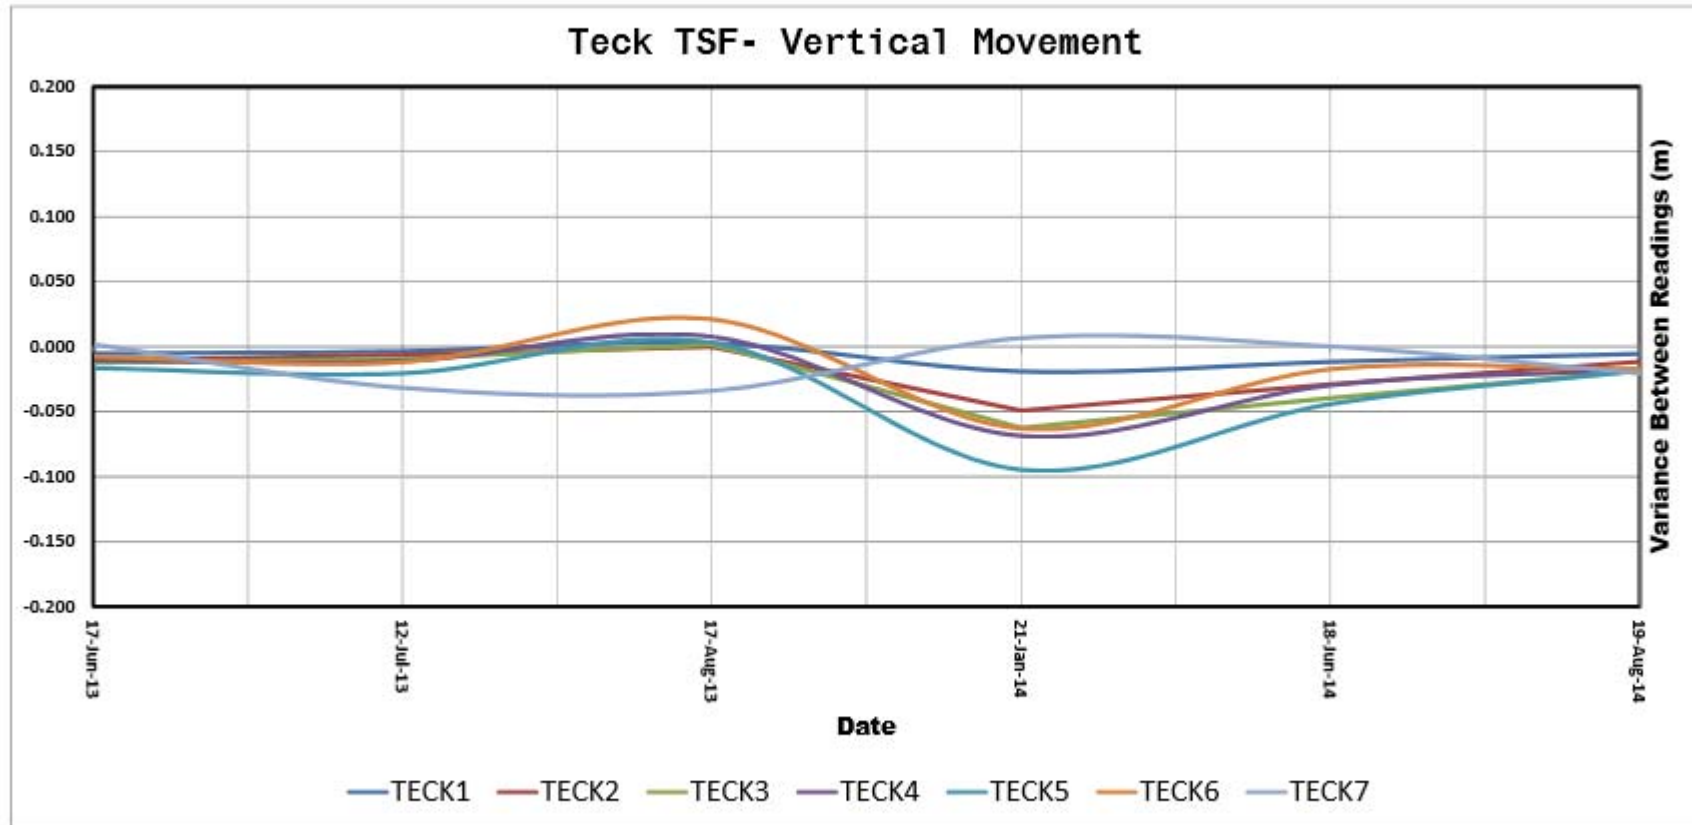
Teck TSF - Vertical Movement
Comparison to baseline (October 15, 2012)

Negligible movement can be attributed to environmental differences from day to day.

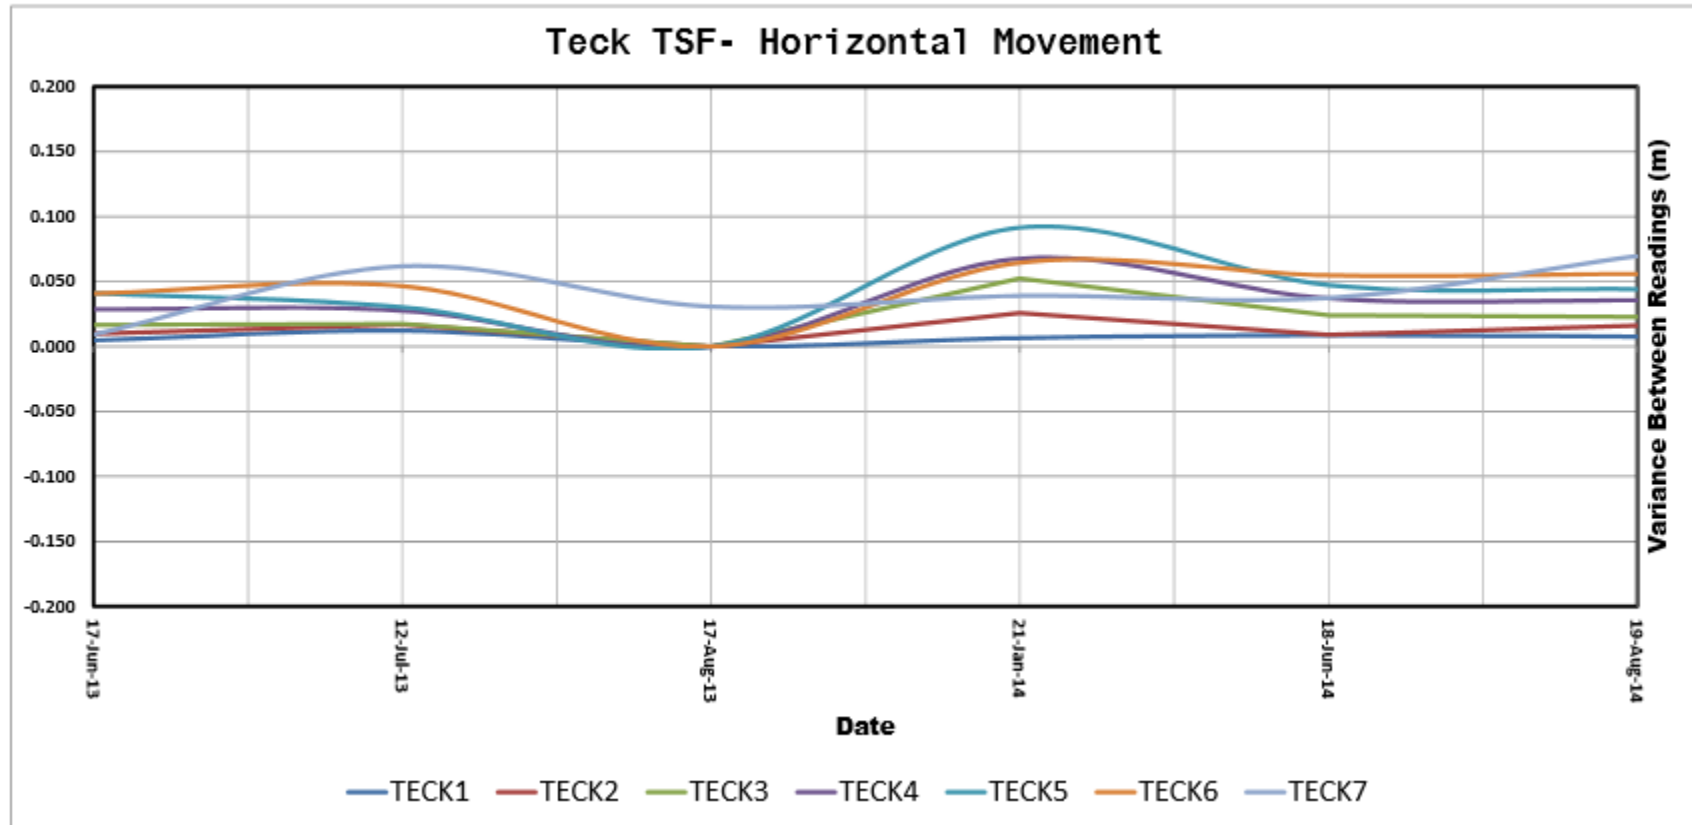
Teck TSF - Horizontal Movement
Comparison to baseline (October 15, 2012)

Negligible movement can be attributed to environmental differences from day to day.

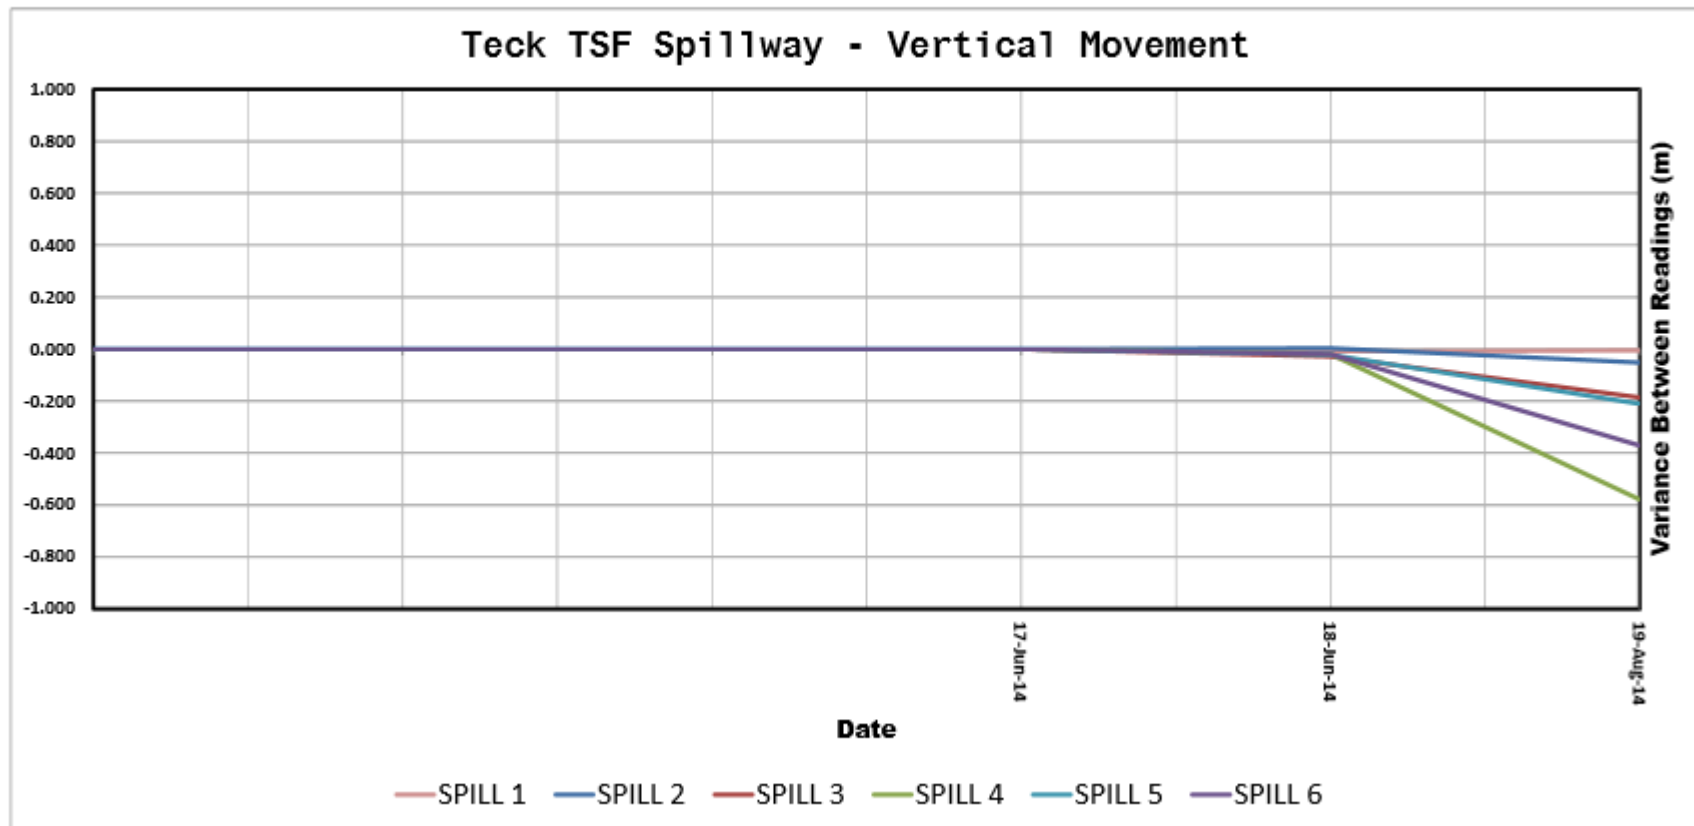
Teck TSF Spillway -Vertical Movement Comparison to baseline (October 15, 2012)

New Prism's just added to monitor area of cracking.

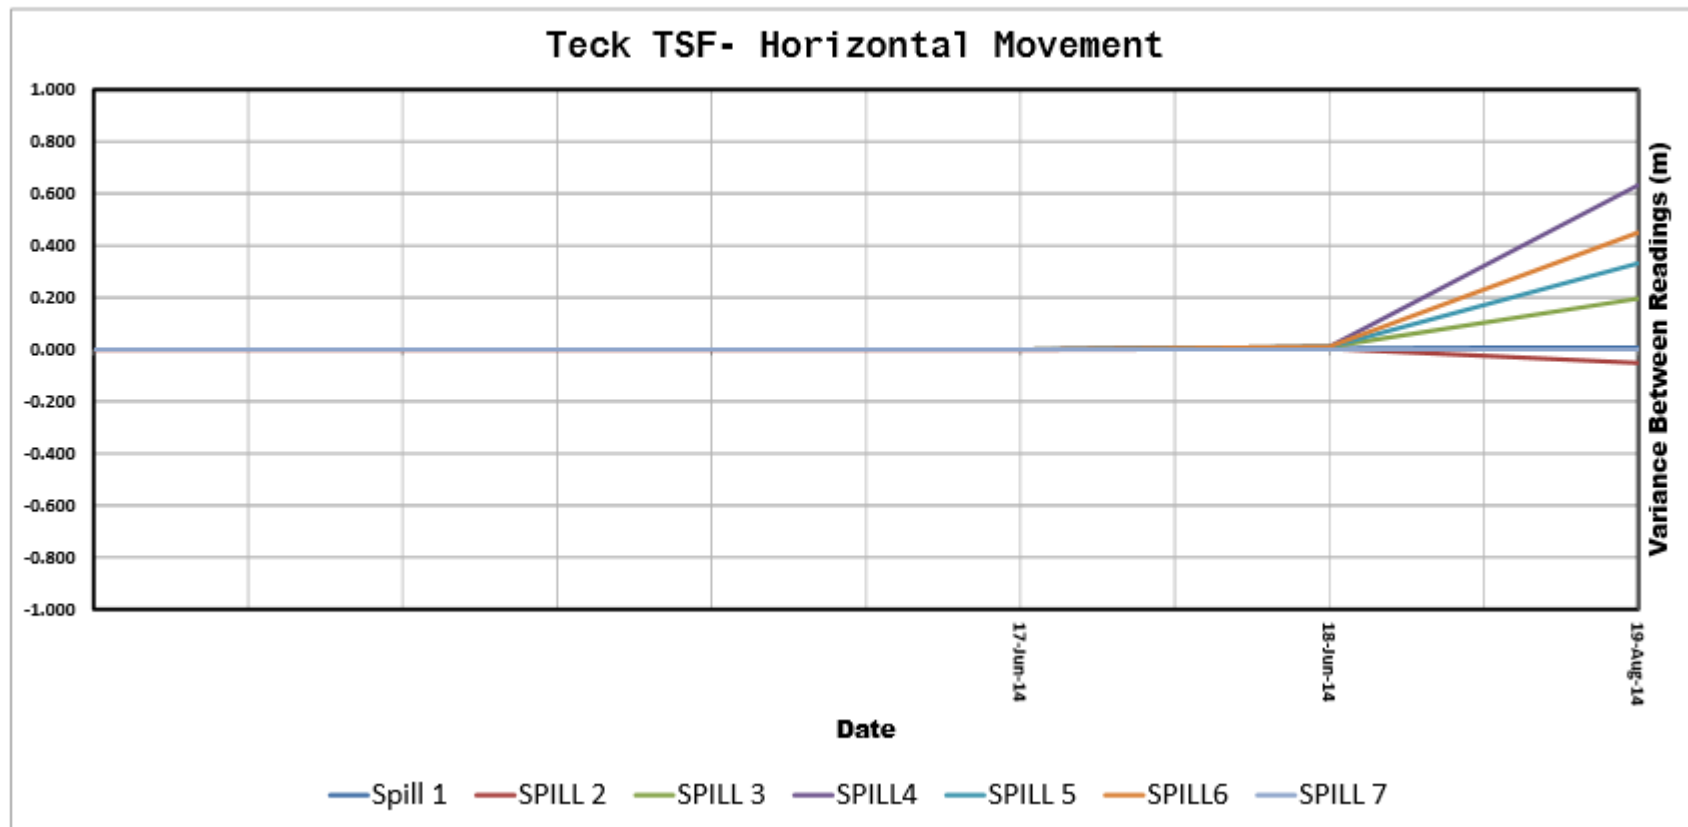
Teck TSF Spillway - Horizontal Movement Comparison to baseline (October 15, 2012)

New Prism's just added to monitor area of cracking.
