29 April 2015

VM00482D.1.300

Re: Copper Mountain Mine Tailings Management Facility Response to February 3, 2015 Ministerial Orders

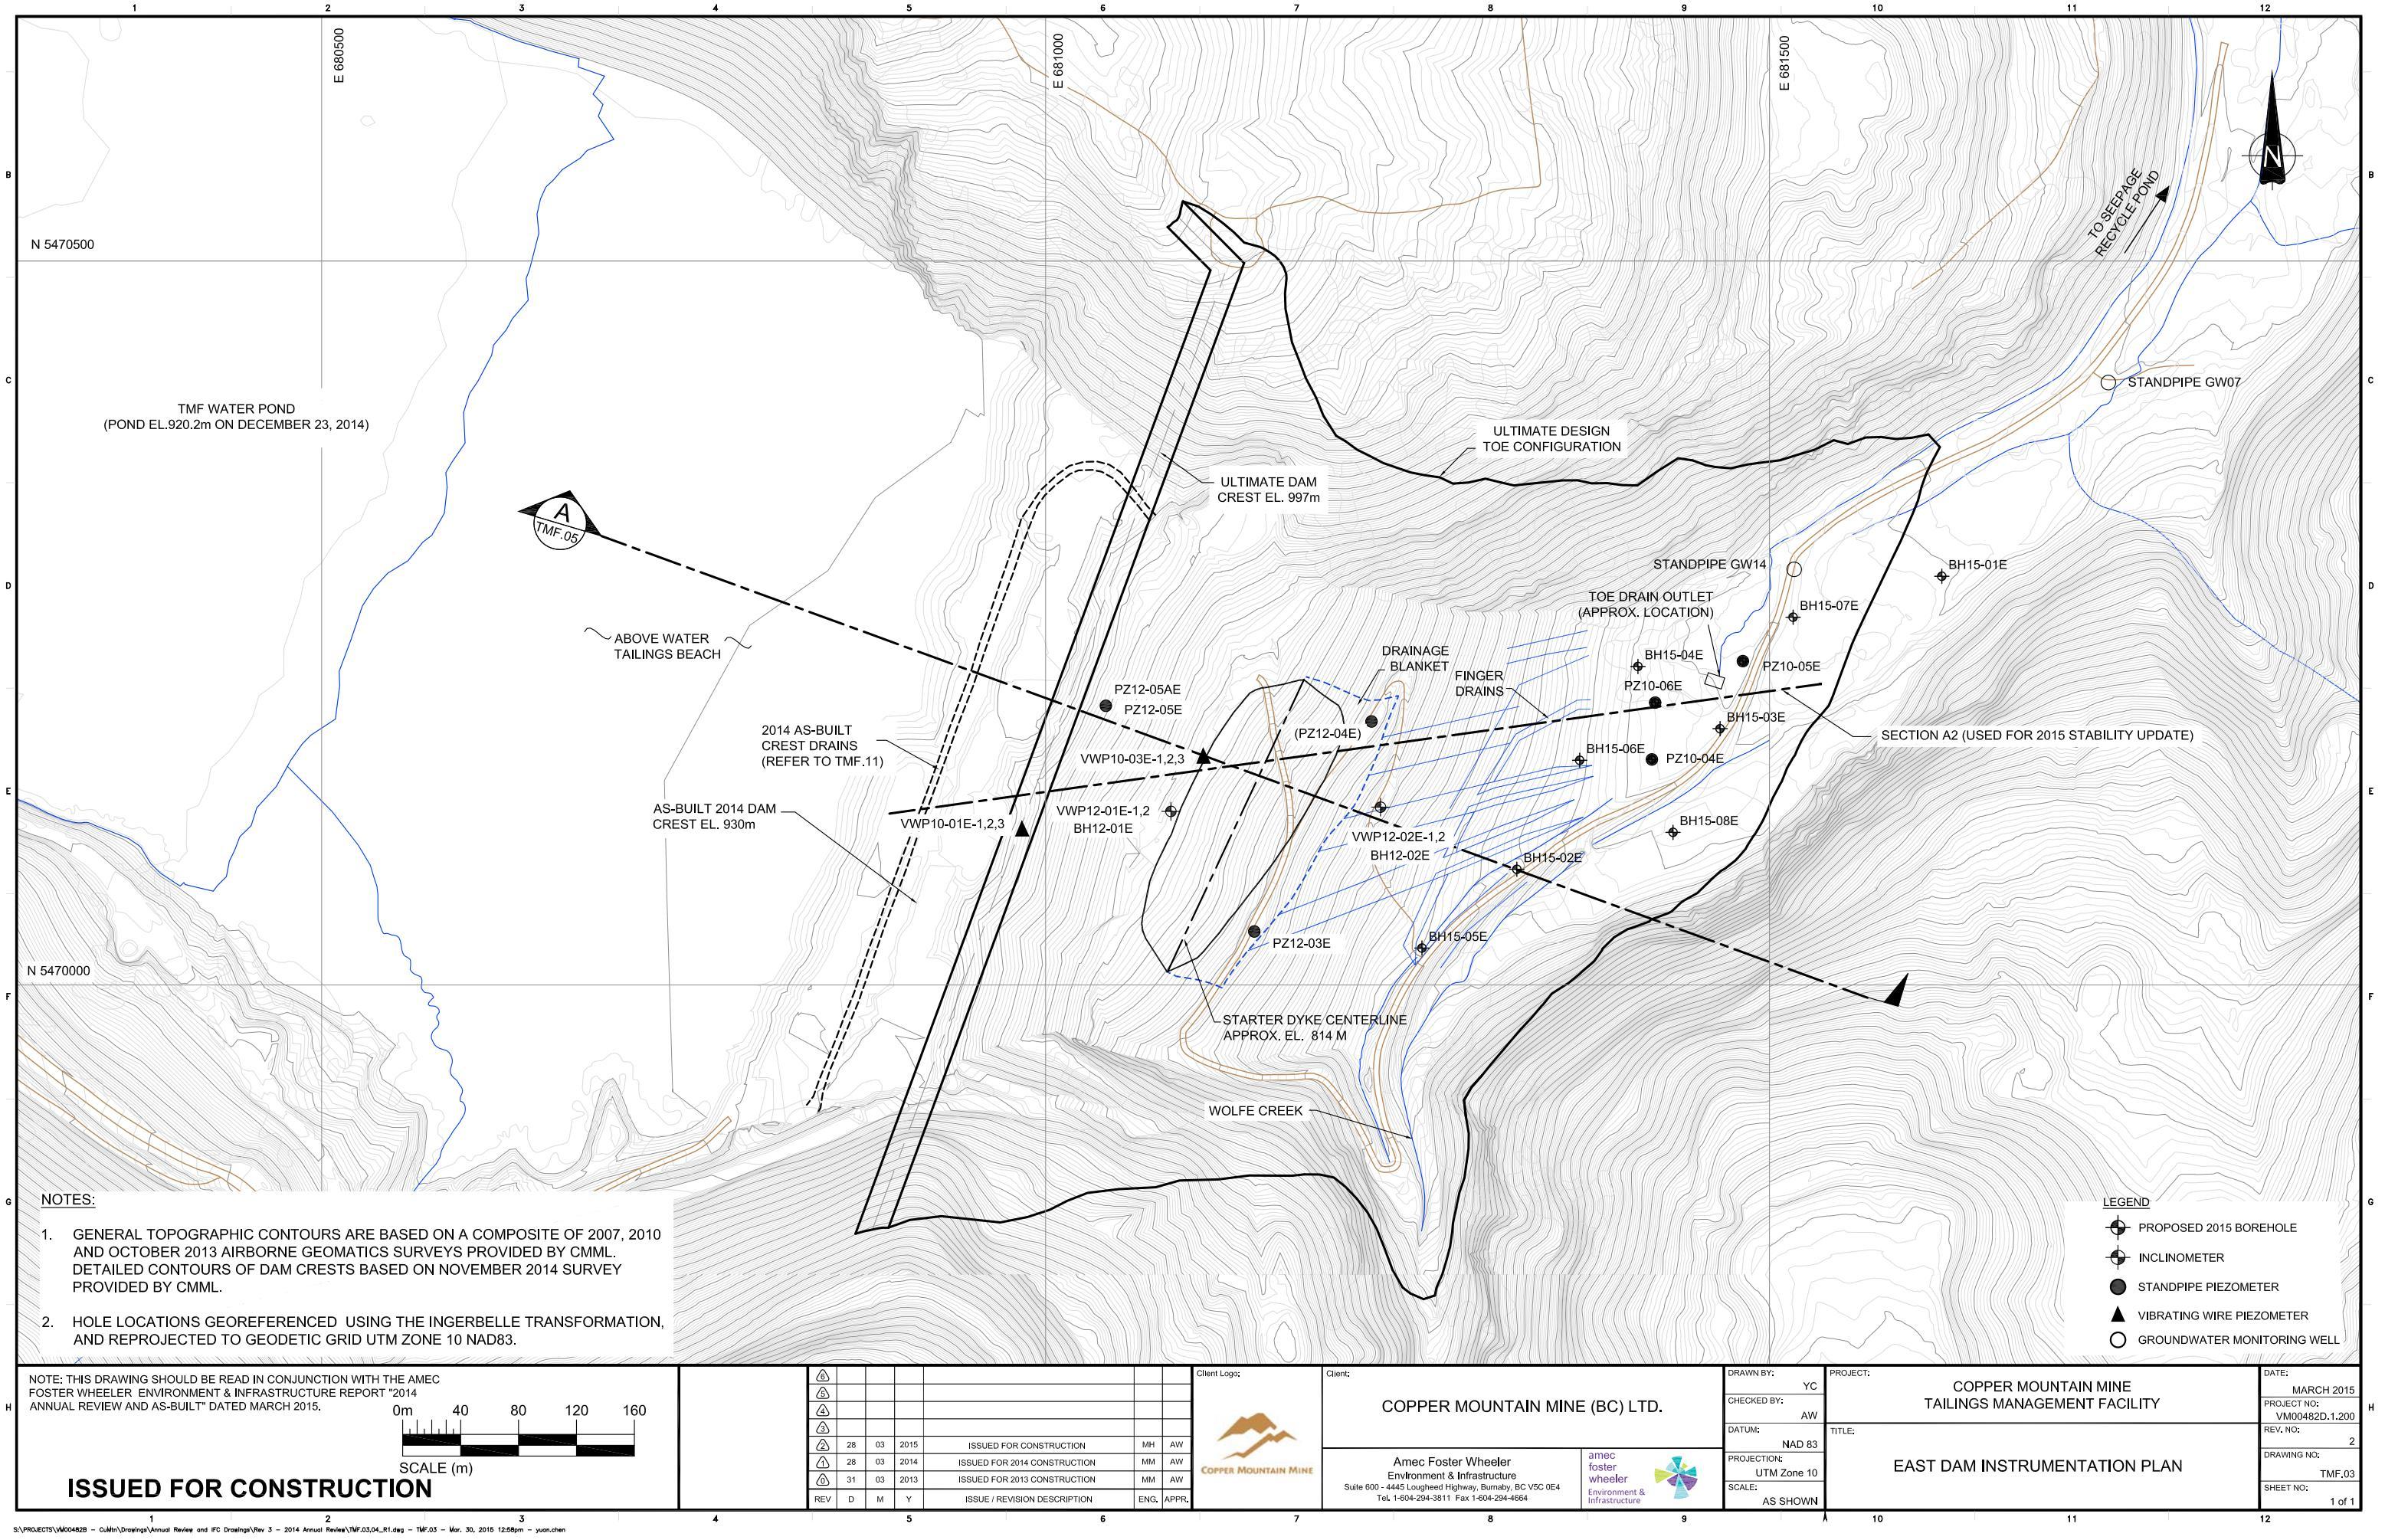
As shown on drawing TMF.03, the toe of the east dam is laterally constrained by bedrock cliffs within the relatively narrow Wolfe Creek valley. Since 2010, eight boreholes have been drilled into the foundation soils; two upstream of the starter dam (BH1E and BH12-01E) and six downstream of the starter dam (BH12-02E, BH10-04E, BH10-05E, BH10-06E, GW07, and GW14). The glaciolacustrine layer is interpreted to be discontinuous below the East Dam, only encountered upstream of the starter dam (at BH12-01E) and possibly downstream of the ultimate dam toe (at GW07), which is consistent with the observed behavior of the dam over the past 40 years and the monitored performance of the reactivated facility to date.

The design of the East Dam is predicated on two stability analysis sections as shown on Drawing TMF.03. Section A1 as shown on Drawing TMF.05, perpendicular to the dam crest, coincides with the section utilized in the detailed design stability sections (AMEC 2011) and the 2014 stability update (AMEC 2014). This design section was updated in 2015 to more accurately reflect the topography of the valley, namely the large bedrock hillside opposite Wolfe Creek that rises up from the toe of the dam. A second section (A2), aligned slightly oblique to the crest and oriented more to the north and downstream, was also analyzed. This section was chosen as it trends along the valley bottom. Despite not being the steepest section of the dam, it was assessed as it may represent a critical direction for potential movement due to the lack of passive buttressing afforded by the bedrock hillside. For the purposes of stability modeling, the glaciolacustrine layer was extended from BH12-01E to the upstream model limits in the foundation below the original Smelter Lake as a 4 m thick layer (conservatively assumed despite only encountered at 0.5 m thick in BH12-01E). For the sake of conservatism, the layer was extended to the downstream as far as BH12-02E, a sonic borehole drilled to bedrock where glaciolacustrine clay was absent.

As previously noted, additional investigation has been planned for 2015 to further delineate the extents of the glaciolacustrine layer encountered upstream of the East Dam starter dam and increase confidence in the current geological model (discontinuous glaciolacustrine layer) which forms the basis for the East Dam design. Although glaciolacustrine sediments have not been encountered to date at the West Dam, additional drill holes have been planned to further validate its absence and gain additional understanding of the foundation stratigraphy to inform design decisions. Additional piezometers will be installed at both dams to supplement the existing network and support the continued use of the observational approach to design and construction. The proposed 2015 investigation locations are also shown on Drawings TMF.03 and TMF.04.

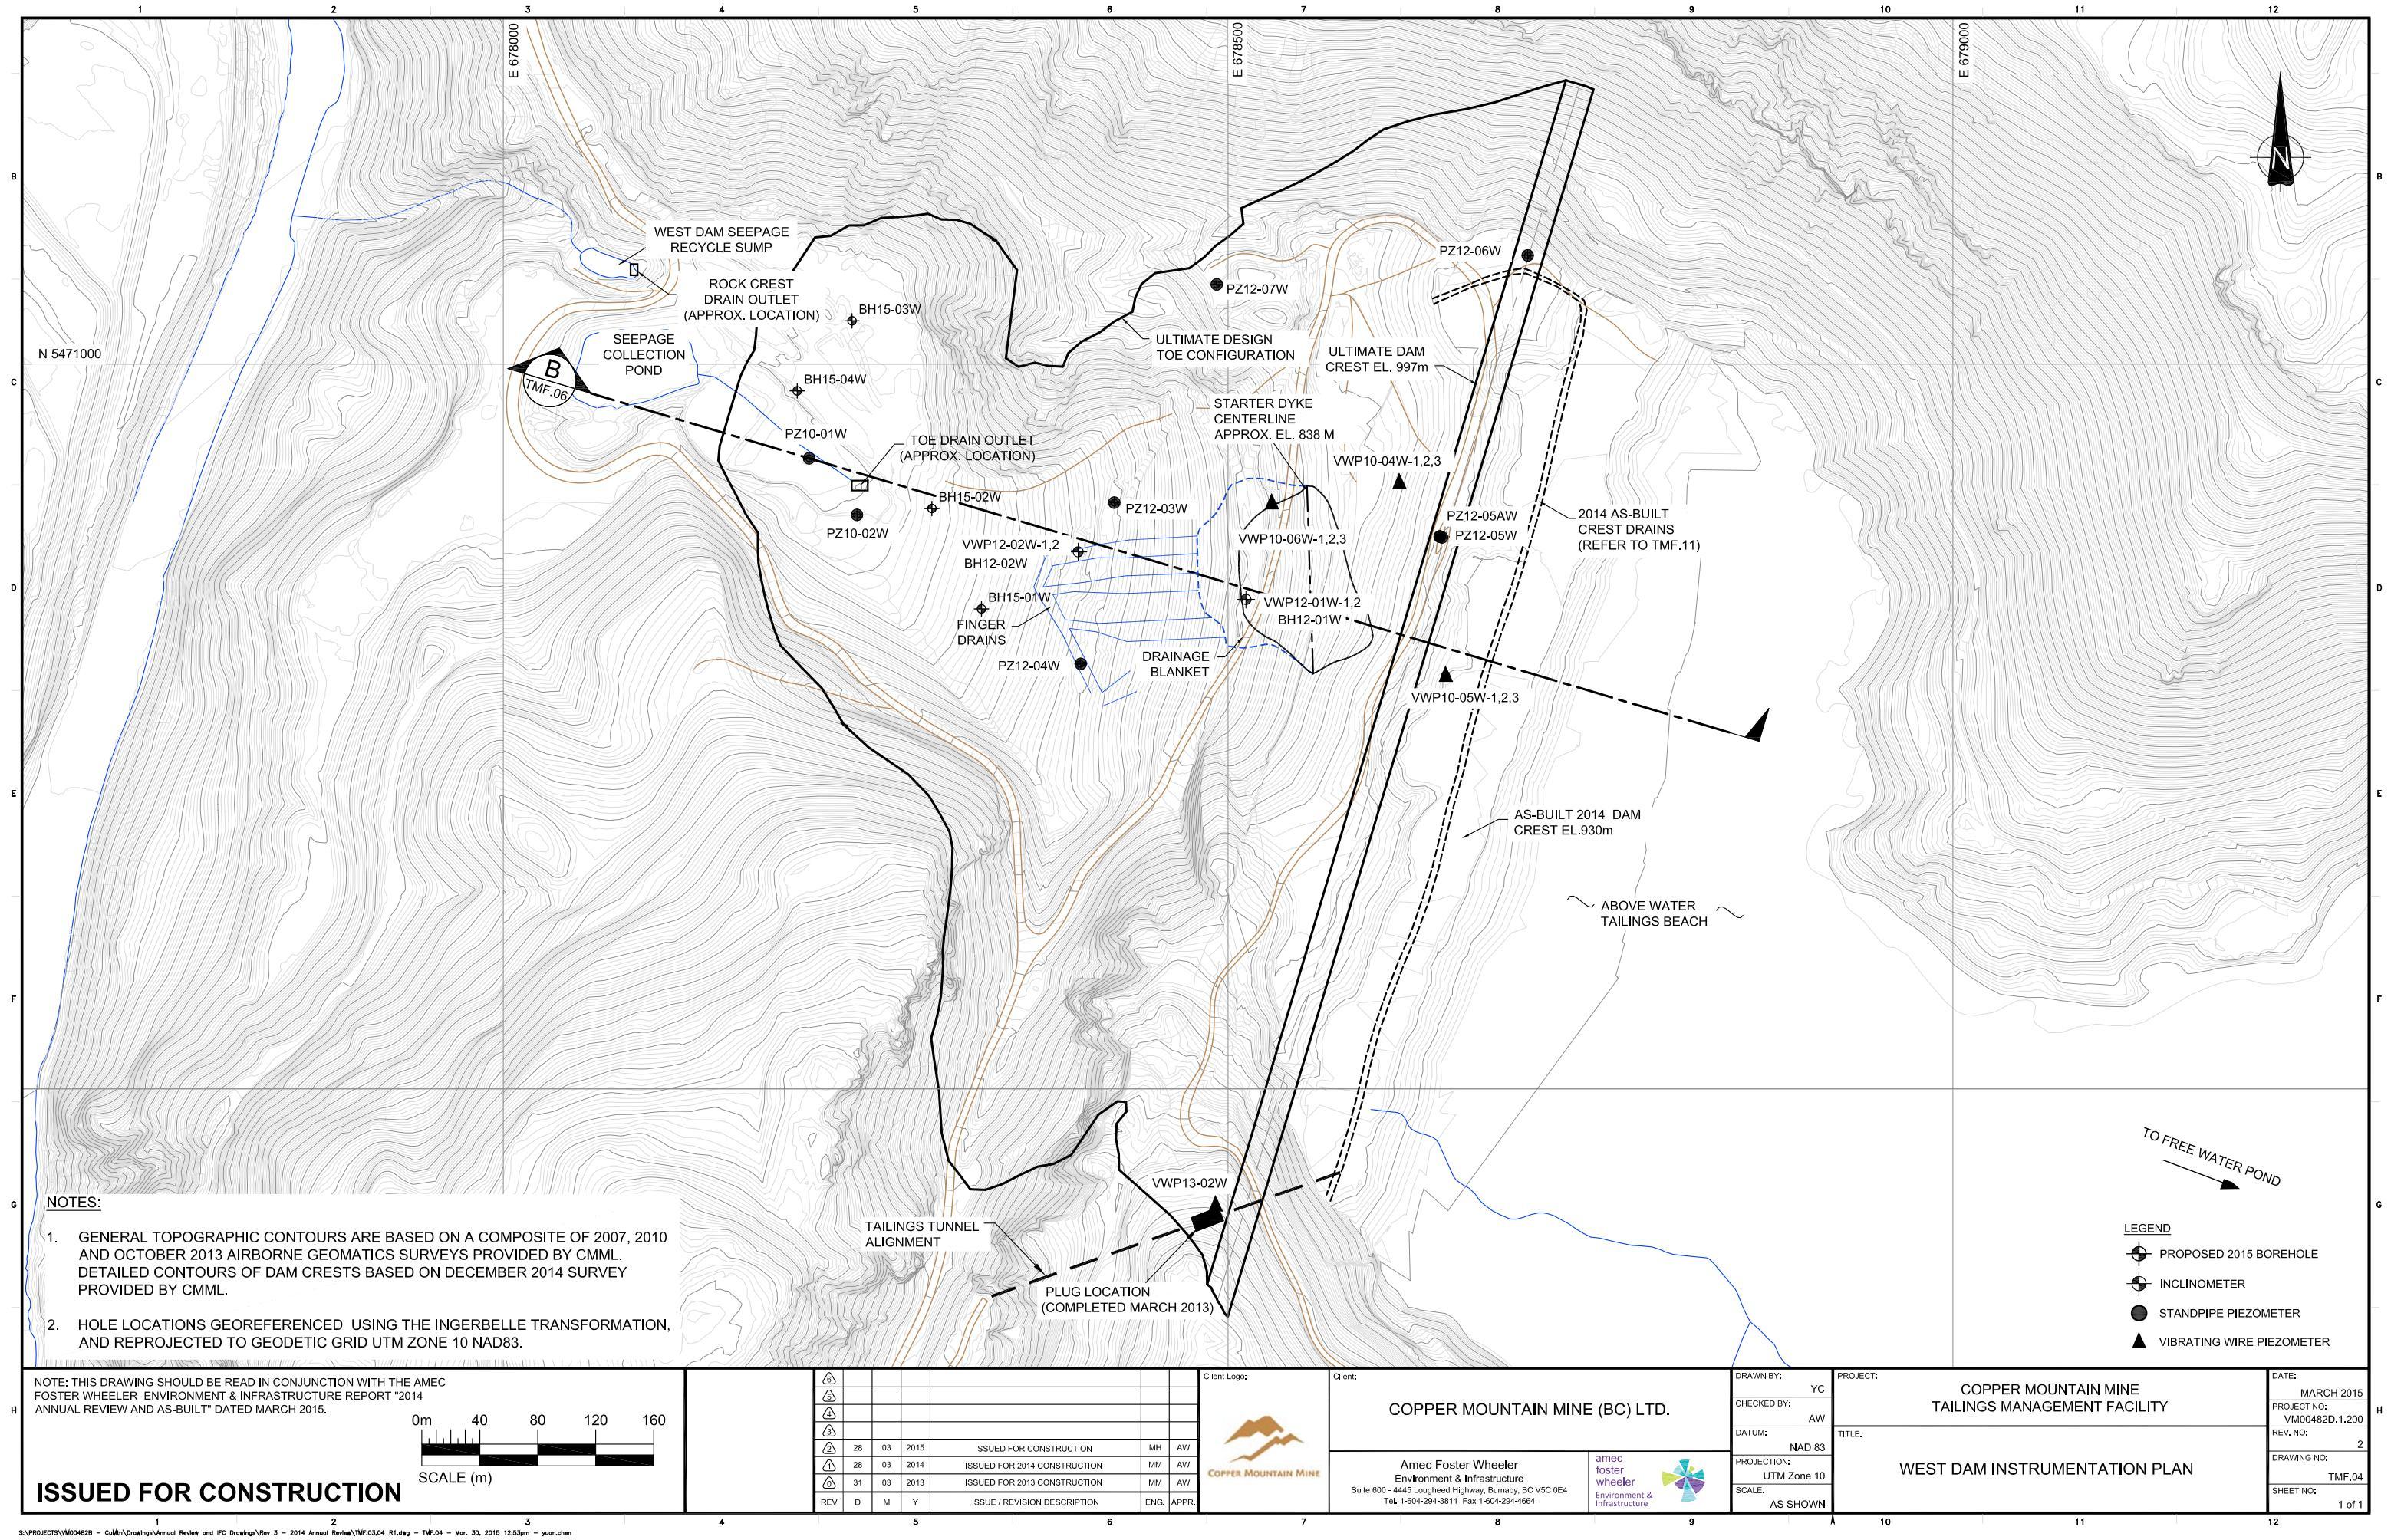
This toe of the West Dam is similarly constrained as shown on Drawing TMF.04 by the meandering bedrock hillsides. Since 2010 six boreholes have been drilled into the foundation of the West Dam without encountering glaciolacustrine sediments (BH12-01W, BH12-02W, BH10-01W, BH10-02W, BH10-04W, BH10-05W).

To date no glaciolacustrine sediments have been encountered beneath the starter dam or downstream shell of the West Dam which is interpreted to be founded on a relatively thin veneer of sand and gravel overlaying competent bedrock. As noted by Amec Foster Wheeler (2015), in both static and post-seismic analyses, critical slip surfaces for the West Dam represent shallow sliding surfaces within the outer cyclone sand shell, for both the proposed 2015 and ultimate dam configurations maintaining a FoS at or above the target of 1.5. Post-seismic stability analyses for the West Dam satisfy the target FoS of 1.2 under the loading of the MCE.

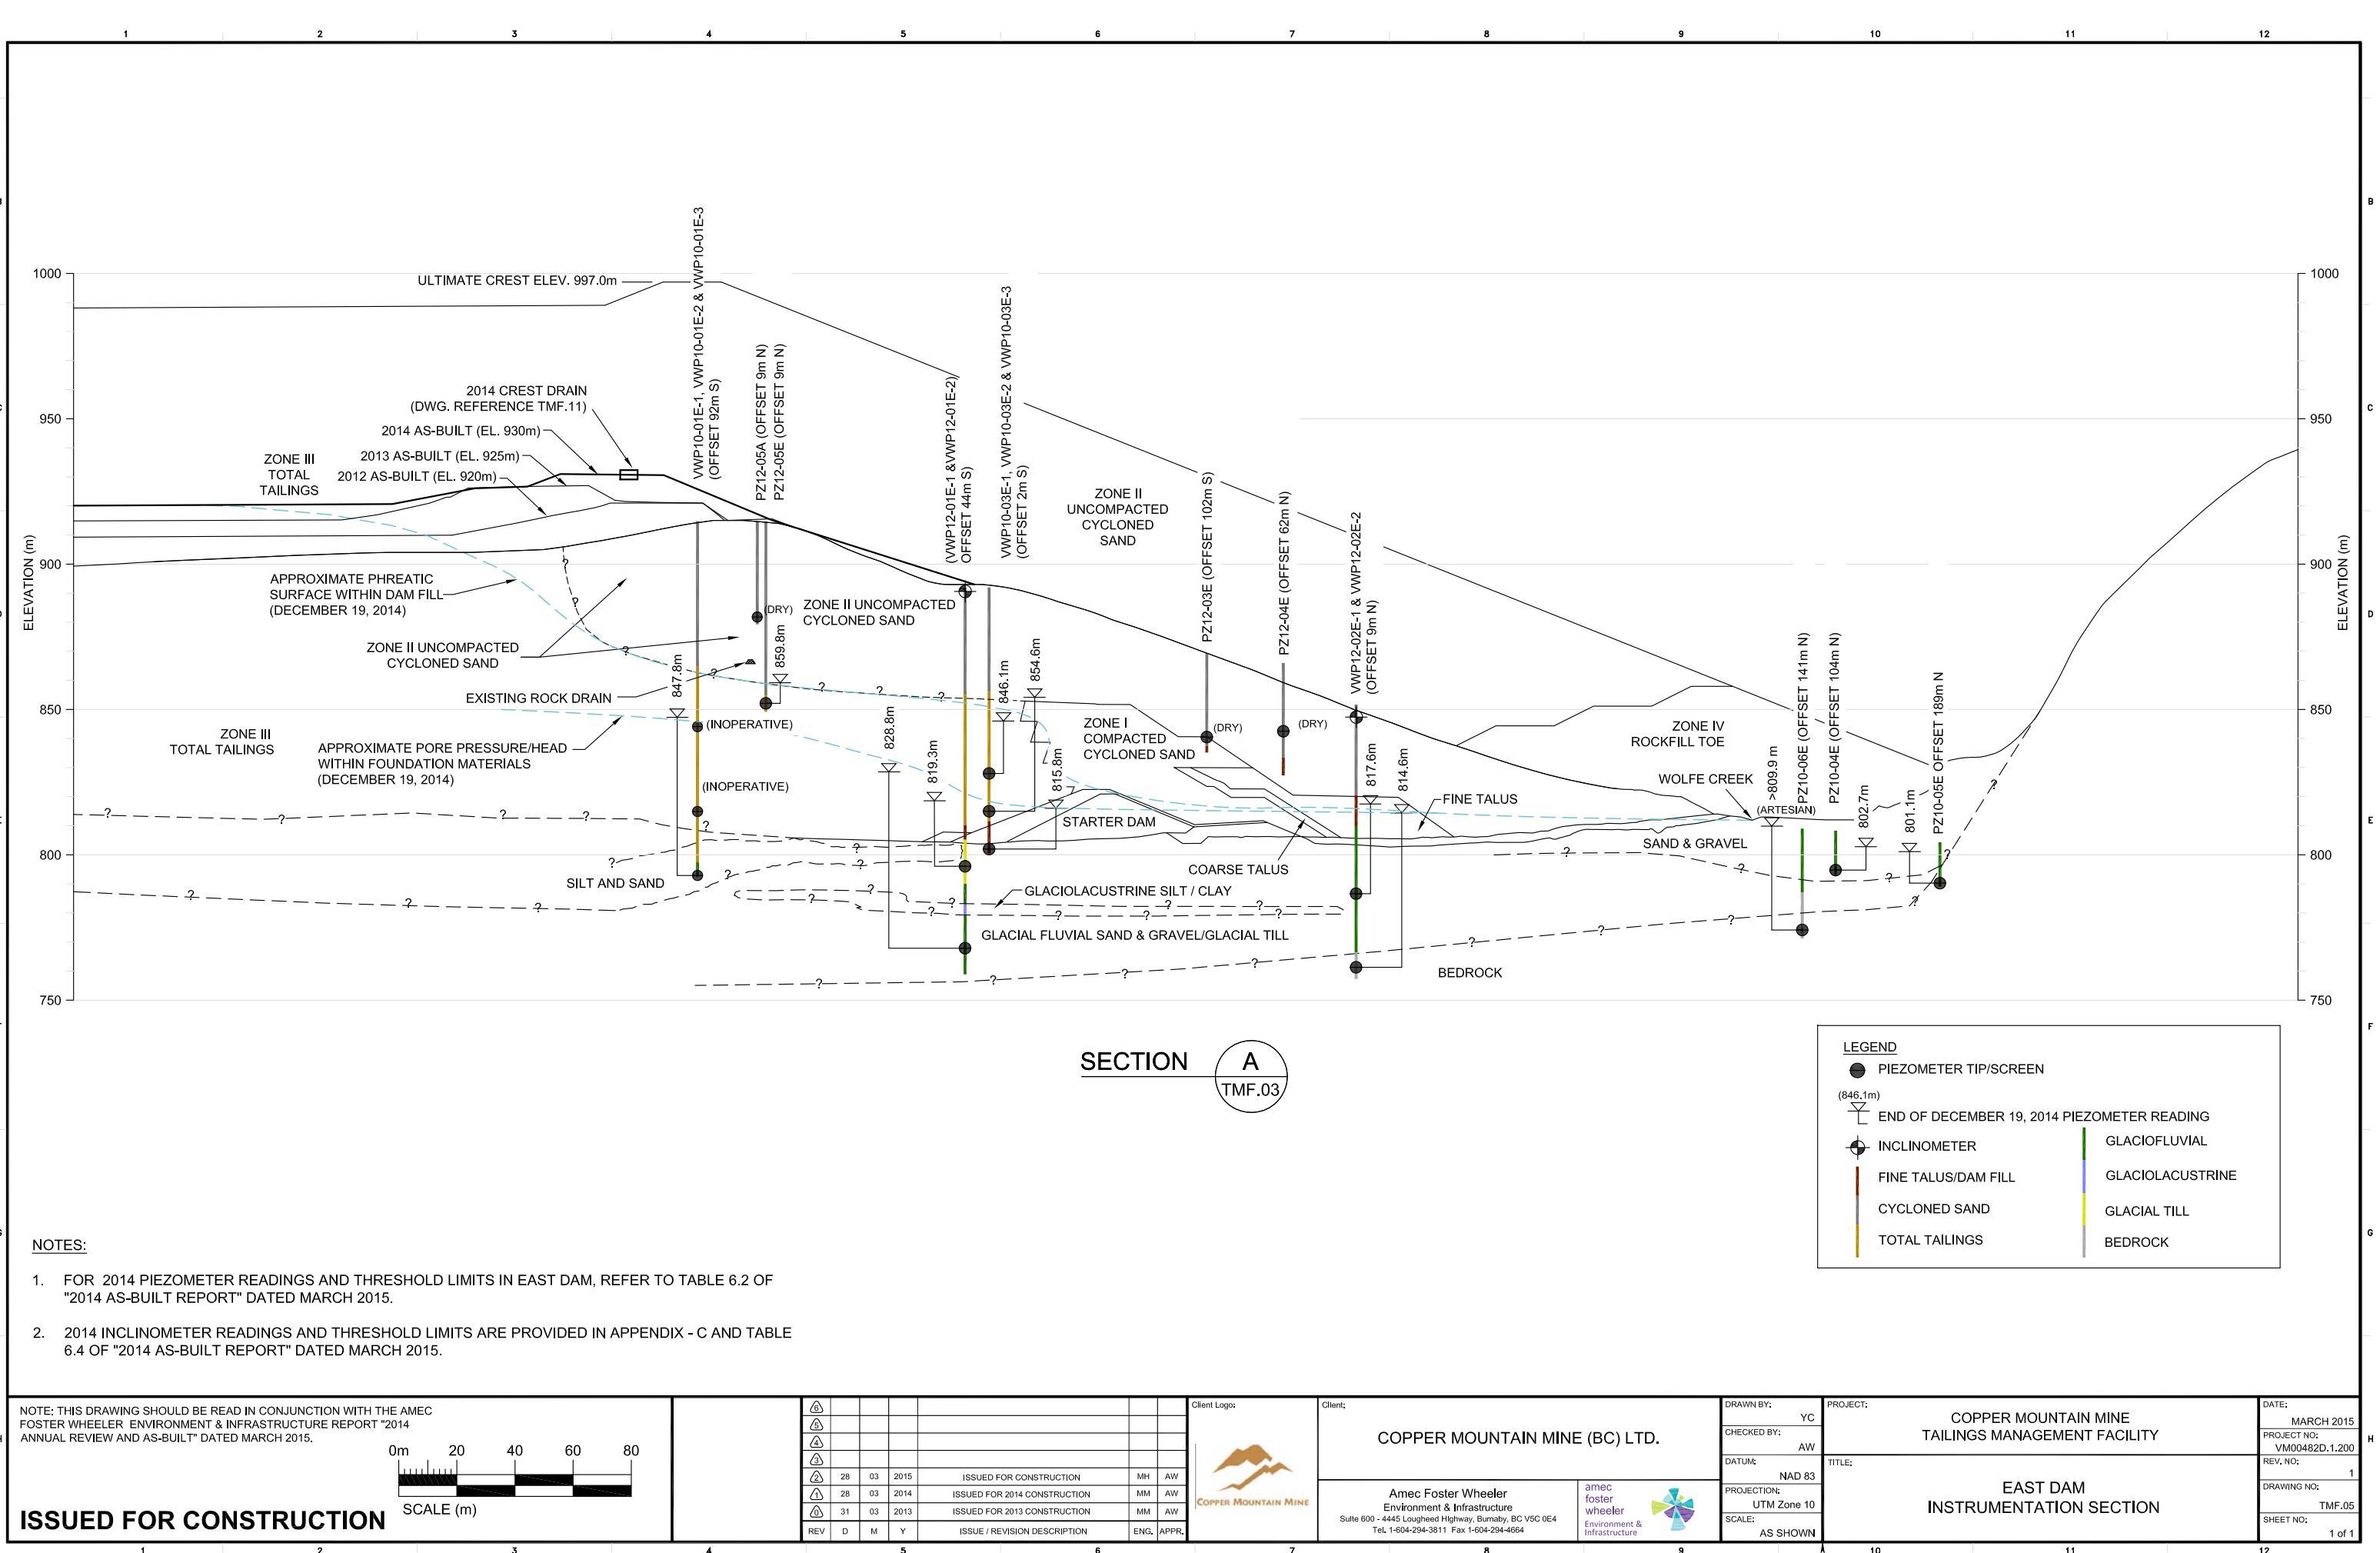
BH12-01E consisted of very stiff, pre-sheared silt and clay that is interpreted to be deposited prior to regional cover by glaciation, as it was encountered 25 m below the original ground surface, below a glacial till layer. However, it appeared this the glaciolacustrine silt and clay layer was discontinuous throughout the valley bottom and believed to have been eroded away by the higher energies associated with the later deposition of sands and gravels in the Wolfe Creek drainage (Matthews 1944)². This was evidenced by the lack of glaciolacustrine sediments encountered in BH10-04E, BH10-05E, BH10-06E and BH12-02E downstream of the starter dam and closer to Wolfe Creek. Environmental groundwater monitoring wells installed separately by CMML in 2011 suggest the presence of a clay layer on the valley side slopes further down the Wolfe Creek valley in the lower gradient areas which further substantiates the conceptual model of a previously continuous glaciolacustrine layer locally eroded at the toe of the East dam by the higher energy flows associated with Wolfe Creek development and deposition. Drawing TMF.05 presents the interpreted geologic cross section which forms the current basis of the East Dam design.

The resulting FoS predictions for the East Dam indicate that for discontinuous glaciolacustrine layer with a S_u/σ_v ' ratio of 0.21 (analytically equivalent to a residual strength friction angle of 12°), a static FoS of 1.5 is maintained for both the proposed 2015 crest elevation and the ultimate dam configuration which meets the target FoS as per CDA guidance (Amec Foster Wheeler 2015). Sensitivity analysis on the strength and continuity of the glaciolacustrine layer also suggests that continuity in the foundation has a significant effect on the calculated FoS. However, it is noted that even for the worst conceivable case, with several layers of conservatism (i.e. a continuous glaciolacustrine layer despite known absences, very low residual strength values below empirically derived values, entirely normally consolidated and hydrostatic pore pressures despite observed downward gradients, and no consideration of 3D effects), a static FoS of 1.2 is still maintained in all cases. The required post-seismic FoS of 1.2 is achieved for both the proposed 2015 crest elevation and the ultimate dam configuration under the loading from the Maximum Credible Earthquake (MCE). The MCE is defined as a
