Tailings Impoundment and Water Management Structures 2014 Dam Safety Inspection

Equity Silver Mine Houston, British Columbia

FINAL REPORT

October 14, 2014

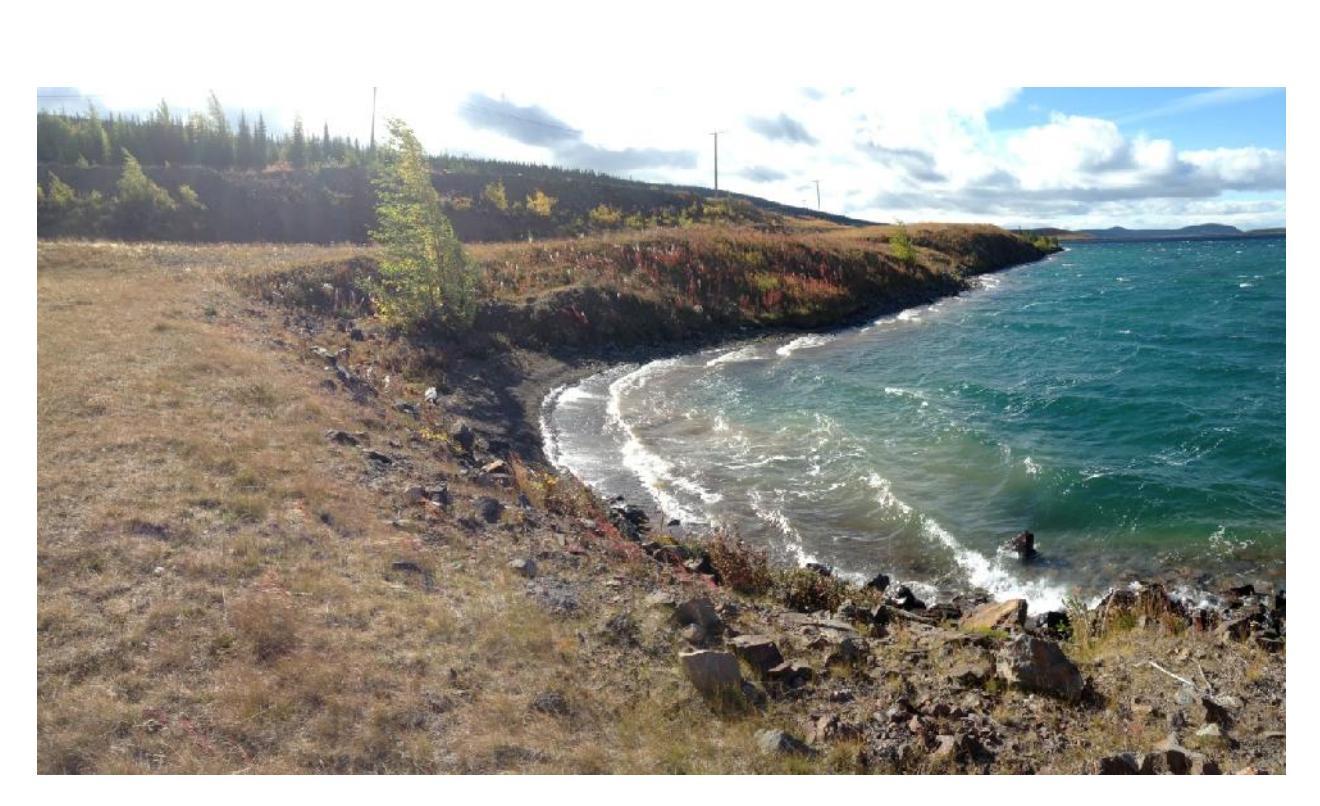
From a thorough visual inspection, Dam No. 1 appeared to be in good physical condition with no visible signs of erosion, settlement or slope deformation. Photos 3, 4, and 5 show the upstream face of Dam No.1. Photos 6 and 7 show the crest of Dam No. 1. Photos 2 and 8 through 16 show the downstream face and toe of the dam including seepage conditions. The following observations were made during the field inspection:

• The four areas of erosion on the upstream face noted in the 2011 annual inspection (AMEC 2012) and repaired in that same year were observed to be performing well with no obvious signs of distress or deterioration. These areas are known for having increased wave action, due to the prevailing winds in the South-North direction, as noted in previous reports and shown in the photos. These areas have received attention in the past, and partial repairs to the riprap have been completed on an "as-needed" basis (Klohn Crippen 2002, 2003; AMEC 2004a, 2005, 2008, 2009a, 2010). Although no specific repair work is required at this time the riprap should be continually monitored each year as part of the annual review to see if/when the riprap deteriorates with repairs

Photo 3: Dam No. 1, view of the upstream slope and right abutment to the emergency spillway inlet.

to be made on this basis. However, consideration should also be given to the development of a more permanent riprap repair program utilizing more durable, appropriately graded materials. This would minimize the need for ongoing repairs in the same areas that have a documented history of erosion susceptibility due to their exposure to wind and wave action.

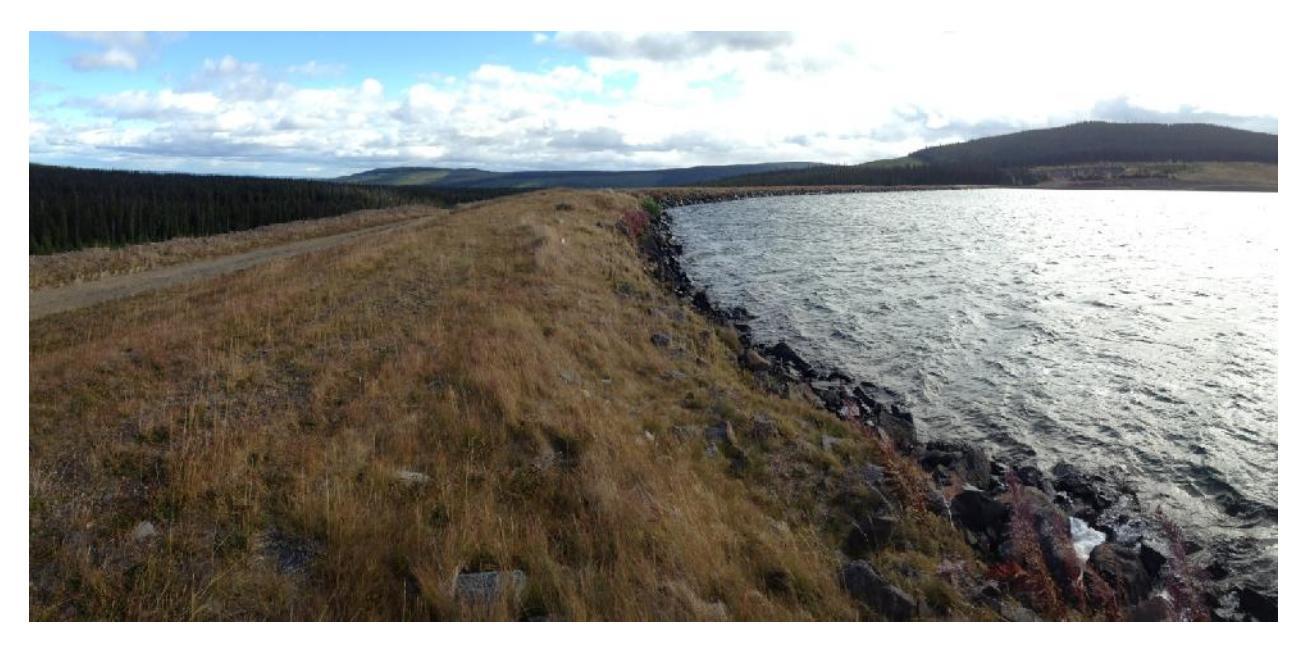
Photo 4: Dam No. 1, view of the upstream slope and riprap protection looking east.

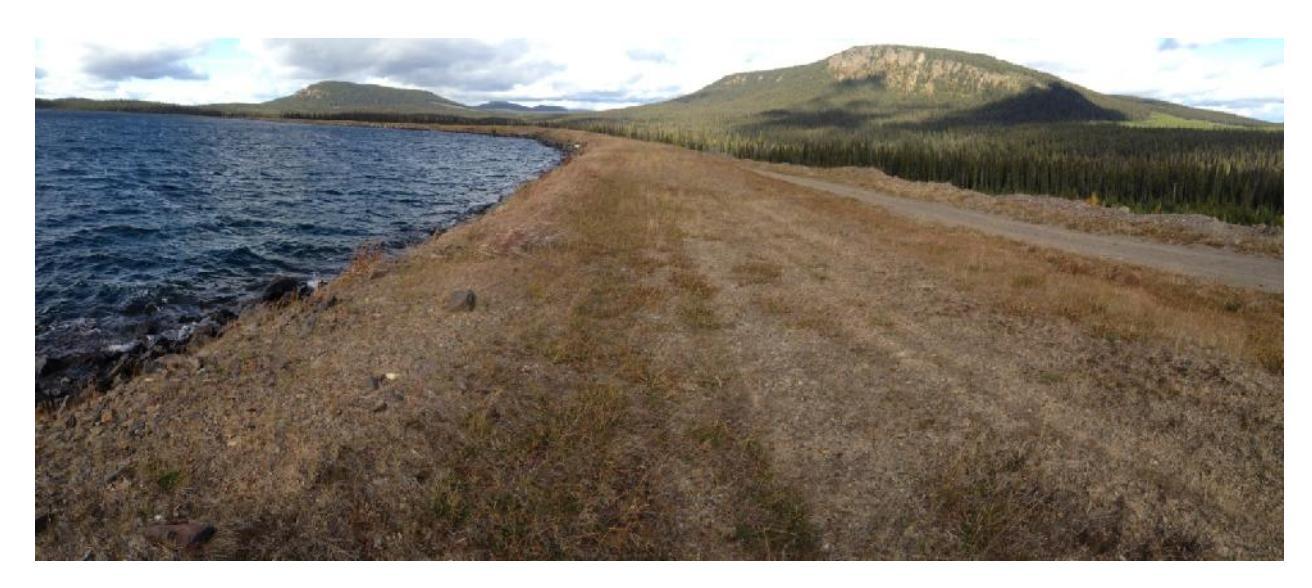
- Sections of the dam crest were noted to be rutted from tire traffic, most likely from past maintenance activities (Photos 6 and 7). Revegetation of rutted areas has occurred however ruts are subject to further erosion, and traffic should avoid sharp turns, or work immediately following wet climatic conditions, when soft ground conditions may be encountered. Revegetation should be considered, following riprap repair campaigns, with the appropriate seed mixes.

Photo 6: Dam No. 1, view of the crest road bench and crest of dam looking west.

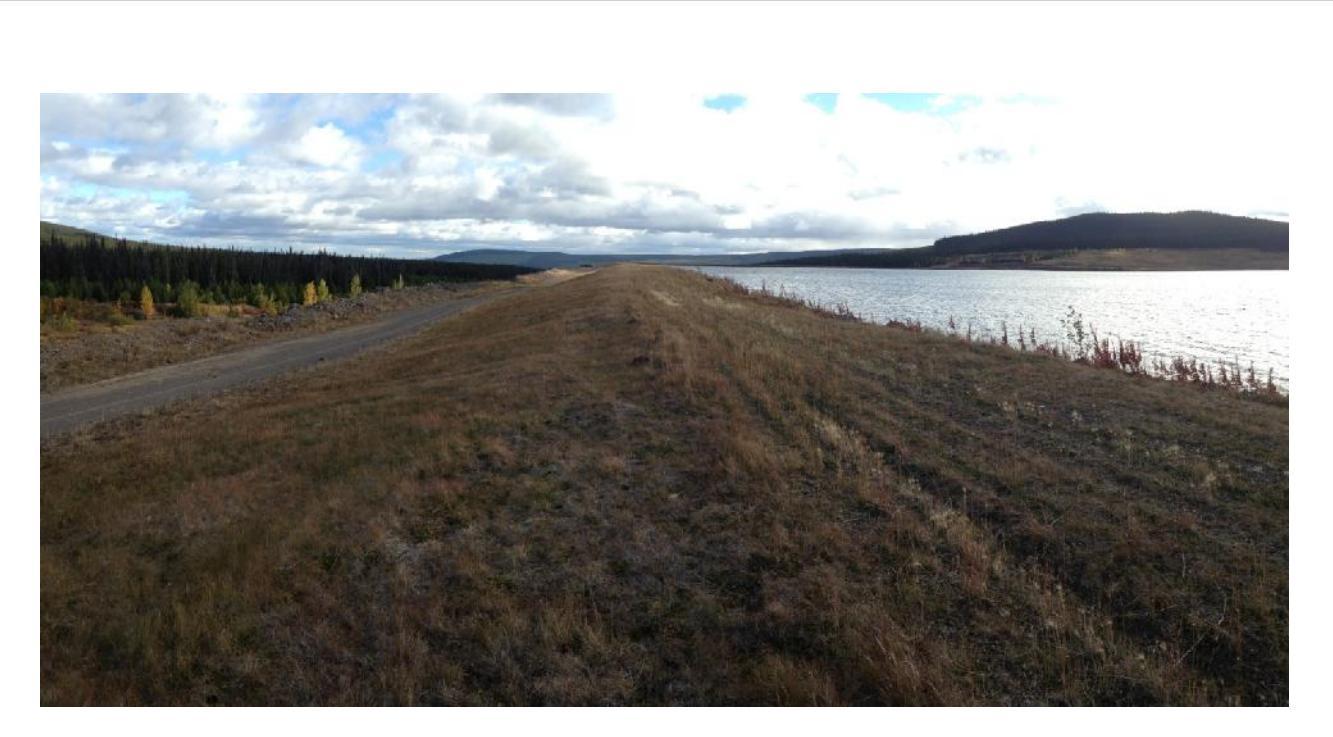
Photo 7: Dam No. 1, view of the dam crest bench, looking east.

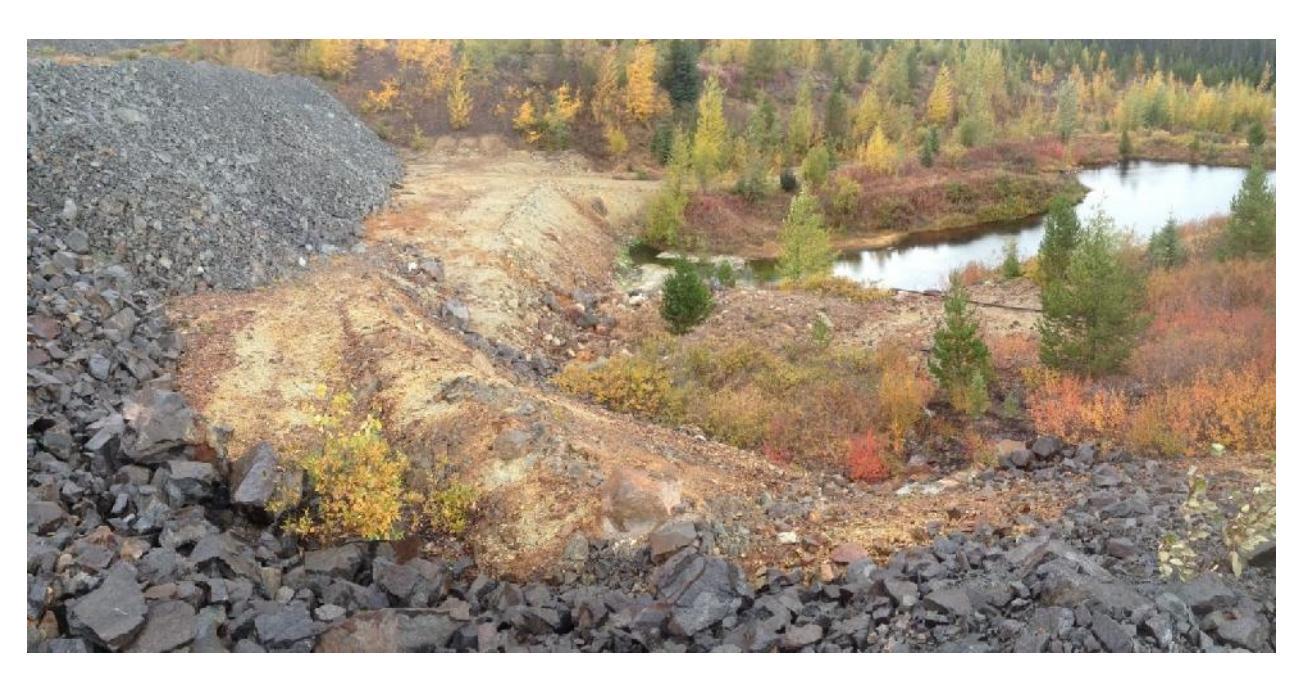
Photo 15: Dam No. 1, view of downstream toe. Note active seepage into pond.

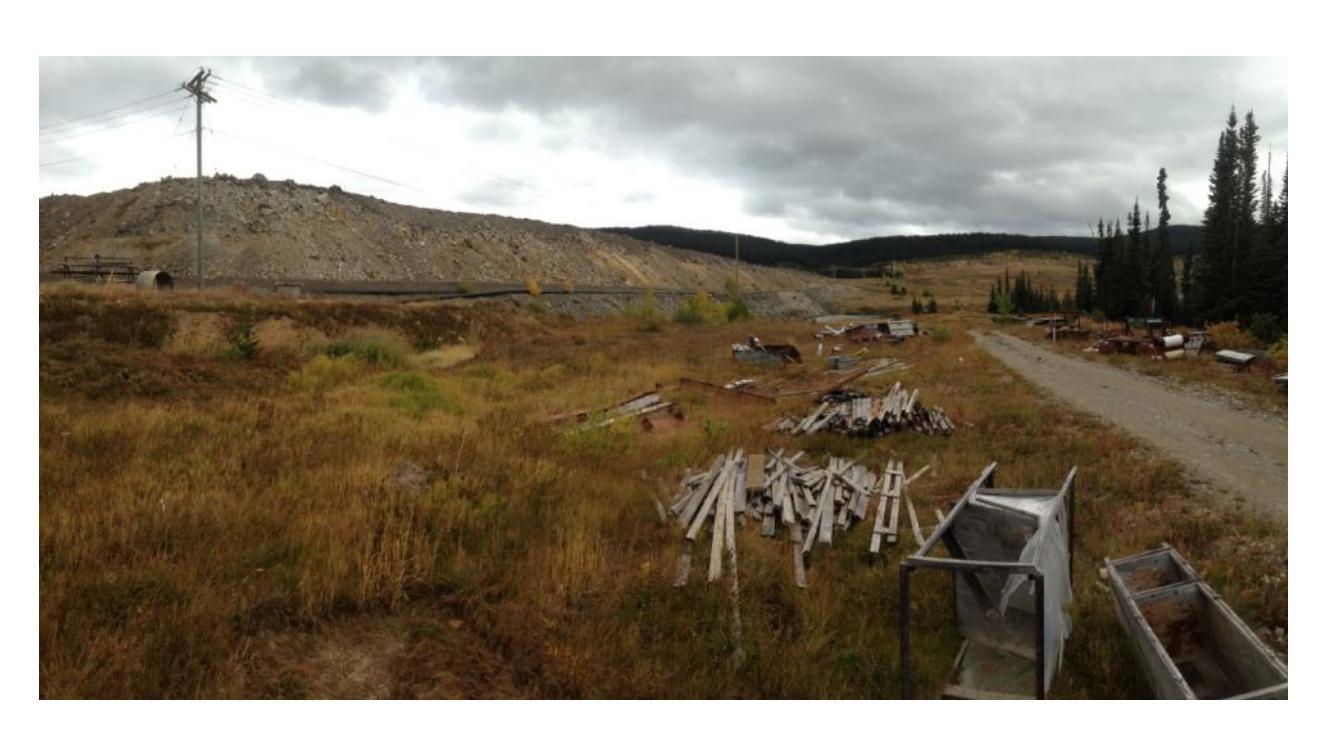
Dam No. 2 makes up the southern boundary of the tailings impoundment. Dam No. 2 appeared to be in good physical condition with no visible signs of erosion, settlement or slope deformation. Typical views of the downstream slopes, upstream face and crest of Dam No. 2 are shown in Photos 21, 22, 23 and 24. The following observations were made during the field inspection:

Photo 21: Dam No. 2, view of the downstream face.

- As with the other tailings dams, regular monitoring of the condition of the upstream slope protection should continue with repairs made as required (Photo 23).
- Removal of any large vegetation (shrubs, trees) and regular maintenance, dictated by the rate of vegetation growth.
- Similar to previous inspections, ponded water was observed at the toe of Dam No. 2 (Photo 22). The pond does not appear to have changed significantly from previous inspections. There were no visible seepage points along the toe. Any seepage would collect at a low area at the downstream toe and be directed to the ARD collection system further downstream.

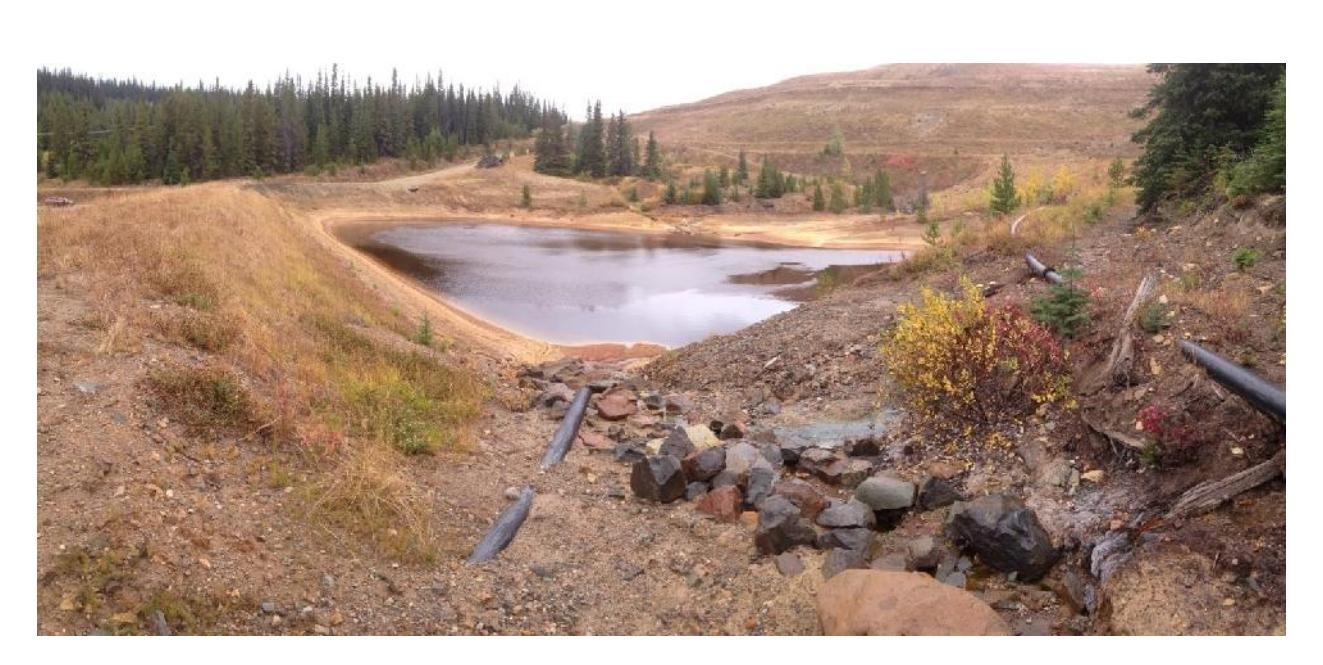
Photo 43: ARD Surge pond left abutment. Note water flowing alongside pipe through riprap.

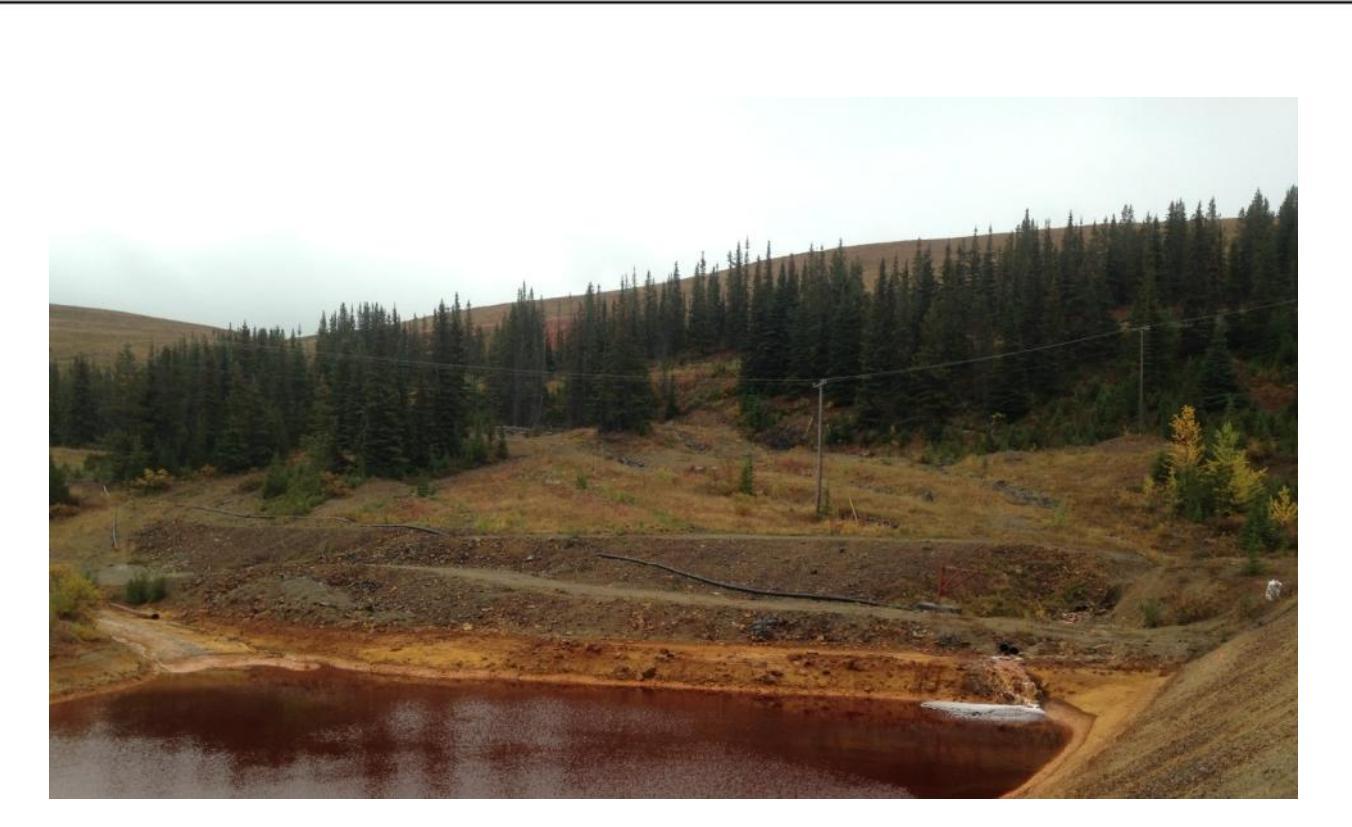
Photo 59: Main ARD Pond Slope, view from opposite side of Main ARD pond. Note active seepage was observed in the central counterfort drain, although less so than 2013.

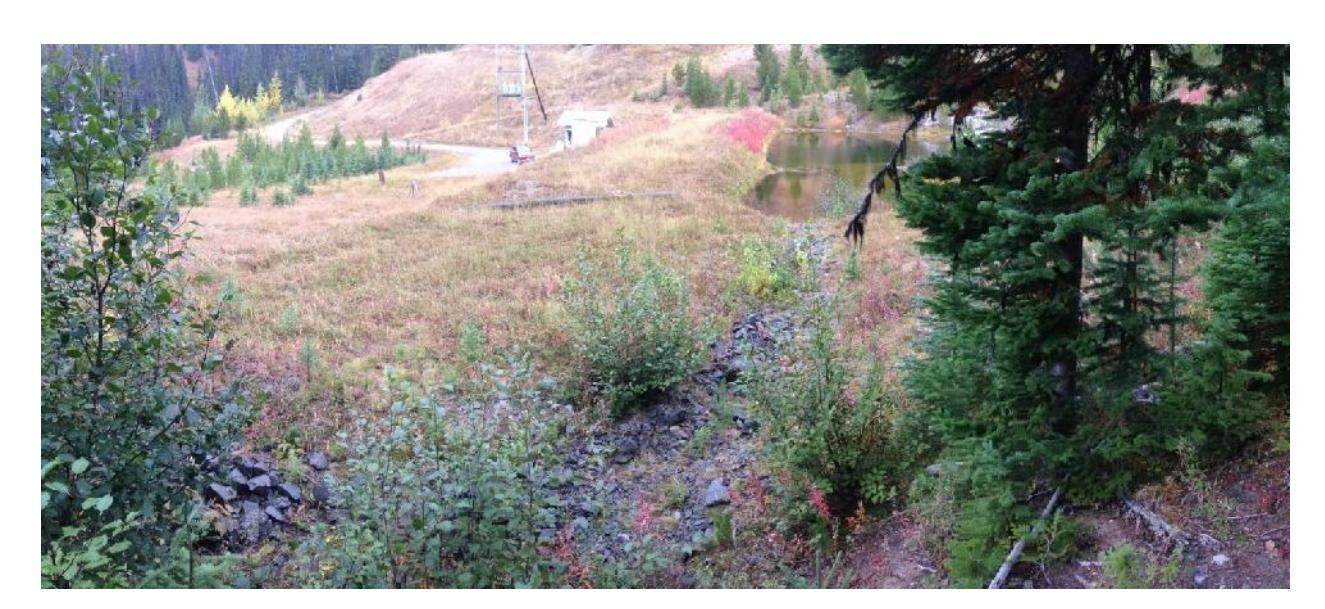
Photo 73: Getty Creek Pond Dam, view of the dam crest and upstream slope. Note siphon towards the left abutment and spillway channel in foreground.

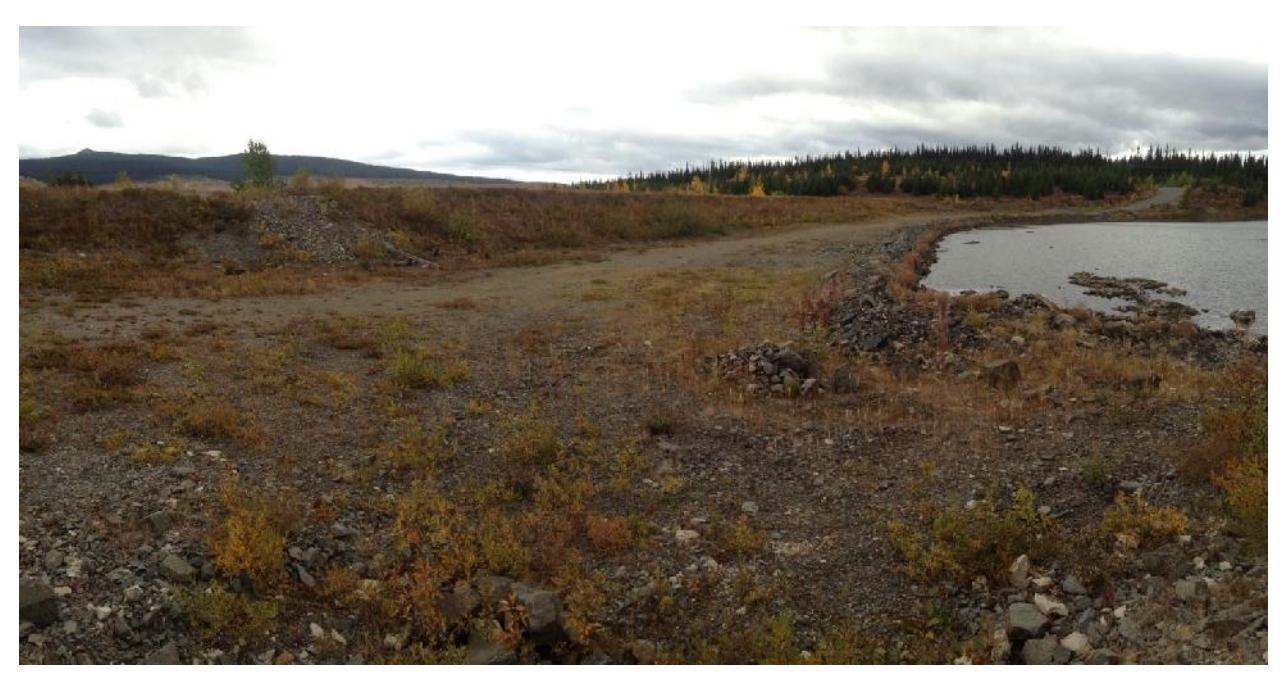
Photo 76: Dam No. 3, view of the crest and downstream face of the dam (with downstream bench). Note impounded water downstream of dam.

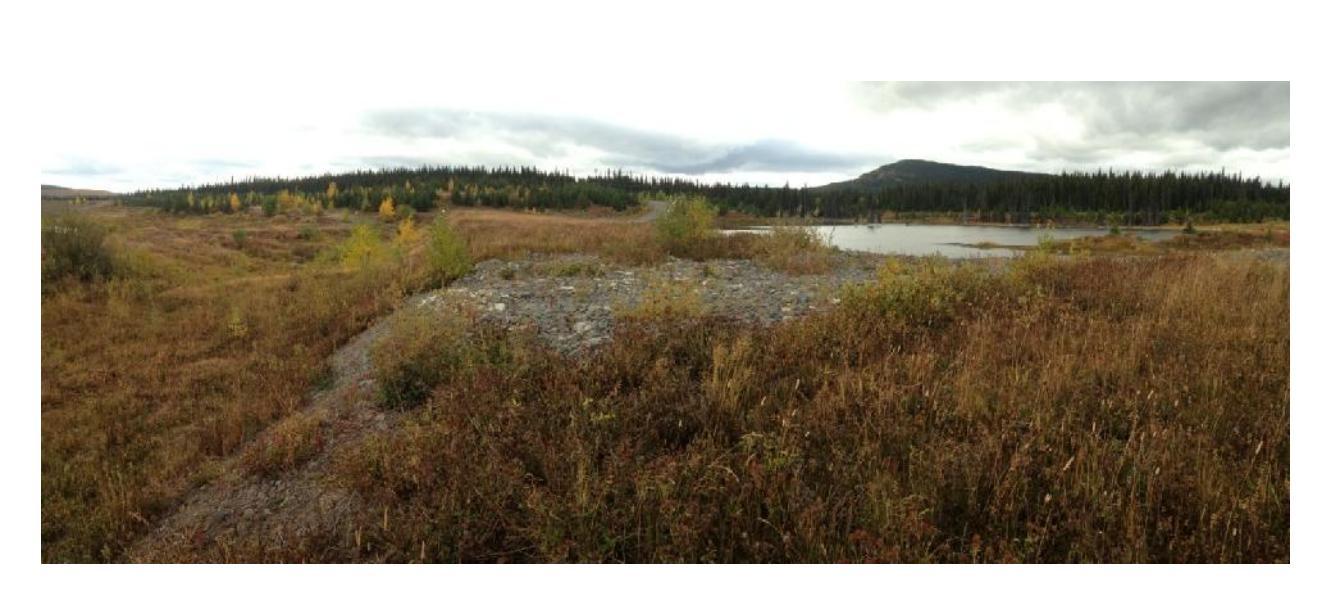
Photo 79: Dam No. 3, view of the dam crest with emergency spillway in the foreground (lined with rockfill). Note spillway invert elevation almost the same as the crest elevation. Note vegetation growing in channel.

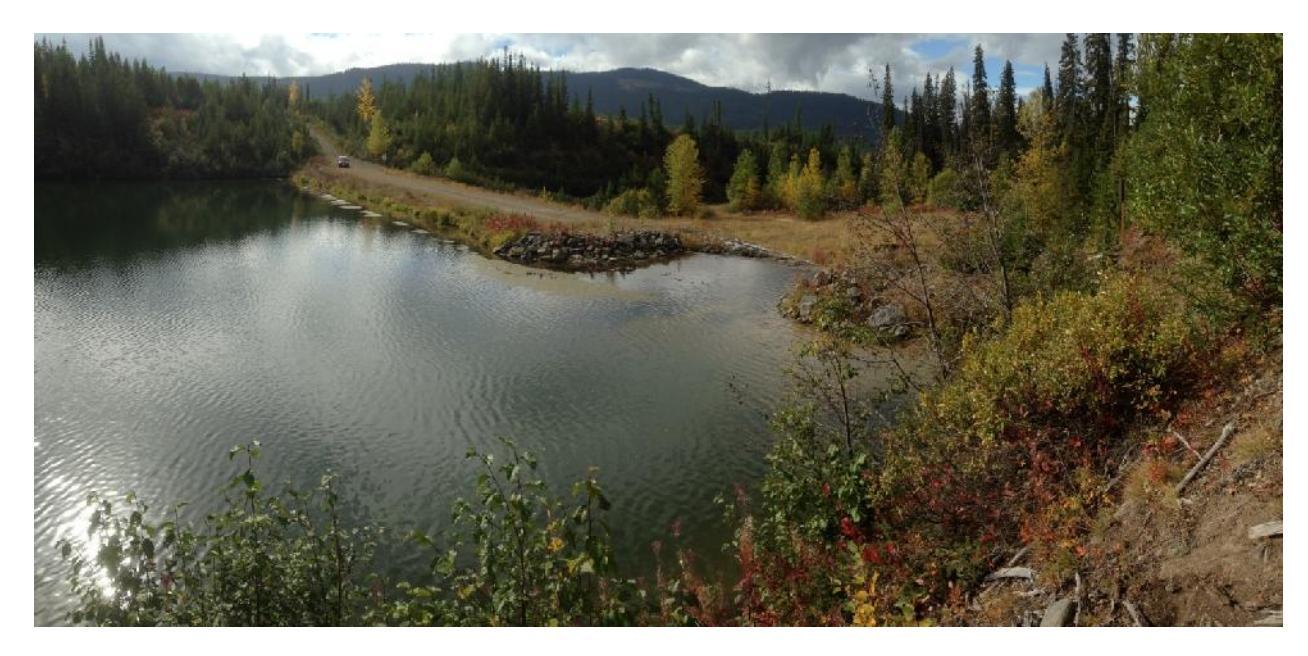
Photo 80: Bessemer Creek Silt Check Dam, view of dam crest and upstream face. Note spillway flowing in foreground and vegetation at right abutment.

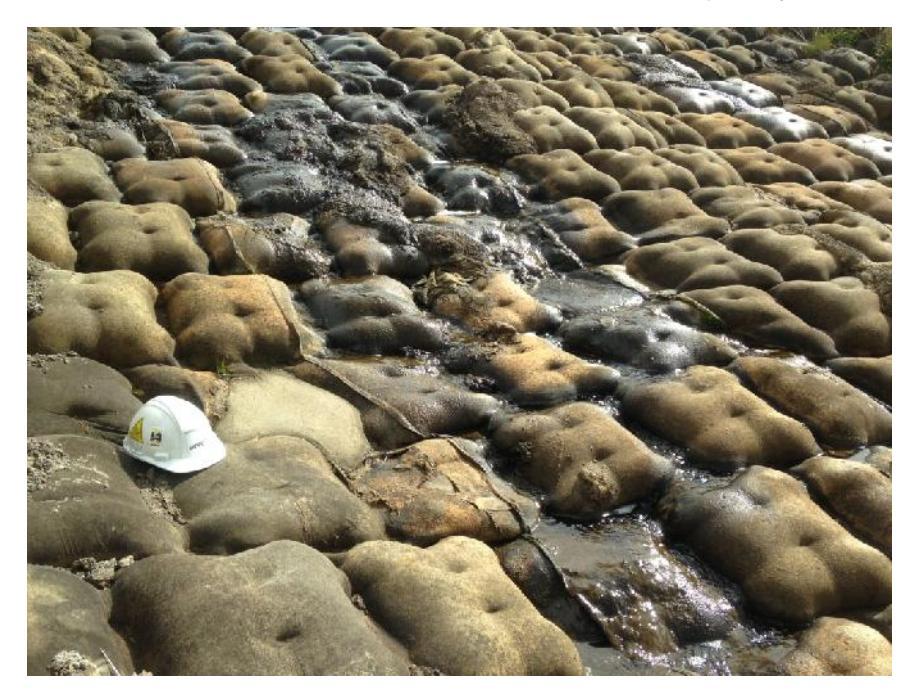
Regarding surface water control, inspection of the Bessemer Creek silt check spillway remedial works indicated that the two repaired revetment blocks appeared to be in good condition with no obvious signs of deterioration or bulging at the toe.

Photo 86: Bessemer Creek Silt Check Dam, repaired blocks in spillway.

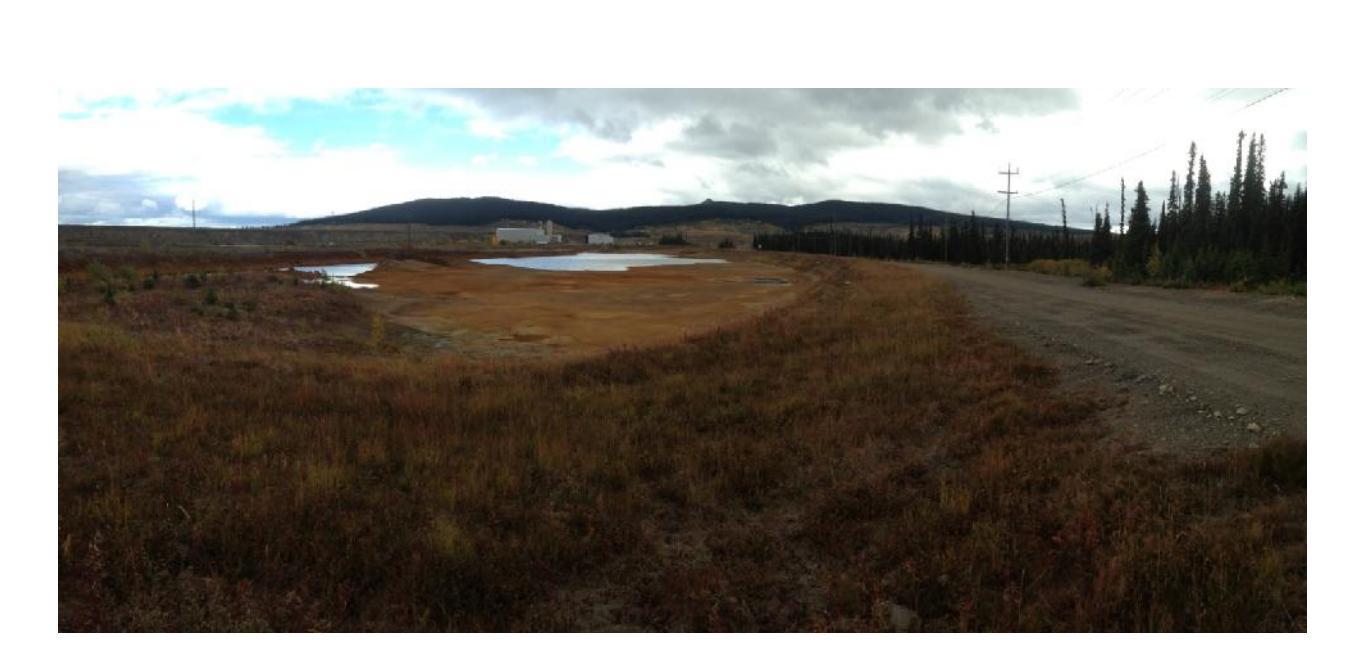
Photo 87: ARD Storage Pond, view of pond and upstream side of dam, and South Dam on left hand side of photo. Note low water level.

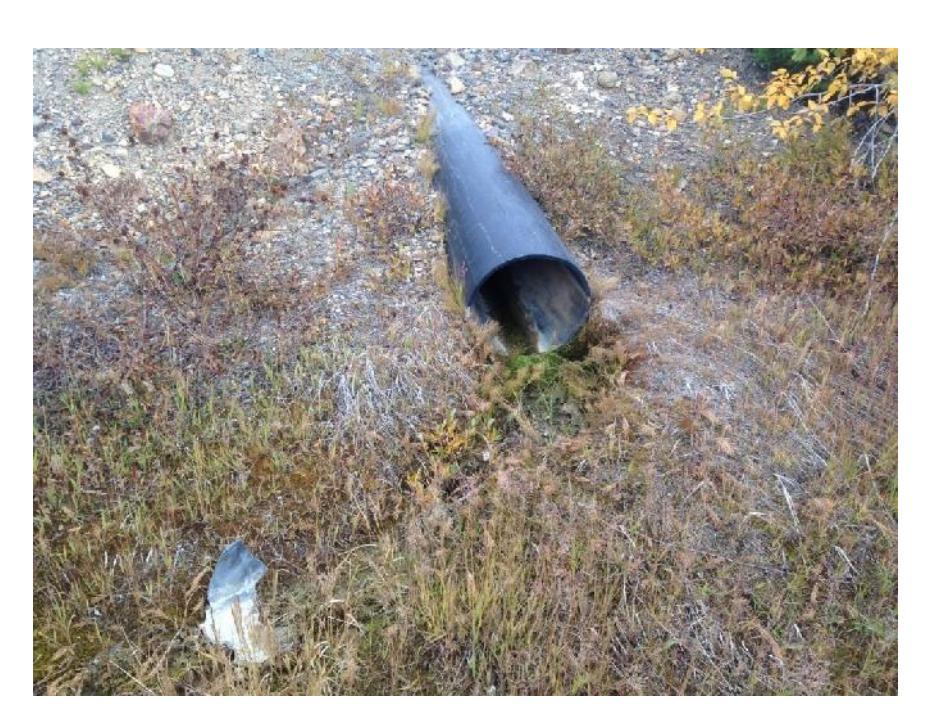
Photo 91: ARD Storage Pond south dam, view of outlet of road culvert opposite "Closed Gate" sign. Minor flow observed from culvert.

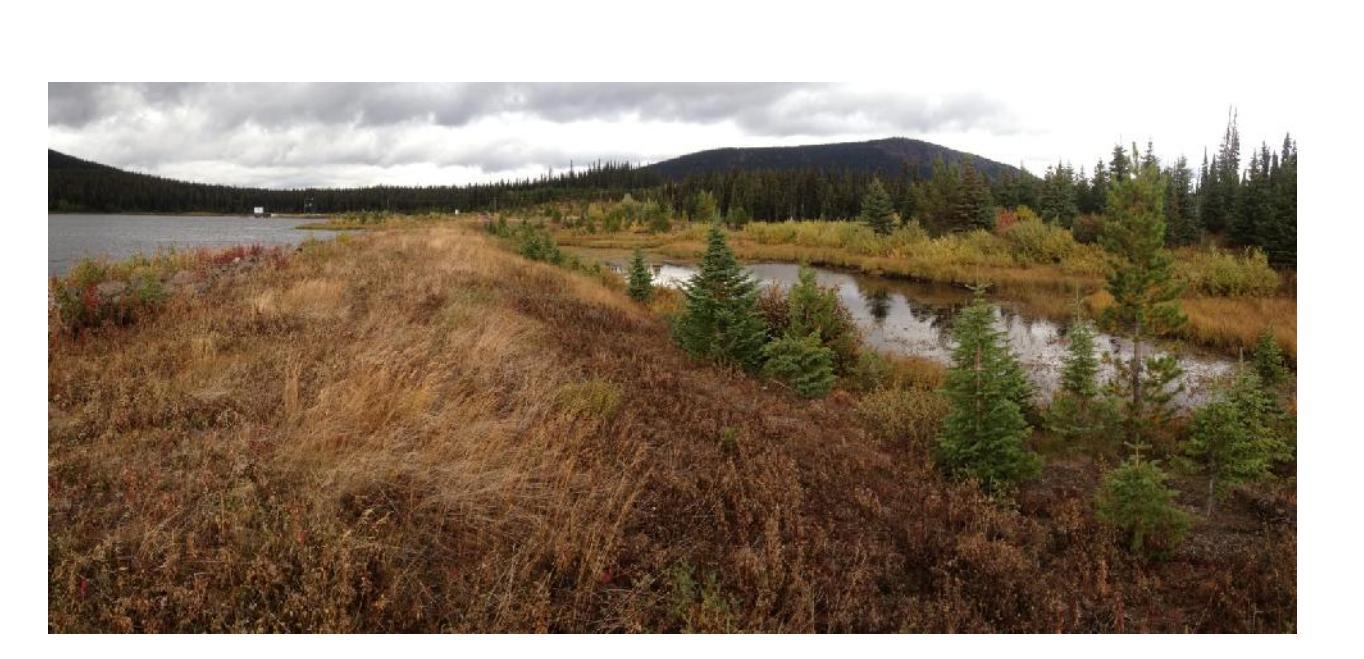
Photo 107: Lu Lake South Dam crest and downstream slope, view from right abutment. Note ponded water at toe and vegetation on slope.
