**Myra Falls Tailings Disposal Facilities  
Dam Breach Inundation Study**

Submitted to:  
**Nyrstar Myra Falls**  
Campbell River, British Columbia

Submitted by:  
**AMEC Environment & Infrastructure**  
Nanaimo, British Columbia

January 2015

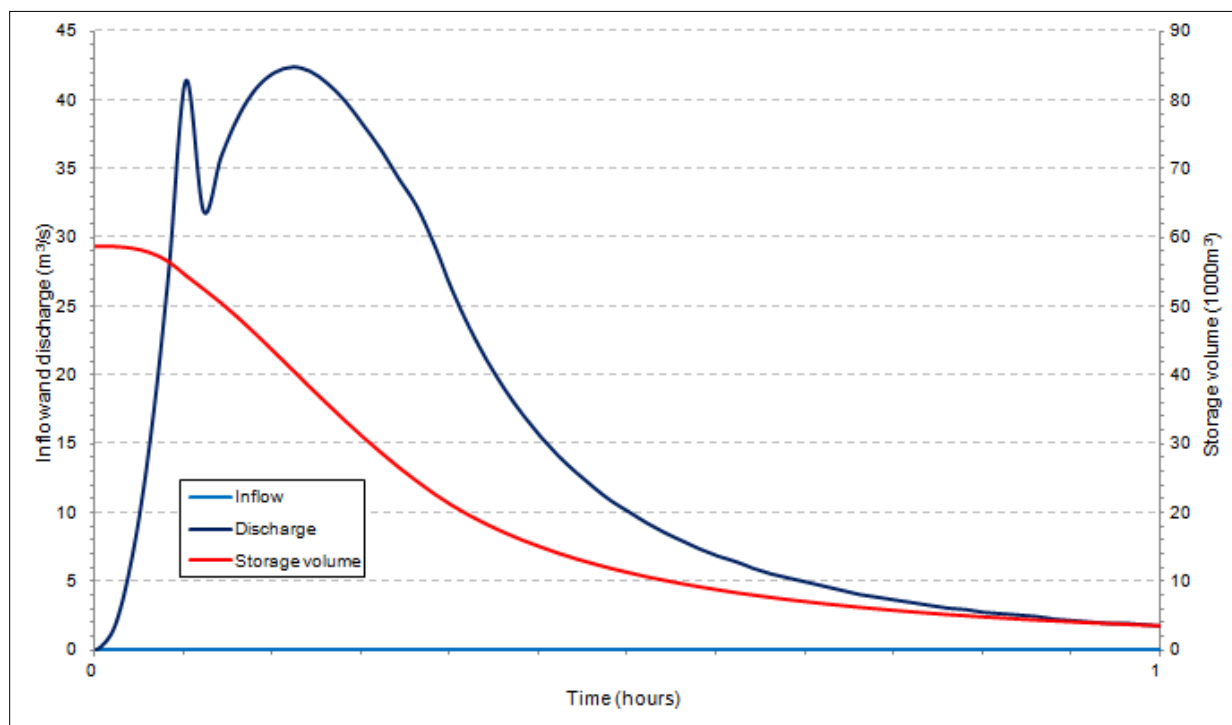
**Figure 4 Lynx TDF Breach Hydrograph, Current (2014) Configuration, Non-flood Failure**

Because the reach between the Lynx TDF and Buttle Lake is short with limited floodplain storage, there is little attenuation of the hydrographs. The peak discharge, rather than total volume is therefore the key parameter in determining inundation extents. The highest peak discharge occurs for the non-flood, ultimate configuration breach. This has been modelled as a piping failure with a peak discharge of 1,446 m<sup>3</sup>/s (**Figure 6**) – more than three times higher than the corresponding flood-induced peak discharge (446 m<sup>3</sup>/s) shown on **Figure 7**. This is likely due to the breach mechanism: the non-flood failures have been modelled as piping events, whereas most flood-induced failures have been modelled as overtopping events. The non-flood peak discharge has been compared against published equations for estimating peak discharge and is within the expected envelope, which ranges from 1,000 to 5,000 m<sup>3</sup>/s.

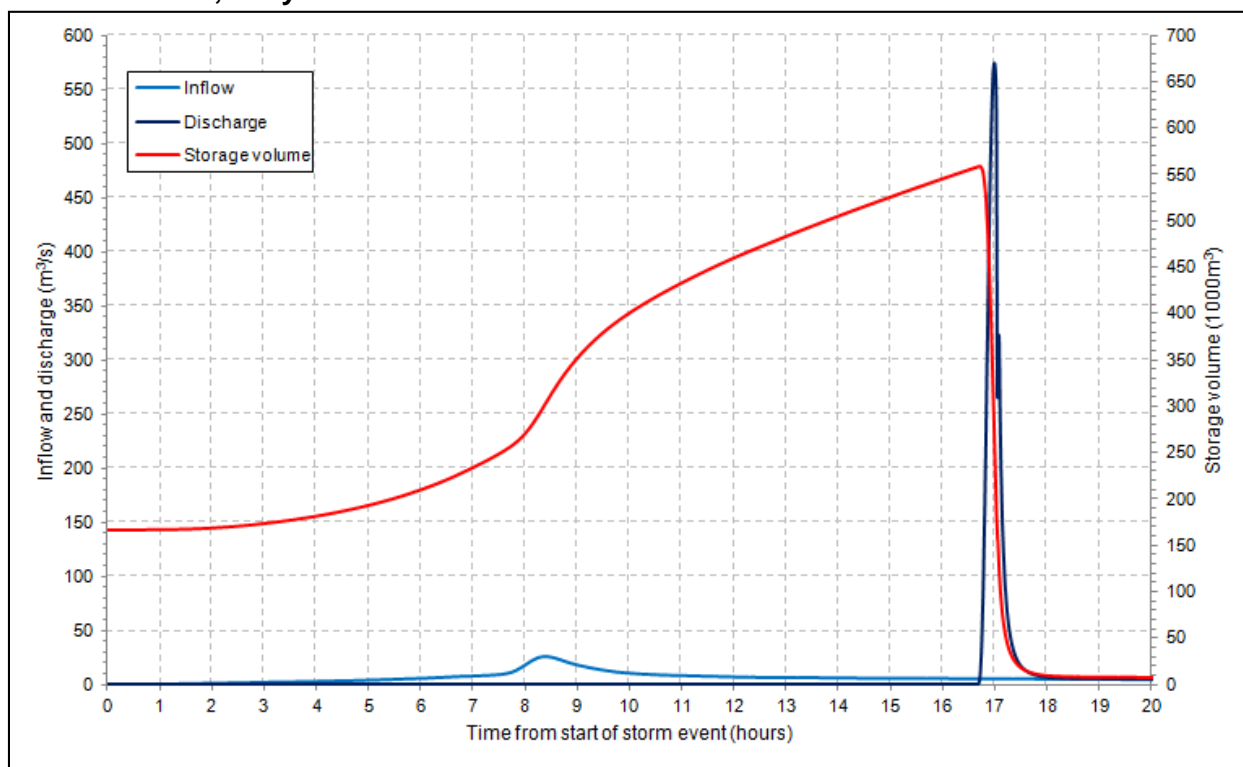
**Figure 5**      **Lynx TDF Breach Hydrograph, Current (2014) Configuration, 1/3<sup>rd</sup> 1,000-year ARI and PMF Failure**

In both flood-induced failure cases, the breach occurs before the inflow hydrograph reaches its peak. This happens because the failure mechanism is overtopping and the model was set to initiate the dam breach when the water level reaches the dam crest. The available storage volume in the TDF is filled and the water level rises to the dam crest before the peak inflow occurs. This creates a double peaked breach hydrograph, where the first peak is due to the breach and the second is the un-attenuated inflow hydrograph discharging through the breach. Because the flood-induced failures occur before the peak inflow, the total volume of water and tailings released in these failures is higher than that estimated using Rico's (2008) equation. However, the total volume in the TDF at time of failure is correct. **Figure 3** shows the estimated release volumes for each of the four Lynx TDF scenarios plotted onto Rico's data and envelope equations. **Figures 4** through **7** show the breach hydrographs.

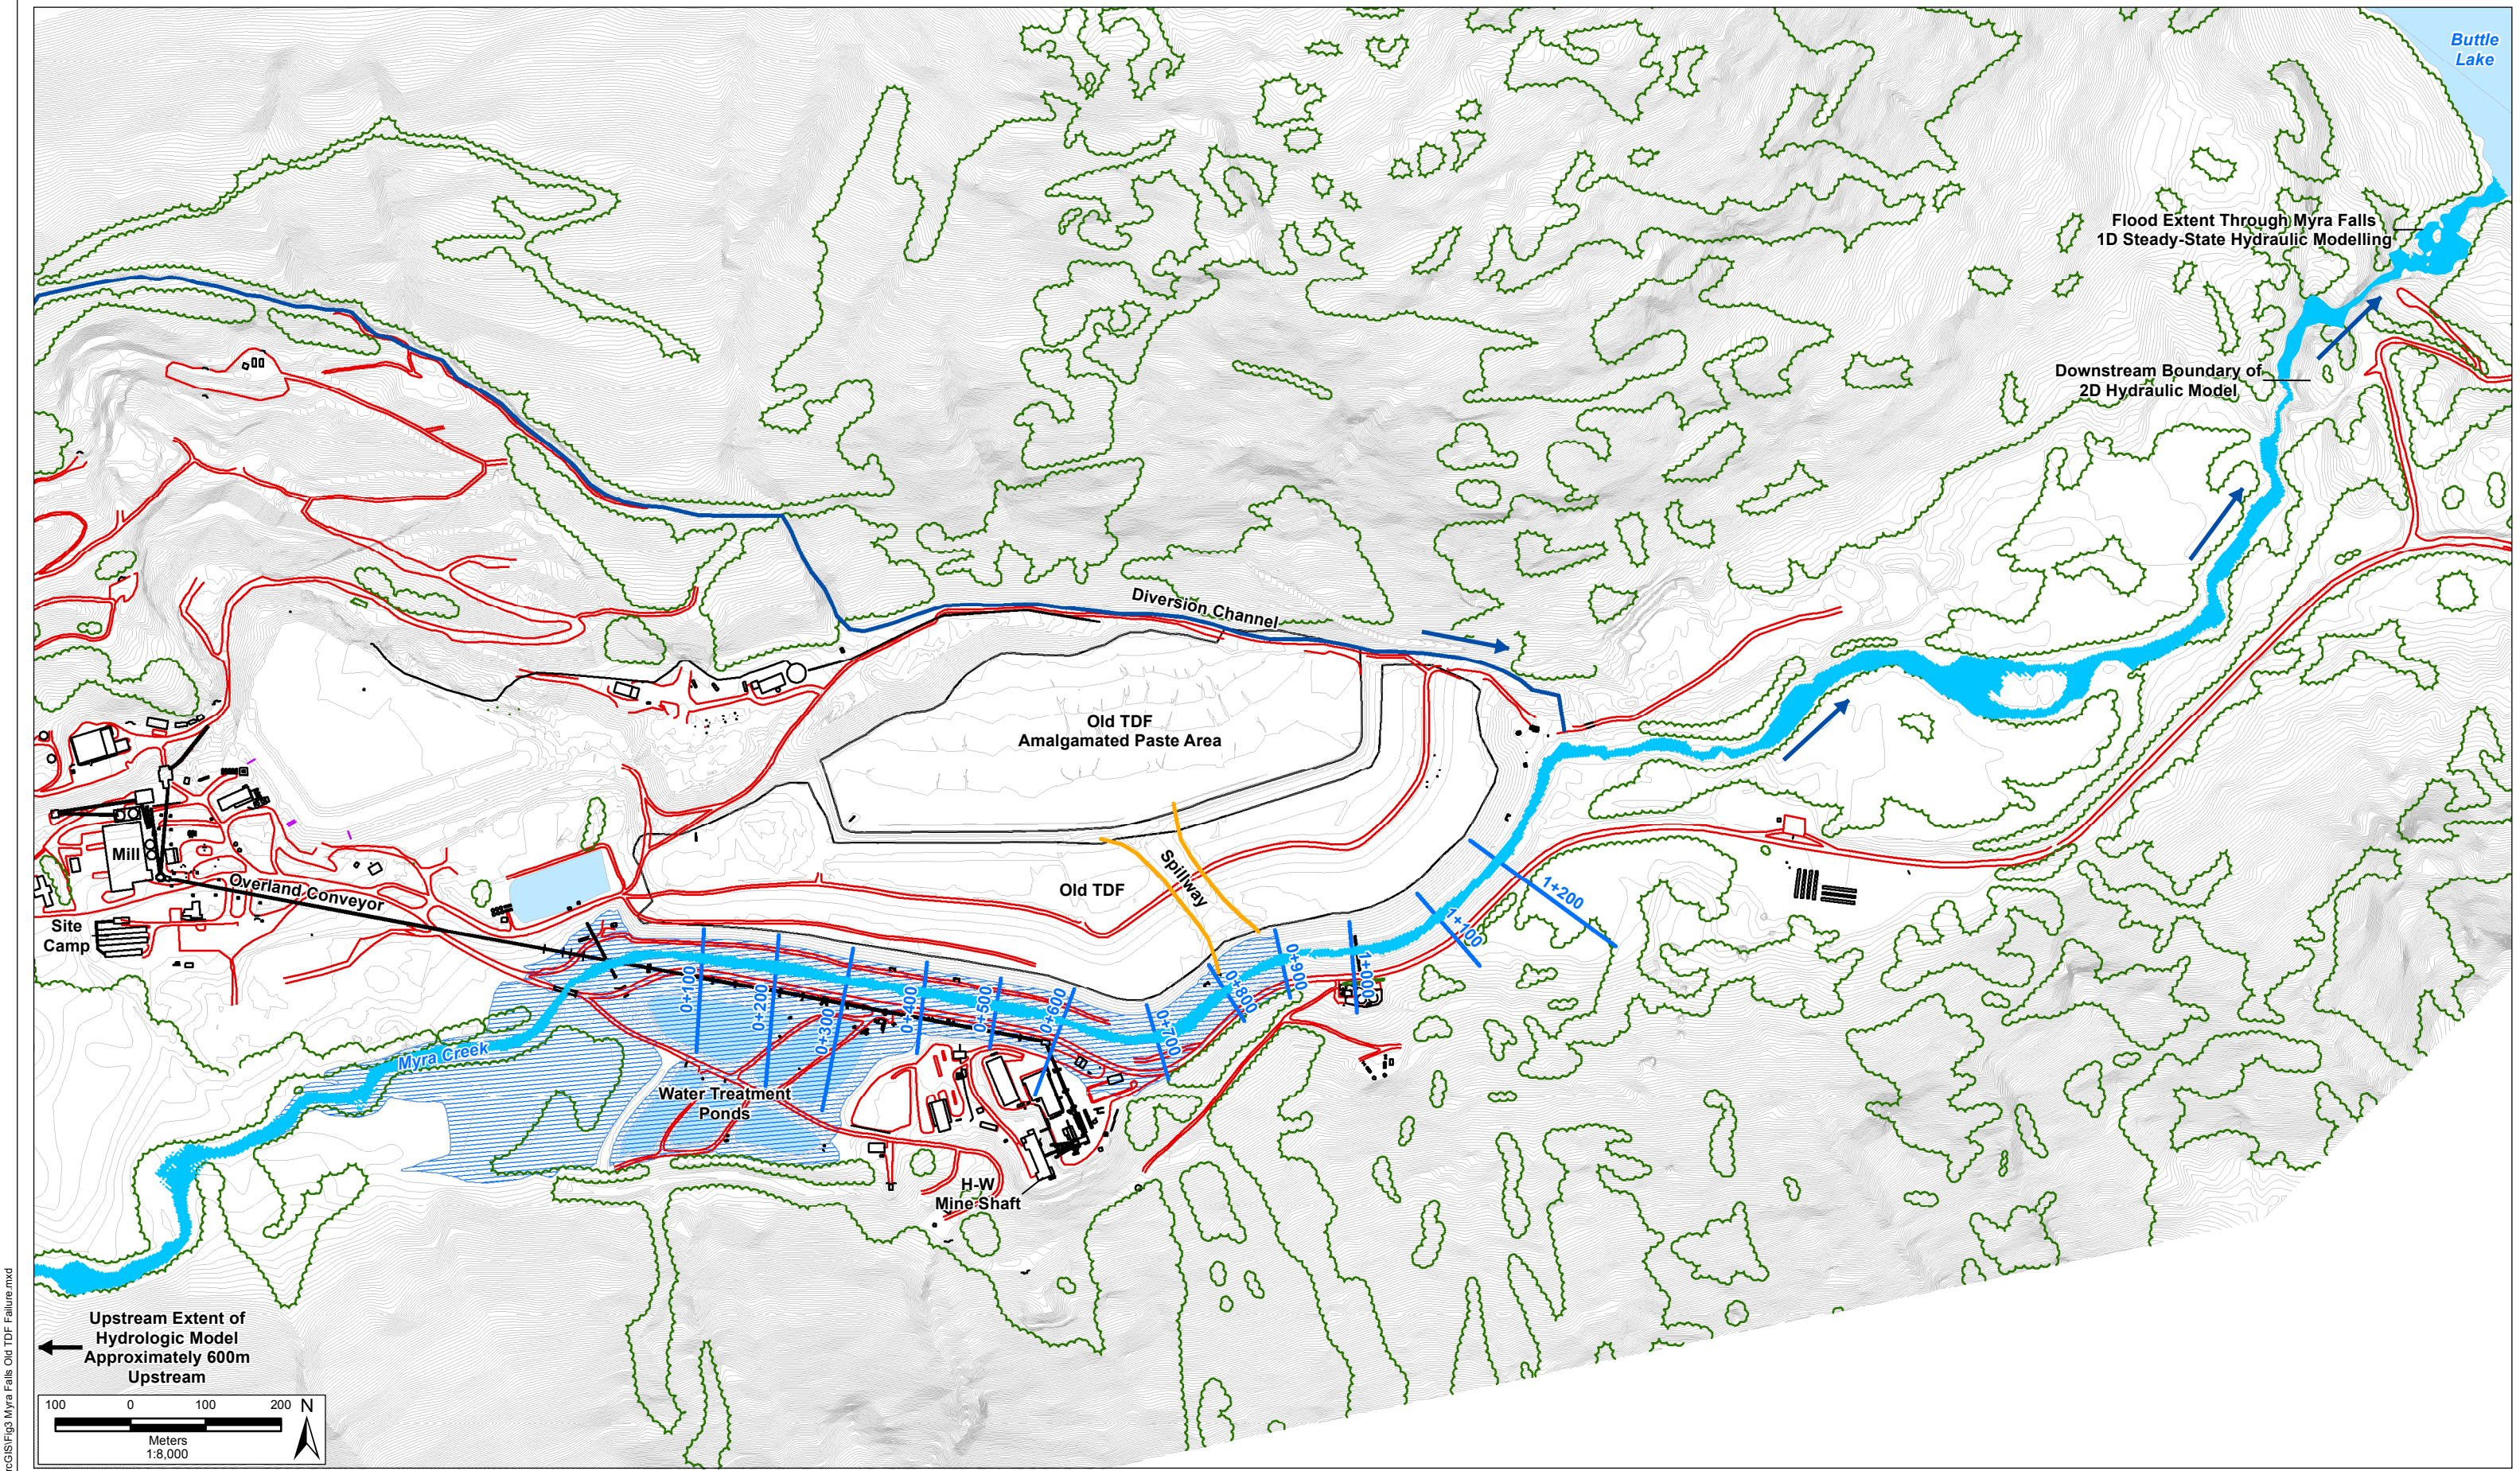
The station locations and upstream inundation extent are shown on Drawing 080303 in **Appendix C**. A failure between stations 0+800 and 0+900 would cause the greatest upstream inundation, with water ponding to a level of 3,365.9 m (1.1 m below the mine shaft elevation at 3367 m cited by KC (2003)) before erosion of the tailings occurs. This would inundate all six water treatment ponds on the south bank of Myra Creek, low-lying parts of the mine head works and the main access road through the site. The overland conveyor would also be damaged. Anyone on the north bank near the mill or the site camp would be trapped but would not be at risk of flooding.

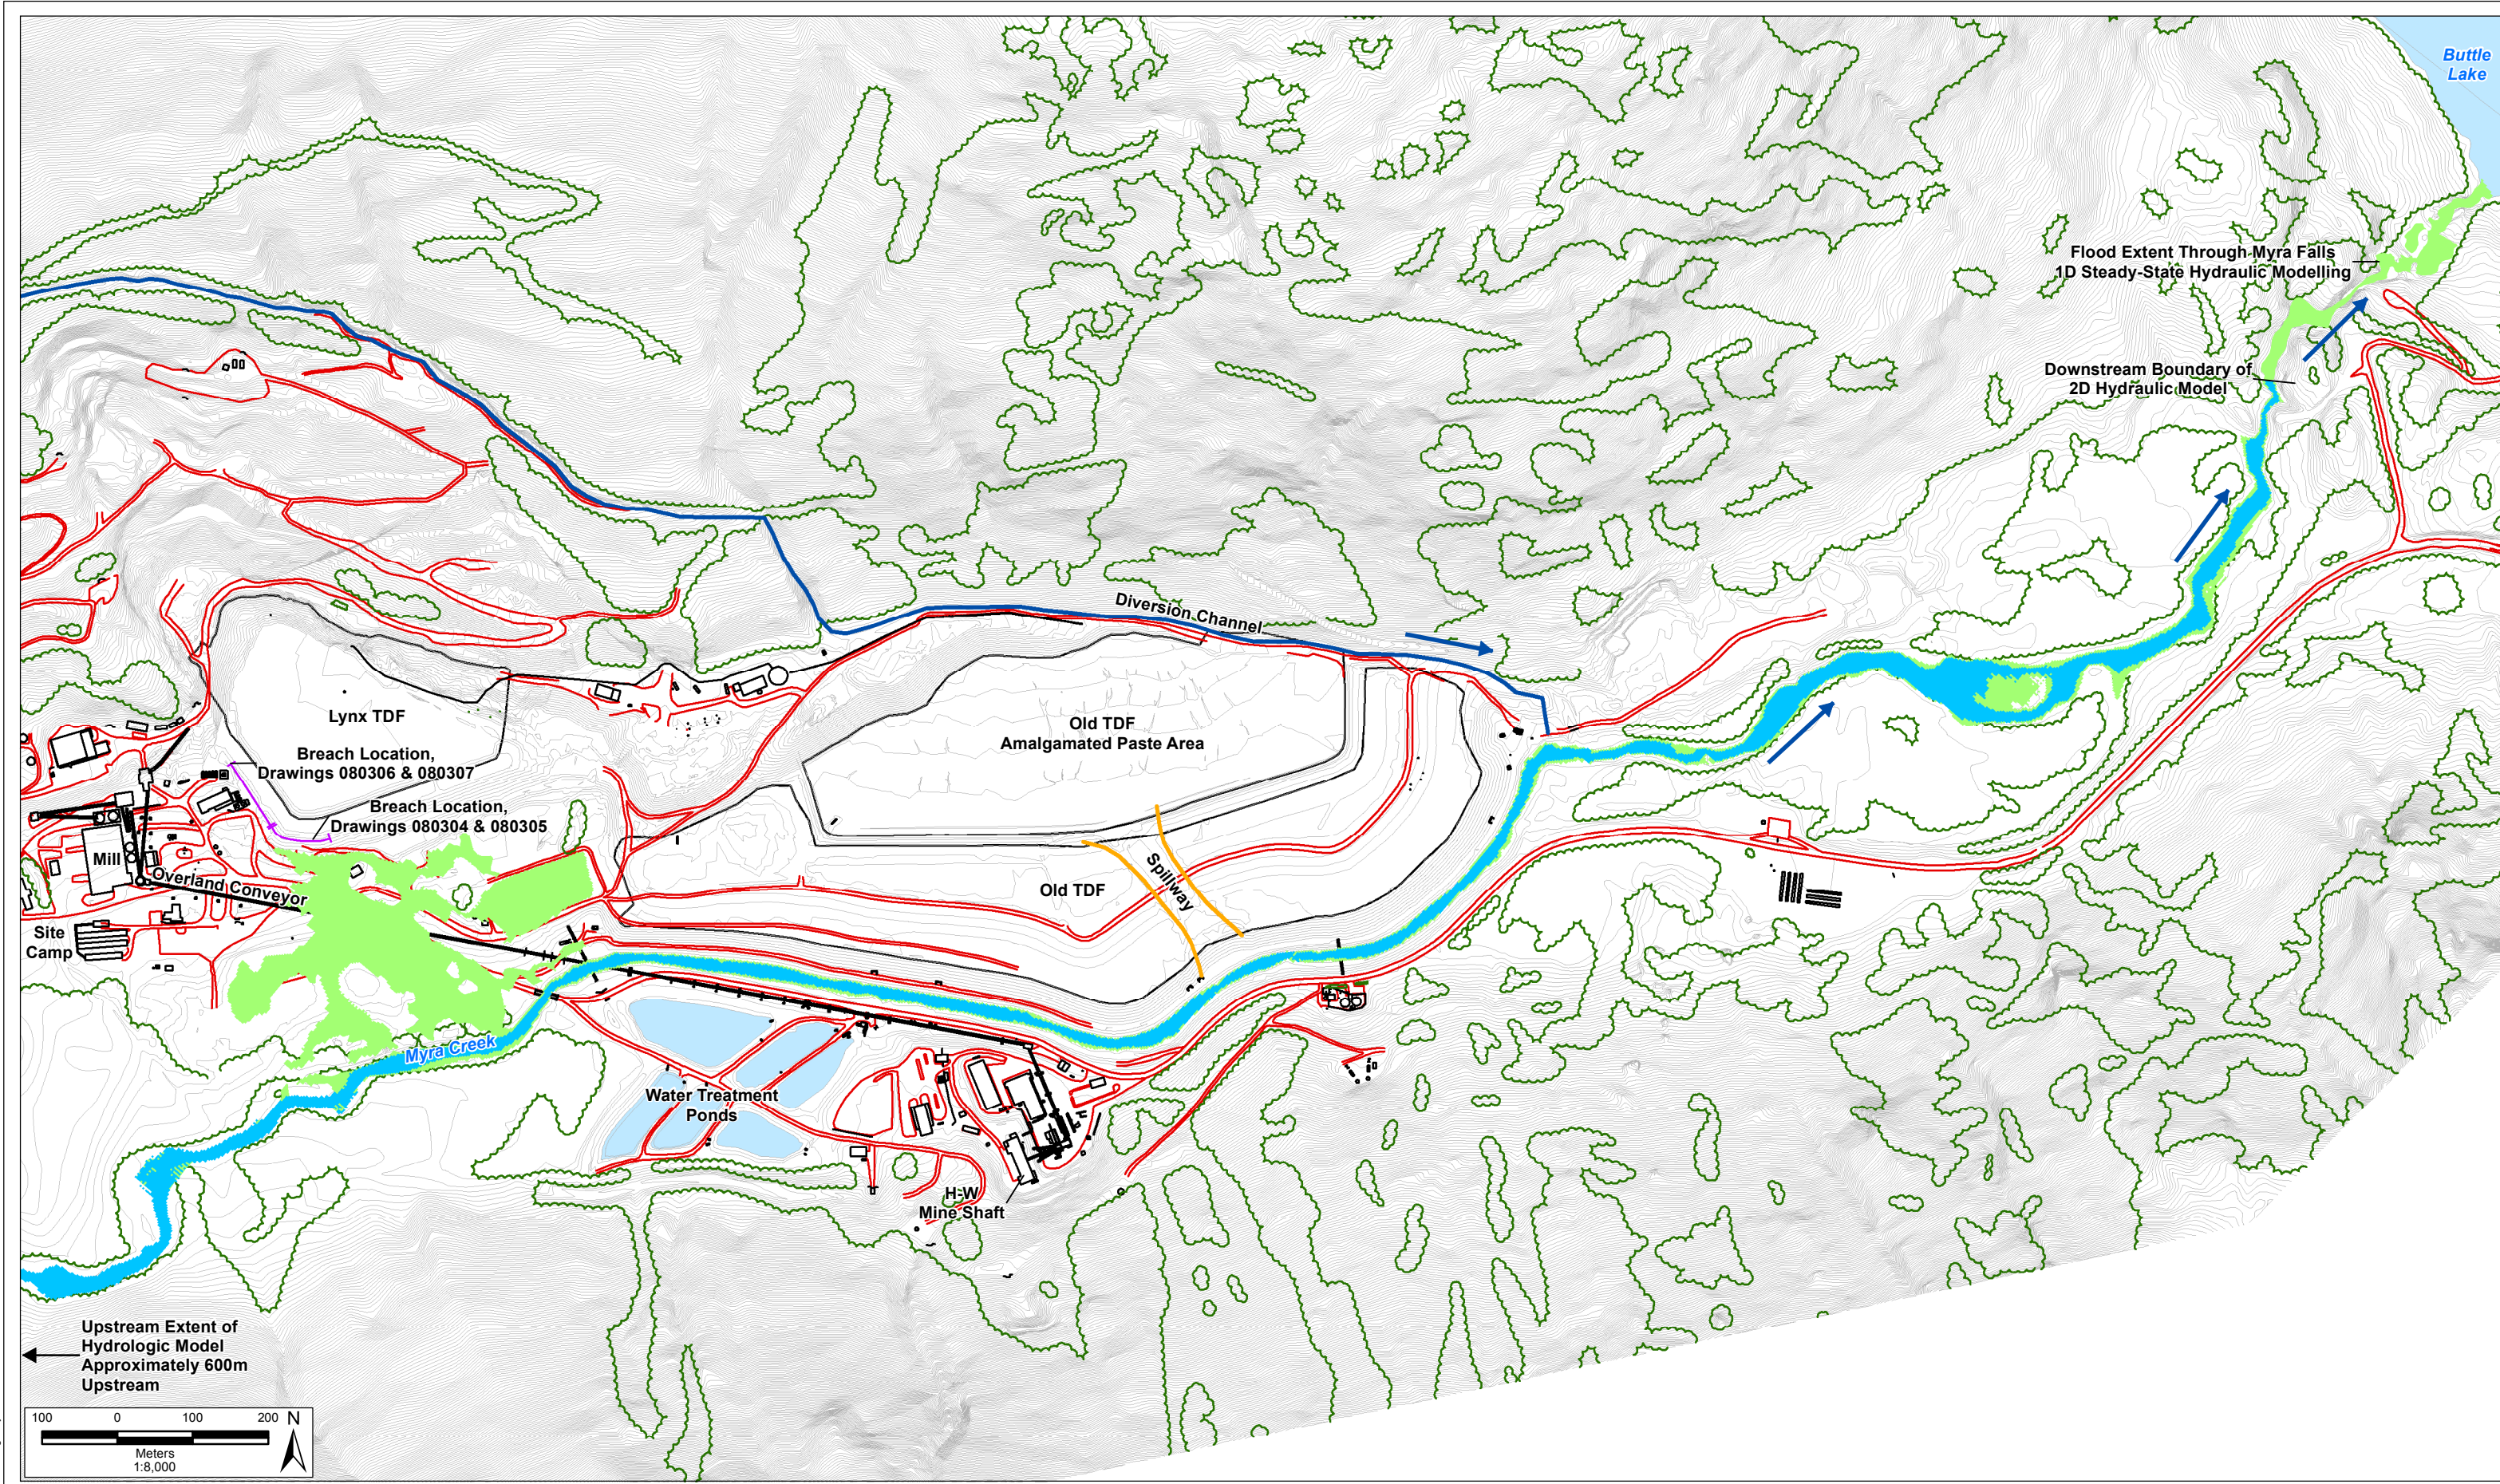
DATE: January 2015		<b>Drawing 080304</b> 
ANALYST: NH	QA/QC: PC RA GB	
PDF: Fig4 Myra Falls Flood Failure Current 15-01-12

For the flood-induced failures, the incremental consequences and flood impacts are similar for all flood magnitudes. Most of the incremental flood impacts are confined to the mine site, between the Lynx TDF and the mine head works. The following bullet points summarise the inundation consequences.
