**IMPERIAL METALS CORPORATION  
MT. POLLEY PROJECT**

**RESPONSE TO REVIEW COMMENTS  
ON TAILINGS EMBANKMENT DESIGN  
(REF. NO. 1625/6)**

**JANUARY 25, 1996**

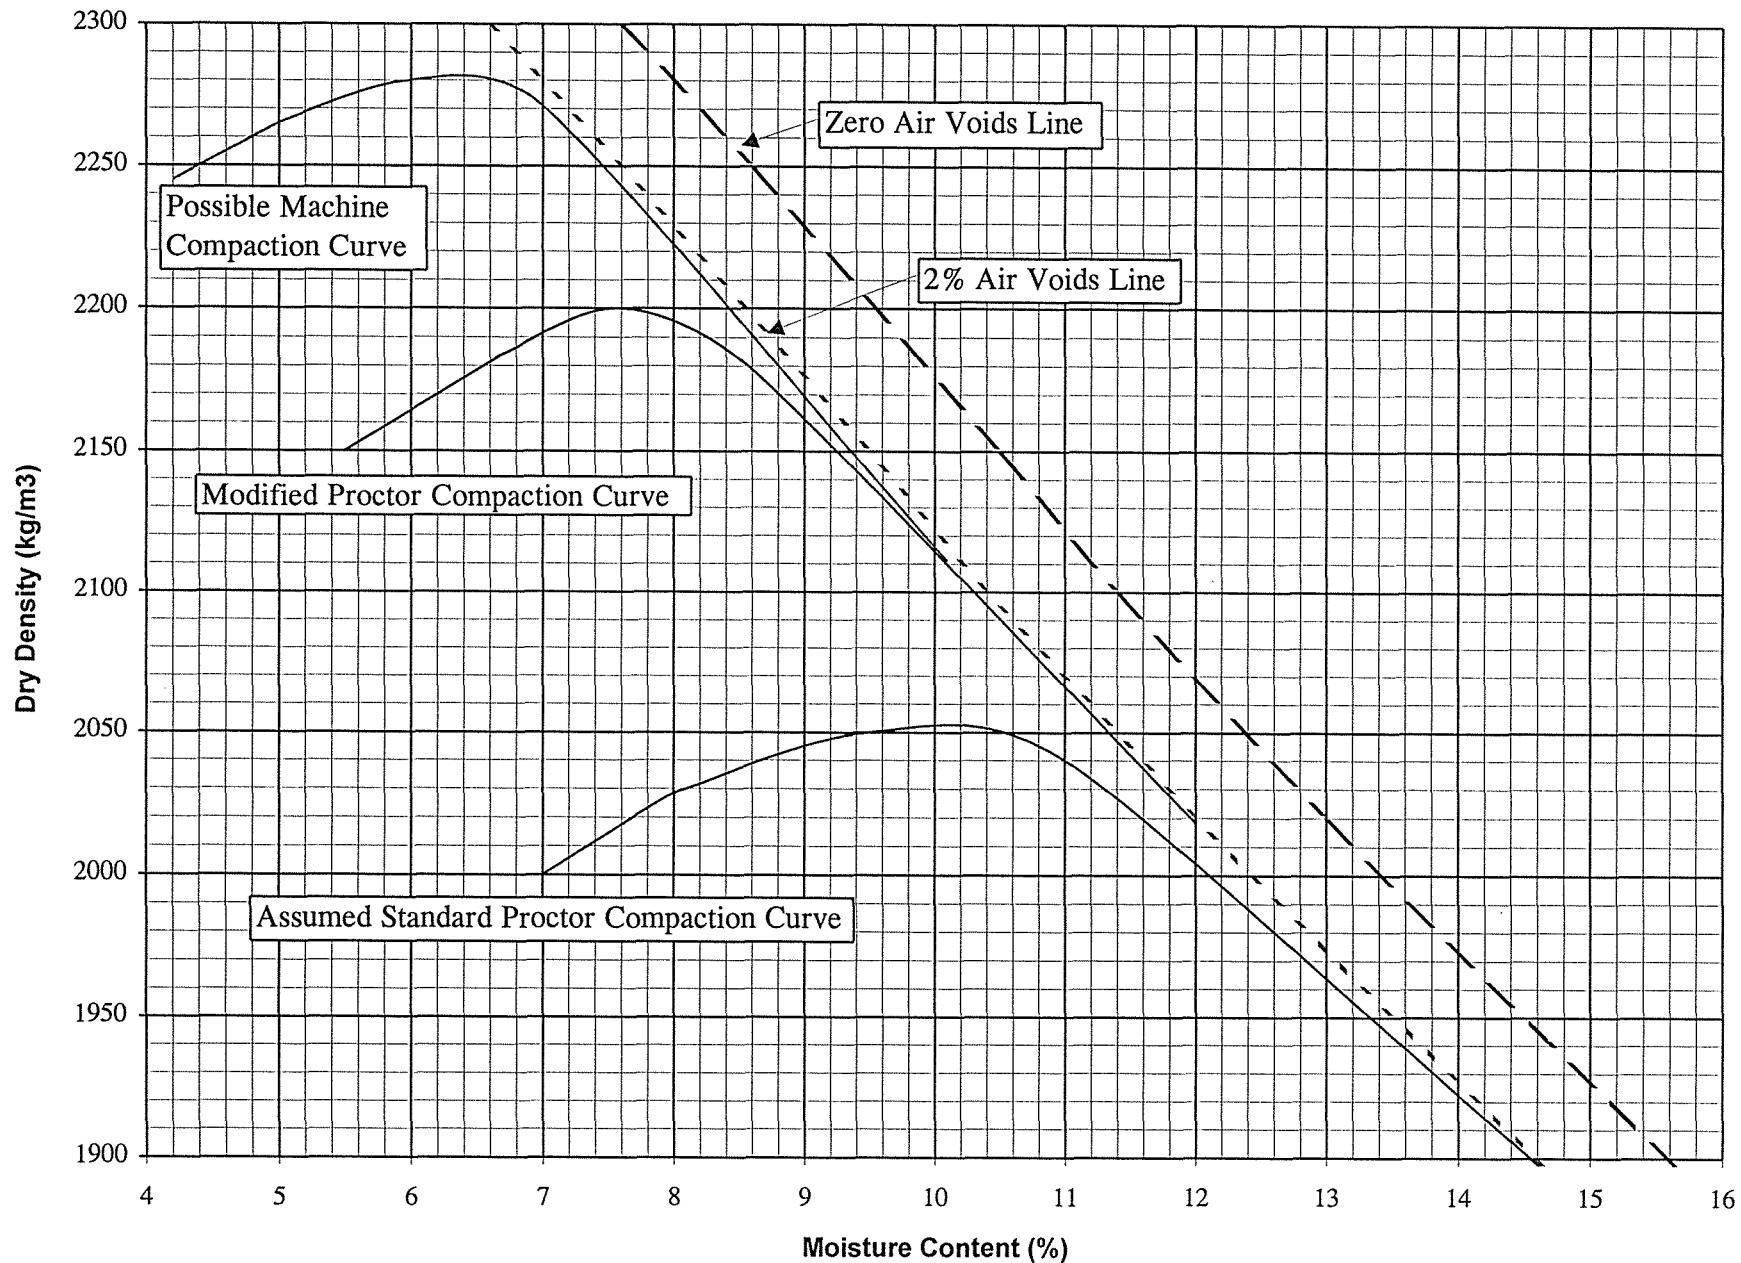
FIGURE 2

RELATIONSHIP BETWEEN COMPACTION ENERGY AND MOISTURE CONTENT - DENSITY  
(CHARACTERISTIC COMPACTION CURVES FOR GLACIAL TILL)

Mr. Brawner's statements reflect a common misconception within the earthworks construction industry. As indicated on Figure 1, there are different moisture-density relationships depending on the level of compactive effort applied. The Standard Proctor energy is lower than for the Modified Proctor test and, for the given example, the machine compaction energy is still higher.

It is evident from Figure 2 that if one only considers the individual test results, the 'maximum' density decreases as the compaction effort is reduced, and the 'optimum' moisture content also increases as the compactive effort is reduced. However, the theoretical moisture content - density relationship for a soil is defined by the zero air voids line, but we generally find that the 2% air voids line is usually the control in practice. Consequently, if the Standard Proctor moisture density criteria are

specified, a lower density fill with a higher permeability and greater compressibility can result. Also, if the contractor attempts to place the fill at the standard proctor optimum moisture content with the heavier compaction equipment, he will sometimes find that excessive rutting, weaving and pore pressure development (or moisture profiles) can occur in fine grained soils. Knight Piésold have therefore used the Modified Proctor test as the reference as it provides a moisture - density relationship which is closer to the relationship expected from the specified compaction equipment.

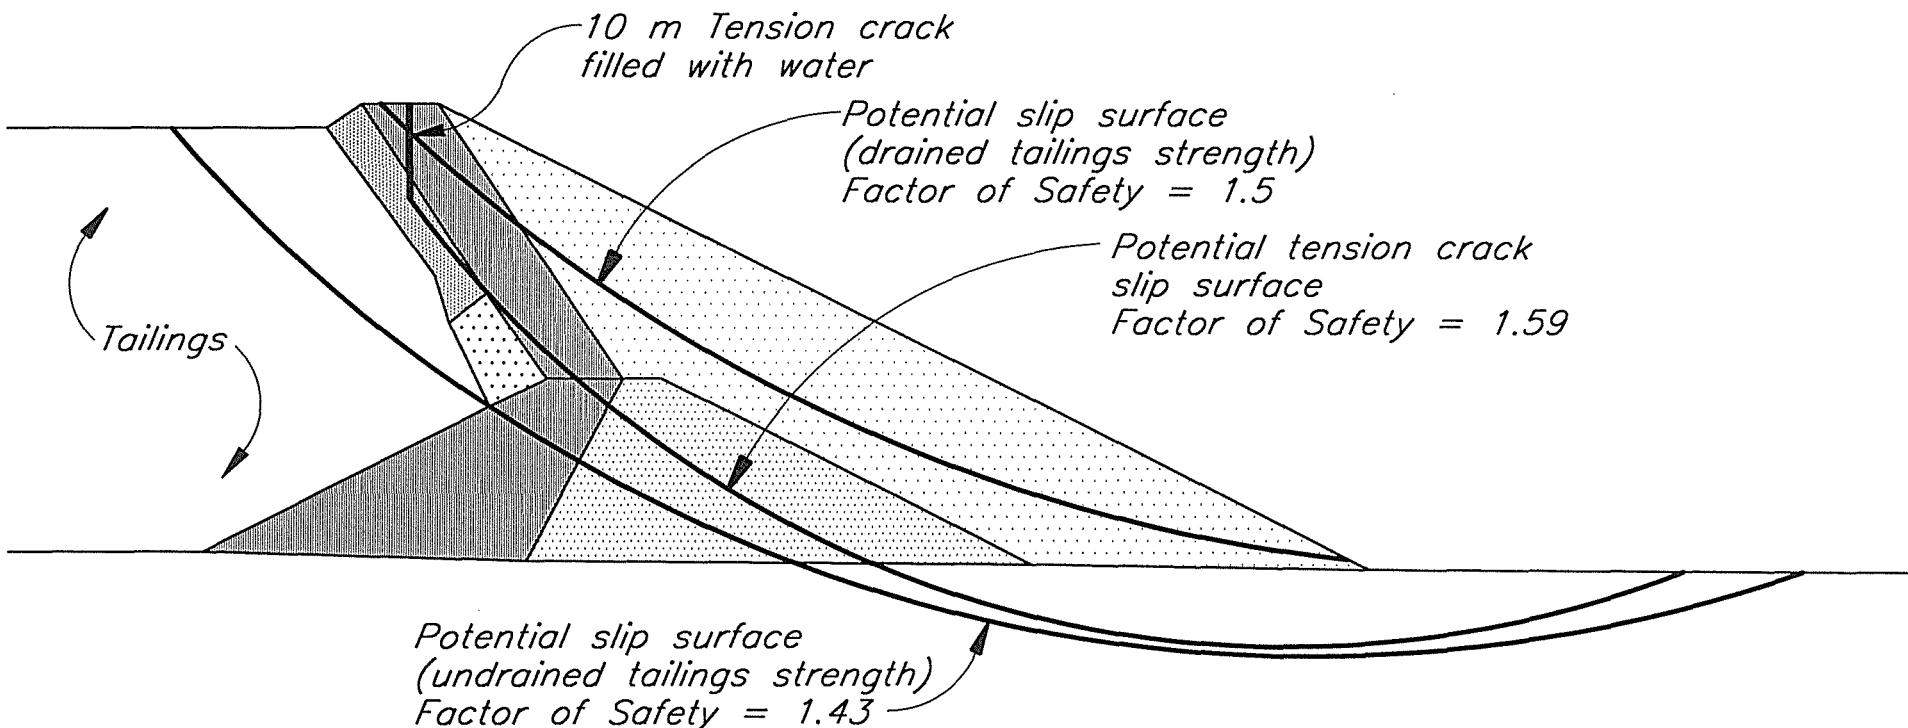
FIGURE 3

IMPERIAL METALS CORPORATION  
MT. POLLEY PROJECT  
STATIC STABILITY

Based on our experience with similar construction methods and comparable tailings materials, it is highly unlikely that 10 m deep tension cracks can develop along the crest of the embankment. However, as suggested by Mr. Brawner, stability analyses have been conducted for a 10 m deep tension crack filled with water, as shown on Figure 3. The factor of safety for the water filled tension crack is higher than for the previously reported stability analyses. Therefore, the previously reported minimum factors of safety for the tailings embankment are unchanged even if a 10 m water filled tension crack occurs.

An upstream slip surface for a 10 m water filled tension crack was also evaluated. The results showed that this case is also not critical as the factor of safety is well in excess of 1.5.

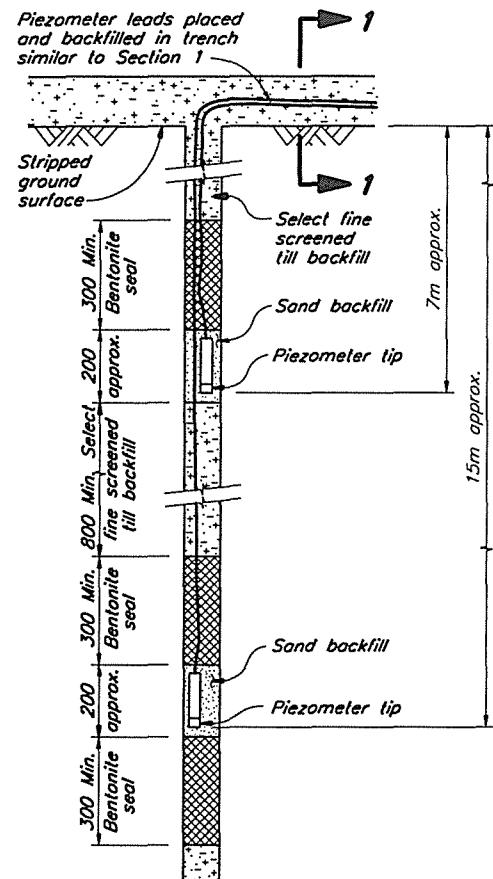
**DETAIL A  
INSTALLATION OF PIEZOMETERS  
IN BOREHOLES**  
N.T.S.

One hole has been drilled in the Main Embankment area (MP89-234), as noted by Mr. Brawner. It has previously been discussed with Mr. Headley (MEMPR) and it was agreed that three additional holes will be drilled, logged and sampled by a geotechnical engineer during the initial stages of construction as part of the embankment instrumentation and monitoring requirements. The holes are specified in

the Technical Specifications and shown on Drawing Nos. 510-77-01-1625.220 and 1625.221. They will be drilled to about 15m depth and will be located in the bottom of the main valley, where significant overburden is known to be present. Lab testing will be conducted on the samples as required and vibrating wire piezometers will be installed in the embankment foundation for long term water pressure monitoring.
