01 December 2014  
Final Report

Eskay Creek Gold Mine Site (Closed)  
Tom MacKay Lake Tailings Storage Facility  
Dam Safety Inspection Report

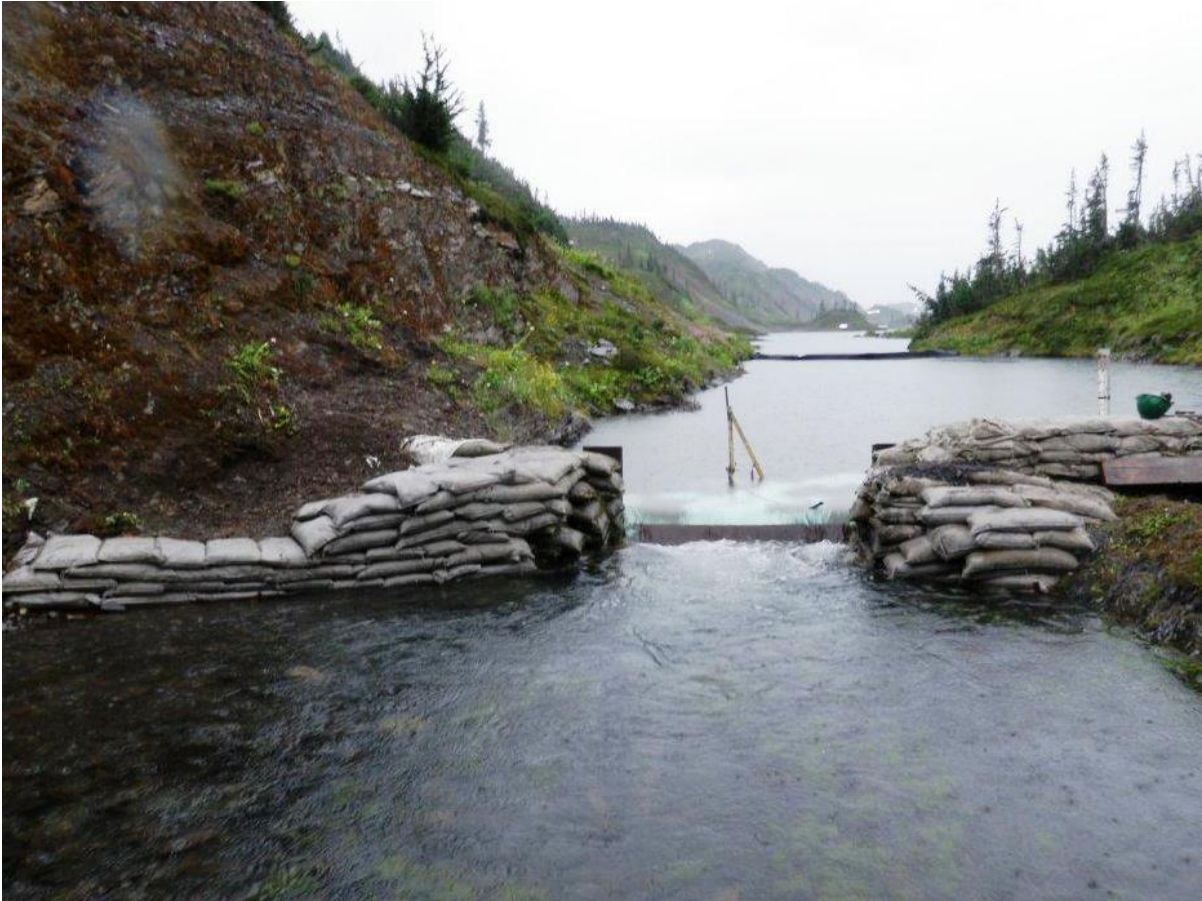
Figure 2. Outflow measurement weir at the northeast end of the Tom MacKay Lake TSF.

No design or as-built drawings of the measurement weir at the northeast end of the Tom MacKay Lake TSF were available for inclusion in this report, but the general arrangement of the structure is shown in Figure 2. The flow section of the contracted rectangular weir plate reportedly measures 610 mm (24") high by 1,829 mm (72") wide.

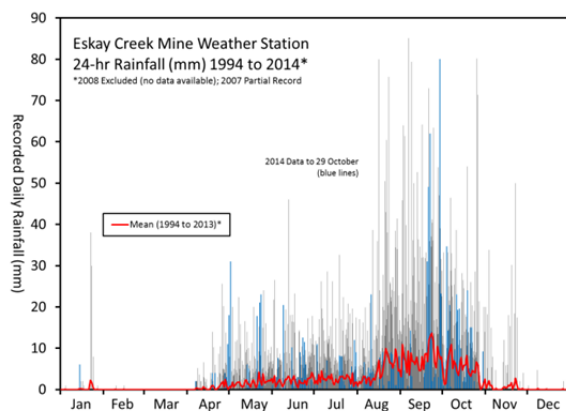
Figure 4. Daily rainfall.

Figures 4 and 5 summarize respectively the daily and monthly rainfall values as obtained from the Eskay Creek Mine weather station; Figures 6 to 8 summarize respectively the daily, monthly and seasonal cumulative snowfall values recorded at the weather station.

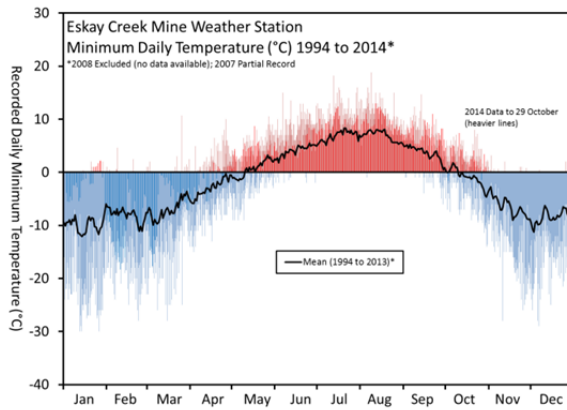
Figure 9. Daily minimum temperature.

Figures 9 and 10 summarize respectively the minimum and maximum daily temperatures as obtained from the Eskay Creek Mine weather station. On average, day-round freezing conditions at the site camp exist from early November to mid-March. As indicated above, slightly cooler temperatures and greater freezing degree day values would be expected at the Tom MacKay Lake TSF.

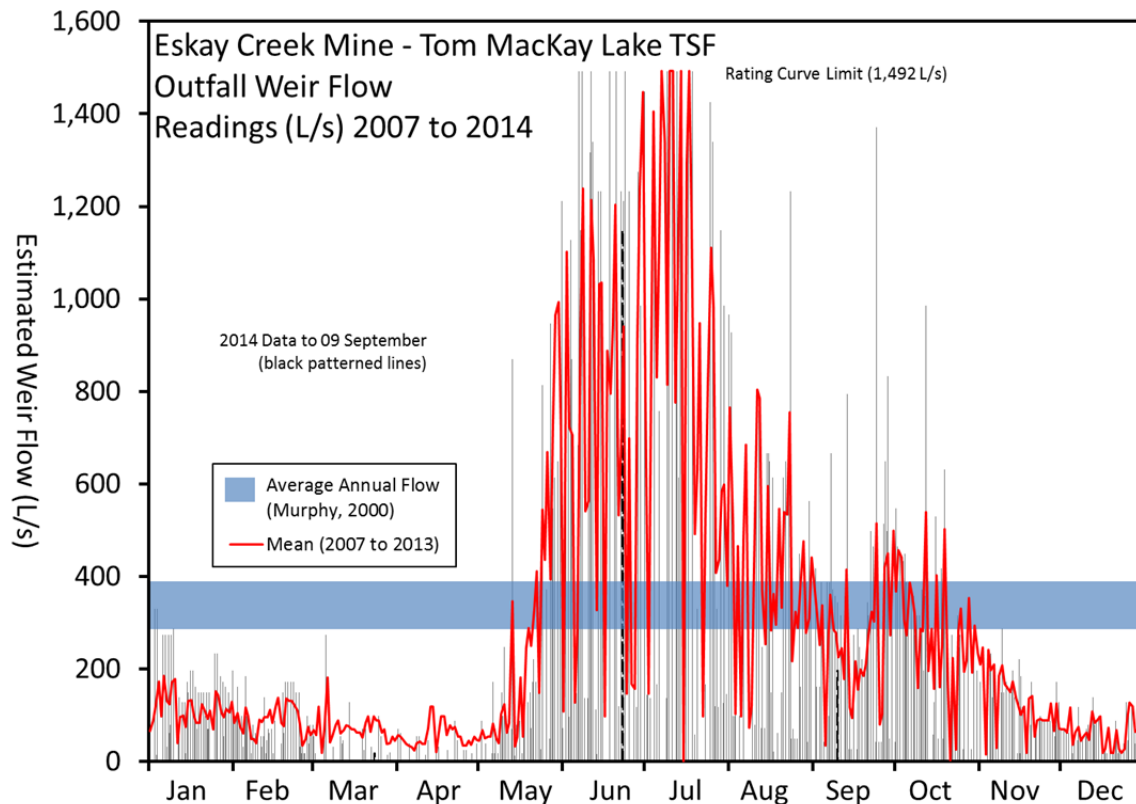
Figure 11. Estimated Tom MacKay Lake TSF outflow rates.

Flow out of the Tom MacKay Lake TSF has been measured since 1999 via the contracted rectangular, sharp-crested weir located at the northeast end of the lake, just downstream of the lake's natural outflow point into Tom MacKay Creek and founded in the natural channel. Figure 11 summarizes the estimated flow rates over the calendar year for the period 2007 to September 2014. The 2007 and 2008 data sets are the most complete (daily readings with some gaps), as the reading interval progressed from weekly to biweekly and finally quarterly from 2009 to present.

The slightly bimodal distribution of water outflow from the Tom MacKay Lake TSF incorporates the much greater contribution from snowmelt in late spring to early summer and the lesser, but still notable, contribution from the release of direct precipitation and runoff water in late summer to early fall. Although the estimated flow rates depicted in Figure 11 are subject to error associated with the imperfect approach channel and nappe (the sheet of water flowing over the weir plate) conditions at the installation, particularly for the high flow events of the late spring to early summer freshet, the relative differences in seasonal flows are believed to be representative.

The 2007 to September 2014 weir data are generally consistent with predicted seasonal discharge characteristics for Tom MacKay Lake as summarized by Price (2000), with the following exceptions:

- the greatest freshet flows appear to occur in July rather than June; and
- August seems to be a moderate, rather than low, flow month.

As well, the estimated average annual flow rate for the Tom MacKay Lake watershed (Murphy, 2000 as cited by Price, 2000) as shown in Figure 11 appears to be consistent with the measured values.

Barrick intends to continue collecting weir flow readings four times per year while qualified on-site staff members are available. In the longer term, reading frequencies may be reduced and/or automated data acquisition systems may be installed.

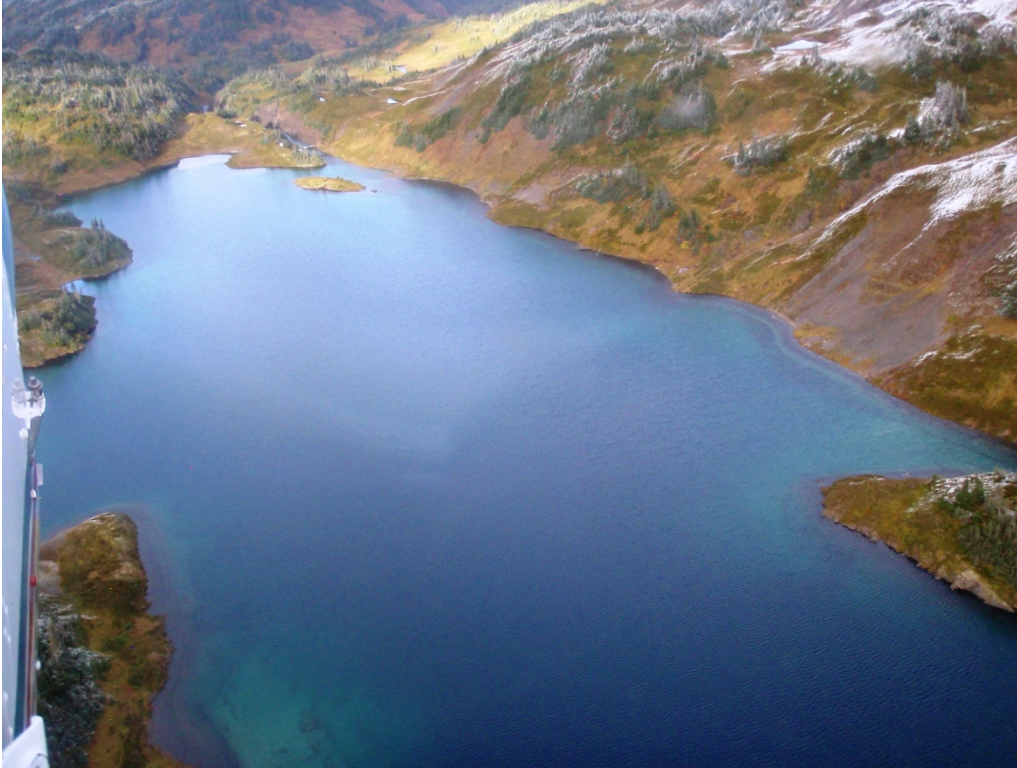
Tom MacKay Lake TSF looking southwest towards the natural outlet channel.

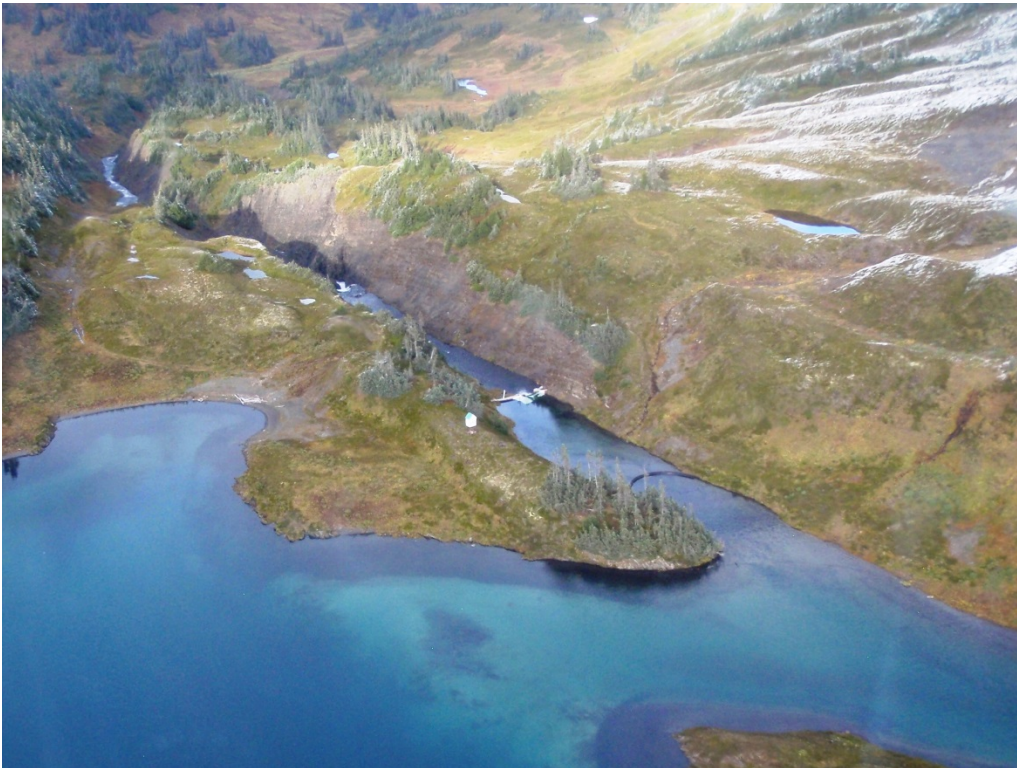
During operation of the Tom MacKay Lake TSF, a float boom was established across the natural outlet channel at the northeast end of the facility, just upstream of the measurement weir. Geotextile filter cloth was suspended from the floats to assist with reducing the release of any suspended sediments via the natural outlet channel, during active tailings discharge into the lake. The current condition of the filter cloth originally suspended from the float boom is not known.

Closer view looking west of the float boom and measurement weir located in the natural outlet channel (which becomes Tom MacKay Creek) of Tom MacKay Lake.

With no more active tailings disposal or any post-closure activity that would otherwise generate significant quantities of suspended sediments, the float boom no longer serves the purpose for which it was designed. Barrick intends to remove the boom, subject to obtaining any necessary approval from the regulatory agencies.

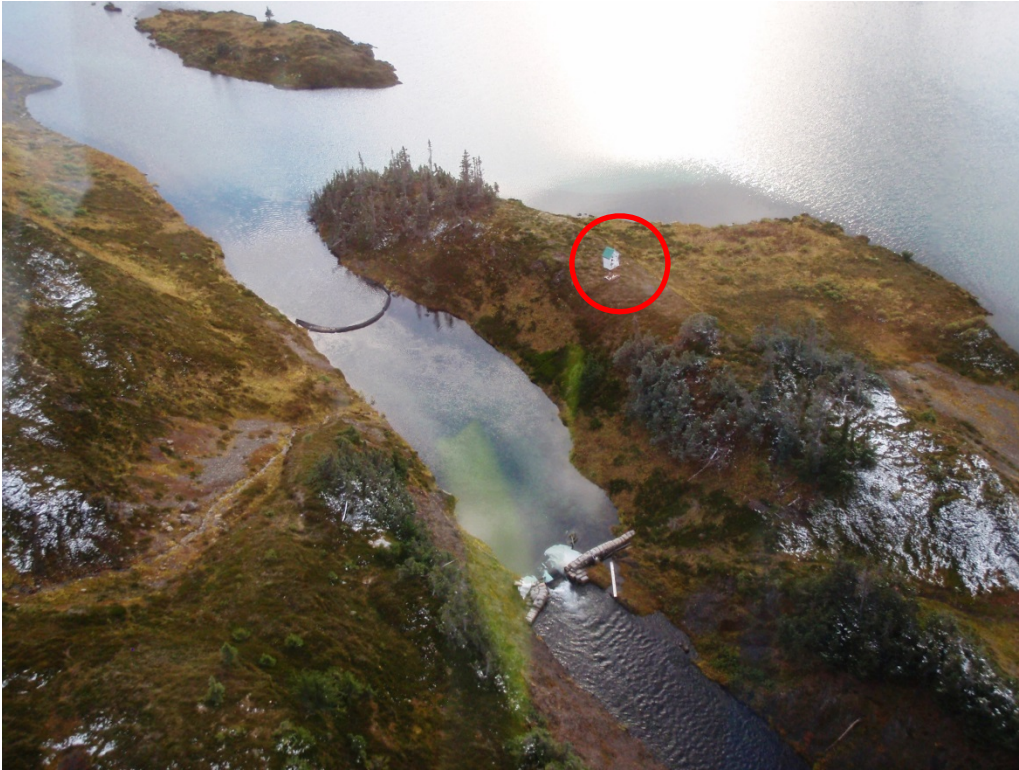
View looking northeast of the float boom and measurement weir in the Tom MacKay Lake outlet channel. The red circle indicates the location of the inactive datalogger shack.

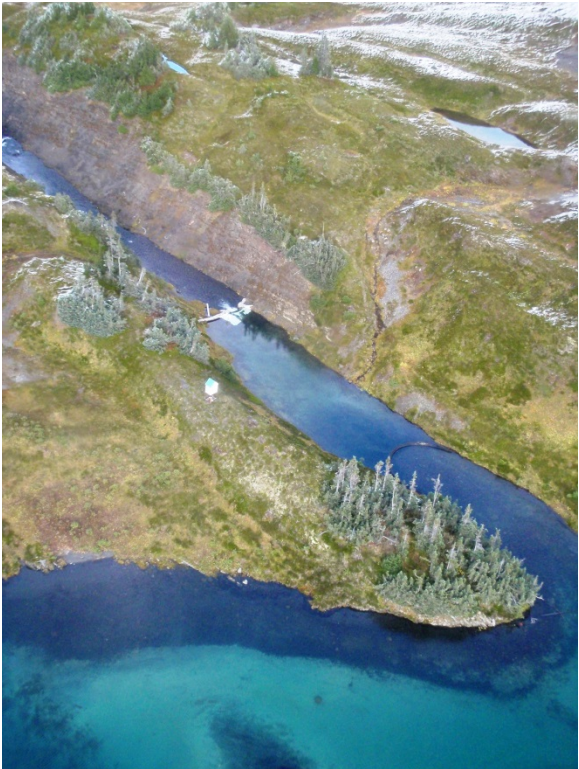
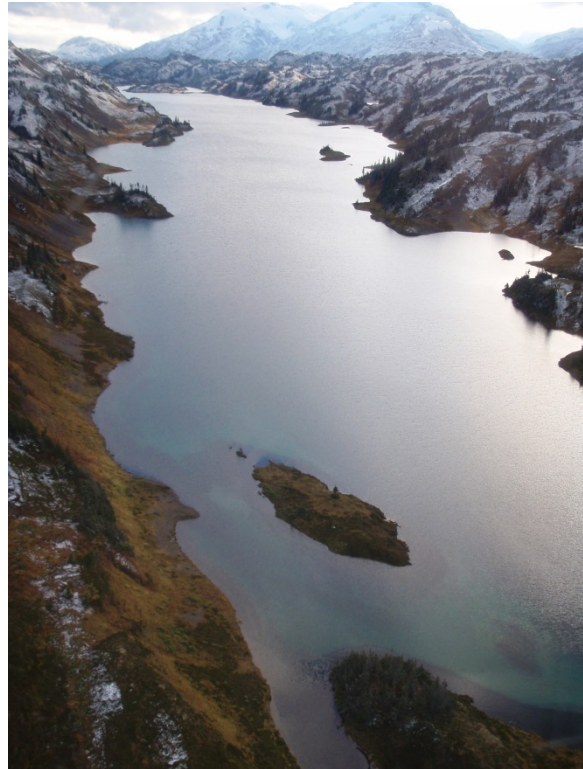
Further detail looking west of the natural outlet channel (left photo) and looking northeast of the closed Tom MacKay Lake TSF (right) taken from approximately above the channel.
