June 30, 2015  
Ref No.: PM-0866003.0011

**Re: BGC Support in Response to Chief Inspector's Order of February 3<sup>rd</sup>, 2015**

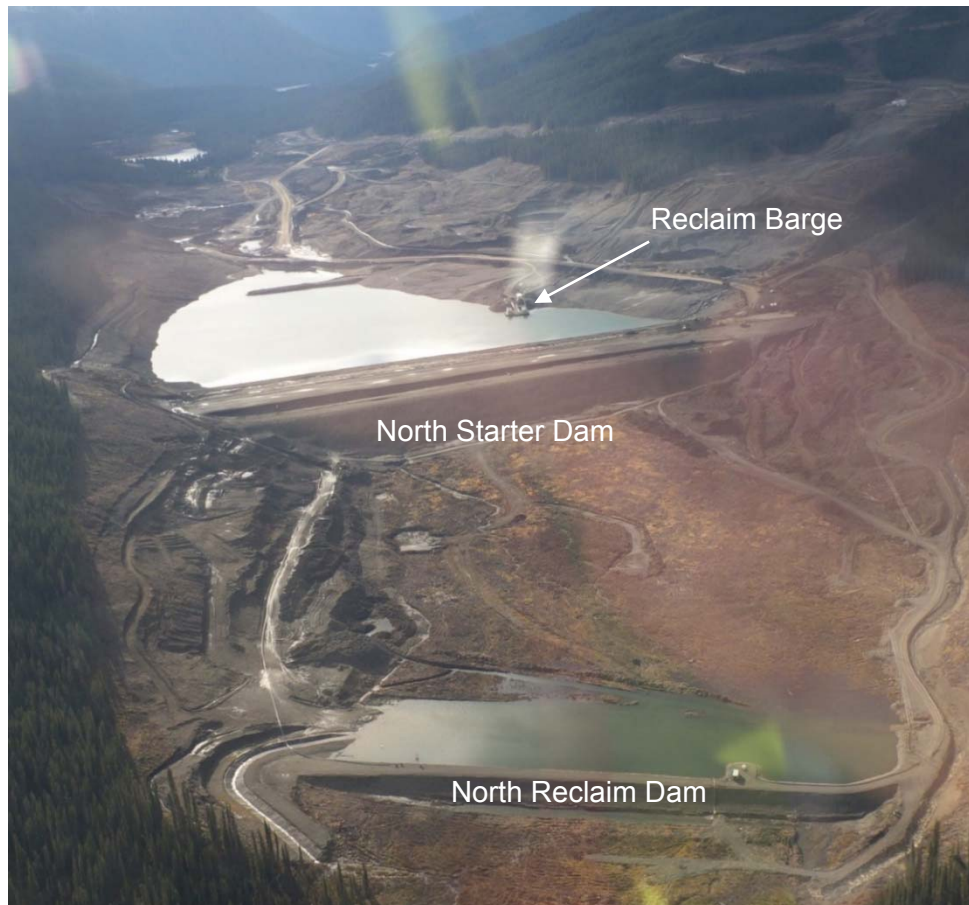
**Figure 1. Aerial view of the Red Chris TSF looking south (October 2014). The North Reclaim Dam is approximately 300 m long and the North Starter Dam approximately 600 m long.**

The current TSF is formed by the North Starter Dam (NSD) to the north of the impoundment and a topographic high to the south as shown in Figure 1. The North Reclaim Dam (NRD) has been constructed downstream (north) of the NSD where seepage that has surfaced between the NSD and NRD and associated catchment runoff is collected and pumped back to the TSF.

The NRD was completed to its final crest El. 1053 m in 2013 corresponding to a maximum height of 7 m. The dam crest is 11 m wide and 330 m long. The upstream (Zone 1) and downstream slopes of the dam are 2.5H:1V and 2.25H:1V, respectively. The upstream riprap zone has been placed at about 1.75H:1V.

At the end of the 2014 construction season, the crest elevation of the NSD was 1097 m corresponding to a maximum height of 30 m. The crest was 130 m wide and 570 m long. The dam had an upstream slope of 2H:1V and a downstream slope of 2.5H:1V. The NSD is currently being raised towards the 2015 target crest elevation of 1118 m, at which time it will be about 51 m high.
