**MOUNT POLLEY MINING CORPORATION
MOUNT POLLEY MINE**

**TAILINGS STORAGE FACILITY
REPORT ON 2010 ANNUAL INSPECTION**

**TAILINGS STORAGE FACILITY
REPORT ON 2010 ANNUAL INSPECTION
(REF. NO. VA101-1/29-2)**

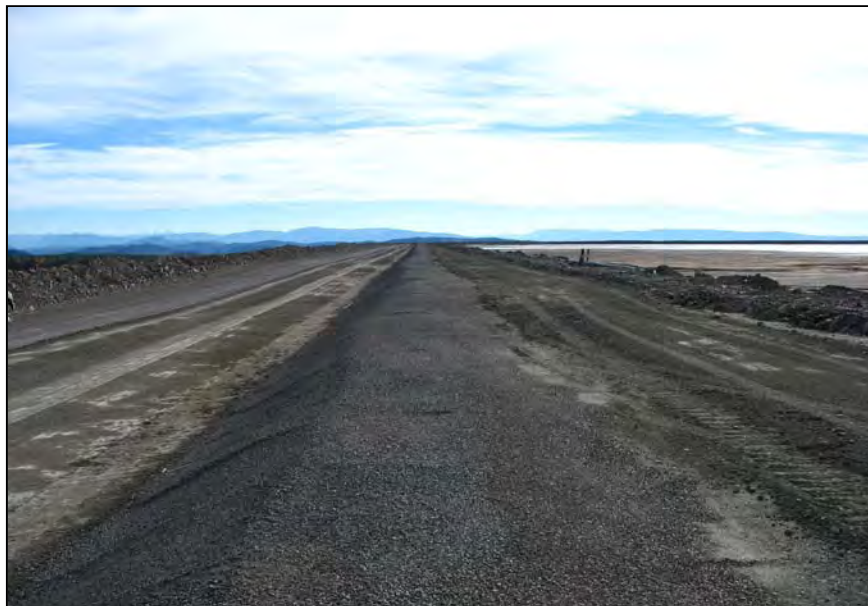
PHOTO 1 – Perimeter Embankment Crest.

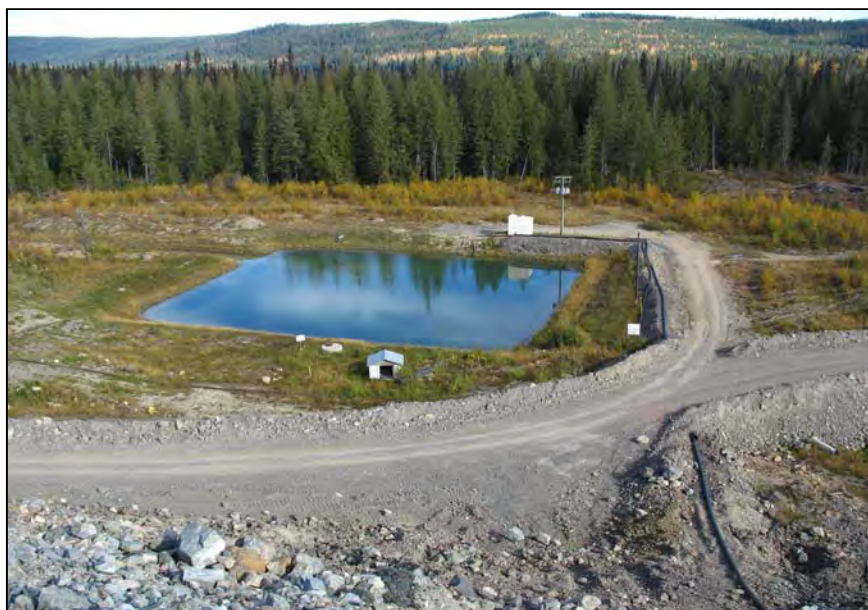
PHOTO 2 – Perimeter Embankment Seepage Collection and Recycle Pond.

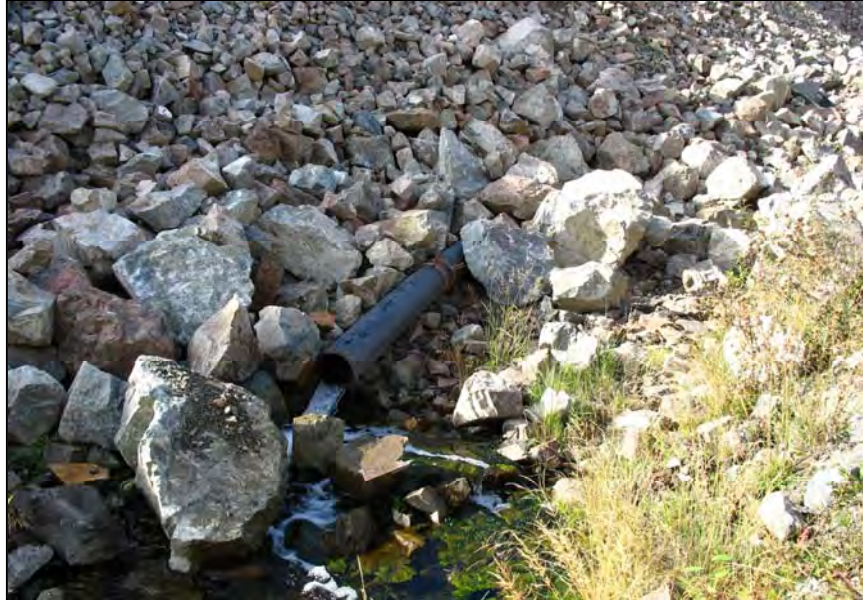
PHOTO 3 – Perimeter Embankment Toe Drain Flow.

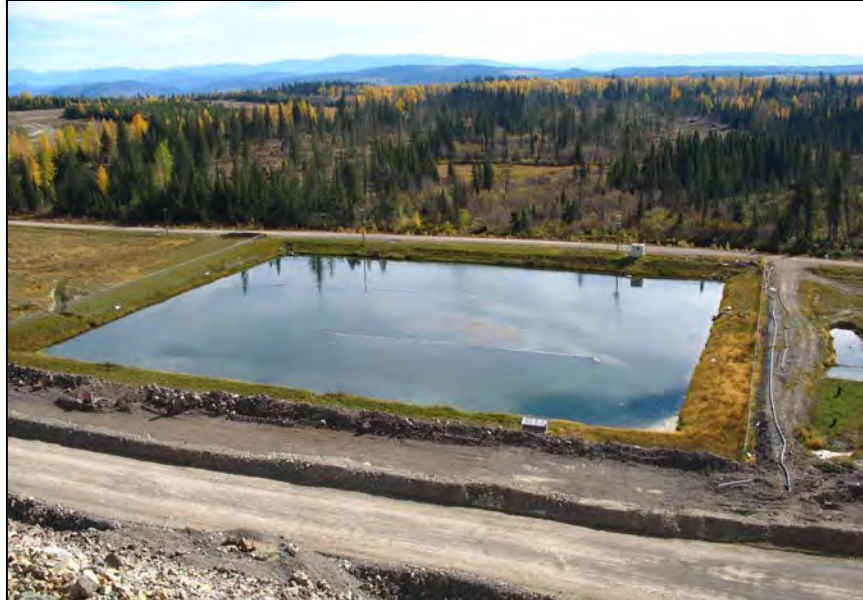
PHOTO 9 – Main Embankment Seepage Collection and Recycle Pond.

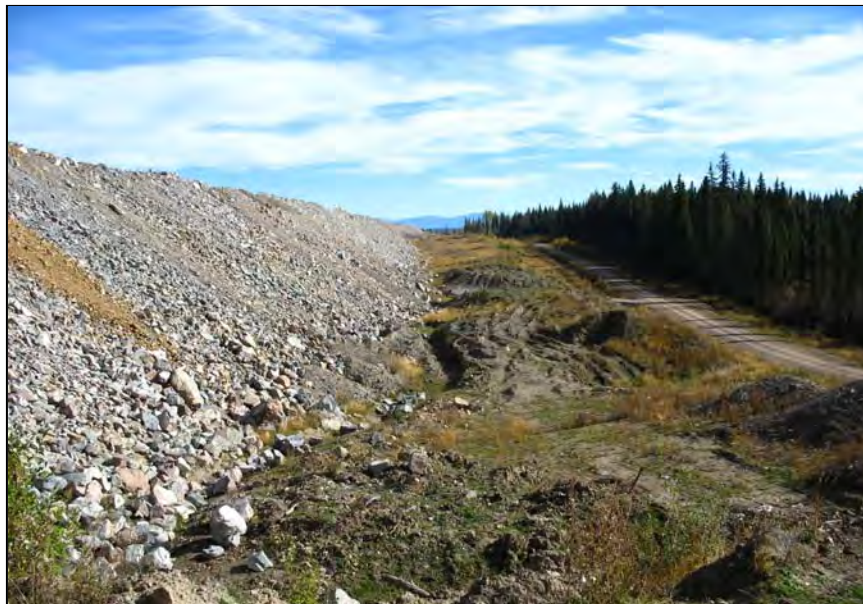
PHOTO 12 – Downstream Slope of South Embankment.

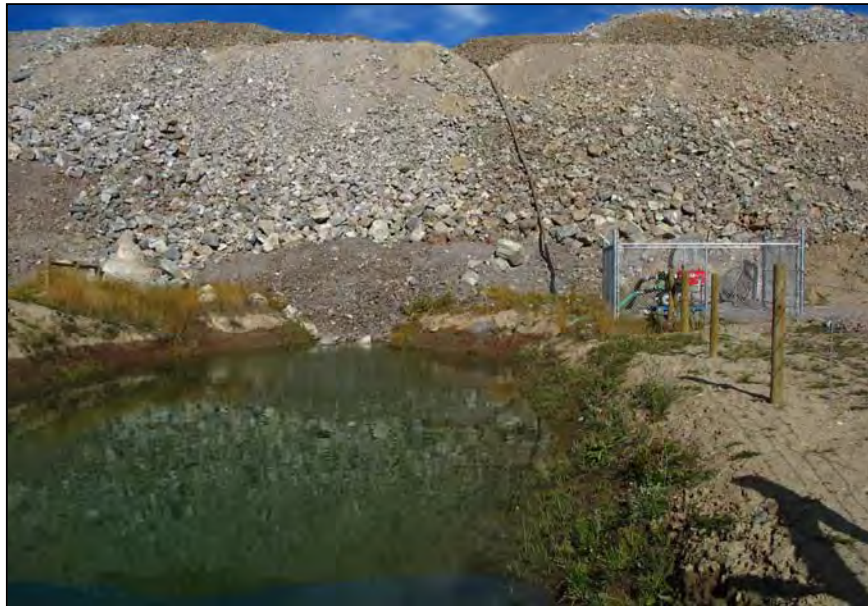
PHOTO 14 – South Embankment Seepage Collection and Recycle Pond.

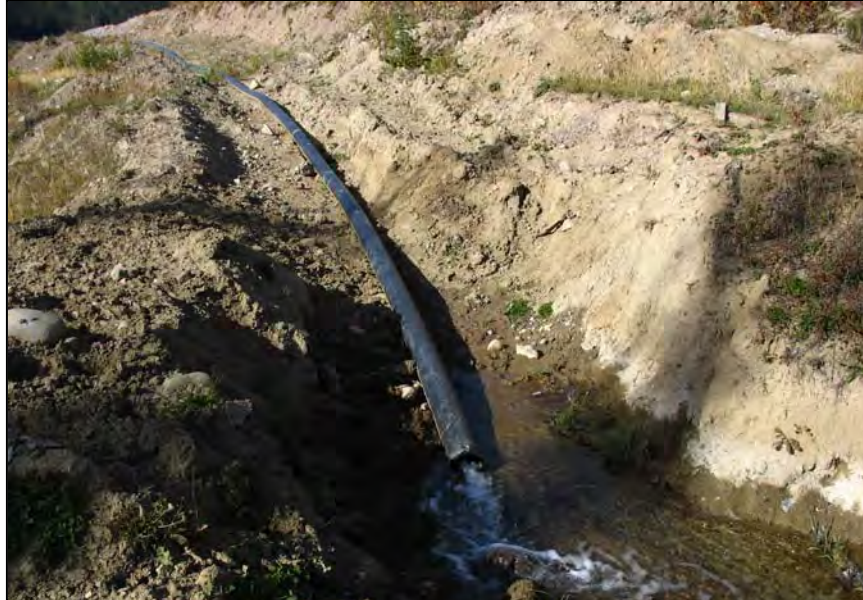
PHOTO 15 – South Embankment Upstream Toe Drain flow.

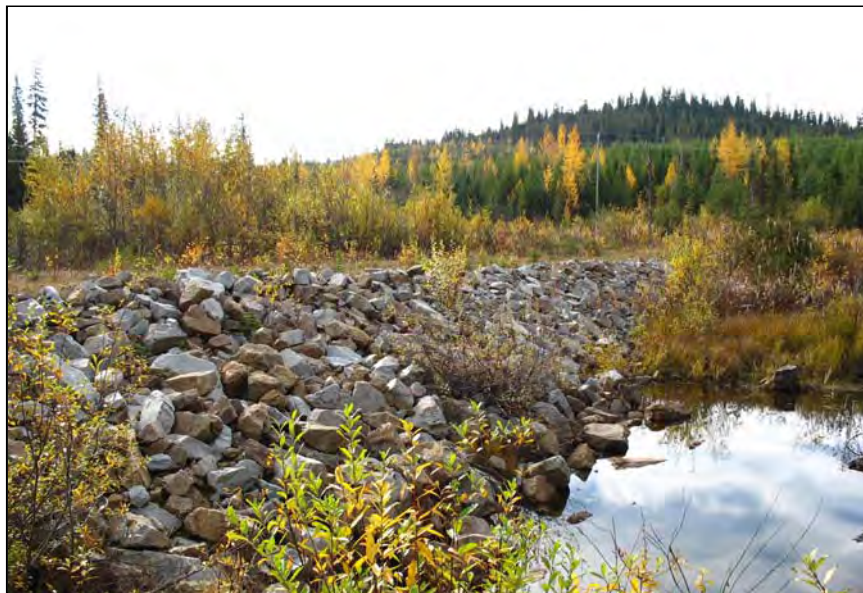
PHOTO 16 – South Bootjack Dam.
