## GEOTECHNICAL ENGINEERING SERVICES FOR AFTON TAILINGS STORAGE FACILITY

# Phase 1: Review Possibility of Mount Polley Mine Conditions at Afton TSF site

**Report Number:** 1526512

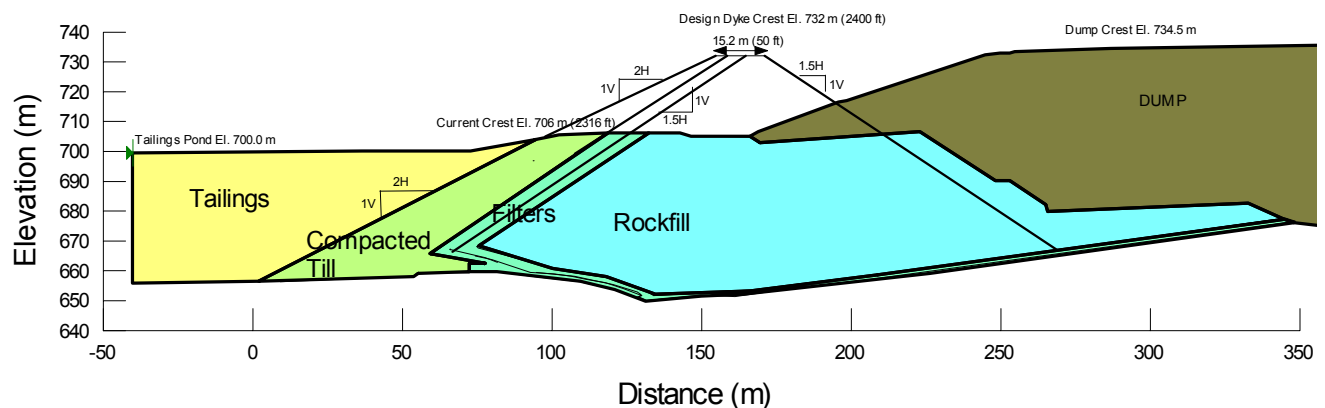
Figure 4: East Dam Inferred Estimated As-built Section (Section B-B', Figure 2)

Since the end of operation in 1997, the West and East Dams have maintained approximate crest elevations of 706 m. This is about 25 m lower than the original design crest elevation of 731.5 m. As a result, the crest of both dams is more than 100 m wide instead of the design final crest width of 15 m. Figures 3 and 4 compare the inferred as-built sections to the design sections for the West Dam and East Dam, respectively.

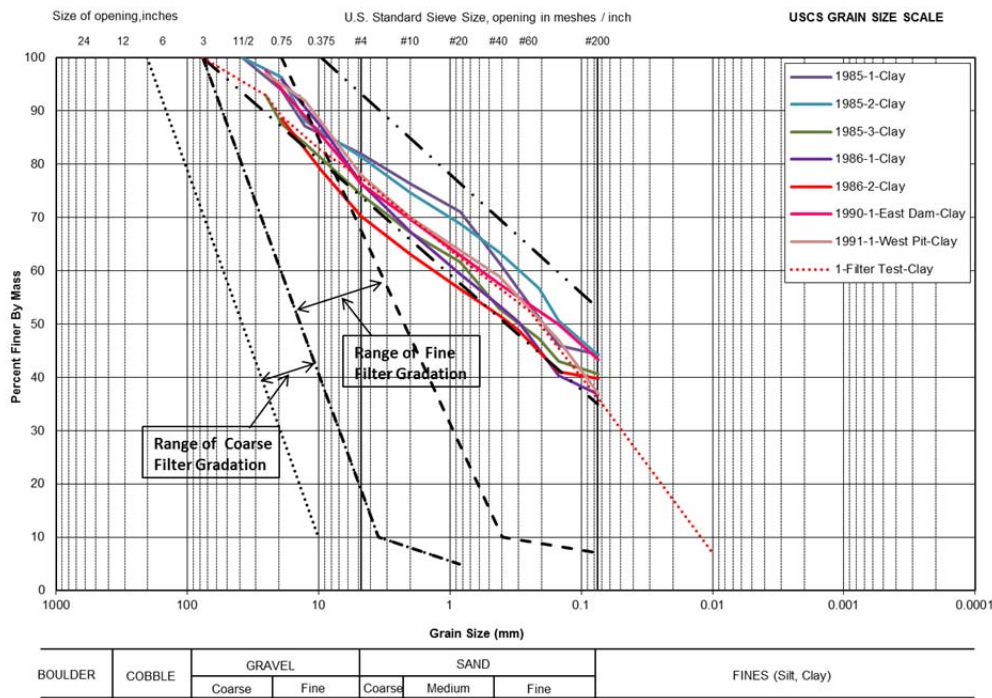
Figure 7: Compacted Till PSD Test Results

Gradation curves for samples of the fine filter, coarse filter and compacted till are presented in the KL 1979 letter as well as in some of the yearly construction reports (KL (1979a), AOC (1981 to 1991)). Figures 7 to 9 show the particle size distribution (PSD) curves for the compacted till, fine filter, coarse filter based on information in the reports.

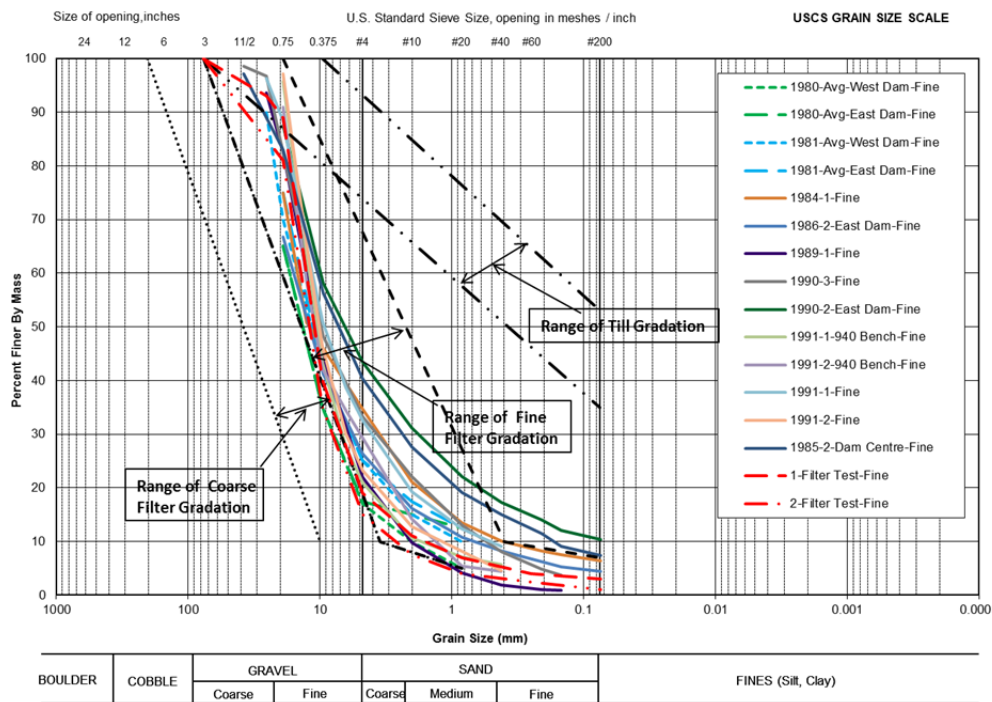
Figure 8: Fine Filter PSD Test Results

The  $C_u$  of the fine filter is in the range of 5 to 10 and the maximum particle size is limited to about 75 mm (3') (Figure 8). The  $C_u$  of the coarse filter is about 20 and the maximum particle size is limited to about 100 mm (Figure 9).

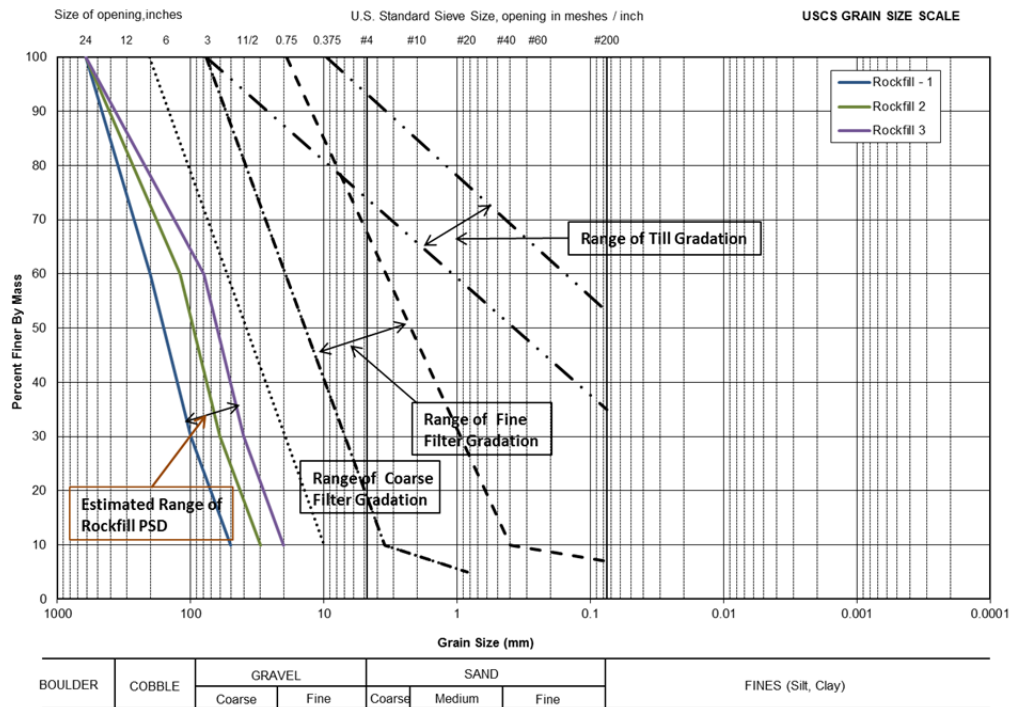
Figure 10: Estimated Range of PSD for Rockfill

PSD curves for rockfill were not available but the maximum design particle size of the rockfill is 24" (610 mm). Photos of the rockfill are presented in the KL letter report "Results of Laboratory and Field Tests on Filter Material for Tailings Dams" (KL 1981). In the photos, the rockfill gradation appears to match the maximum particle size requirement of 610 mm apart from some larger boulders. The material also seems well graded. Based on this information, we developed a possible gradation range for the rockfill as presented in Figure 10.

| Material | Parameter | Range (mm) | Average (mm) | Comments |
|---|---|---|---|---|
| Rockfill | D <sub>15</sub> | 23 to 60 | 35 | Gradation estimated as shown in Figure 10 |
