**Reference: Bell Mine Site
2014 Dam Safety Inspection**

BELL MINE SITE
2014 DAM SAFETY INSPECTION
FINAL REPORT

November 2014

AMEC File: TE143007

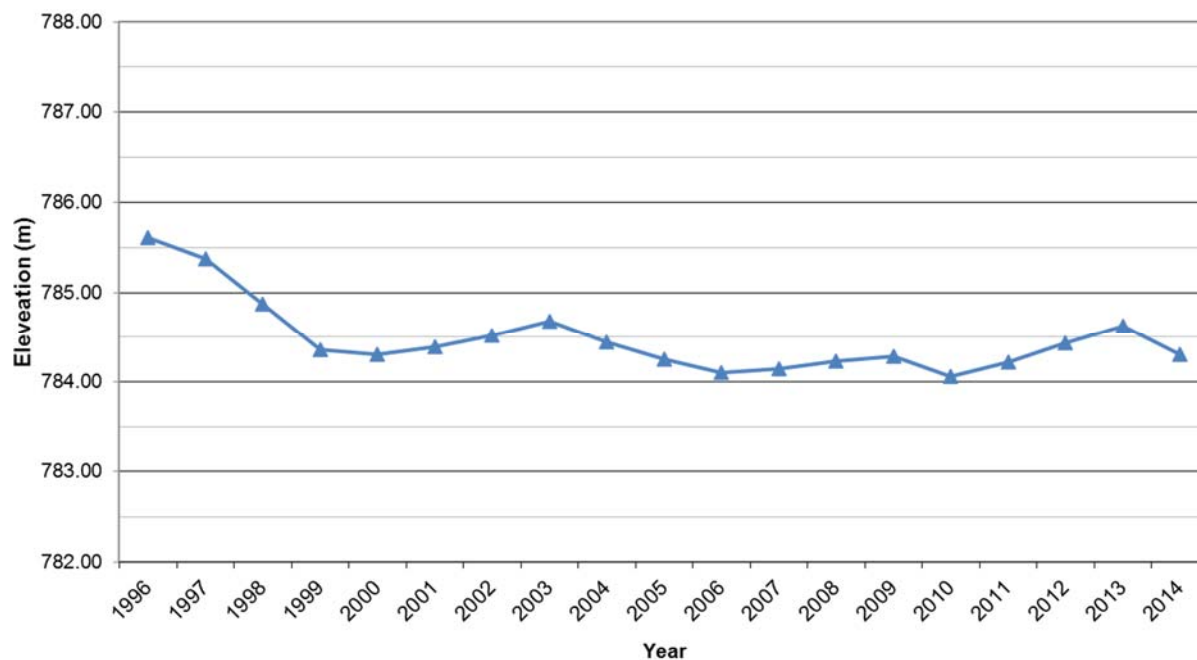
Figure 5.5 Historic Tailings Pond Water Levels for the Main Tailings Pond

beaches has not significantly changed over the last 15 years. Available freeboard does not appear to represent an issue for the Main and TEX Tailings Impoundments, as a very minor water pond of limited extent was observed at the Main Tailings Impoundment and the impoundment's freeboard was approximately 8 m. Figure 5.5 presents the historic tailings pond water levels for the tailings pond, at the Bell Mine site.

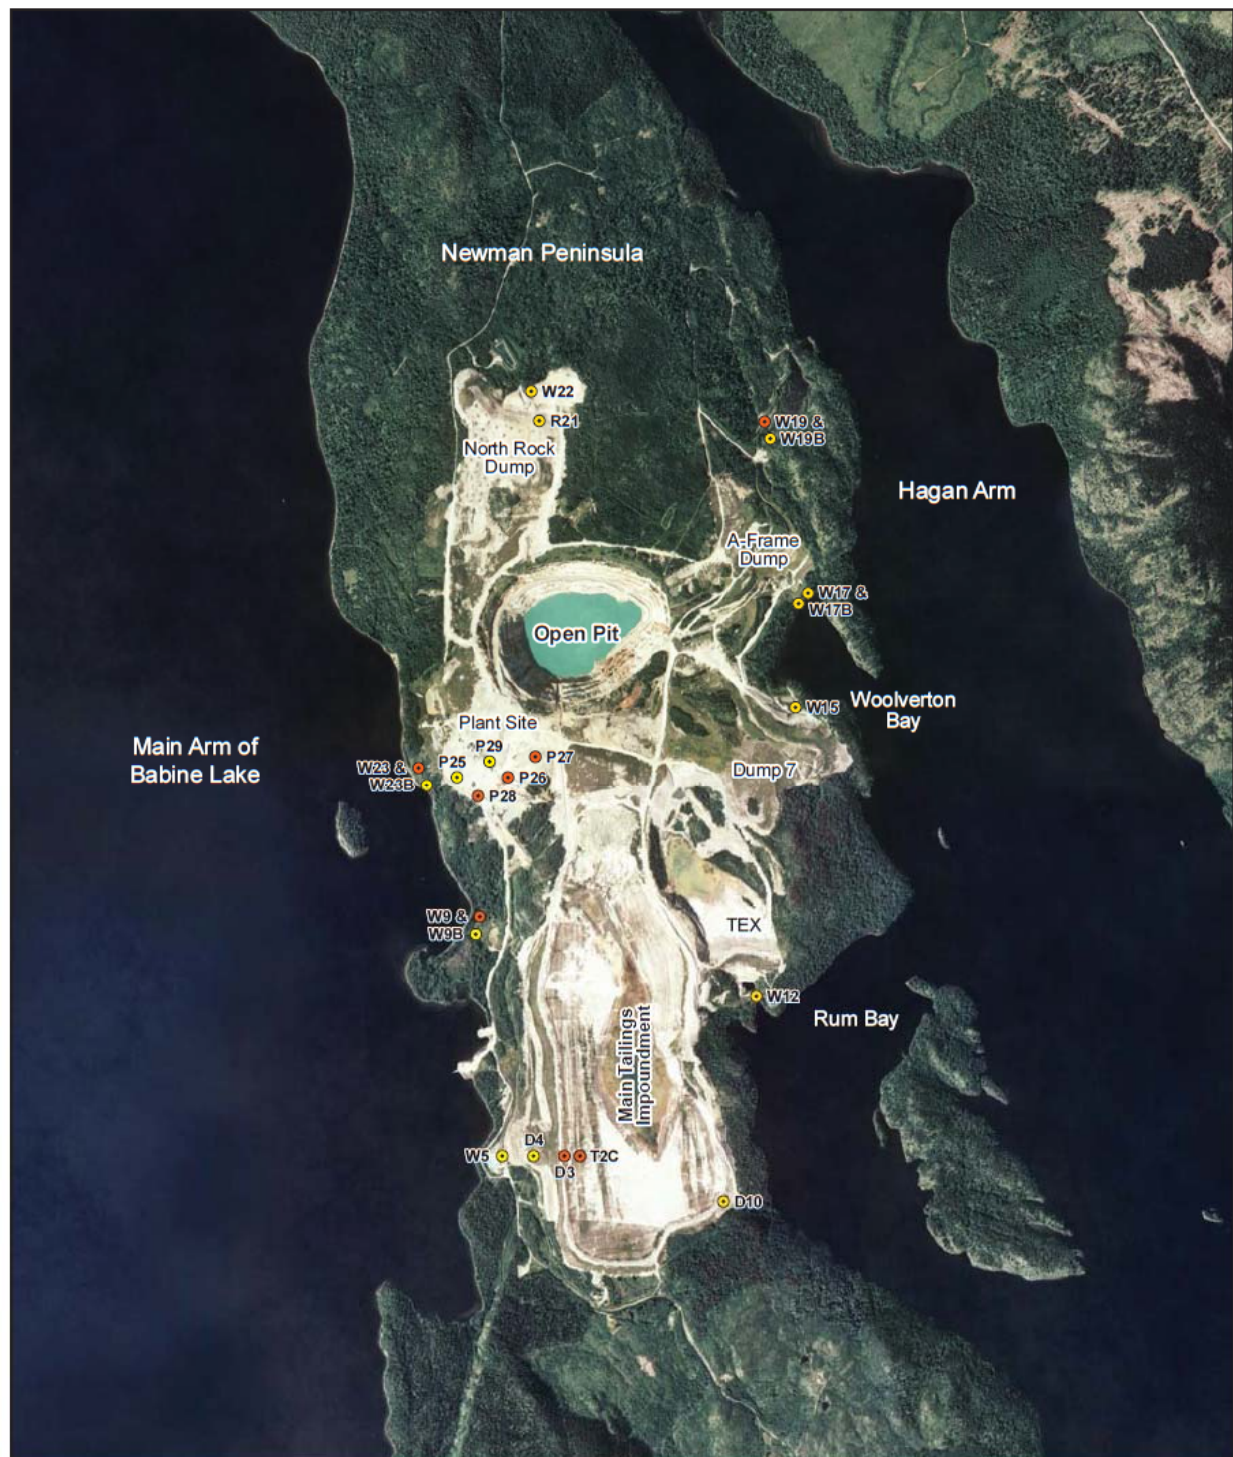
Figure 6.1 Monitoring Well Locations (source: EcoMetrix)

There are six piezometers installed in the Bell tailings impoundments (see Figure 6.1). Water levels measured in these piezometers are presented in Figures 6.1 to 6.6. No significant changes in piezometric levels were noted that would indicate potential problems with the stability of the tailings dams.

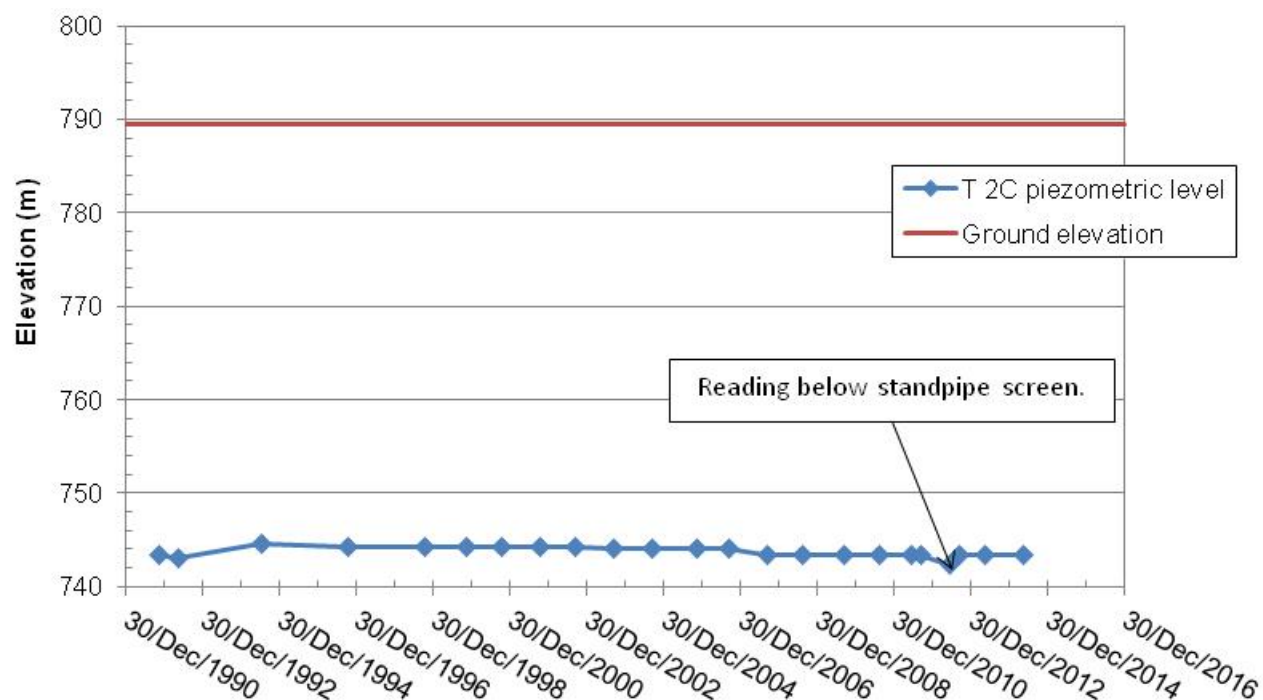
Figure 6.3 Piezometer T 2C - Historic Water Levels (location: tailings)

The piezometric levels are generally steady. Immediately upstream of the tailings dams, the tailings are essentially fully drained ('semi-dry'). Piezometer T 2B is now reading dry. For the other standpipes, it is not clear that the readings that are being measured are reflective of the pore pressure conditions at those locations. The piezometric elevations that are measured are 1 to 5 m above the base of the standpipe. When undertaking future readings, Glencore should also locate the bottom of the pipe below the measured water level to determine if the water level that is being measured in the standpipe is actually reflective of the surrounding groundwater conditions and not as a result of the standpipe being infilled with soil which could give a false reading.

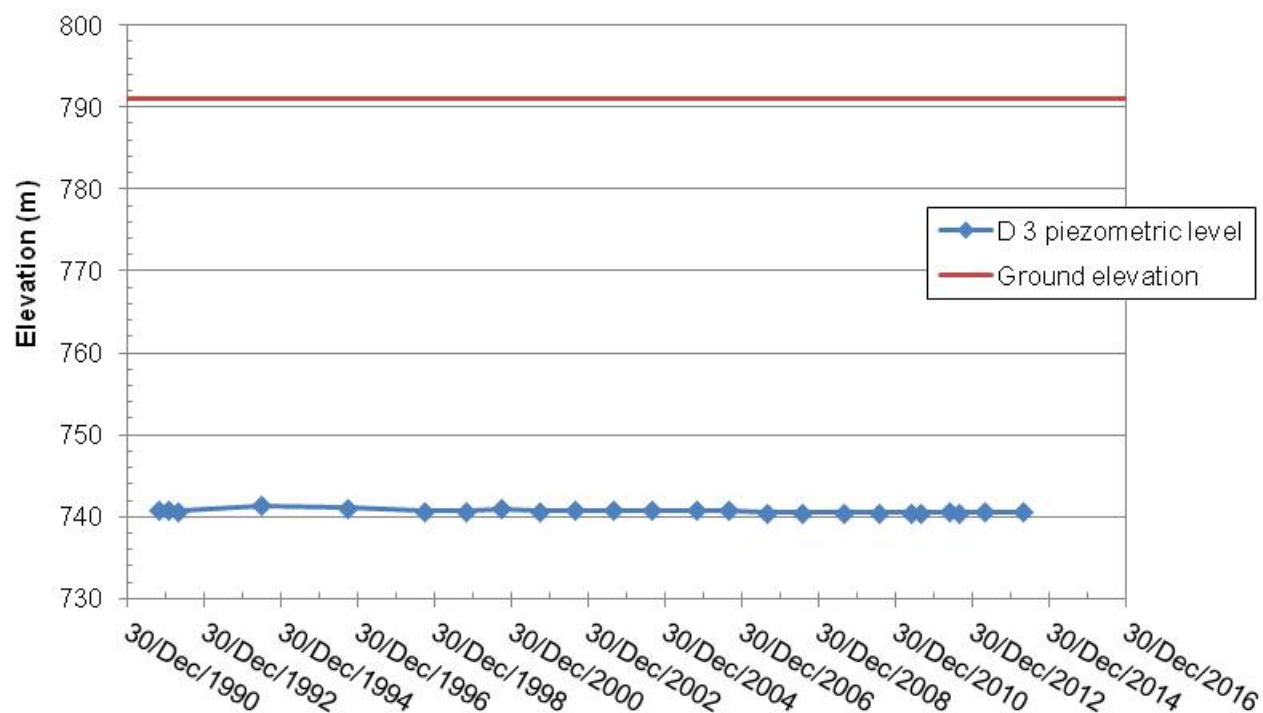
Figure 6.4 Piezometer D3 - Historic Water Levels (location: Dam 1)

As noted in MBS 2013, Piezometers D3 and D4 are located in Dam 1, next to the stabilizing berm, in an area where strong ARD is generated in the dam rockfill shell. This might affect the performance of the piezometers. However, D3 is reading dry now.

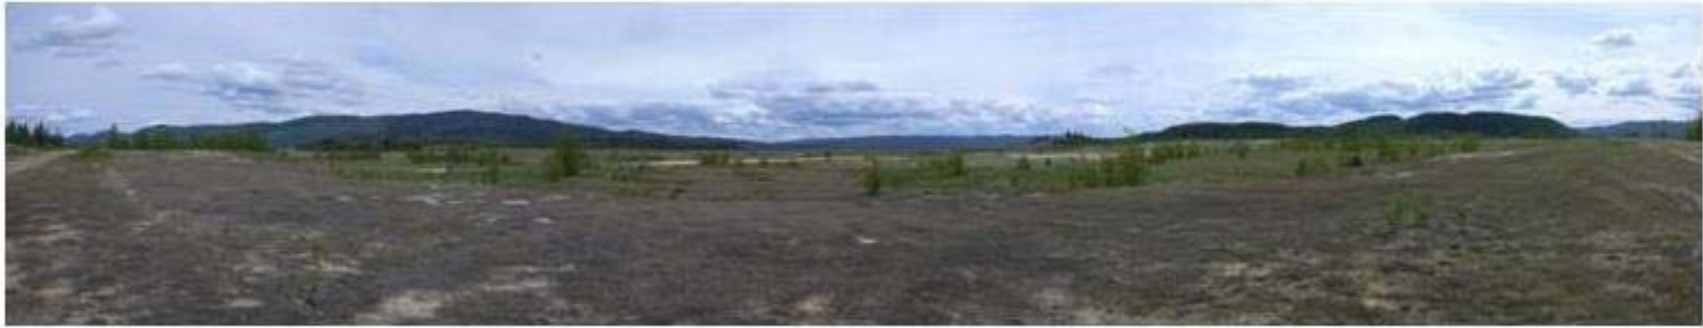
Photo C1-1: View of the upstream tailings beach, looking east from about one third of the way along the crest of Dam 1. (11 June 2014)

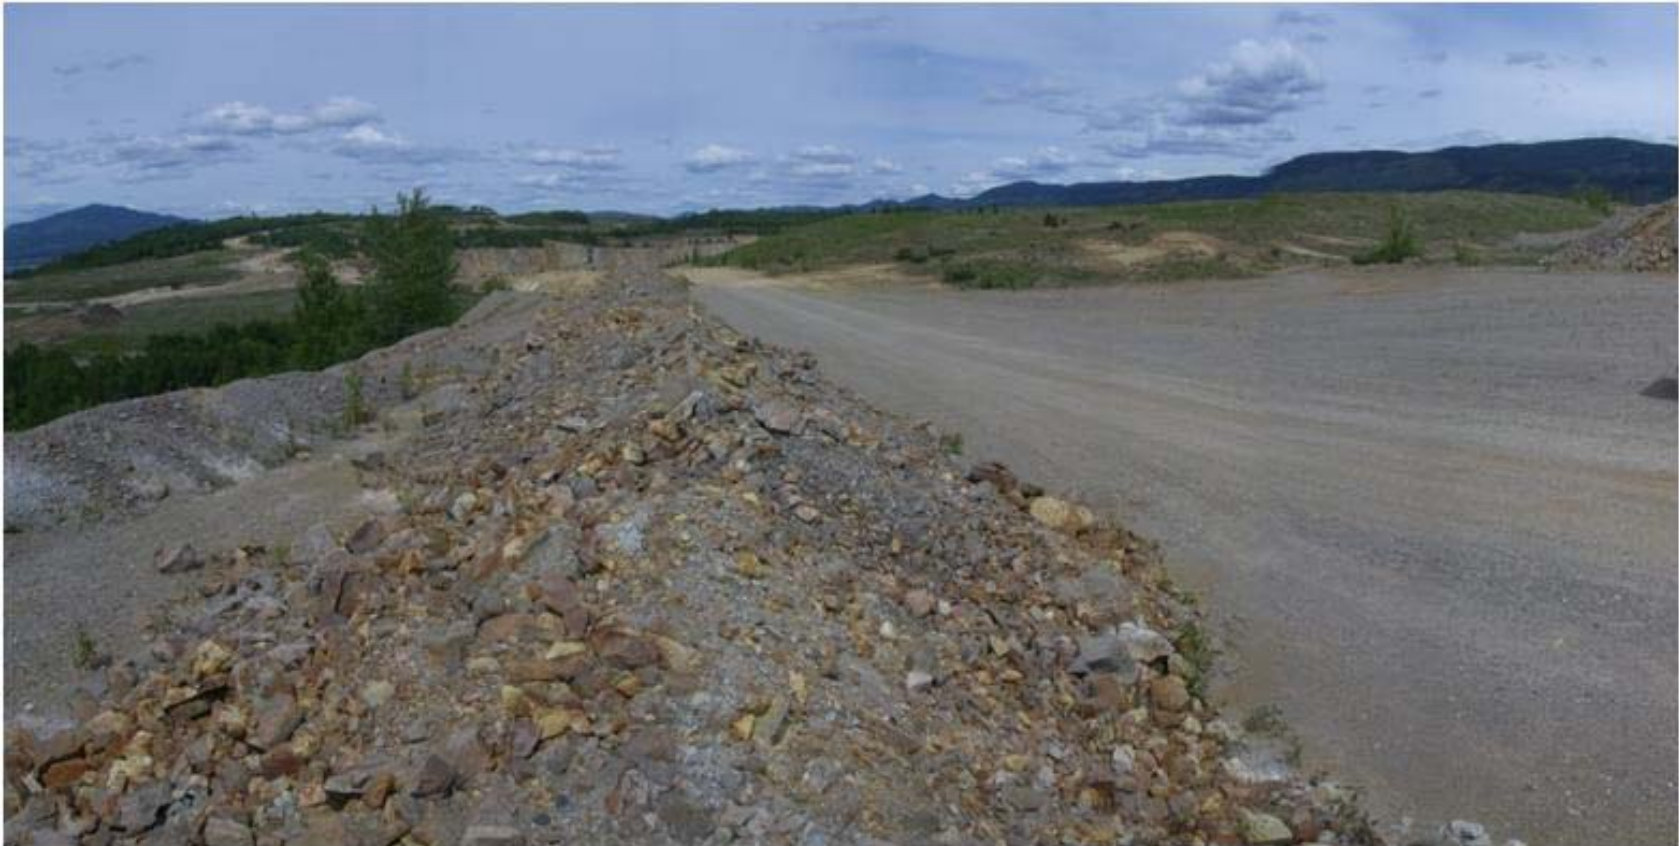
Photo C1-2: View of Dam 1 crest, about one quarter of the way along the dam, looking north from above CP1-5. (11 June 2014)

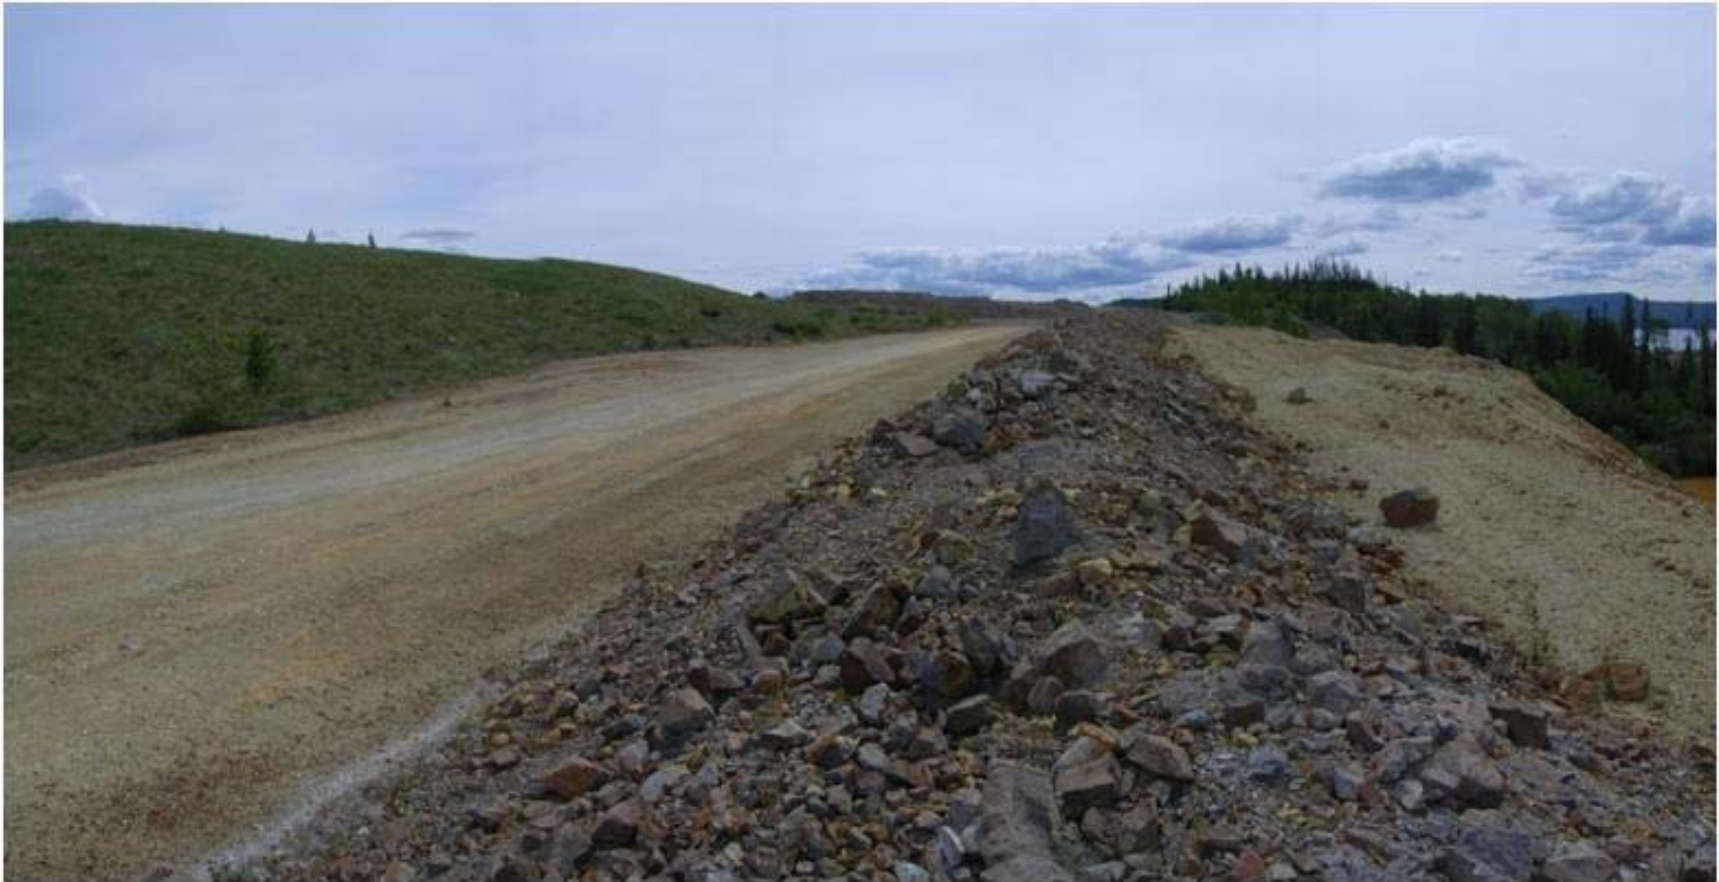
Photo C1-3: View of Dam 1 crest from same location as previous photo, looking south. (11 June 2014)

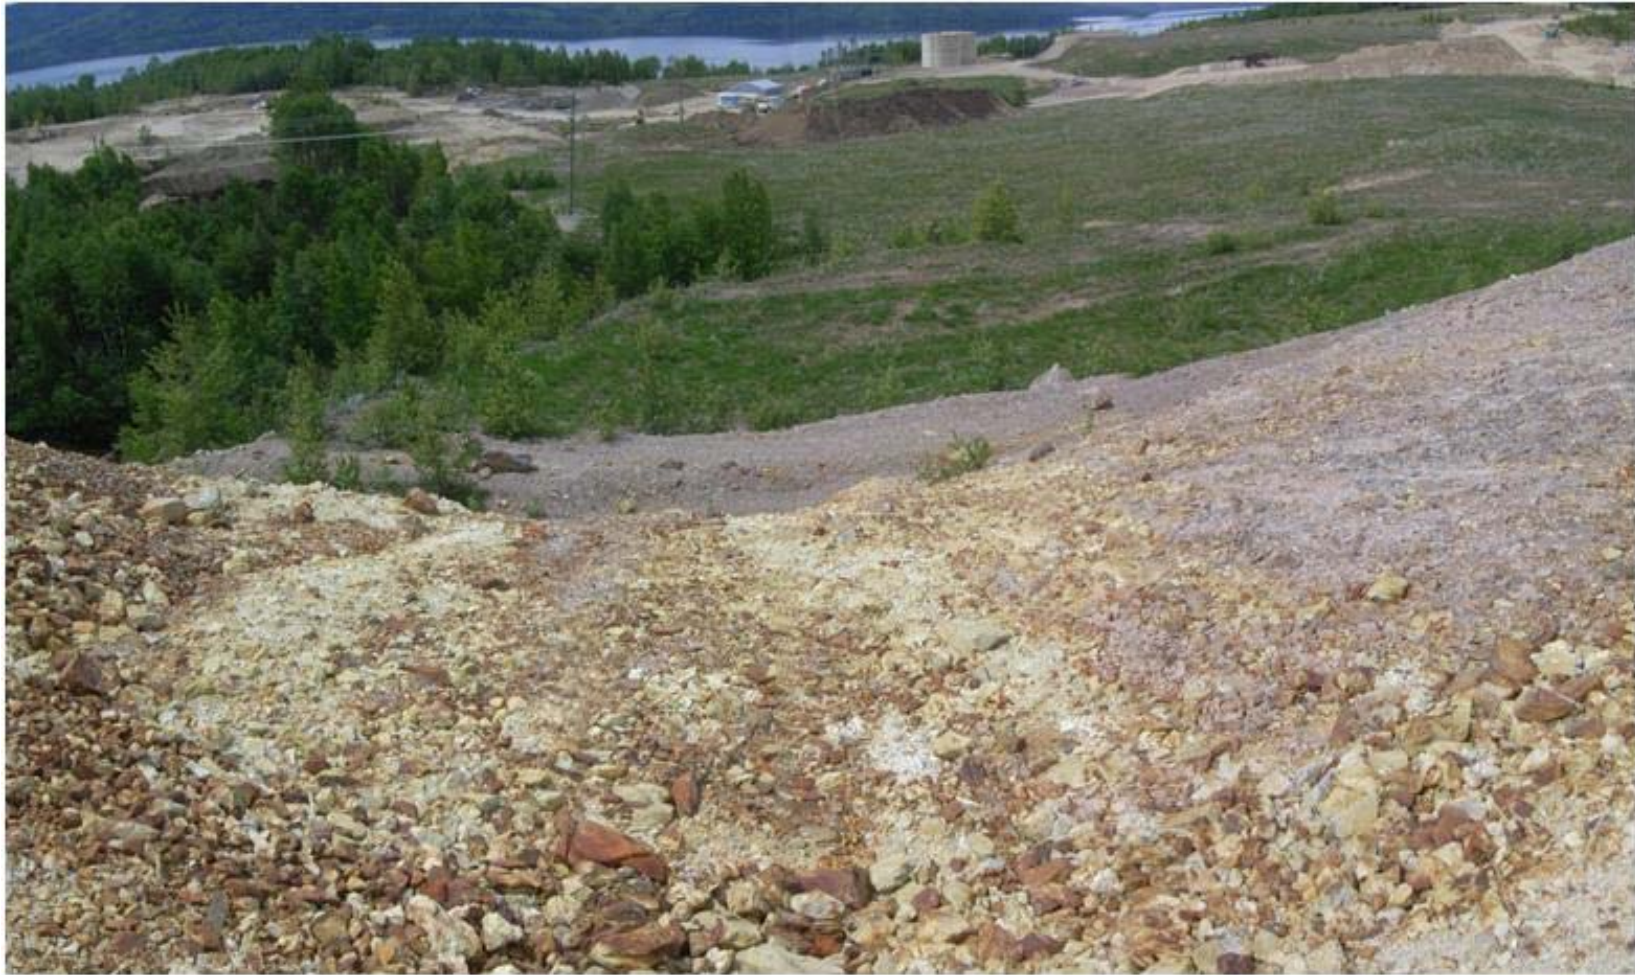
Photo C1-5: View of downstream slope and toe of Dam 1, looking west from crest. Note former mill site in the background. (11 June 2014)

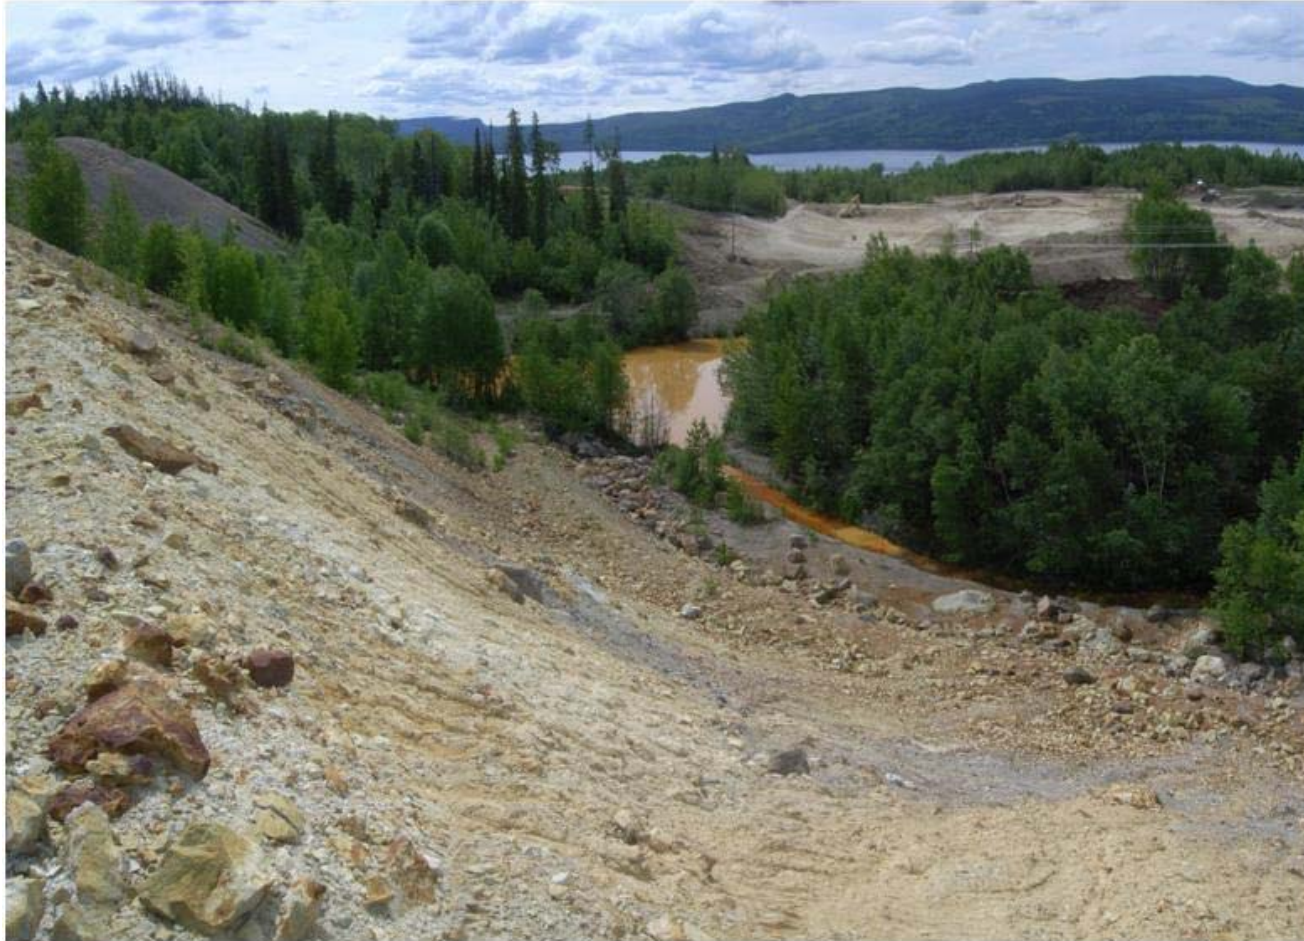
Photo C1-6: View of downstream slope and toe of Dam 1, looking south from north end of the dam.
Note CP1-5 in the background. (11 June 2014)

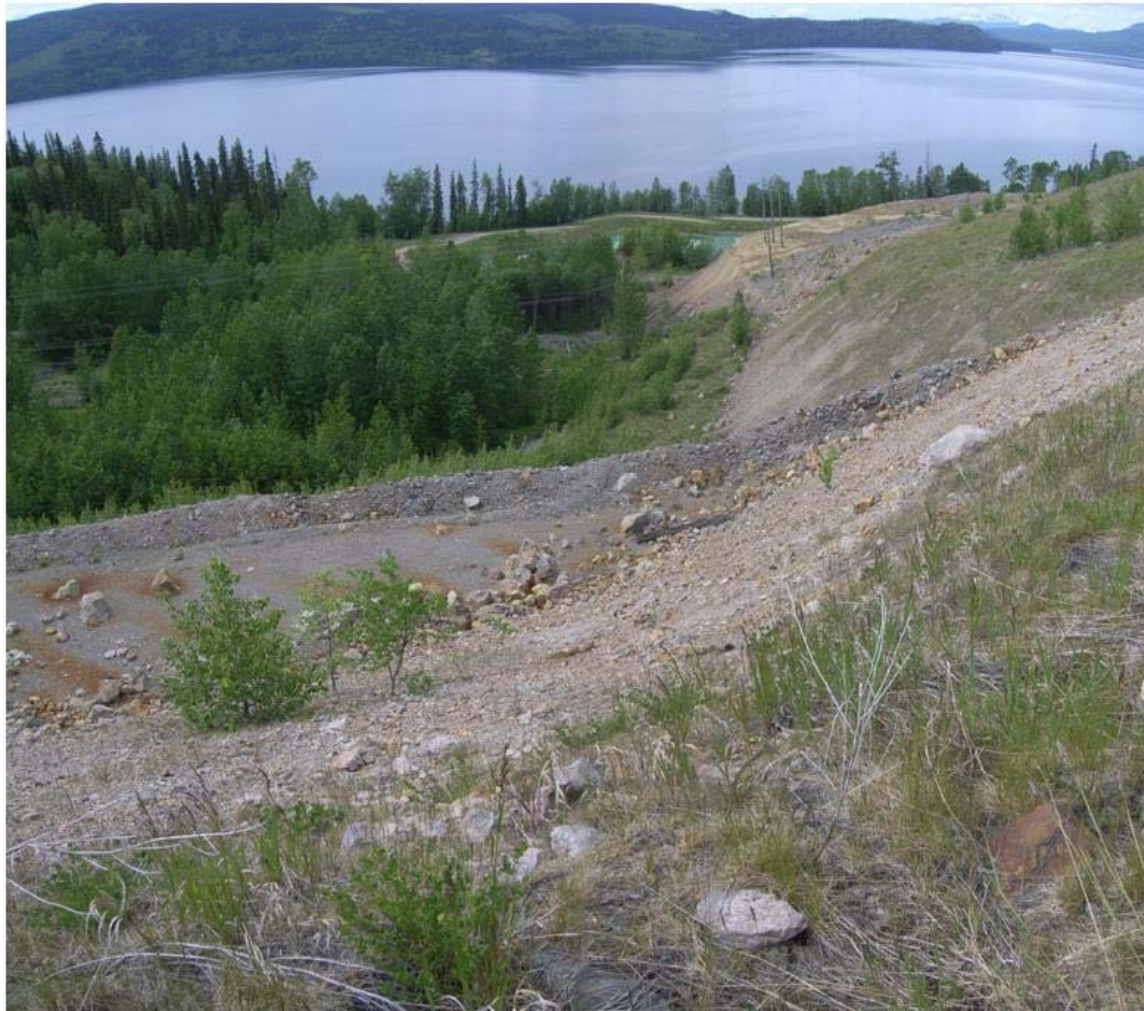
Photo C1-7: View of downstream slope and toe of Dam 1, looking west from crest, toward CP1-3. (11 June 2014)

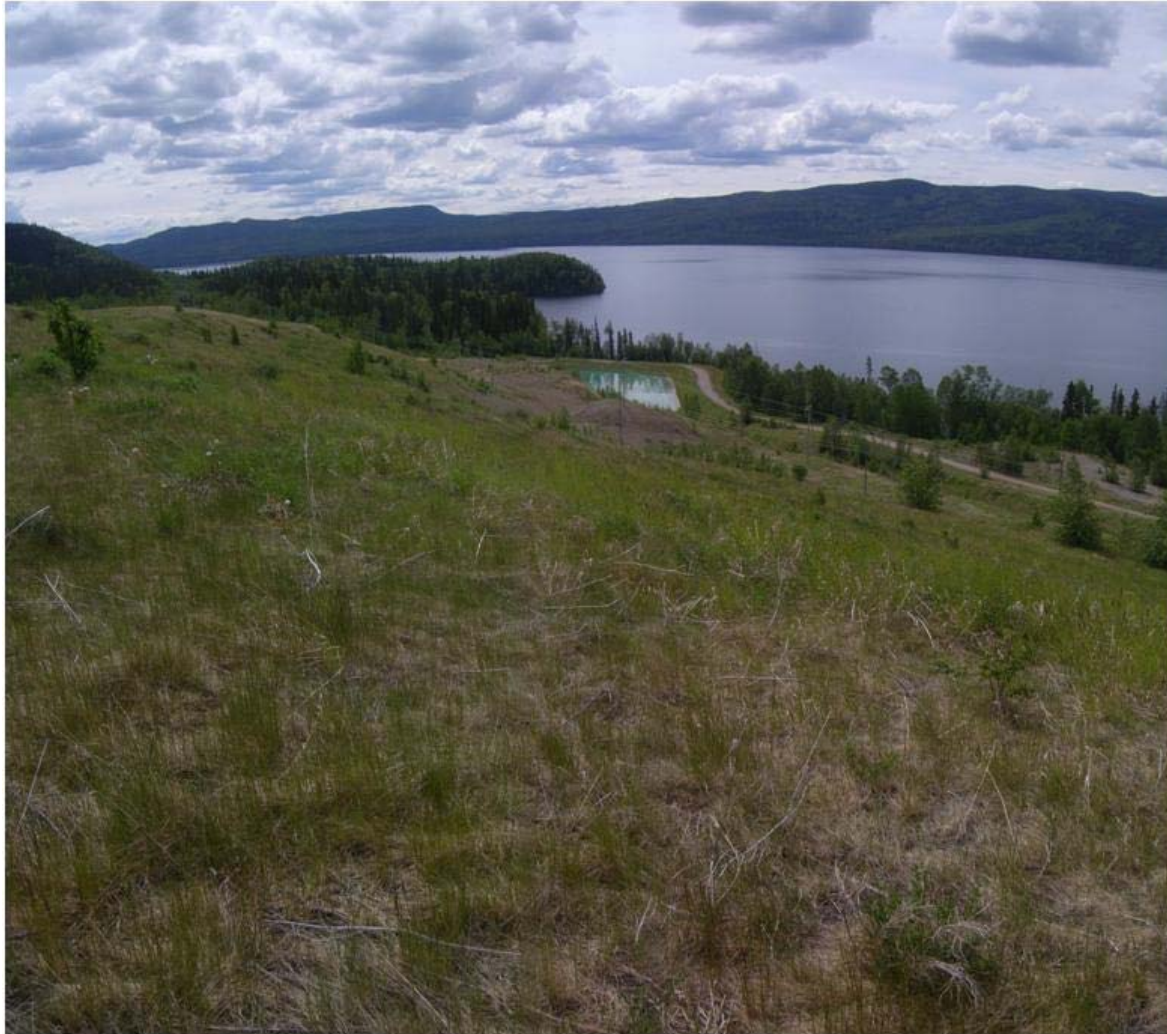
Photo C1-8: View of downstream slope and toe of Dam 1, looking south from about midway along the dam crest.
Note good vegetation and CP1-3 in the background. (11 June 2014)

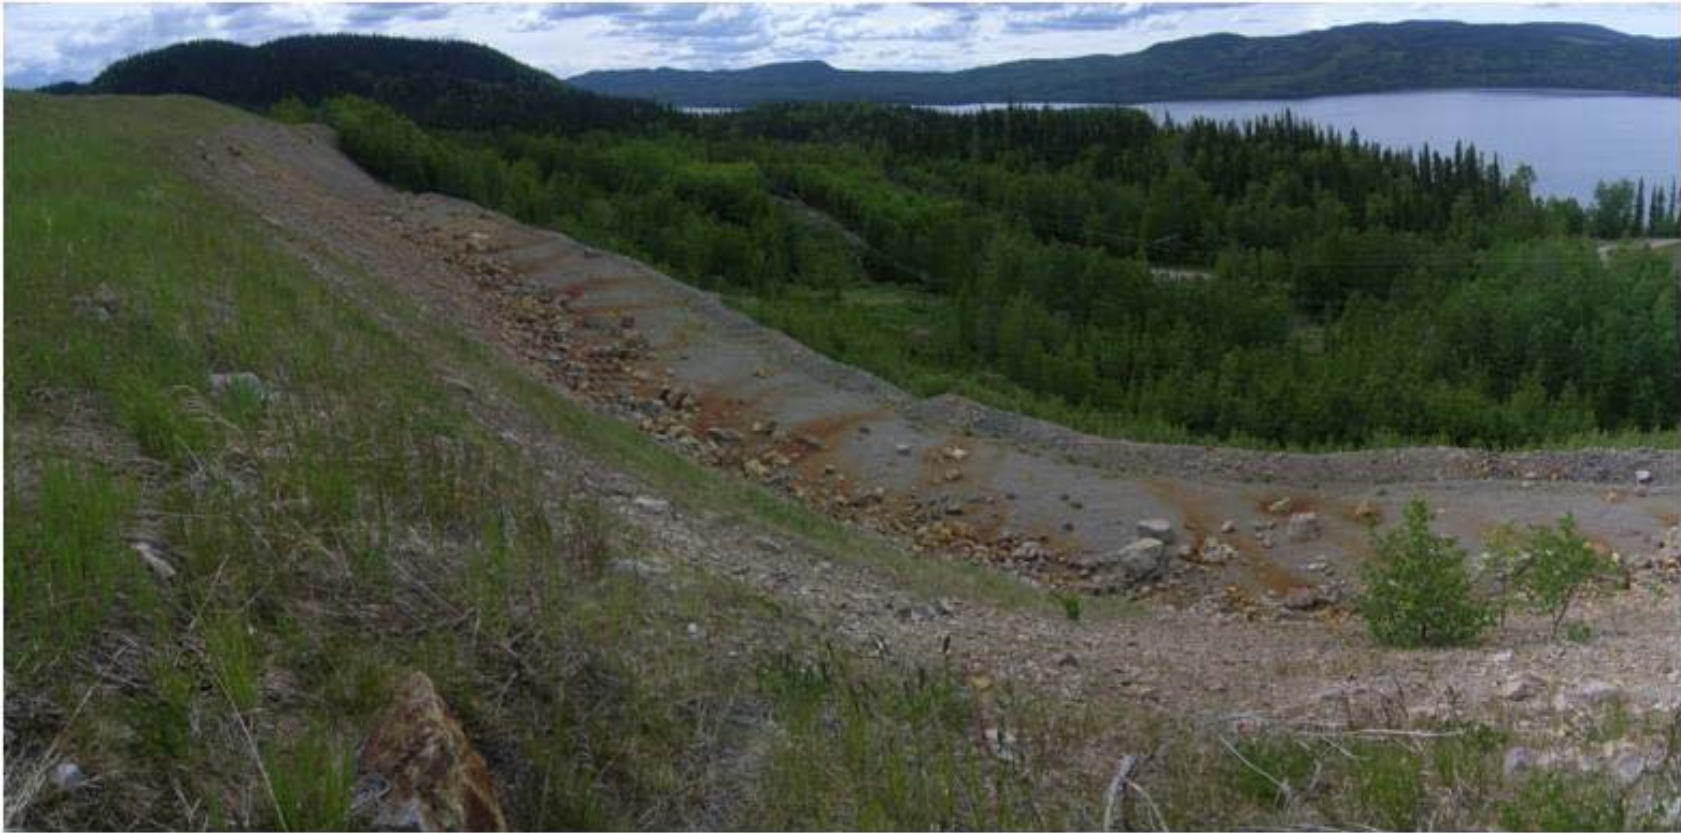
2.4 Concerns with Low Areas on the Crest		X		
2.5 Other Unusual Conditions		X		
3.0 Downstream Dam Slope				
3.1 Evidence of Erosion		X		
3.2 Evidence of Sloughing/Sliding	X			The steep portion of Dam 1 toe is stable (no change)

Photo C1-9: View of downstream slope and toe of Dam 1, looking south from the about two thirds along the dam, looking south of CP1-3. (11 June 2014)

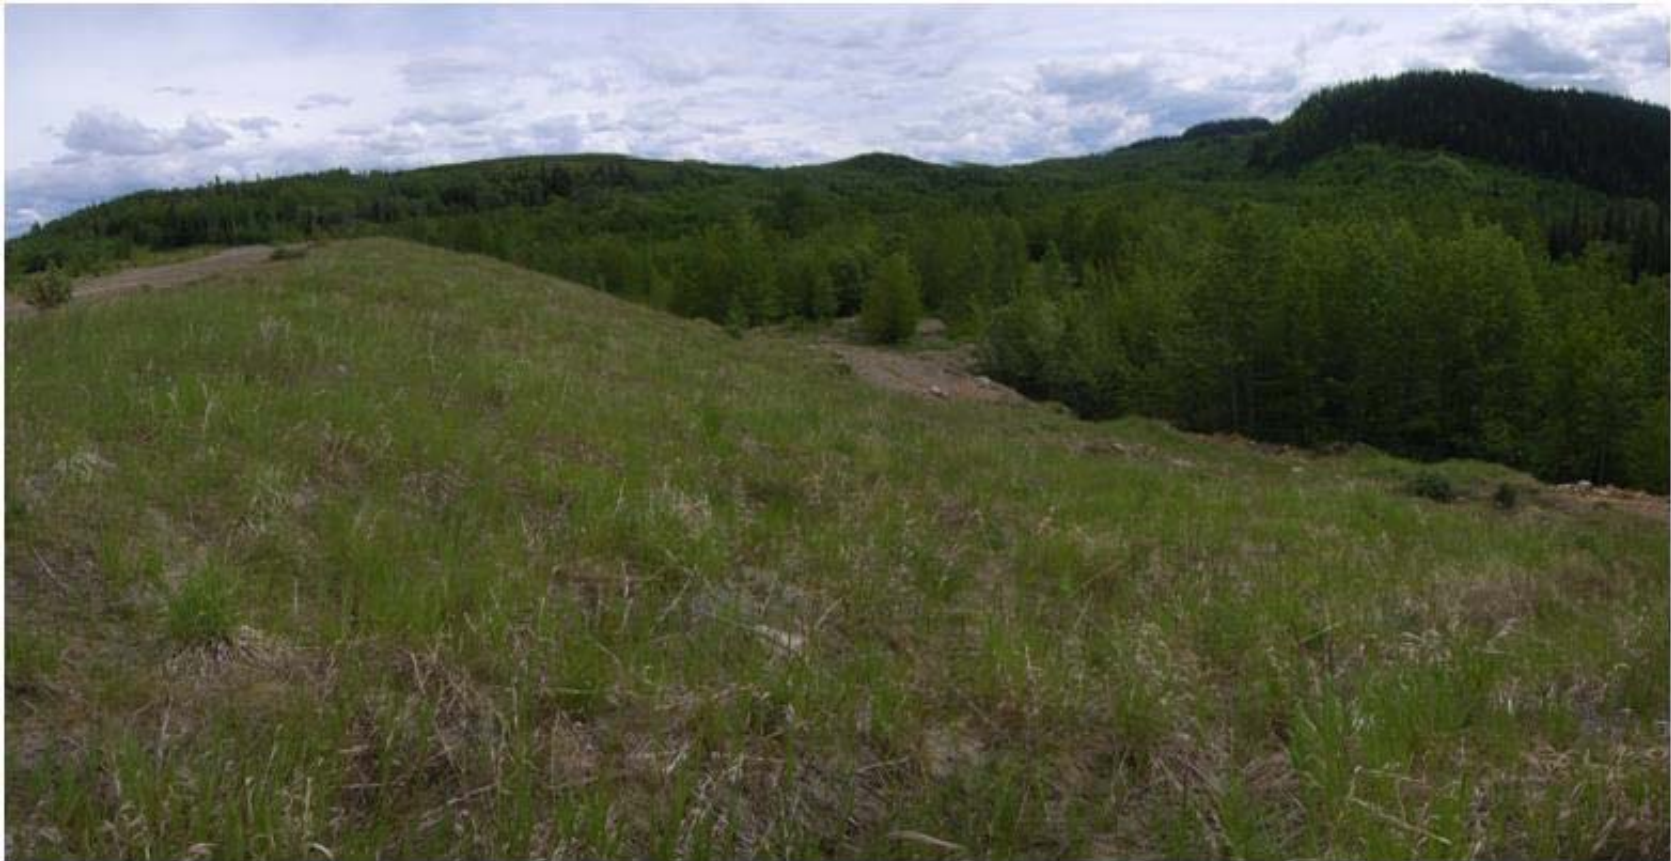
Photo C2-1: View of downstream slope of Dam 2, looking east from west end of the dam.
Note the slope is well vegetated. (11 June 2014)

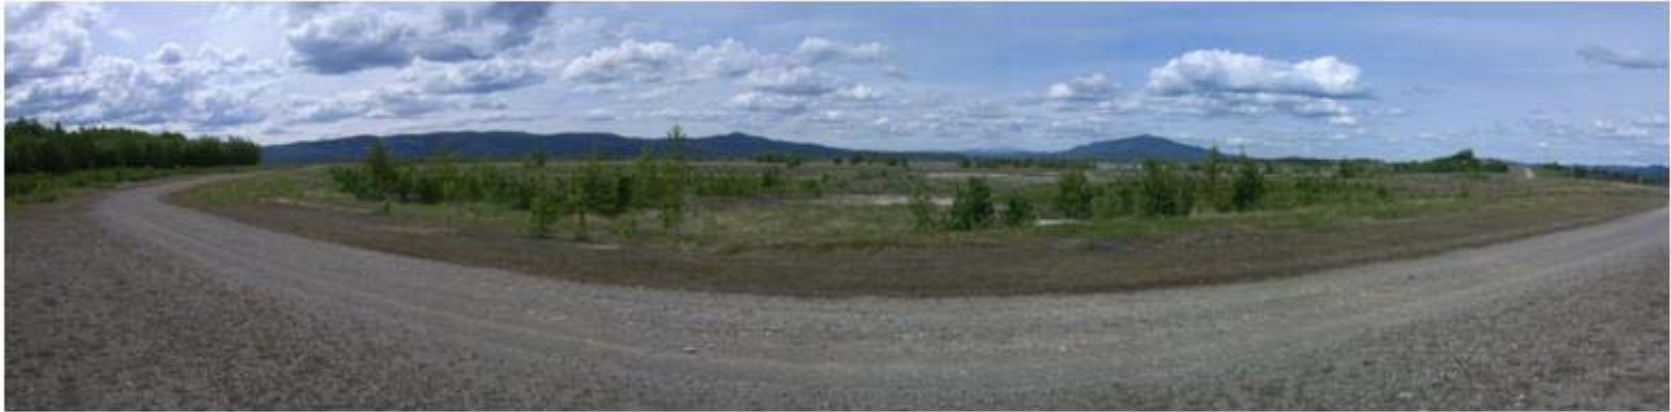
Photo C3-1: View of upstream beach at Dam 3. Looking west from south end of the dam. (11 June 2014)

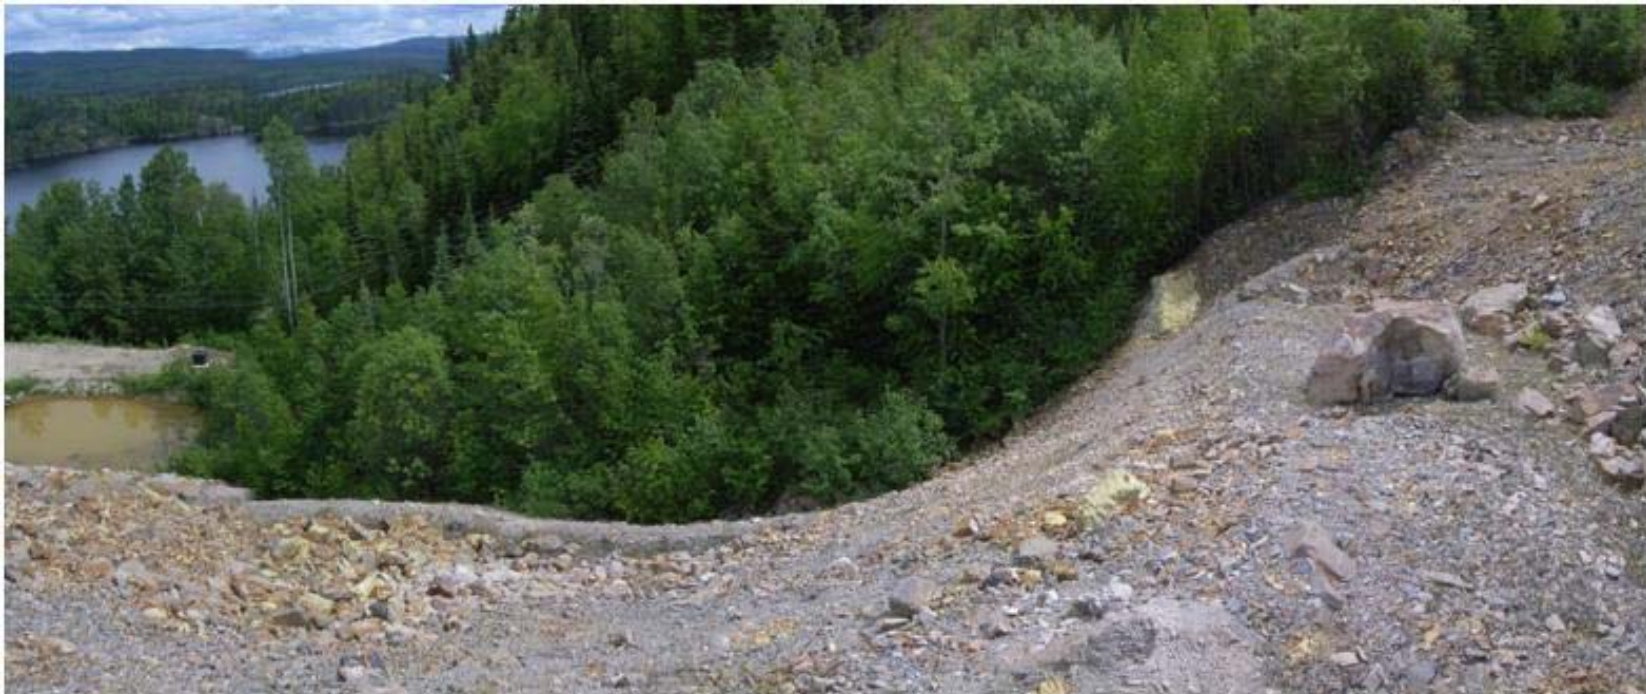
Photo C3-3: View of Dam 3 south abutment.
Note CP3-1 is shown on the left. (11 June 2014)

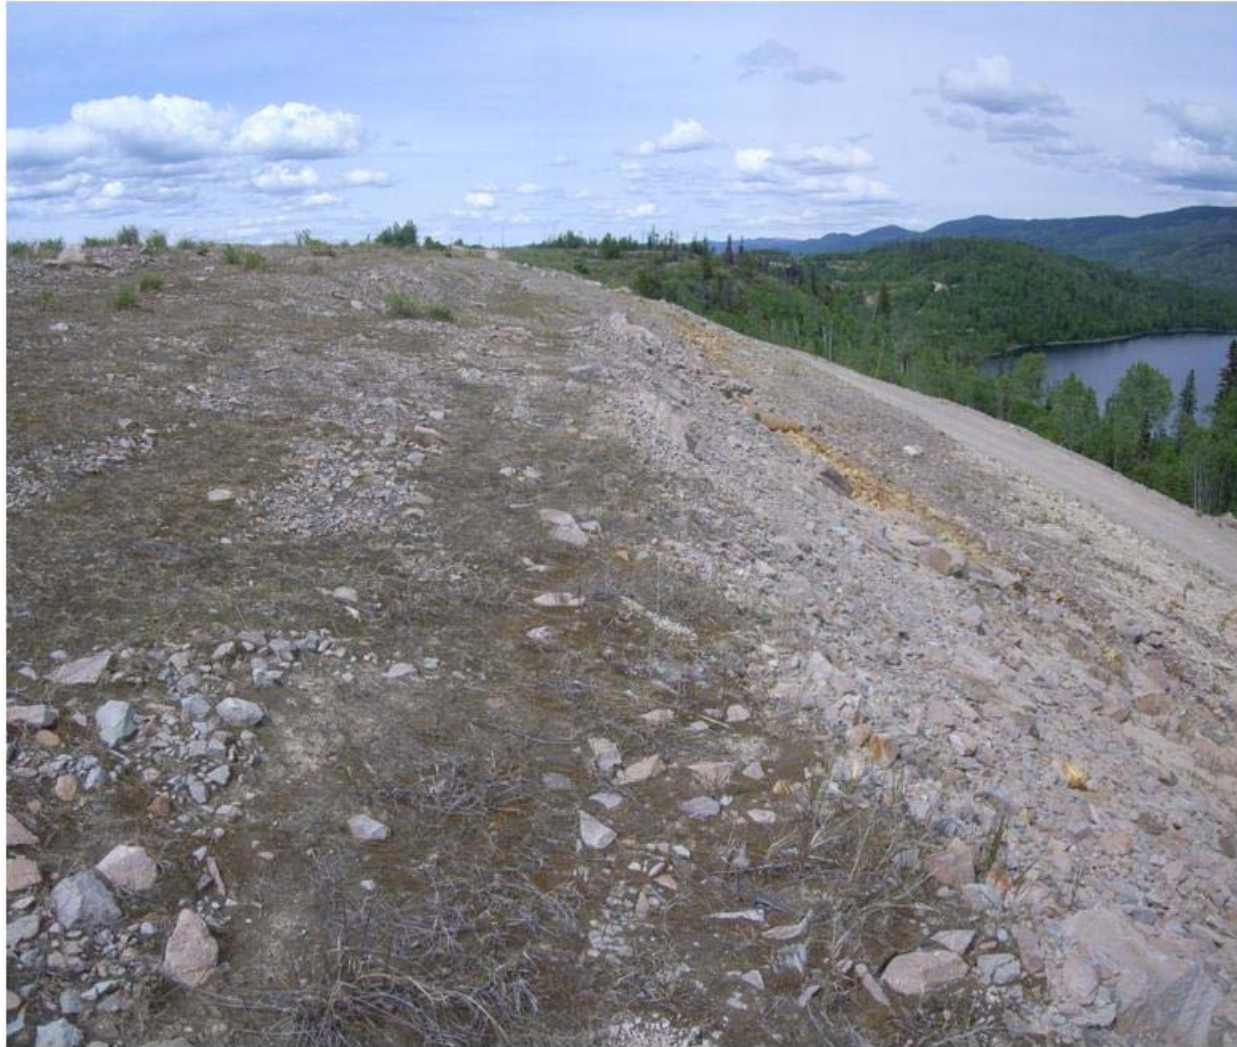
Photo C3-7: View of downstream slope of Dam 3, about midway along the dam from the south, looking north east. (11 June 2014)

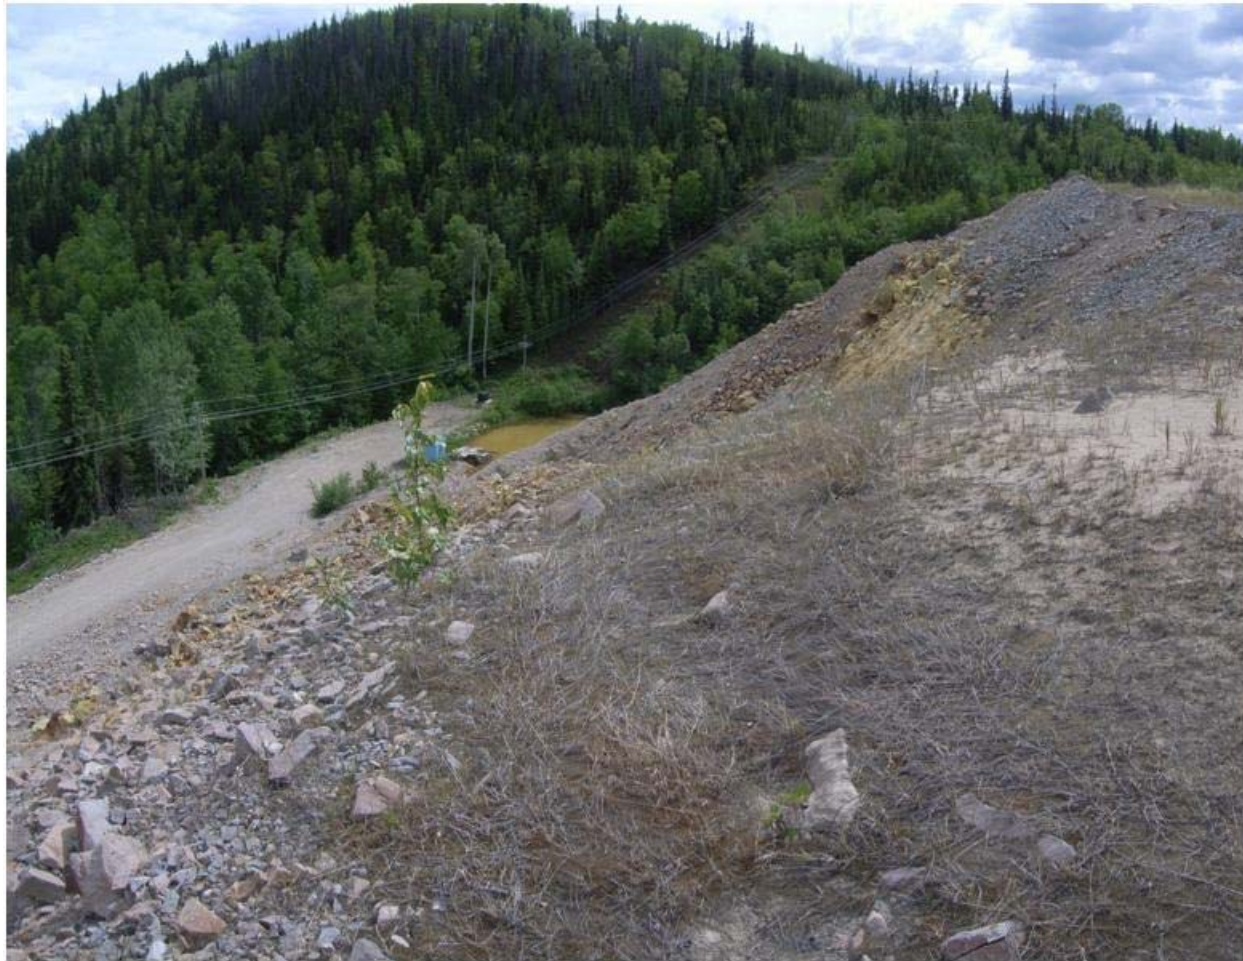
Photo C3-9: View of downstream slope of Dam 3, looking south. Note CP3-1 in the background. (11 June 2014)

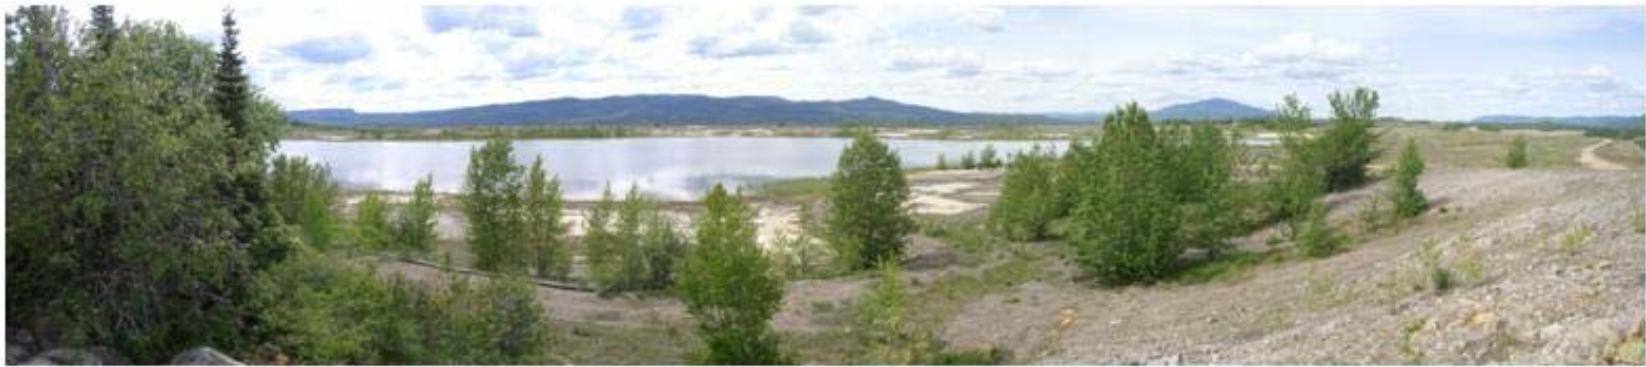
Photo C4-1: View of upstream beach and pond upstream of the junction between Dams 3 and 4. Looking north-west from the junction between the two dams. The road on the right is along the crest of Dam 4. (June 11, 2014)

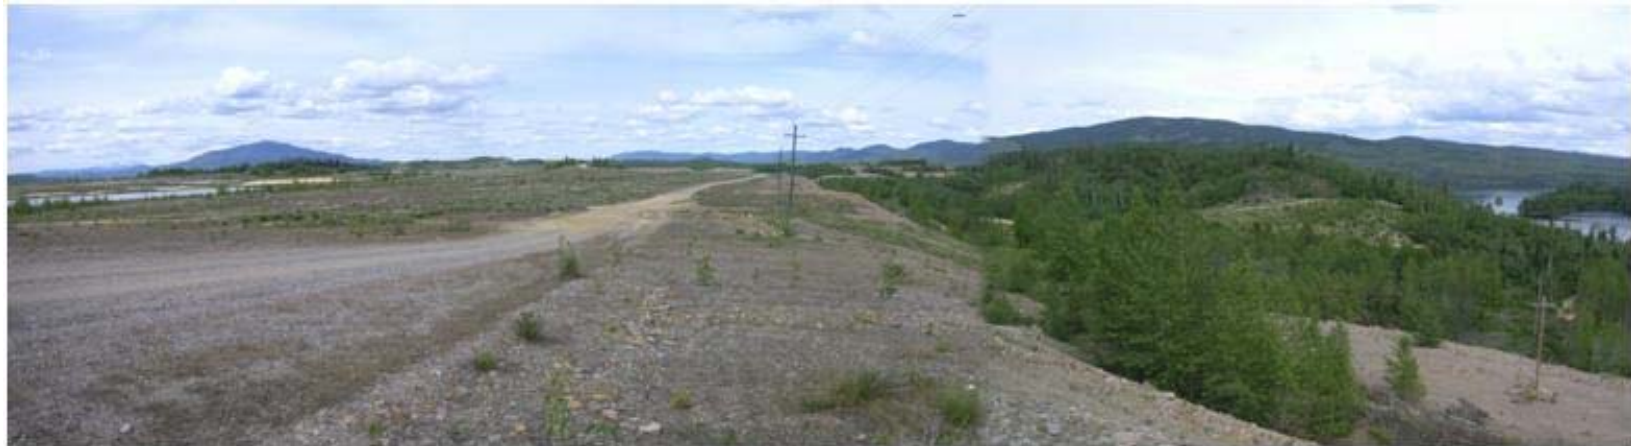
Photo C4-2: View of crest and downstream slope of Dam 4, looking north east from the south end of Dam 4. (June 11 2014)
