**Reference: Bell Mine Site
2014 Dam Safety Inspection**

BELL MINE SITE
2014 DAM SAFETY INSPECTION
FINAL REPORT

November 2014

AMEC File: TE143007

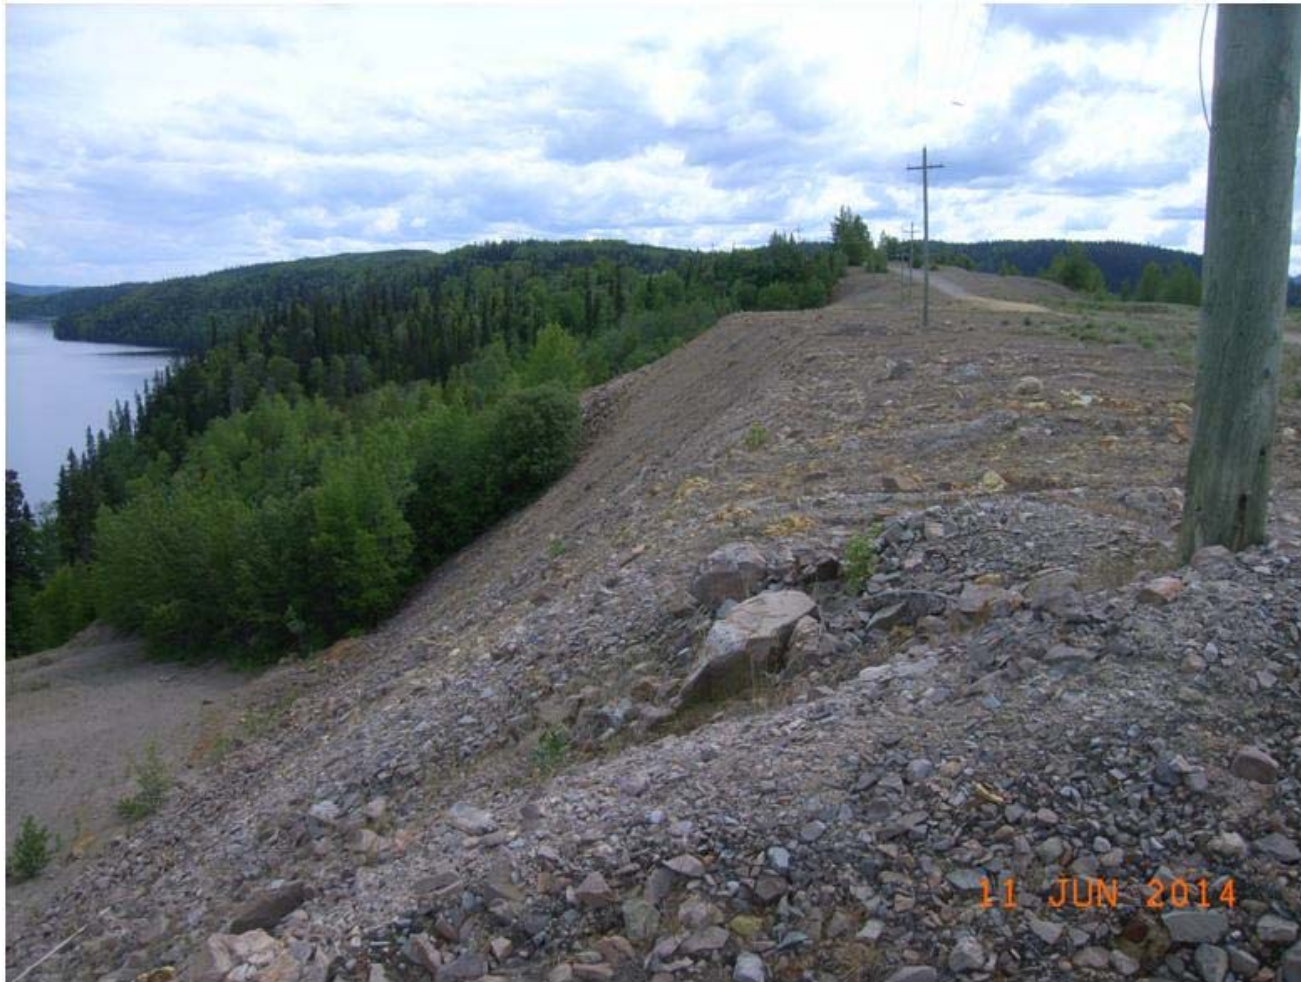
Photo C4-3: View of downstream slope and toe of Dam 4, looking south from the north end of the dam. (June 11, 2014)

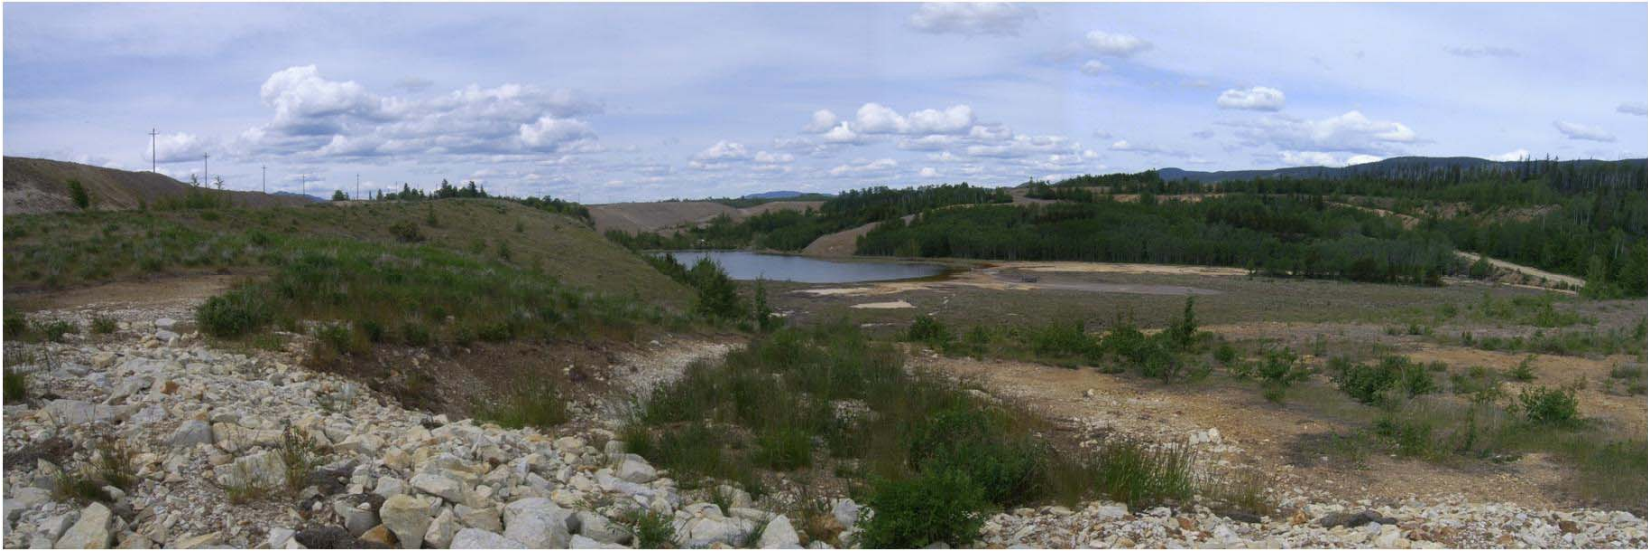
Photo C5-1: View of downstream slope and toe of Dam 5, looking northeast from the downstream slope of Dam 5. Note tailings beyond the toe of Dam 5 as part of Tailings Pond Expansion area. (11 June 2014)

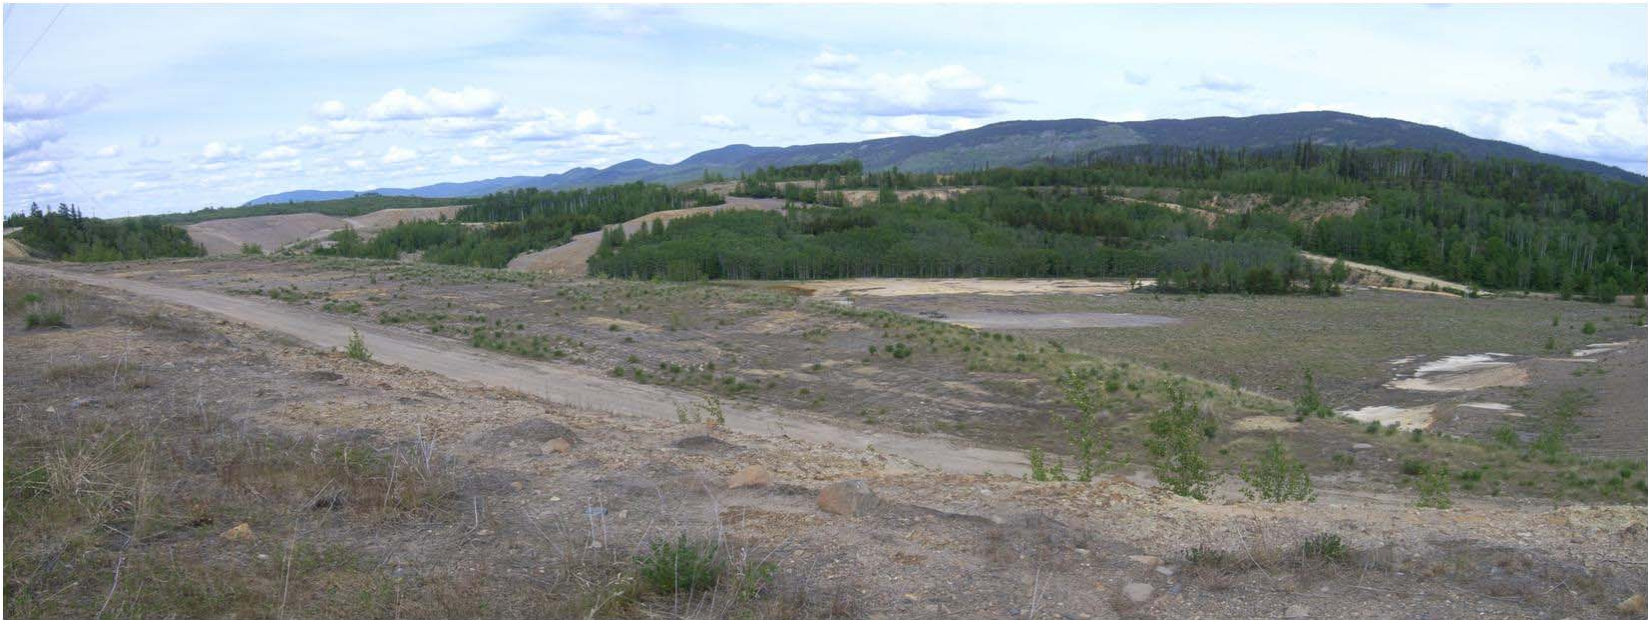
Photo C5-2: View of downstream slope and toe of Dam 5, looking north from the downstream slope of Dam 5. Note that the beach shown in the photo (on the right side) is just upstream of Dam 7. (11 June 2014)

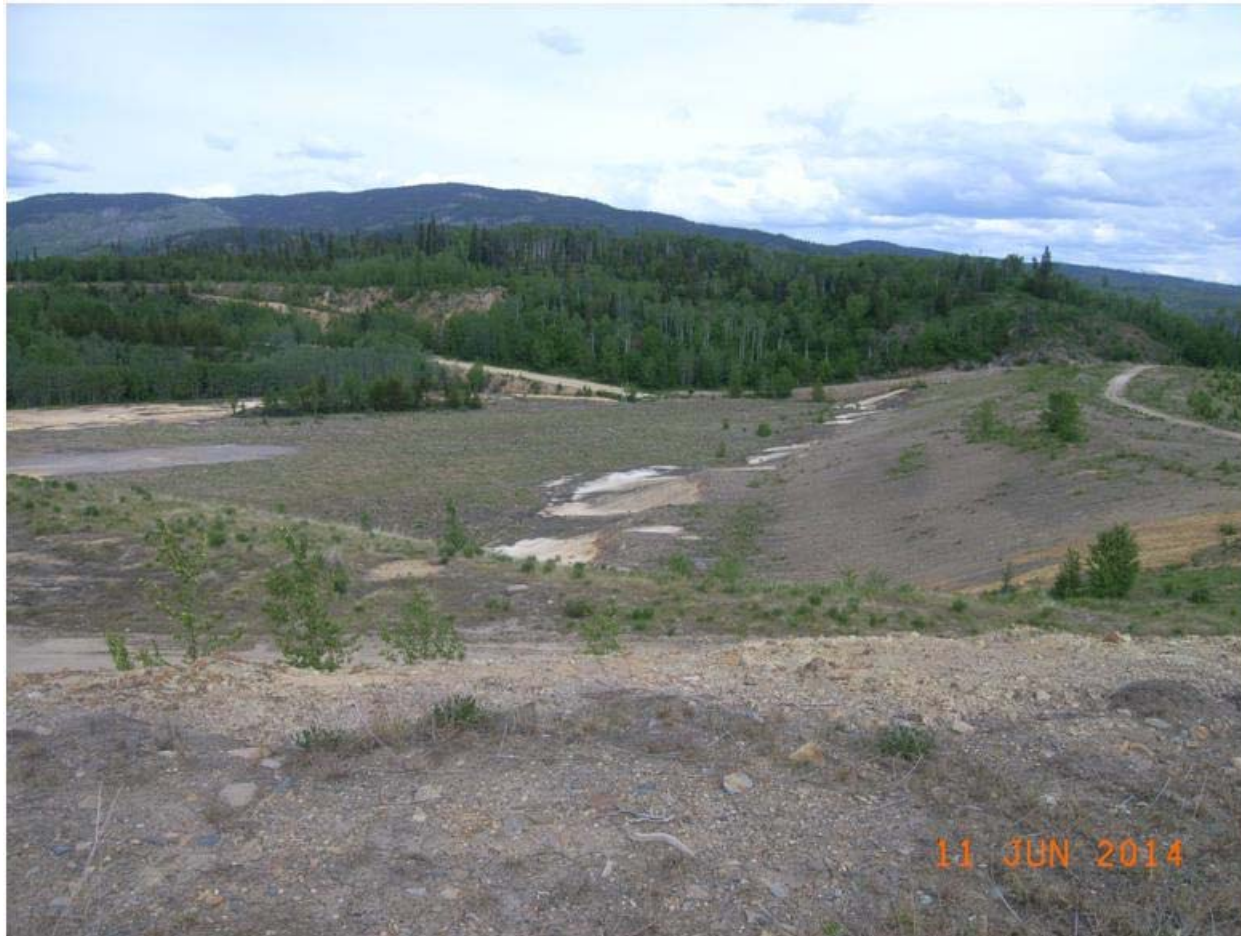
Photo C7-1: View of upstream beach and crest of Dam 7, looking east from Dam 5. The crest of Dam 7 is on the right. (11 June 2014)

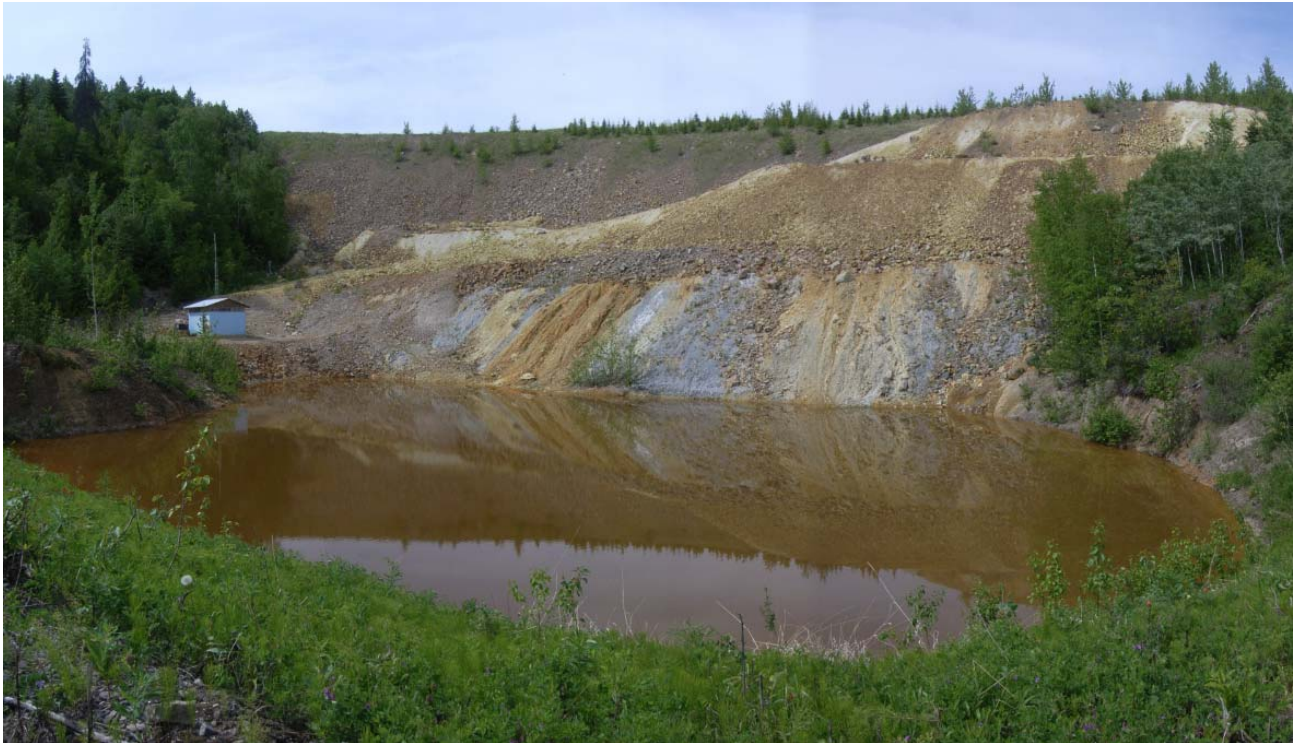
Photo C7-3: View of downstream slope of Dam 7, on the left side of Overview of Collection Pond CP7-1, looking north from south end of the CP7-1 pond. (11 June 2014)

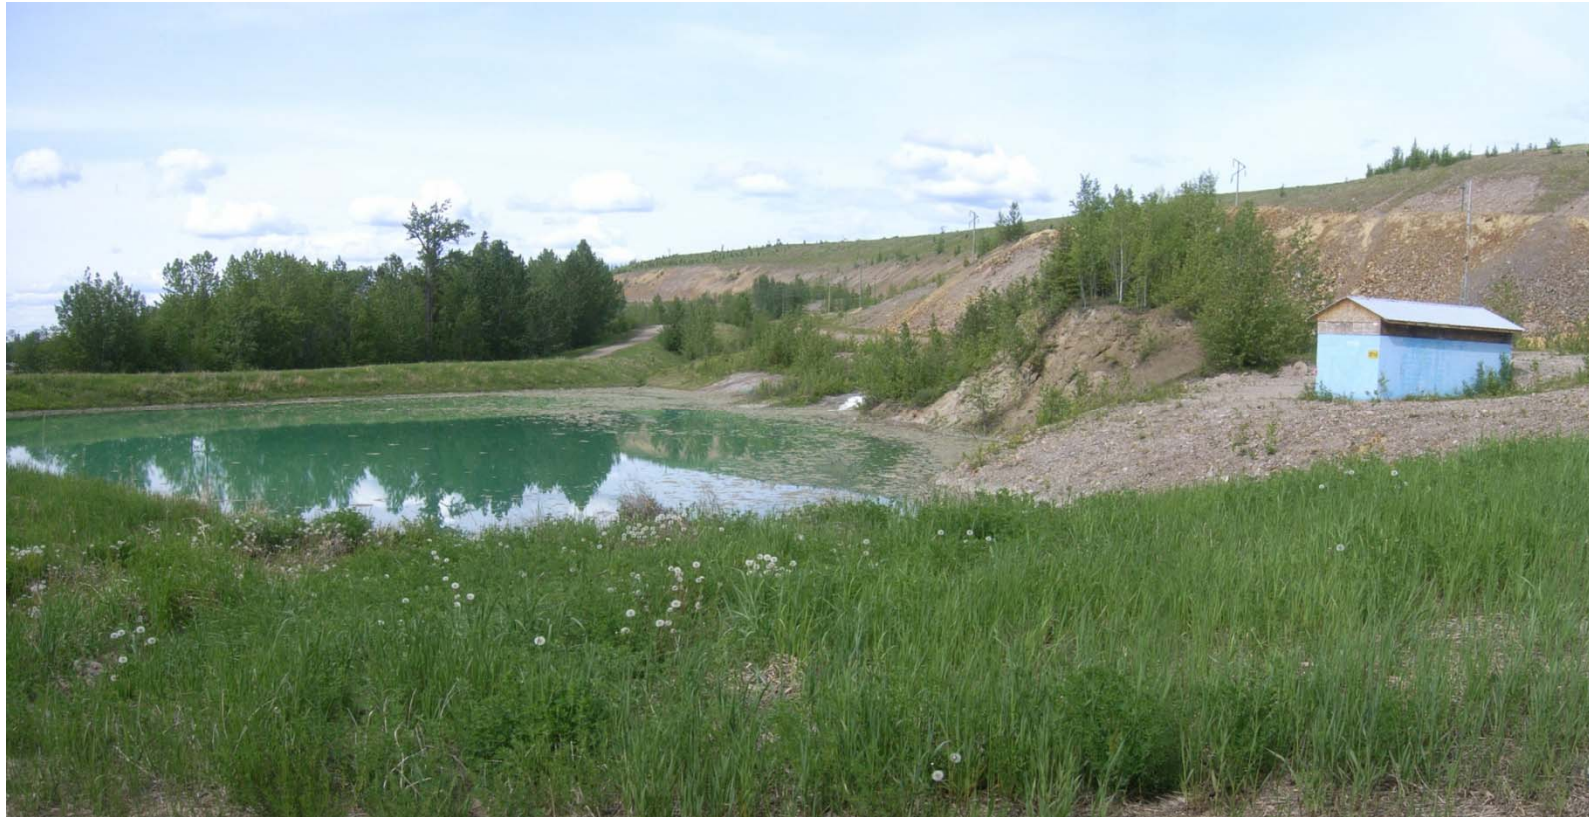
Photo D1-1: Overview of Collection Pond CP1-3, looking north from south dam segment. (11 June 2014)

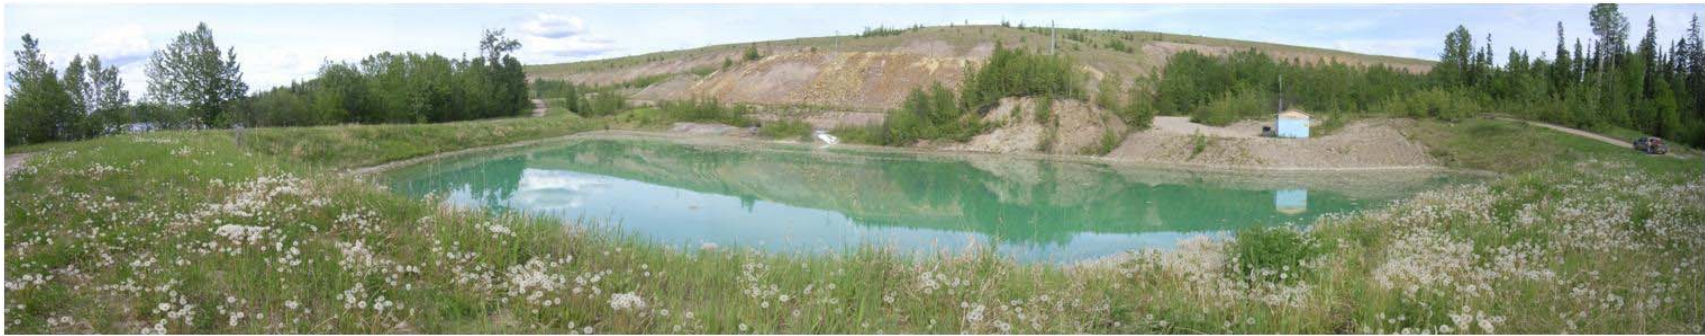
Photo D1-2: Overview of Collection Pond CP1-3, looking north and east from south west corner of the pond (11 June 2014)

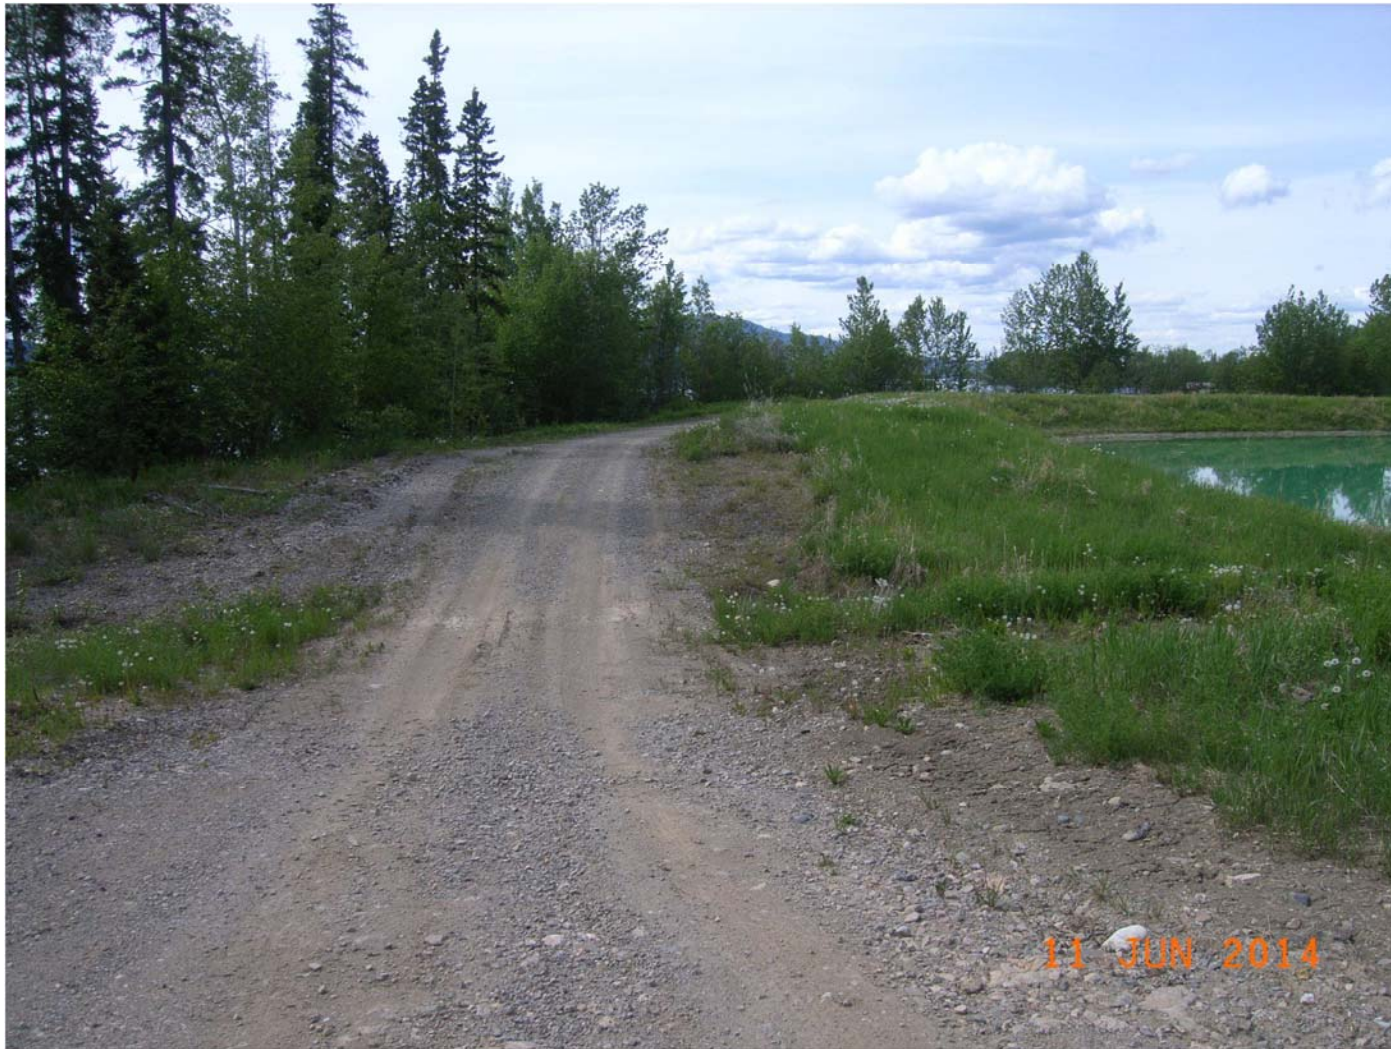
Photo D1-3: View of CP1-3 crest, looking north from south end of the crest. (11 June 2014)

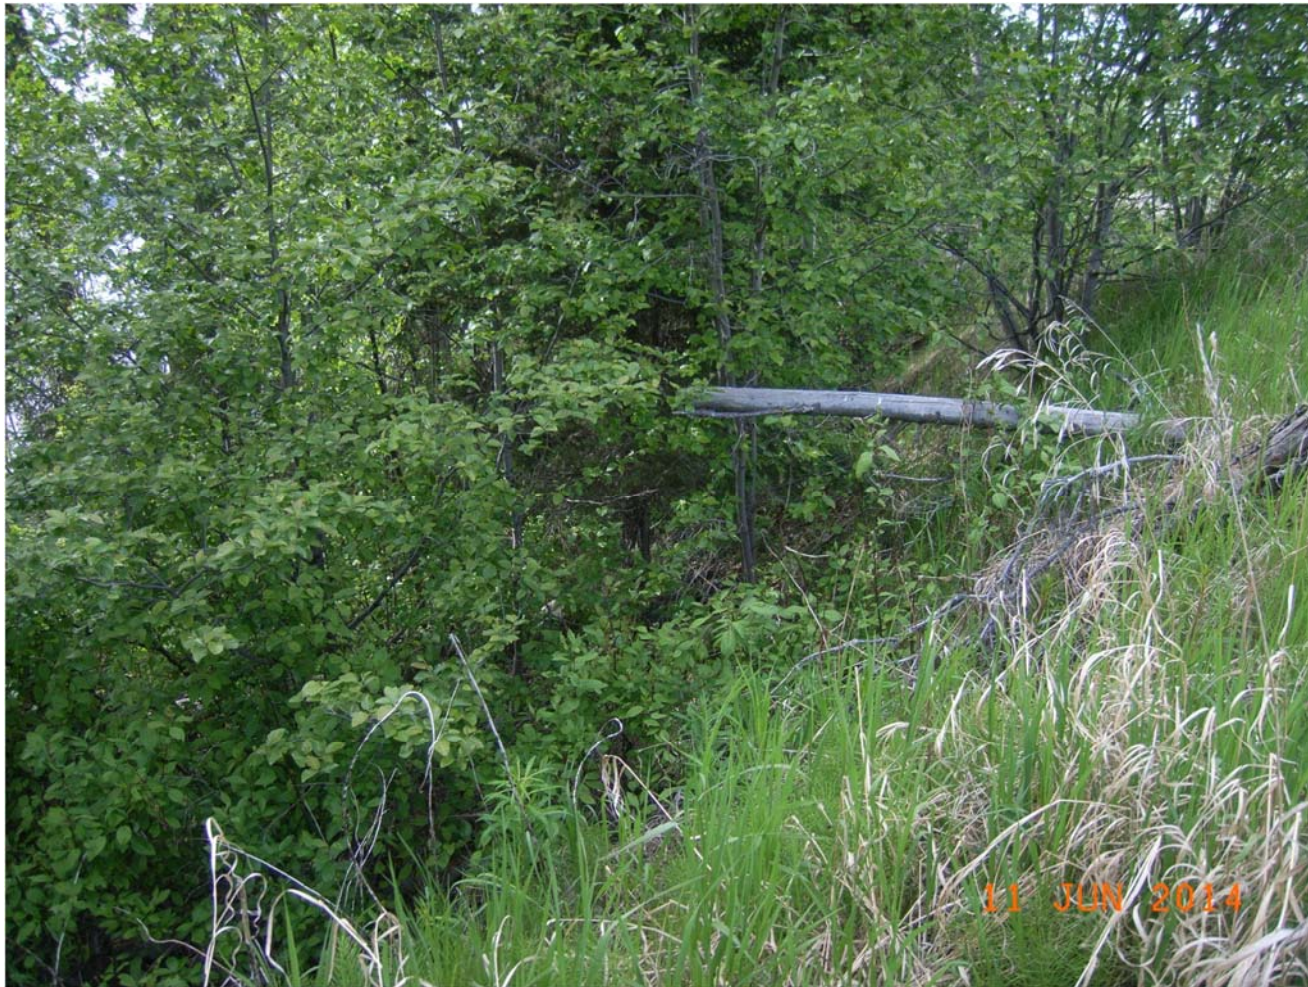
Photo D1-4: Close up view of CP1-3 downstream slope, looking north from south portion of the western segment of the dam.
Note the downstream slope is heavily vegetated. (11 June 2014)

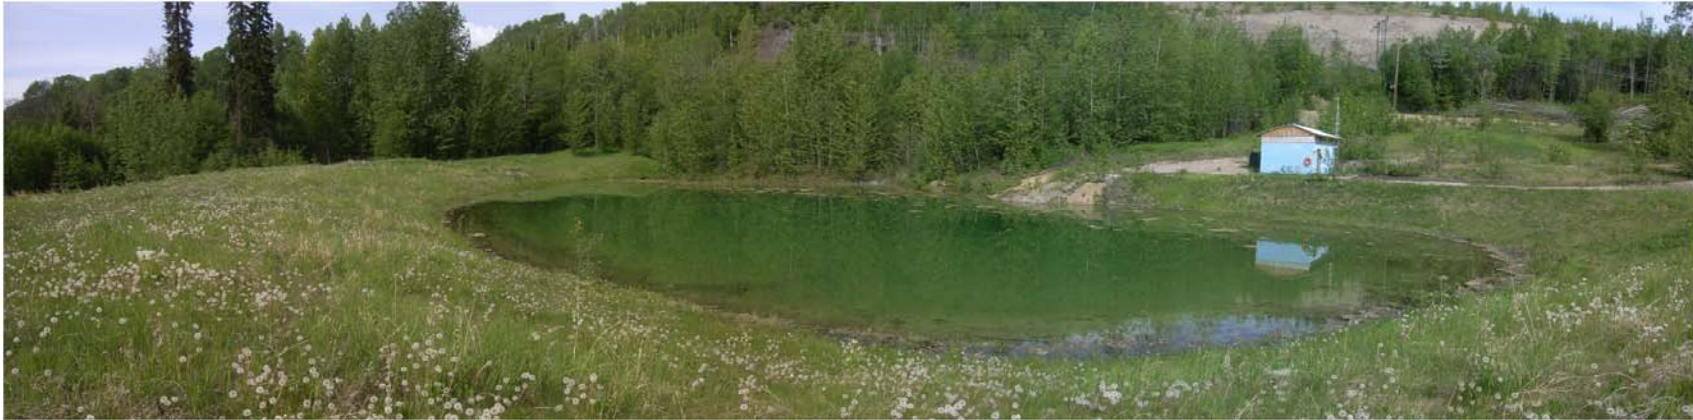
Photo D2-1: Overview of Collection Pond CP1-5 and upstream slope, looking east from west side of pond. (11 June 2014)

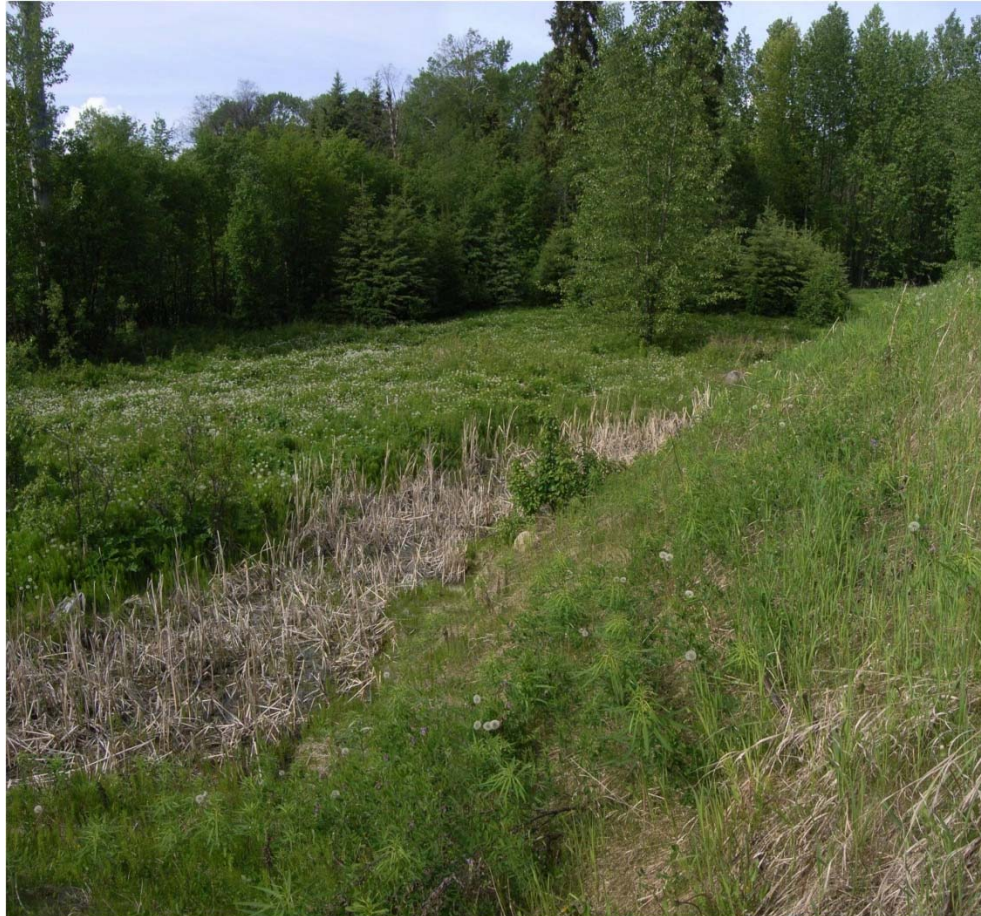
Photo D2-6: View of downstream slope and toe of CP1-5, north from crest of west segment. Note there are no signs of adverse seepage. (11 June 2014)

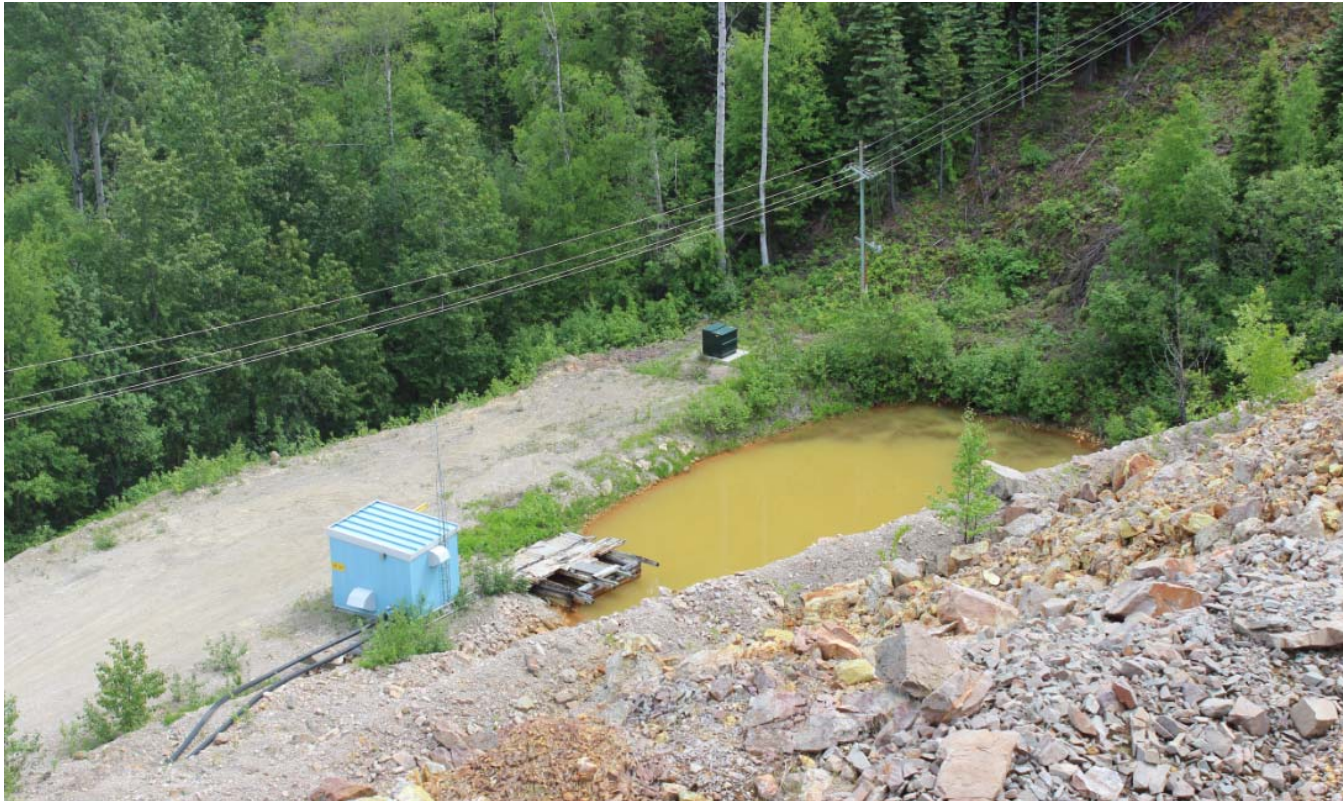
Photo D3-1: View of CP3-1 from crest of Dam 3, looking southeast. (11 June 2014)

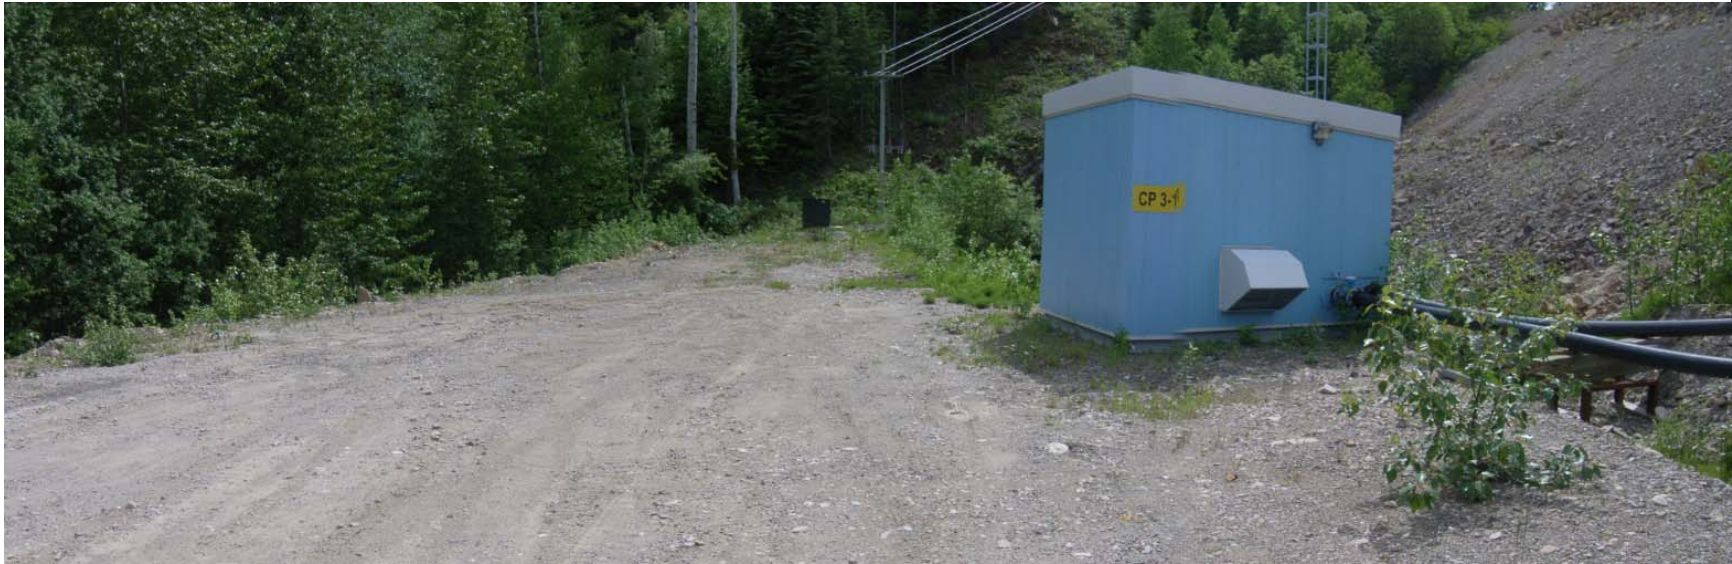
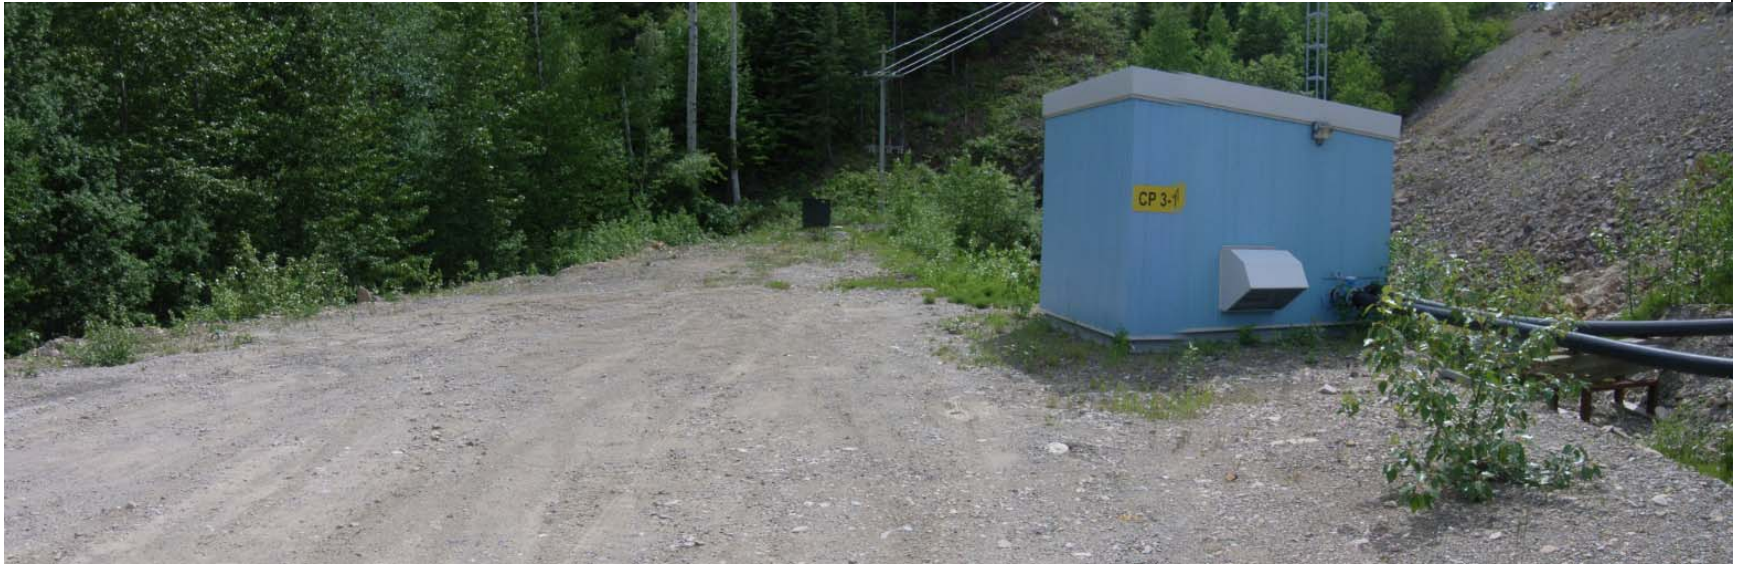
Photo D3-2: View of CP3-1 pumphouse looking south, the pond is behind the pumphouse, the crest of the dam is left of the pumphouse, and the toe of Dam 3 is located to the right. (11 June 2014)

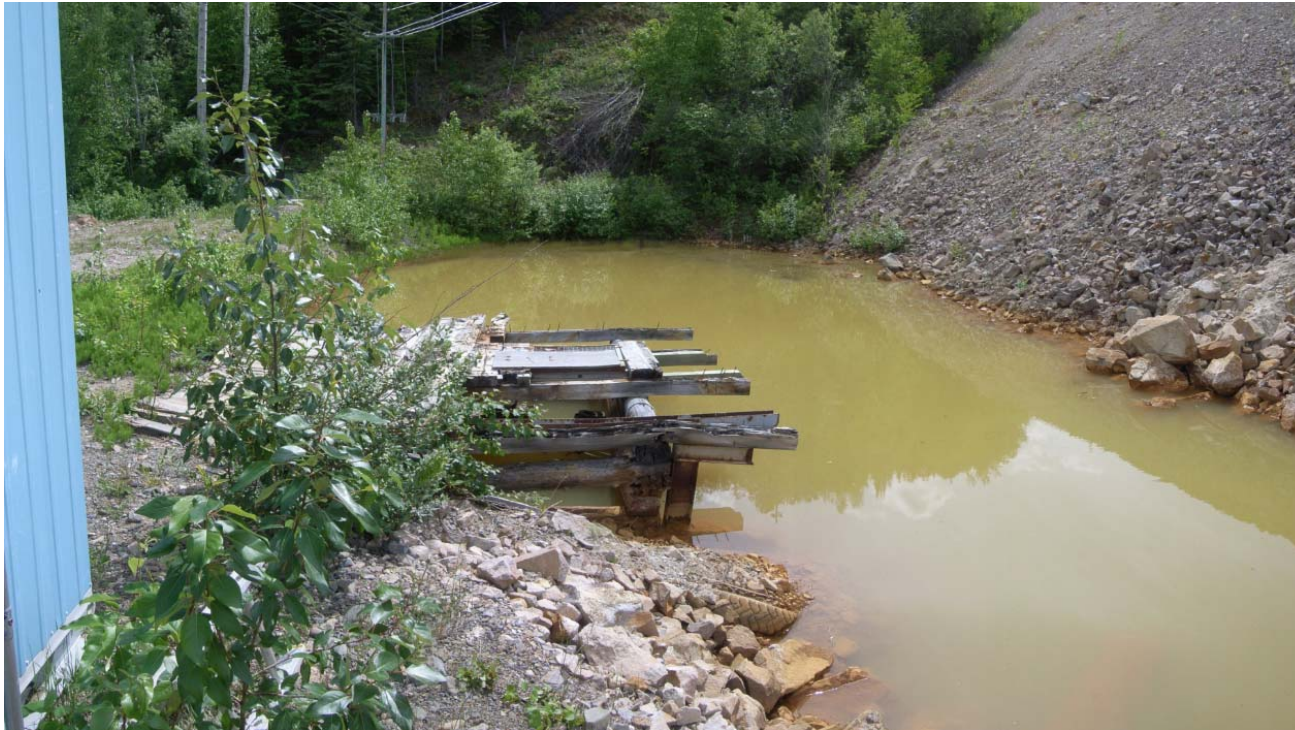
Photo D3-3: The wooden frame is around pipes that discharge water to the environment when the water is high enough to flow through them. . (11 June 2014)

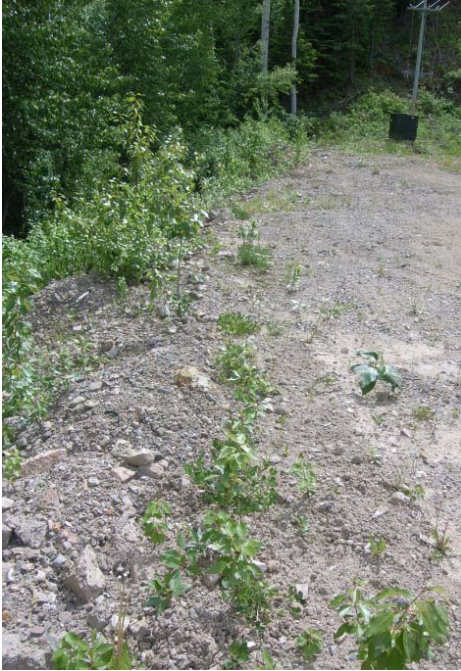
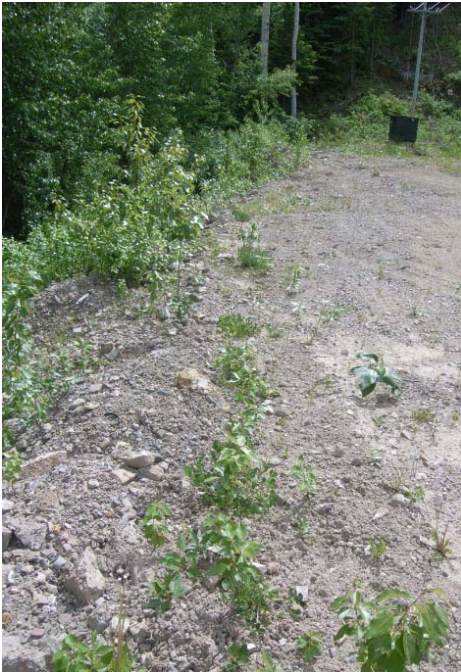
Photo D3-4: Crest of dam looking south toward abutment.
(11 June 2014)

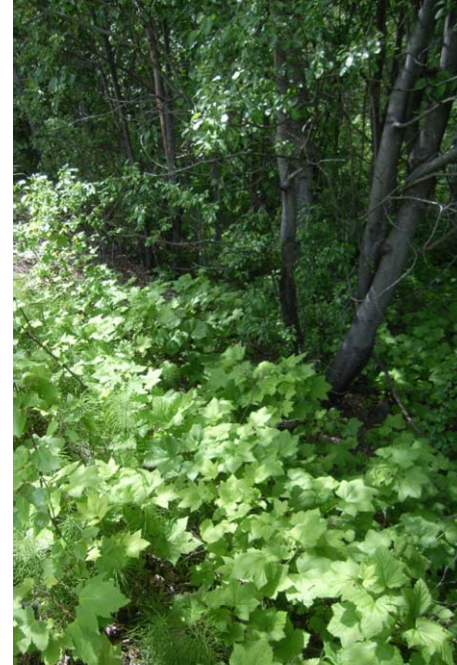
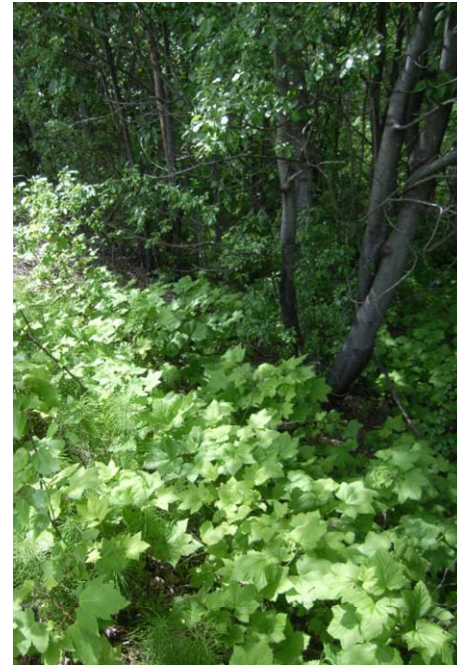
Photo D3-5: Downstream slope and toe, heavily vegetated.
(11 June 2014)

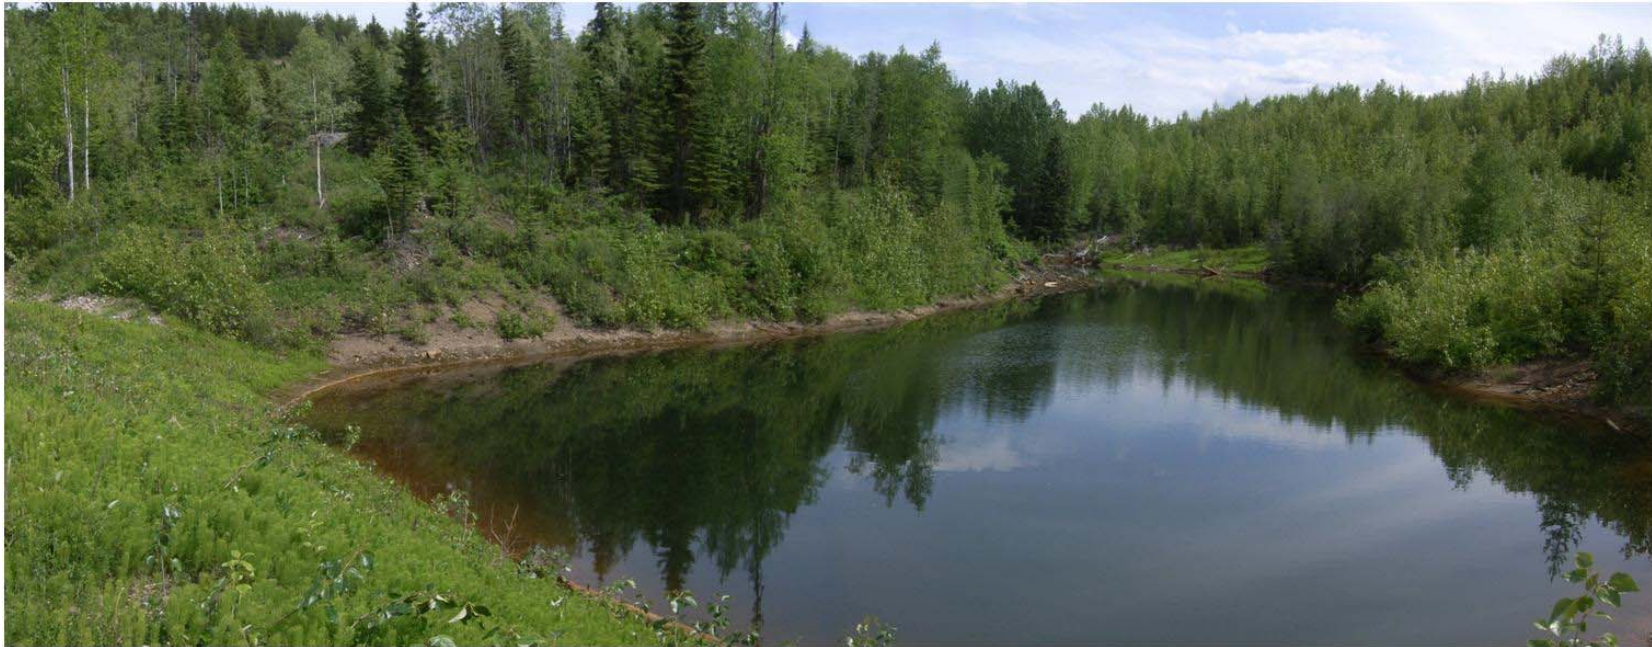
Photo D4-1: Overview of Collection Pond CP4 and upstream slope of dam on the left, looking northeast from west segment of the dam. (11 June 2014)

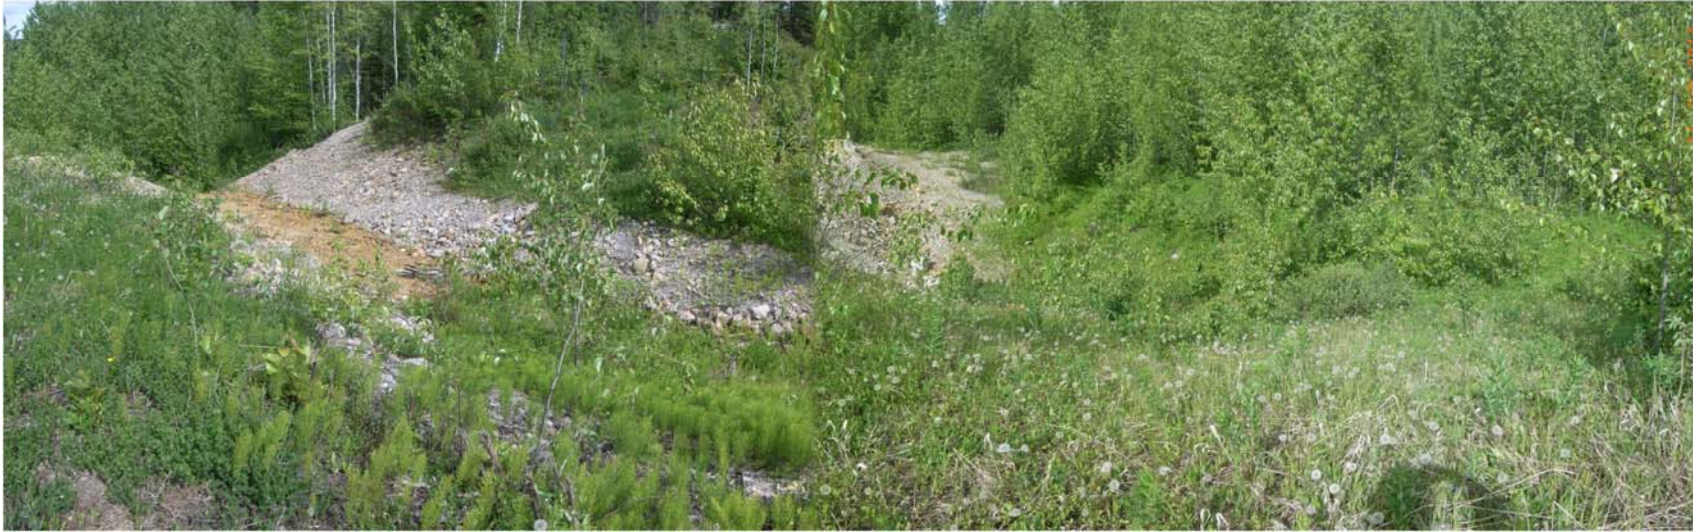
Photo D4-2: View of spillway at north end of CP4's dam, north-east from crest. (11 June 2014)

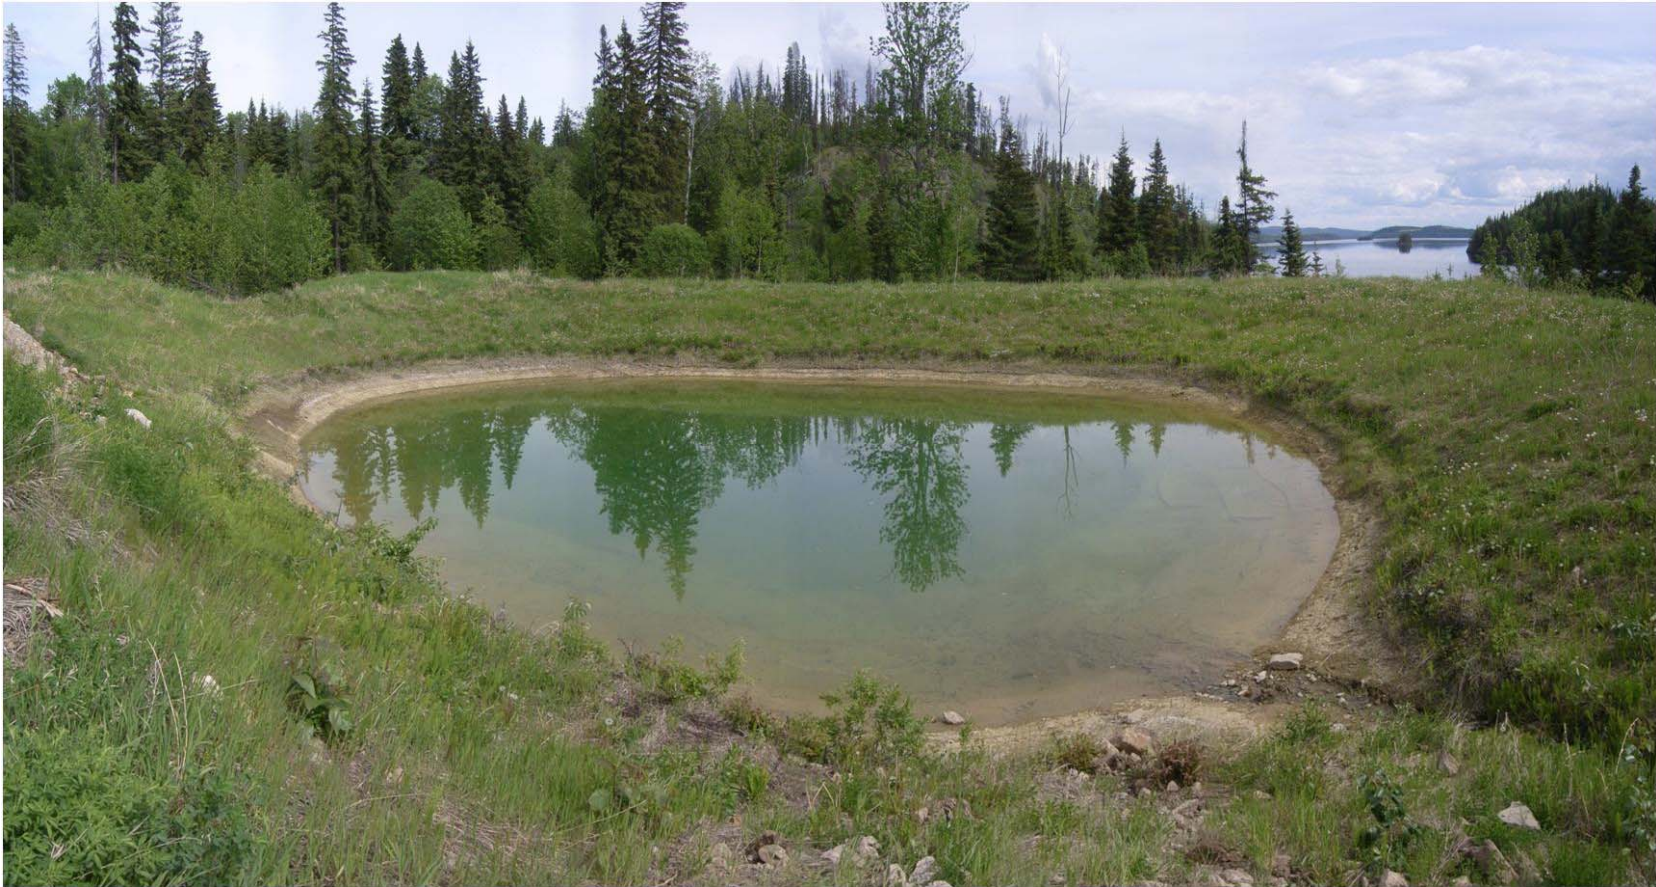
Photo D5-1: Overview of Collection Pond CP5, looking south-east from west side of pond. (11 June 2014)

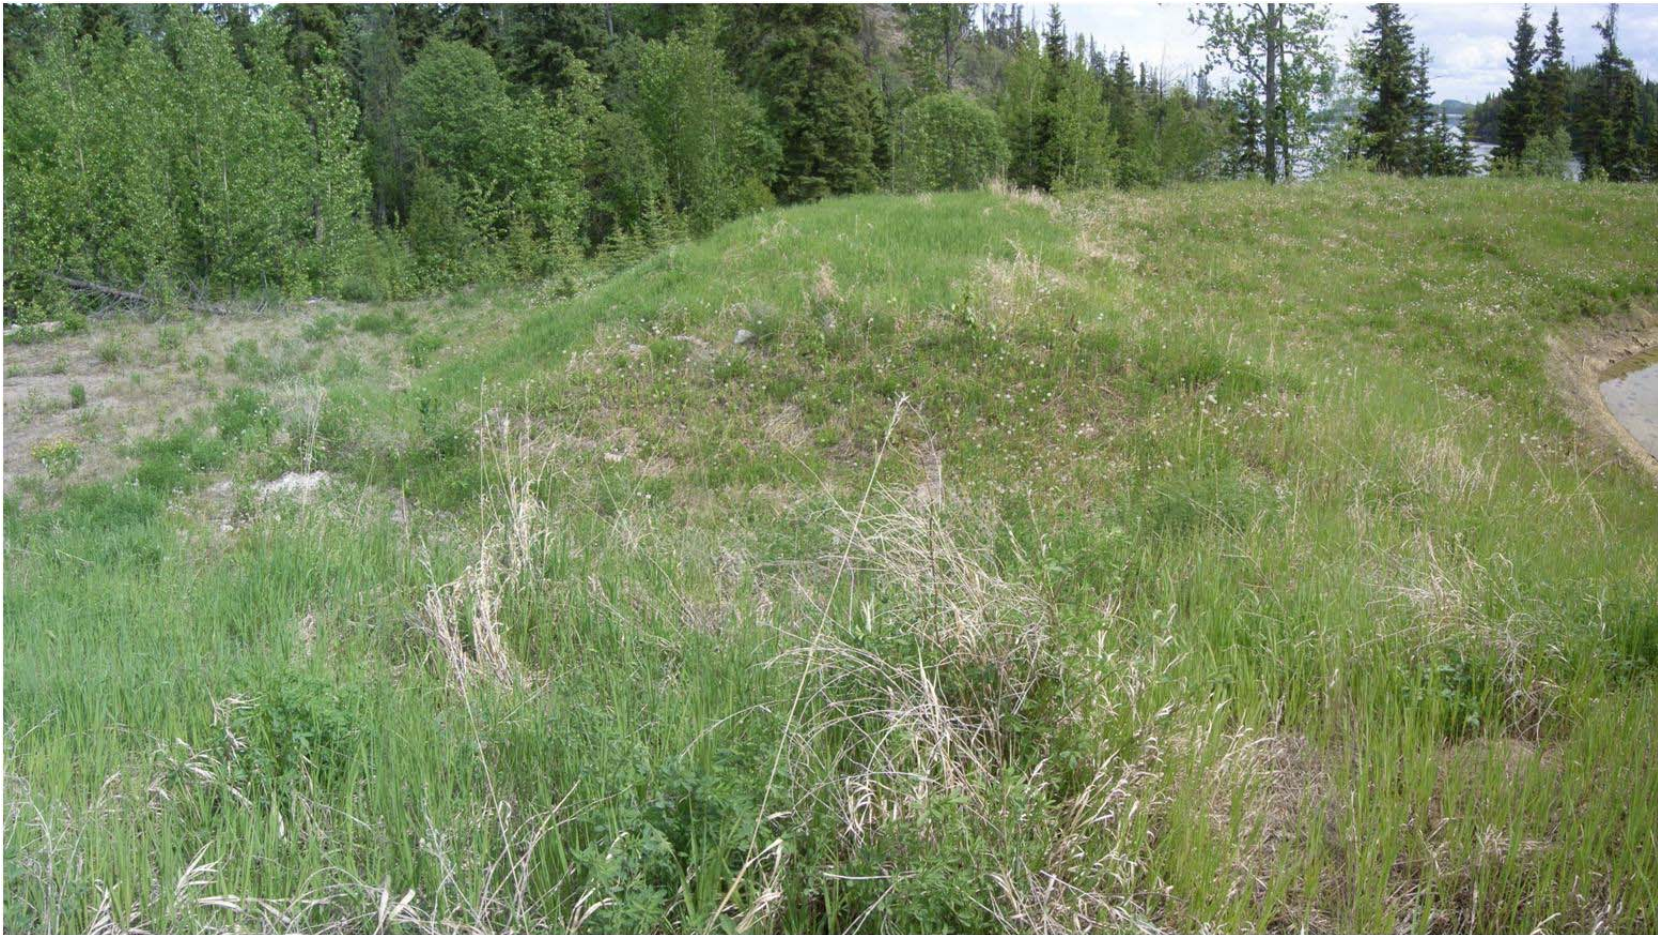
Photo D5-2: View of crest and downstream slope of CP5 Dam, south-east from east side of pond. (11 June 2014)
