**Reference: Bell Mine Site
2014 Dam Safety Inspection**

BELL MINE SITE
2014 DAM SAFETY INSPECTION
FINAL REPORT

November 2014

AMEC File: TE143007

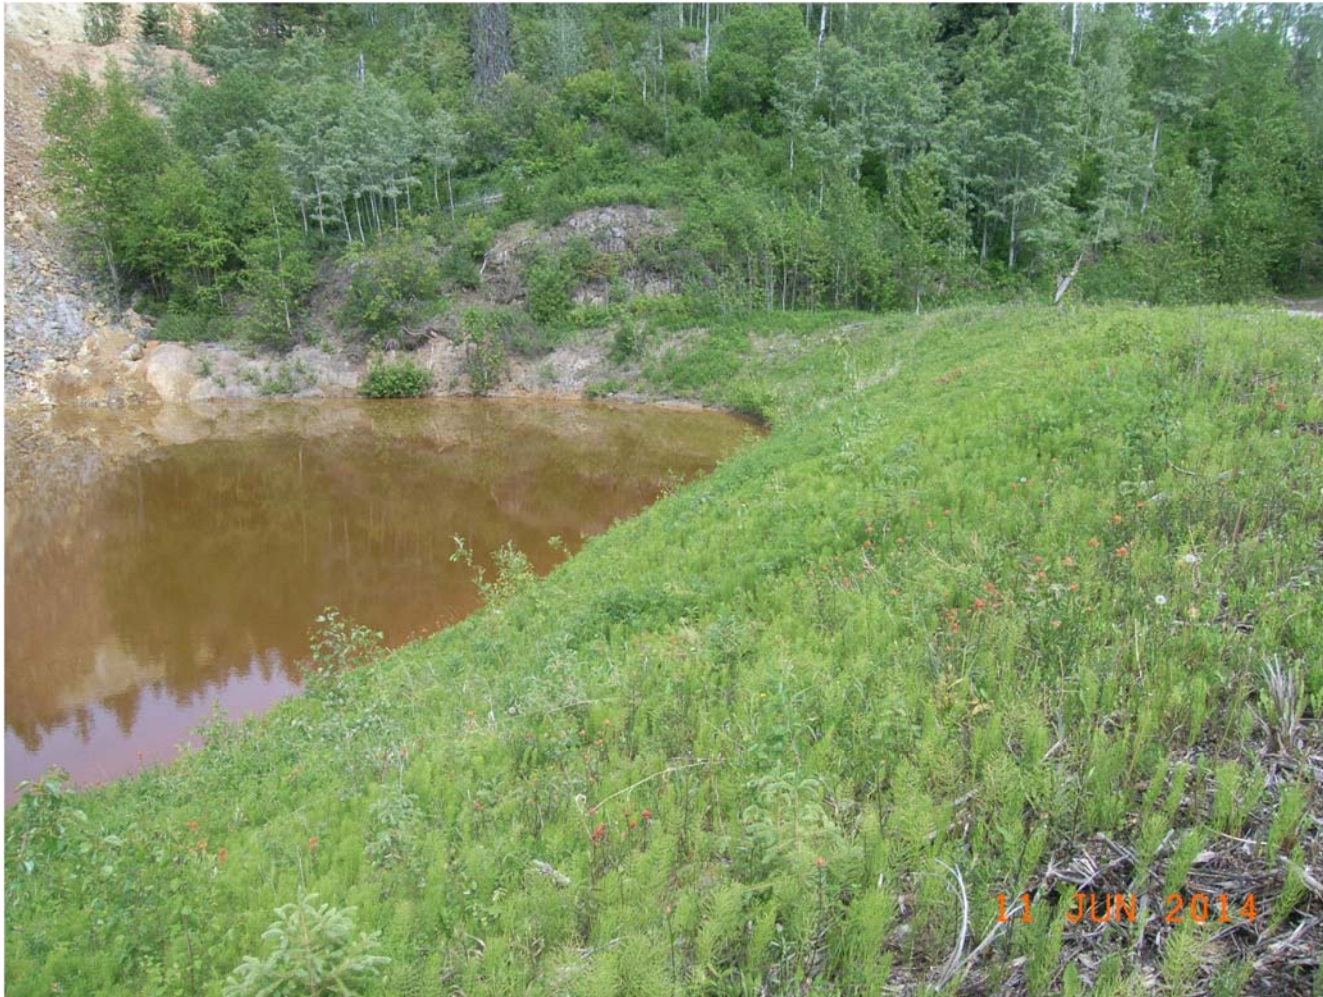
Photo D6-2: View of upstream slope of CP7-1 Dam, looking east from right end of the south dam. (11 June 2014)

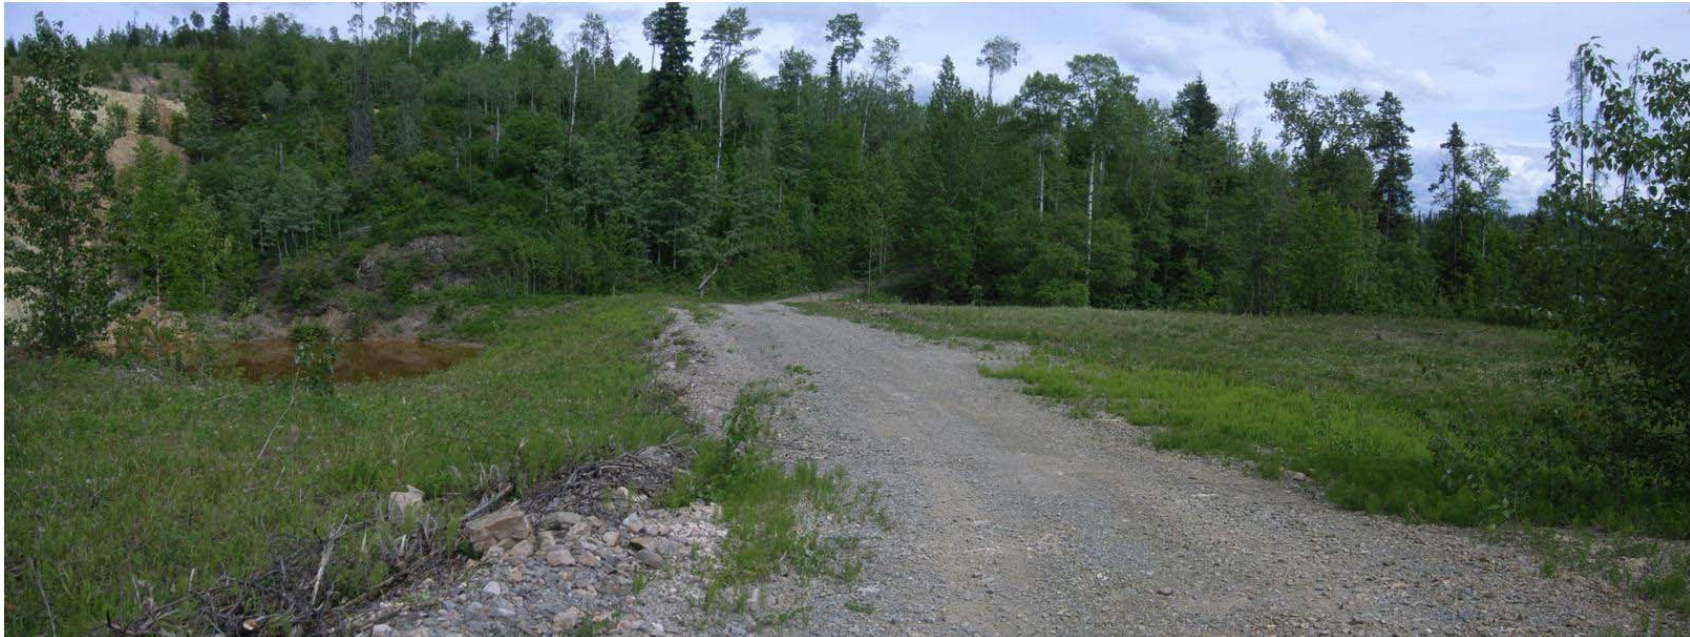
Photo D6-3: View of crest of CP7-1 Dam, showing pond on the left and downstream slope on the right. Looking east from right end of the dam. (11 June 2014)

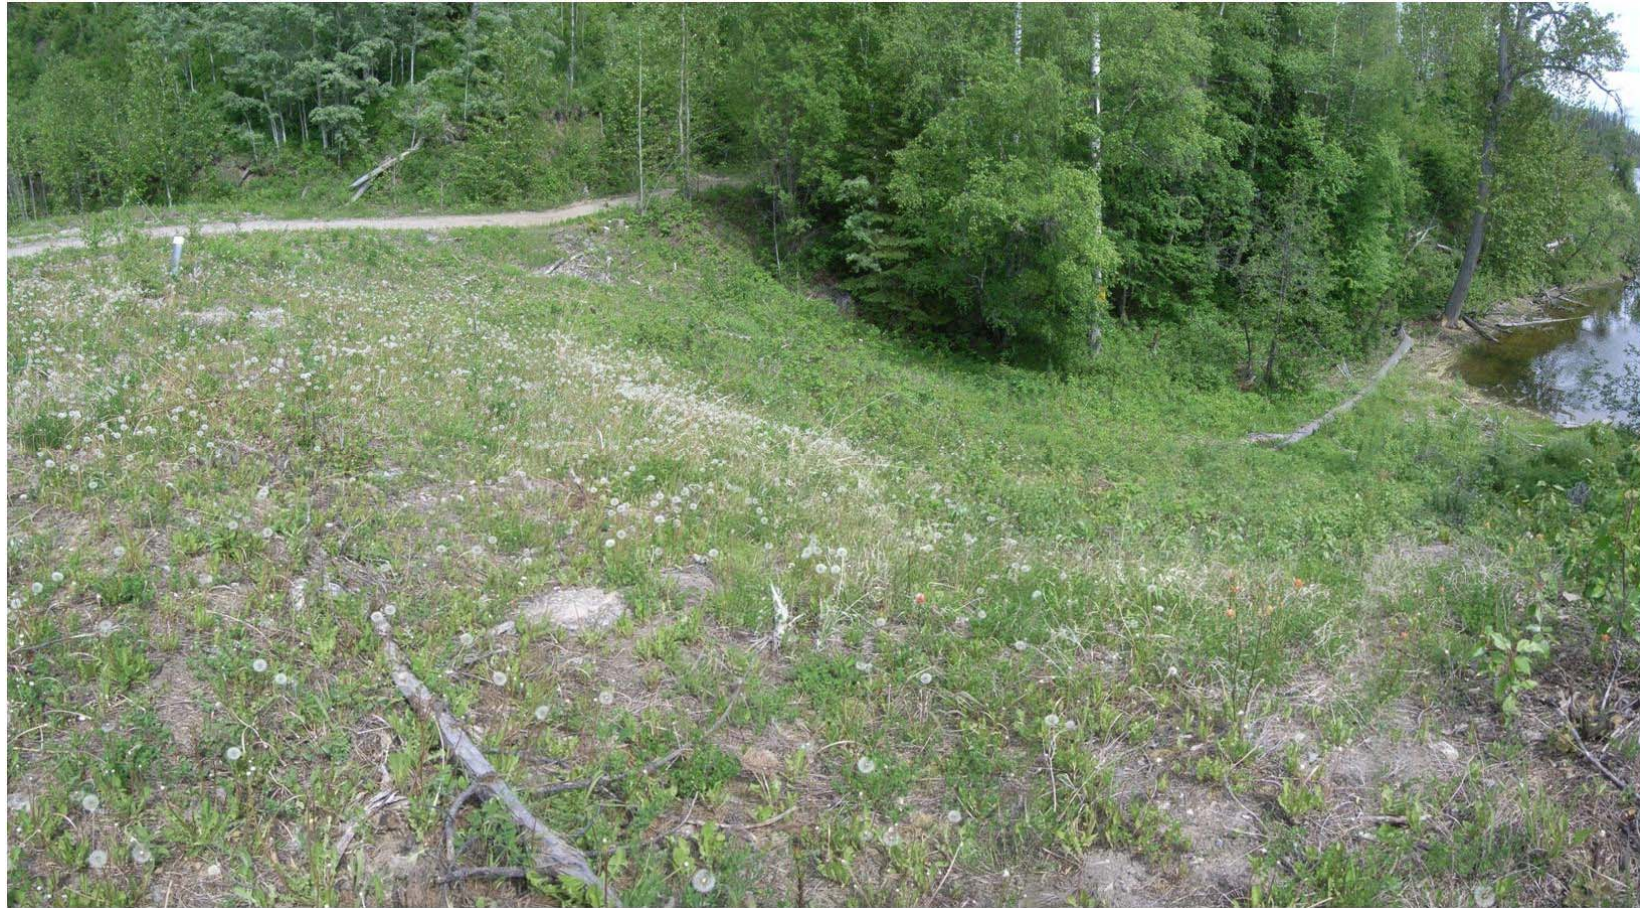
Photo D6-5: View of downstream slope and toe of CP7-1 Dam, looking south east from the crest of the dam. (11 June 2014)

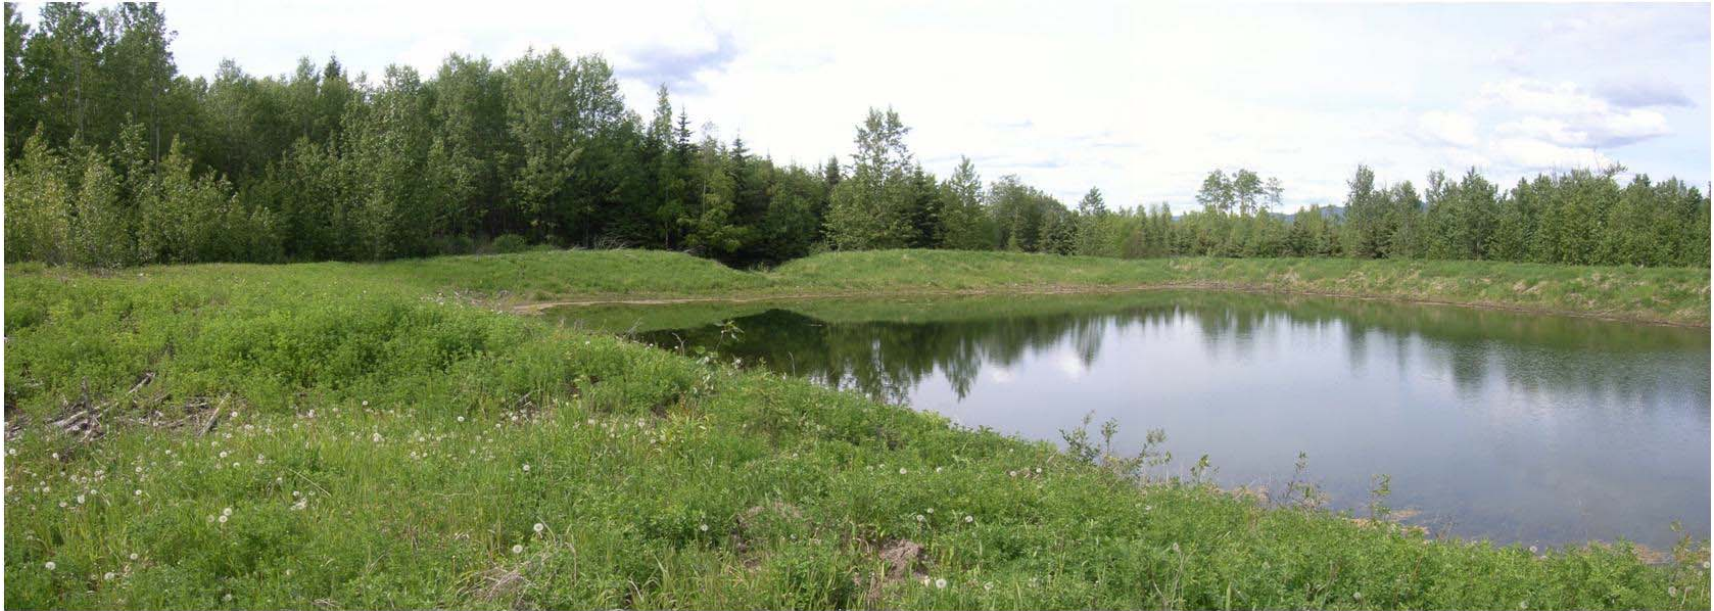
Photo D7-1: Overview of Collection Pond CP8, northeast from west side of pond. (11 June 2014)

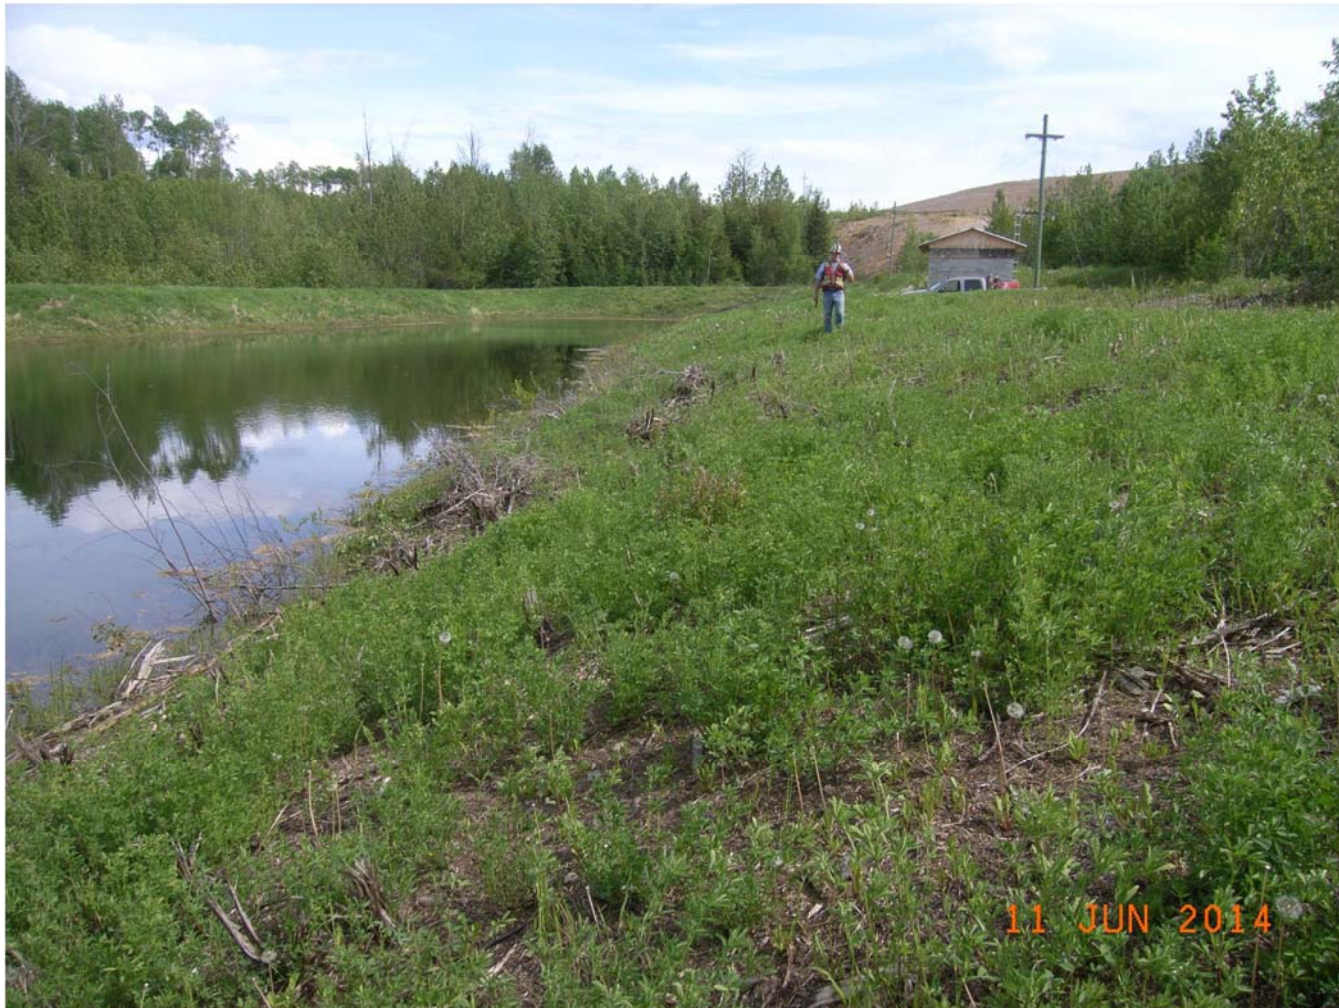
Photo D7-2: View of upstream slope of CP8 Dam, southeast from north-west corner. (11 June 2014)

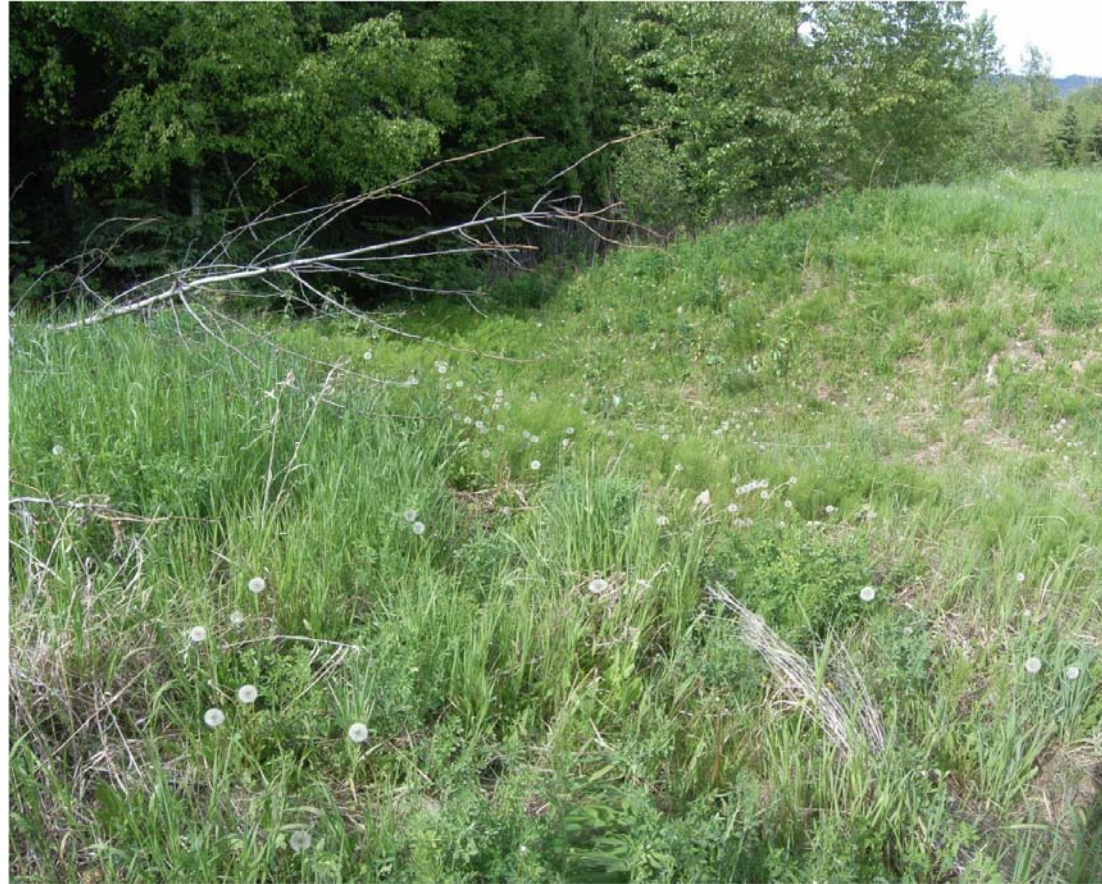
Photo D7-5: View of downstream slope of CP8 Dam, looking east from west end of north dam, note heavy vegetation (11 June 2014)

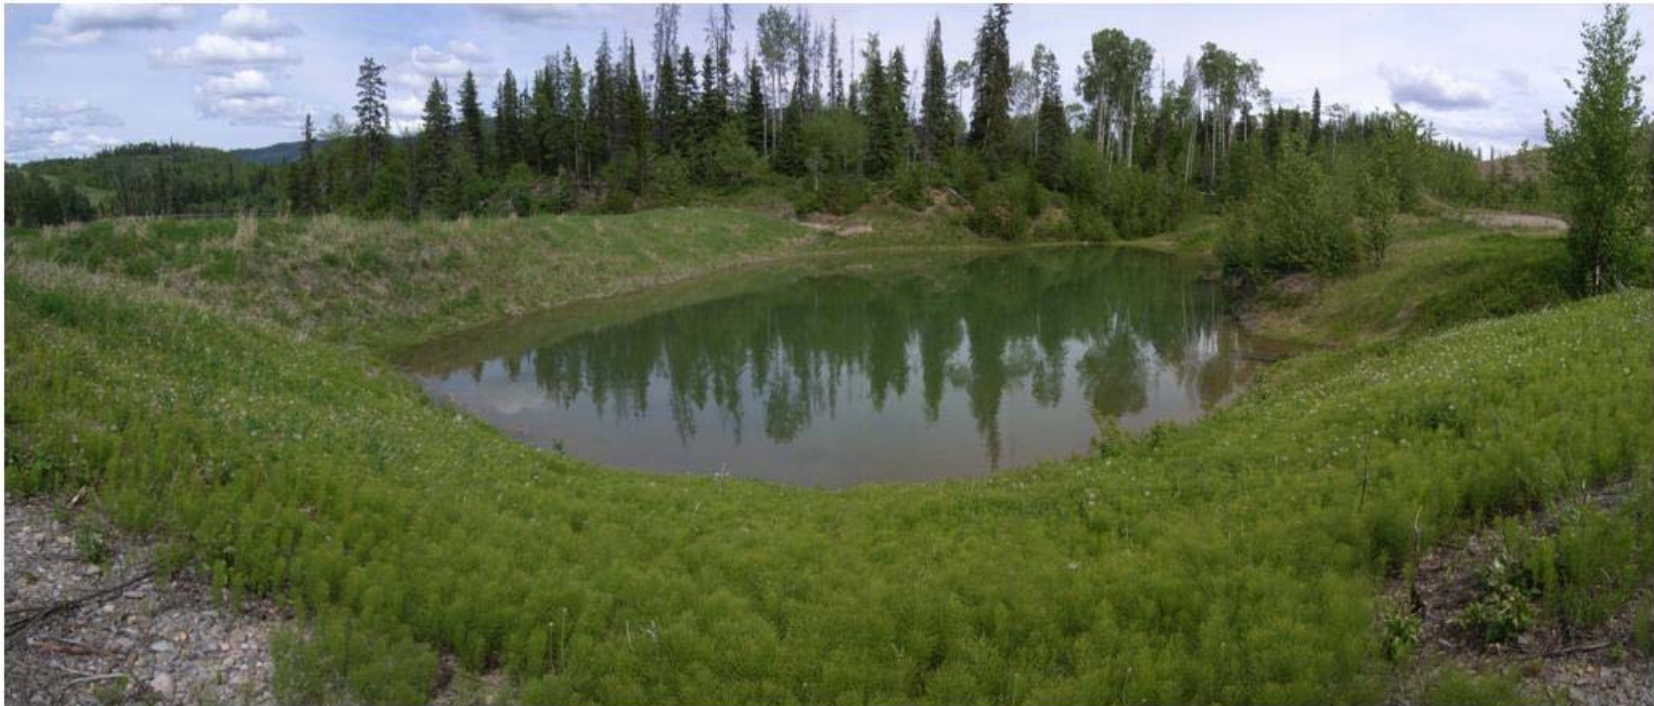
Photo D8-1: Overview of Collection Pond CPD-7, looking north from south east corner of the pond. The CPD-7 dam is located on the west side of the pond (11 June 2014)

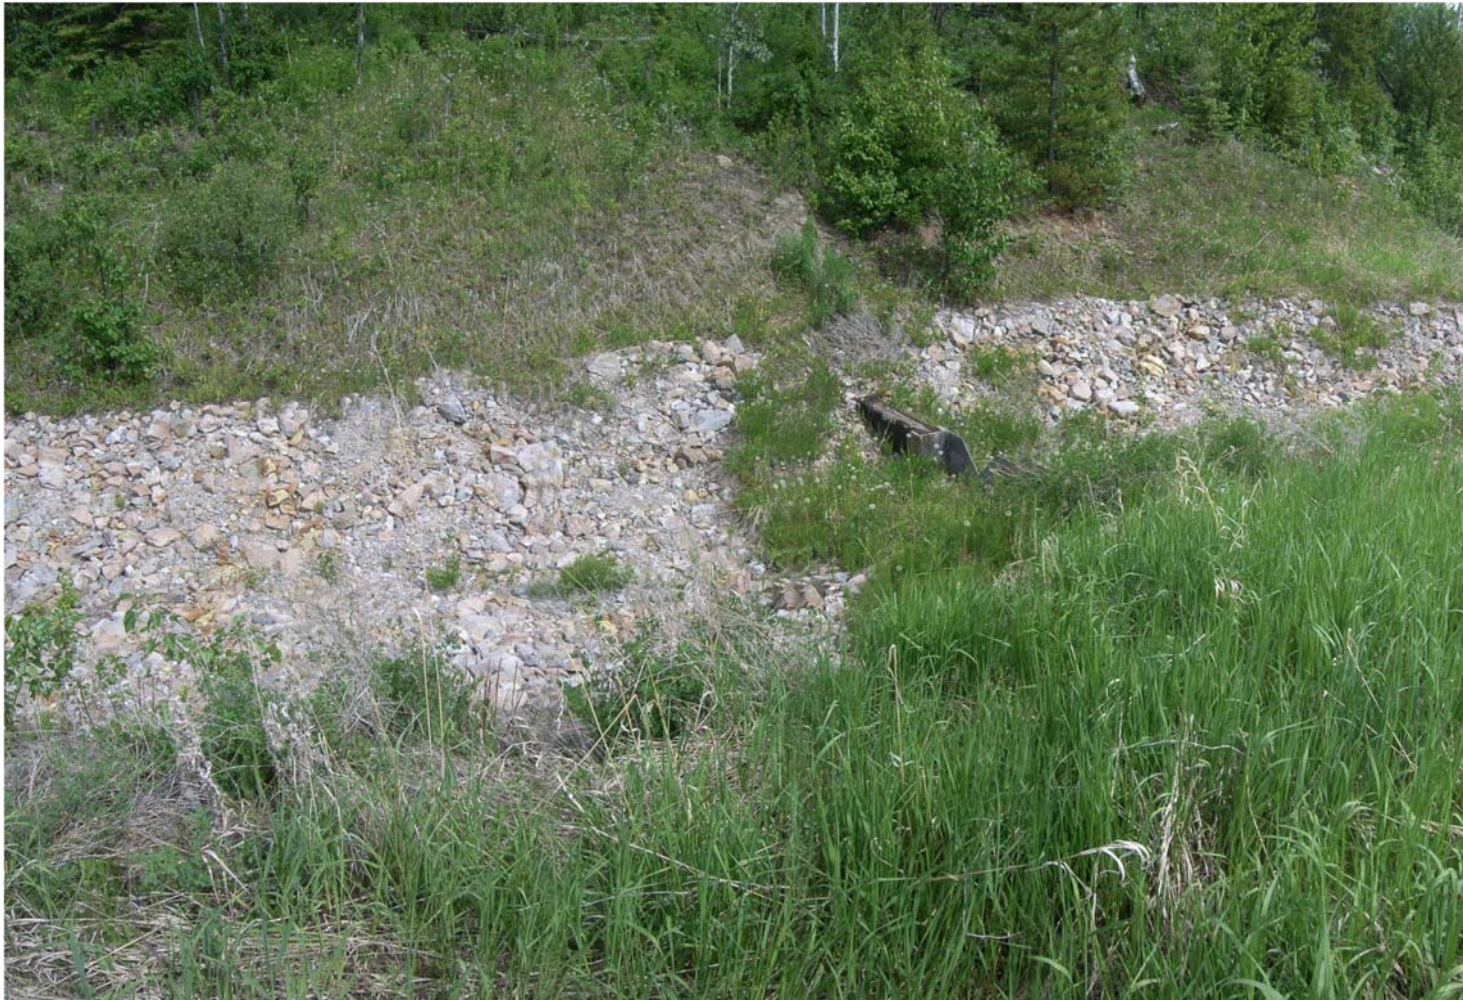
Photo D8-2: View of CPD-7 Dam spillway, located at north end of the dam, looking north. (11 June 2014)

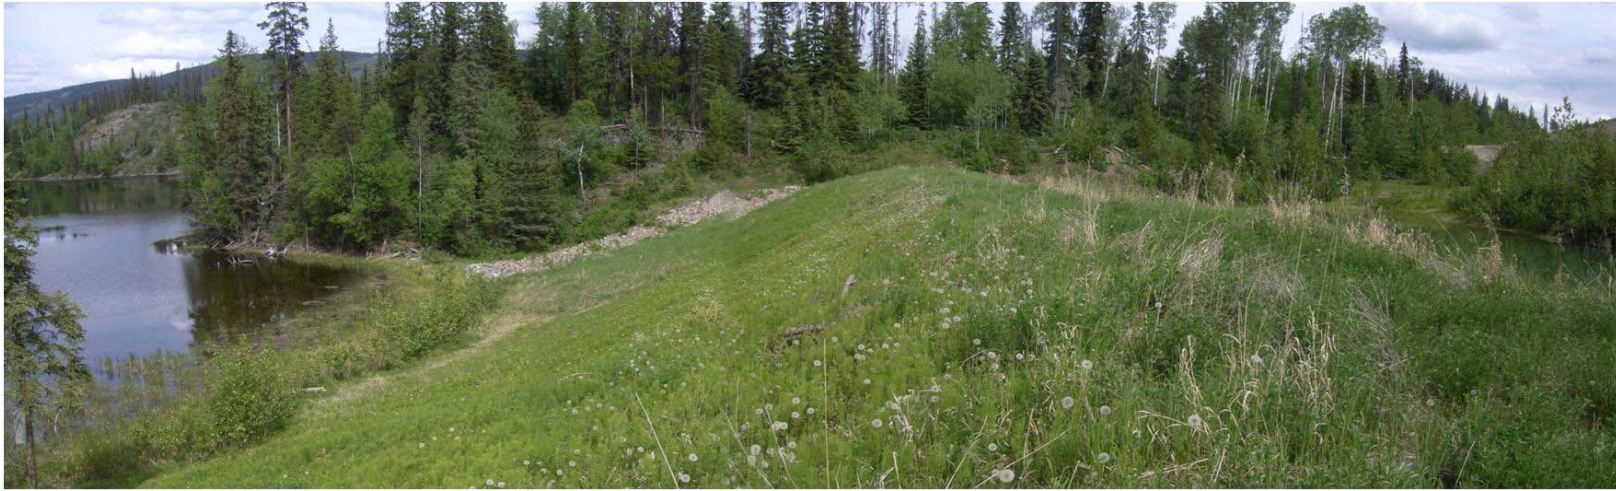
Photo D8-3: View of downstream slope of CPD-7 Dam, looking north along dam, from south (left) end. (11 June 2014)

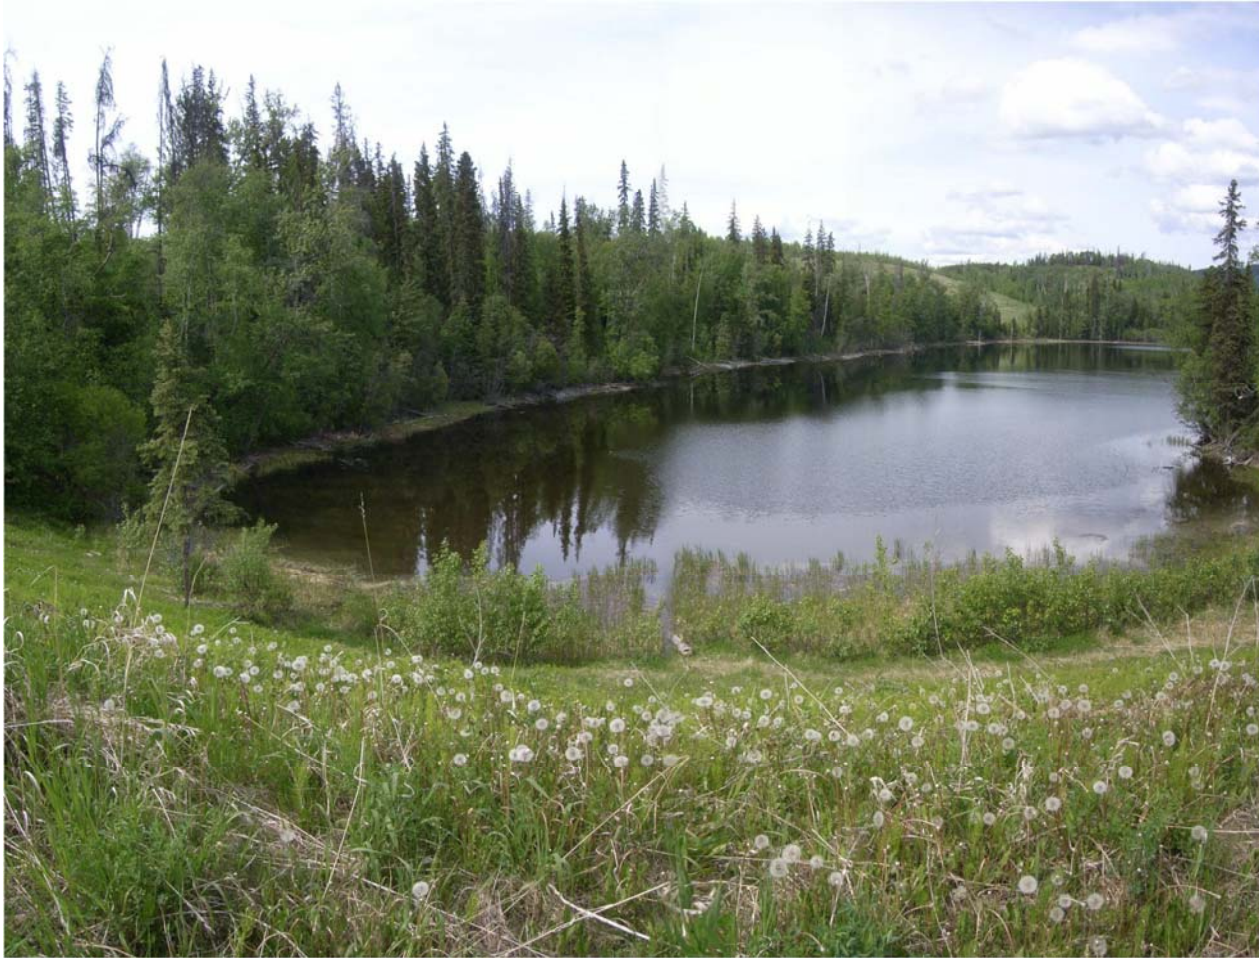
Photo D8-4: View of pond downstream of CPD-7 Dam, west from the dam, showing the downstream environment. (11 June 2014)
