# SONA RESOURCES CORPORATION BLACKDOME MINE TAILINGS STORAGE FACILITY

## REPORT ON 2014 ANNUAL INSPECTION

VA101-70/15-1  
Rev 0  
November 19, 2014

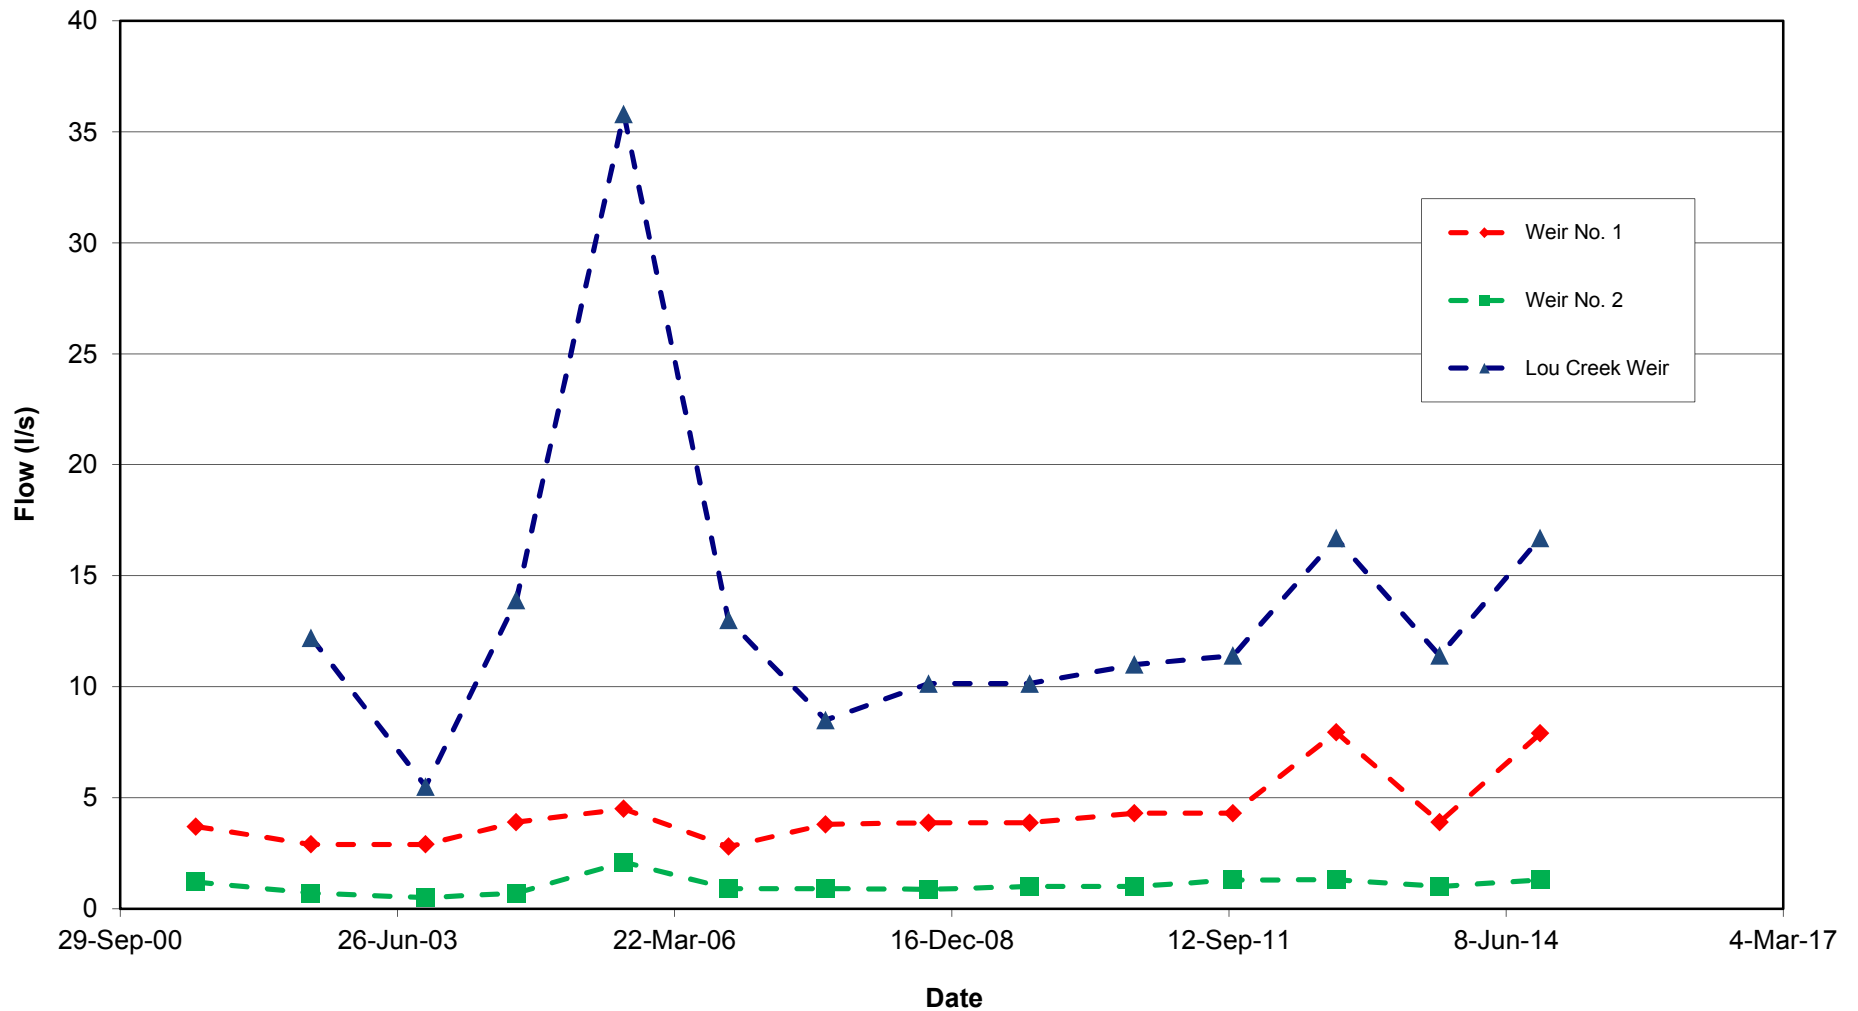
SONA RESOURCES CORPORATION	
BLACKDOME MINE	
<b>TAILINGS STORAGE FACILITY 2014 ANNUAL INSPECTION WEIR FLOW RATES</b>	
<i><b>Knight Piésold</b></i> CONSULTING	P/A NO. VA101-70/15 REF NO. 1
<b>FIGURE 2.3</b>	
REV 0

A seepage flow rate of approximately 8 l/s was measured at Weir No. 1 at the downstream toe of the tailings embankment above the Seepage Collection and Recycle Pond. A flow rate of approximately 1.3 l/s was measured at Weir No. 2 in the diversion ditch below the right abutment of the TSF embankment. Flows at both weirs were clear. A history of flow monitoring at Weirs No. 1 and No. 2 is summarized in Table 2.3. The weir flows dating back to 2001 are shown on Figure 2.3. The flows recorded at Weirs No. 1 and No. 2 are similar to those measured during previous inspections.

The Lou Creek Weir, located just below the toe of the Seepage Collection and Recycle Pond, monitors the surface water flows from the TSF, the South Diversion Ditch, and flows through and beneath the Seepage Collection and Recycle Pond. Flow over the weir at the time of the inspection was measured at approximately 17 l/s. The flow at the Lou Creek Weir was clear. A history of the flow monitoring at the Lou Creek Weir is shown in Table 2.3. The Lou Creek flows dating back to 2001 are shown on Figure 2.3.

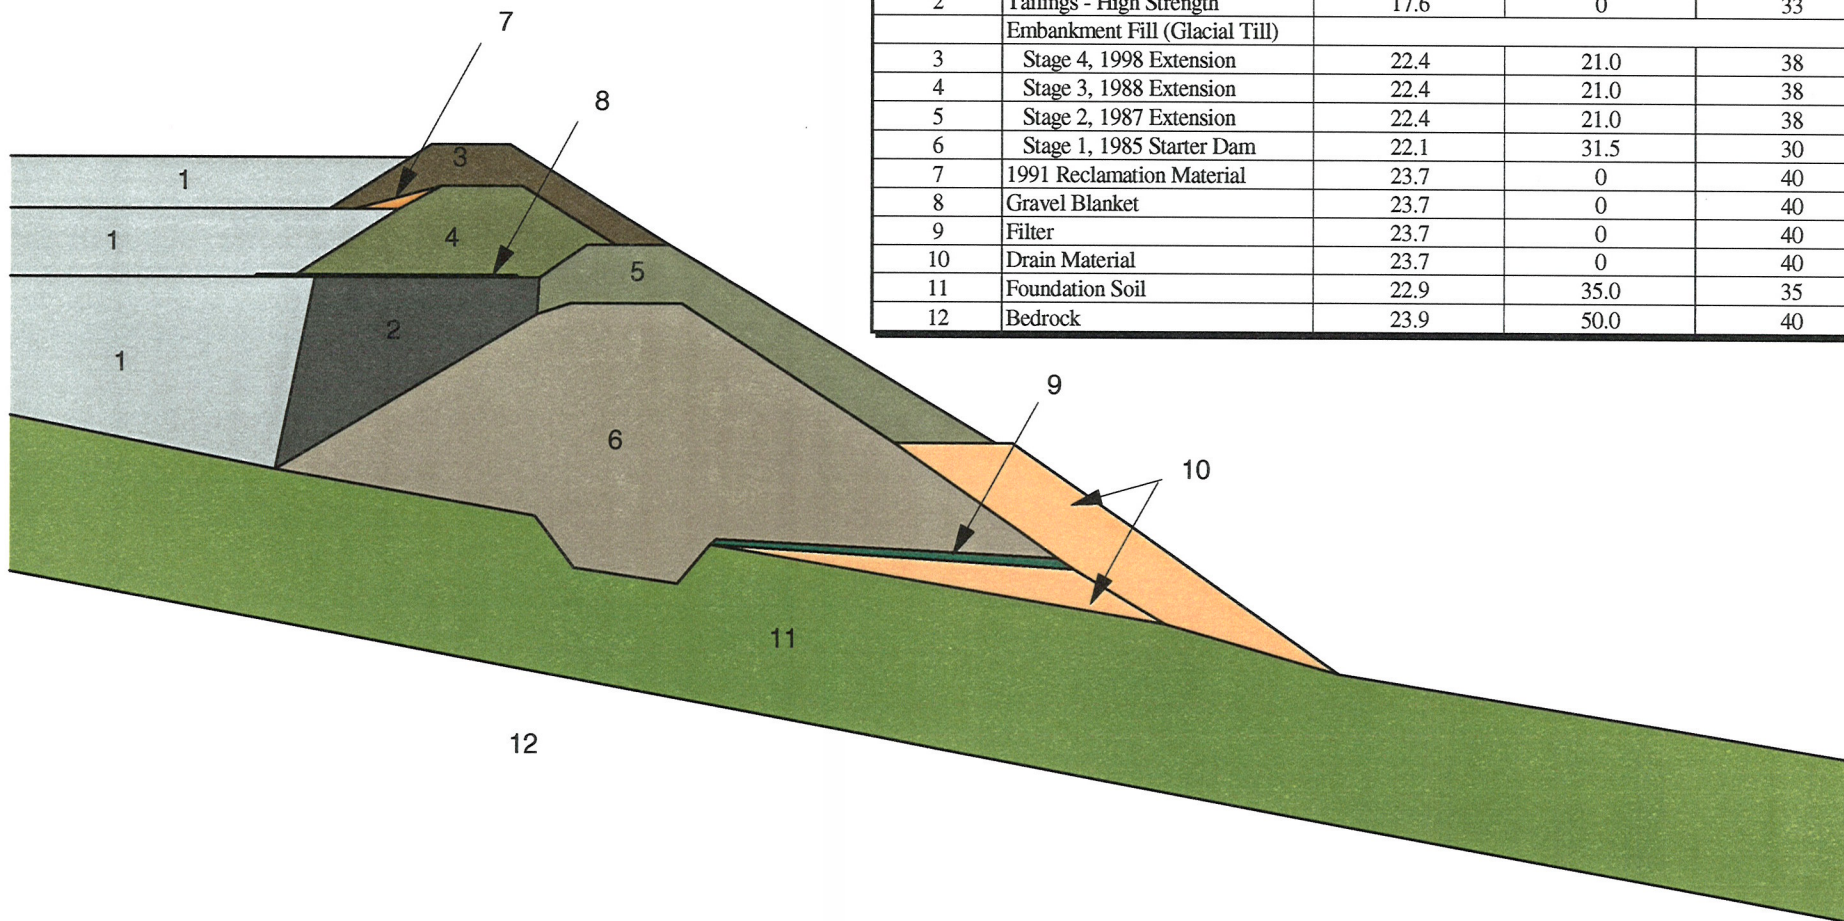
FIGURE 4.9

The geometry, material parameters and location of the phreatic surface for the stability analyses are illustrated on Figure 4.9.

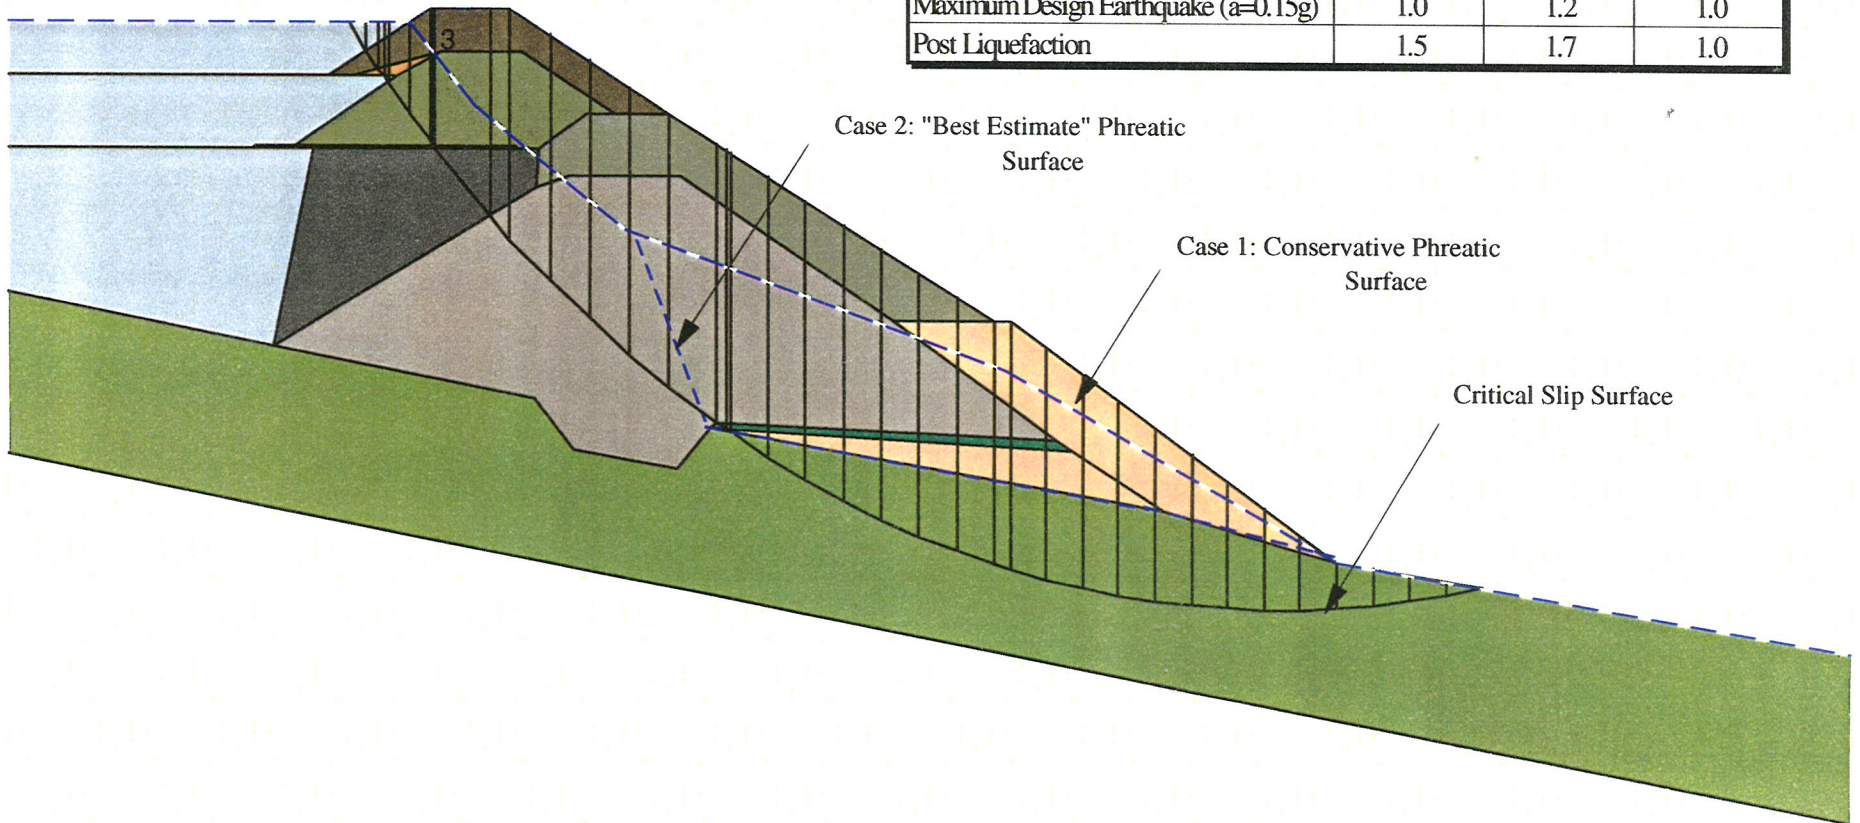
FIGURE 4.10

Downstream Stability - For the static case during operations with a conservative phreatic surface (Case 1) a minimum factor of safety of 1.5 was calculated. Figure 4.10 shows the critical slip surface for this case as well as the results for the other scenarios analyzed. For Case 2, which models the phreatic surface with an operational seepage collection system, a minimum factor of safety of 1.7 was calculated. The minimum required factor of safety during operations is 1.3. The minimum required factor of safety for post closure is 1.5, which the present embankment configuration satisfies. Thus, no buttressing or other remedial actions would be necessary to attain the required factor of safety if no further embankment raises are completed.

Condition	Case 1	Case 2	Minimum Required
Static Stability	1.5	1.7	1.5
Operating Basis Earthquake (a=0.063g)	1.2	1.5	1.2
Maximum Design Earthquake (a=0.15g)	1.0	1.2	1.0
Post Liquefaction	1.5	1.7	1.0
