# **Teck Resources Limited**

**Bullmoose Mine**

***Tailings Storage Dam***

***2014 Dam Safety Inspection***

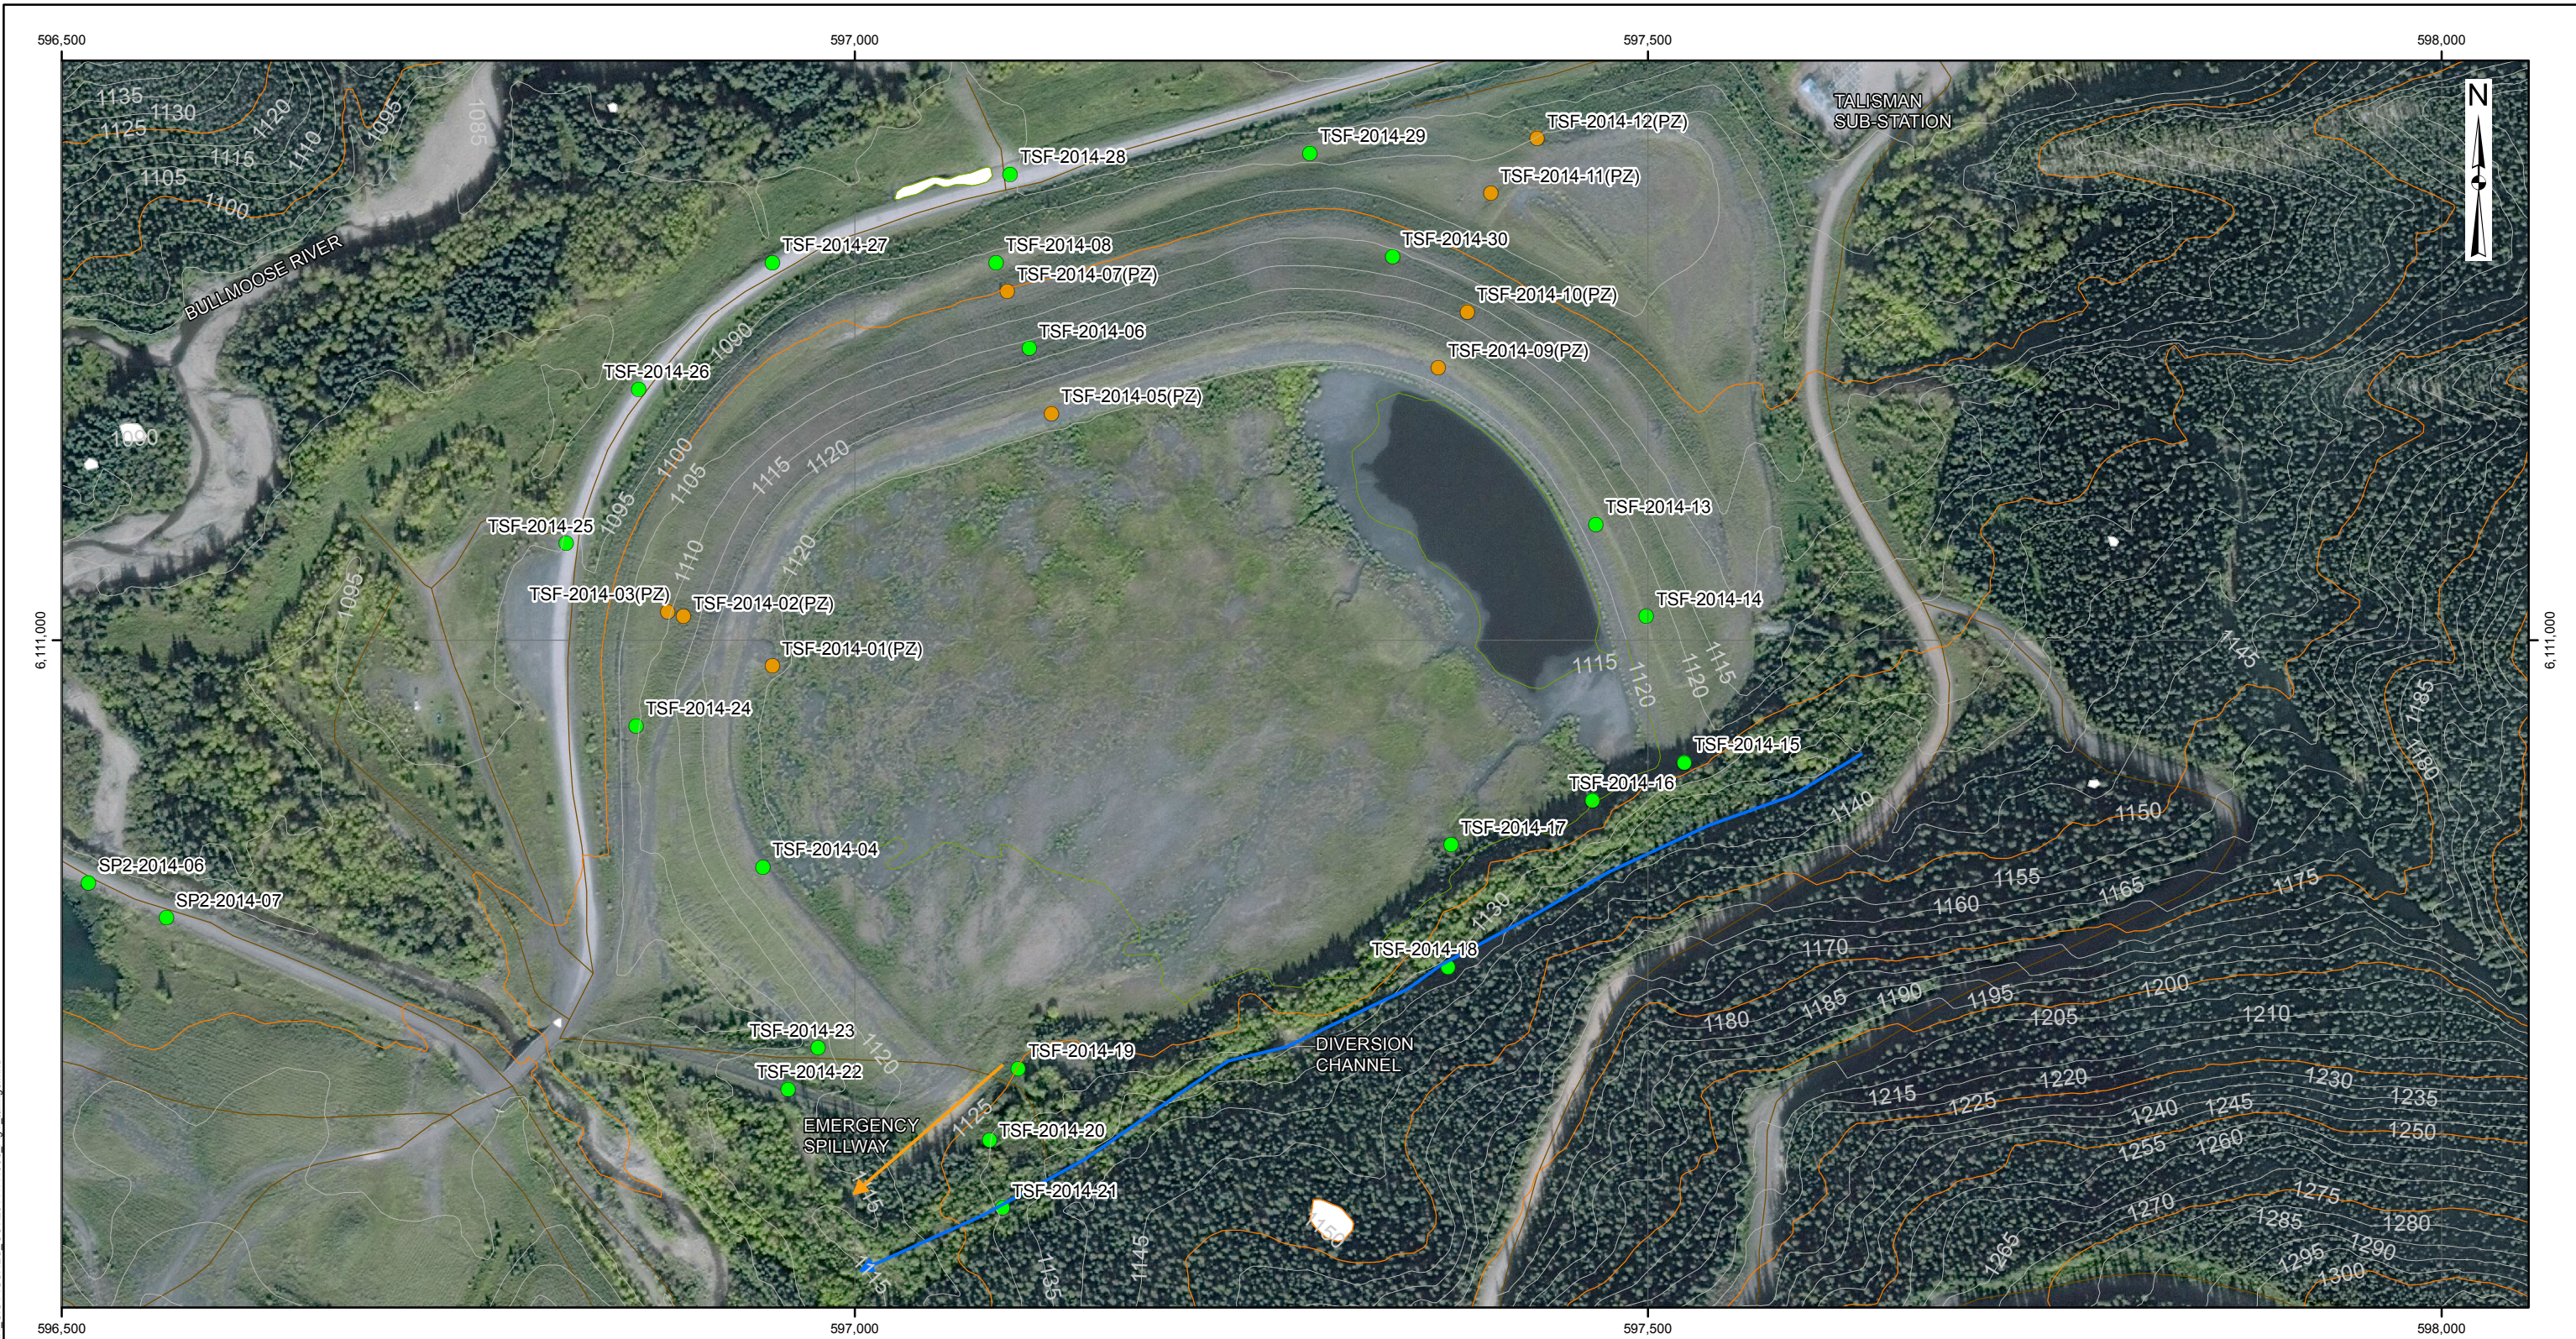
0  125m	
PROJECT	<b>BULLMOOSE 2014 DAM SAFETY INSPECTION</b>
TITLE	<b>TAILINGS STORAGE DAM</b>
PROJECT No.	M09893A02
FIG No.	1

This report presents the DSI for the Bullmoose Tailings Storage Dam (BTD), previously referred to as the South Fork Tailings Dam. The DSI was completed by Mr. Rick Friedel (P.Eng.) on July 23, 2014 between 12:00 pm and 4:30 pm. During the DSI the weather was cloudy with sunny periods and no precipitation. Refer to Figure 1 for an overview of the facility with inspection waypoints.

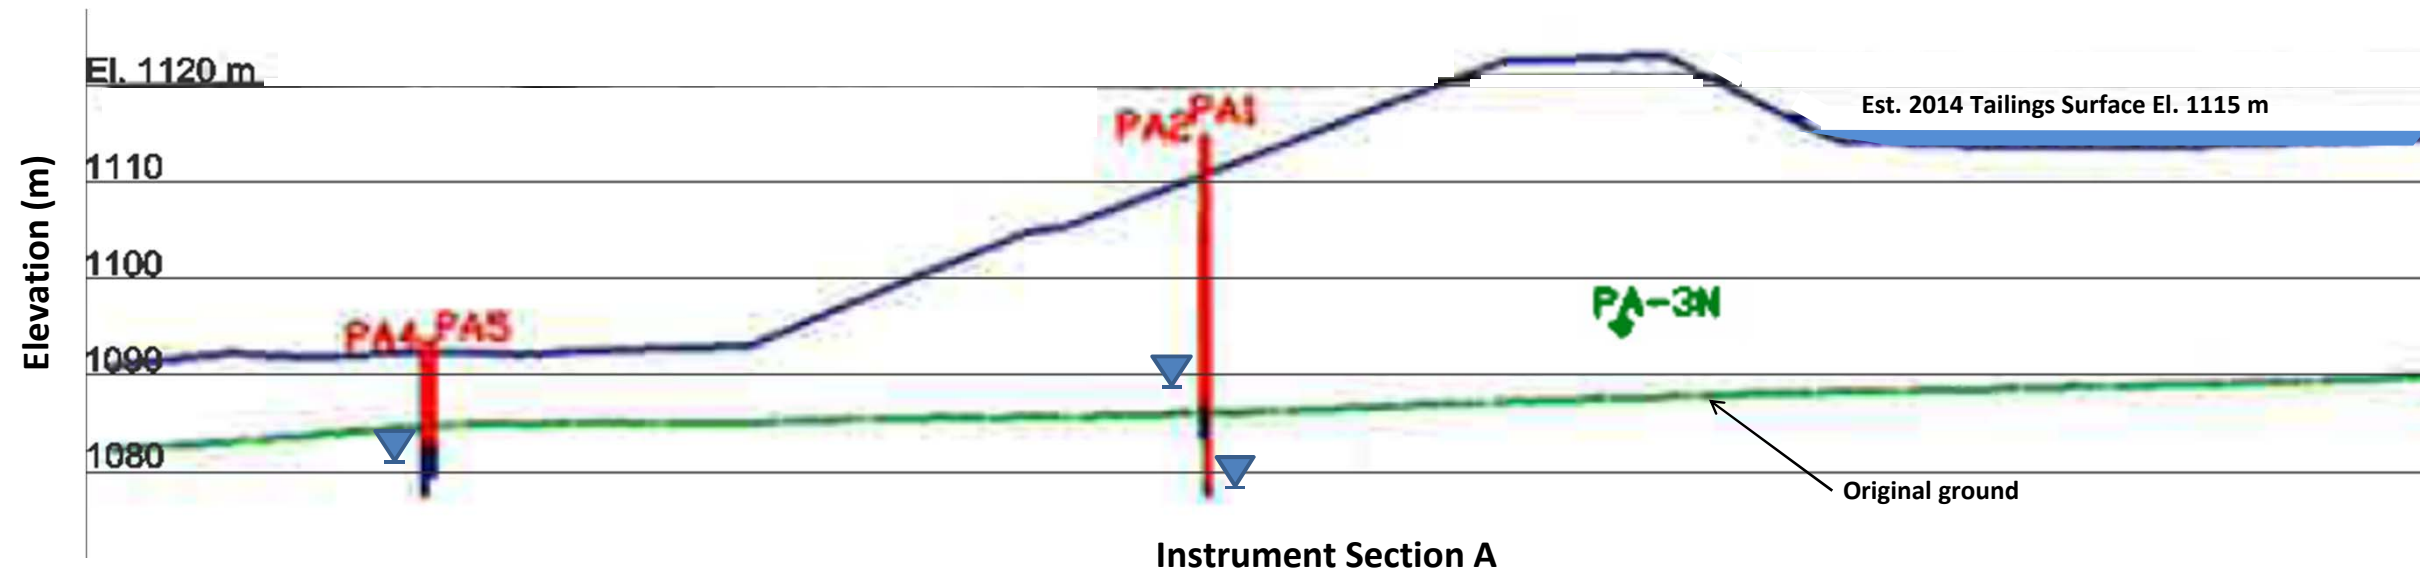
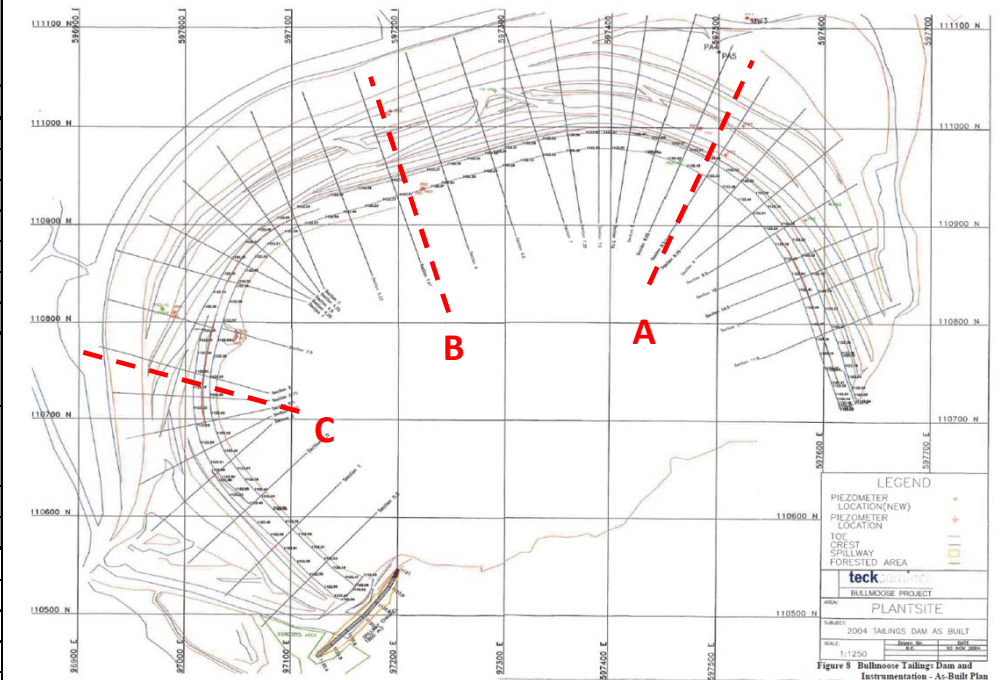
PROJECT:	Bullmoose 2014 Dam Safety Inspections		
TITLE:	Tailings Storage Dam 2014 Piezometer Readings and Locations		
PROJECT NO.	M09893A02	FIGURE	2

Piezometers were measured on July 23, 2014 (during DSI). These are the first documented readings from the piezometers since 2004. Figures 2 and 3 summarize piezometer readings with a comparison to historical readings and design threshold values (KC, 1999). The following observations are made based on the data:

- ◆ 6 piezometers were ‘dry’ (water table below tip elevation).
- All measured piezometers have similar or lower pore pressure than last measurement with the exception of PA1 and PA2 but both readings are similar to average reading measured between 2001 and 2003 (refer to Figure 3).

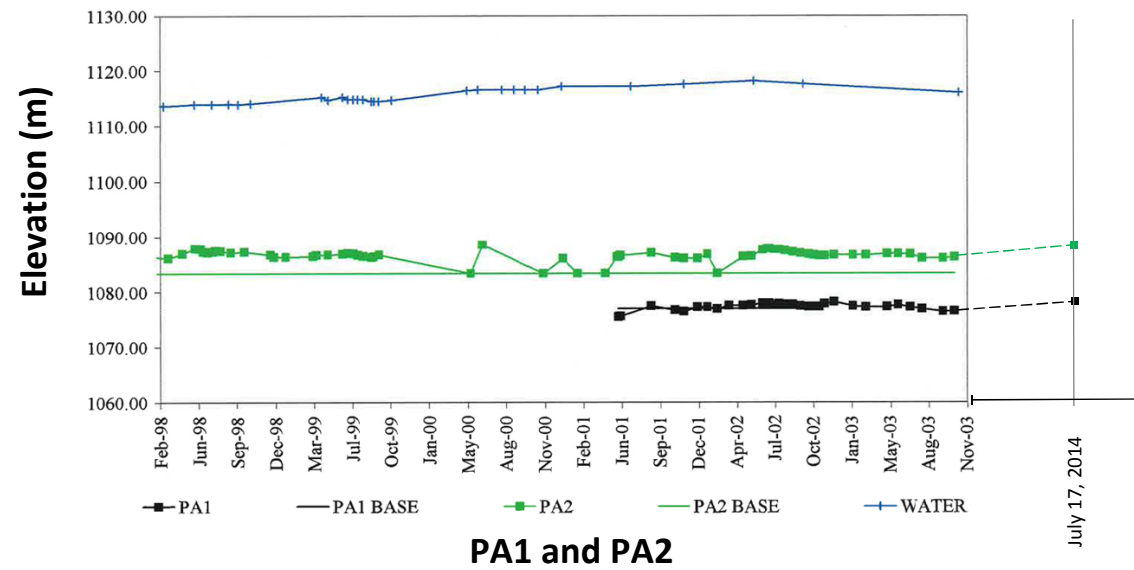
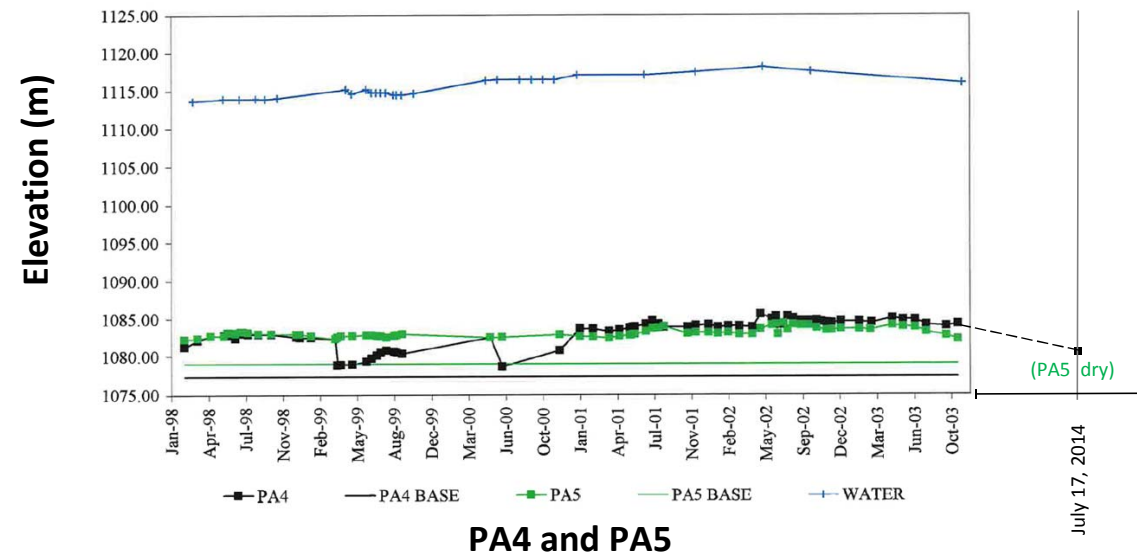
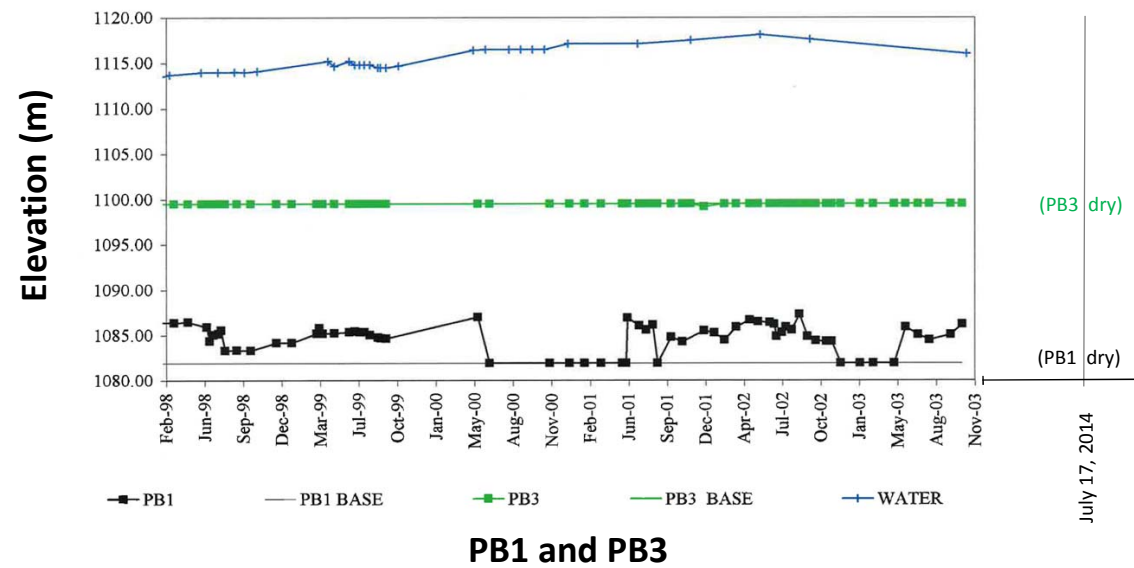
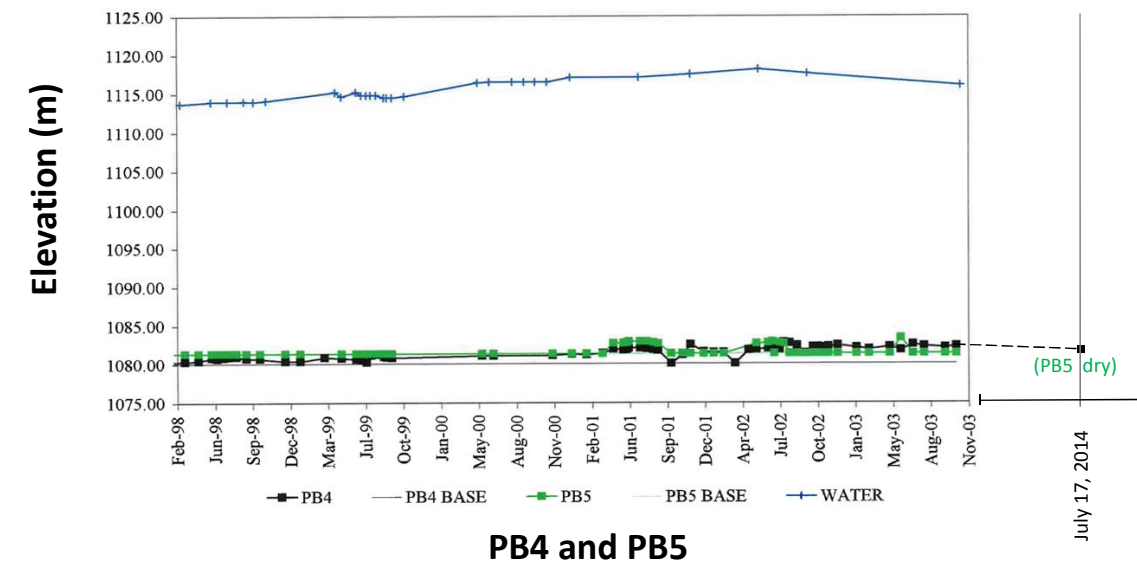
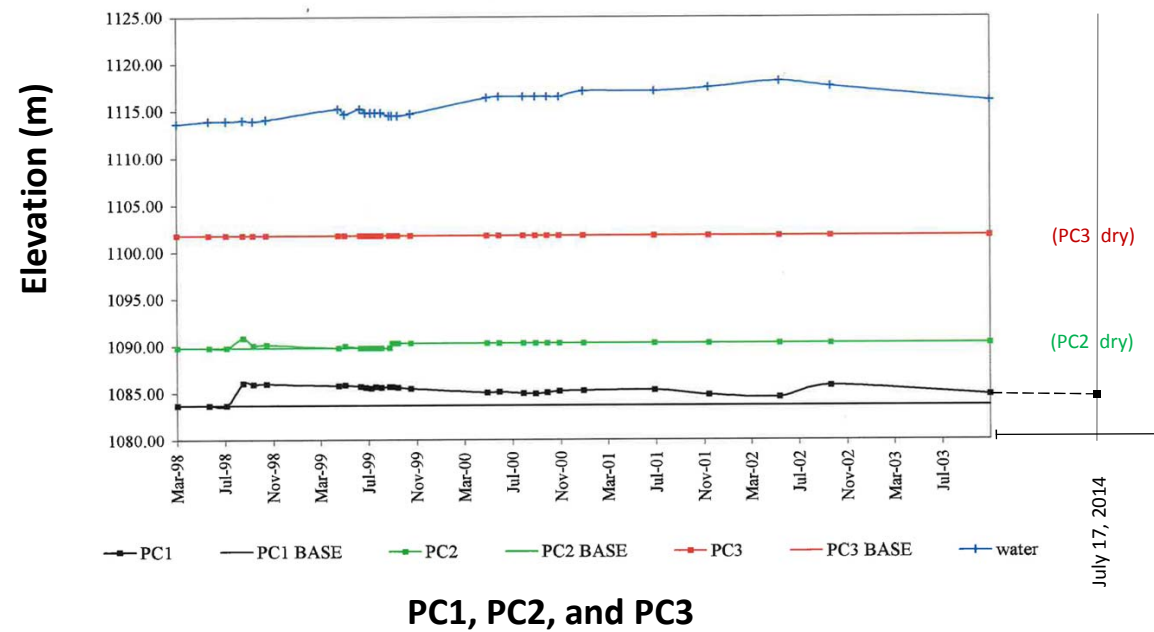
PROJECT:		Bullmoose 2014 Dam Safety Inspections	
TITLE:		Tailings Storage Dam Historical Piezometer Readings	
PROJECT NO.	M09893A02	FIGURE	3

**Note:**  
 1. No historic data available for PA-3N, PC-3N, MW1, MW3, MW4 or MW5.  
 2. "BASE" refers to tip elevation of piezometer.

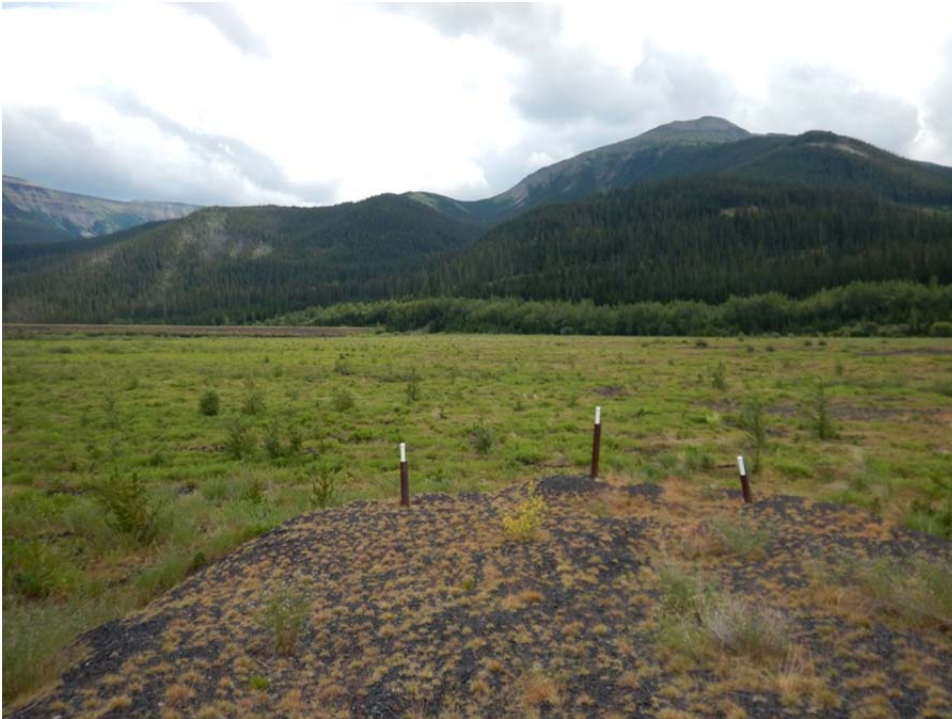
**Photo I-10** Piezometer standpipes (PC1, PC2, PC3) in tailings beach. (TSF-2014-01)

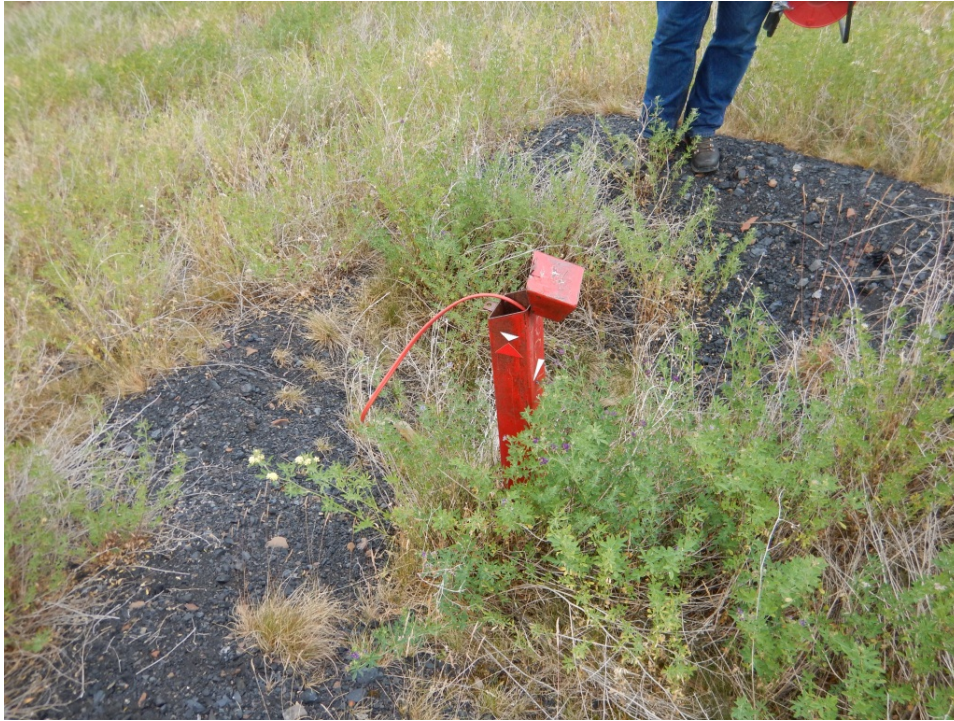
**Photo I-12 Pneumatic piezometer (PC-4N). (TSF-2014-03)**
