Subject: 2014 Dam Safety Inspection – Huldra (Old Craigmont) Mine, Merritt, BC
Final Report
Our file: 623839-0000-4GER-0001-00

2014 Dam Safety Inspection Old Cragmont Mine

FINAL REPORT

HULDRA SILVER INC.

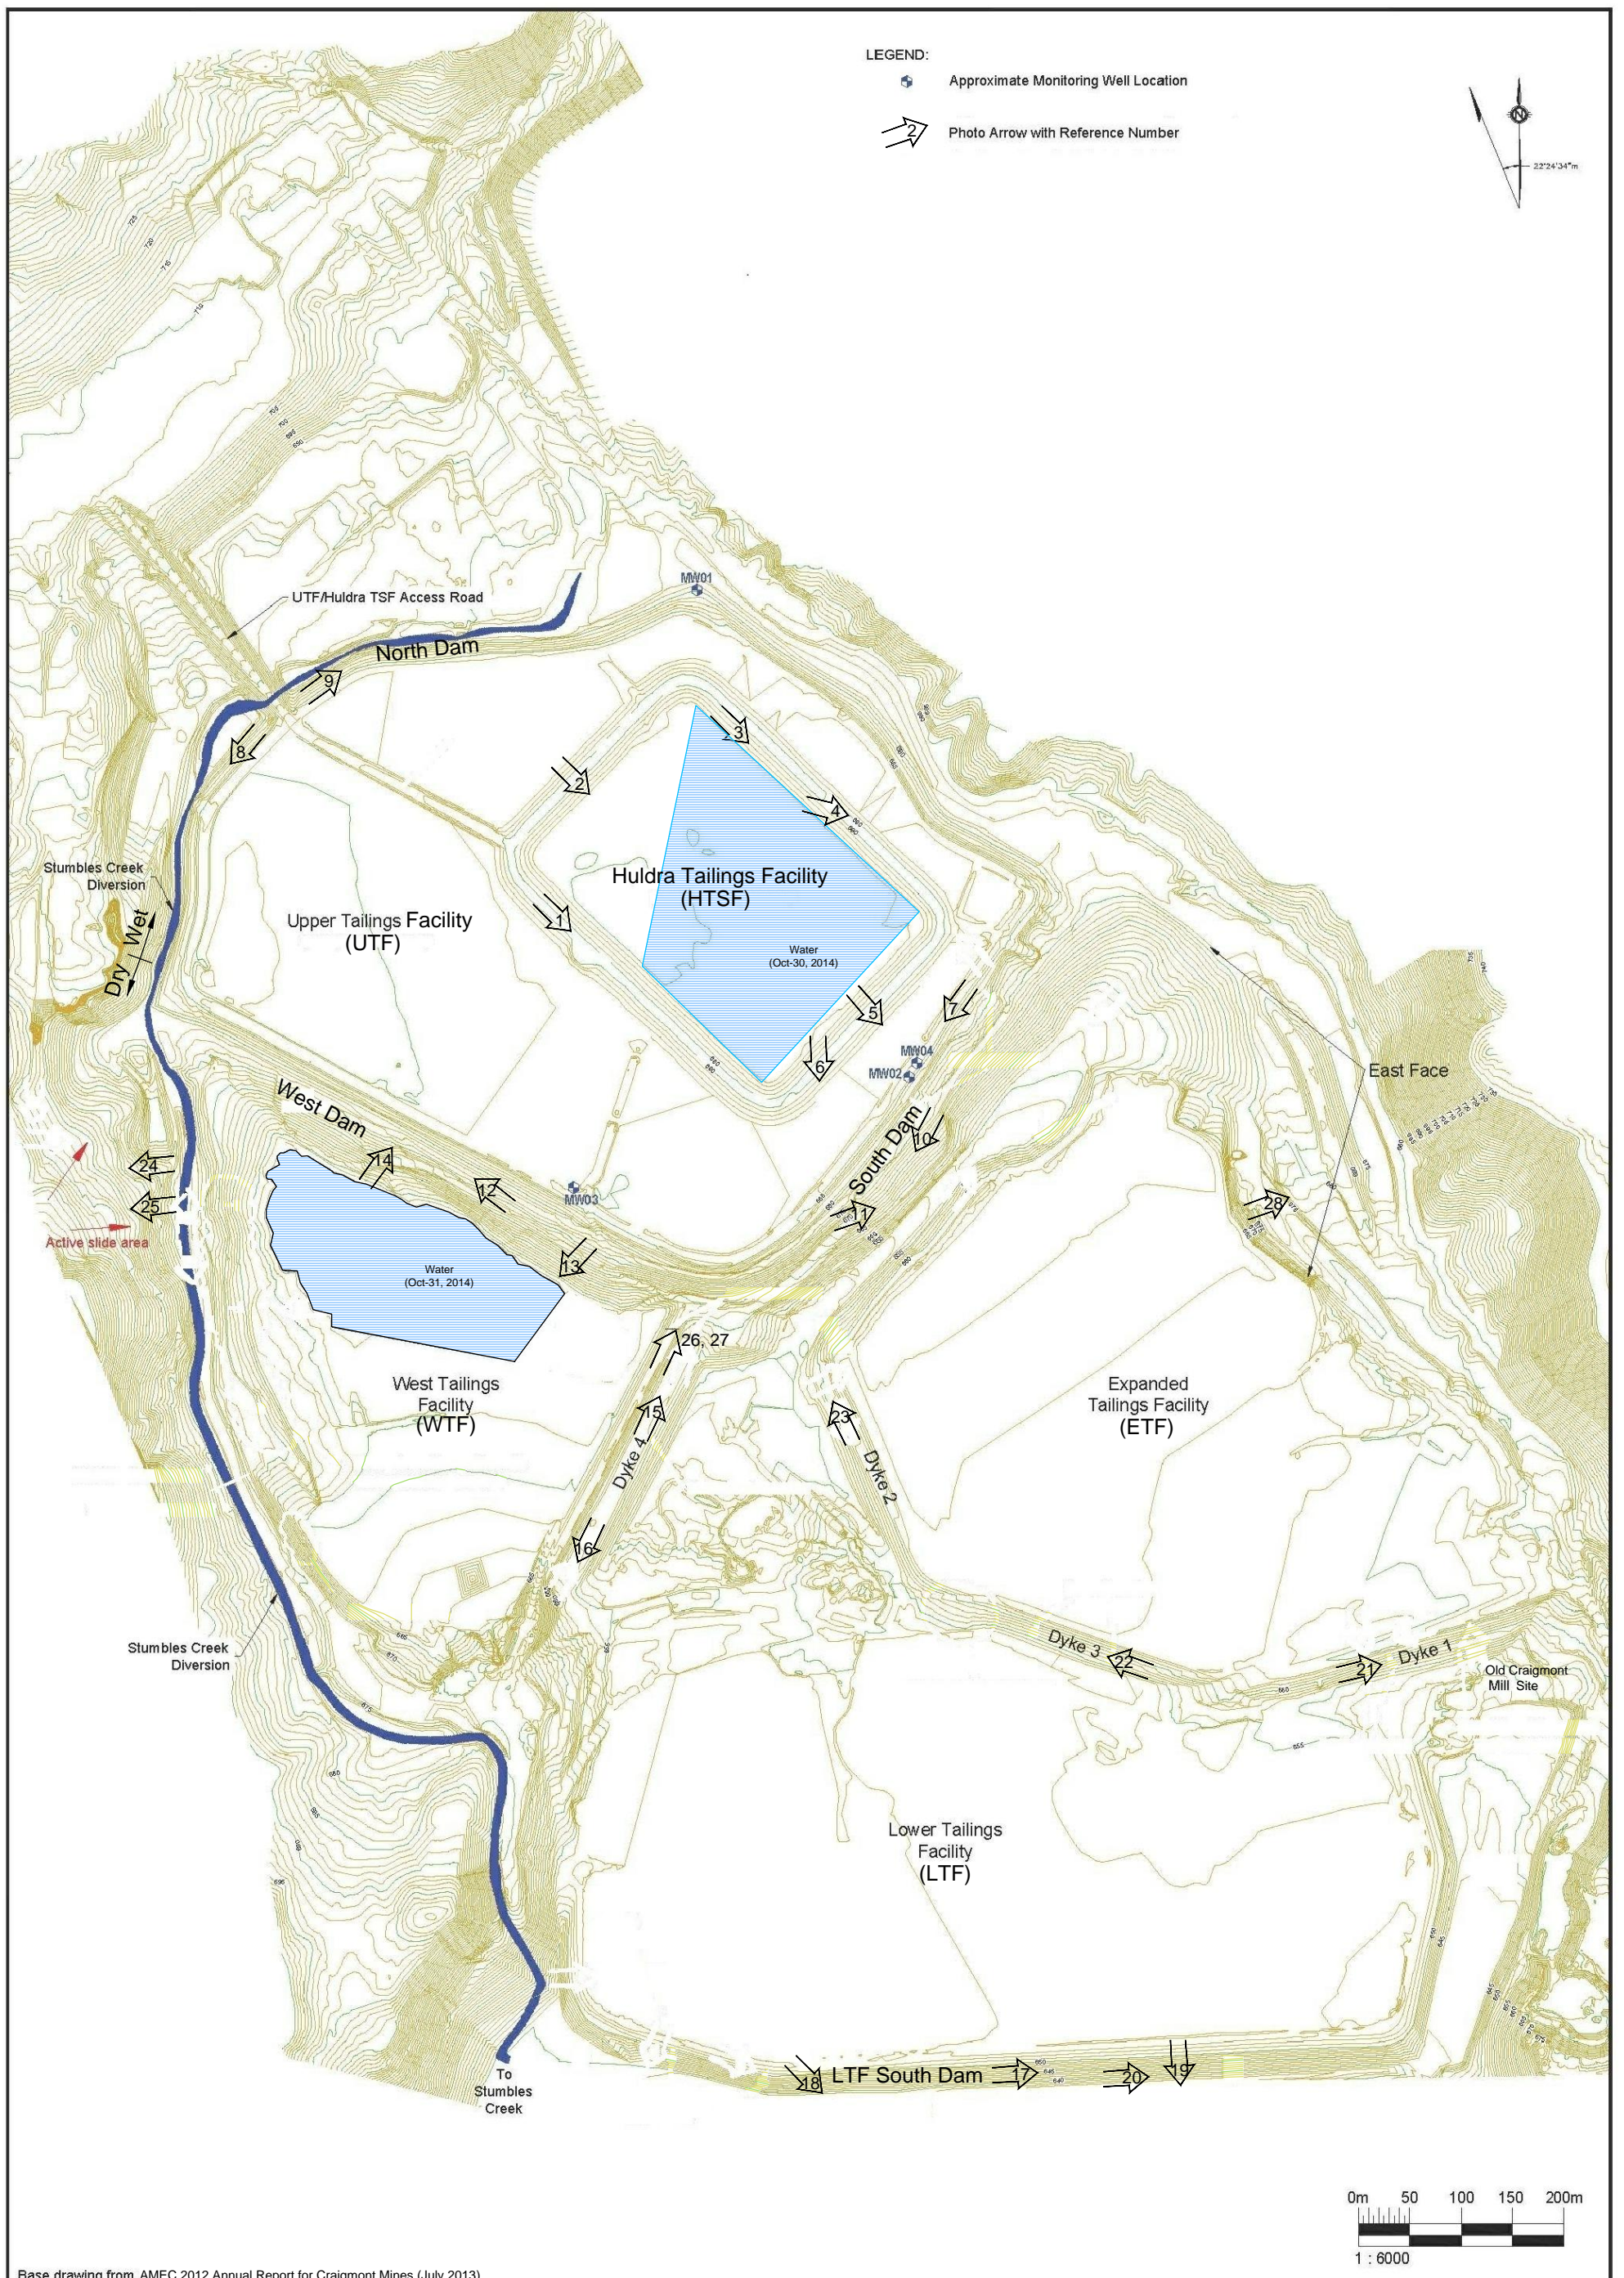
Sustainable Mine Development Global Mining & Metallurgy SNC LAVALIN INC. 1111 West Georgia suite 900 Vancouver (BC) Canada V6E 4M3	DATUM: NAD83	PROJECT HULDRA MINES 2014 DSI LOWER NICOLA, BRITISH COLUMBIA	PROJECT No.: 623839
	PROJECTION: UTM Zone 10		FIGURE No.: FIGURE 1
	SCALE: 1:6000

The UTF is located at the north end of the site, as shown on the site plan of Figure 1 of Appendix C. The UTF facility is inactive and consists of a perimeter dam and there is no water being retained inside. According to Figure 4 of AMEC (2013), the UTF is equipped with a rock filter dyke in its west corner but this was not observed.

The LTF, located at the south end of the site, is bounded by a LTF South Dam, as shown on the site plan of Figure 1. At the time of the inspection, the facility was dry and inactive, and the Upper Reclaim Pond observed by AMEC (2013) in the southwest corner of LTF was dry. There were

Tailings facilities at the site are currently not in operation and the tailings facilities are dry with very little water (precipitation) in two locations as indicated on Figure 1 of Appendix C. Tailings lines have been de-commissioned or removed.

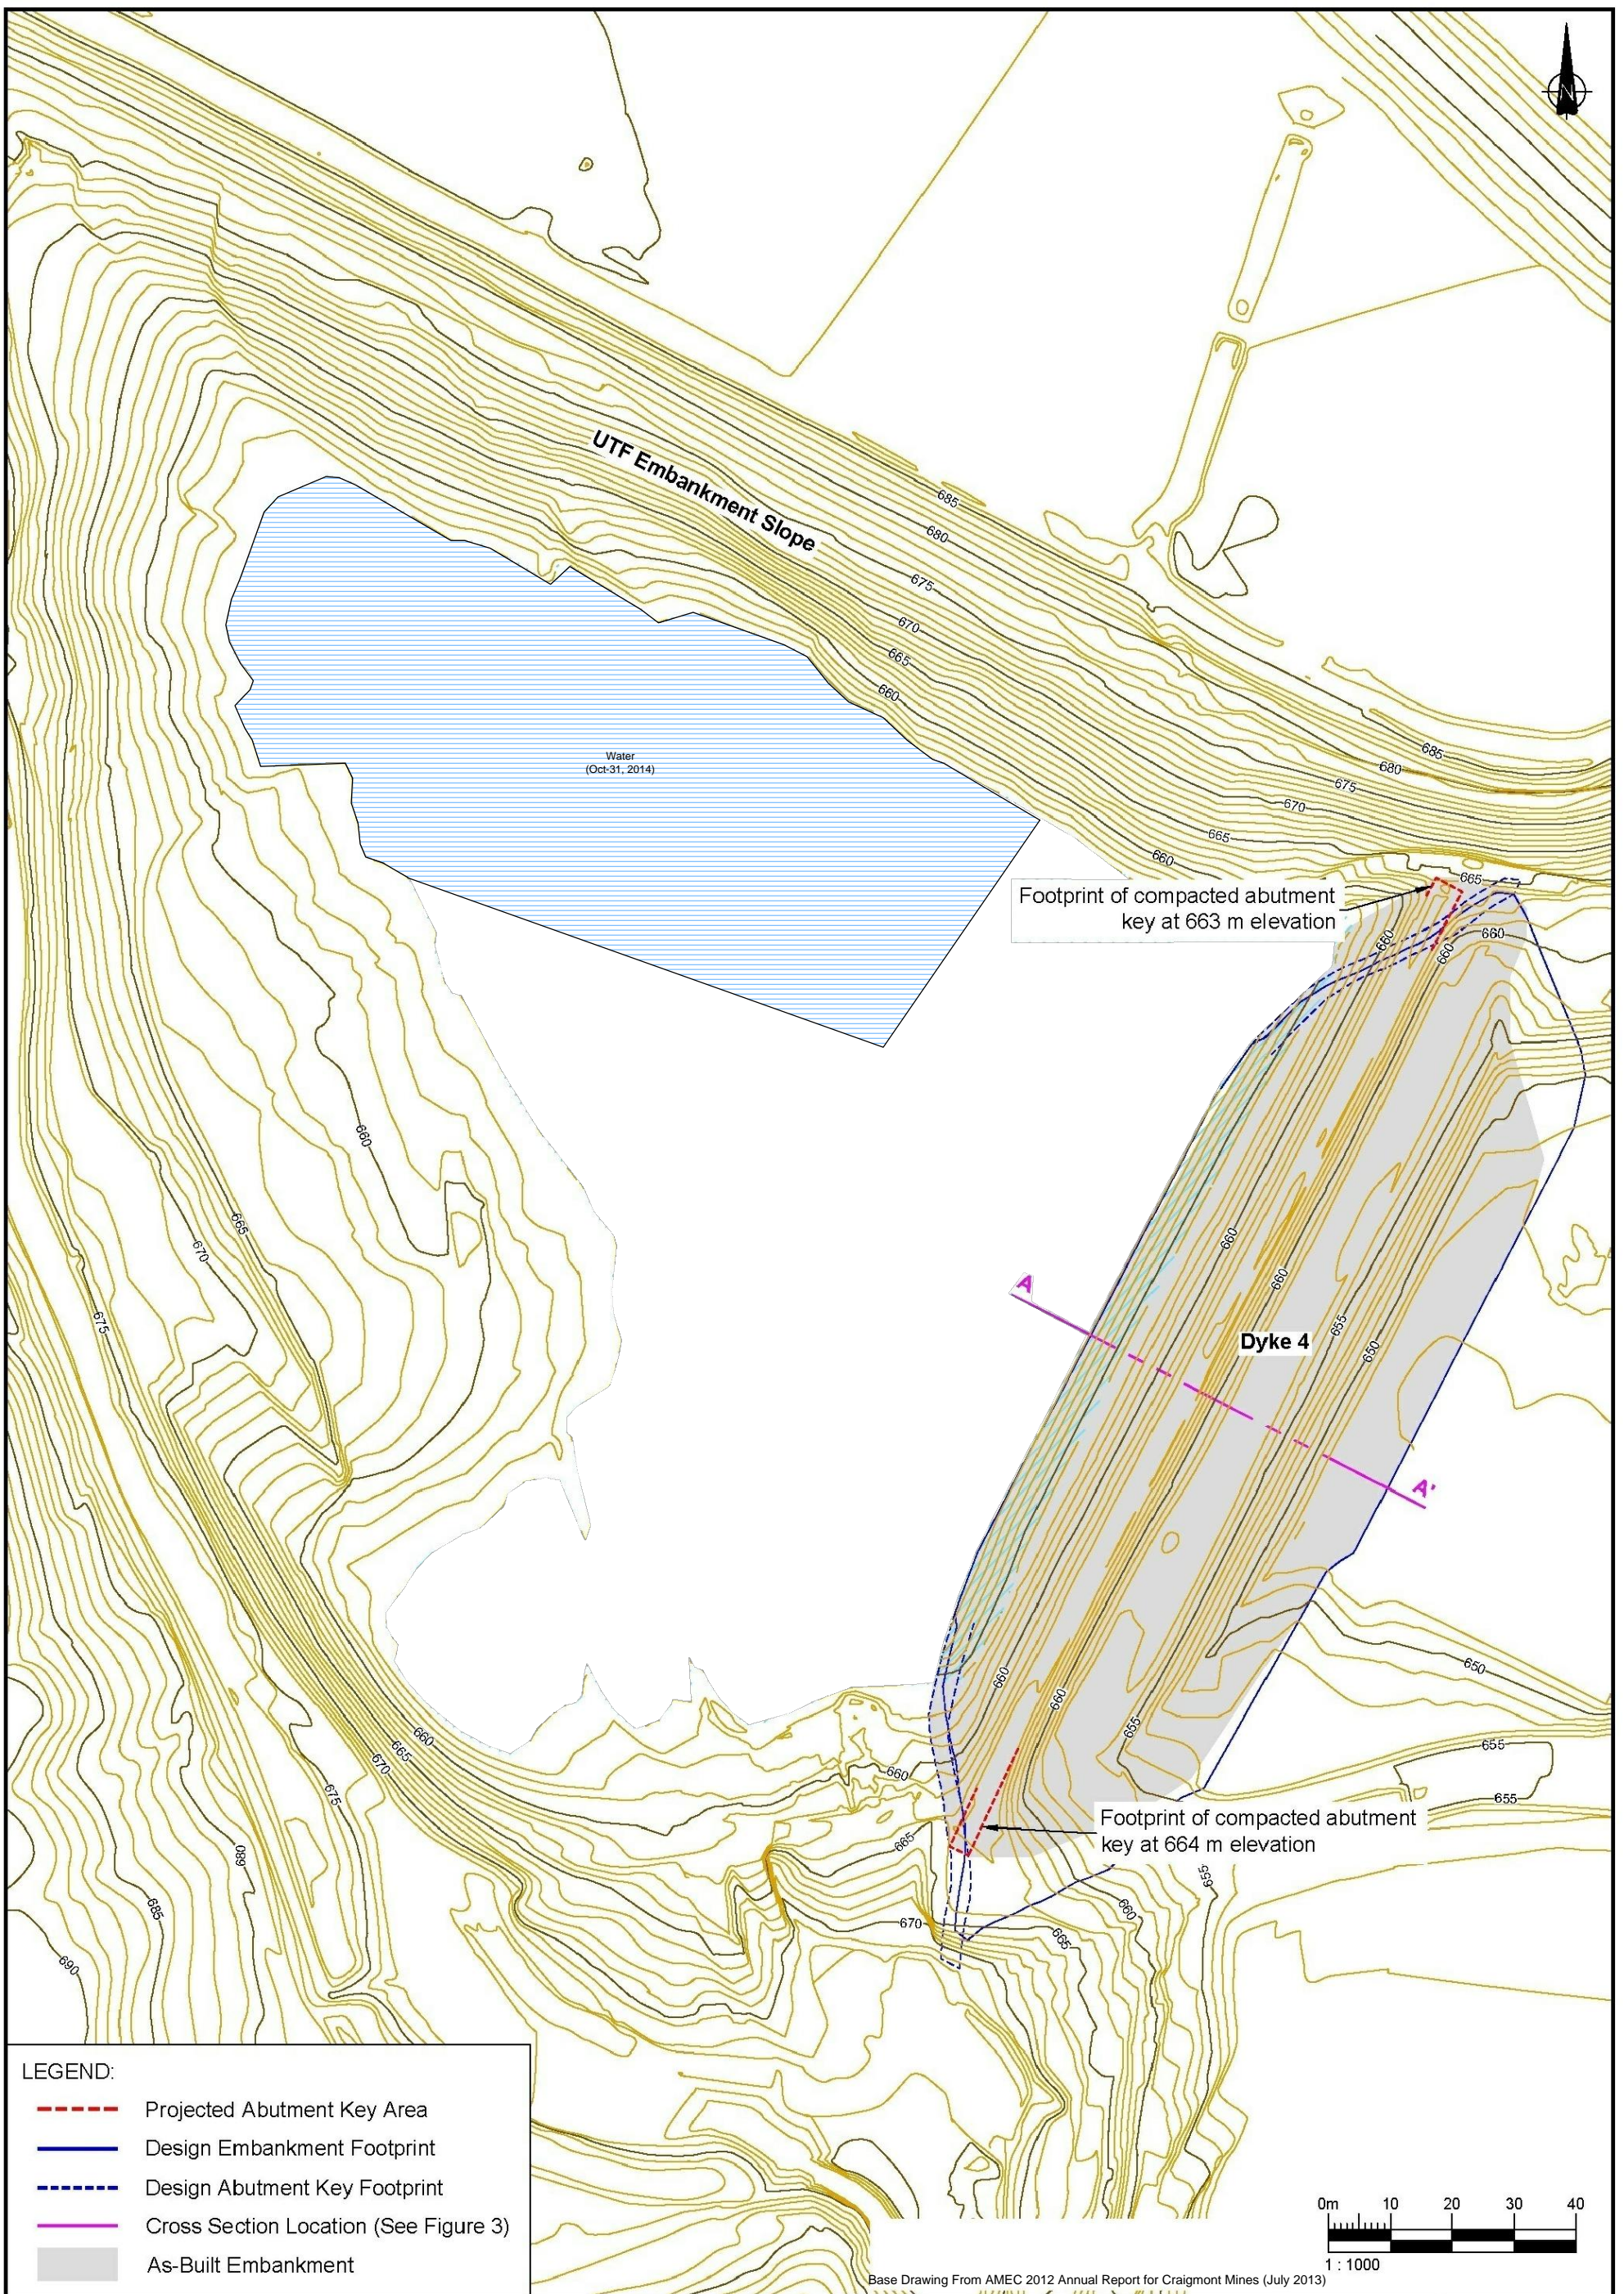
Locations of the above listed structures are indicated in the site plan drawing in Appendix C. No representative cross-sections of the different dykes forming the tailings facilities were provided to SLI by Huldra except for the as-built drawings of Dyke 4 that can also be found in Appendix C.
