01 December 2014  
Final Report

Eskay Creek Gold Mine Site (Closed)  
Albino Lake Waste Rock Storage Facility  
Dam Safety Inspection Report

## 2010 ALBINO LAKE DAM INSPECTION

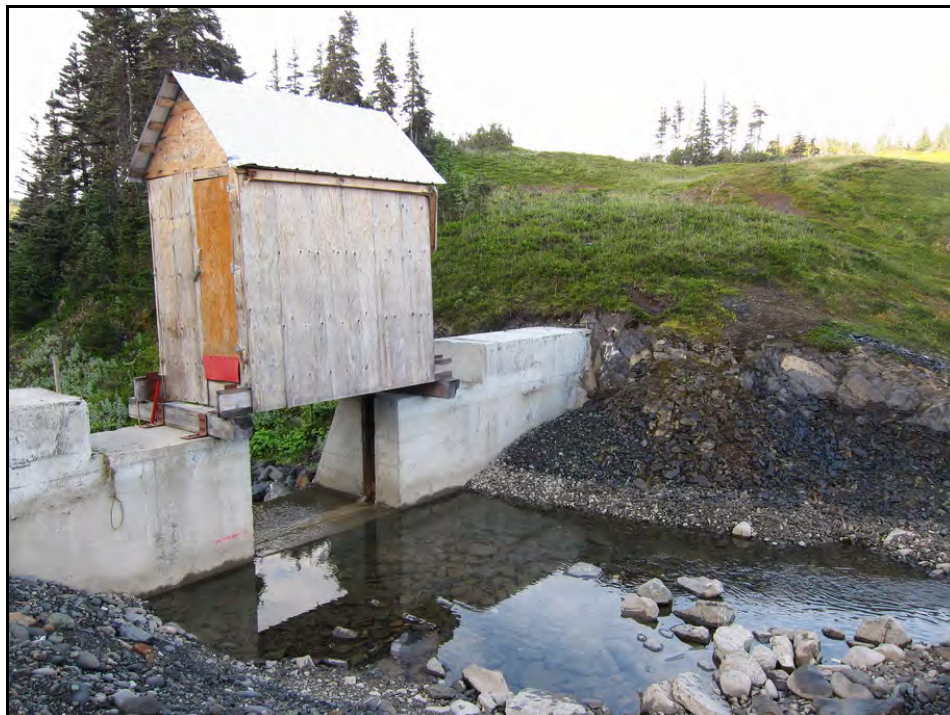
The dam is a concrete gravity structure founded on bedrock with a centrally located stop-log discharge structure and overflow section (Photos 1 and 2). The dam is about 20 m long with a design crest elevation of 1052.2 m. The 20 m length includes a 5 m long overflow section with a crest elevation of 1051.7 m and a 2 m wide slot for stop-logs with a minimum elevation of 1050.4 m. The height of the dam shown on conceptual drawings, prepared and marked "PRELIMINARY" by AMEC (attached as Appendix A), indicate the dam was assumed to be approximately 3.2 m high. No "as-built" drawings were available. Details of the Albino Lake Dam were obtained from the following two letters prepared by AMEC, and provided by Barrick:

**PHOTO 2** – Upstream face of dam.
