### **Dam Safety Inspection, Gallowai Bul River Mine Tailings Storage Facility, Bull River, BC**

**Bul River Mineral Corp.**

**November 24, 2014**

**Project 623505**

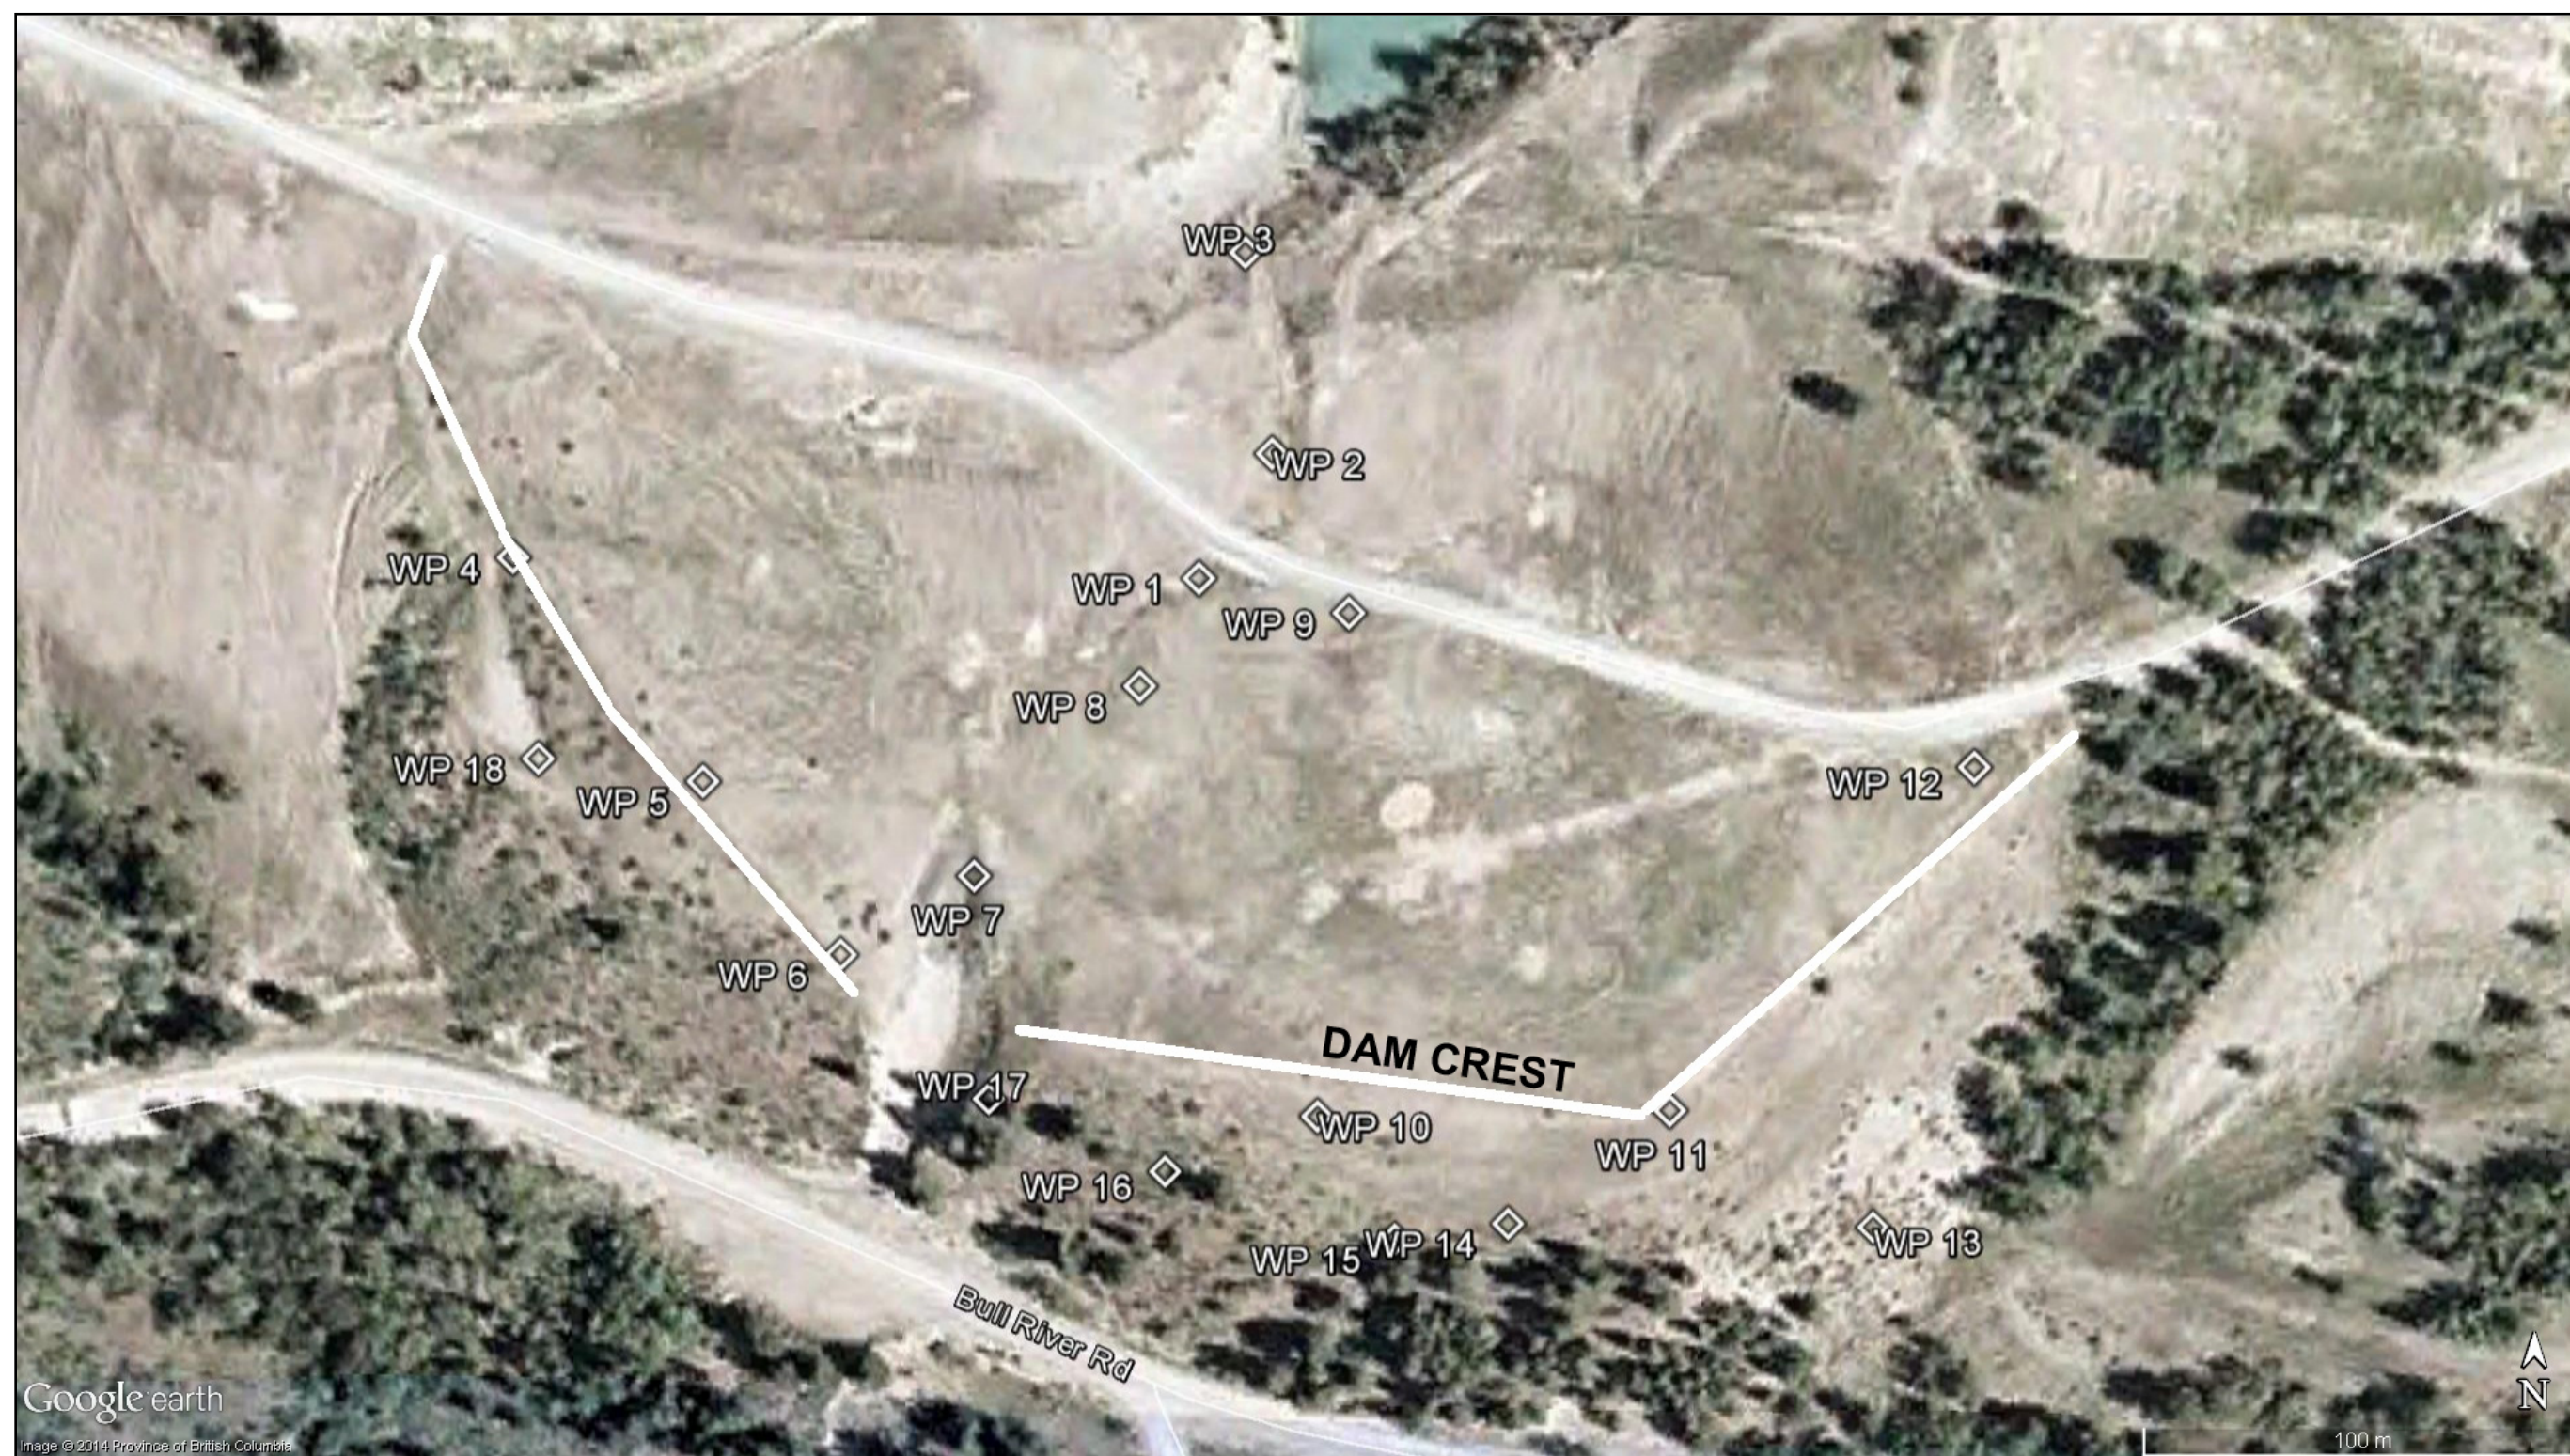
**Figure 3: Tailings Storage Facility Layout and Visual Inspection Waypoint Locations**

Field conditions were suitable for performing a visual inspection. The temperature was approximately 8° C. Weather conditions were cloudy; ground conditions were nearly dry, although light rain showers had fallen during the previous two days and night. The site was photographed during the inspection and selected photographs are included in this report. SNC-Lavalin’s waypoint locations were plotted using a handheld GPS. The waypoints from the foot traverse are shown on Figure 3 below.

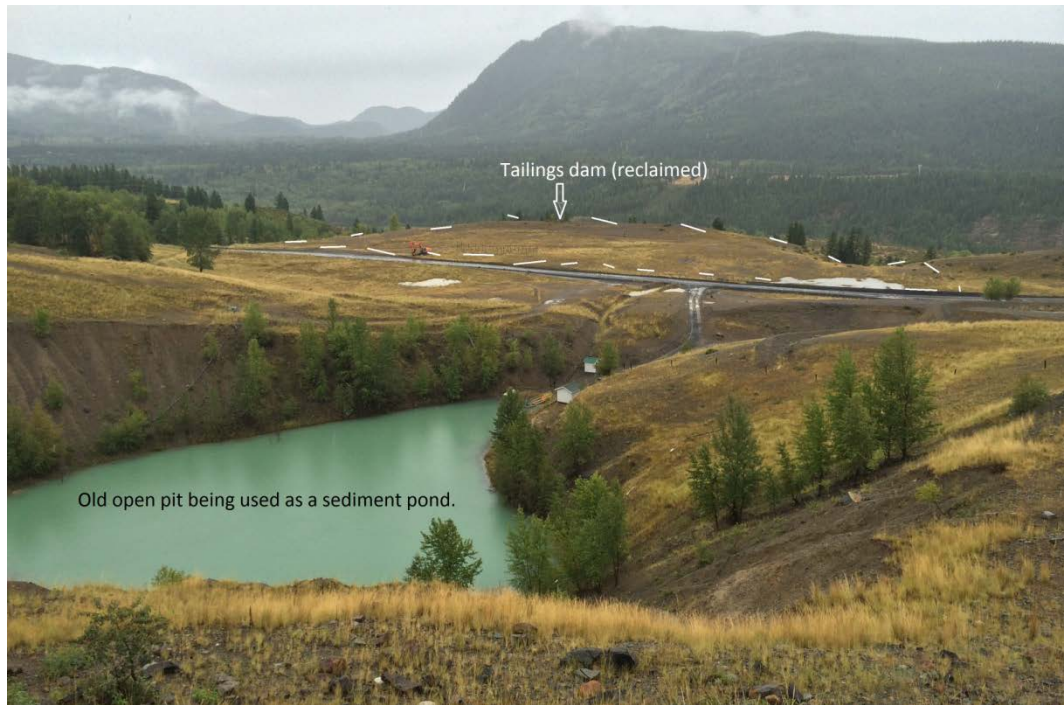
Overall, the TSF is situated on relatively gentle to moderate pre-construction slopes above a steep-faced natural glaciofluvial terrace north of the Bull River Road. A second flat to gentle terrace extends south from the road toward escarpments above the Bull River. The TSF is pictured in Photographs 1 and 2 in Appendix A. Figures 2 and 3 show the general layout of the TSF and surrounding features.

**Photograph 1:** View to south showing the old open pit and pumphouses in the foreground and the TSF in the background. The Bull River is in the valley floor beyond the TSF.

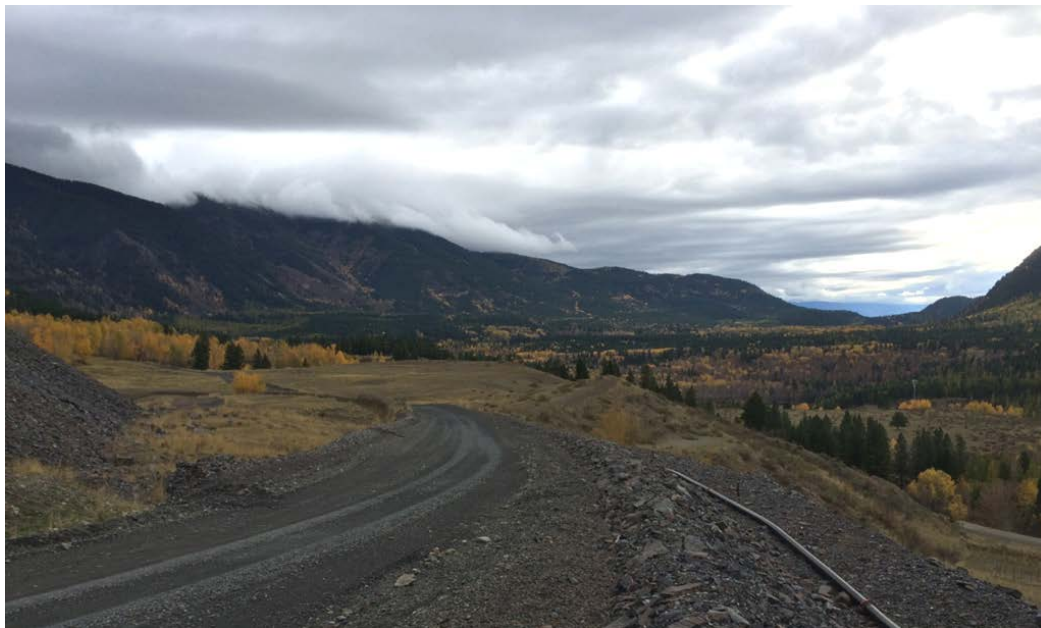
**Photograph 2:** View to the east from the mine haul road to the TSF. The Bull River Road is visible in the lower right corner. The mill site is located beyond the left middle area of trees with autumn foliage.
