November 26, 2014

INDEPENDENT REVIEW OF 2014 DAM SAFETY INSPECTION REPORT

Giant Nickel Tailings Dams

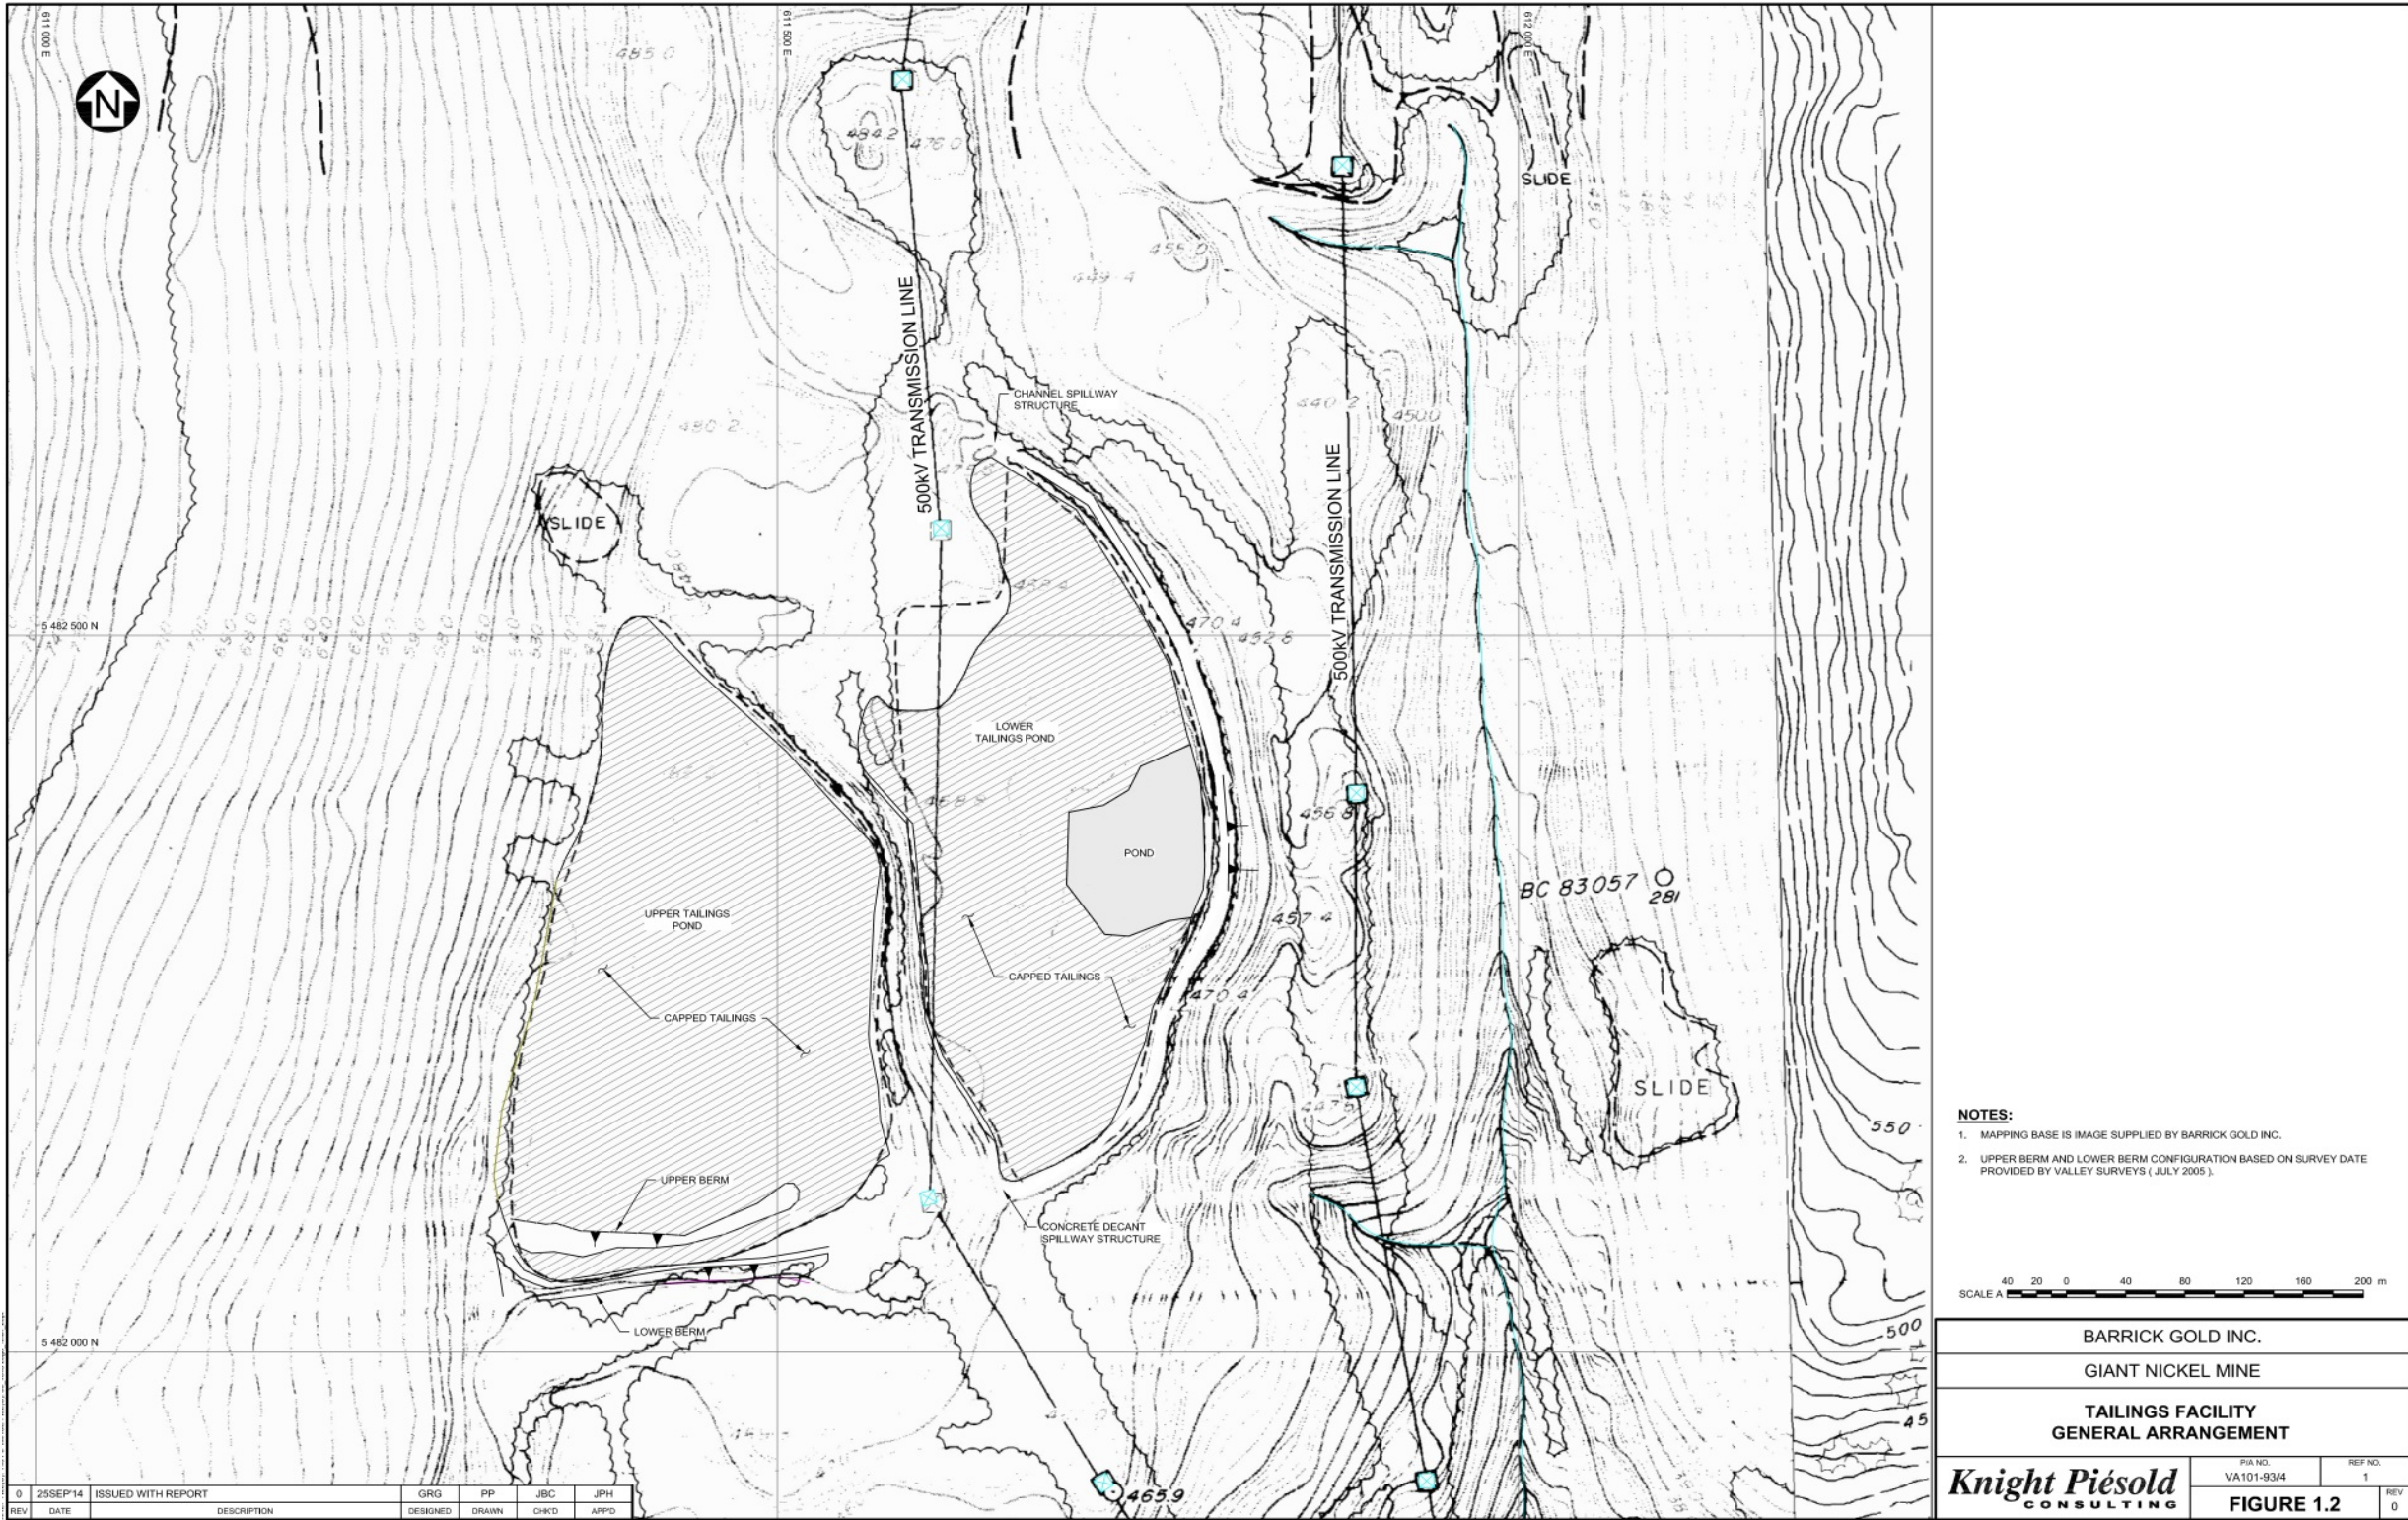
Figure 1: Tailings Facility – General Arrangement

Giant Nickel Mine (Giant Nickel) was an underground mine operation located 8 km north of Hope and 2 km west of the Fraser River in southwest British Columbia. The mine is located in mountainous terrain of the coastal mountains. The tailings facility layout is shown in Figure 1.
