**BARRICK GOLD INC.  
GIANT NICKEL MINE**

**TAILINGS FACILITY  
2014 DAM SAFETY INSPECTION REPORT**

VA101-93/4-1  
Rev 0  
November 25, 2014

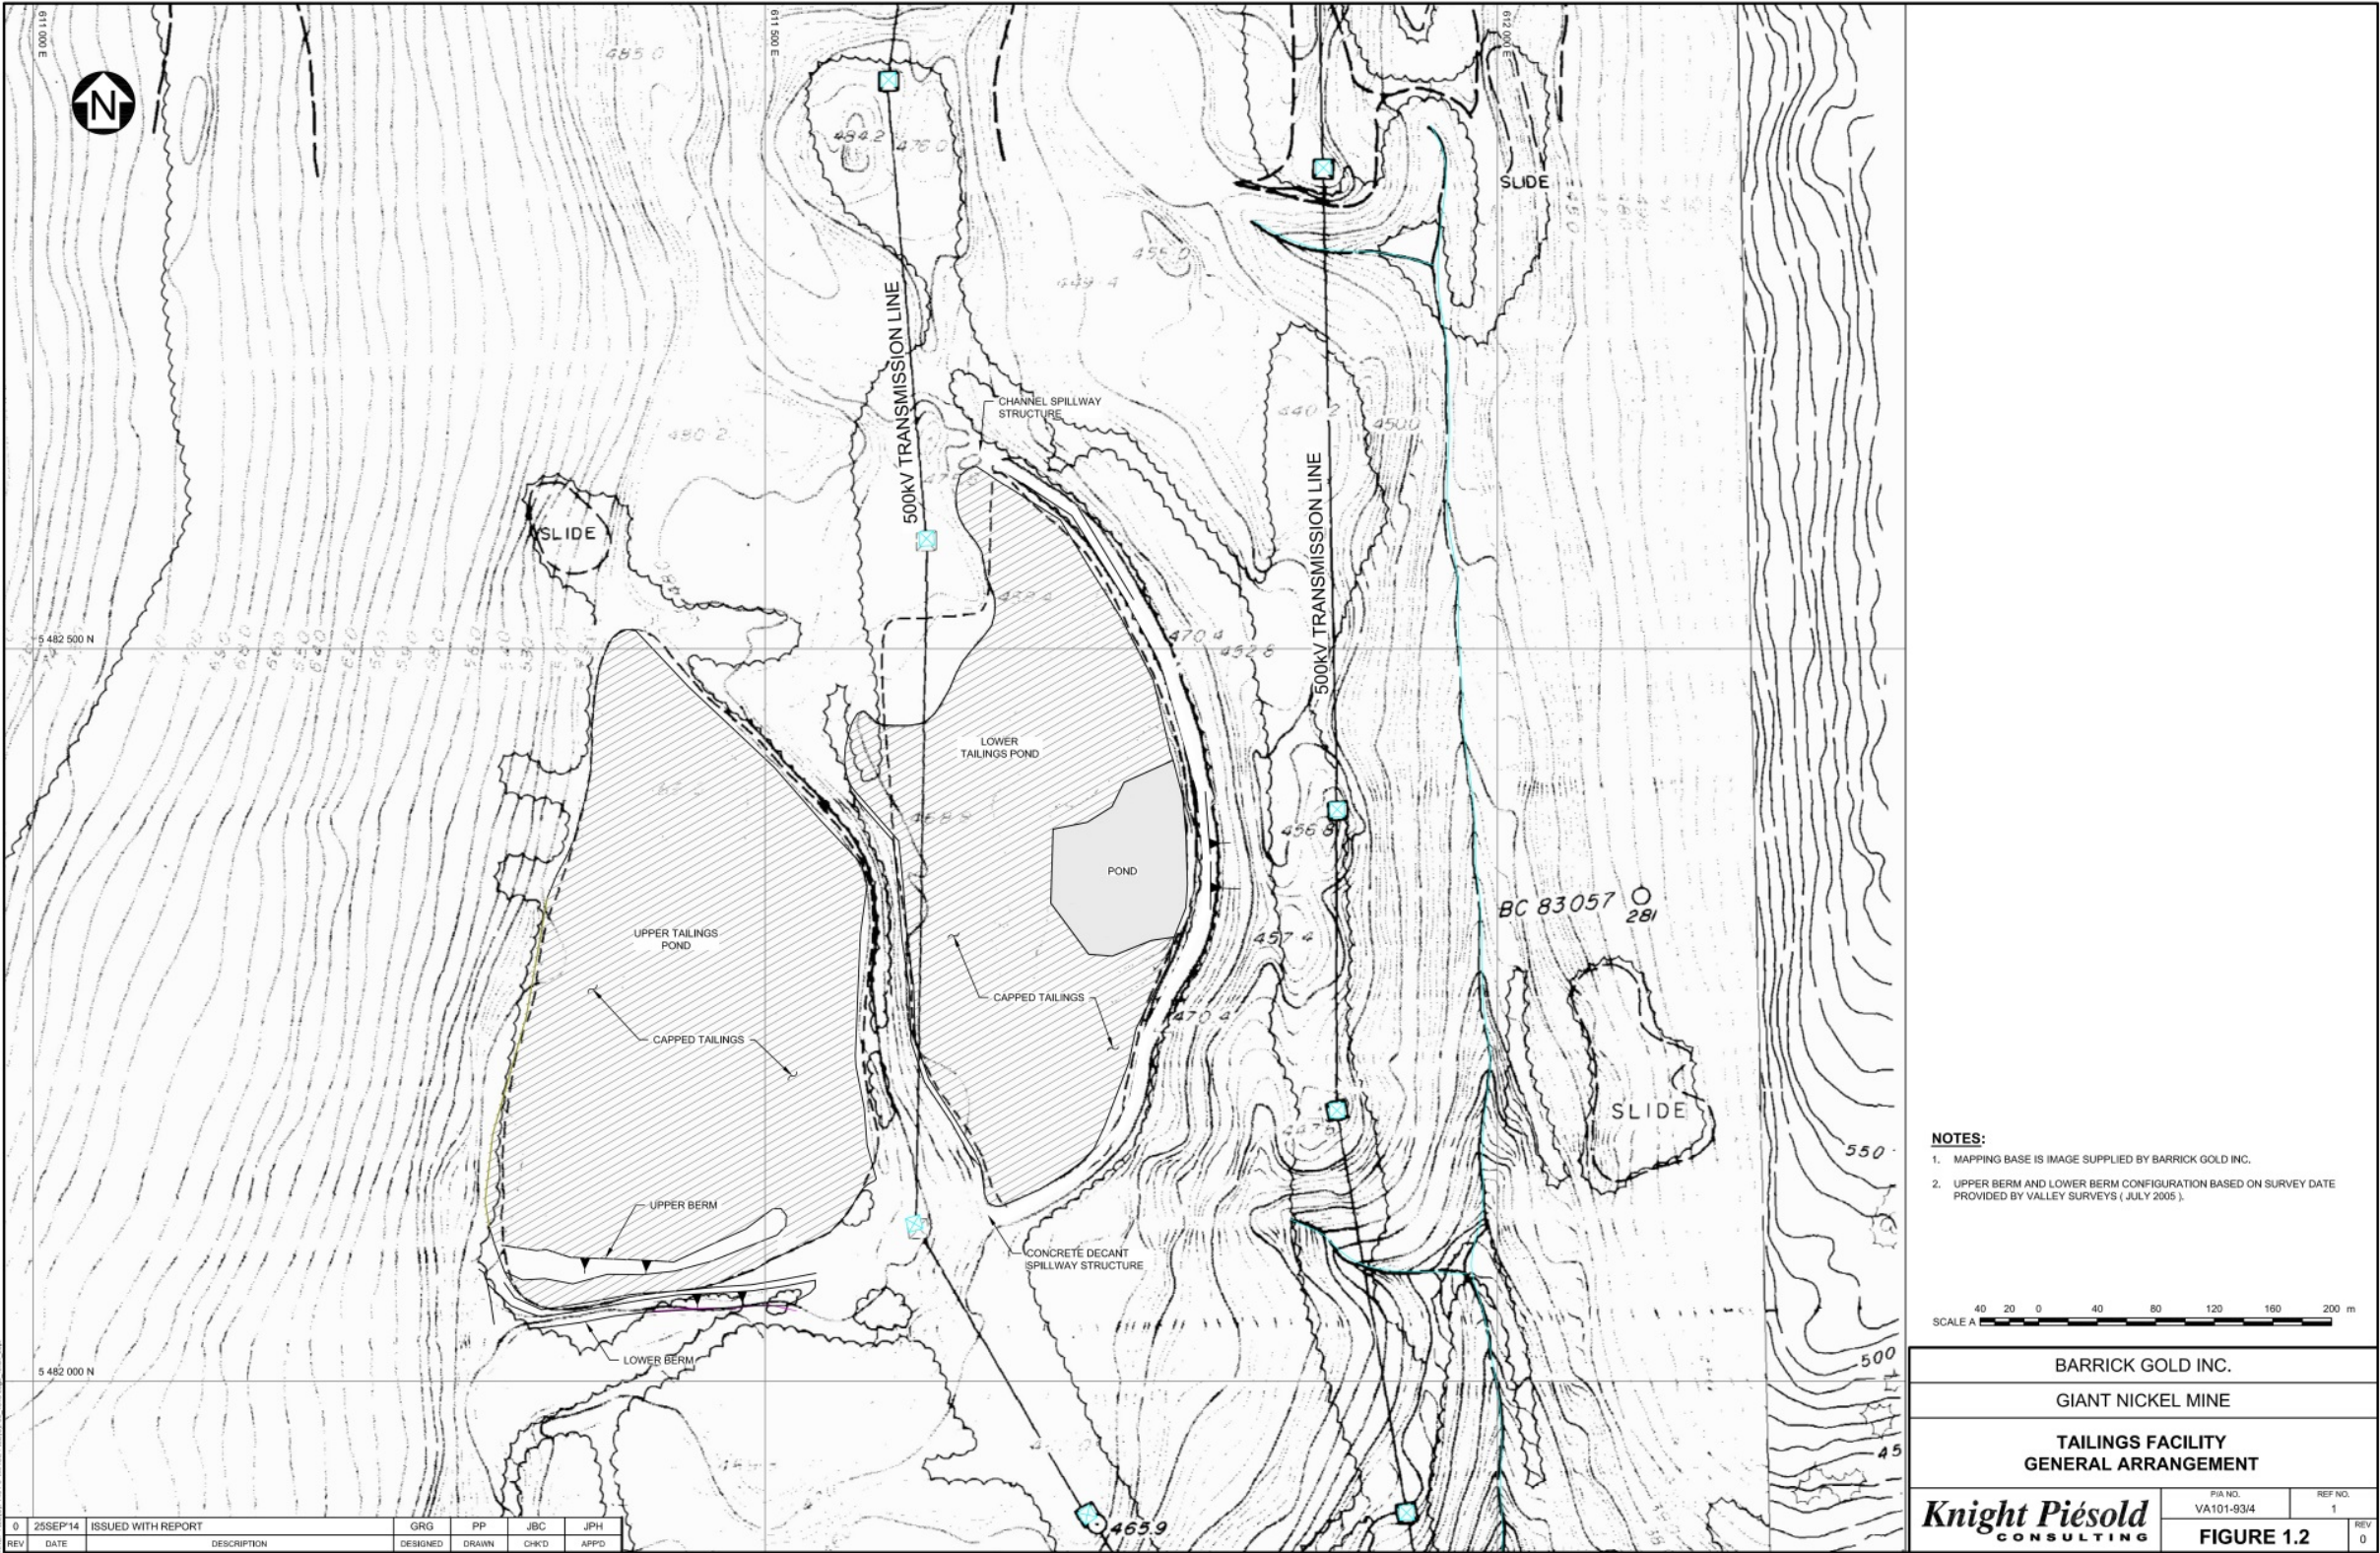
Figure 1.2 Tailings Facility – General Arrangement

Flood water inflows to the tailings facility are temporarily stored within the facility and then discharged through two spillways. A channel spillway is located at the northern corner of the lower tailings pond and a concrete decant spillway structure is located at the southern corner, as shown on Figure 1.2. The concrete decant spillway is currently partially blocked by debris.

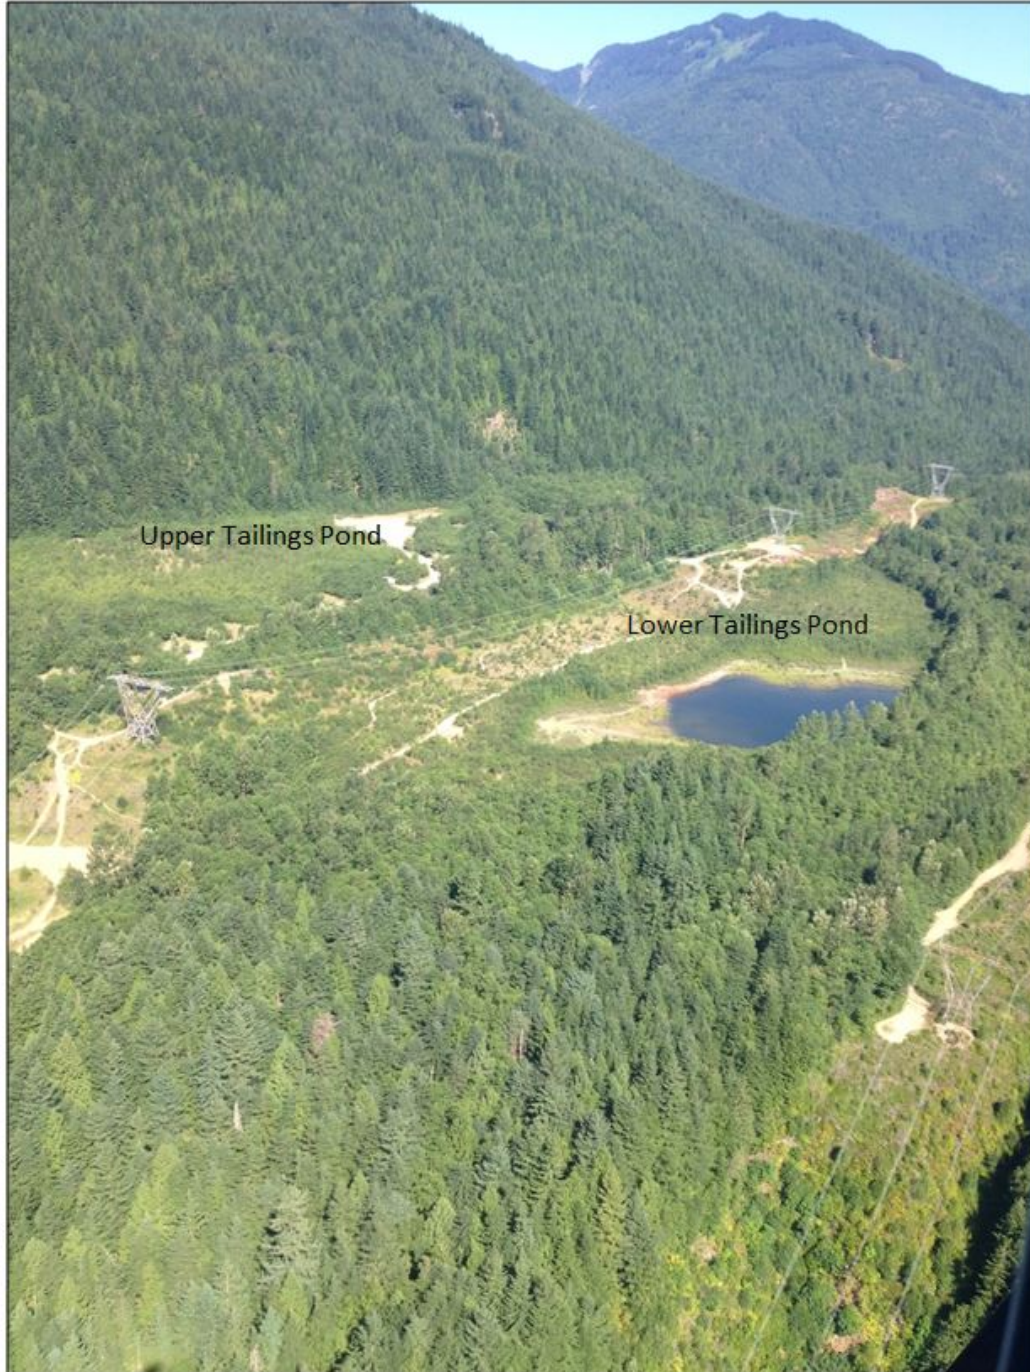
**Figure 1.3      Aerial Photograph of the Tailings Facility (August 5, 2014)**

The tailing surface is capped and generally well vegetated. Revegetation is lighter in some surface areas, including the recreational trails which cross the capped tailings surface (see Figure 3.1 and Photos 3 and 12). A water pond is present on the Lower Tailings Pond surface, adjacent to the eastern embankment (see Photos 4 to 6). The location of this pond is included on Figure 1.2 and can be seen in the aerial photograph of Figure 1.3. Regrading of the capped tailings surface will facilitate elimination of ponded water on the surface of the facility, as discussed in Section 4.

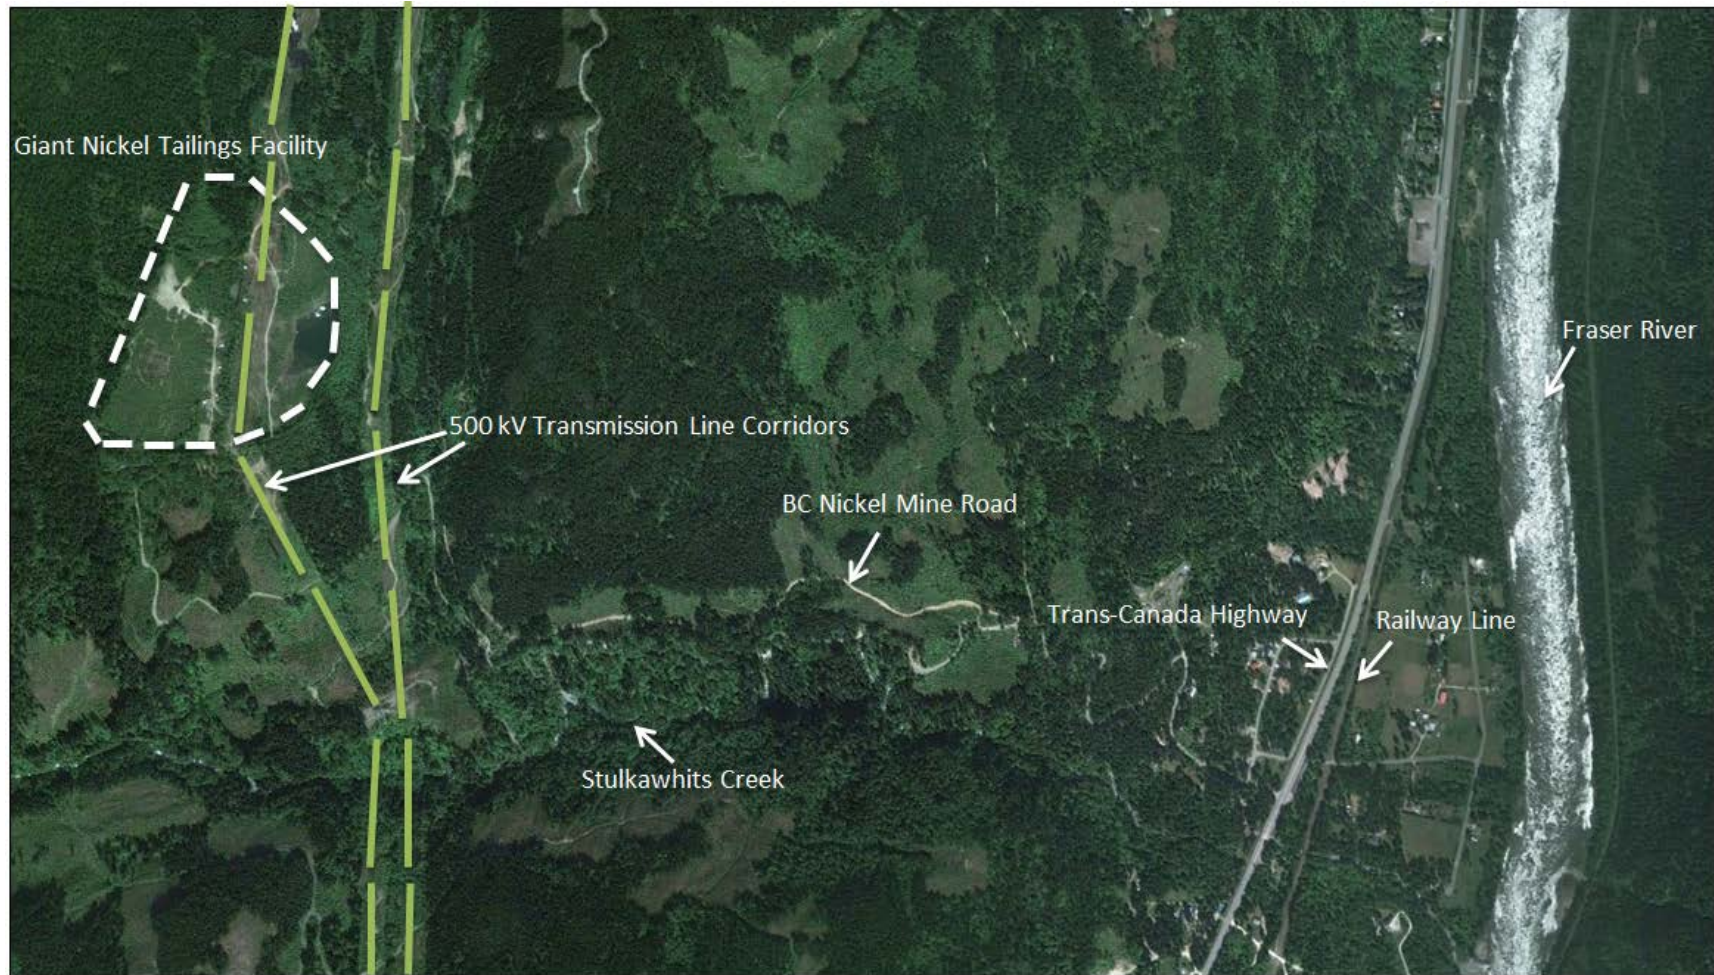
**Figure 2.1      Google Earth Image of the Tailings Facility and Downstream Area**

A preliminary assessment of the potential population at risk downstream of the tailings facility has been assessed using publically available mapping and observations noted during the site inspection of September 8, 2014. Figure 2.1 provides a Google Earth image of the tailings facility and downstream area as far as the Fraser River. There are several dwellings downstream of the tailings facility, located close to Stulkawhits Creek and the Trans-Canada Highway. The potential for loss of life from a dam failure is likely low but cannot be discounted. A dam classification of “HIGH” (loss of life less than 10) is likely appropriate, but may be “VERY HIGH” depending on the predicted inundation area, flood volume and flow velocities.
