Klohn Crippen Berger

Greenwood Gold Project

Tailings Storage Facility - Dam Safety Review

November 25, 2014

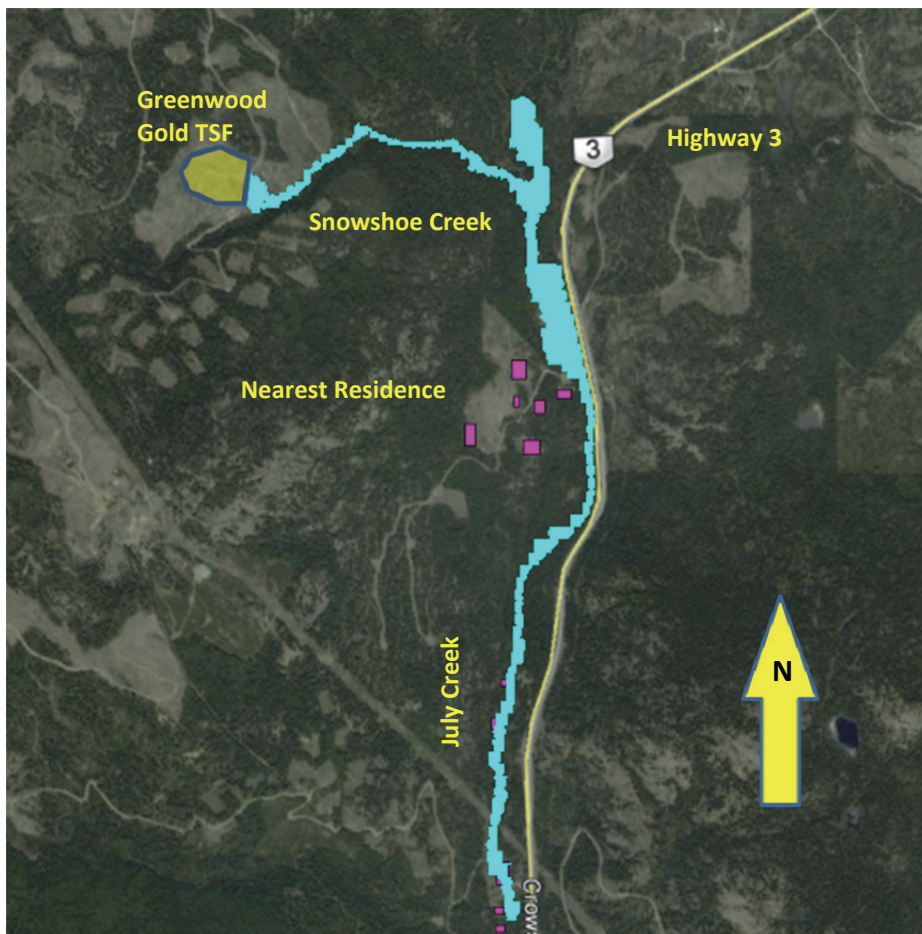
Figure 5.1 Maximum Inundation Area for Rainy Day Dam Breach- 1.7 km from base of TSF to Highway 3 (12% grade) and 2.2 km to nearest permanent dwelling (average 10% grade) (Google Earth 2014)

Figure 5.1 shows the expected inundation flow path, which follows Snowshoe Creek and into July Creek, where it parallels Highway 3 and passes by several residences.
