# 2014 FORMAL ANNUAL DAM INSPECTION OF HB MINE TAILINGS STORAGE FACILITY SALMO, BC

SEPTEMBER 15, 2014  
ISSUED FOR USE  
FILE: K13103109-03

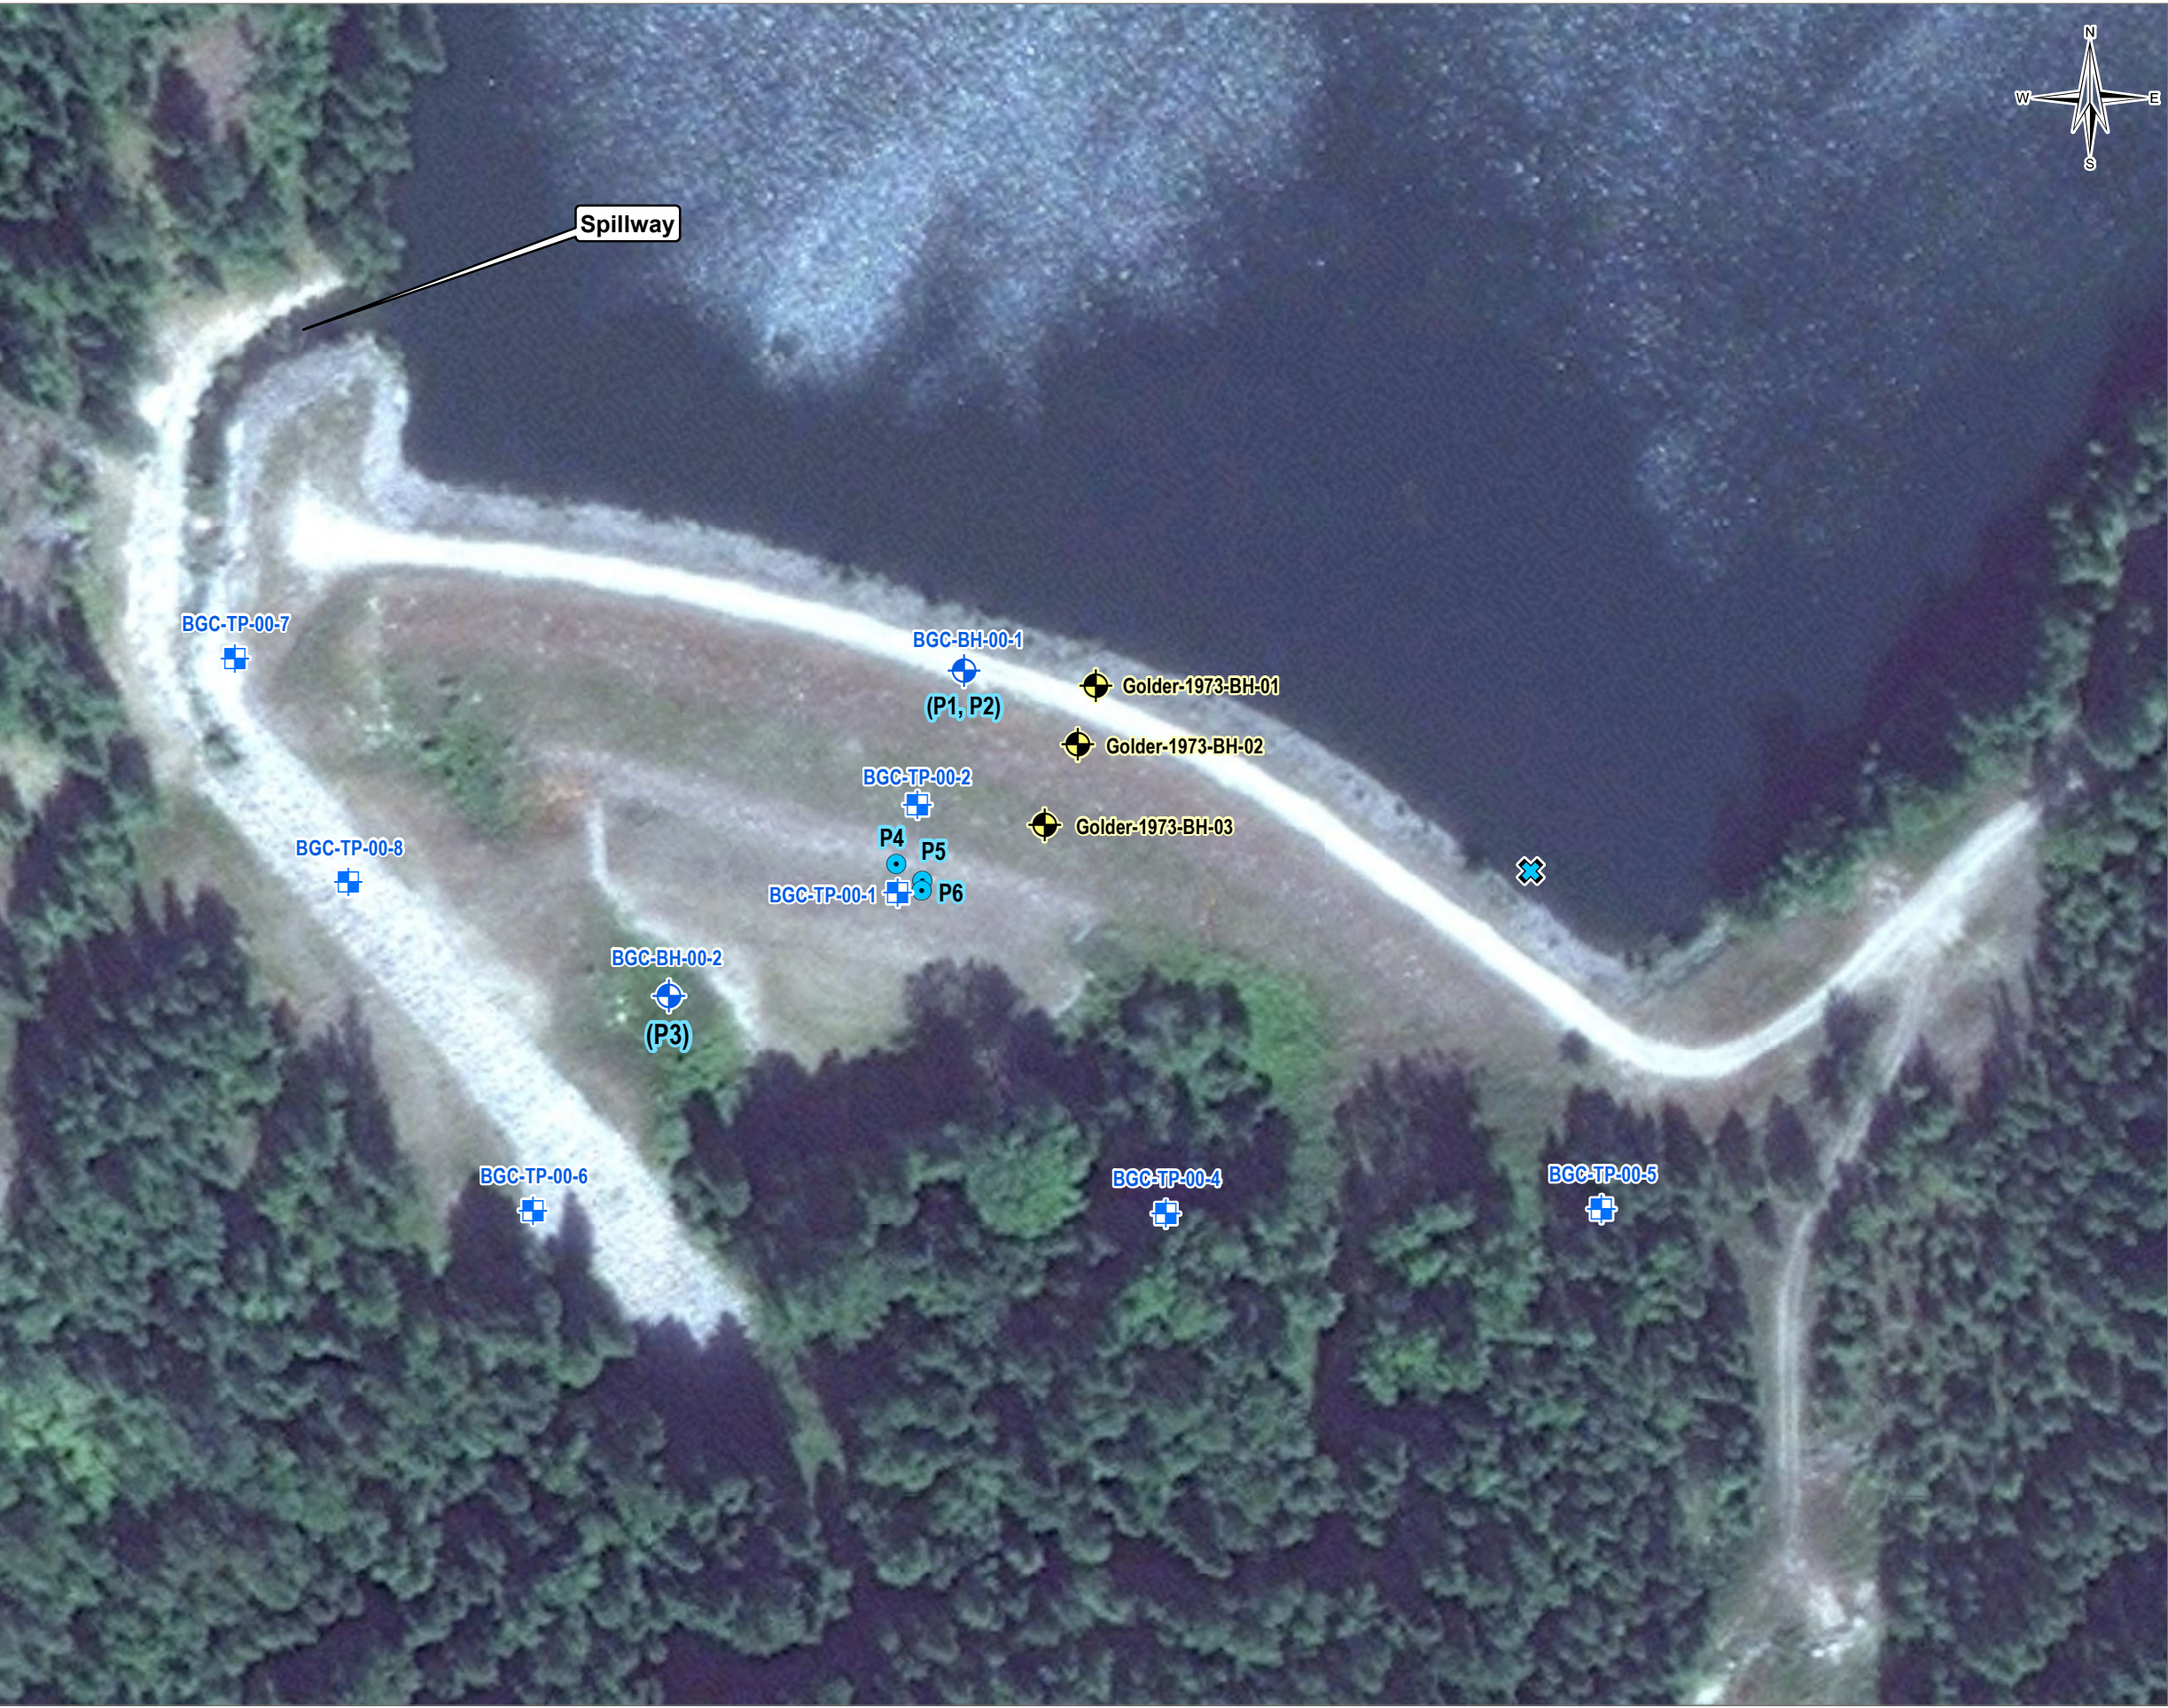
<p>Meters</p>				
FILE NO. Figure 3.7a- Site Instrumentation.mxd				
PROJECT NO. K13103109-01	DWN SB	CKD LM	APVD MJL	REV 1
OFFICE KELOWNA		DATE March 28, 2014		
				Figure 3.2a

The location of the four piezometers is shown on the attached Figure 3.2a.
