# DAM SAFETY REVIEW OF HB MINE TAILINGS STORAGE FACILITY SALMO, BC

**Regional District of the Central Kootenay**

MAY 28, 2014

FILE: K13103109-01

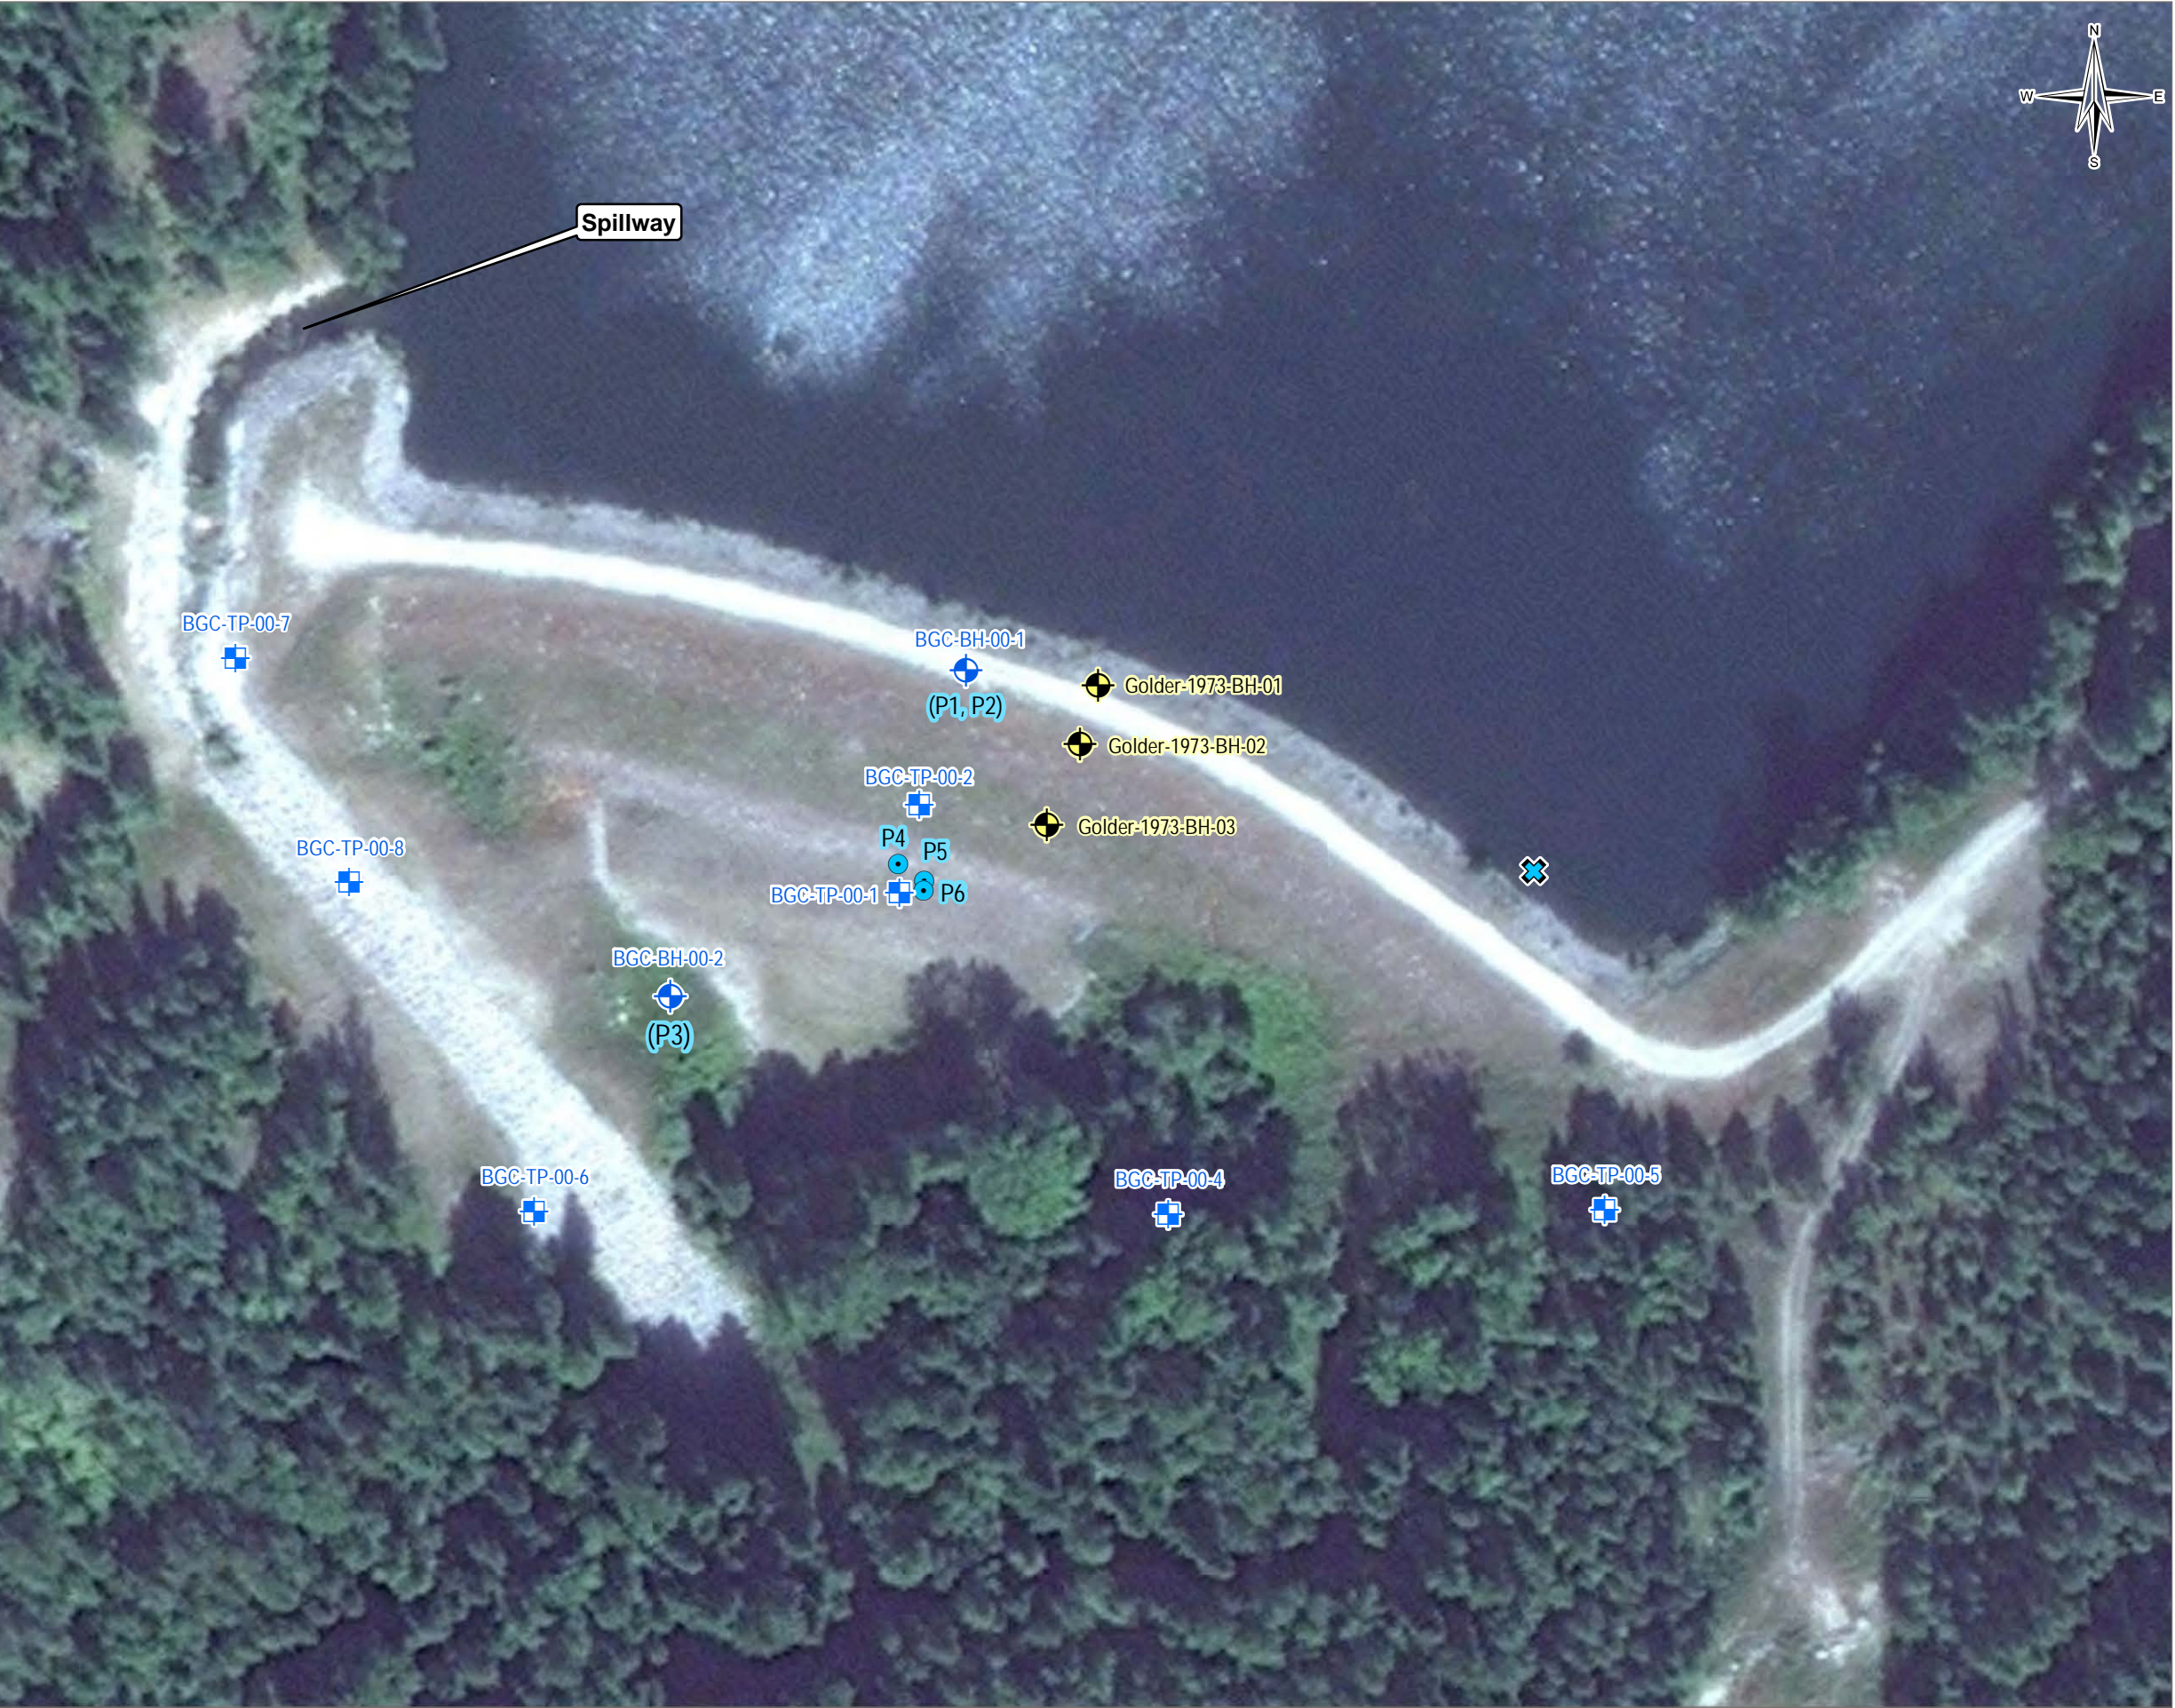
The locations of the piezometers are shown on the attached Figure 3.7a and the water level readings can be seen on the attached Figure 3.7b. Review of the data for the past 12 months indicates that there is an approximate correlation between the pond level and the hydrostatic pressures in the embankment.

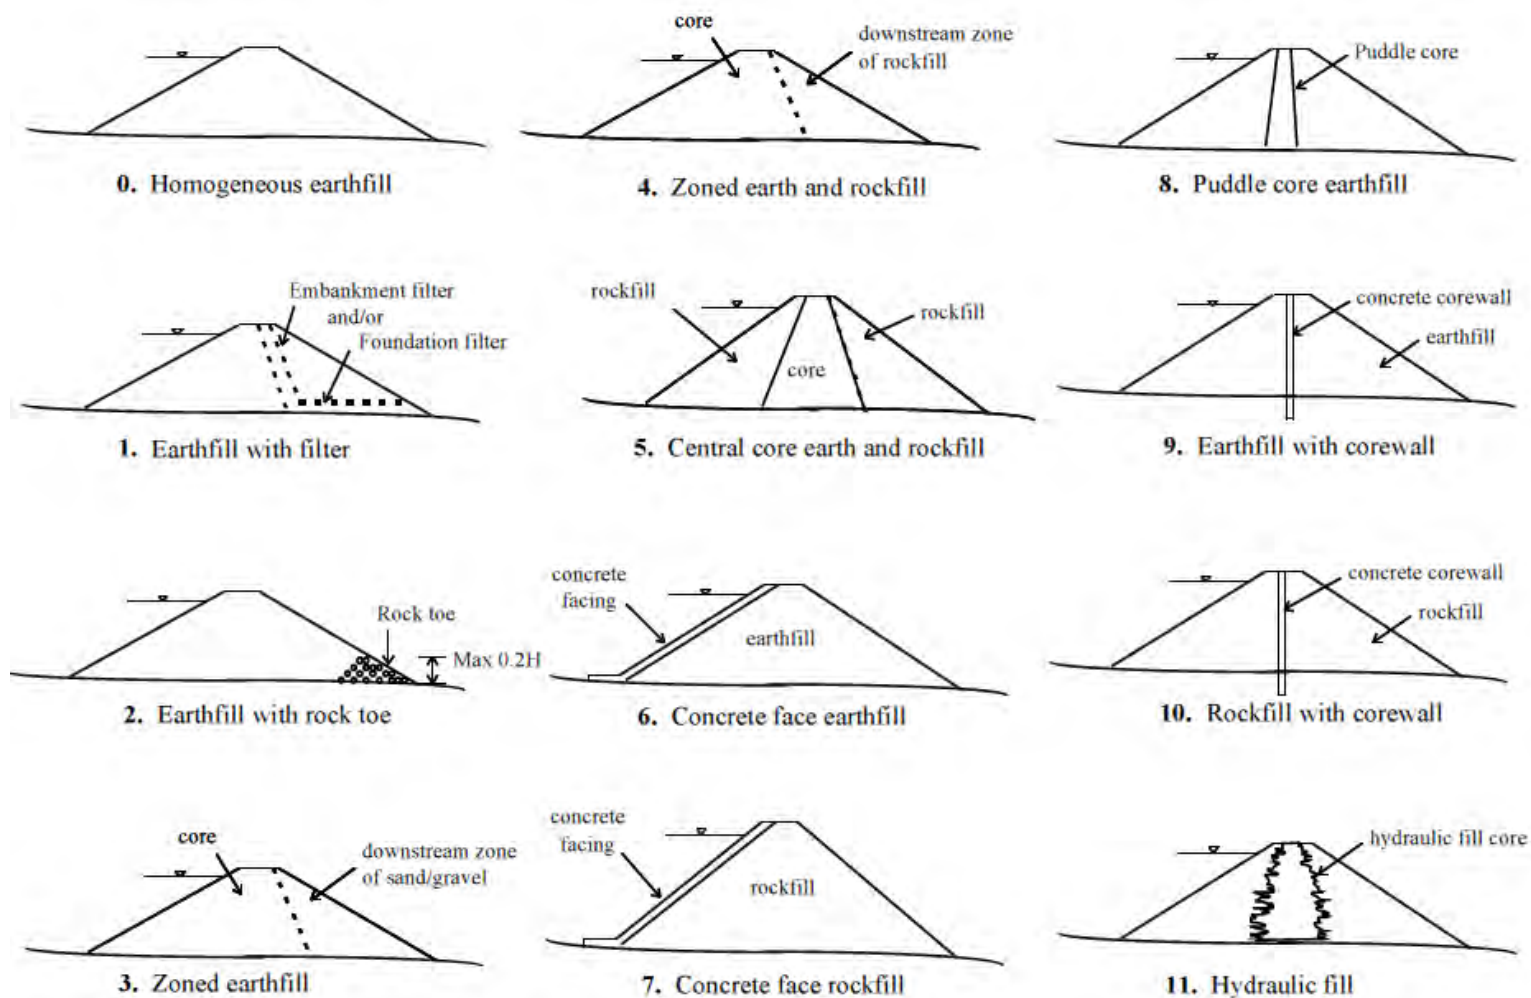
Once internal erosion is initiated, it will continue unless the eroding forces are reduced or the passage of the eroded particles is impeded in some way. Since the 1950s dam engineers have known that the most efficient way to stop the erosion process in embankments is to zone the dam and incorporate filters. Based on the statistics of embankment dam failures and incidents (Foster et al 2000a) these can be categorized in regards to their capability of providing control internal erosion in the embankment as shown in the attached Figure 8.7c and Table 8.7a below.

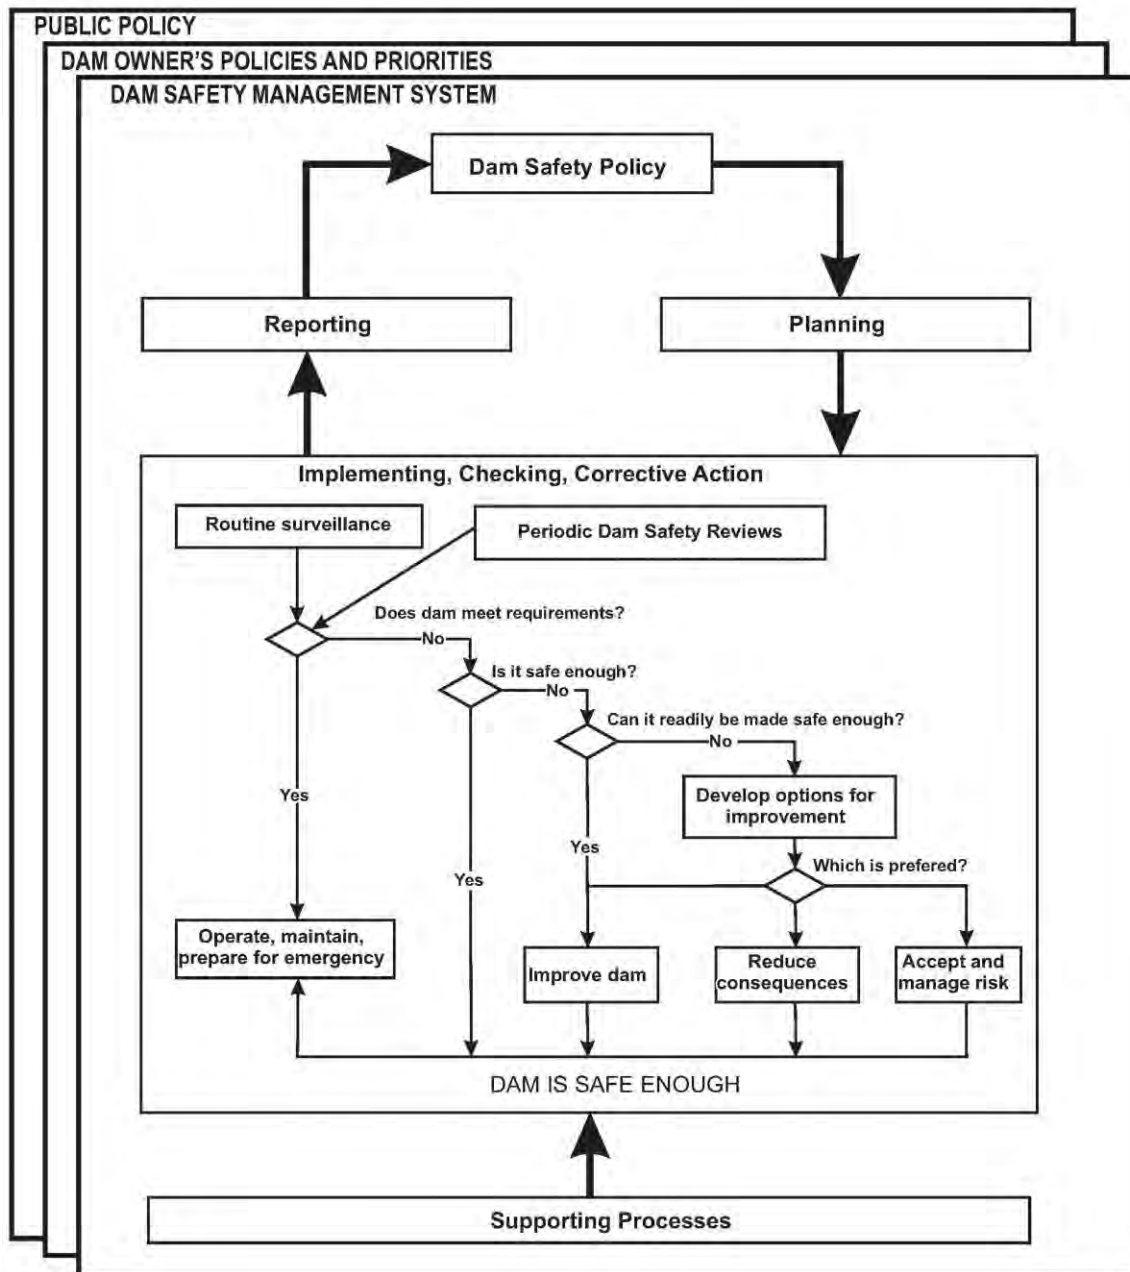
Figure 10.1

A general schematic of a dam safety management system is presented in Figure 10.1. Tetra Tech EBA has assessed the dam safety management system in place for the HB Dam and the results of this assessment are presented in this section.

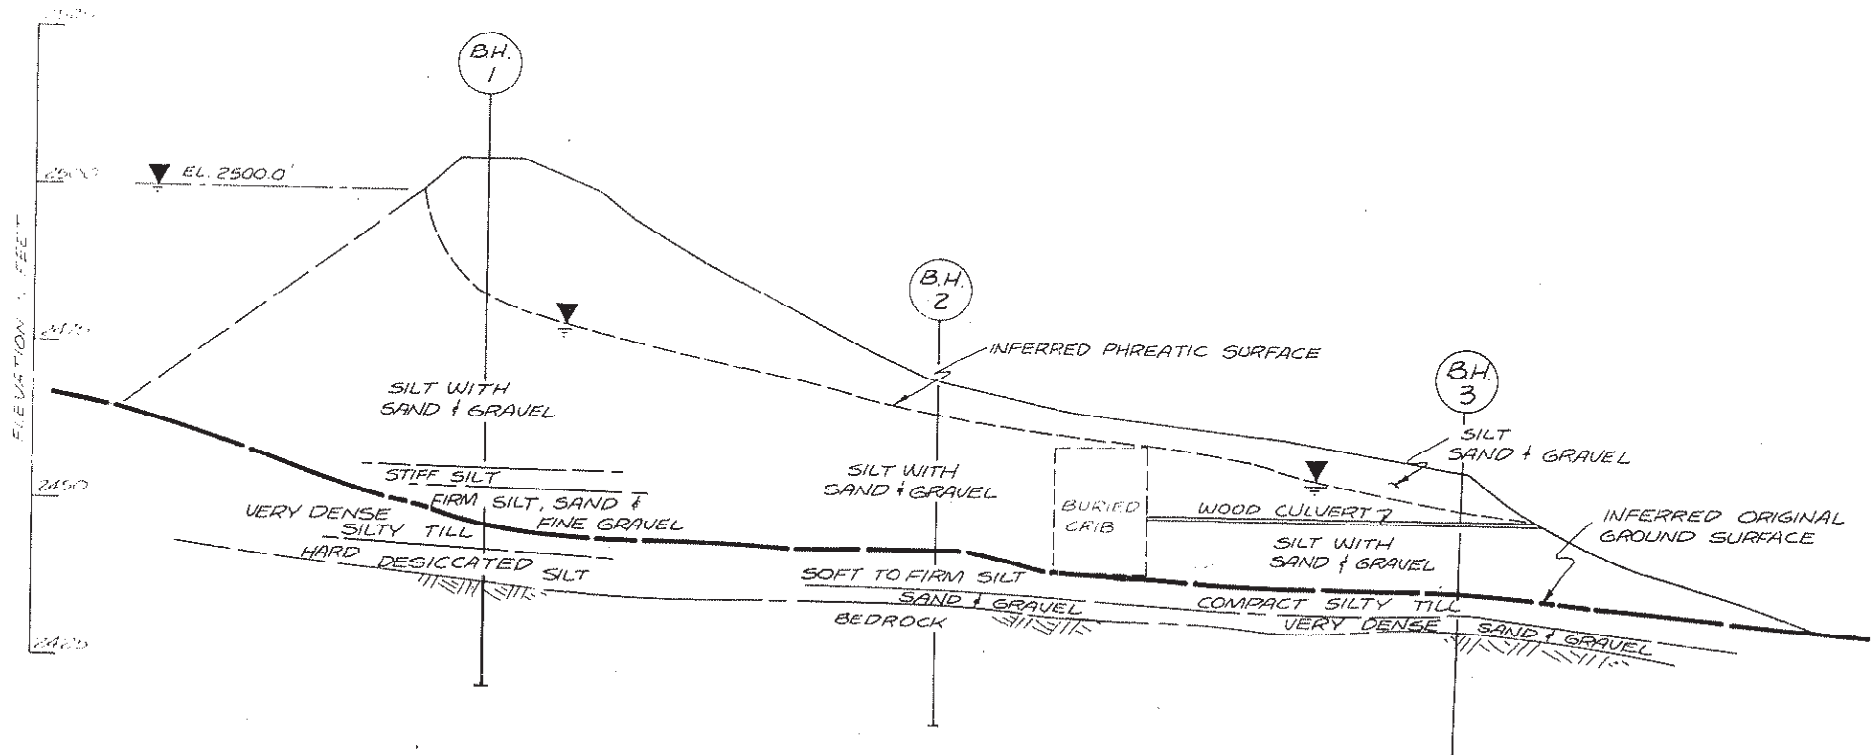
FIGURE 2

CROSS SECTION A-A SHOWING  
INFERRED SOIL STRATIGRAPHY  
& PHREATIC SURFACE
