# **British Columbia Ministry of Energy and Mines**

## **2014 Dam Safety Inspection**

### ***Good Friday and Jumbo Tailings Storage Facilities Red Mountain Mine***

November 28, 2014

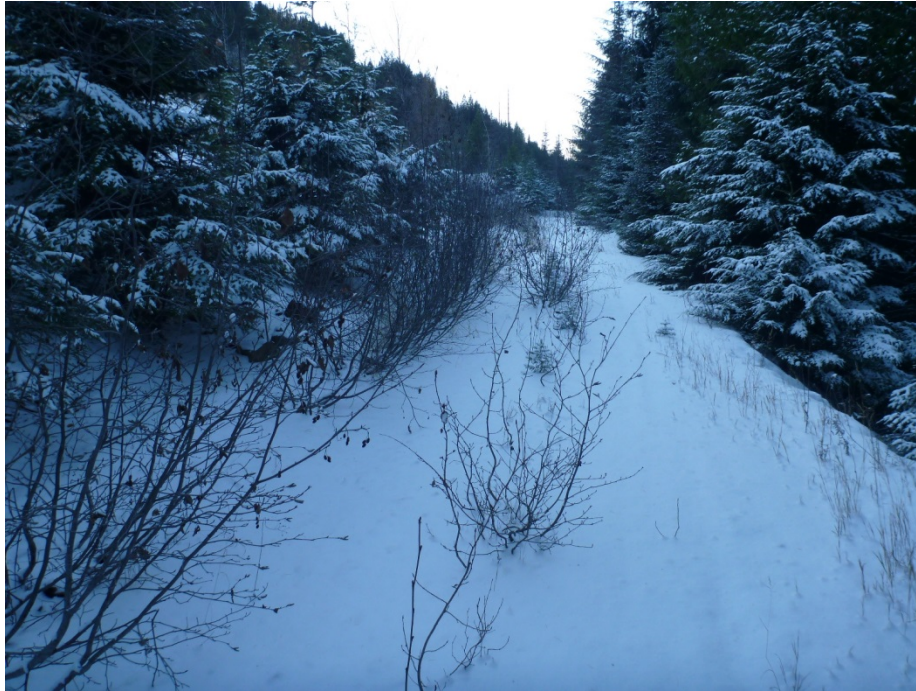
- The downstream slope of the dam consists of a rockfill slope with rockfill particles up to approximately 1.0 m in size. Seepage was visible in the downstream toe area of the West Limb near the right abutment as well as in the northern portions of the downstream toe ditch. The toe access road along the West Limb toe to the southwest corner of the South Limb is becoming overgrown with willows/alders. The rockfill buttress/toe berm repair of the natural slope below the South Limb of the dam appears to be in good condition with no obvious deformations. The downstream slope does not appear to have changed from what is shown in figures included in Appendix I. Deciduous and coniferous trees are growing sporadically on the downstream face of the dam (Photos 1 through 9).

Photo 3 – Good Friday, West Limb of dam, downstream toe area. Photo taken facing south approximately 20 m past barricade entrance to toe access road. Natural slope downstream of dam, to left in photo) is heavily treed.

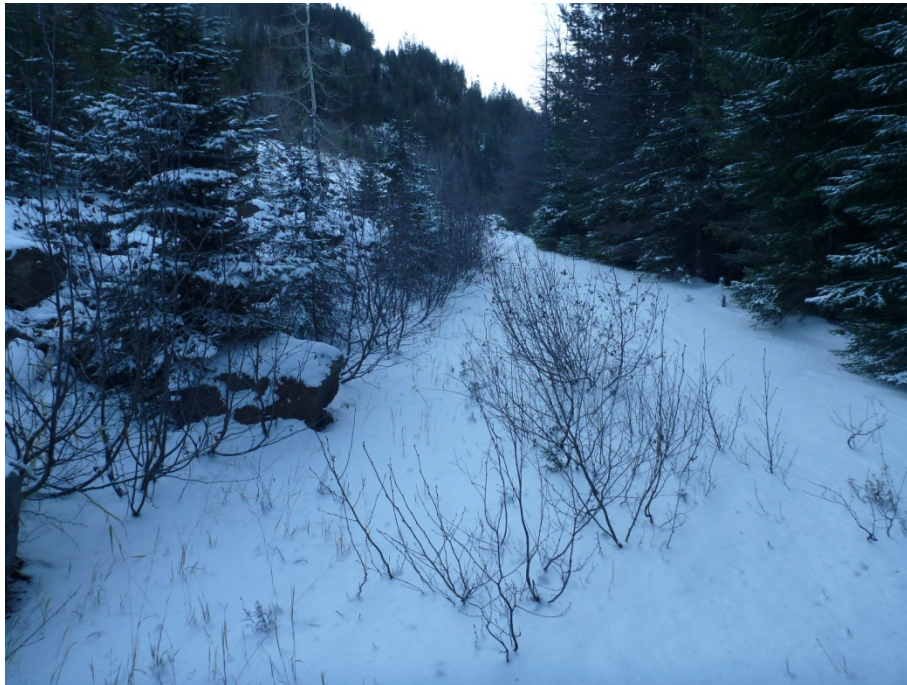
Photo 4 – Good Friday, start of South Limb of dam. Photo taken facing south on downstream toe access road.

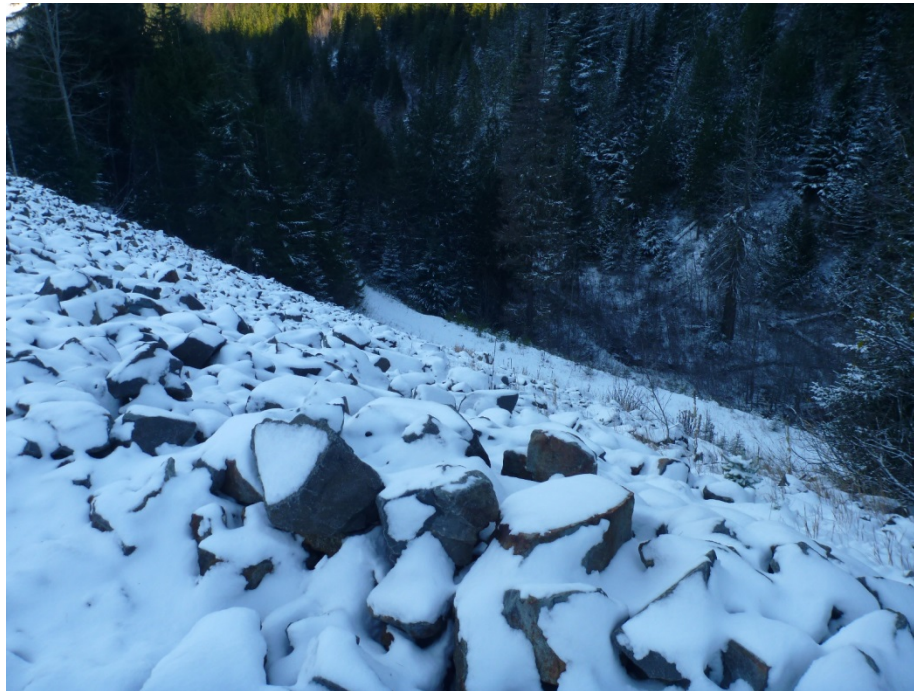
Photo 6 – Good Friday, downstream toe area. View looking downslope over rockfill buttress repaired natural slope above main access road from Hwy 3B. Photo taken facing south east.

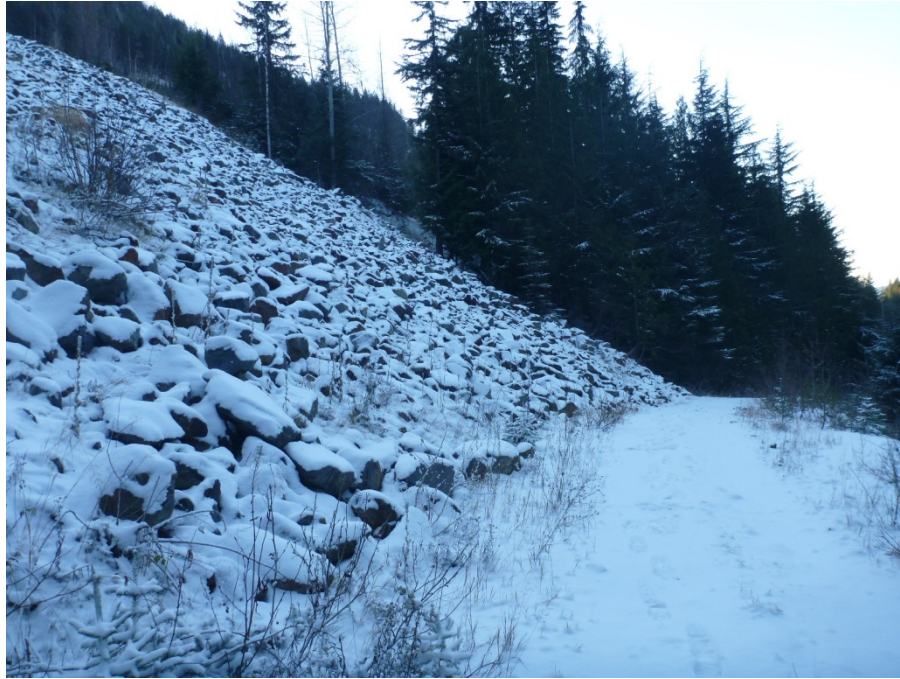
Photo 7 – Good Friday, downstream toe area. Photo taken facing south along access road from Hwy 3B of rockfill stabilized natural slope below South Limb of dam.

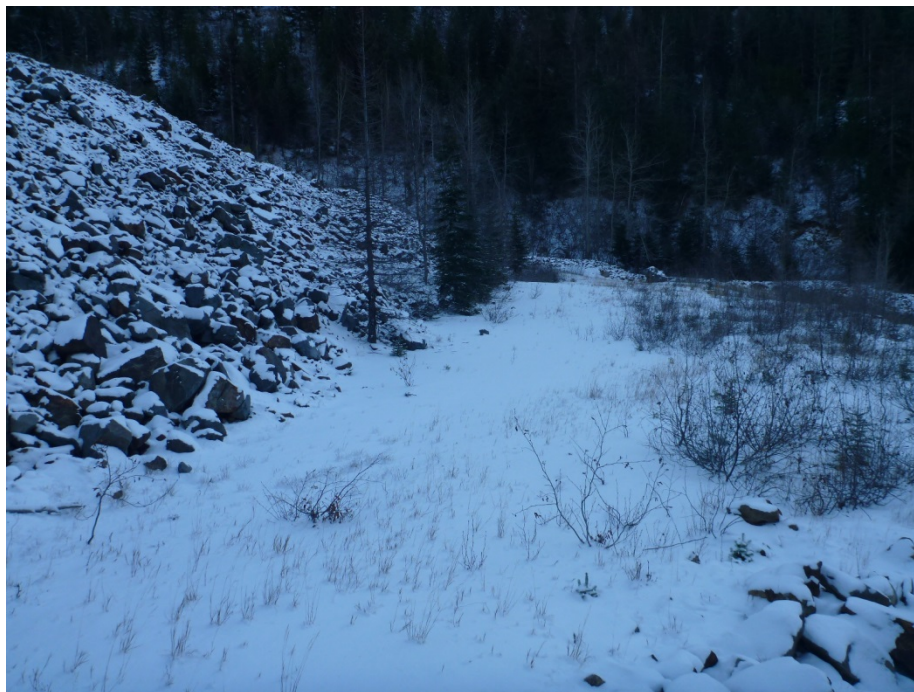
Photo 8 – Good Friday, South Limb downstream toe of dam. Photo taken facing east towards spillway channel.

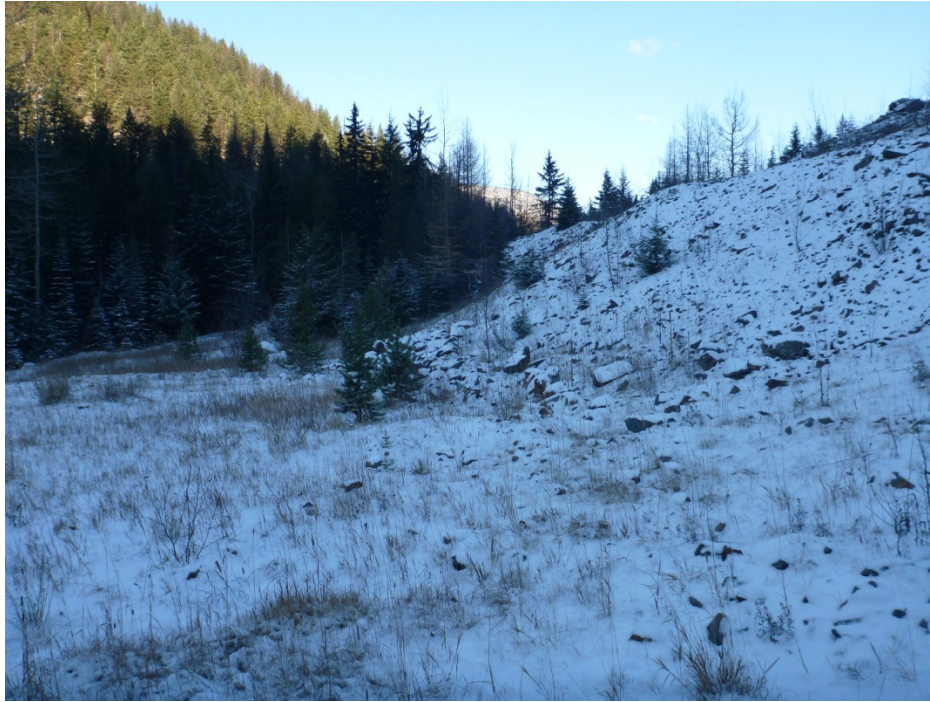
Photo 9 – Good Friday South Limb downstream slope. Photo taken facing north from channel downstream of spillway.

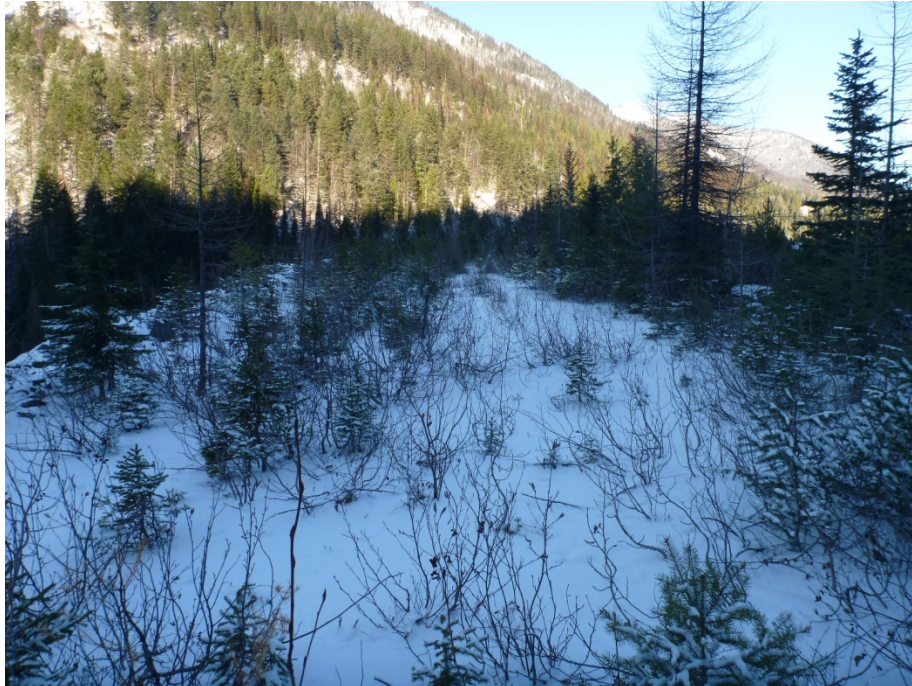
- The crest is relatively even and straight. The upstream crest – tailings transition appears to be defined by the transition from the rockfill crest to the grassed reclaimed tailings surface. Deciduous and coniferous trees are growing sporadically on the crest of the dam (Photos 10 through 15).

Photo 10 – Good Friday crest of South Limb dam. Photo taken facing north west.

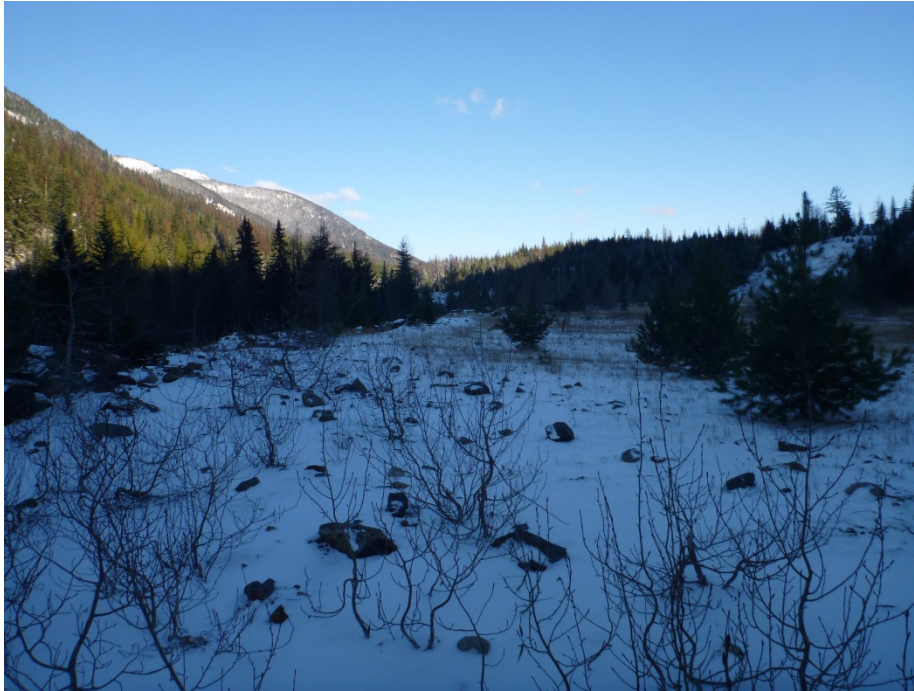
Photo 11 – Good Friday, crest of South Limb of dam. Photo taken facing north towards West Limb of dam.

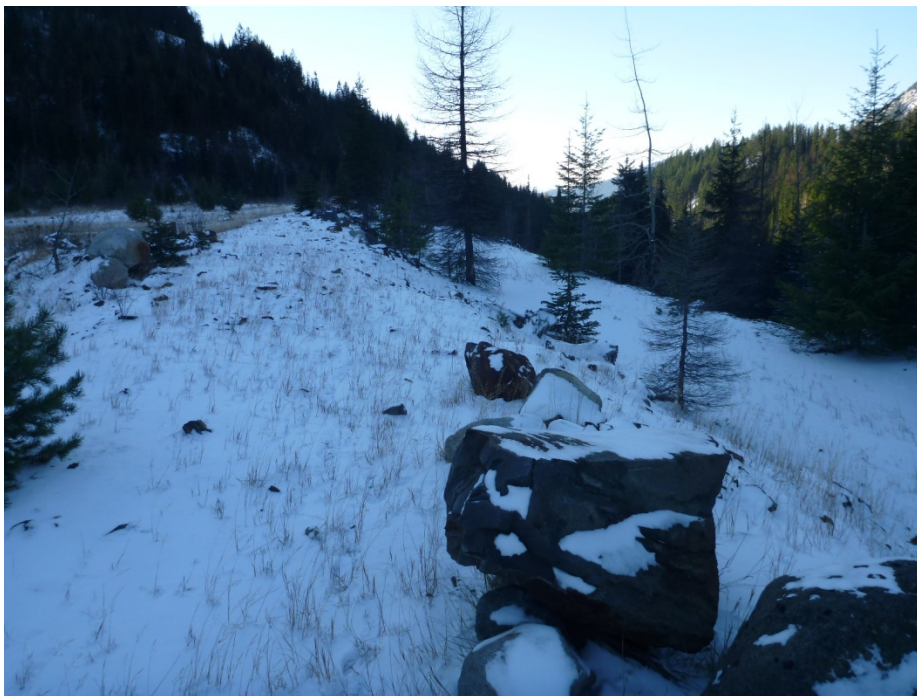
Photo 12 – Good Friday, crest of South Limb of dam. Photo taken facing south. Note toe access road to right of picture.

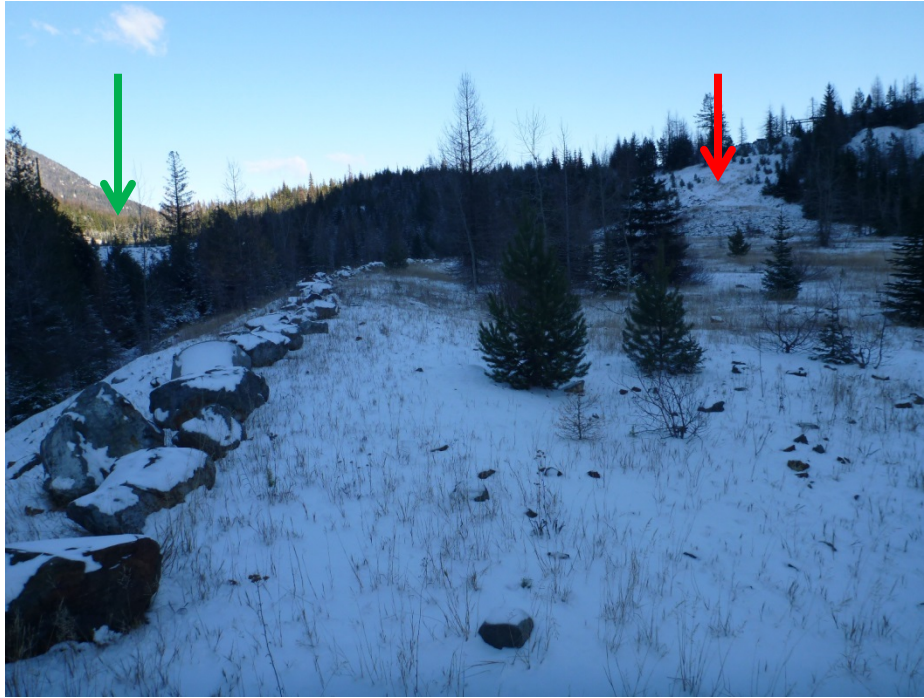
Photo 13 – Good Friday crest of West Limb of dam. Photo taken facing north. Red arrow indicates reclaimed hillside tailings pile. Green arrow indicates location of Jumbo dam.

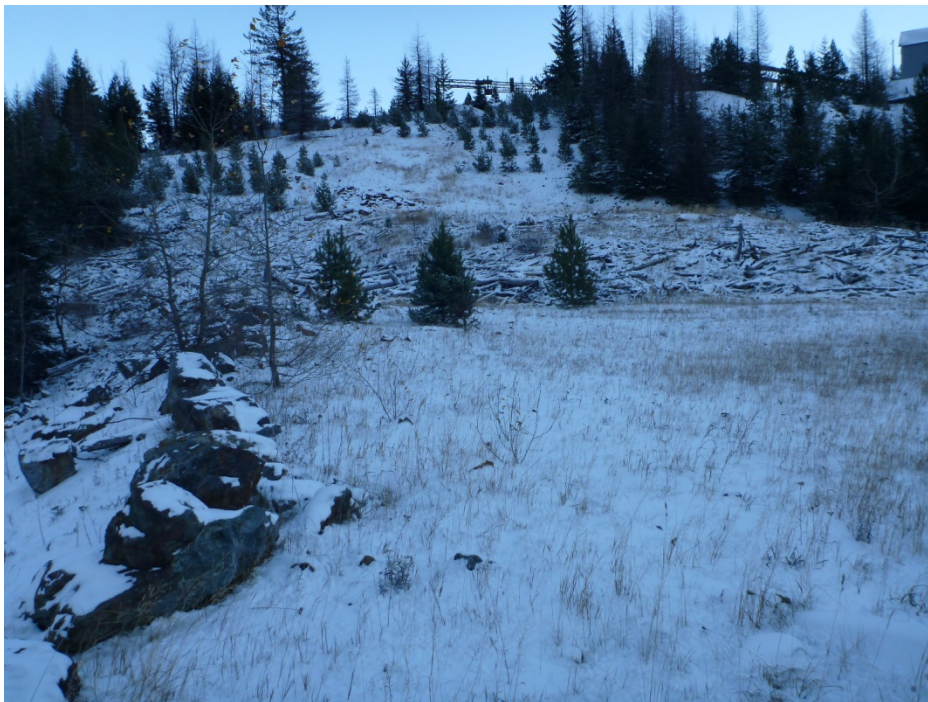
Photo 14 – Good Friday crest of West Limb of dam. Photo taken facing north - north east facing reclaimed hill side tailings pile.

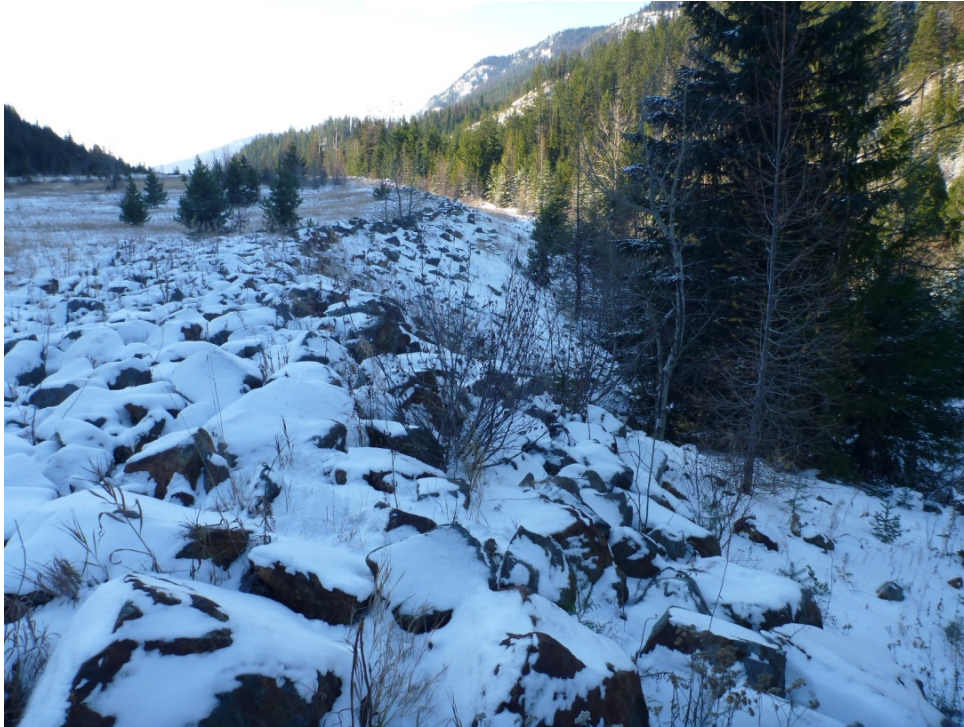
Photo 15 – Good Friday crest of West Limb of dam. Photo taken at right abutment facing south.

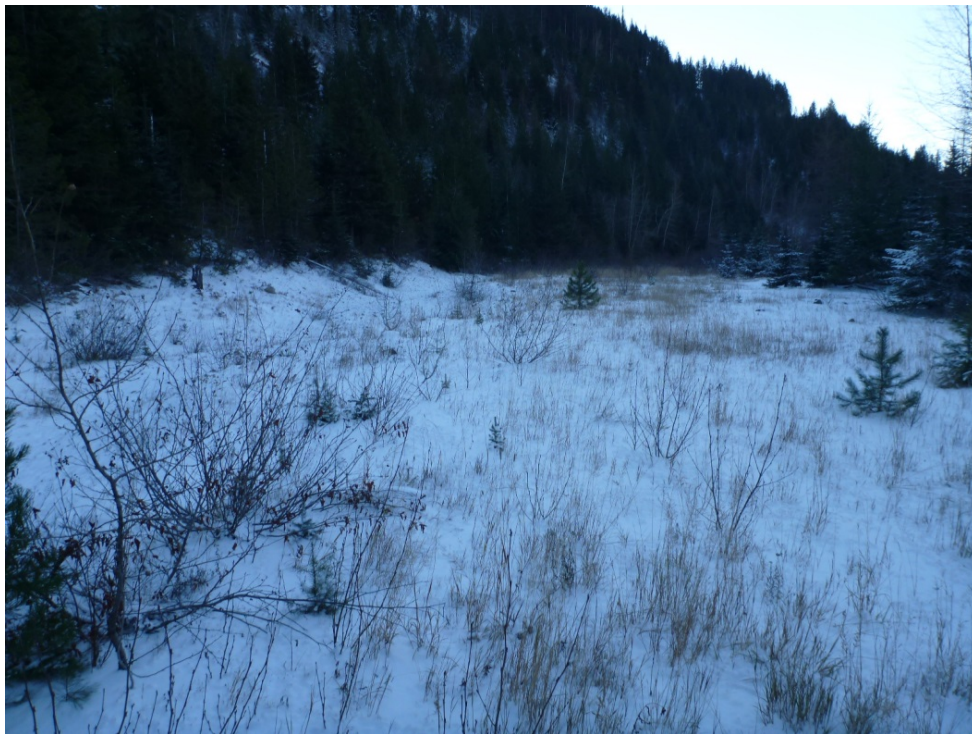
- The drainage channel on the reclaimed tailings surface appears to be in good condition. Some seepage from the slope above the TSF was flowing through the drainage channel in the southern half of the channel (Photos 16 through 19). Evidence of high water marks were not observed during the inspection due to snow cover.

Photo 16 – Good Friday drainage channel on reclaimed tailings surface at toe of slope above impoundment. The north quarter of the channel is shown in this photo. Photo taken facing south east.

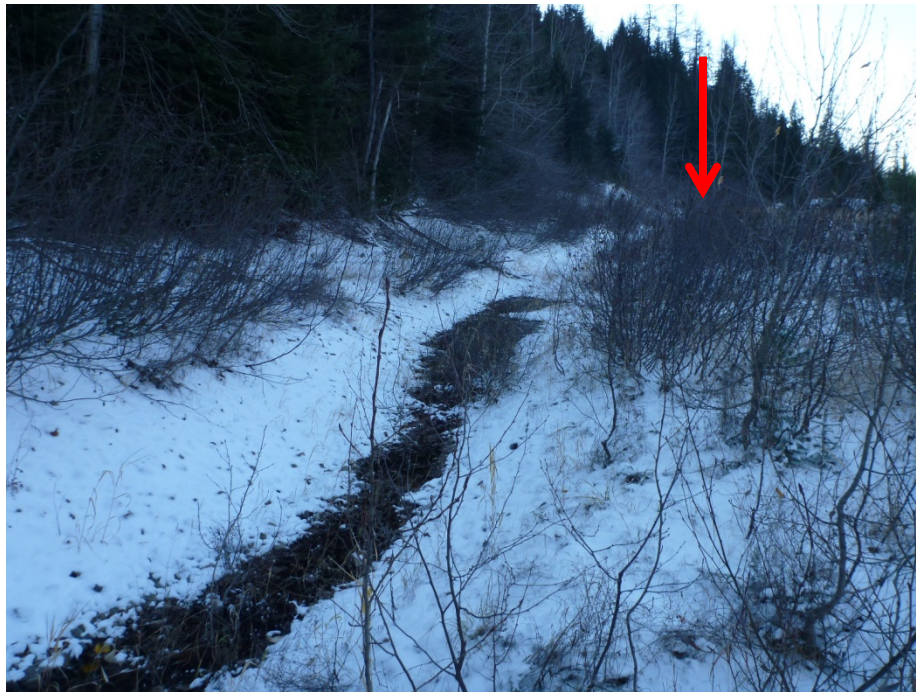
Photo 18 – Good Friday drainage channel. Photo taken facing south towards spillway. Red arrow shows approximate start of spillway.

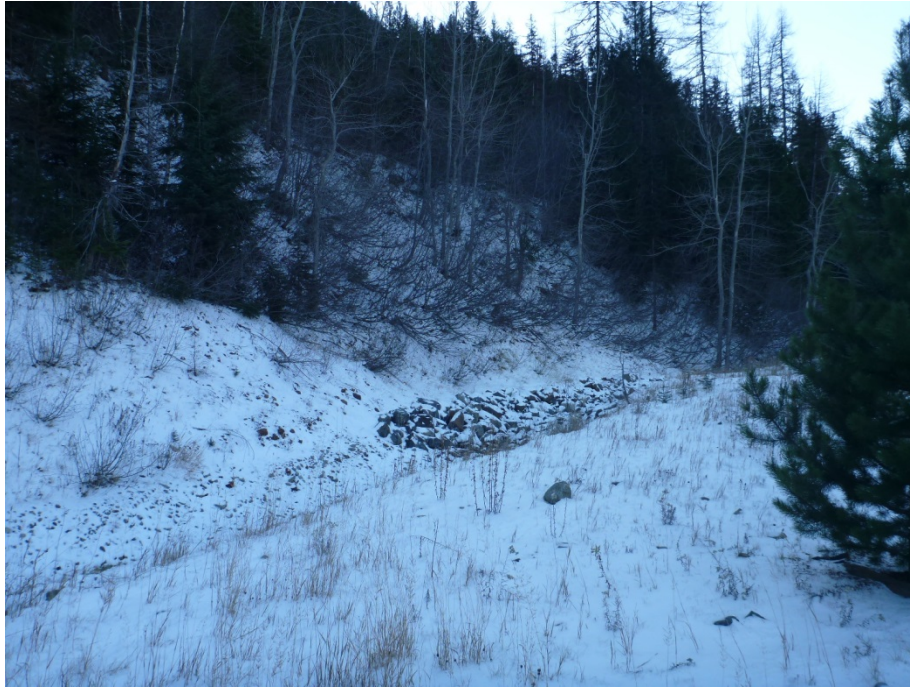
Photo 19 – Good Friday drainage channel and spillway at left abutment. Photo taken facing south east. Transition from drainage channel to spillway is indicated by change in size of channel armouring from gravel and cobbles to rip rap cobbles and boulders.

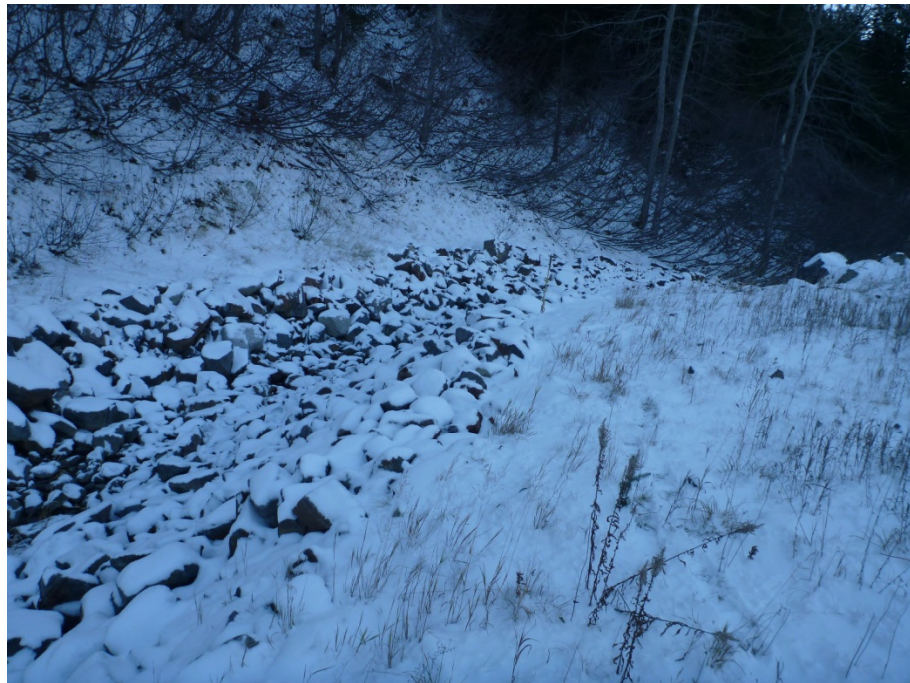
- The spillway on the left abutment of the TSF dam appears to be in good condition. Evidence of high water marks was not observed during the inspection. However, willows/alders and small coniferous trees were noted to be growing in the spillway channel beyond the downstream toe of the dam which would impede water flow through the channel. There appears to be a small instability of a natural slope beyond what is believed to be the downstream limit of the slope drain system constructed as part of the reclamation works. This instability does not appear to pose a risk of blocking the spillway channel (Photos 20 through 22).

Photo 20 – Good Friday spillway channel passing over crest of South Limb of dam. Photo taken facing south east.

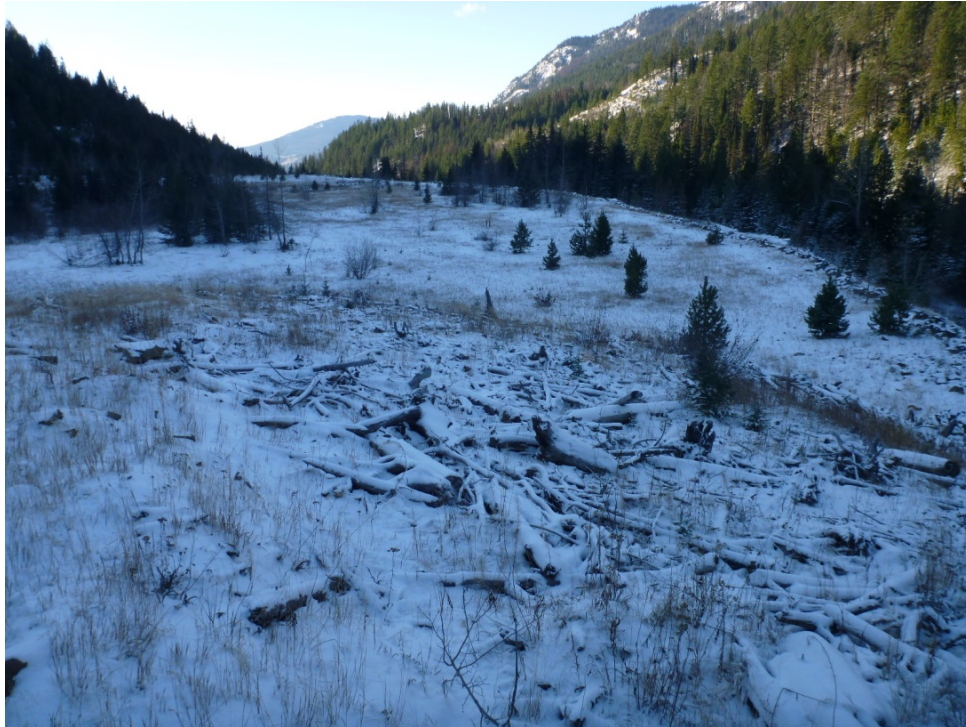
- The reclaimed side hill tailings pile on the north slope above the north portion of the Good Friday impoundment appears to be in good condition (Photo 23).

Photo 23 – Good Friday reclaimed tailings surface. Photo taken facing south from top of reclaimed hill side tailings pile to north of Good Friday impoundment.

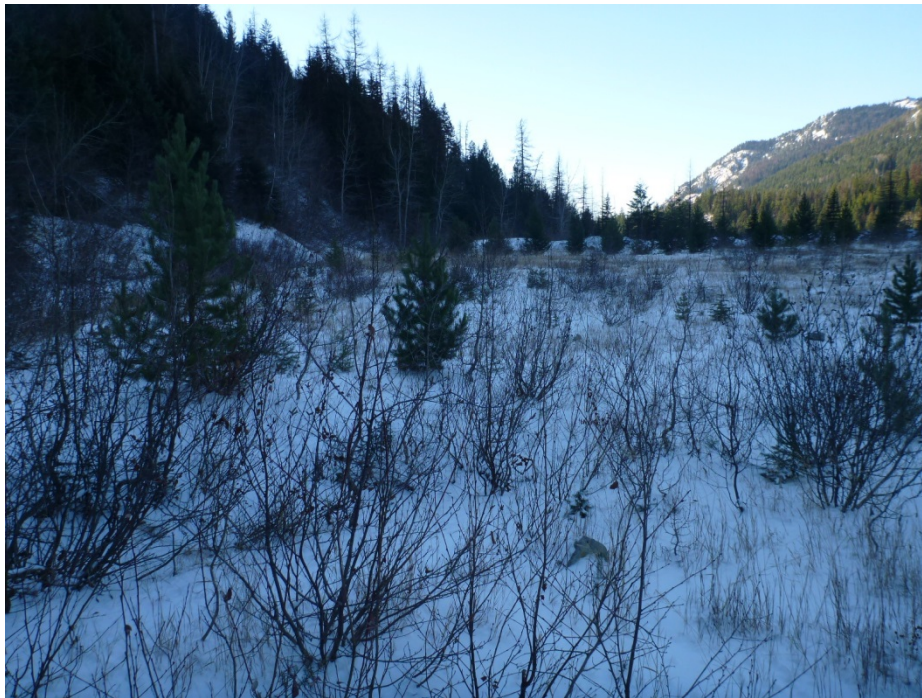
- The reclaimed tailings surface appears to be well vegetated. Ground surface cover appears to be well established in the few areas visible through snow cover. Additionally, there is a grove of deciduous and coniferous trees growing on the reclaimed tailings surface with small deciduous and coniferous trees scattered across the remainder of the reclaimed tailings surface. The reclaimed tailings surface is gently undulating, most likely due to settlement of the tailings under the additional load of the tailings cap and possibly due to landscaping earth works. The markings for the former decant locations appear to have been destroyed since 2004 and could not be located. However, the general area of the former decant locations is generally level with no obvious surface depressions (Photos 24 through 26).

Photo 24 – Good Friday reclaimed tailings surface at south end of tailings impoundment. Photo taken facing south. Drainage channel leading to spillway at left abutment of dam is located to left of photo.

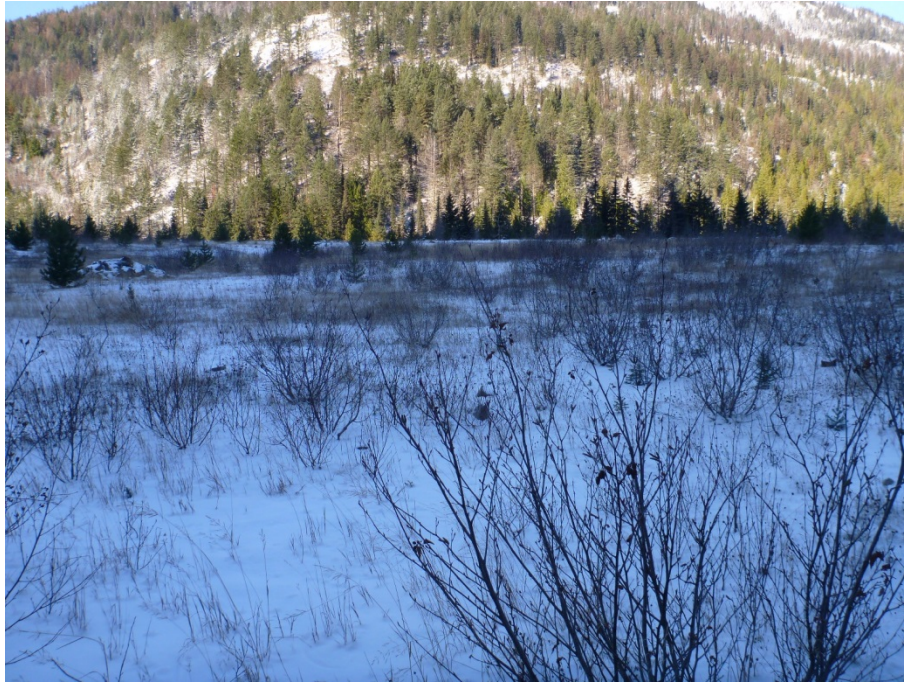
Photo 25 – Good Friday reclaimed tailings impoundment surface. Photo taken facing west towards South Limb dam crest.

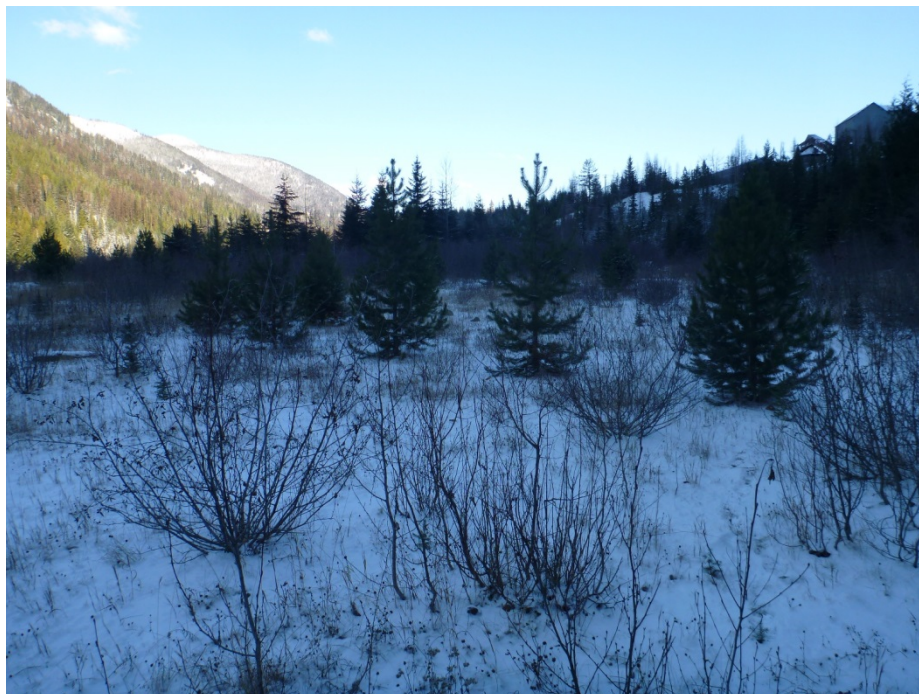
Photo 26 – Good Friday reclaimed tailings impoundment surface. Photo taken facing north towards abandoned mine plant buildings.

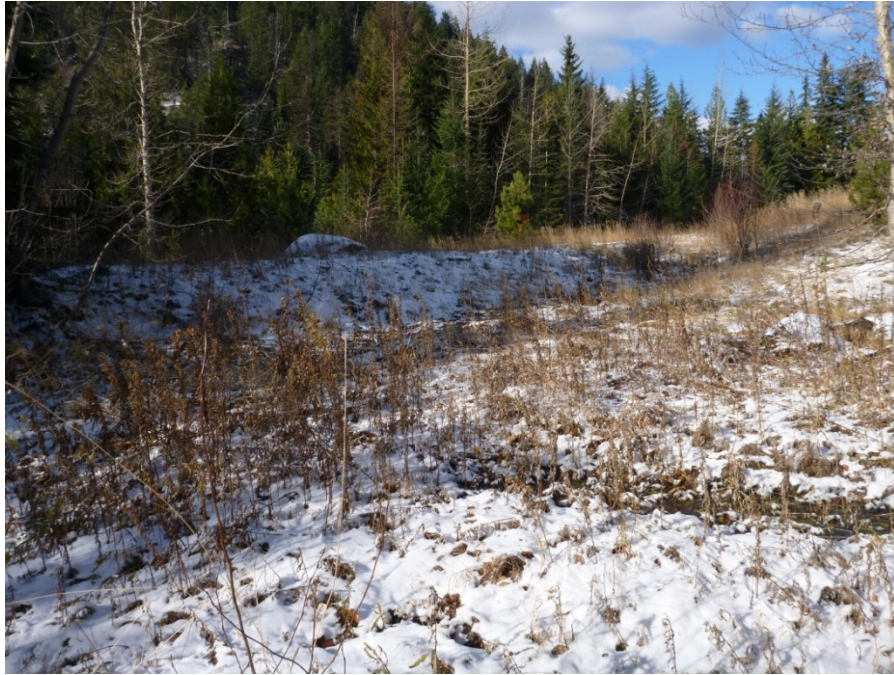
- The reclaimed borrow area downstream of the South Limb of the dam appears to be well vegetated with grass cover. A seepage and/or drainage collection swale was observed at the southwest corner of the South Limb of the TSF dam. Some seepage was observed at the base of this channel through the snow cover approximately 10 m beyond the downstream toe of the dam. Additional seepage was observed approximately 15 to 20 m beyond the downstream toe of the dam that drained towards a cobble and boulder filled drainage ditch that appears to have been constructed to collect seepage. The collected seepage was captured by a drainage ditch that extended down to the creek channel draining from the spillway. Water was ponded up to depths of 0.15 m in this location (Photos 27 through 29).

Photo 29 – Good Friday borrow area. Photo taken facing north west towards Good Friday tailings impoundment from confluence of seepage collection swale with channel downstream of spillway.

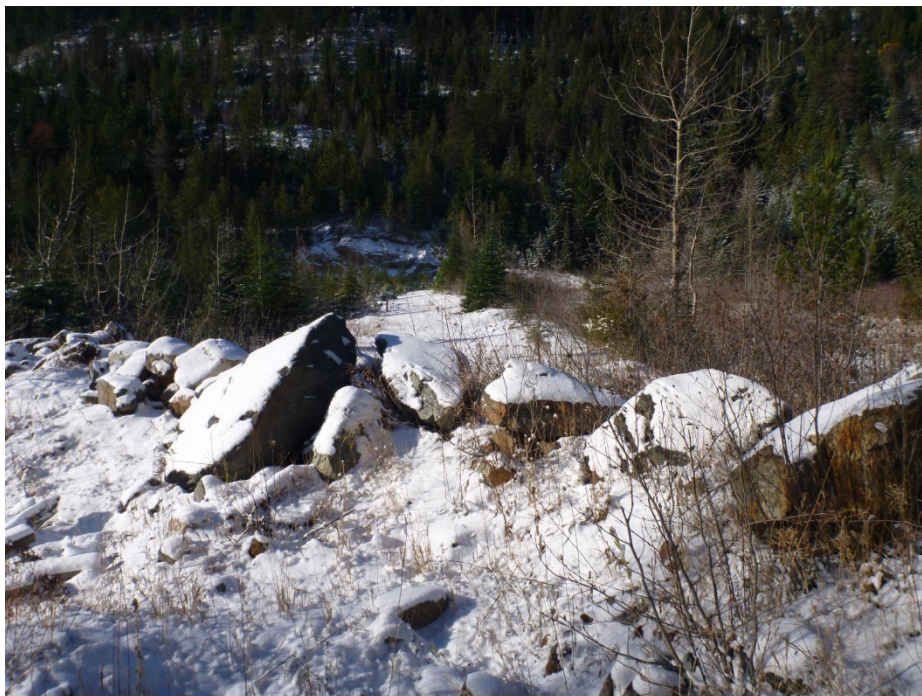
- The crest is uneven and sloped in a downstream direction. Additionally, the downstream crest is uneven, most likely from uneven fill placement or end dumping of fill on the downstream slope of the dam during original construction. There is a berm constructed on the upstream crest of the dam which appears to have been part of the post construction dam raise described in Section 2.3. Deciduous and coniferous trees and shrubs are growing sporadically on the crest of the dam. The spillway is located in native ground at the right abutment and downstream toe area (Photos 34 through 36).

Photo 34 – Jumbo Dam crest. Photo taken from left abutment at access road. Note boulder barricade preventing vehicle access to dam crest or reclaimed tailings impoundment surface.

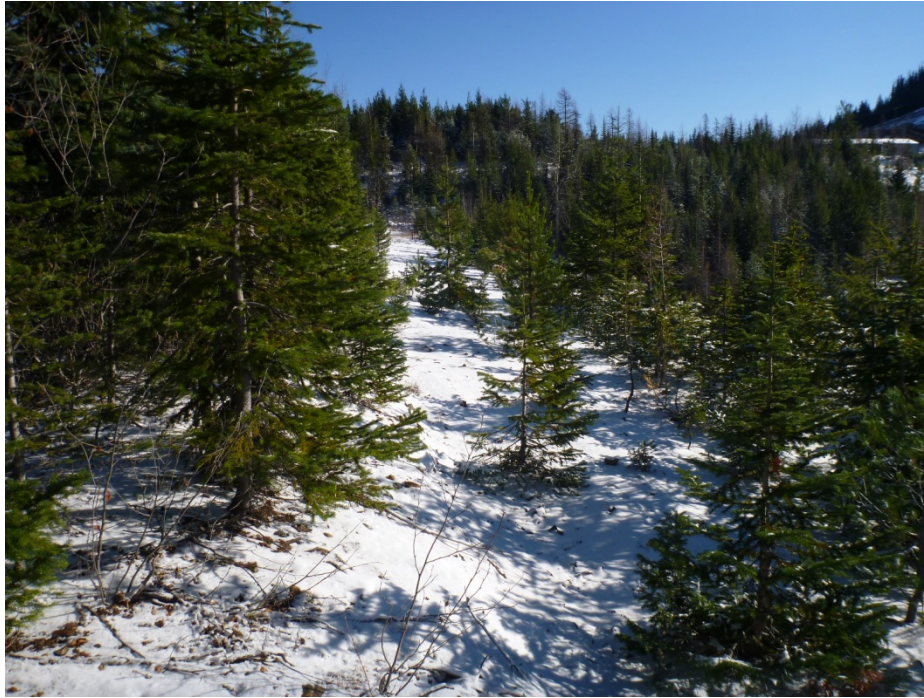
Photo 35 – Jumbo Dam crest. Photo taken facing east from crest of spillway channel. A berm is present between the downstream crest of the dam and the upstream tailings impoundment.

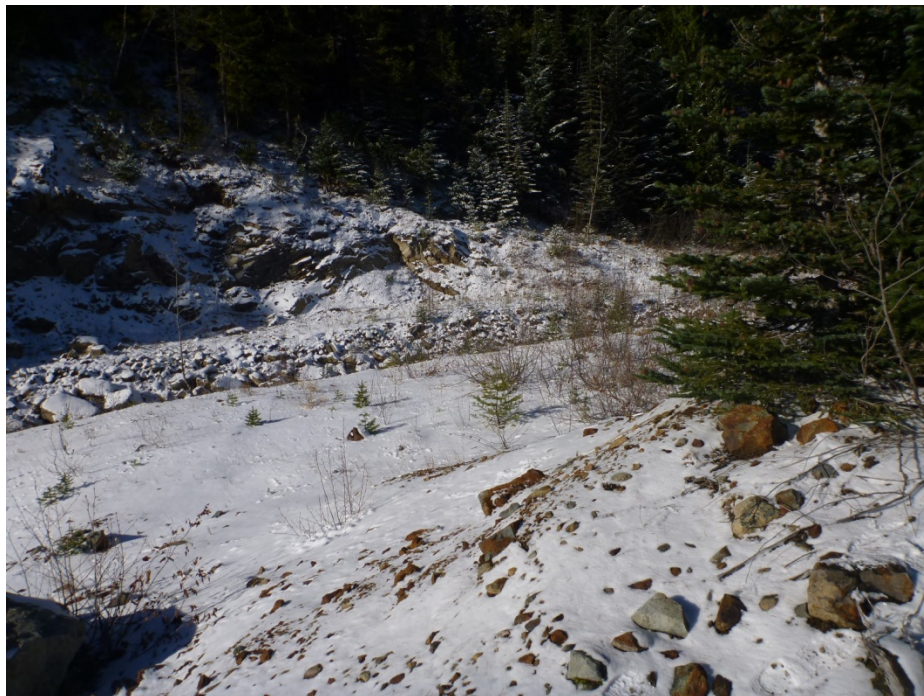
Photo 36 – Jumbo crest of dam, right abutment. Photo taken facing west. Spillway for drainage channel on tailings surface is located at left abutment of dam. Note bedrock cut slope behind spillway.

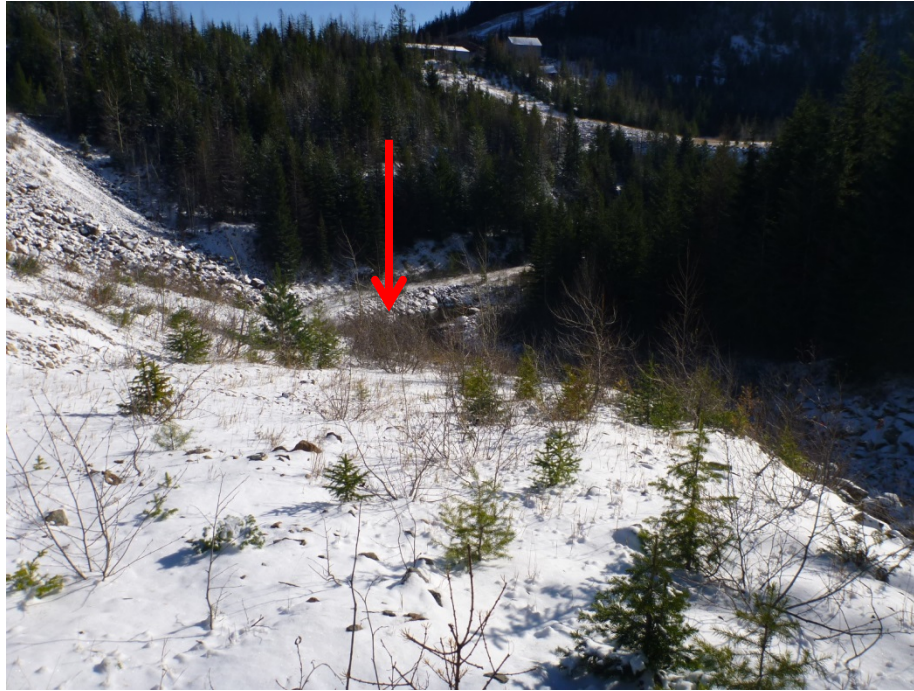
- There is an access road along the downstream toe of the dam along the right abutment between the dam and the spillway channel. A counterfort drain was constructed here during the reclamation work. No seepage was observed through the snow cover. Small deciduous and coniferous trees (3 m tall or less) are present at the downstream toe of the dam (Photos 37 and 38).

Photo 37 – Jumbo Dam, downstream slope and right abutment. Photo taken facing south east. Spillway is located at right abutment and along downstream toe of dam. Red arrow indicates general location of spillway stilling basin.

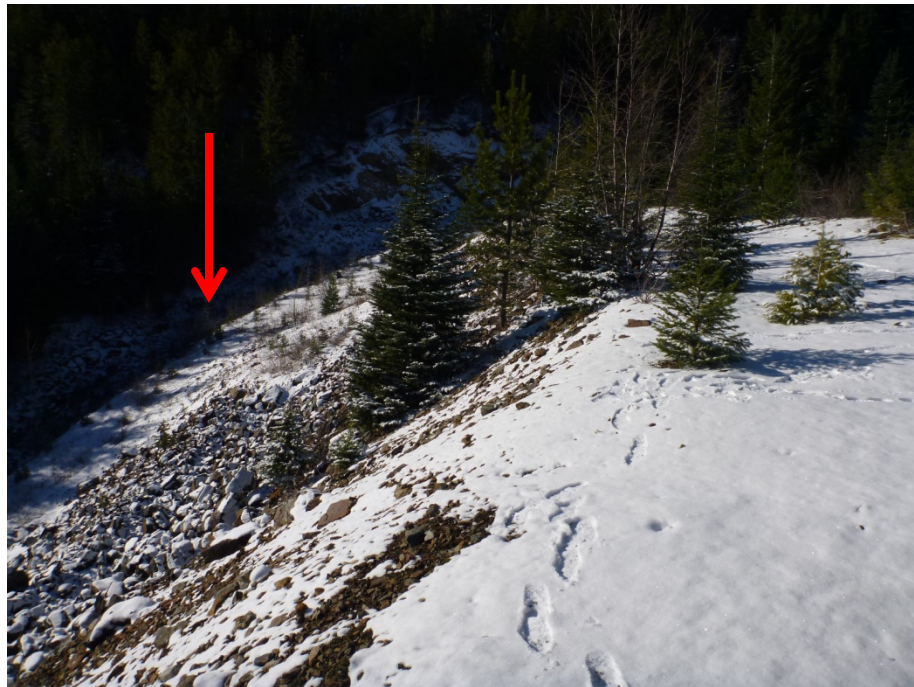
Photo 38 – Jumbo Dam downstream slope. Photo taken facing west from mid-point of crest of dam. Red arrow shows location of spillway channel along downstream toe of dam on right abutment.

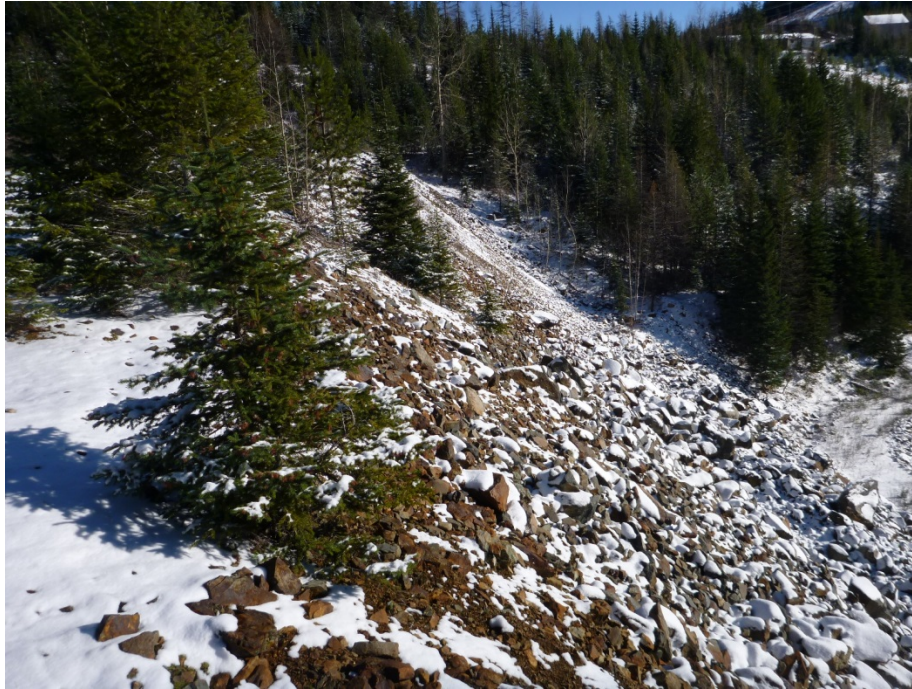
- The downstream slope of the dam is exposed rockfill of variable gradation (maximum size varies from 0.3 m to 1.0 m). The slope is uneven, likely from construction practices during original construction of the dam which may have included end dumping rock fill downslope from the crest. The downstream slope does not appear to have changed from what is shown in figures included in Appendix I (Photos 39 through 43).

Photo 39 - Jumbo Dam downstream slope. Photo taken facing east from mid-point of crest of dam.

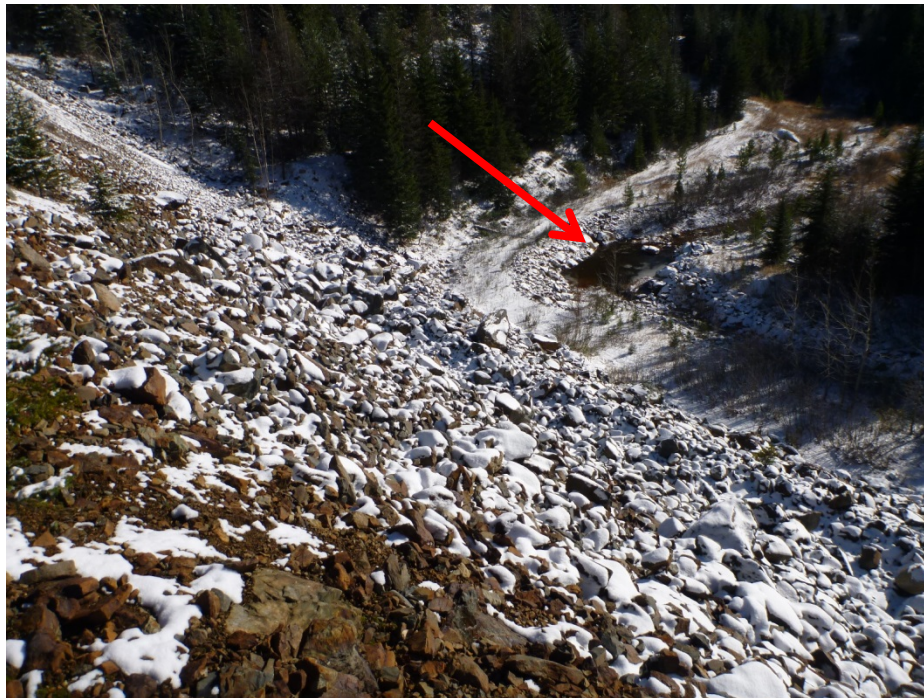
Photo 40 – Jumbo Dam downstream toe. Photo taken facing south east. Red arrow indicates stilling basin at toe of dam.

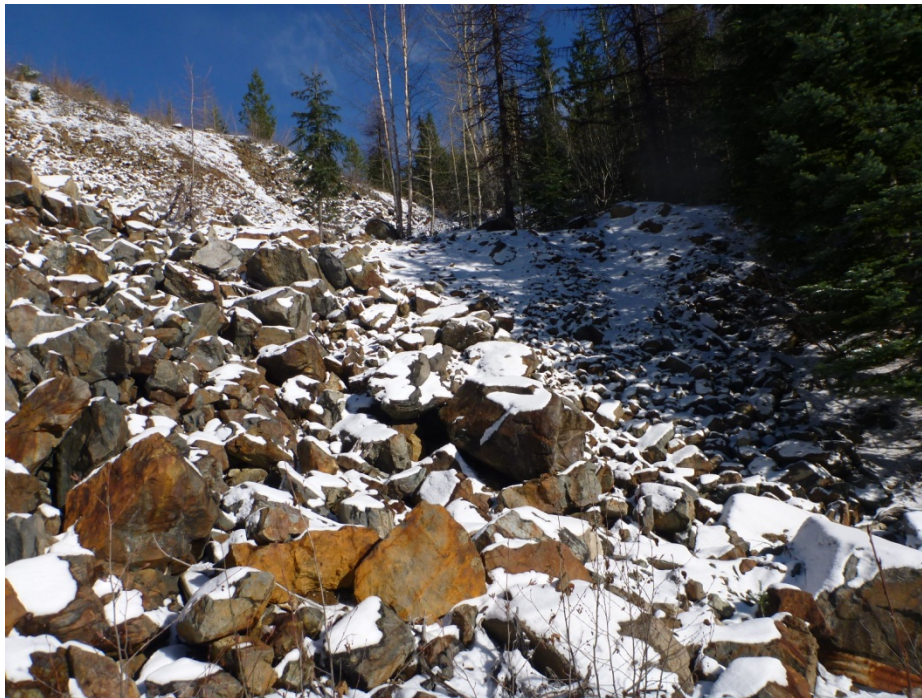
Photo 42 – Jumbo Dam left abutment. Photo taken facing north east from downstream toe.

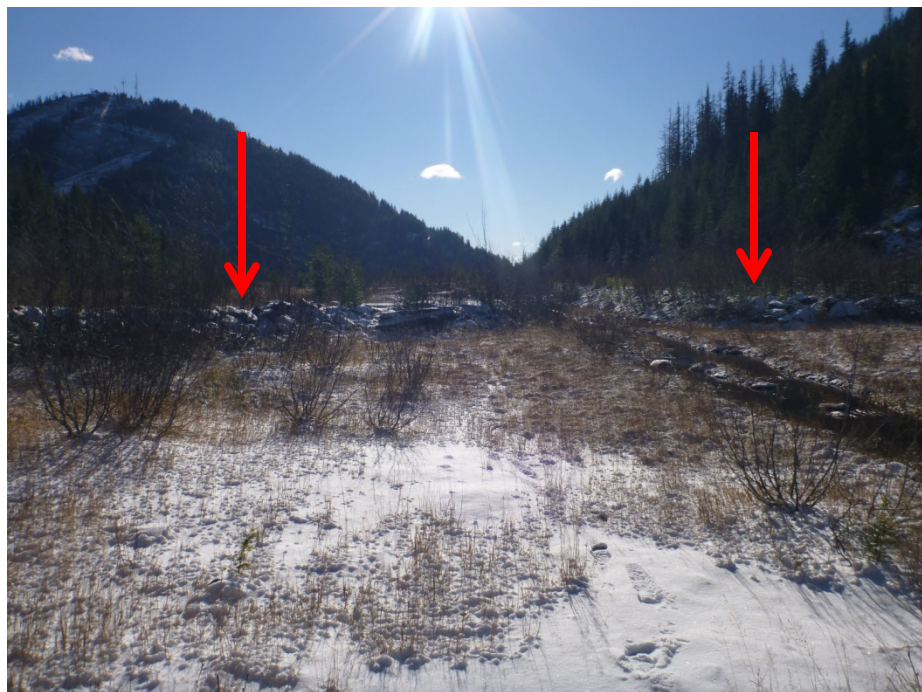
- The guide berms to direct surface water flow into the drainage channel at the head of the TSF (north end of TSF) are in good condition and appear to be functioning as intended (Photo 48).
- Willows and alders are growing on the channel side slopes. Limited grassy vegetation was growing in occasional locations in the middle of the drainage channel. Flowing water in the drainage channel was approximately 10 cm deep. Evidence of high water marks on vegetation growing at the edge of the channel indicates previous high water about 10 cm above current levels (Photos 49 through 51).

Photo 48 – Jumbo tailings impoundment near start of diversion channel over reclaimed tailings surface. Photo taken from start of tailings surface, facing south. Note guide berms to direct creek flow into drainage channel.

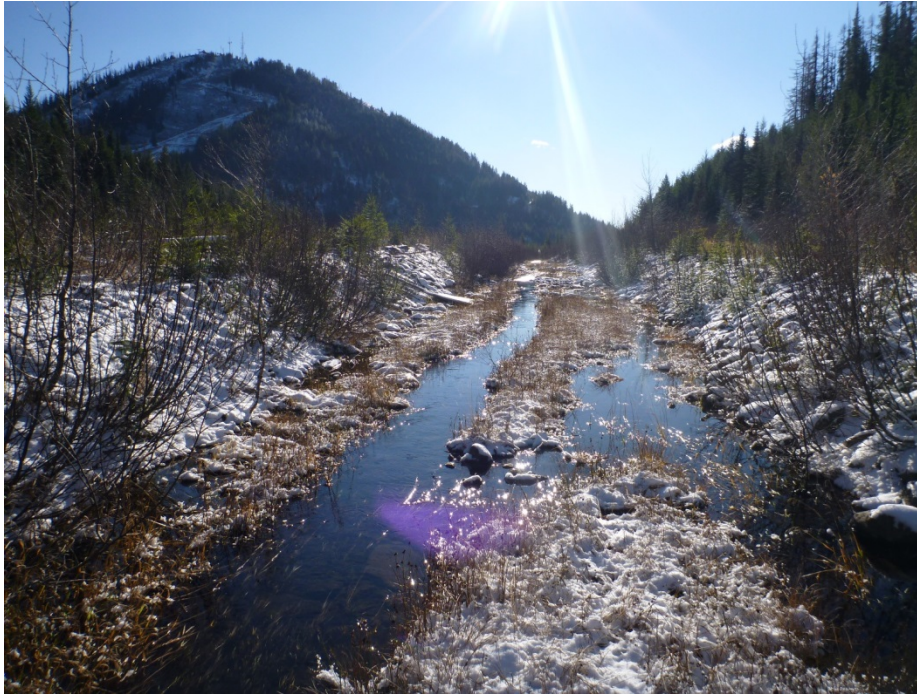
Photo 49 – Jumbo drainage channel on reclaimed tailings surface. Photo taken facing south approximately one third of channel length from entrance to channel shown in Photo 47.
