# **British Columbia Ministry of Energy and Mines**

## **2014 Dam Safety Inspection**

### ***Good Friday and Jumbo Tailings Storage Facilities Red Mountain Mine***

November 28, 2014

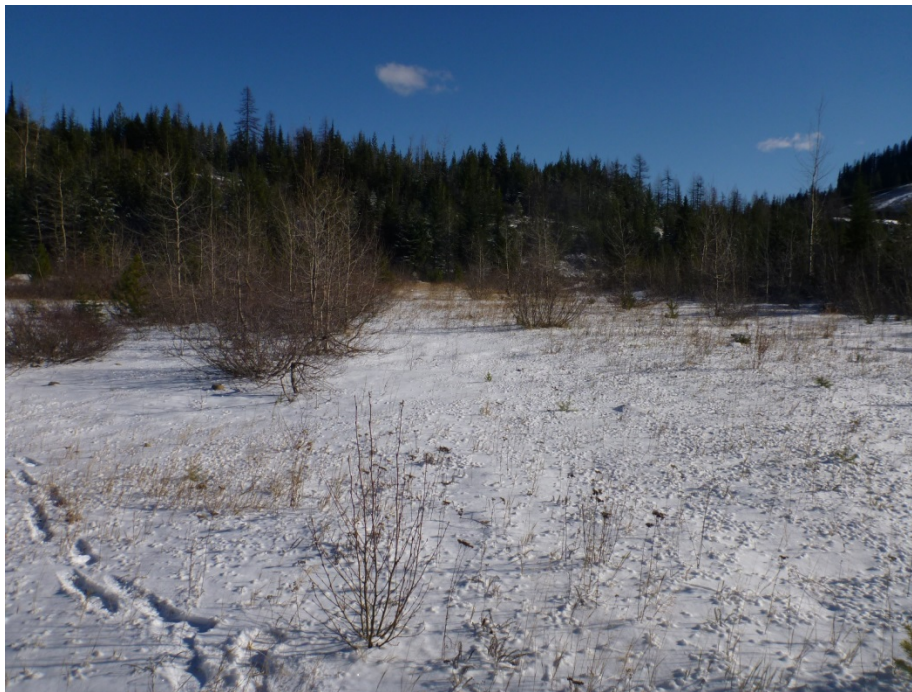
- There appears to be a 0.3m deep depression in the general area of the 1999 sinkhole where the 600 mm CMP failed and caused tailings to be transported beneath the dam through the CMP to the dam toe. There is a drainage swale leading to the diversion channel from this area. The general area of the former decant location is generally level with no obvious surface depressions (Photos 55 and 56).

Photo 56 - Jumbo reclaimed tailings surface upstream of Jumbo Dam. Photo taken facing east.
