APPENDIX B SELECT PHOTOGRAPHS

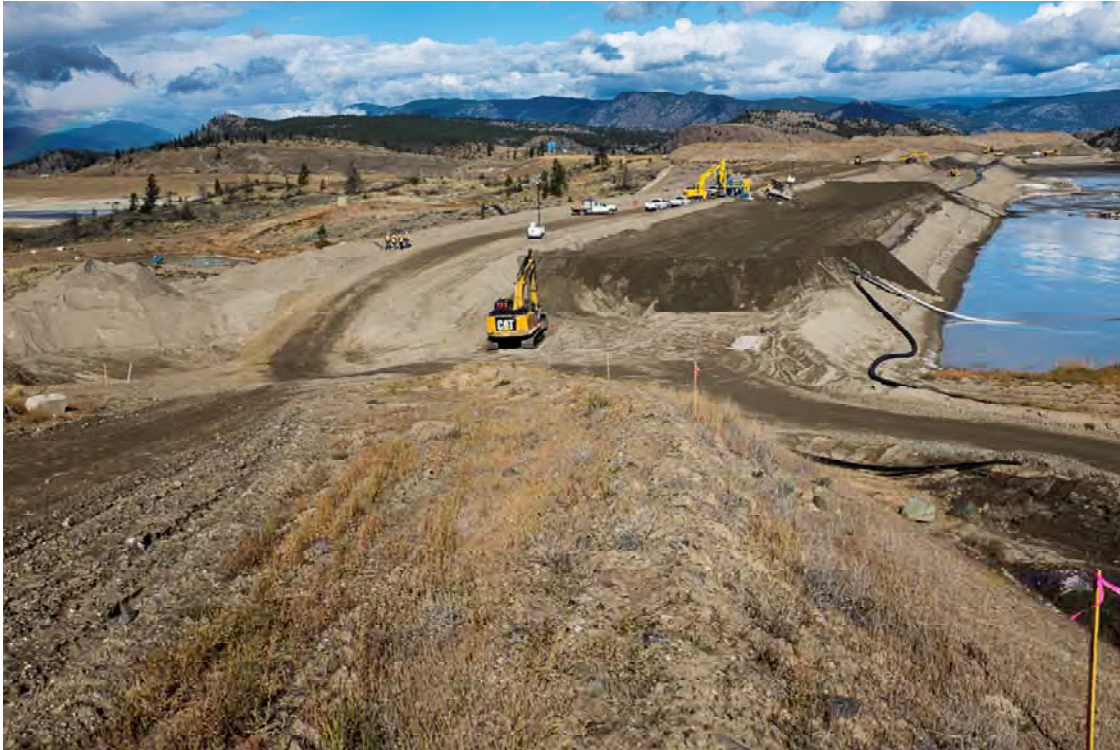
Photo DA01: View looking north from above left abutment of Dam A. Teck TSF and Seepage Pond 1 visible at top left of photo. Note upstream sand cell preparation. Dam B and Dam C visible at top right of photo.

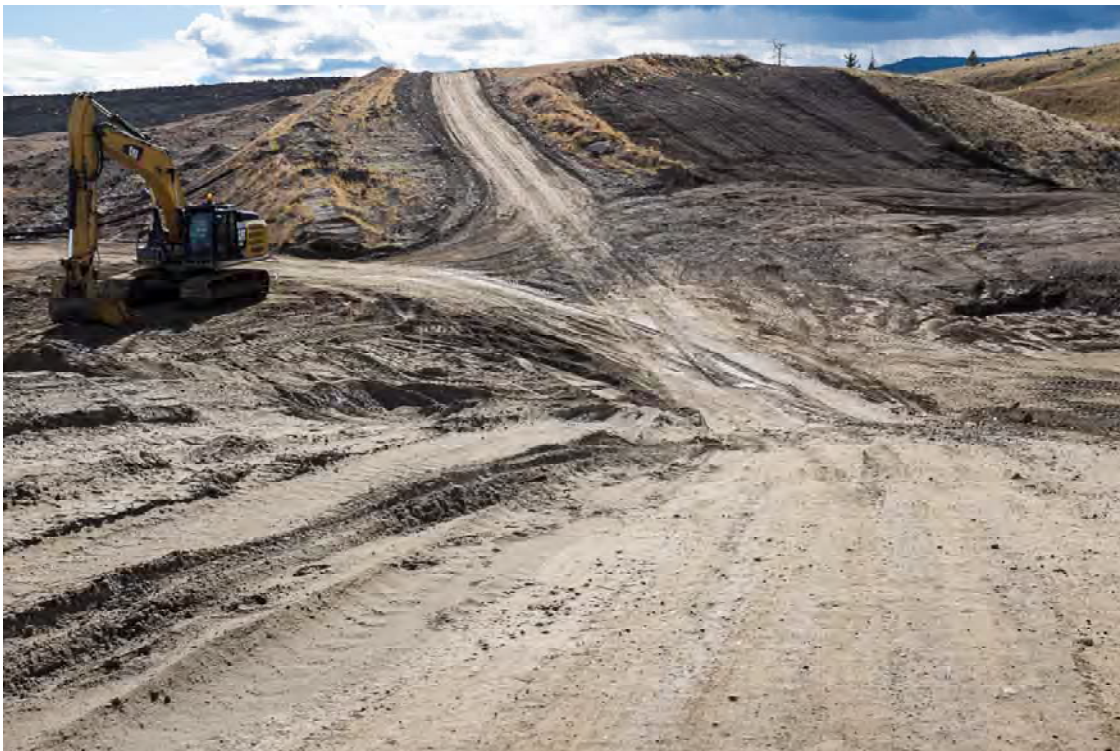
Photo DA02: View looking south at left abutment of Dam A. Dam alignment follows road alignment. Note stakes on middle right of photo denoting downstream edge of till core to be placed as part of the 2014 construction season.

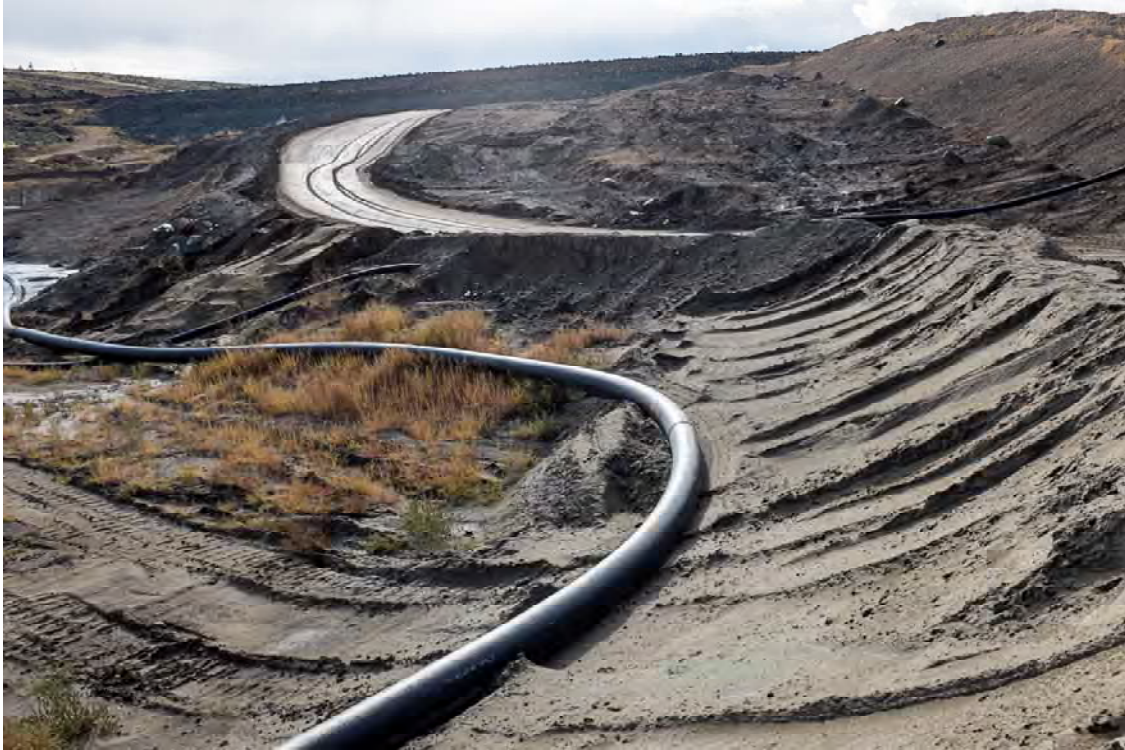
Photo DA03: View looking south at left abutment of Dam A from upstream limit of upstream sand cell at left abutment. West Dam visible at top of photo.

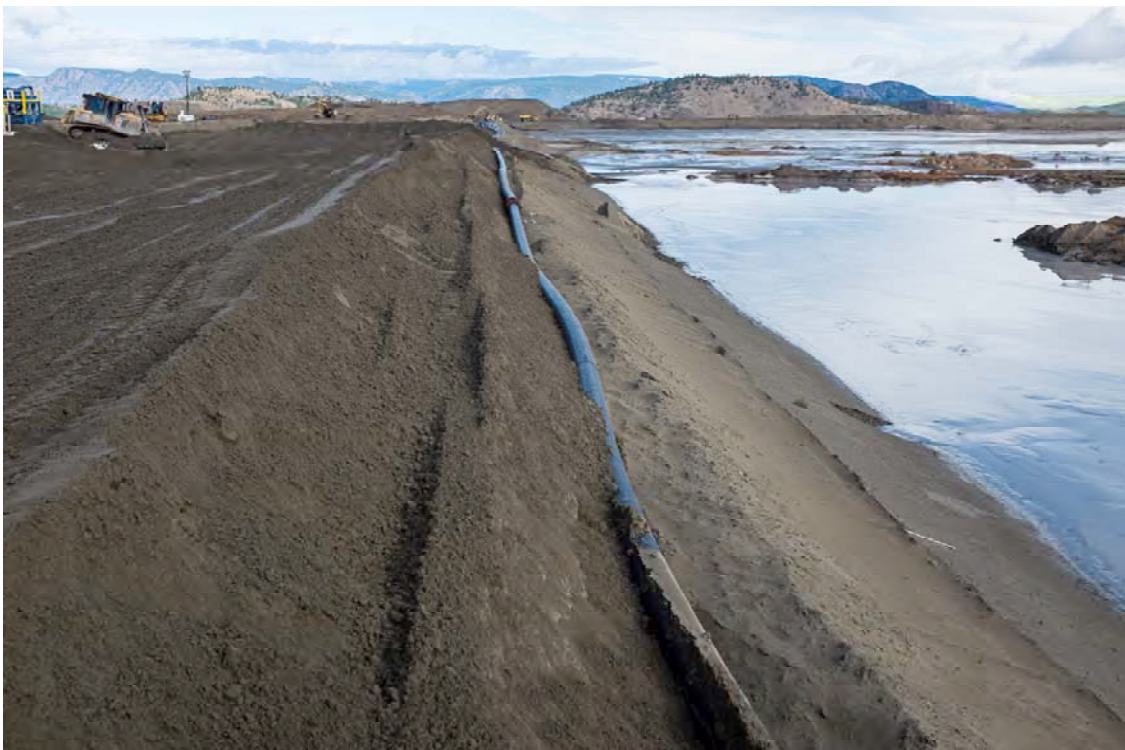
Photo DA04: View looking north at upstream end of sand cell and tailings beach on Dam A. Dam C visible in background right of photo.

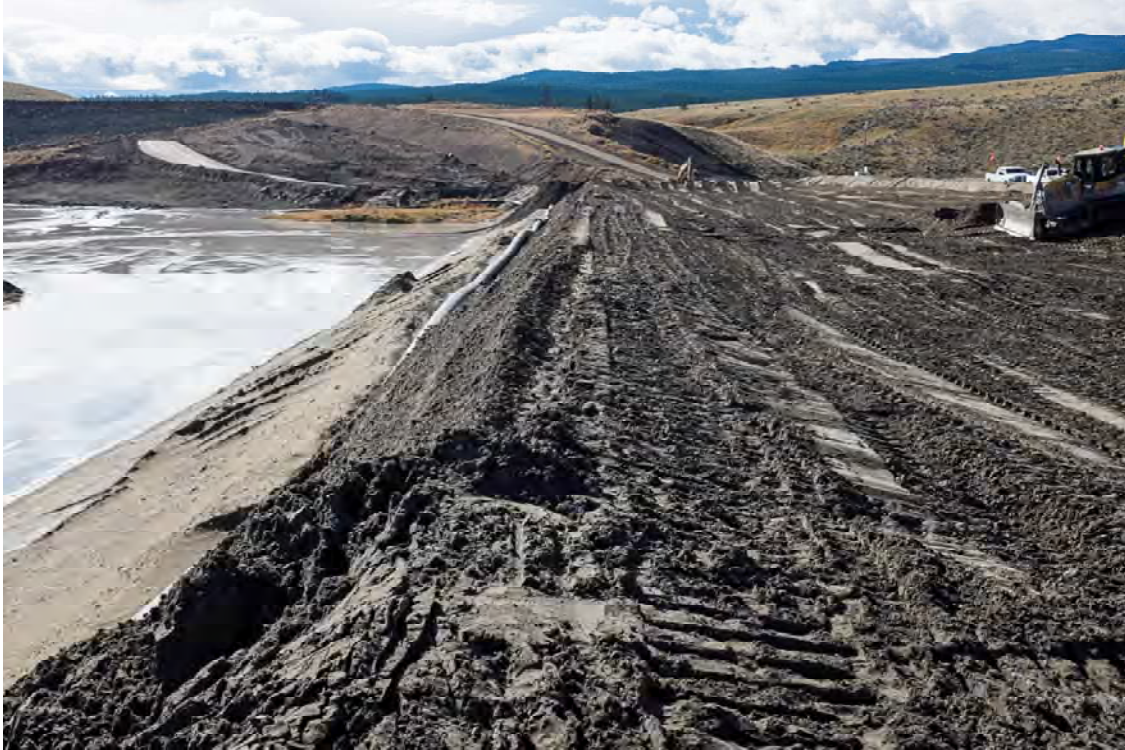
Photo DA05: View looking south at left abutment of Dam A from upstream limit of upstream sand cell. West Dam visible at top left of photo.

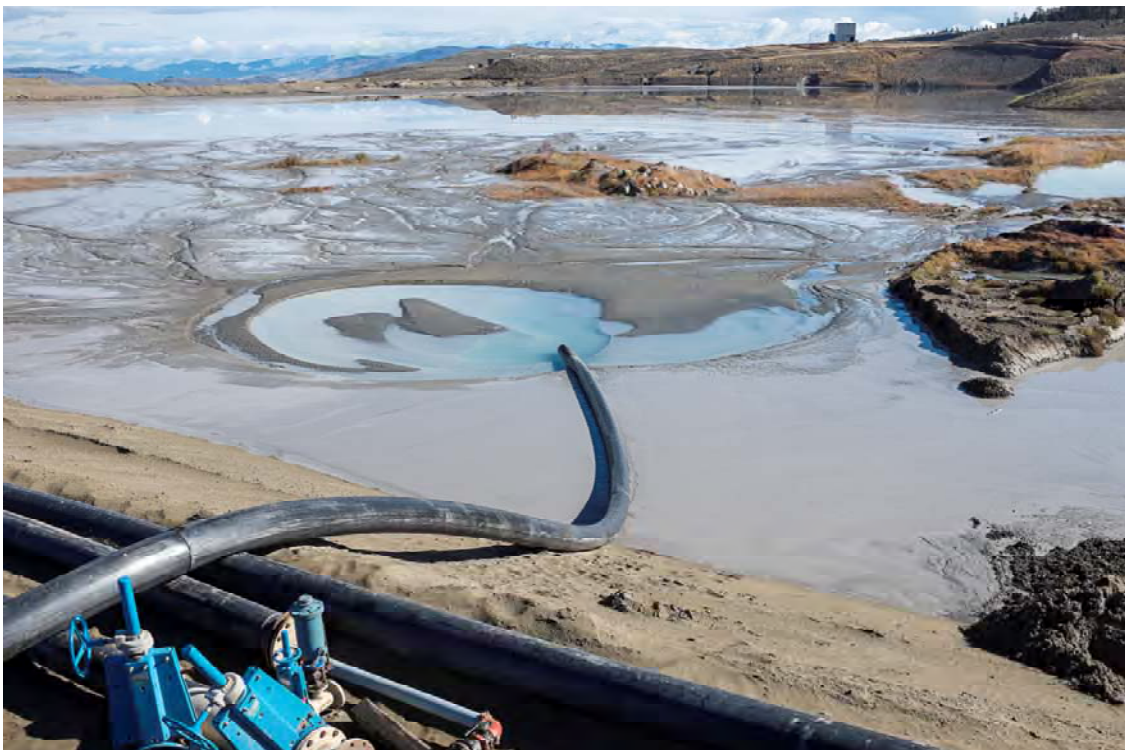
Photo DA06: View looking northeast along secondary overflow spigot line on upstream sand cell on Dam A at approximately 1+700 m.

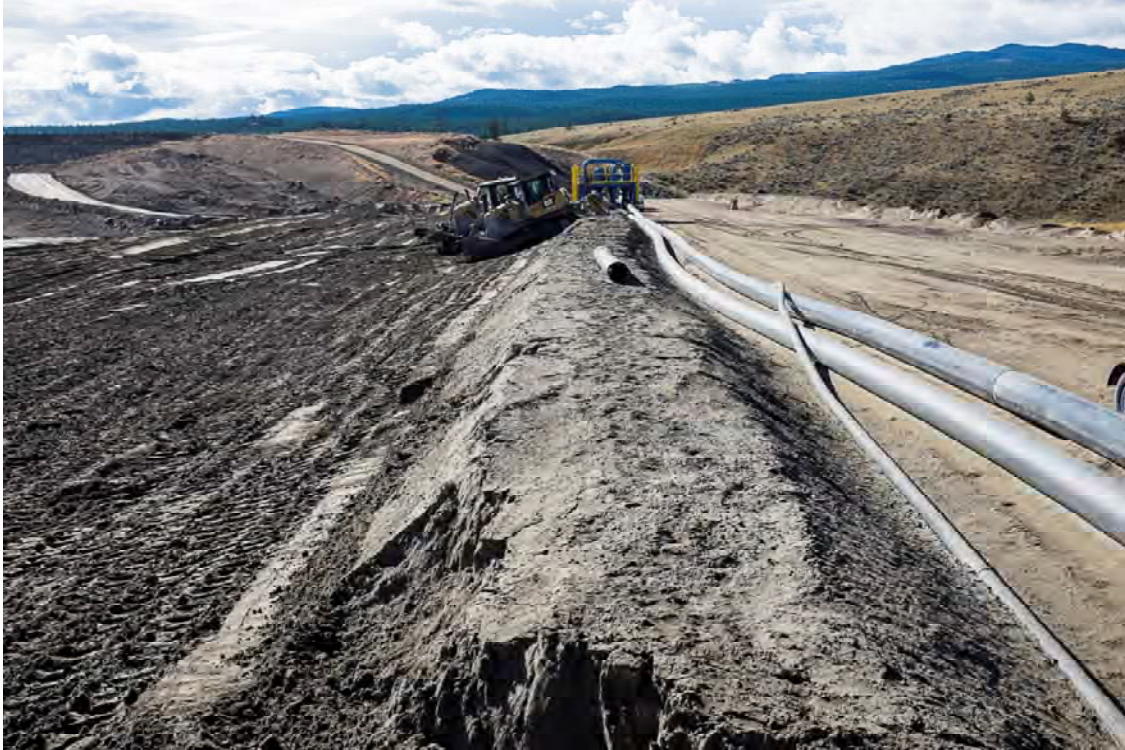
Photo DA07: View looking south toward left abutment of Dam A from approximately 1+700 m at boundary between upstream sand cell and core.

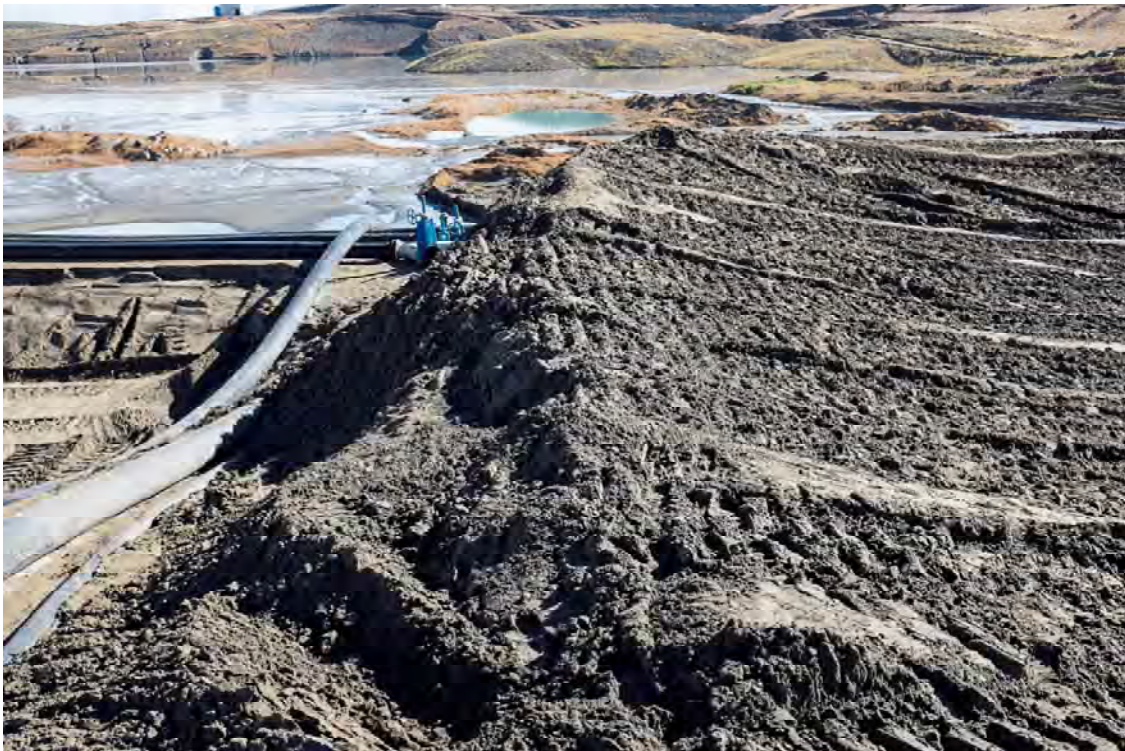
Photo DA08: View looking west at lateral boundary between upstream sand cells at approximately sta. 1+700 m. Primary cyclone visible in top left of photo.

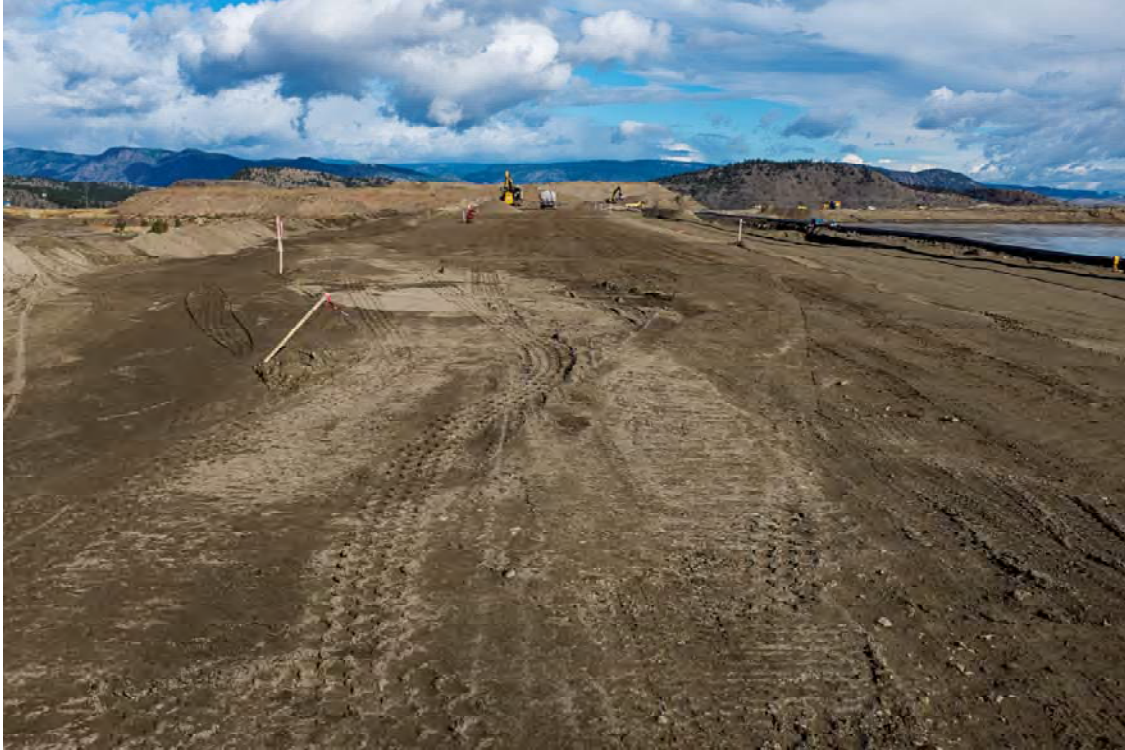
Photo DA09: View looking north at right abutment of Dam A toward Dam B from crest at approximately sta. 1+700 m.

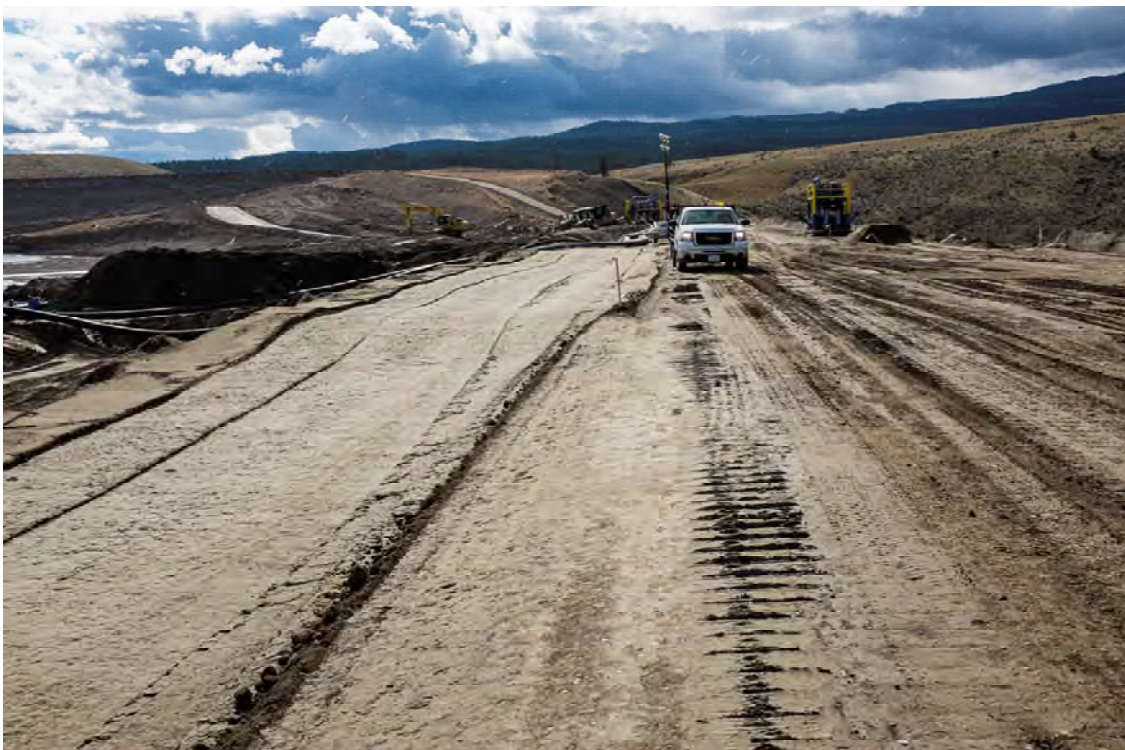
Photo DA10: View looking south toward left abutment of Dam A from upstream side of crest at approximately sta. 1+700 m.

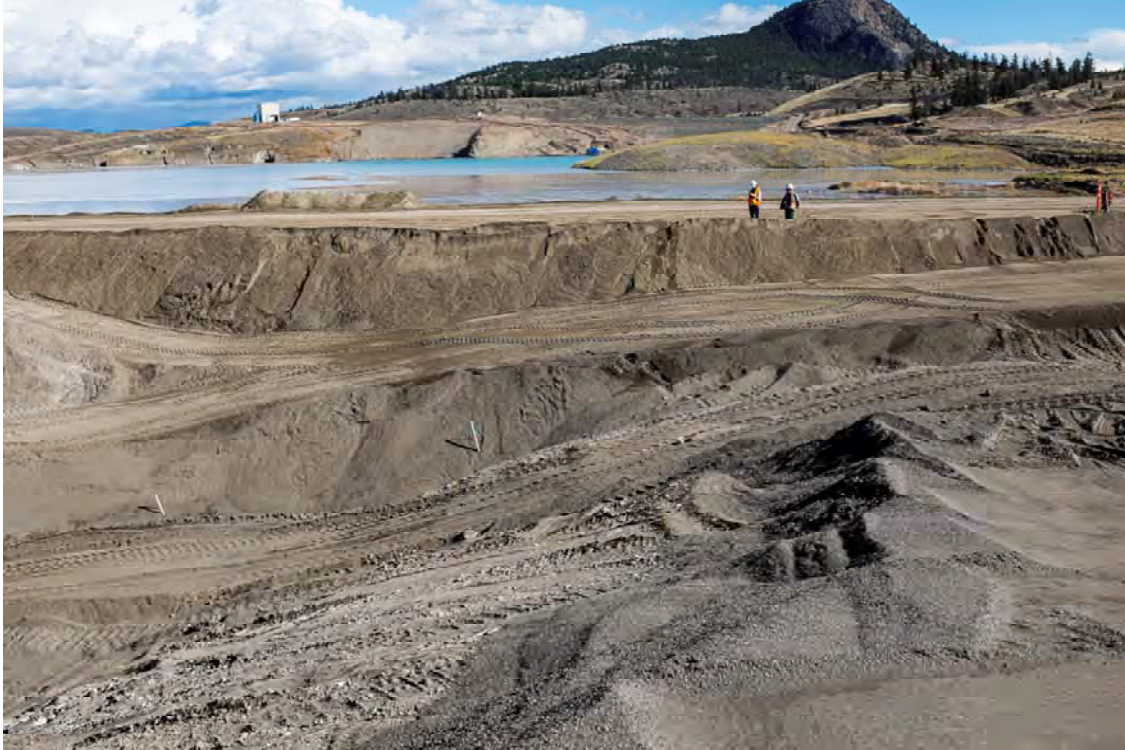
Photo DA11: View looking east from downstream toe of Dam A at boundary with Dam B. South Dam and reclaim barge visible in upper mid-right of photo. Primary cyclone visible in upper left of photo.

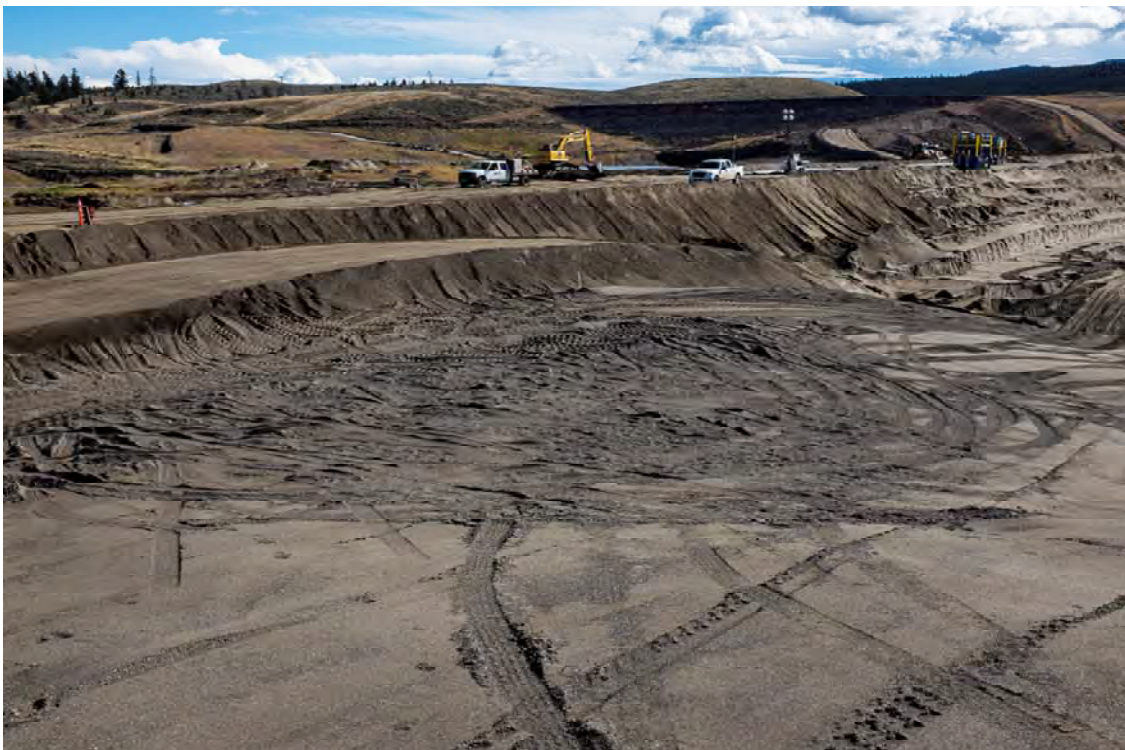
Photo DA12: View looking southeast at downstream face of Dam A from downstream toe of Dam A at boundary with Dam B. West Dam visible in upper right of photo.

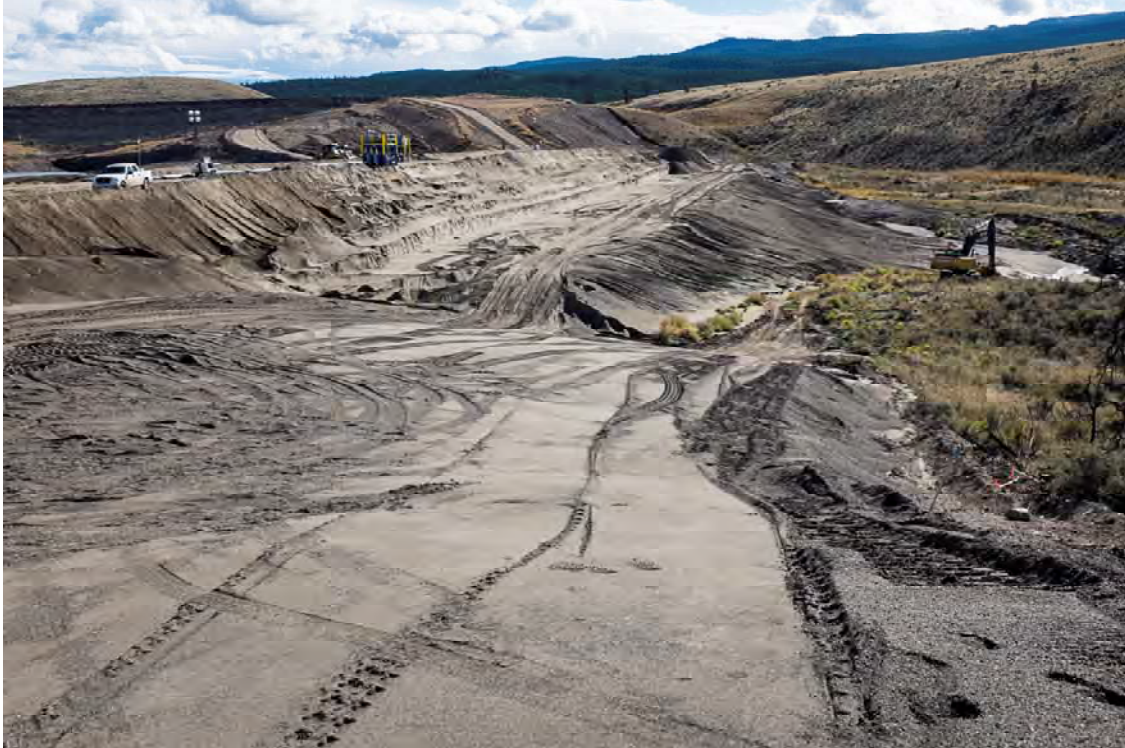
Photo DA13: View looking south from downstream toe of Dam A at boundary with Dam B. West Dam visible at top left of photo. Note change in downstream slope at toe near excavator, and stepped slope closer to dam crest.

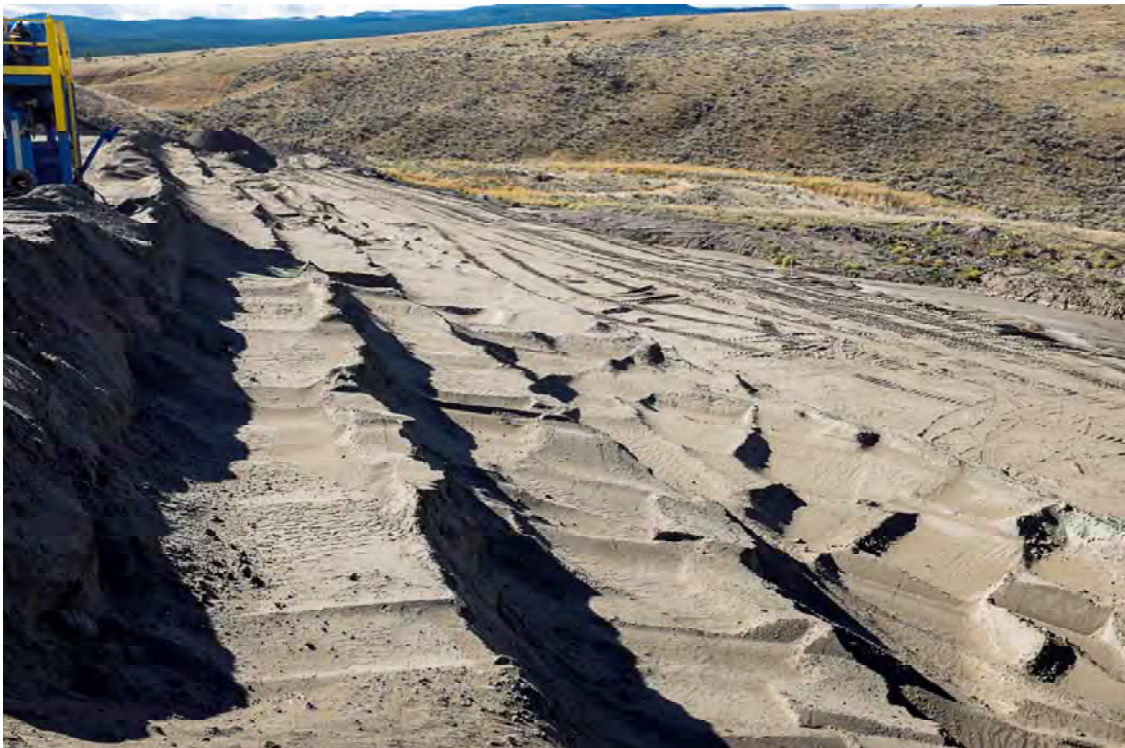
Photo DA14: View looking south at downstream face of Dam A from crest at approximate mid-point of dam. Note stepped downstream slope due to mining of hydraulically placed sand.

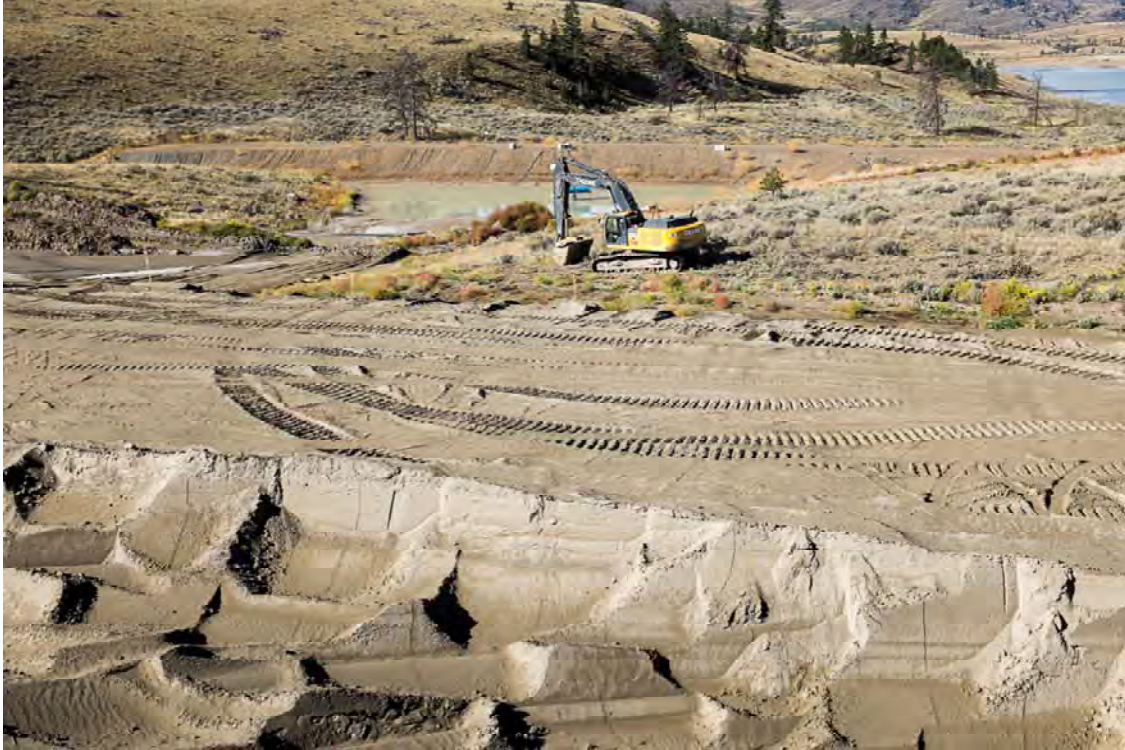
Photo DA15: View looking west at downstream toe of Dam A and Seepage Pond 1. Teck TSF visible in upper right of photo.

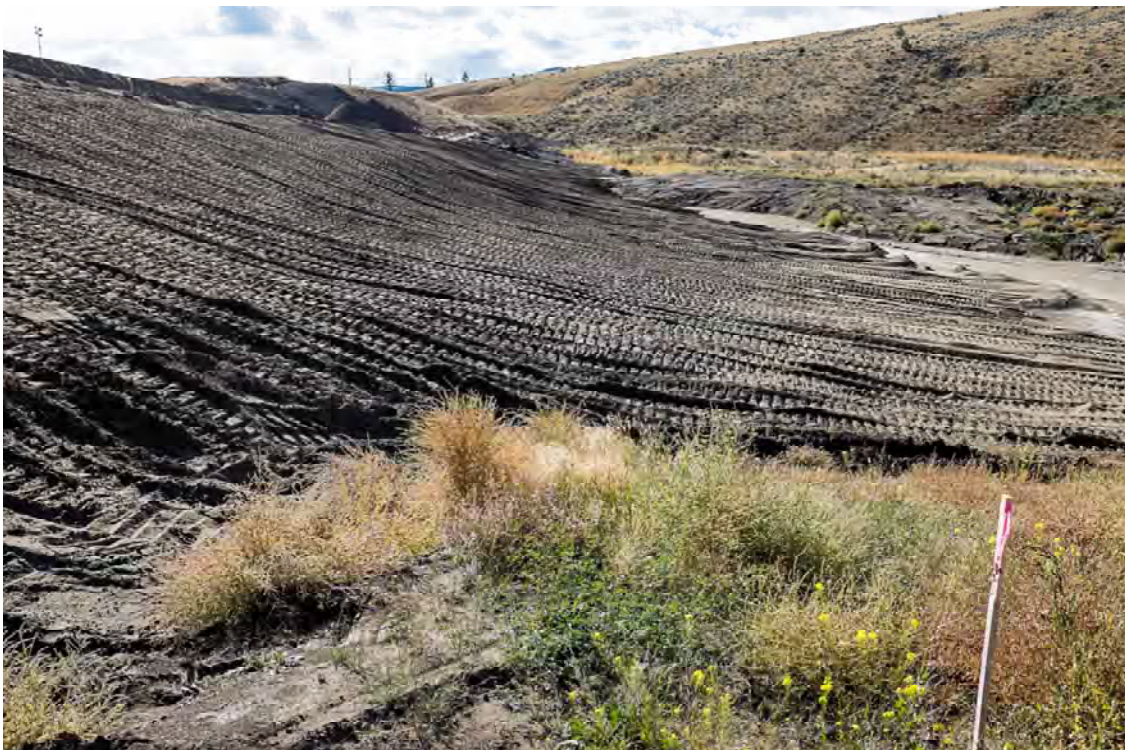
Photo DA16: View looking south at downstream toe and face, and left abutment of Dam A from downstream toe near mid point of dam. Note dressed downstream face.

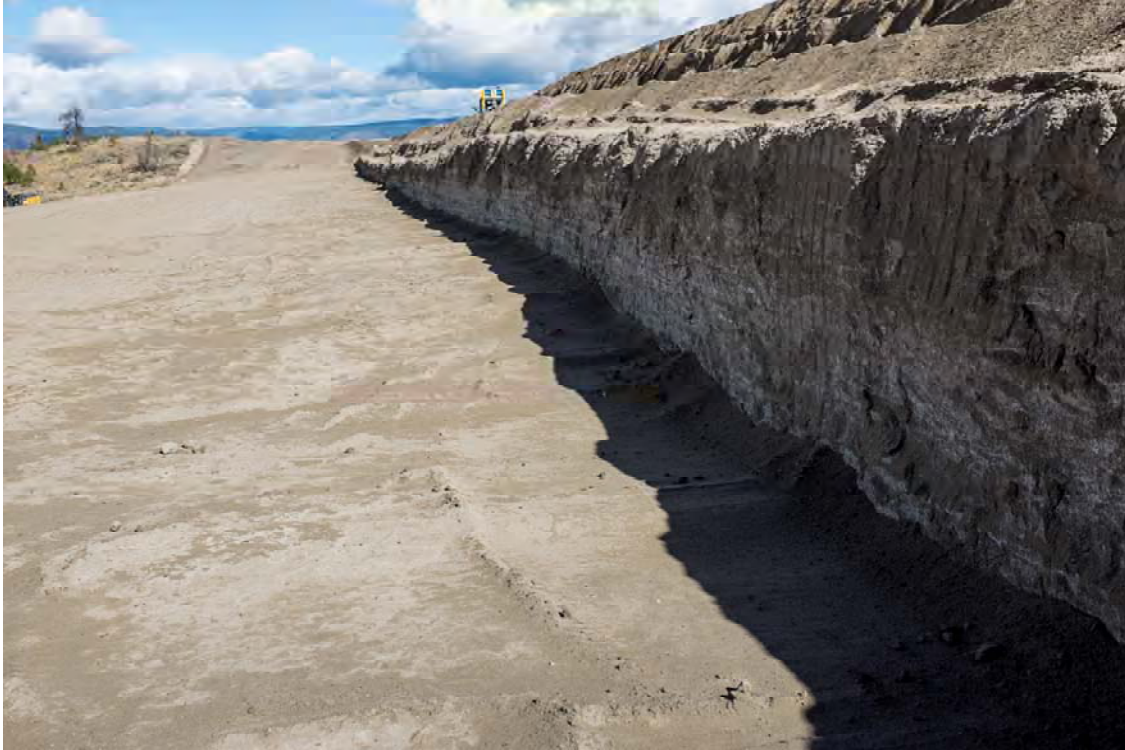
Photo DA19: View looking north of downstream slope of Dam A from close to left abutment. Bench and stepped face due to mining of hydraulically placed sand.

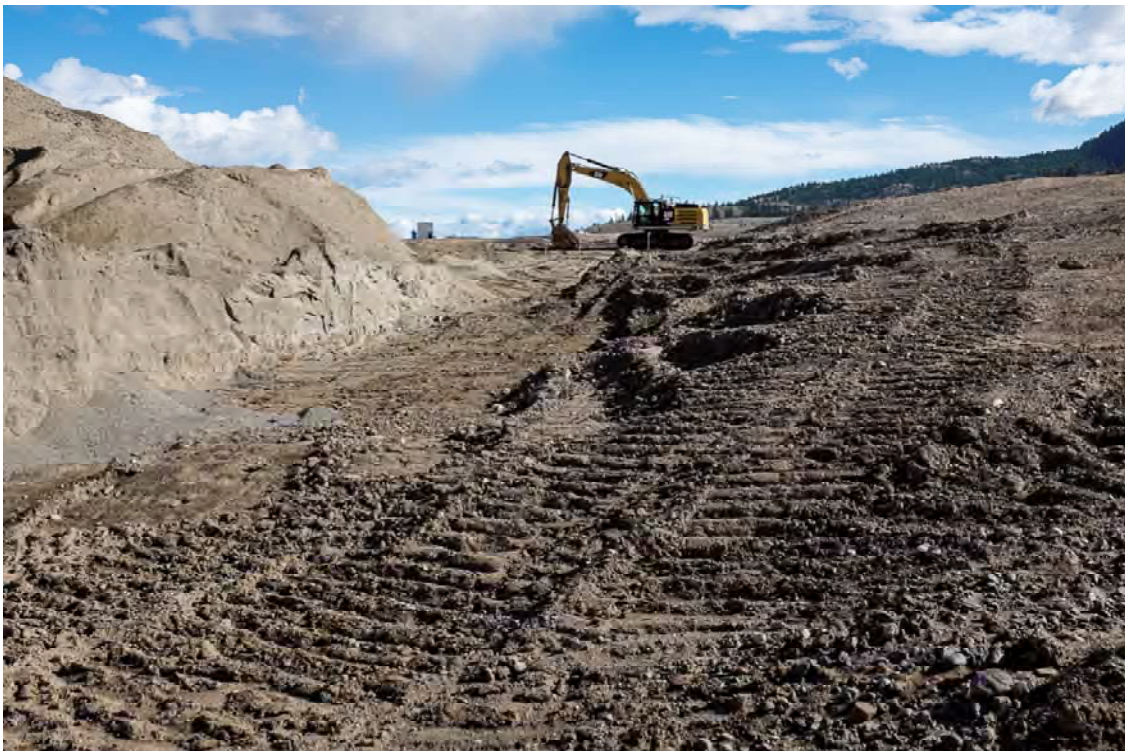
Photo DA20: View looking east at left abutment just downstream of crest of Dam A where dam bends toward West Dam. Staking denotes upper limit of till core to be placed as part of the 2014 construction season.

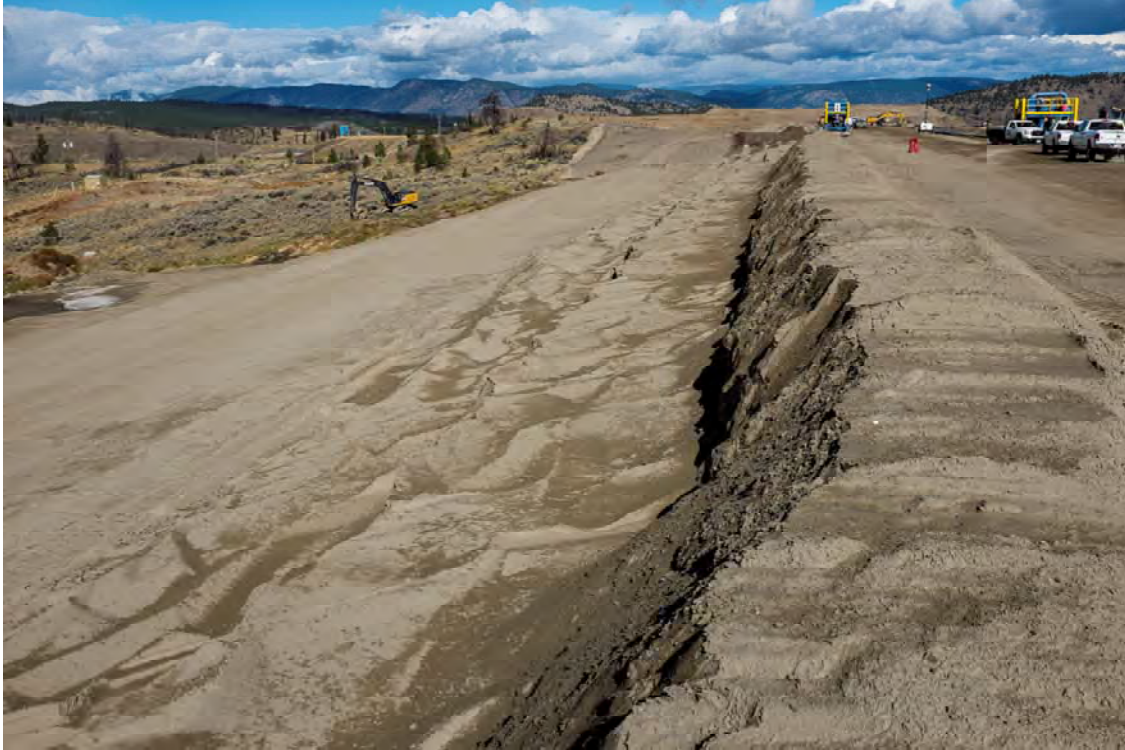
Photo DA21: View looking north at Dam A downstream slope and crest from left abutment looking toward right abutment. Note stepped downstream slope from mining of hydraulically placed sand.

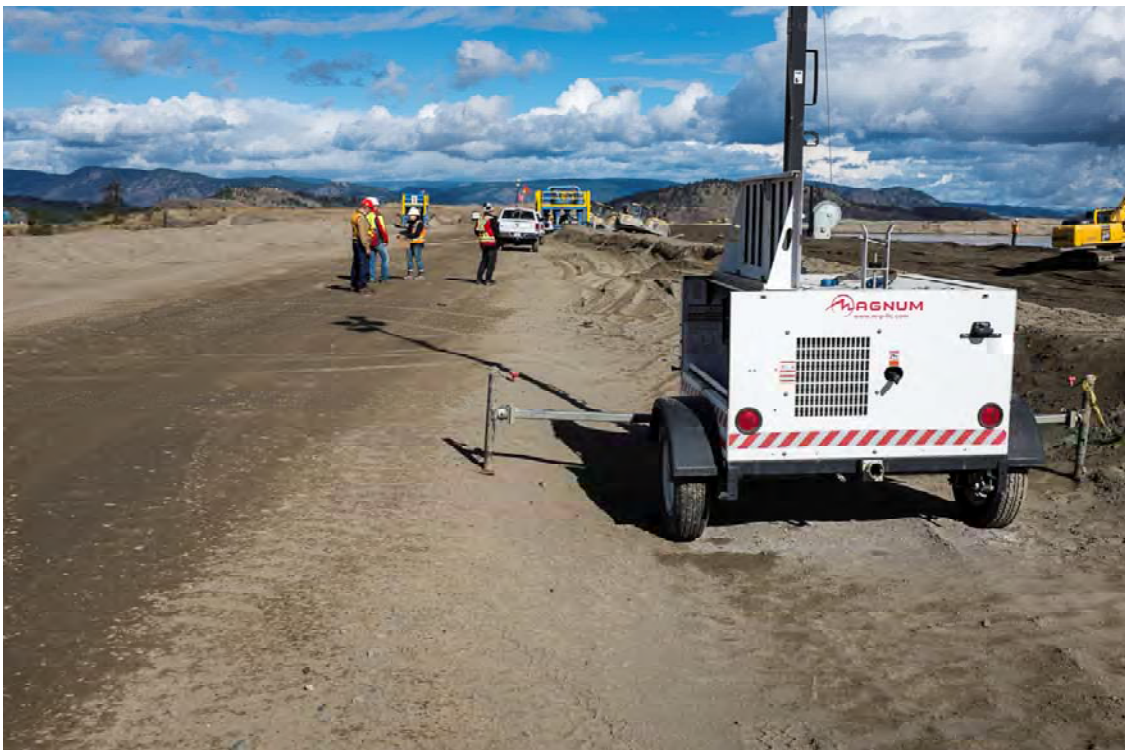
Photo DA22: View looking north at crest of Dam A and upstream sand cell. Dam C visible at top right of photo.

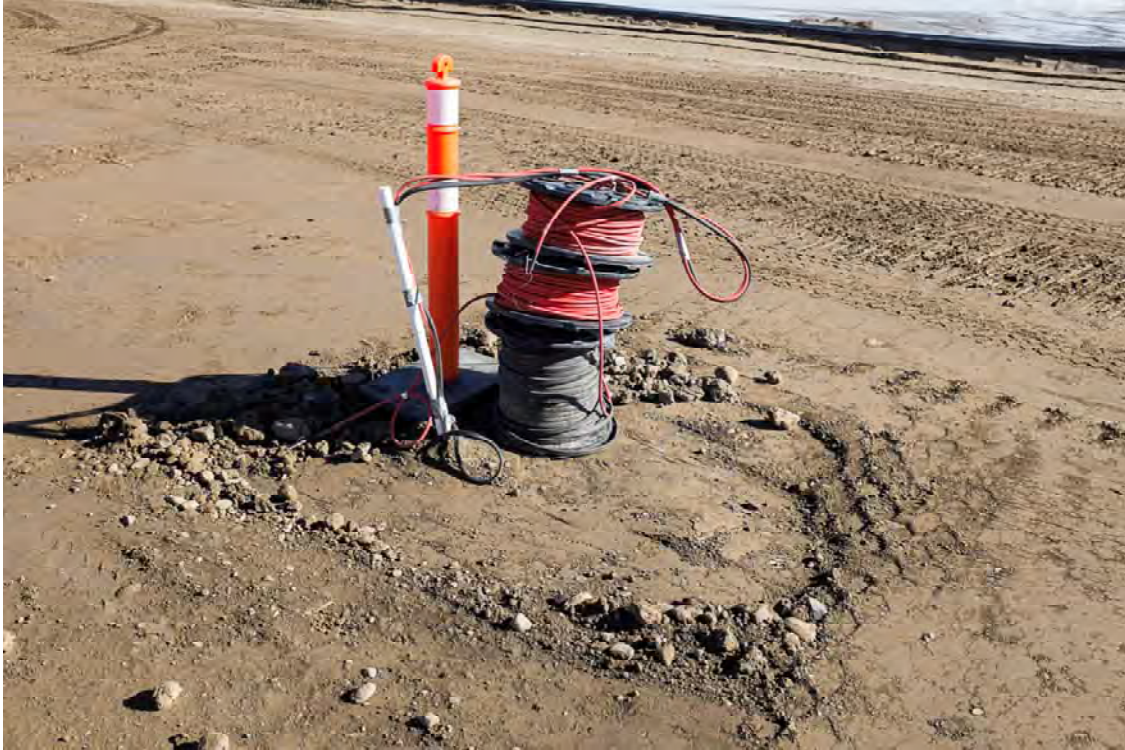
Photo DA23: Veiv of instrumentation leads on crest of Dam A looking northeast at approximately 1+700 m.

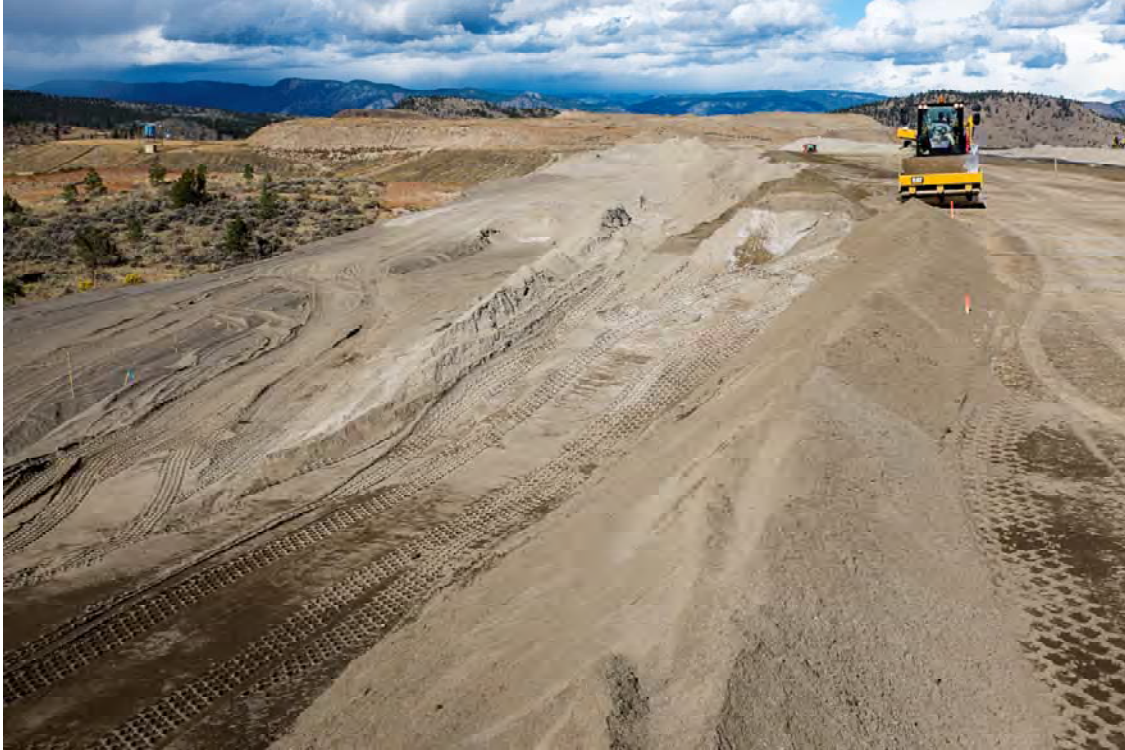
Photo DB01: View looking north at Dam B downstream face and toe from the left abutment crest at boundary with Dam A. Note stepped downstream face, and extent of filter at downstream toe.

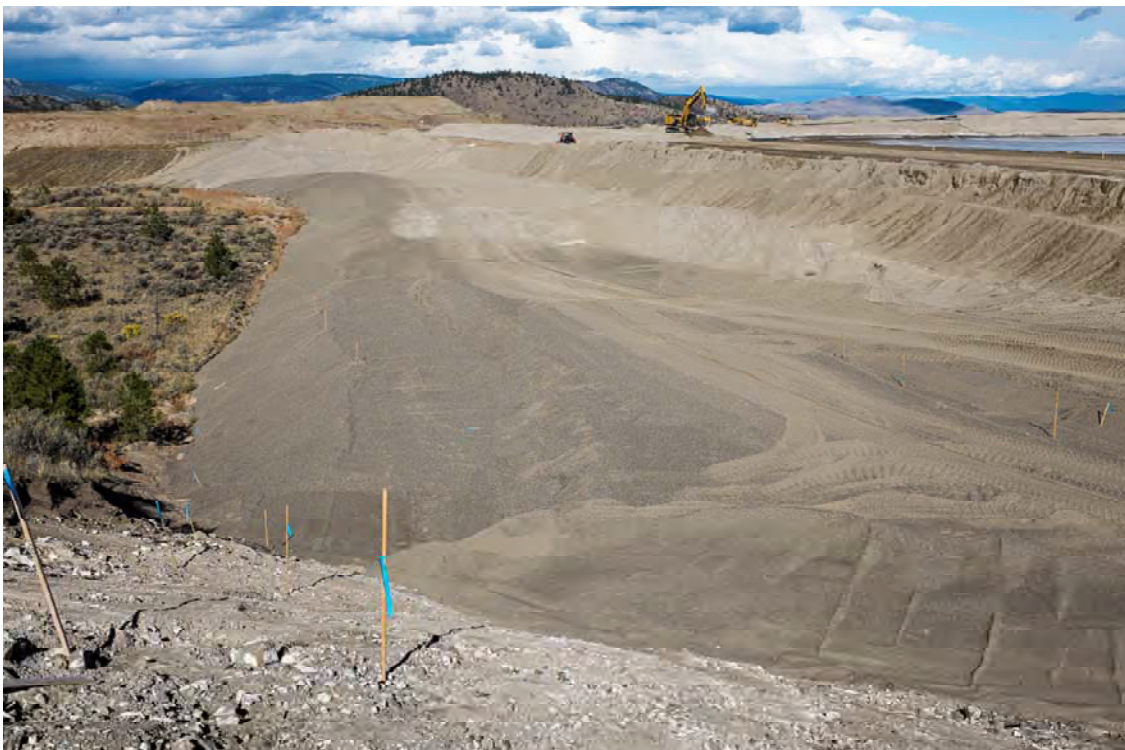
Photo DB02: View looking north at Dam B downstream face and toe from the left abutment downstream toe at boundary with Dam A. Note stepped downstream face, and extent of filter at downstream toe.

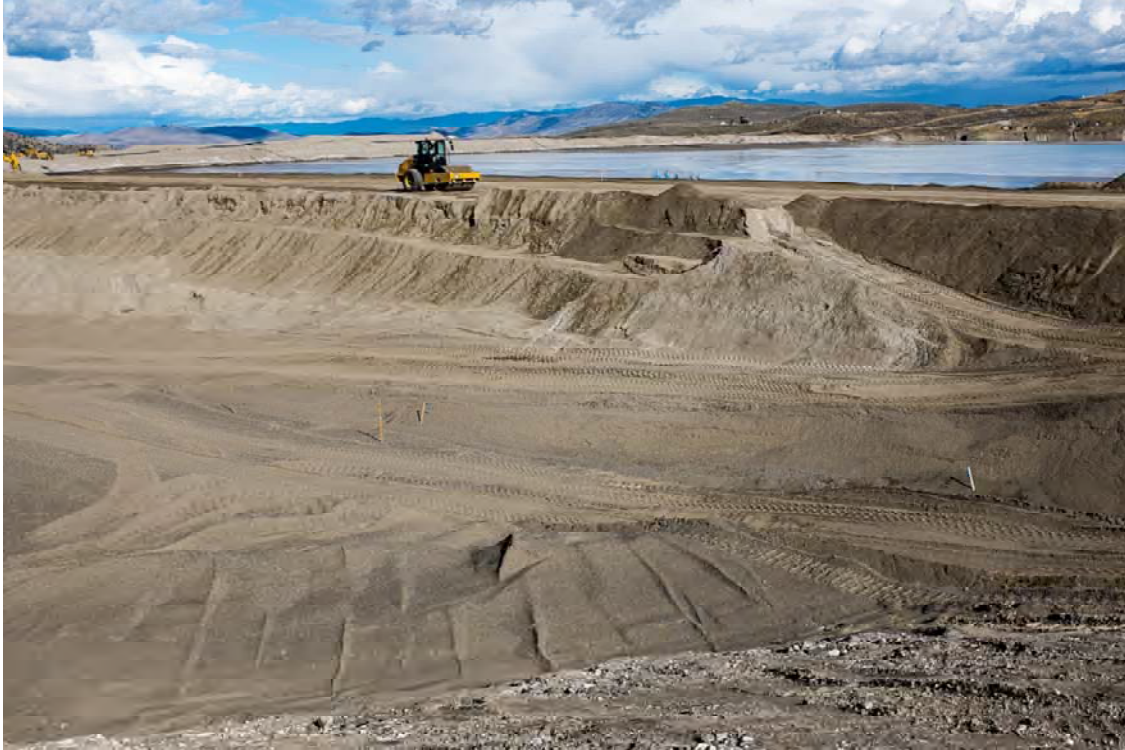
Photo DB03: View looking northeast at Dam B downstream face and toe from the left abutment downstream toe at boundary with Dam A. Dam C visible in the background.

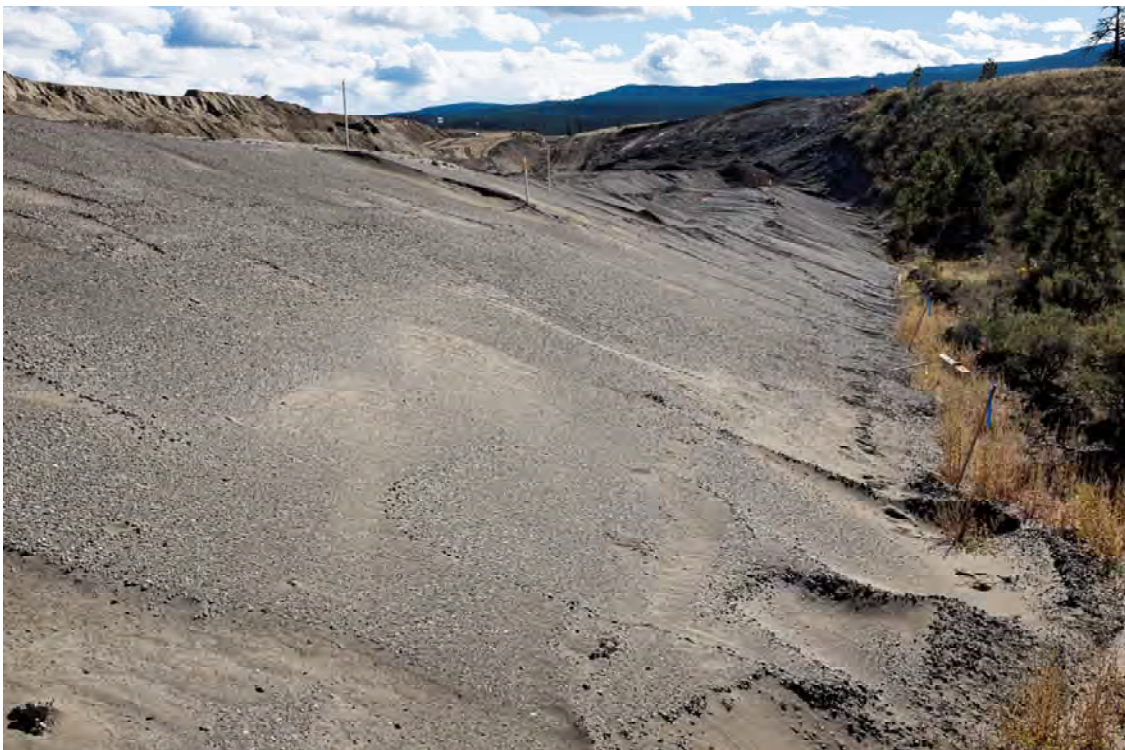
Photo DB04: View looking south at the downstream face and left abutment of Dam B from the downstream toe at approximately sta. 1+500 m.

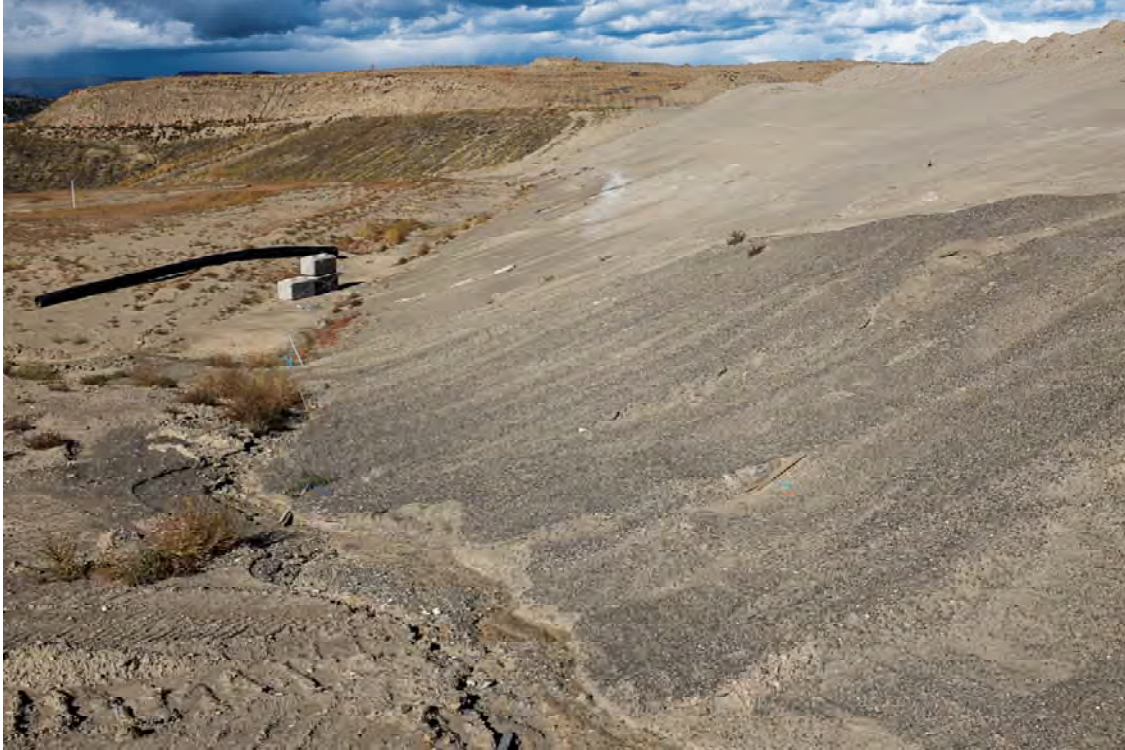
Photo DB05: View looking north at the downstream face and right abutment of Dam B from the downstream toe at approximately sta. 1+450 m.
