APPENDIX B SELECT PHOTOGRAPHS

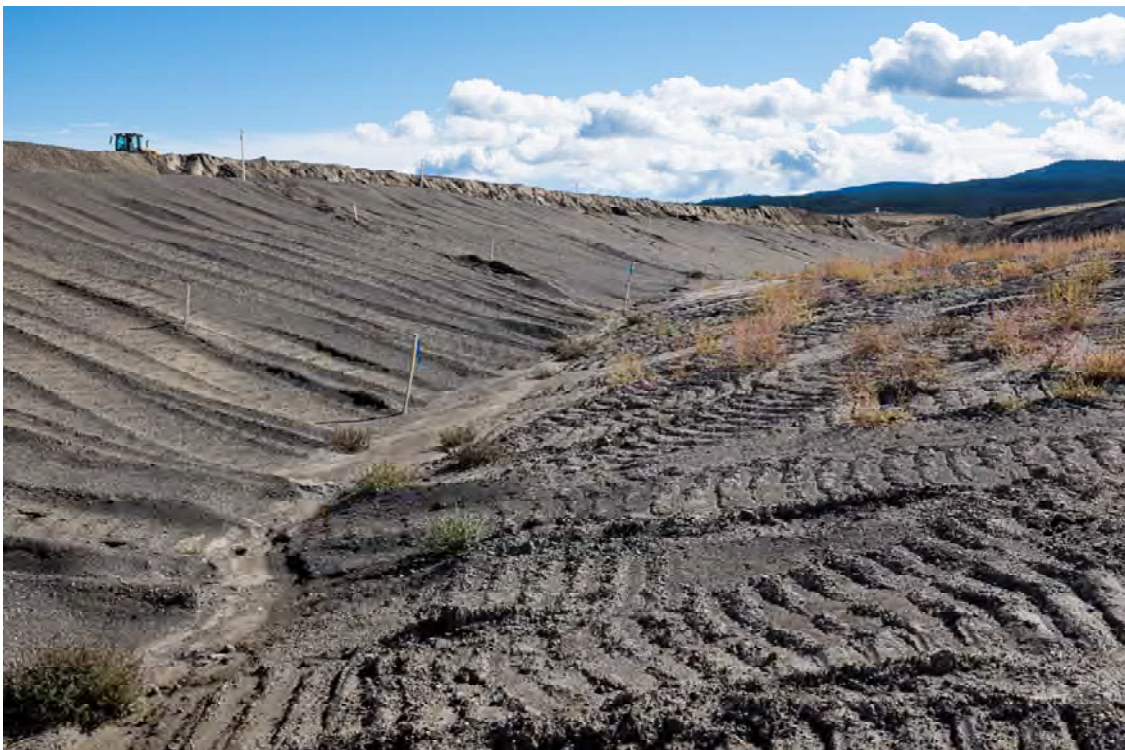
Photo DB06: View looking south at the downstream face and left abutment of Dam B from the downstream toe at approximately sta. 1+450 m.

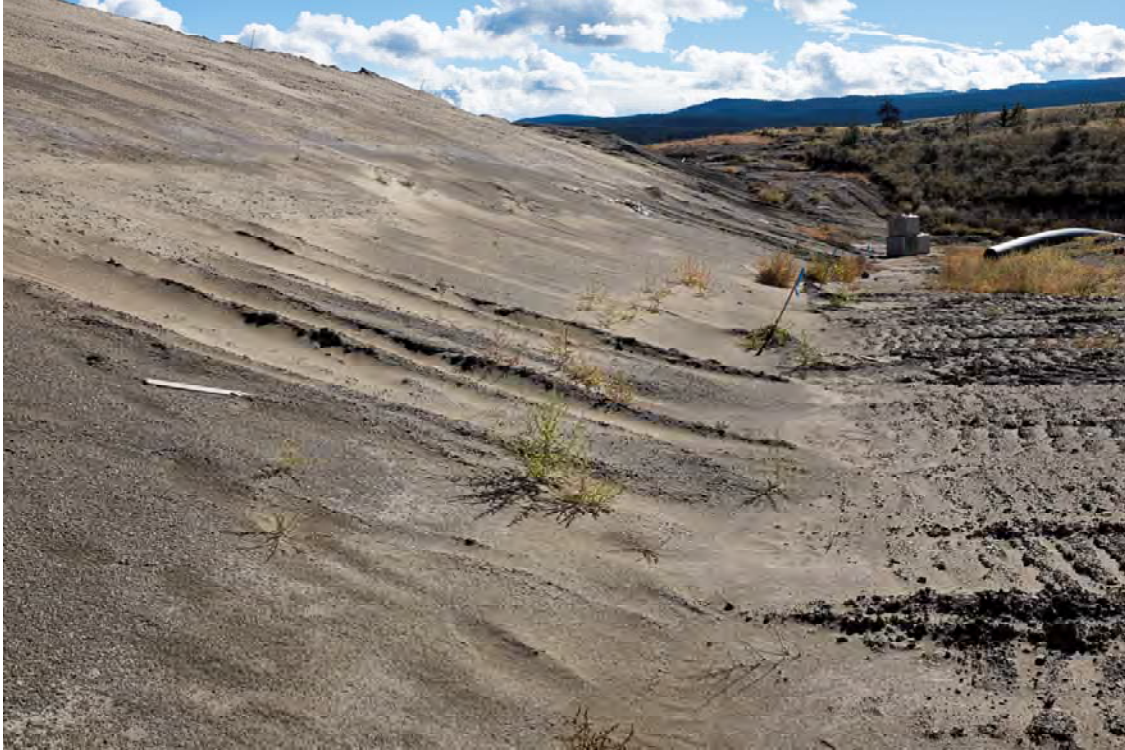
Photo DB07: View looking south at the downstream face of Dam B from the downstream toe at approximately sta. 1+350 m.

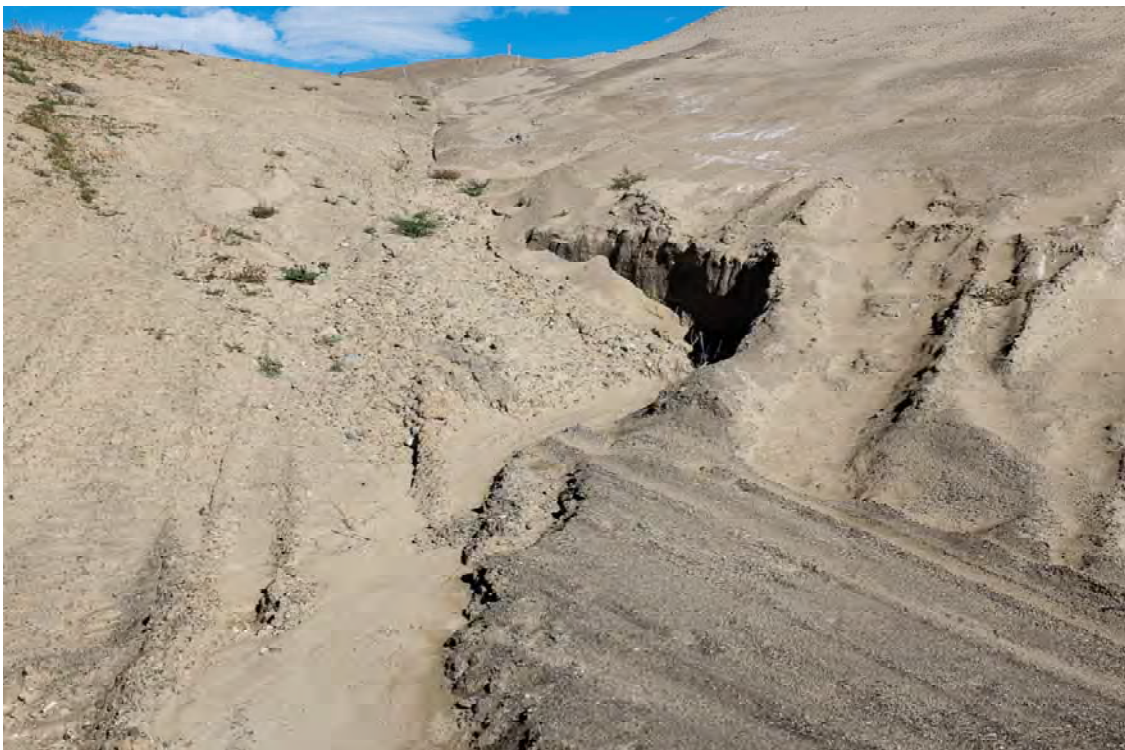
Photo DB08: View looking northeast at the downstream toe at approximately sta. 1+300 m. Note erosion of downstream toe.

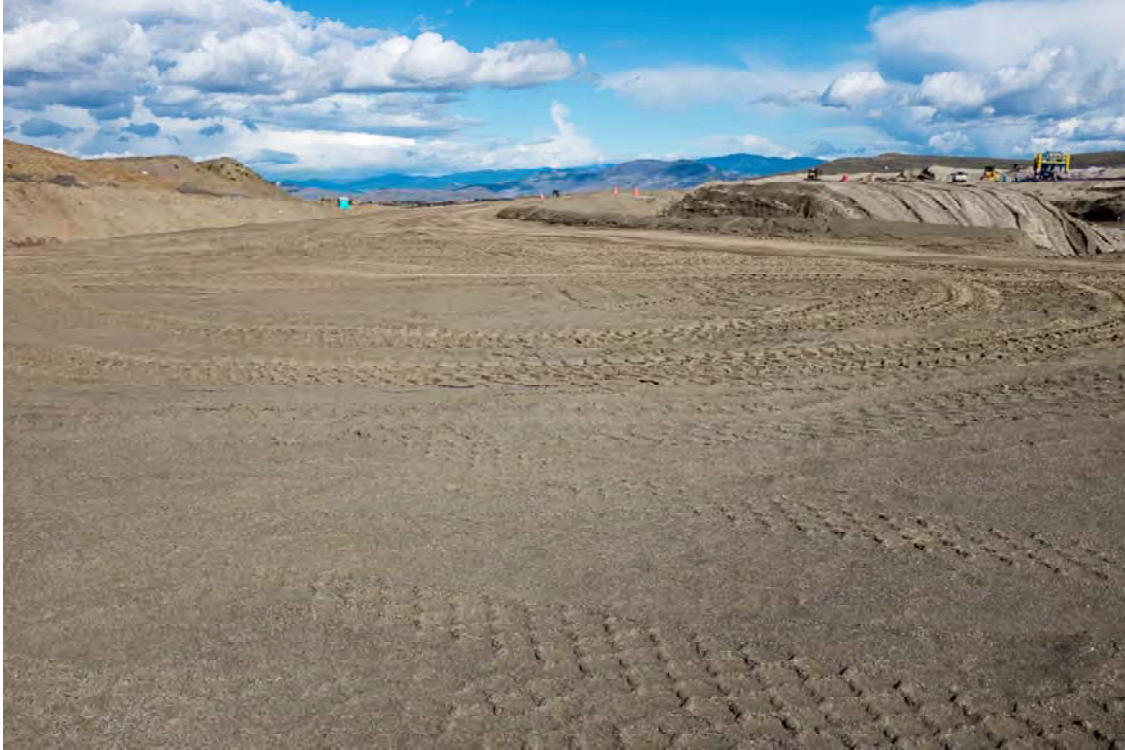
Photo DB09: View looking northeast at right abutment of Dam B from downstream toe. Left abutment of Dam C visible at top right of photo.

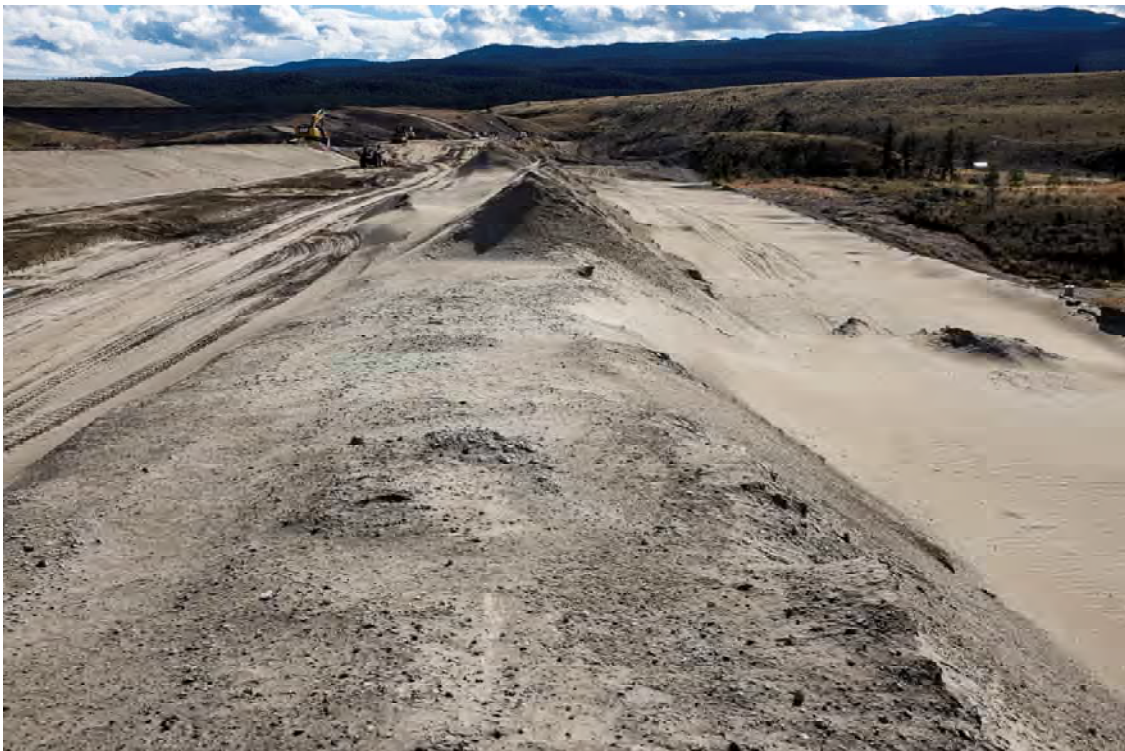
Photo DB10: View looking south at crest and downstream face of Dam B from right abutment. Note liner exposed on left side of photo and prepared bedding surface in anticipation of liner raise. West Dam visible at top left of photo.

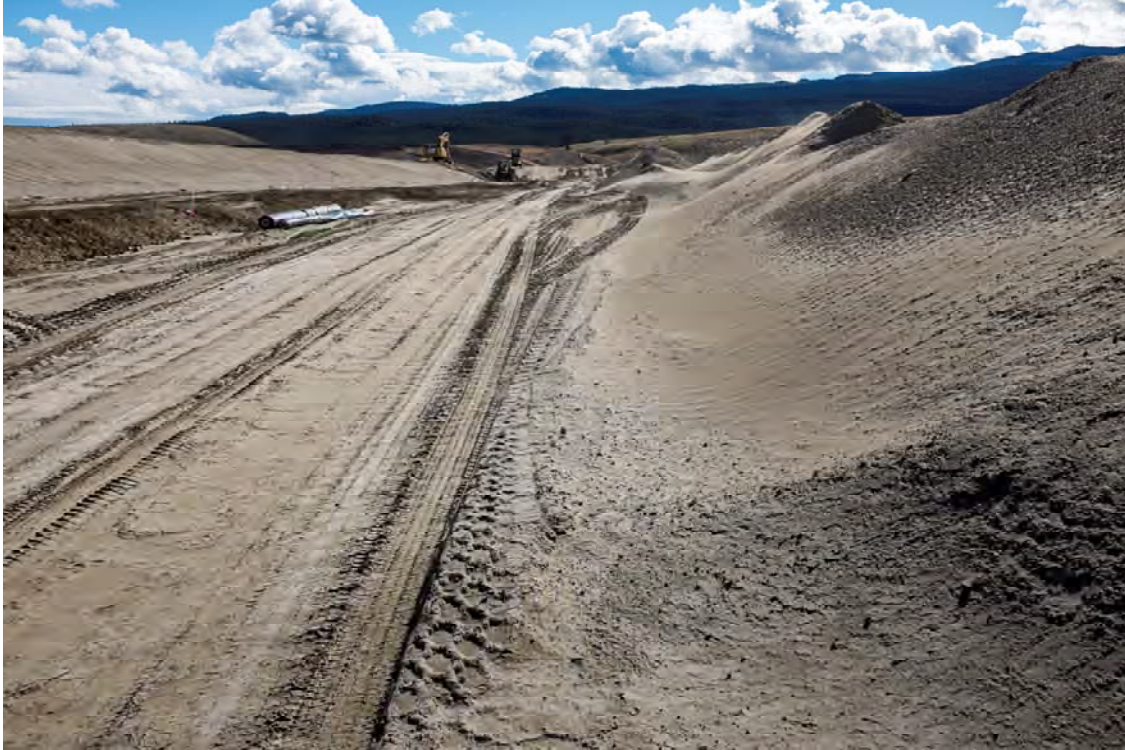
Photo DB11: View looking south at crest of Dam B from right abutment. Note liner exposed on left side of photo and prepared bedding surface in anticipation of liner raise.

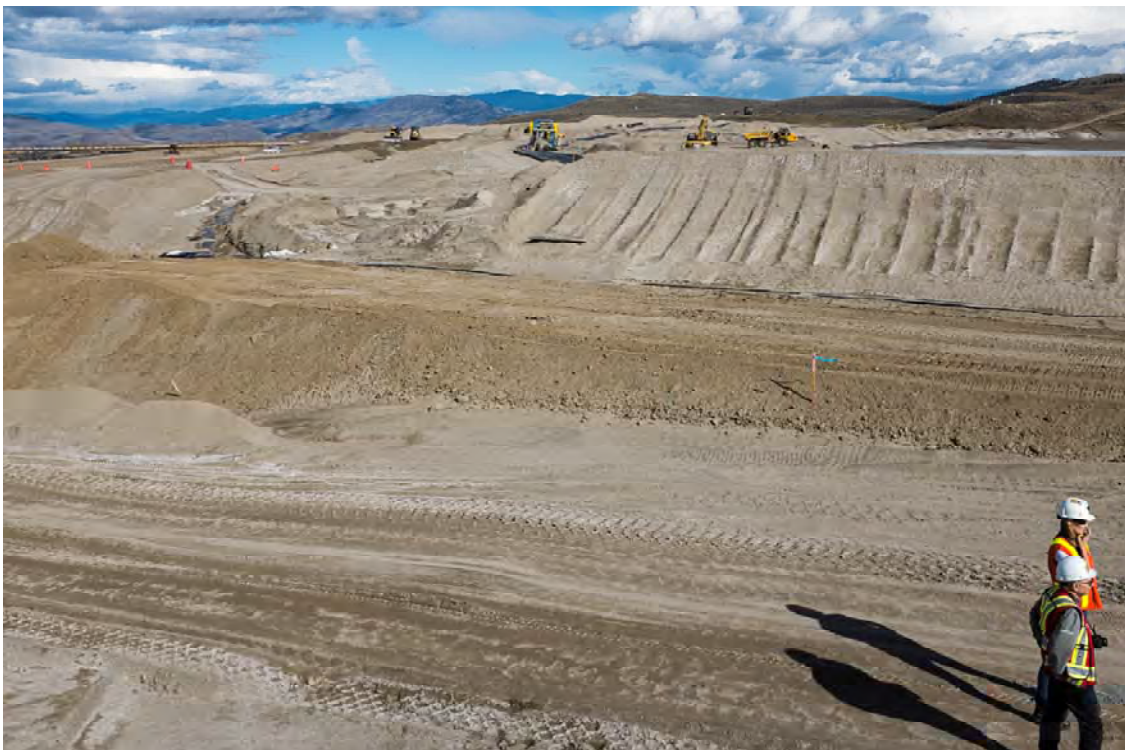
Photo DB12: View looking northeast at right abutment and crest of Dam B from downstream side of crest. Dam C visible at top right of photo. Note exposed liner and prepared slope for liner raise.

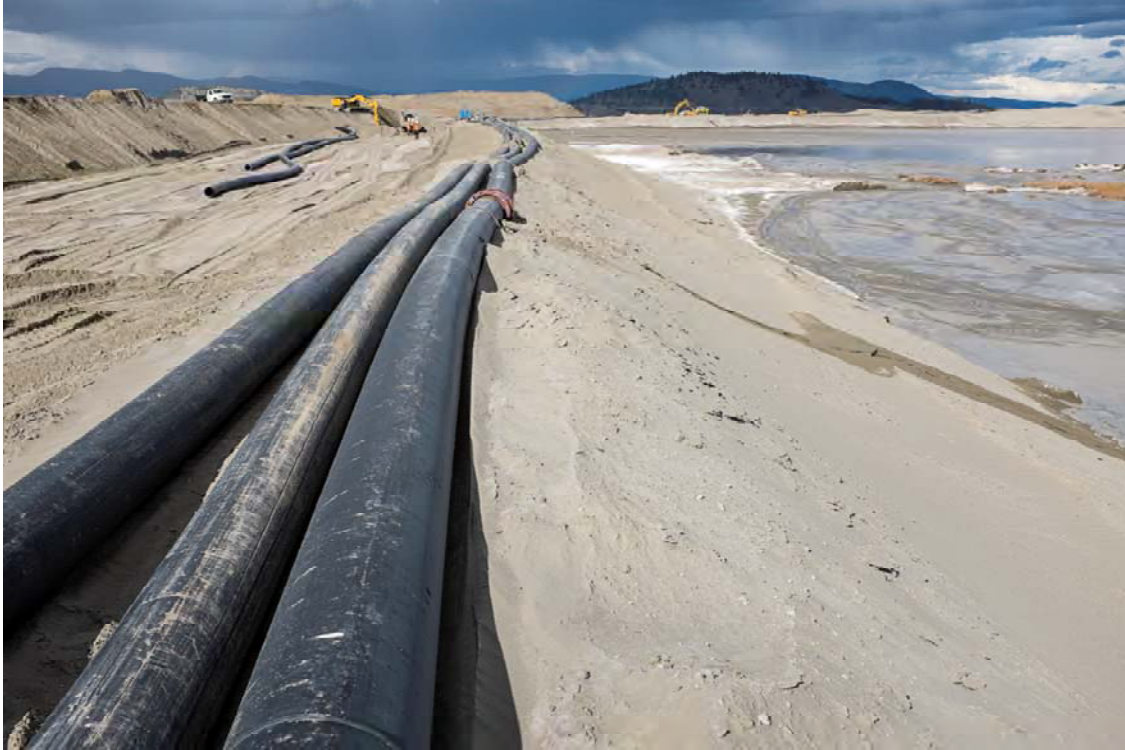
Photo DB13: View looking north at Dam B upstream limit of upstream sand cell from left abutment. Dam C visible at top right of photo.

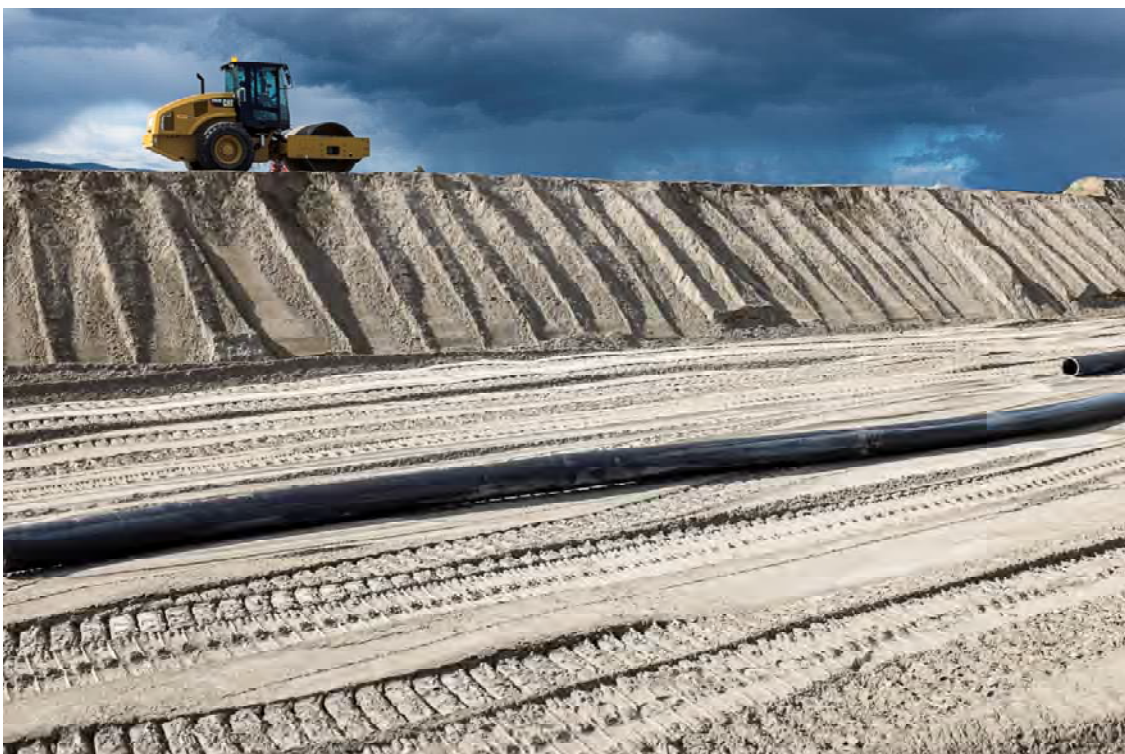
Photo DB14: View looking west at downstream limit of prepared upstream sand cell on Dam B.

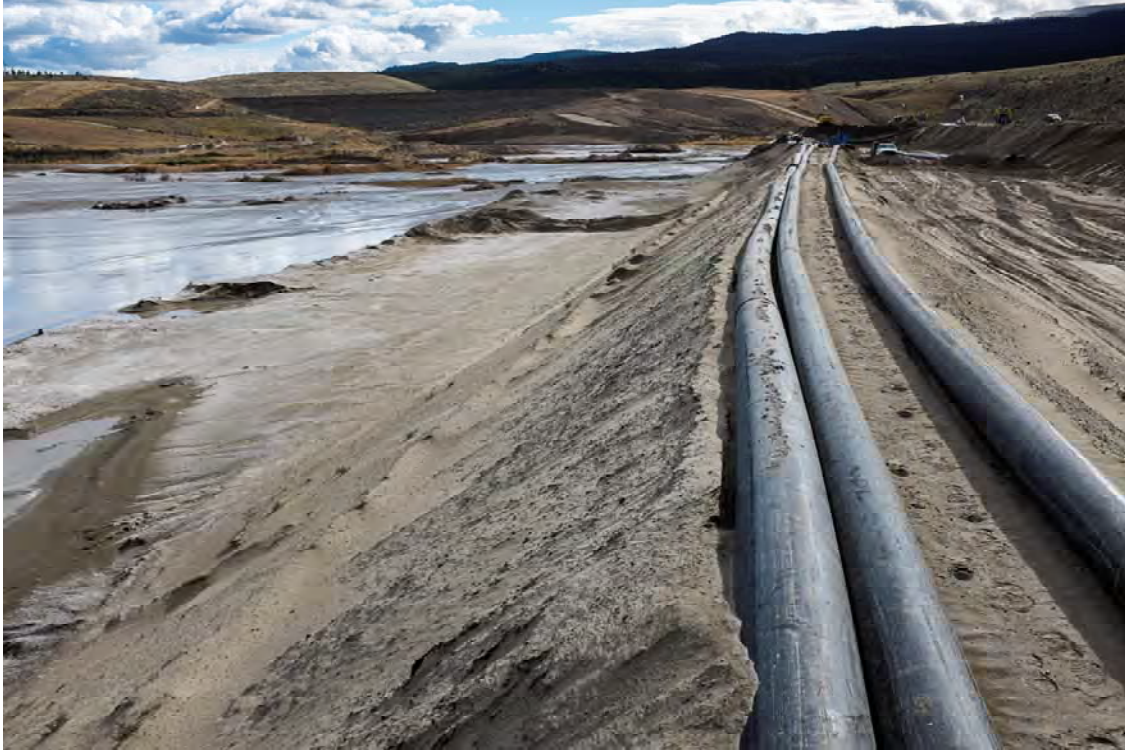
Photo DB15: View looking south at upstream limit of upstream sand cell from left abutment of Dam B toward Dam A. Sand cells being prepared for hydraulic sand placement.

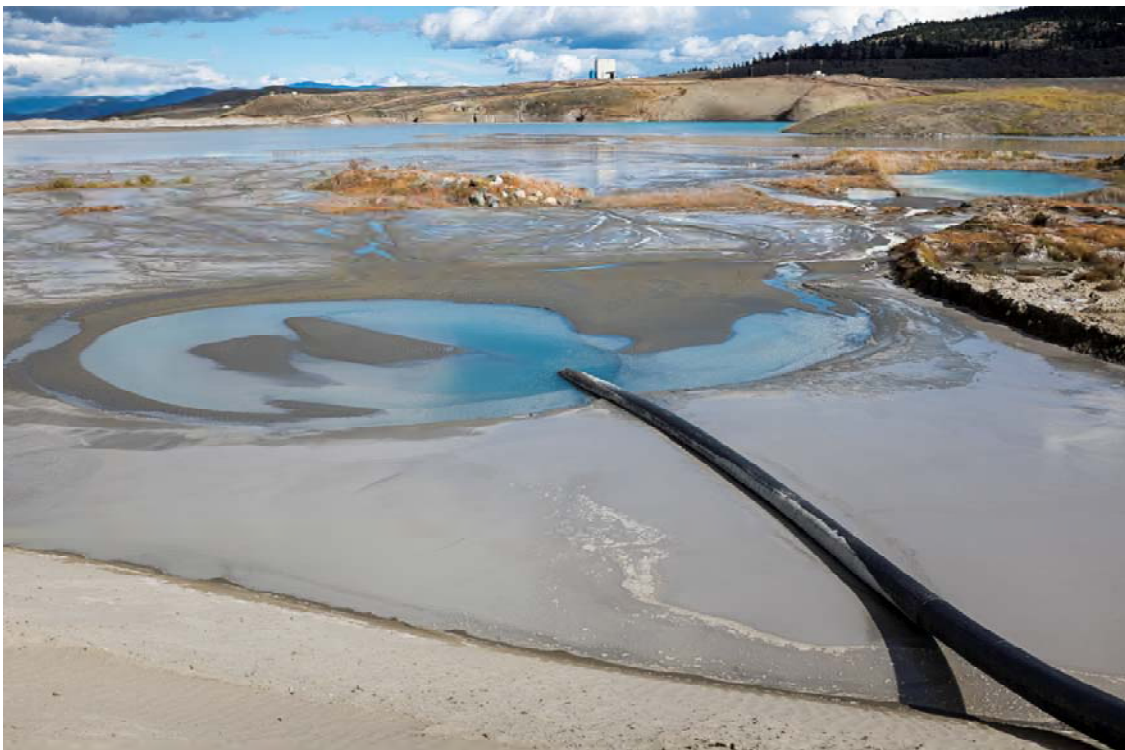
Photo DB16: View looking east at secondary overflow discharge line on beach upstream of sand cell at left abutment of Dam B. Dam C and South Dam visible in the top left and right of photo, respectively.

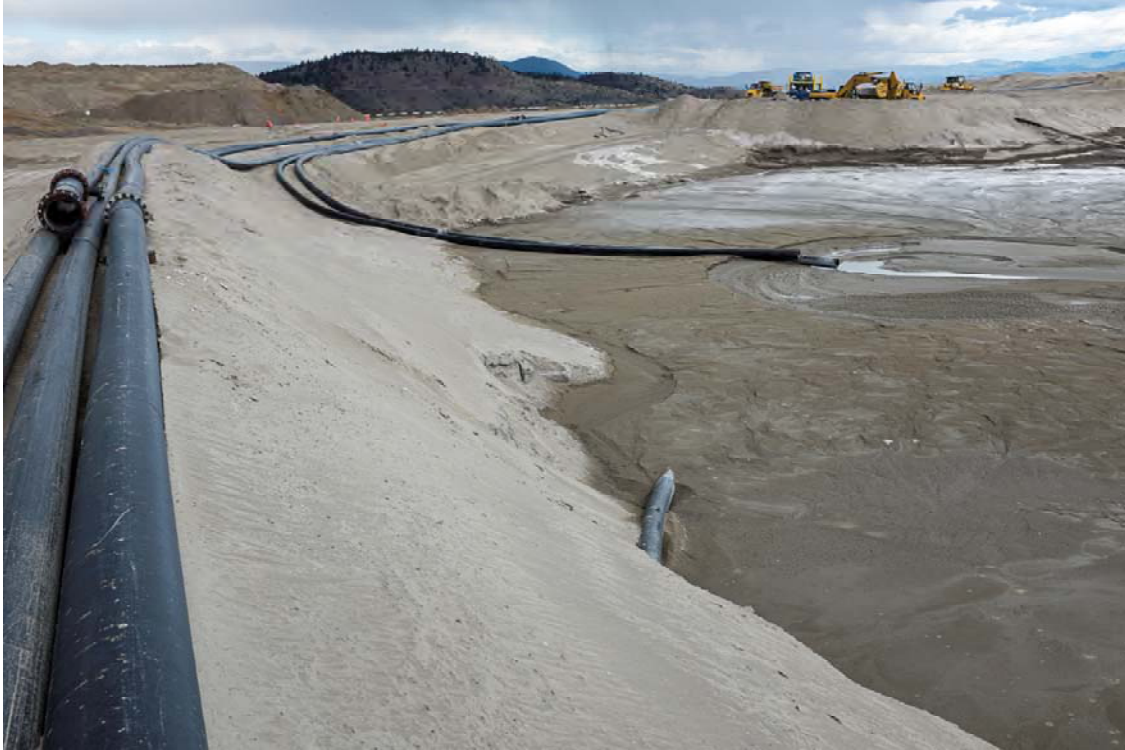
Photo DB17: View looking north at upstream limit of upstream sand cell from right abutment of Dam B toward Dam C.

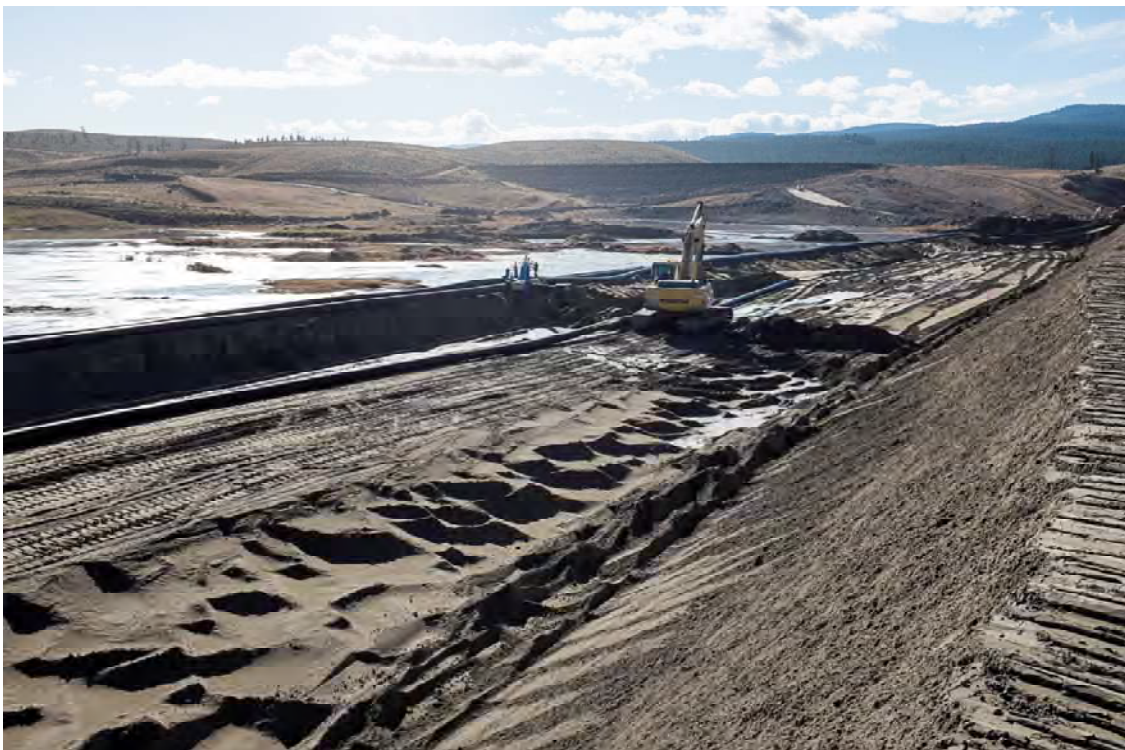
Photo DB18: View looking southeast at upstream sand cells being prepared on upstream face of Dam B at approximately sta. 1+450 m. West Dam visible in background.

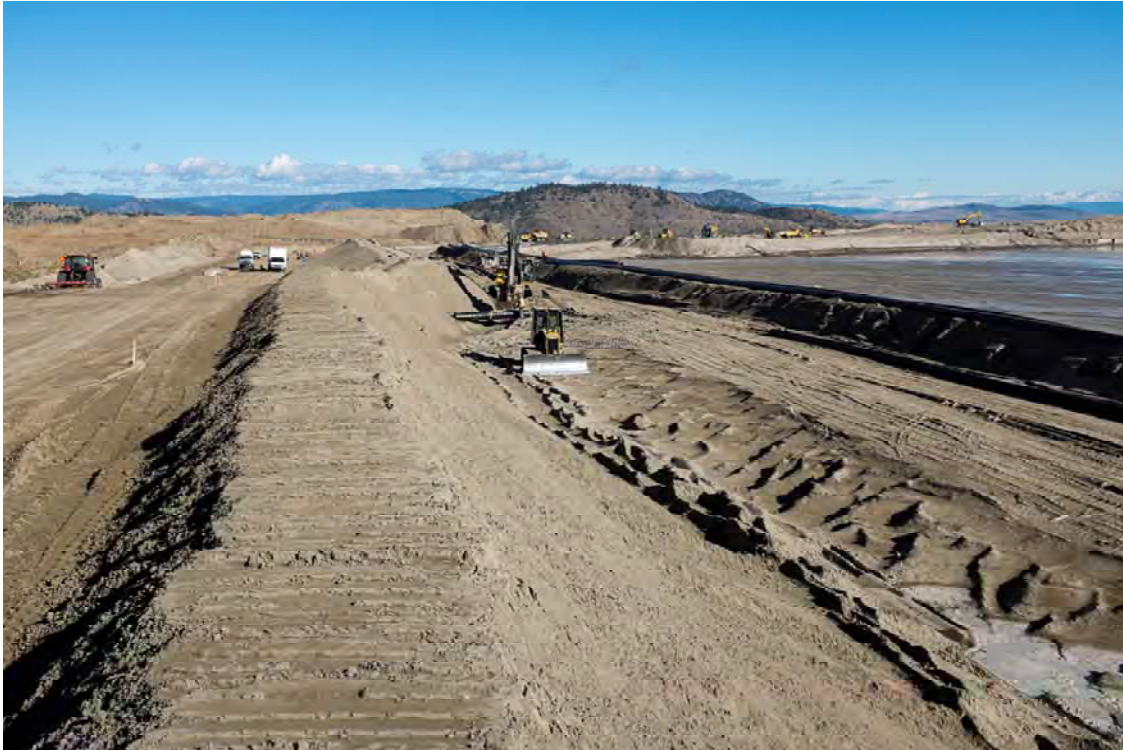
Photo DB19: View looking north at upstream sand cells and crest of Dam B from approximately sta. 1+475 m. Transition between lined and unlined section of Dam B visible in crest offset with lined portion in background.

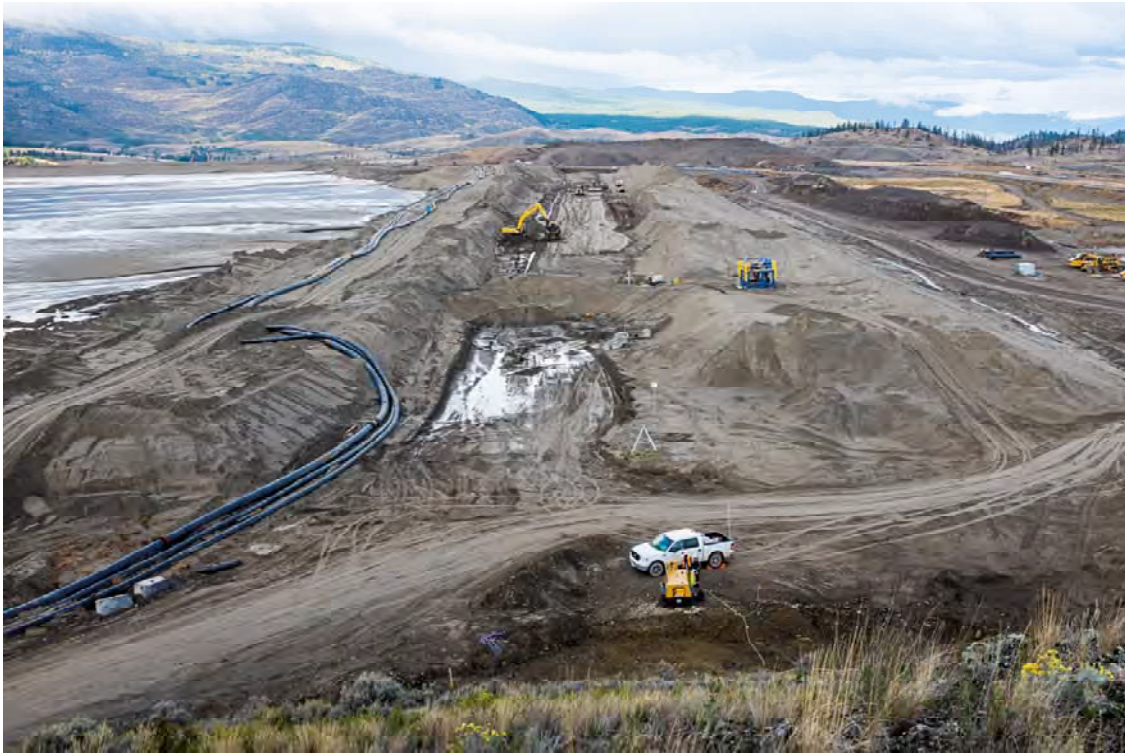
Photo DC01: View of Dam C from survey shed above right abutment looking west.

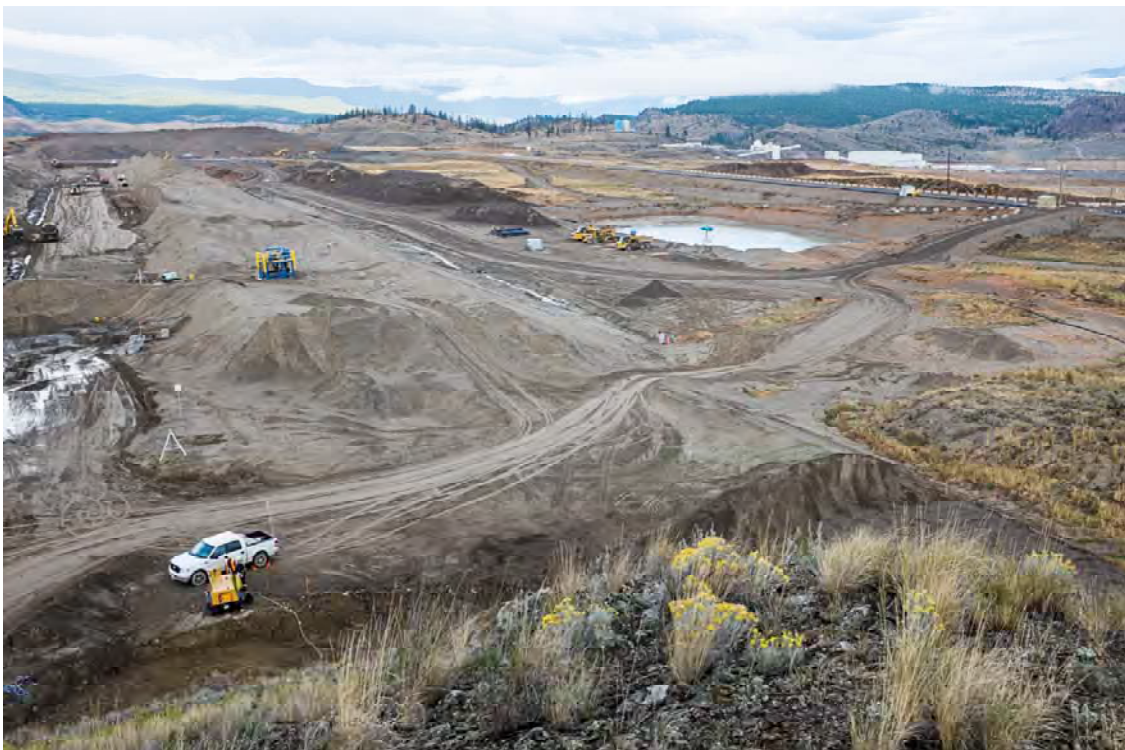
Photo DC02: View of Dam C from survey shed above right abutment looking northwest. Note Seepage Pond 3 to the upper right of the photo.

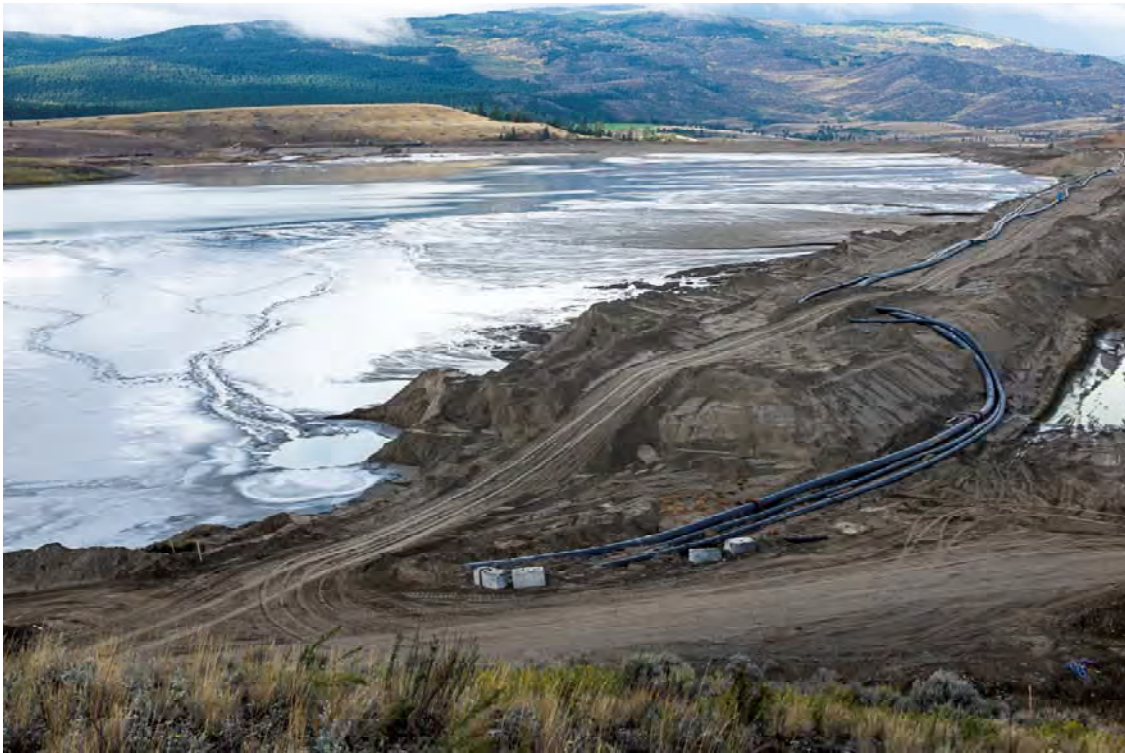
Photo DC03: View of Dam C upstream sand cells and beach looking southwest from survey shed above right abutment.

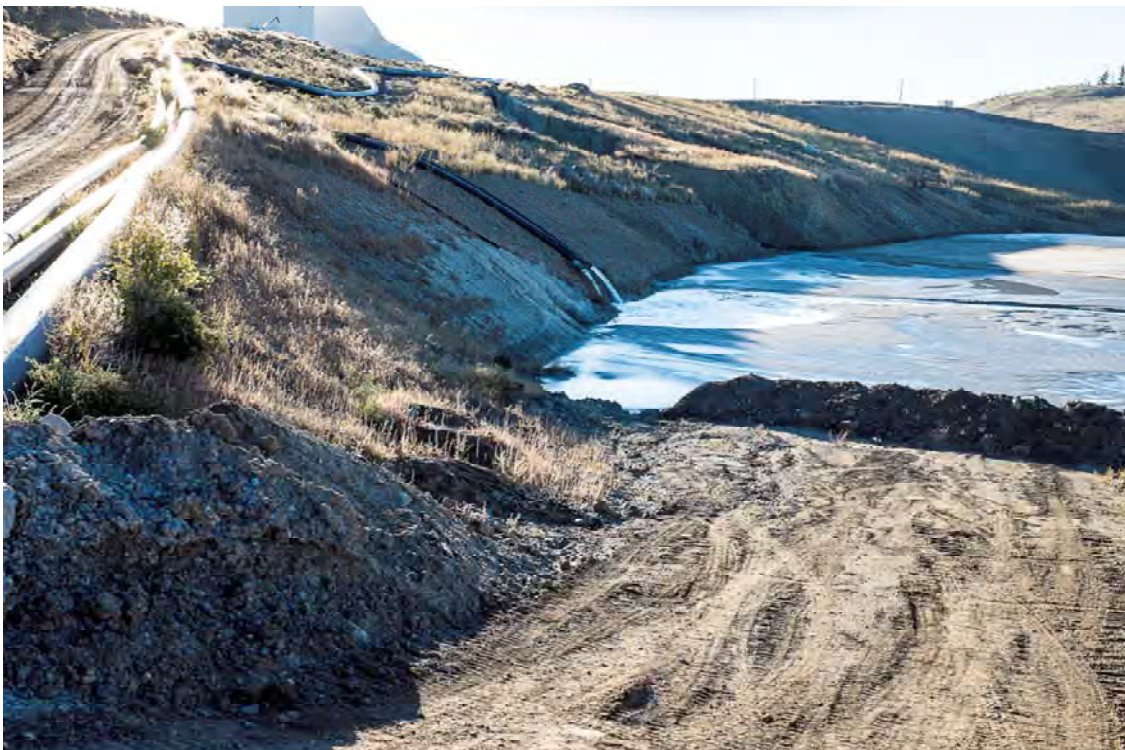
Photo DC04: View of water discharge from Pothook Pit upstream of Dam C. Looking south from right abutment of Dam C.

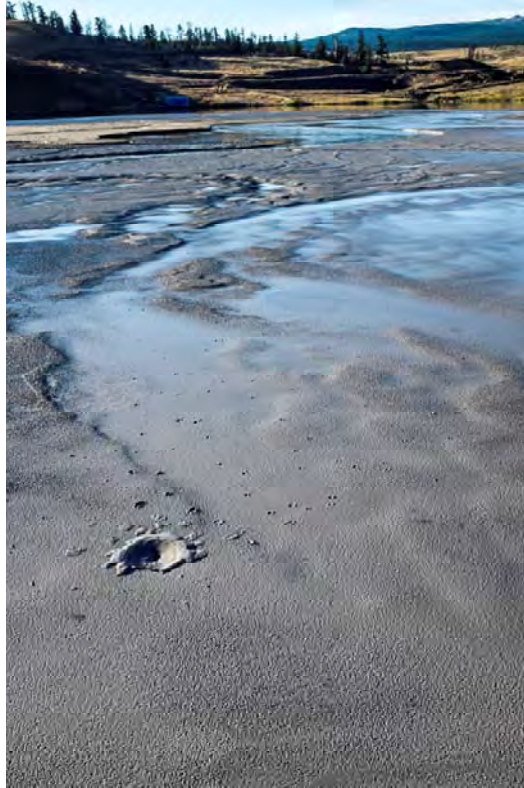
Photo DC05: View of tailings immediately upstream of Dam C looking south. Note crater in beach from rock thrown into tailings.

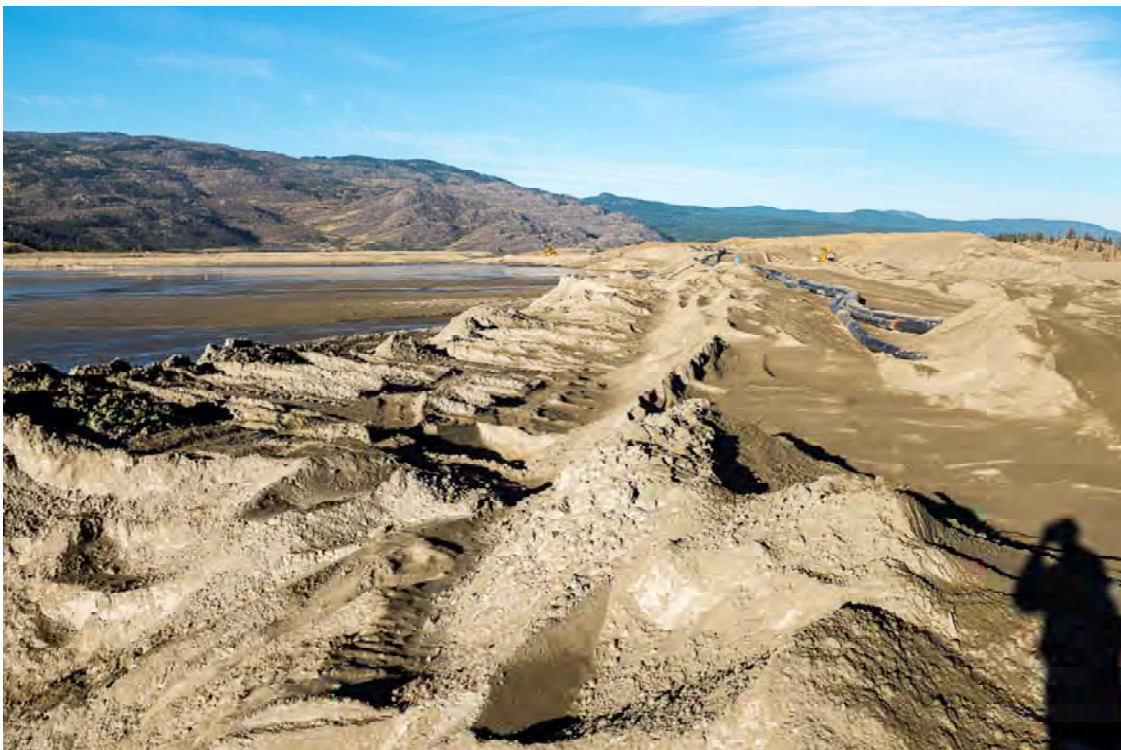
Photo DC06: View of upstream sand cells from right abutment of Dam C looking west. Note tailings that have been pushed into impoundment on left side of photo.

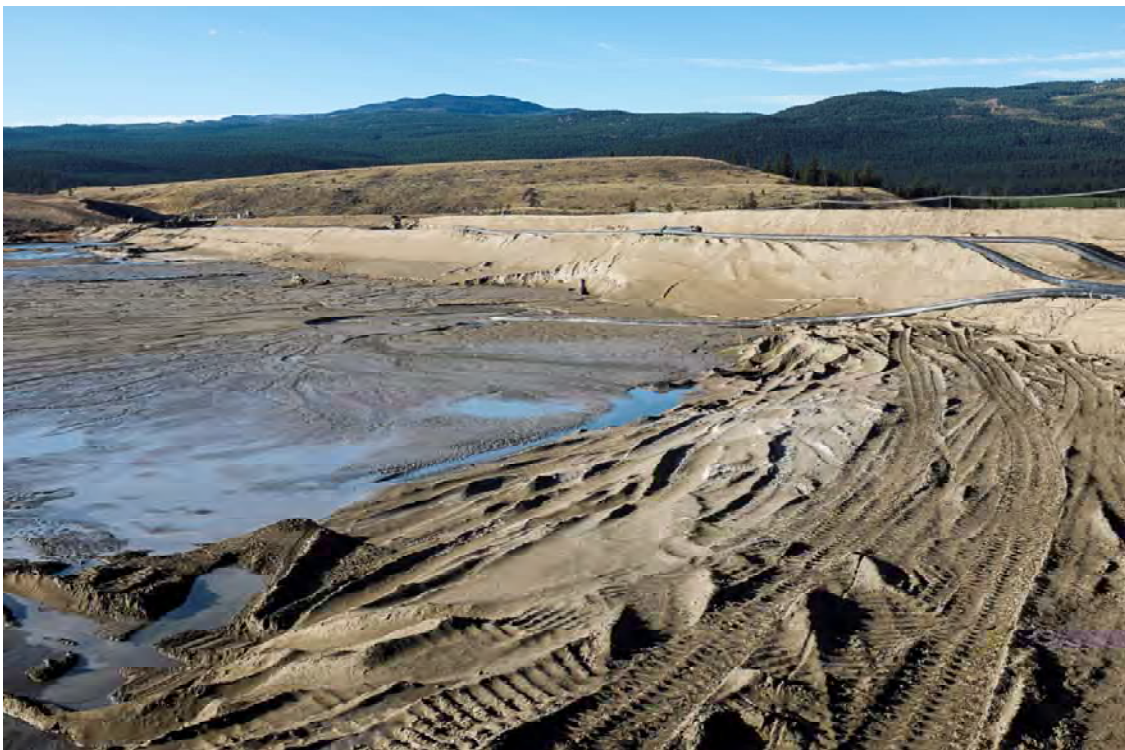
Photo DC12: View of left abutment of Dam C and the right abutment of Dam B from the upstream sand cell of Dam C looking southwest.

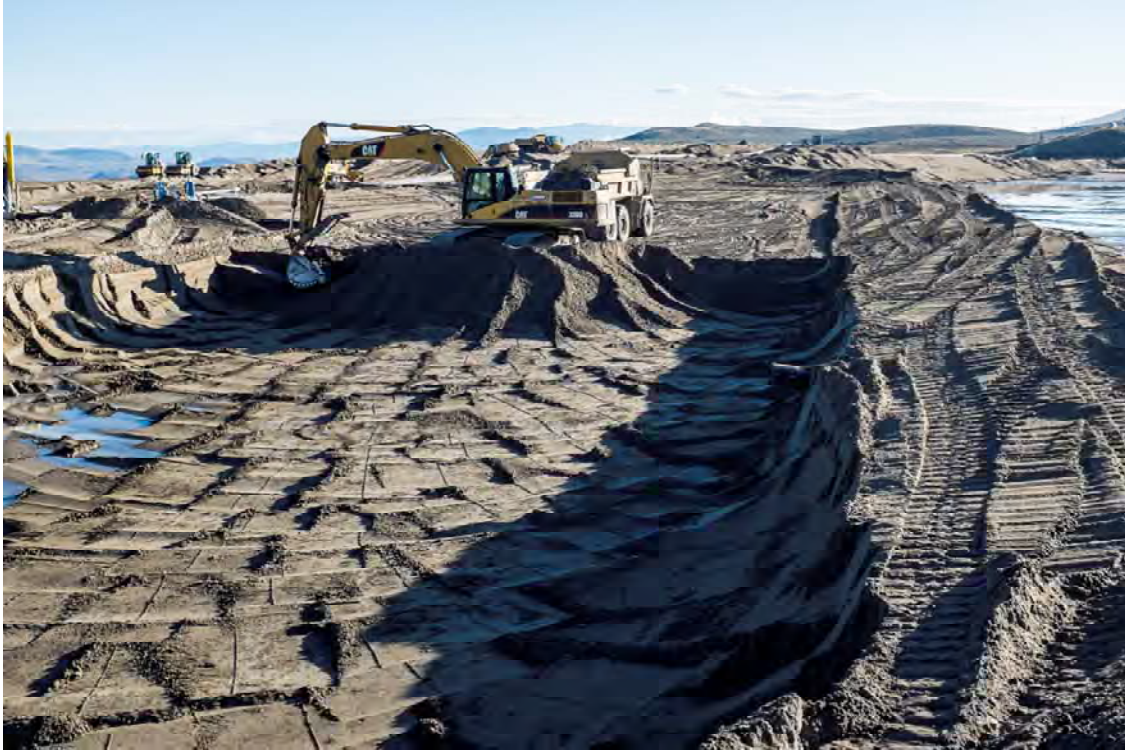
Photo DC13: View of excavation of hydraulically placed sand for use in Dam C construction looking east. Note sand cell decant pipe visible on middle right of photo.

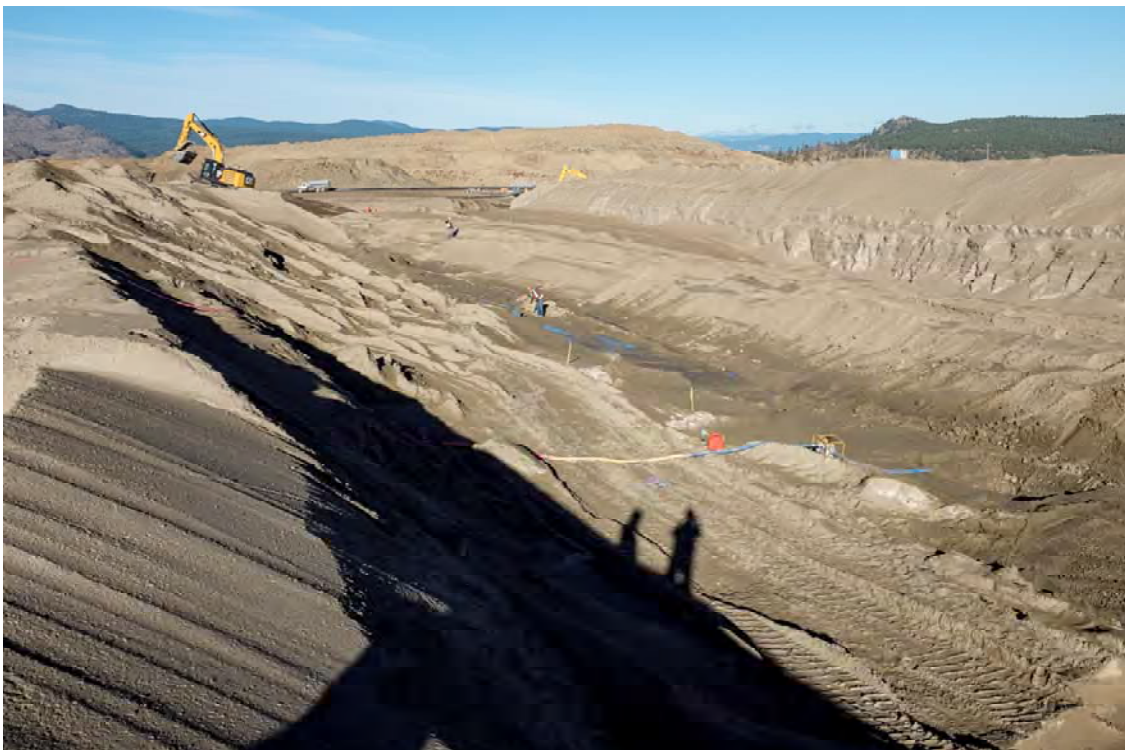
Photo DC16: View looking west along Dam C crest. Pounded water directed to sump and pumped to TSF impoundment.

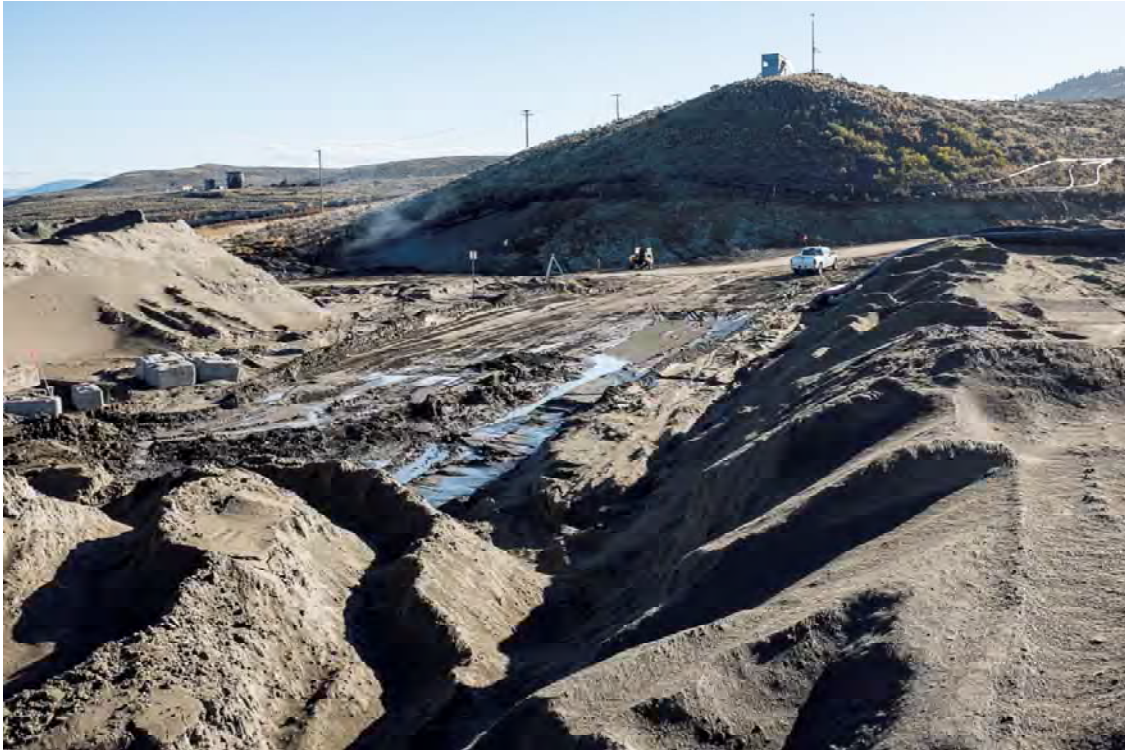
Photo DC17: View of right abutment of Dam C from downstream edge of upstream sand cell looking east. Note ponding on crest and Lock-Block protection around instrumentation installed in Dam C starter dam.

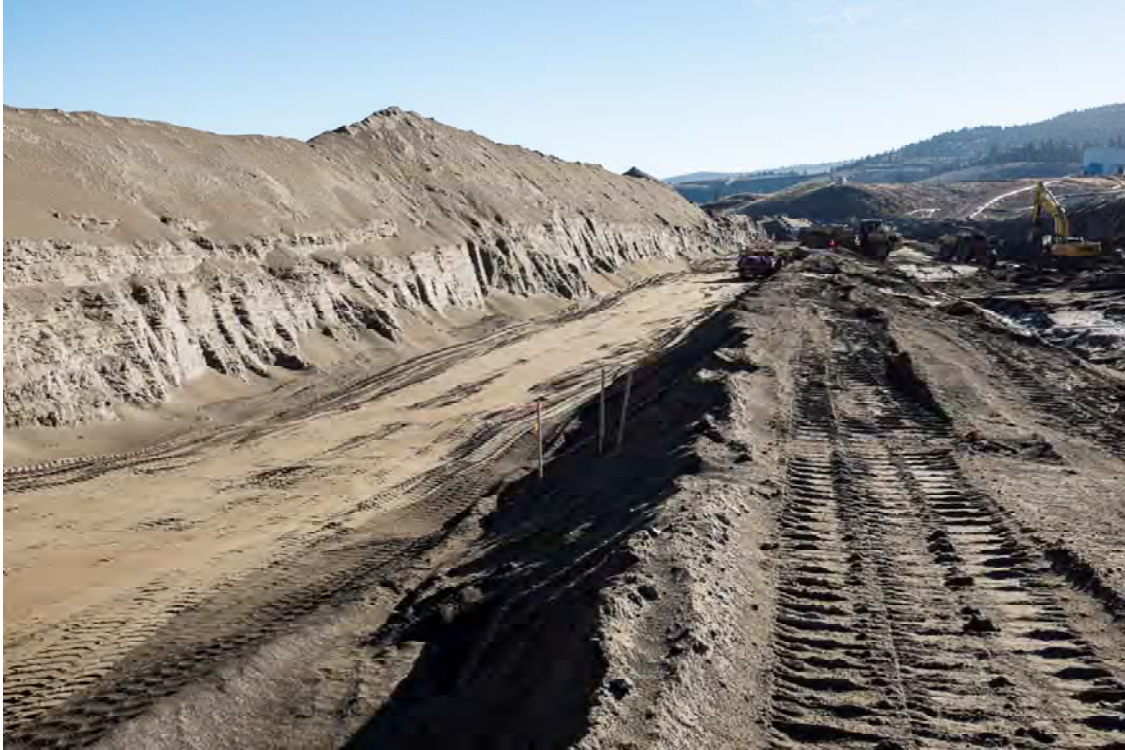
Photo DC21: View looking east toward right abutment of Dam C of crest and limit of downstream sand cell.

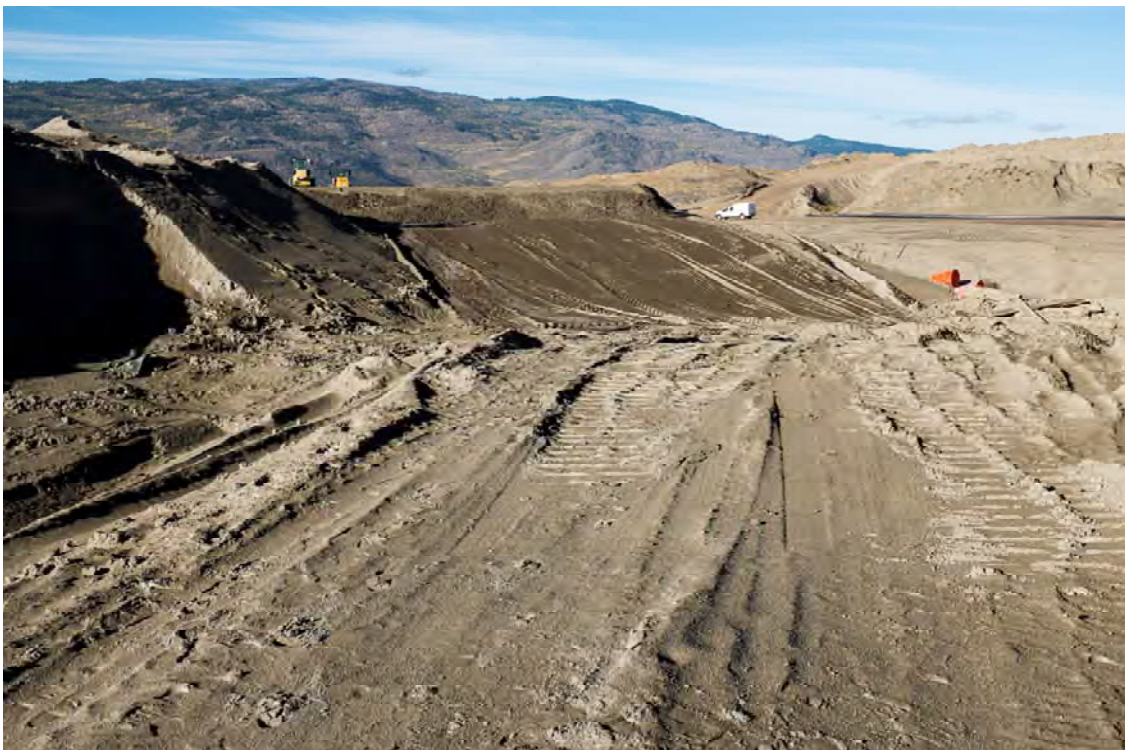
Photo DC22: View looking west toward bend in Dam C at sta. 0+900 m. Note exposed liner at mid-left of photo.
