APPENDIX B SELECT PHOTOGRAPHS

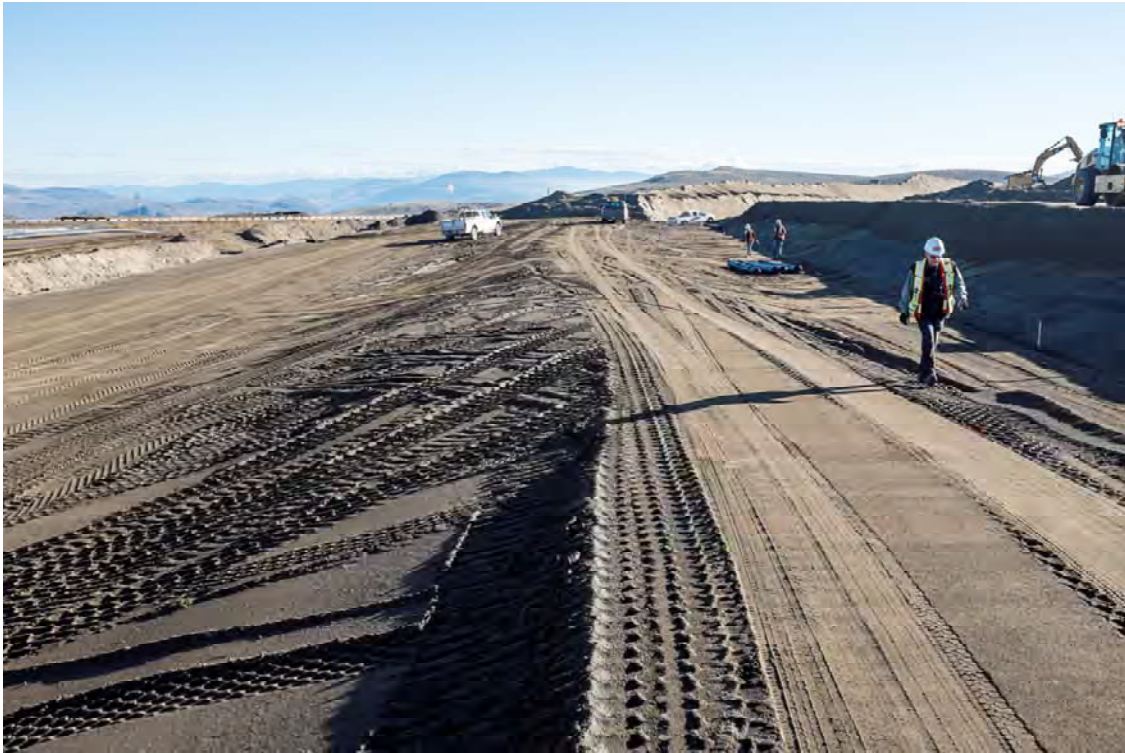
Photo DC23: View looking northeast at crest of Dam C from adjacent to left abutment of Dam C.

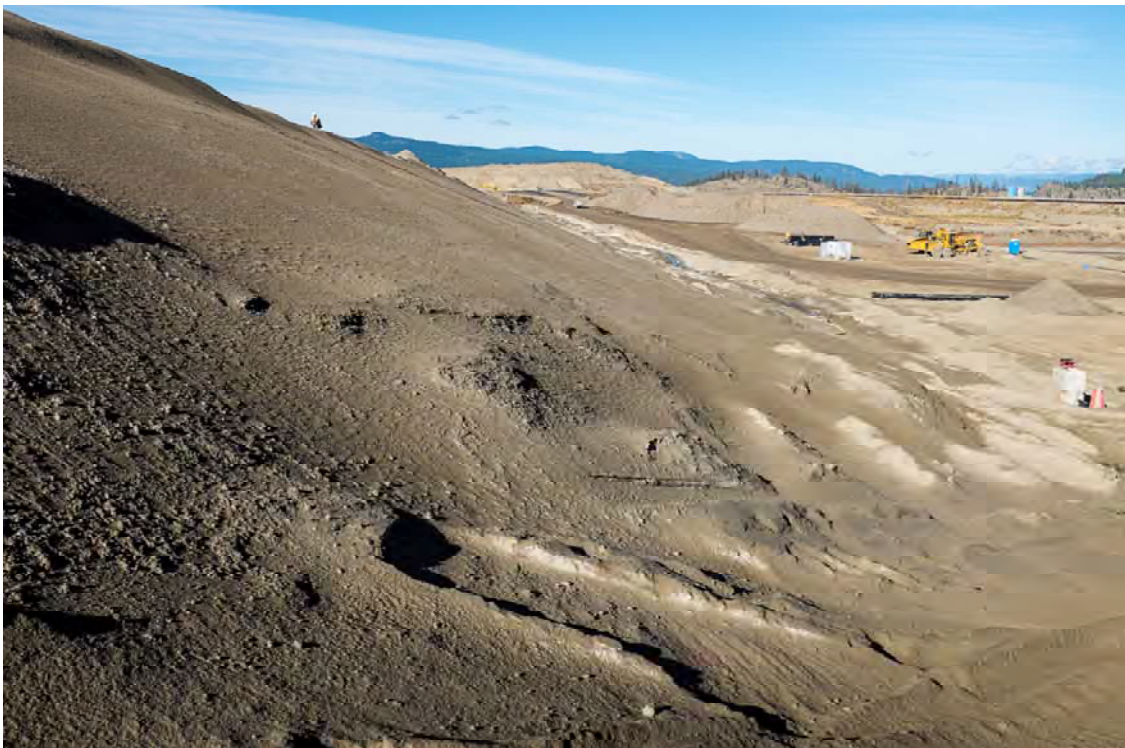
Photo DC24: View looking west from right abutment at downstream face and toe of Dam C. Note uniform downstream slope and filter stockpiles at top right of photo. Downstream face has been sprayed with polymer to prevent dusting.

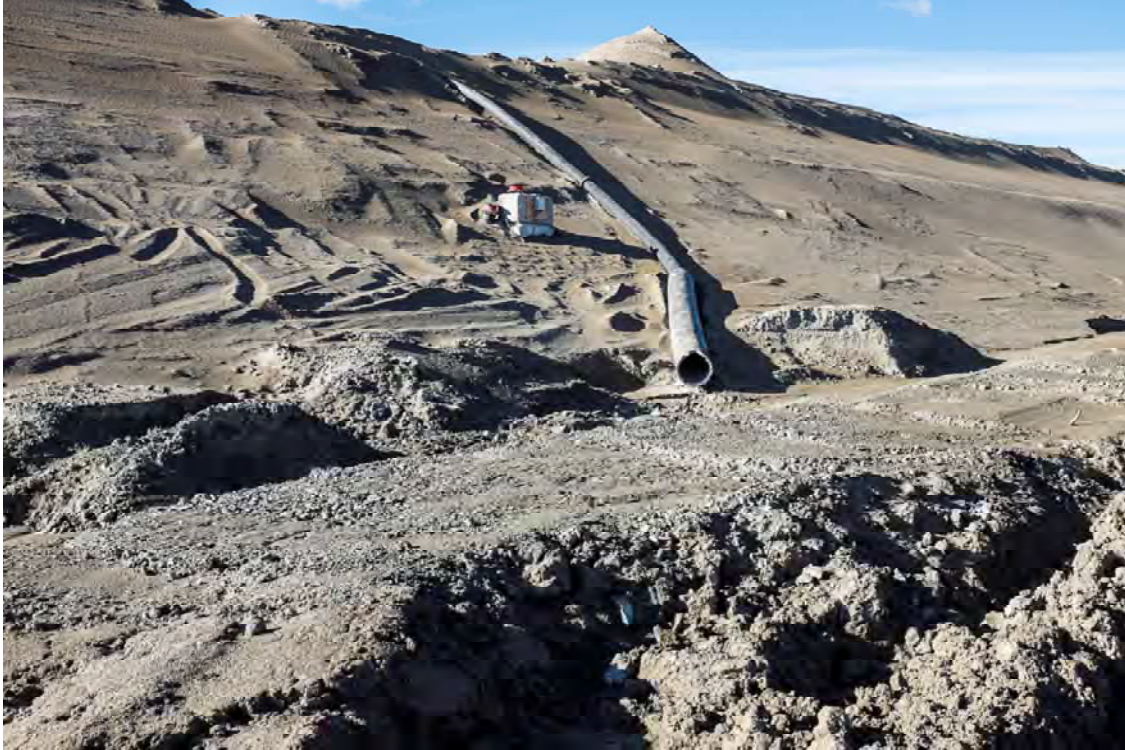
Photo DC25: View looking southwest at instrument leads and decant pipe on downstream face of Dam C at approximately sta. 0+600 m.

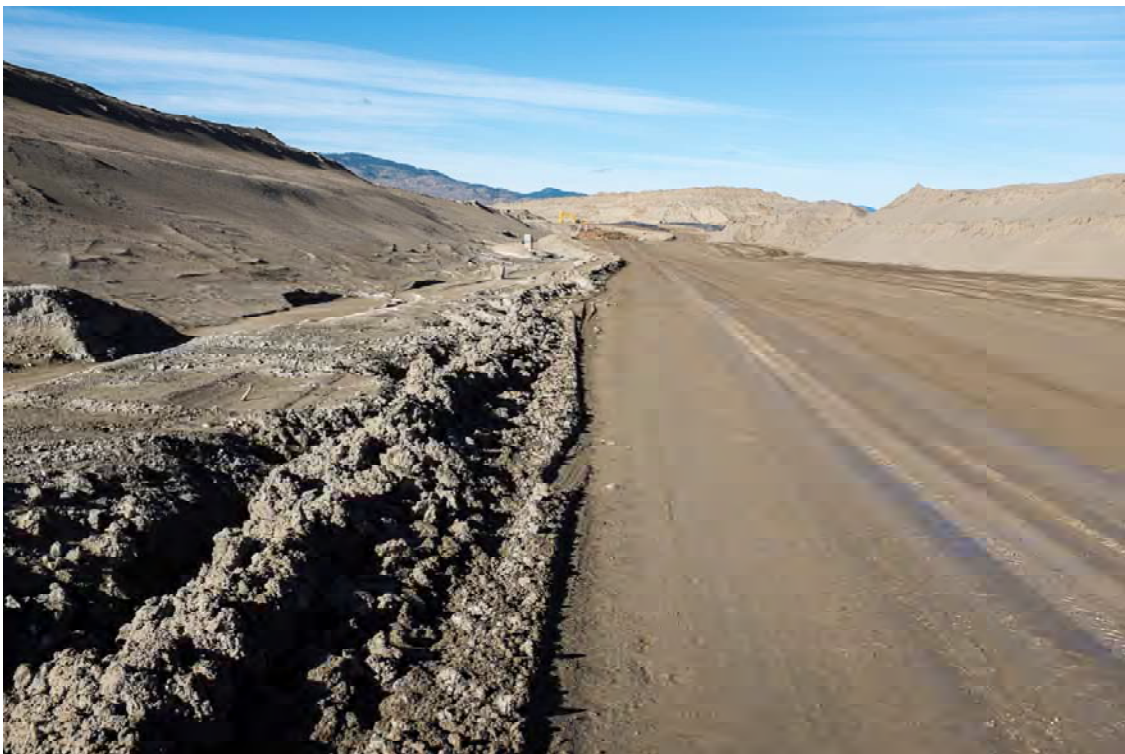
Photo DC26: View looking west from downstream toe of Dam C at approximately sta. 0+600 m.

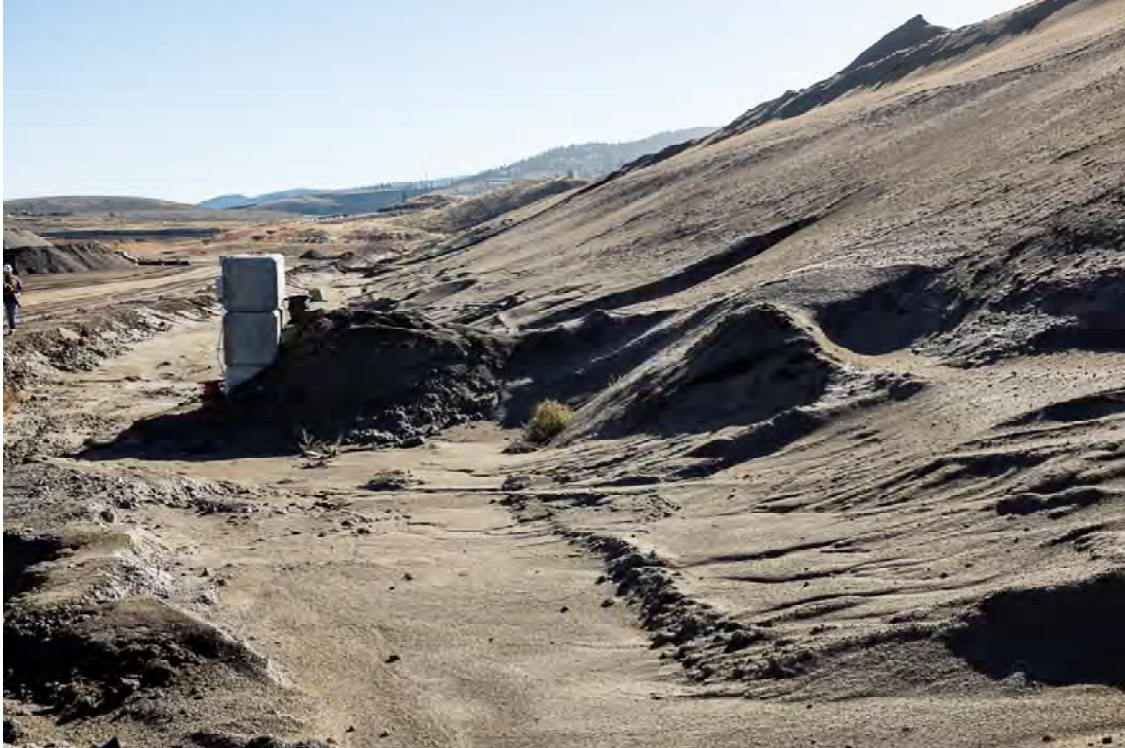
Photo DC27: View looking east toward right abutment of Dam C from downstream toe at approximately sta. 0+800 m. Note instrumentation leads at toe of dam mounted on Lock-Blocks.

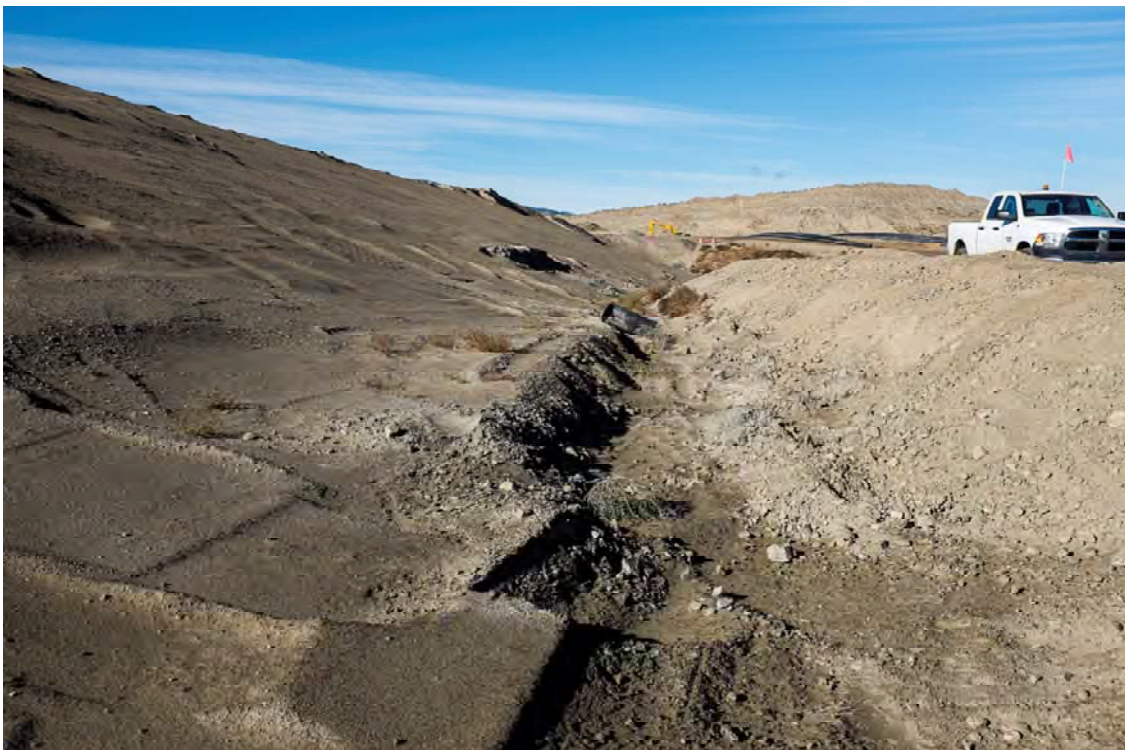
Photo DC28: View looking west from downstream toe of Dam C at approximately sta. 0+850 m. Note till stockpile in background at excavator.

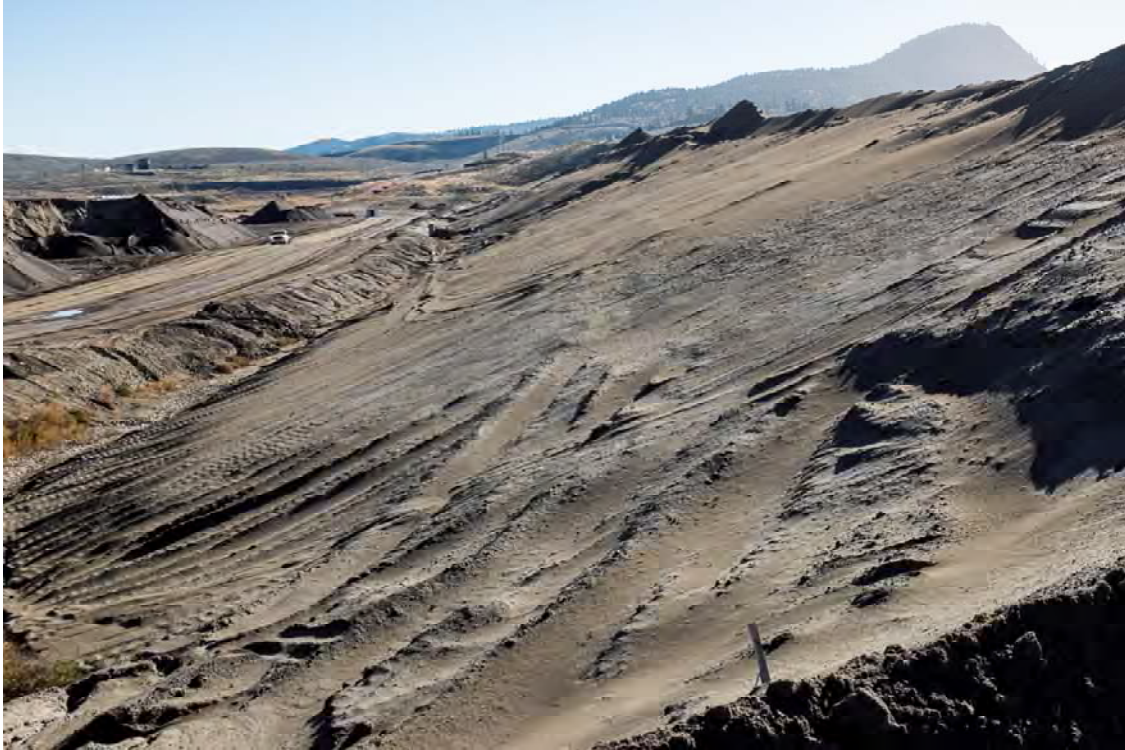
Photo DC29: View looking east toward right abutment of Dam C from downstream toe at approximately sta. 0+950 m.

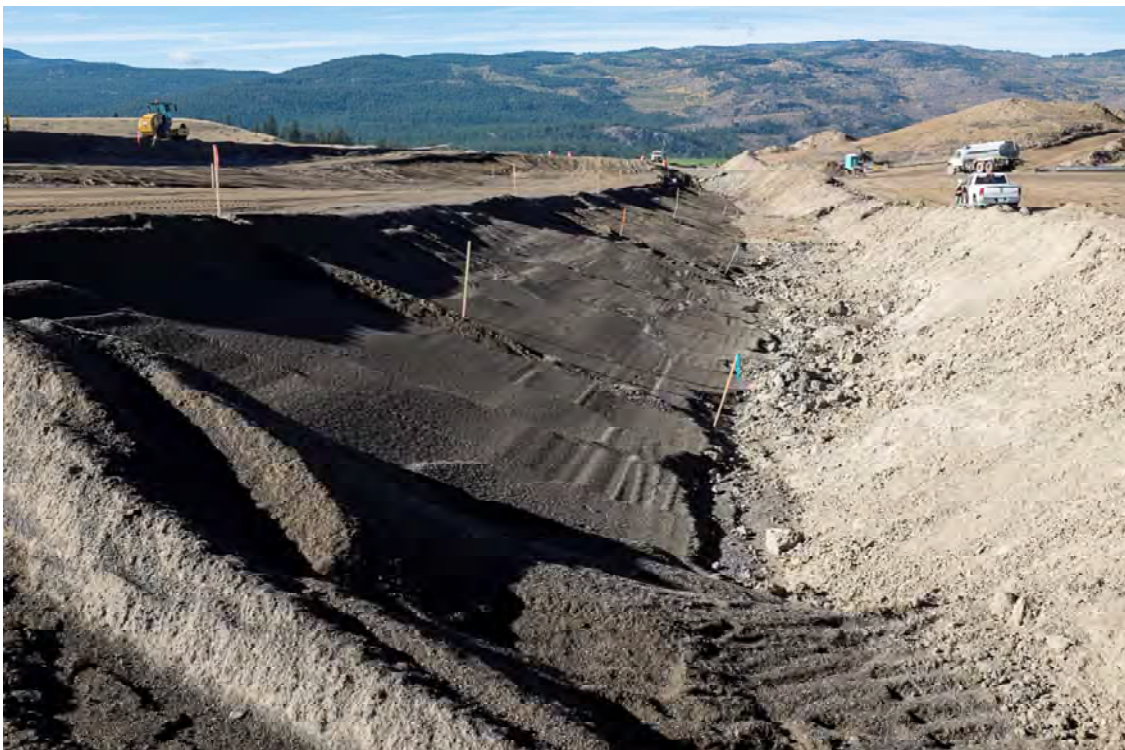
Photo DC30: View looking southwest at downstream toe of Dam C from sta. 1+100 m. Right abutment of Dam B visible in background.

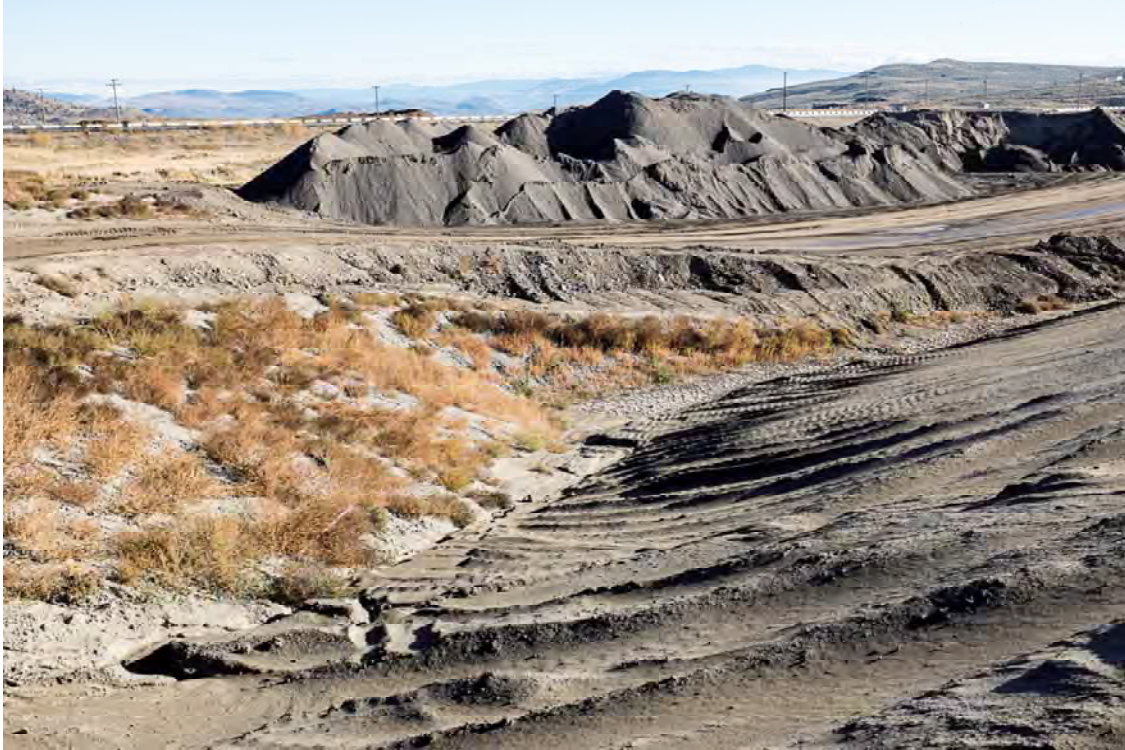
Photo DC31: View looking northeast at downstream toe of Dam C from approximately sta. 0+950 m.
Note filter stockpiles and tailings pipeline in background.

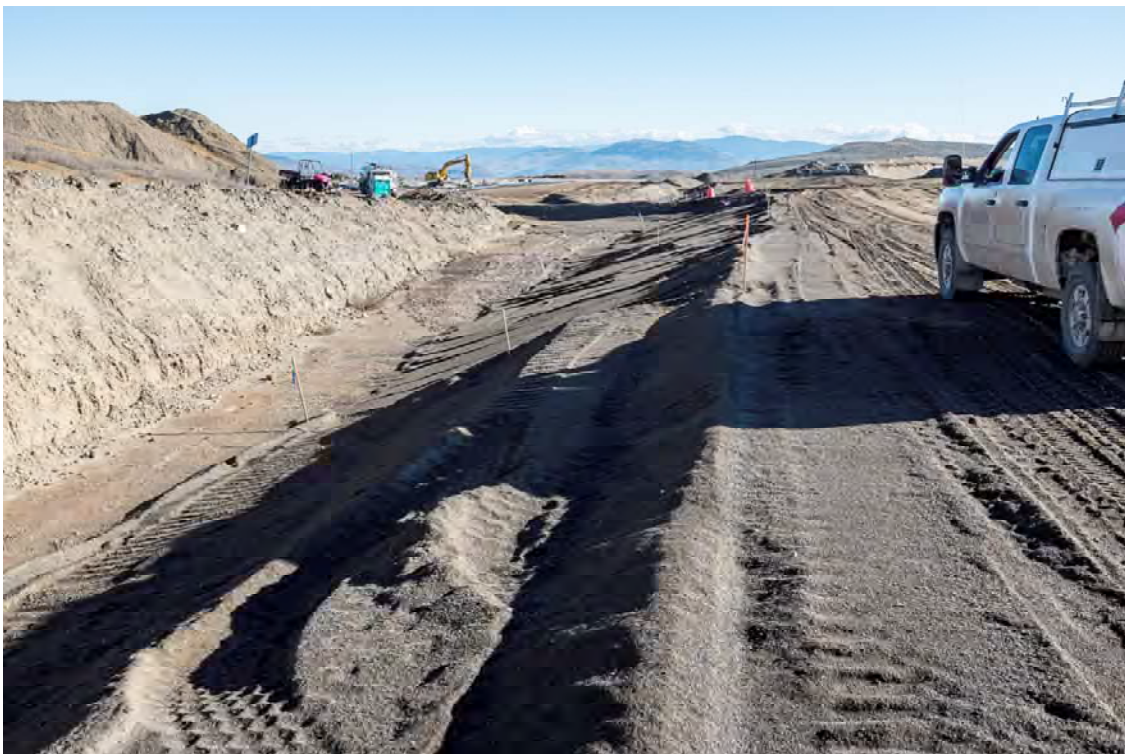
Photo DC32: View looking northeast at downstream toe from left abutment of Dam C.

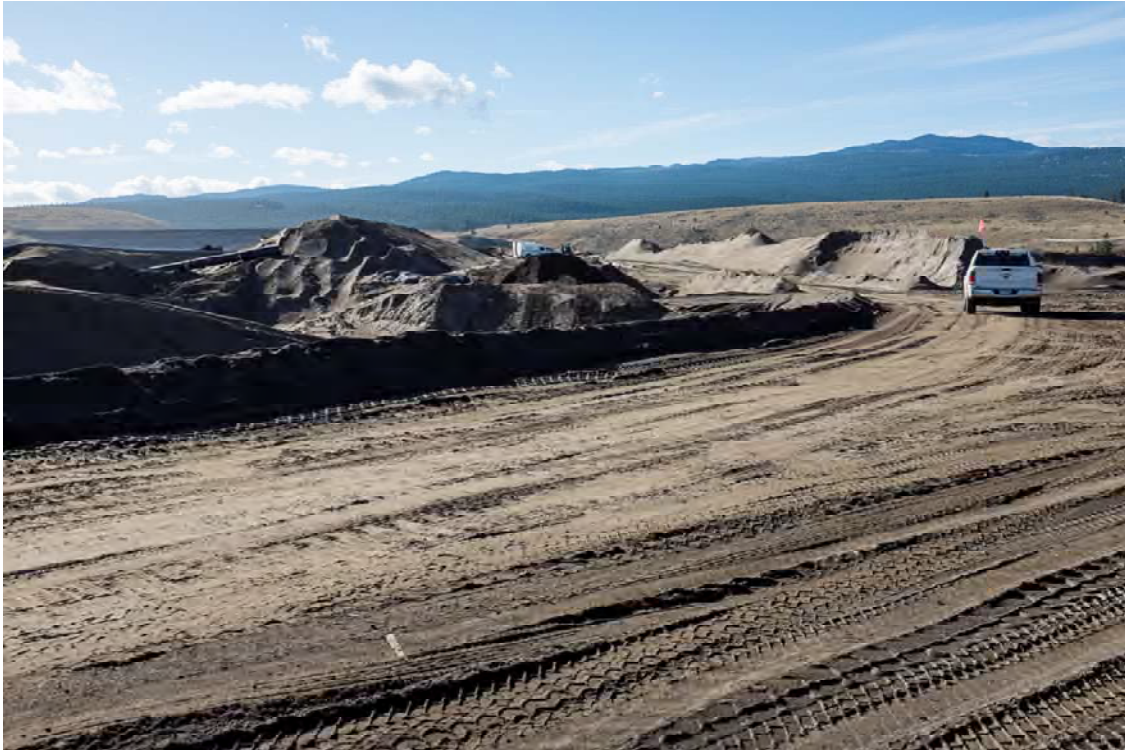
Photo DC33: View looking south at left abutment of Dam C and right abutment of Dam B from downstream toe of Dam C. Note liner raise being prepared on Dam B in middle background of photo where trucks and personnel visible.

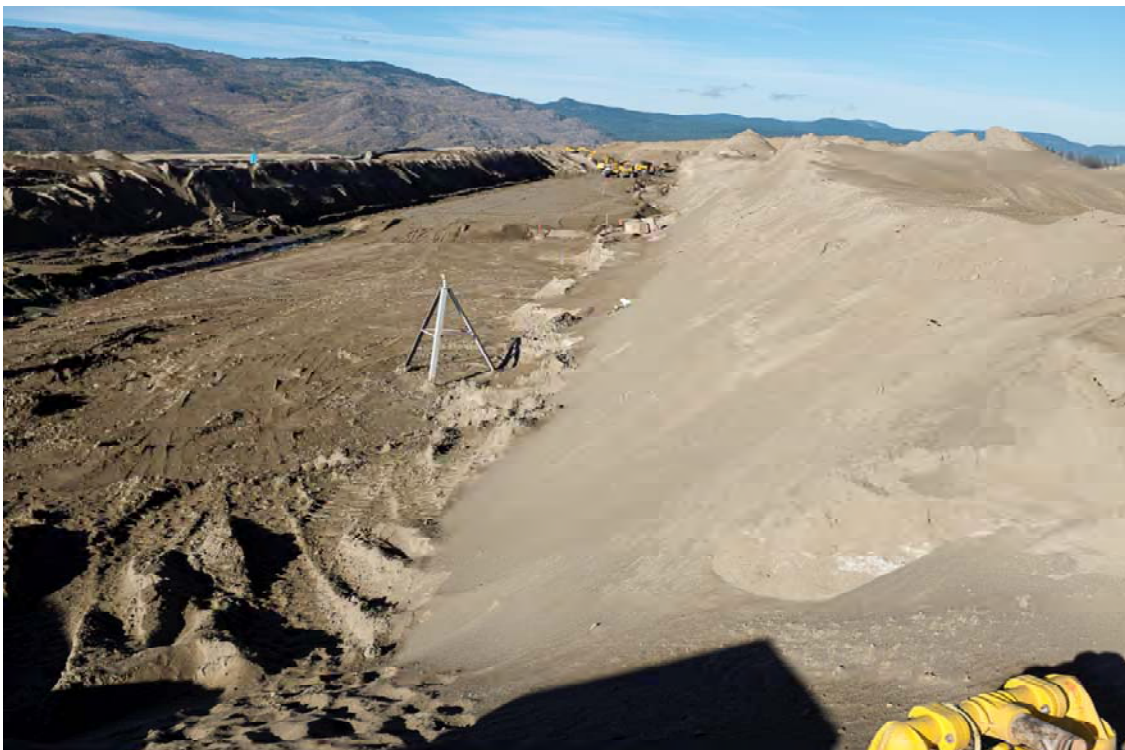
Photo DC34: View looking west from crest at right abutment of Dam C. Note survey tripod, and slope inclinometer protected by Lock-Blocks on downstream side of crest.

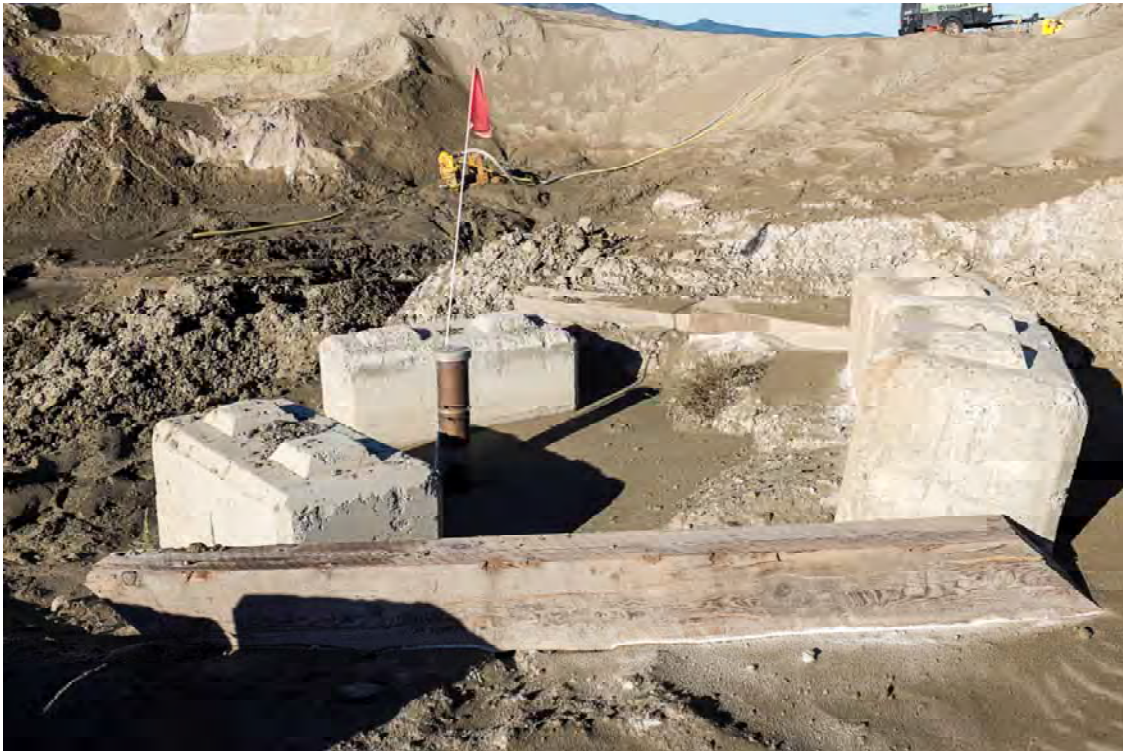
Photo DC35: View looking south west at instrumentation protected by Lock-Blocks on crest at right abutment of Dam C. Note pump used to manage ponded water in background.

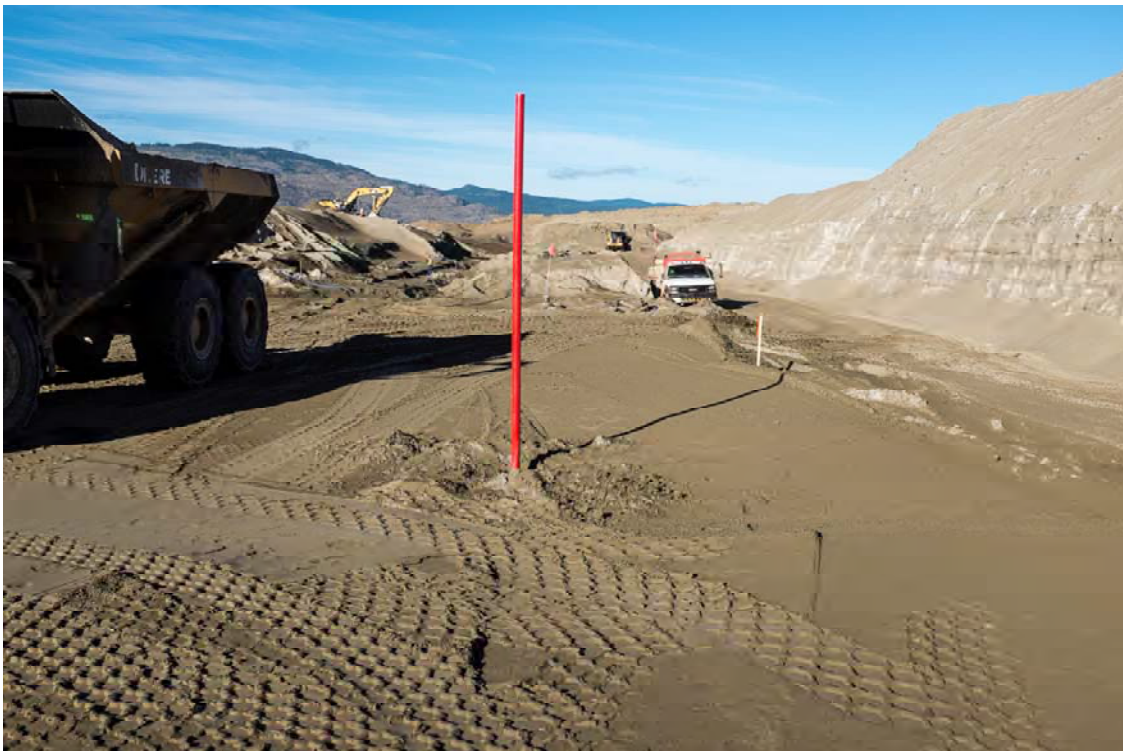
Photo DC36: View looking west at inclinometer riser pipe recently installed on the crest of Dam C at approximately sta. 0+700 m. Note tire tracks from articulated trucks around inclinometer casing. Vibrating wire piezometer leads flagged in the background behind inclinometer casing.

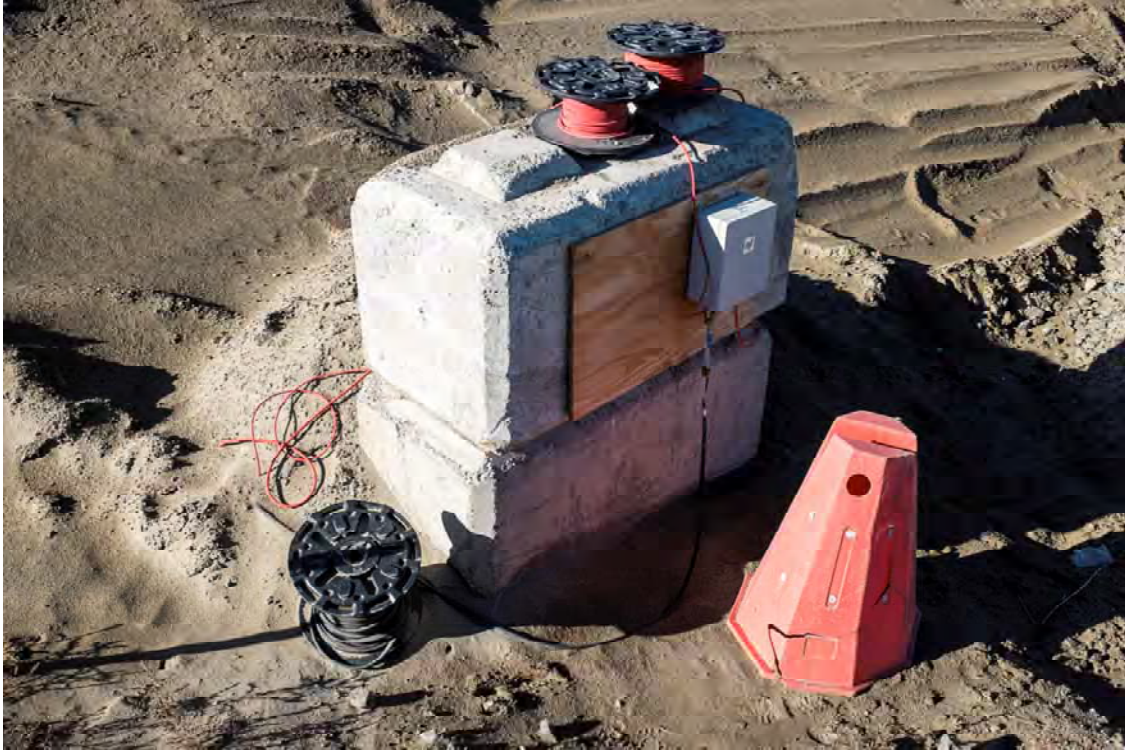
Photo DC37: View looking southwest at instrumentation reporting to datalogger mounted on Lock-Blocks at downstream toe at right abutment of Dam C.

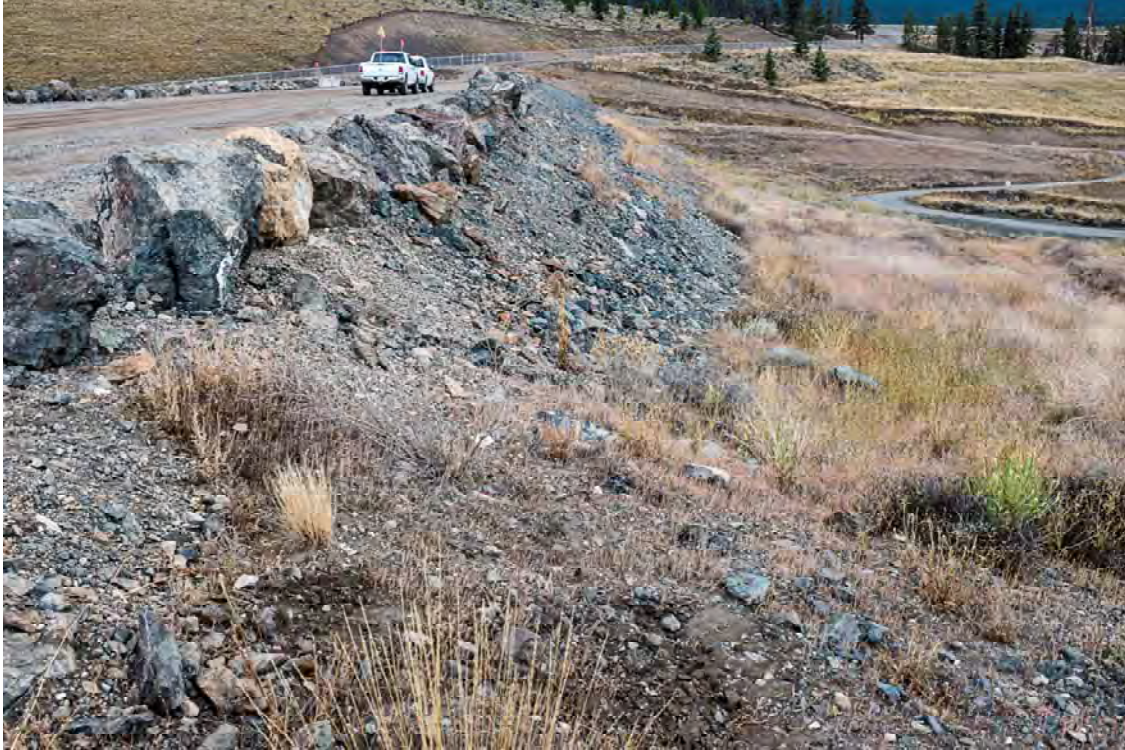
Photo SD01: View of South Dam upstream face and toe from left abutment looking toward right abutment.

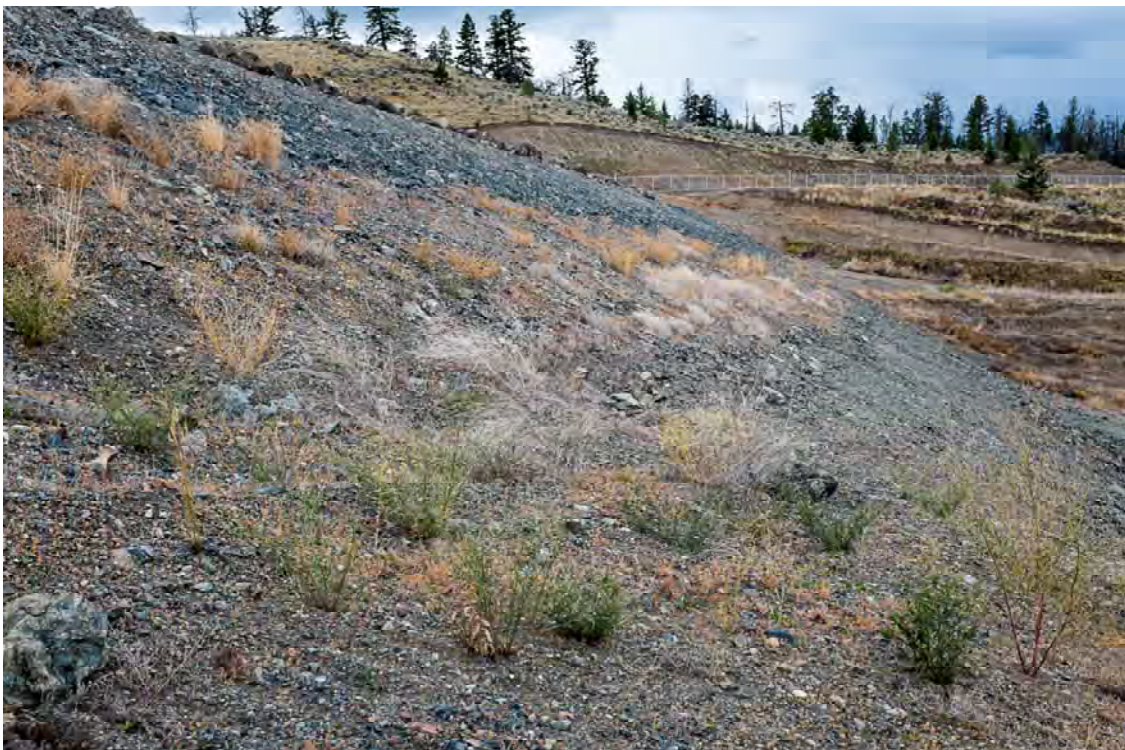
Photo SD02: View of South Dam upstream face and toe from mid-way down the slope on left abutment looking toward right abutment.

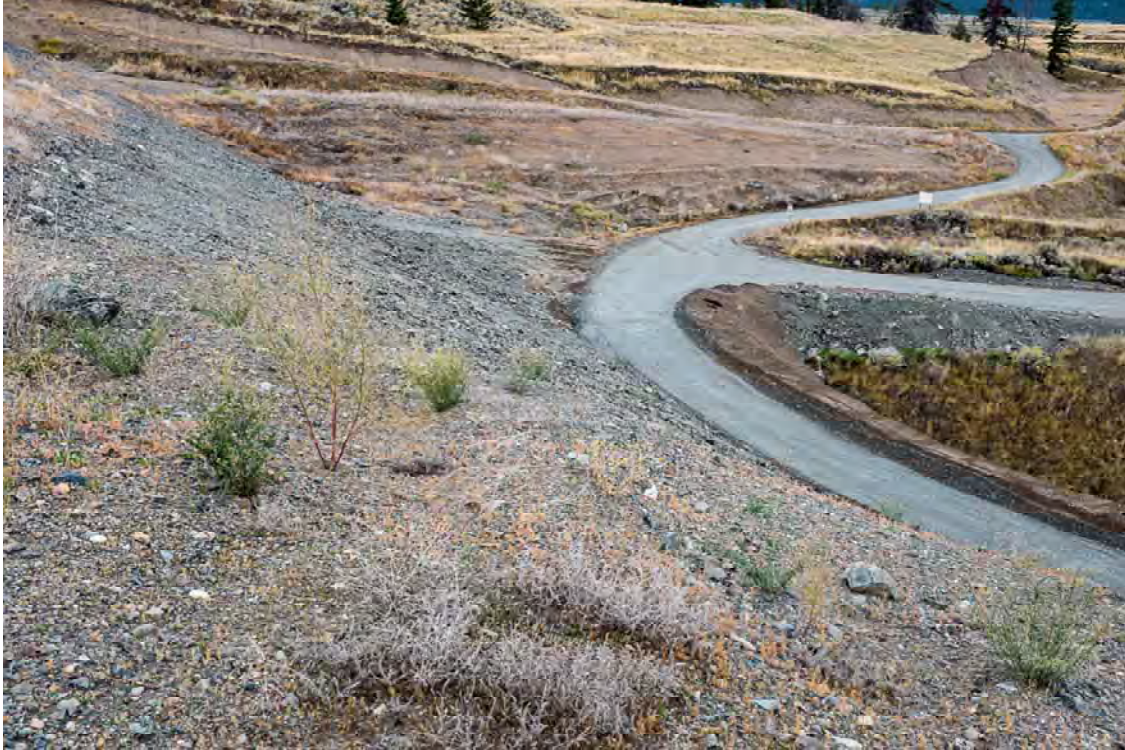
Photo SD03: View of South Dam upstream toe from mid-way down the slope on left abutment looking toward upstream toe.

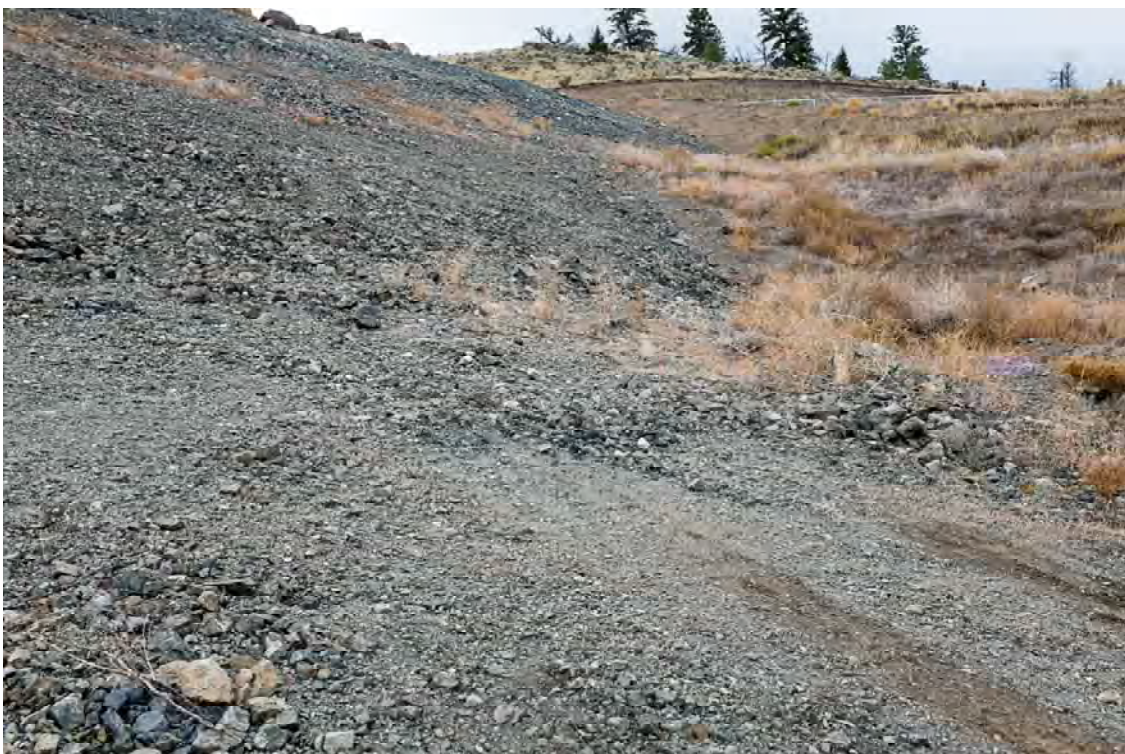
Photo SD04: View of right abutment and upstream face of South Dam from upstream toe.

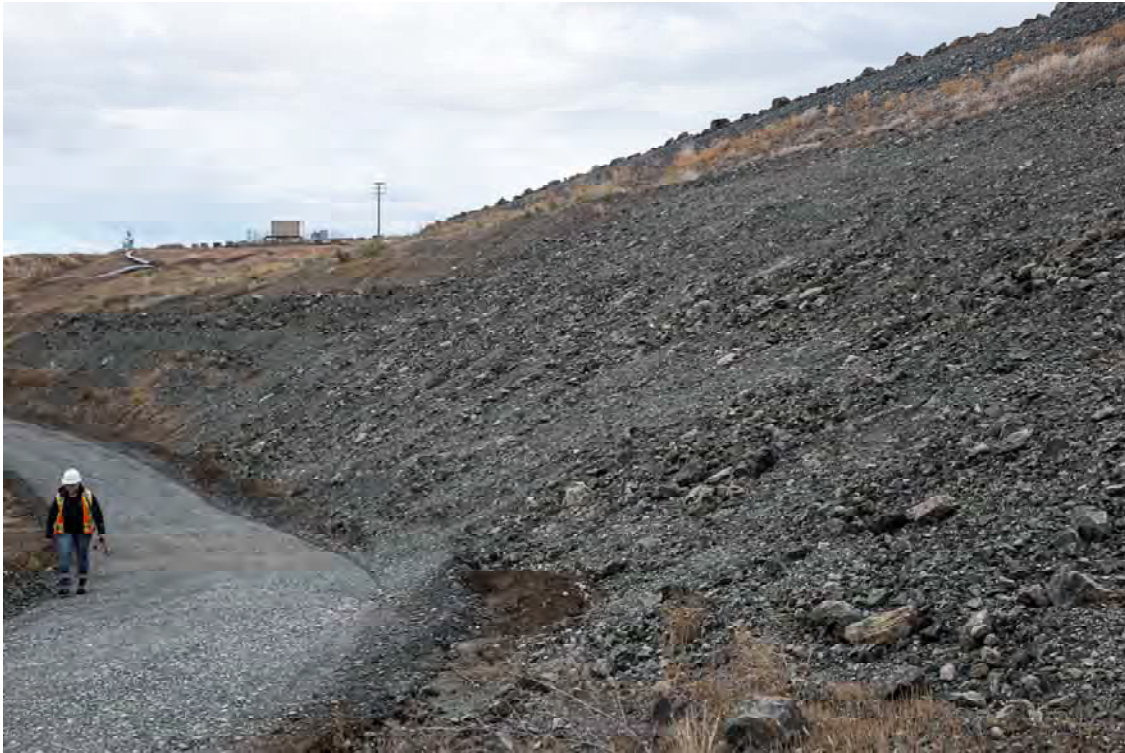
Photo SD05: View of left abutment and upstream face of South Dam from upstream toe.

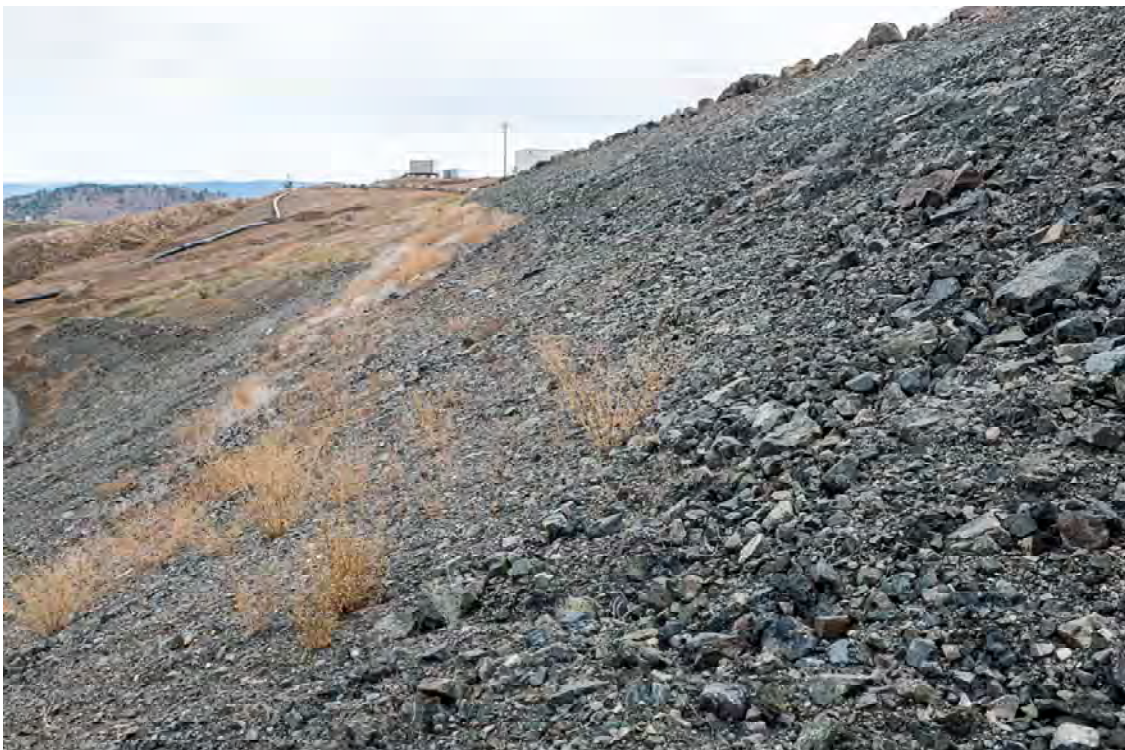
Photo SD06: View of South Dam upstream face and left abutment from mid-way down the slope on right abutment.

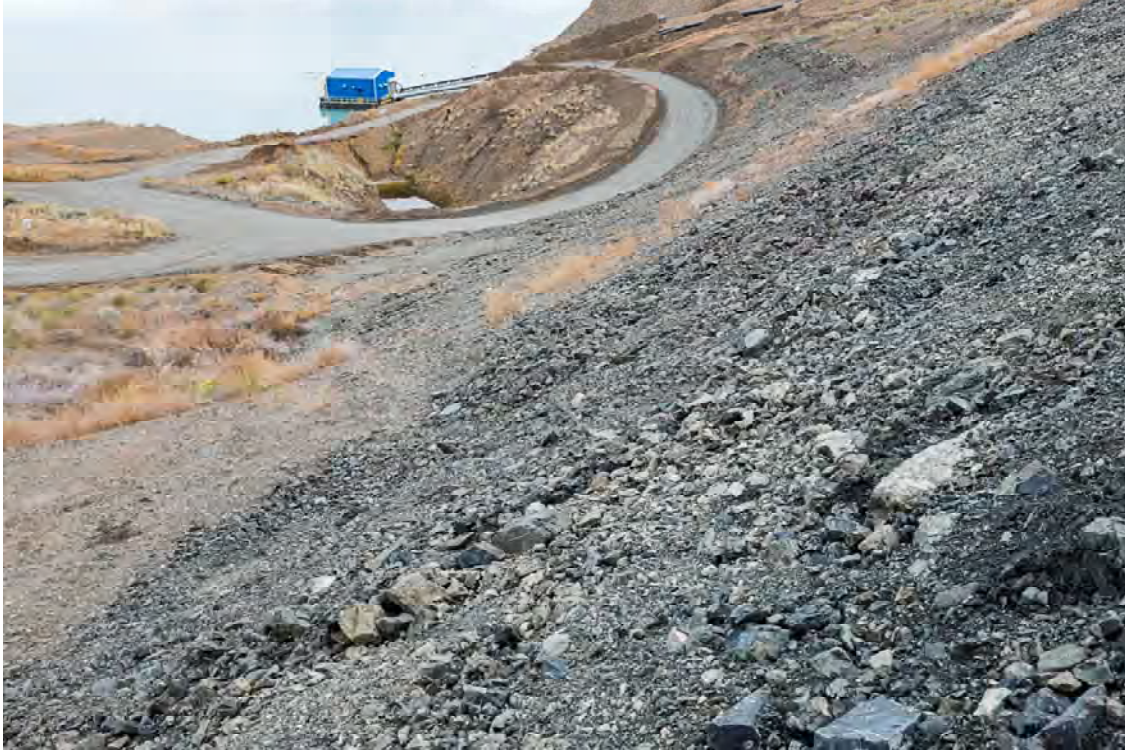
Photo SD07: View of reclaim barge and upstream toe of South Dam from mid-way up the right abutment on the upstream side. Note pond level relative to South Dam.

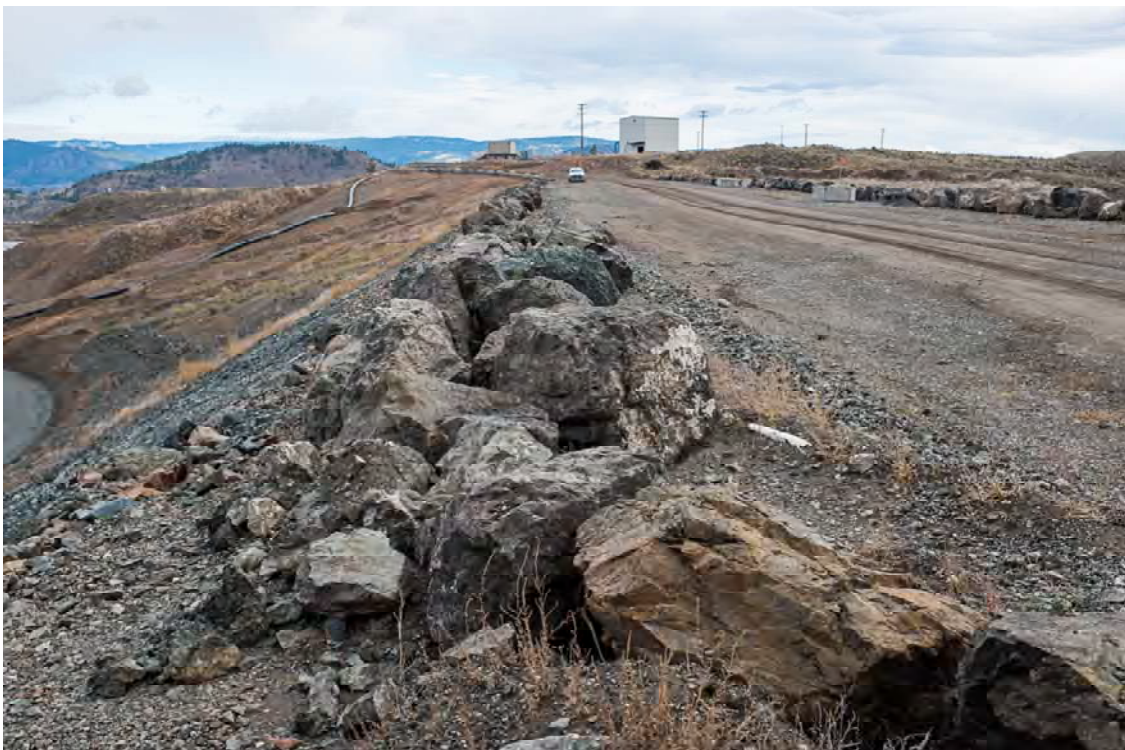
Photo SD08: View of South Dam upstream face and crest from right abutment looking toward left abutment. Primary cyclone visible in background.

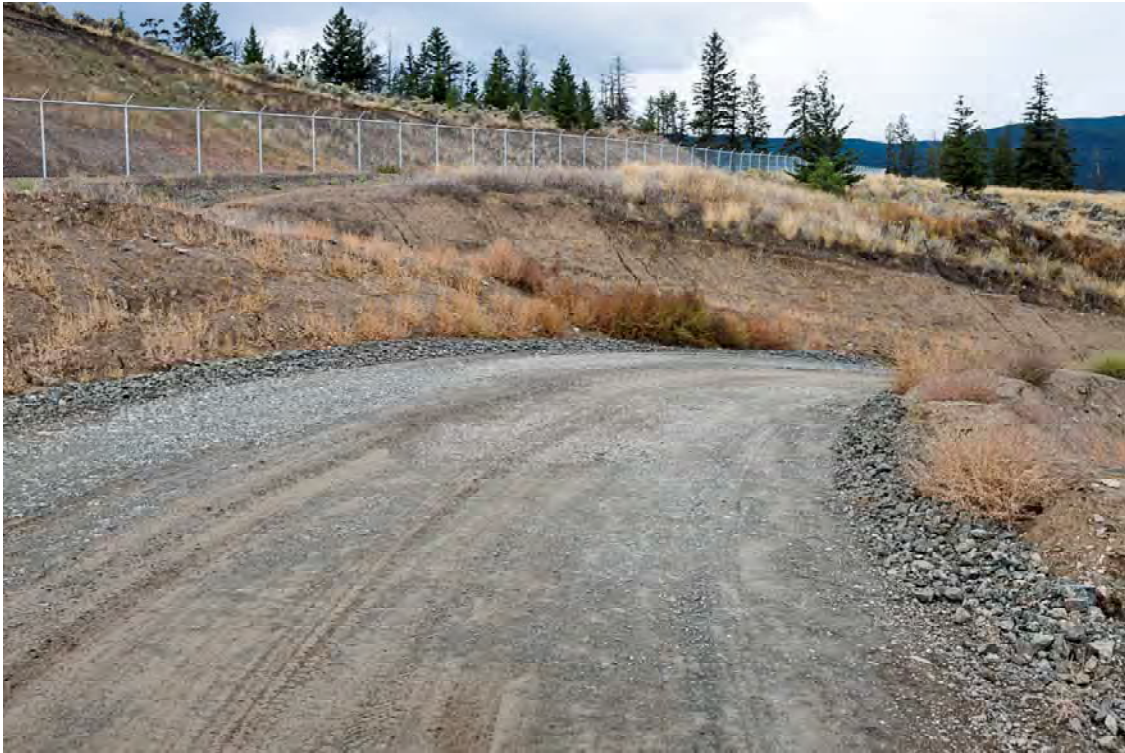
Photo SD09: View of right abutment of South Dam from right abutment crest looking south.

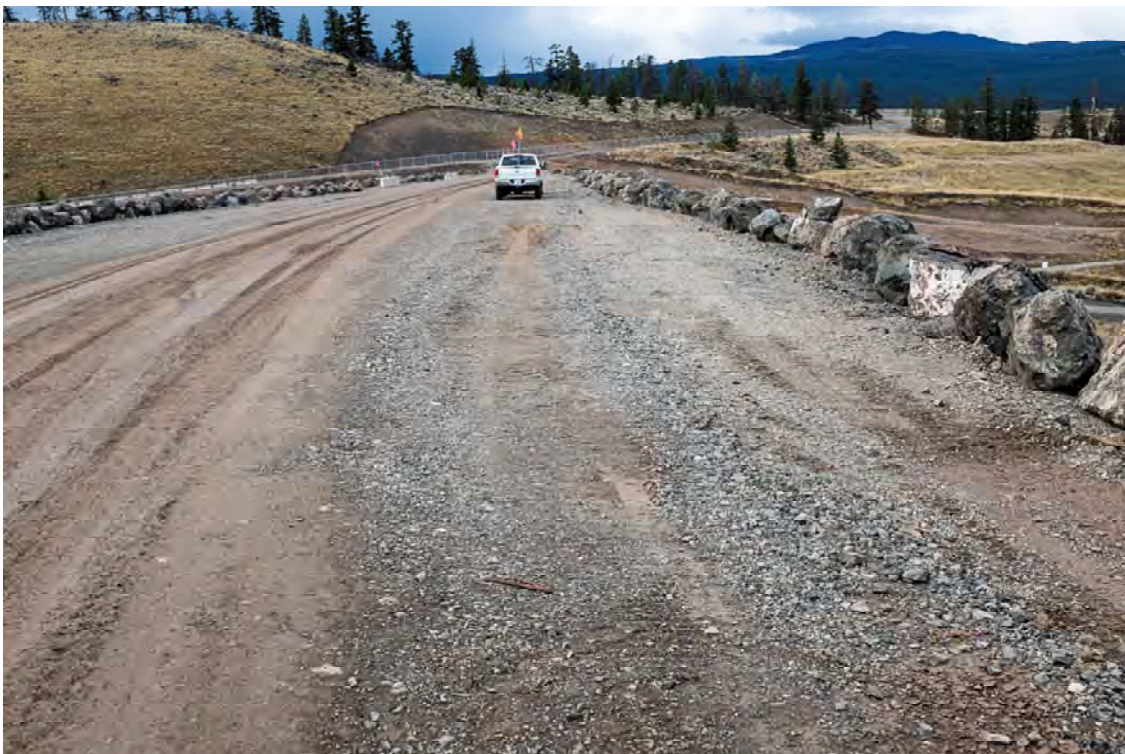
Photo SD10: View of right abutment of South Dam from near left abutment on crest.

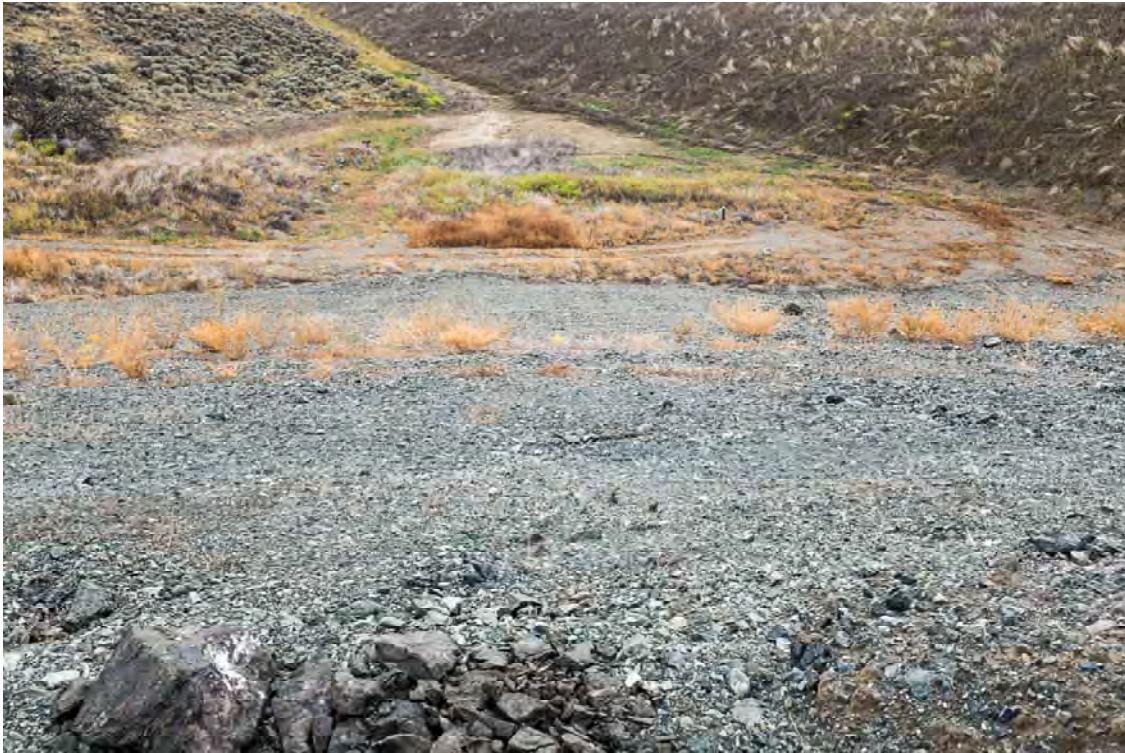
Photo SD11: View of downstream toe of South Dam from mid-point of dam crest.
