APPENDIX B SELECT PHOTOGRAPHS

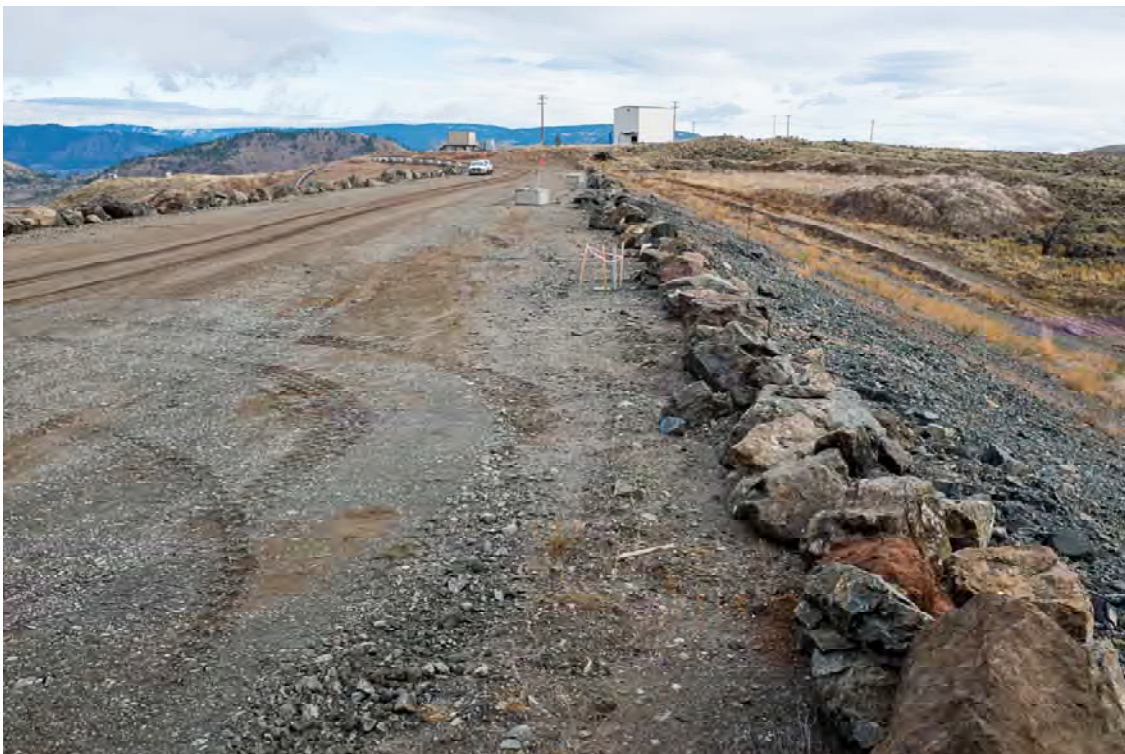
Photo SD12: View of crest and the downstream face of the South Dam from the right abutment.

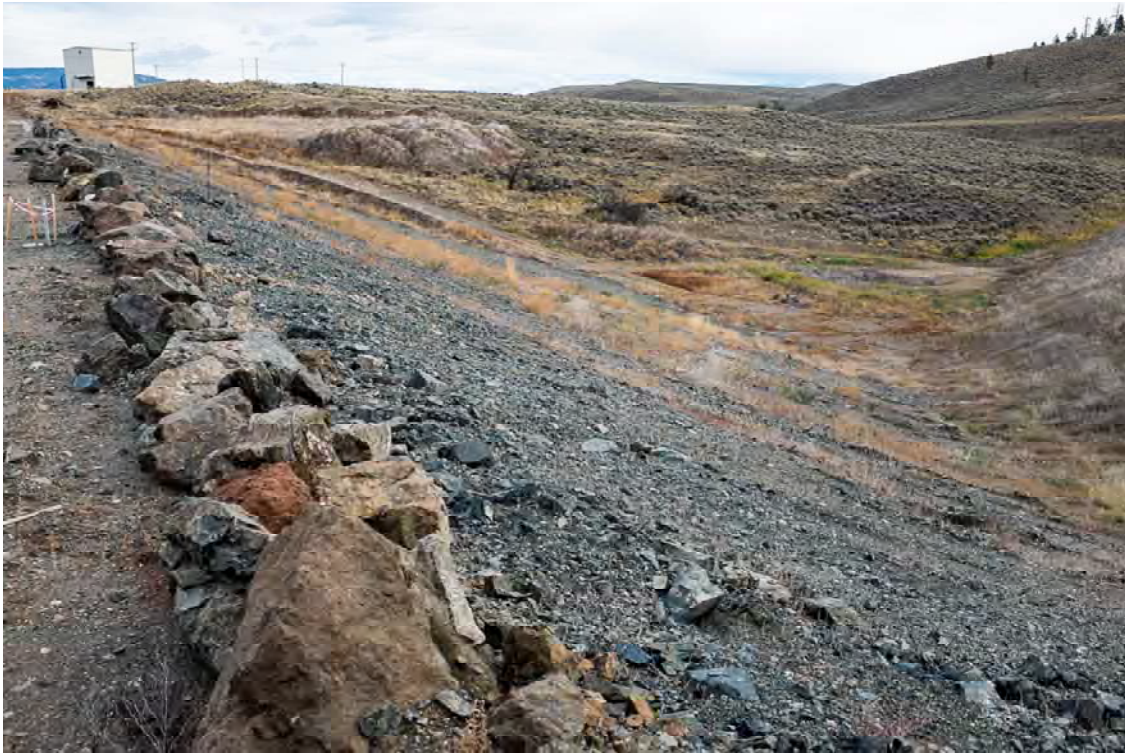
Photo SD13: View of the downstream face and toe from the right abutment crest of the South Dam.

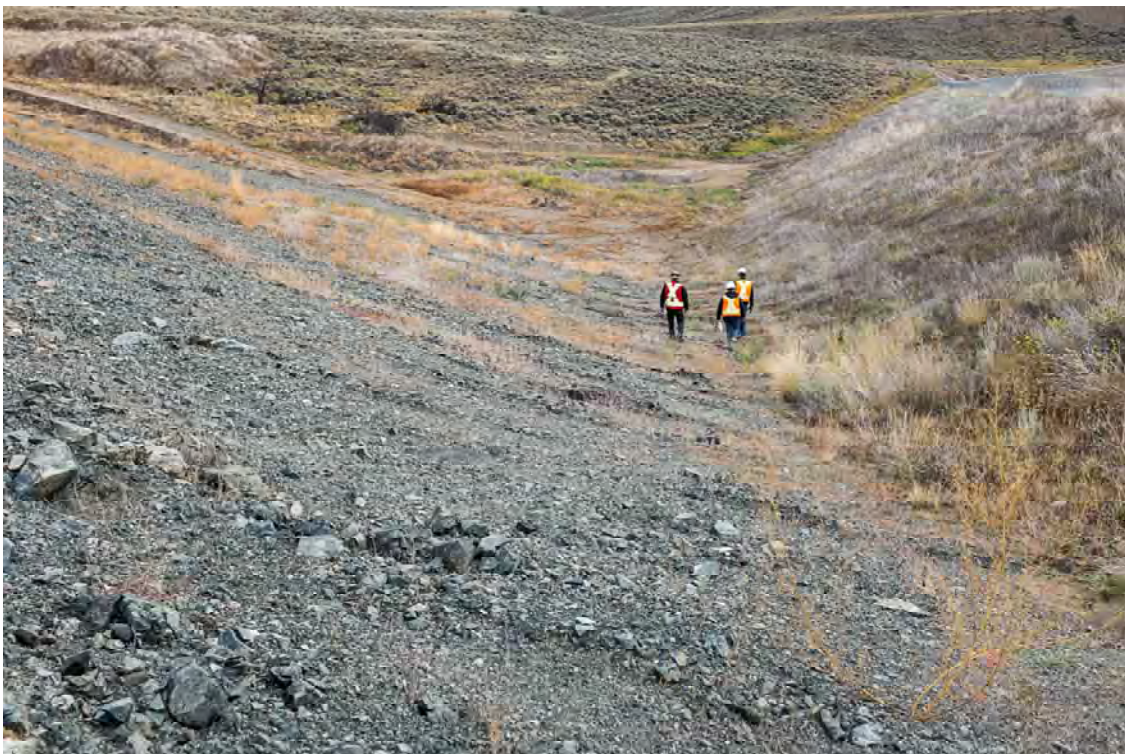
Photo SD14: View of the downstream right abutment and toe from mid-way down the slope.

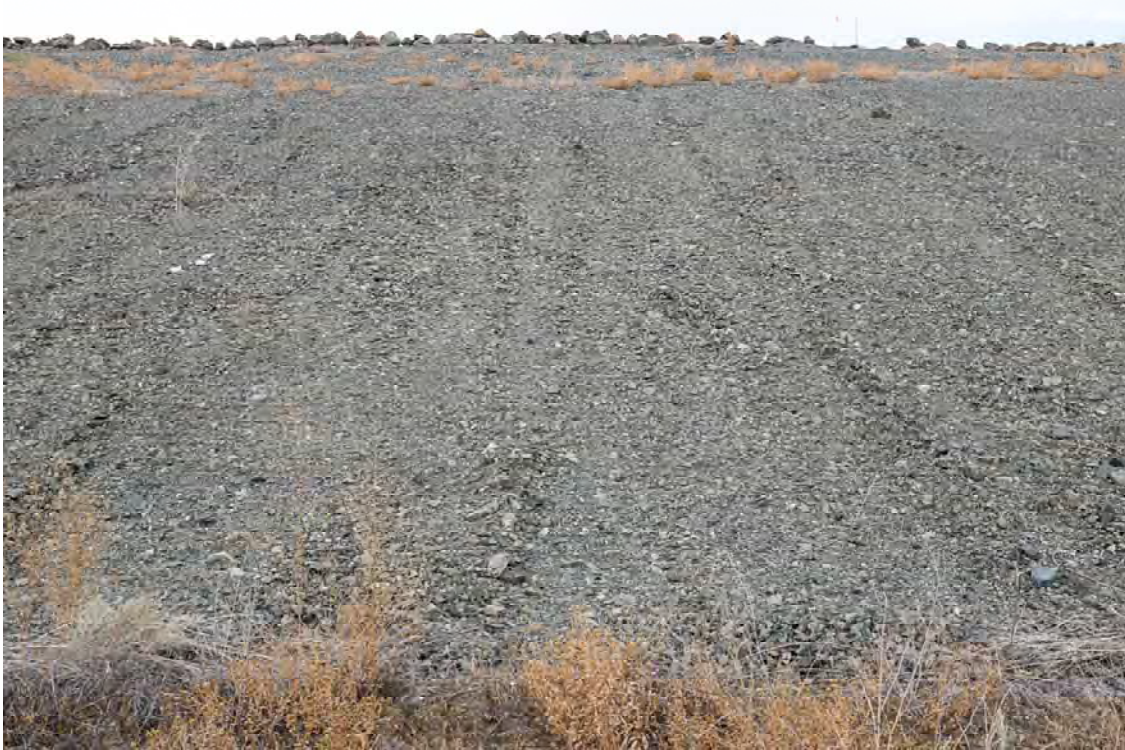
Photo SD15: View of the downstream face from the downstream toe of the South Dam. Note uniform slope and minimal vegetation.

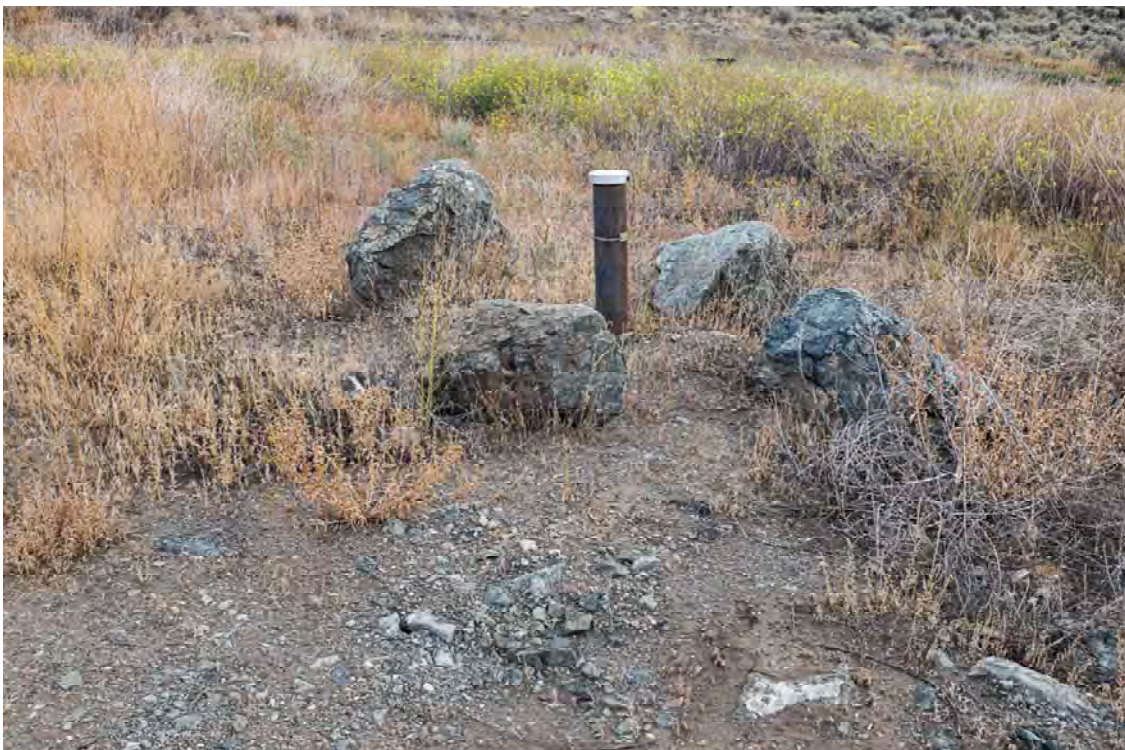
Photo SD25: View of survey monument on the downstream crest of the South Dam near the mid-point of the dam looking east. Note lack of Lock-Block protection.

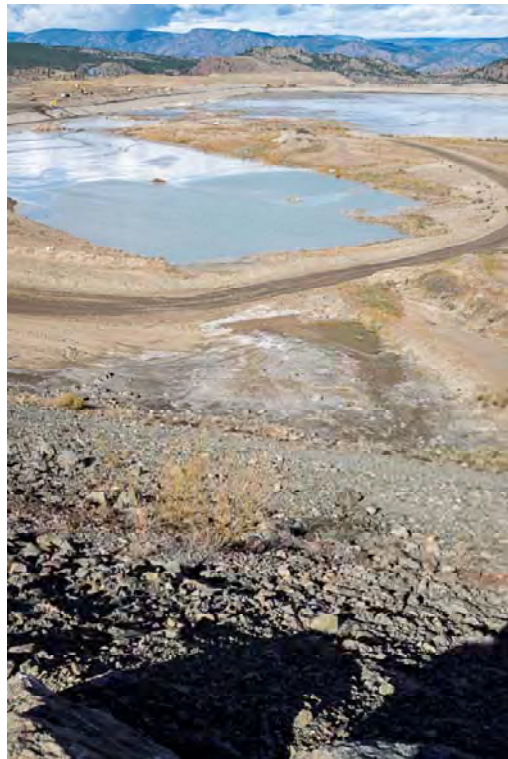
Photo WD03: View of upstream face and toe of West Dam from left abutment. Dam A and Teck TSF visible in upper right of photo. Note location of tailings and pond relative to the upstream toe of the West Dam.

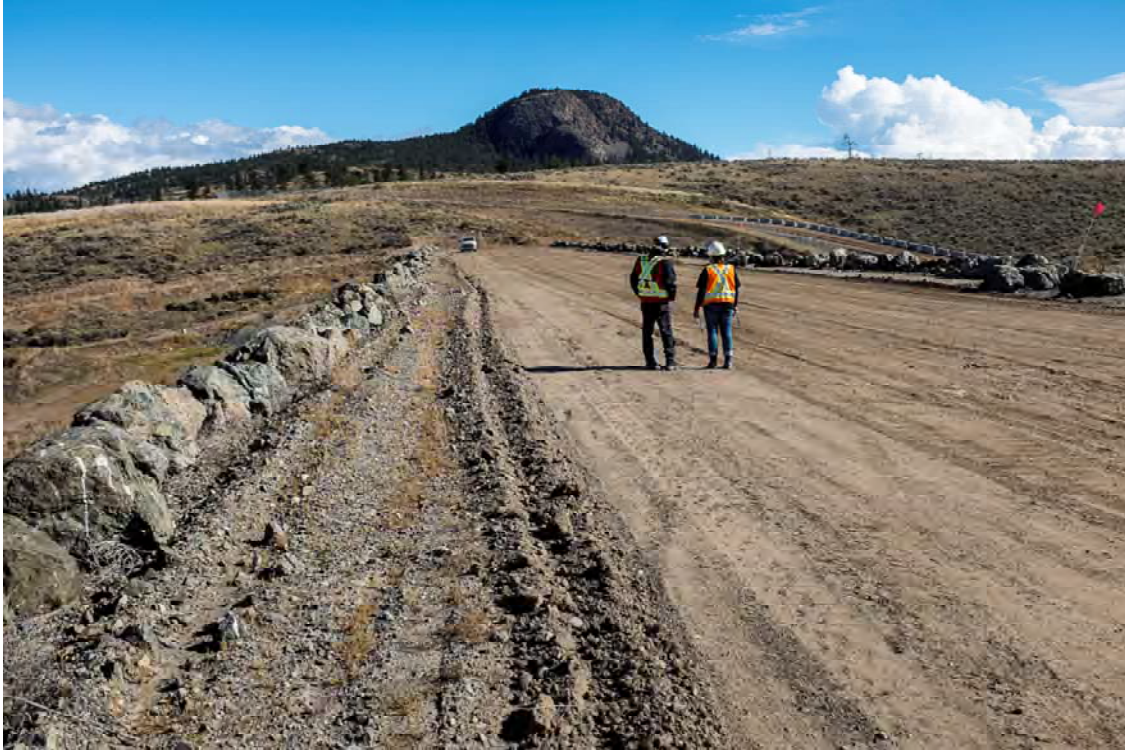
Photo WD04: View of the upstream toe of the West Dam from the crest at the mid-point of the dam looking north. Dam B and C visible in the background. Note ponding at the upstream toe of the West Dam.

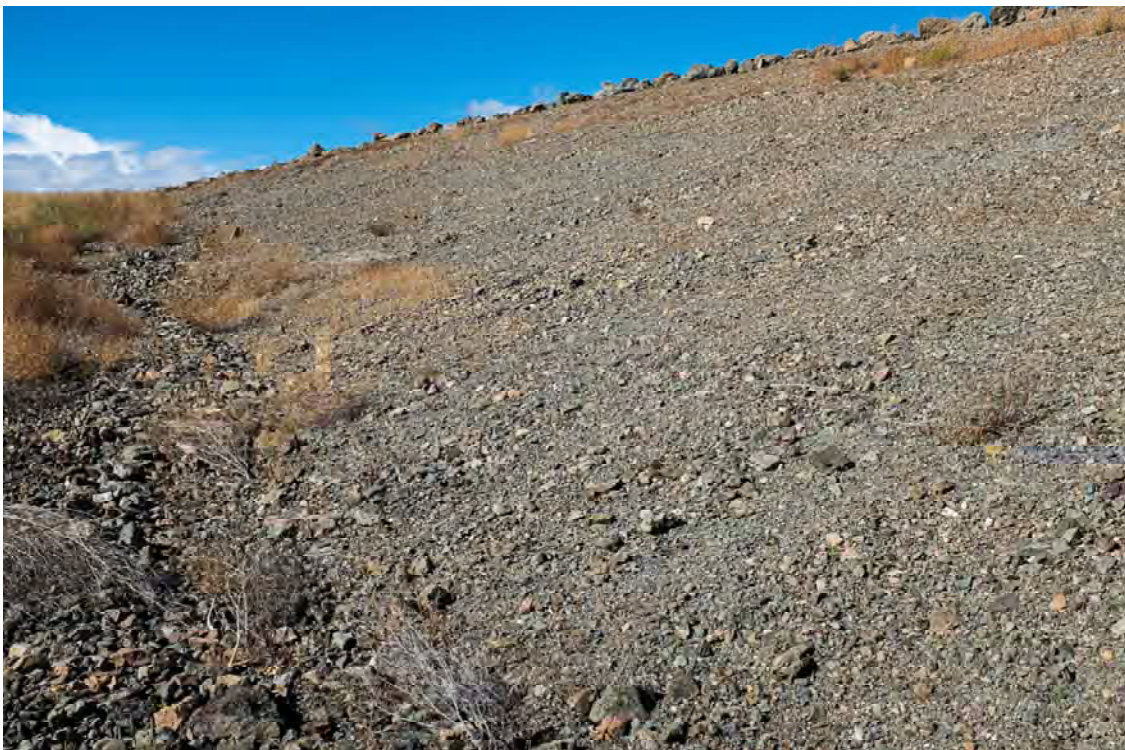
Photo WD13: View of the downstream face of the West Dam downstream toe. Note uniform slope and minimal vegetation.

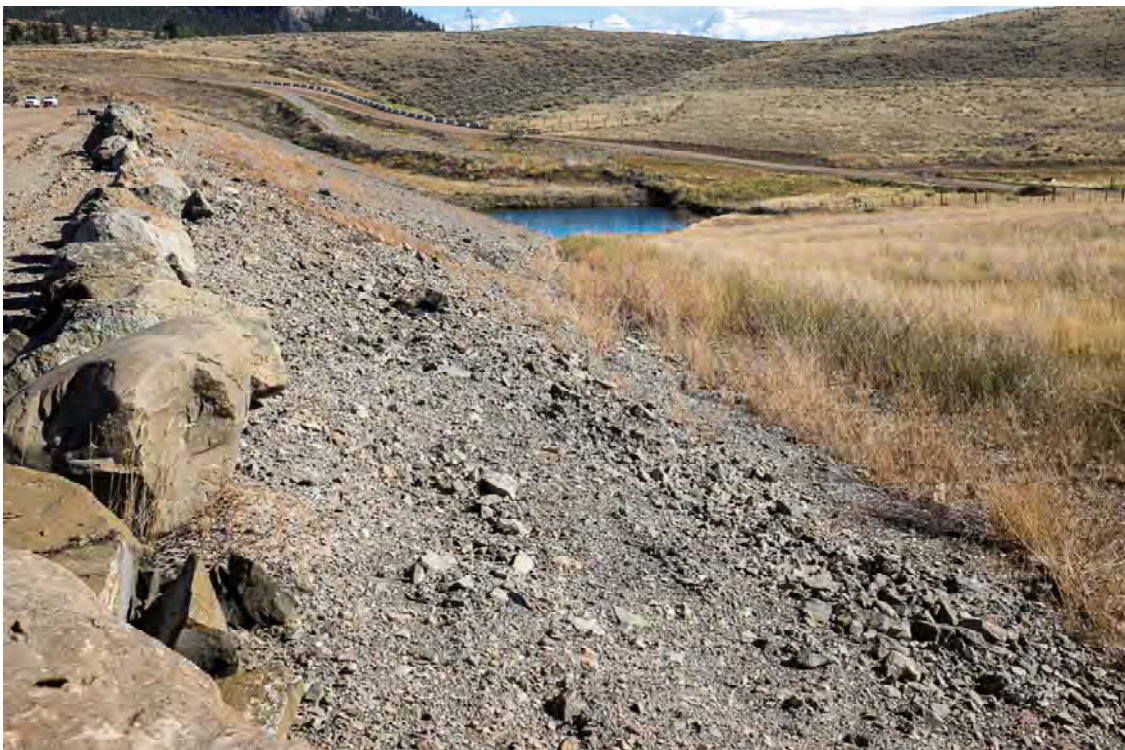
Photo WD15: View of ponding at the downstream toe of the West Dam from just east of the downstream toe looking west.

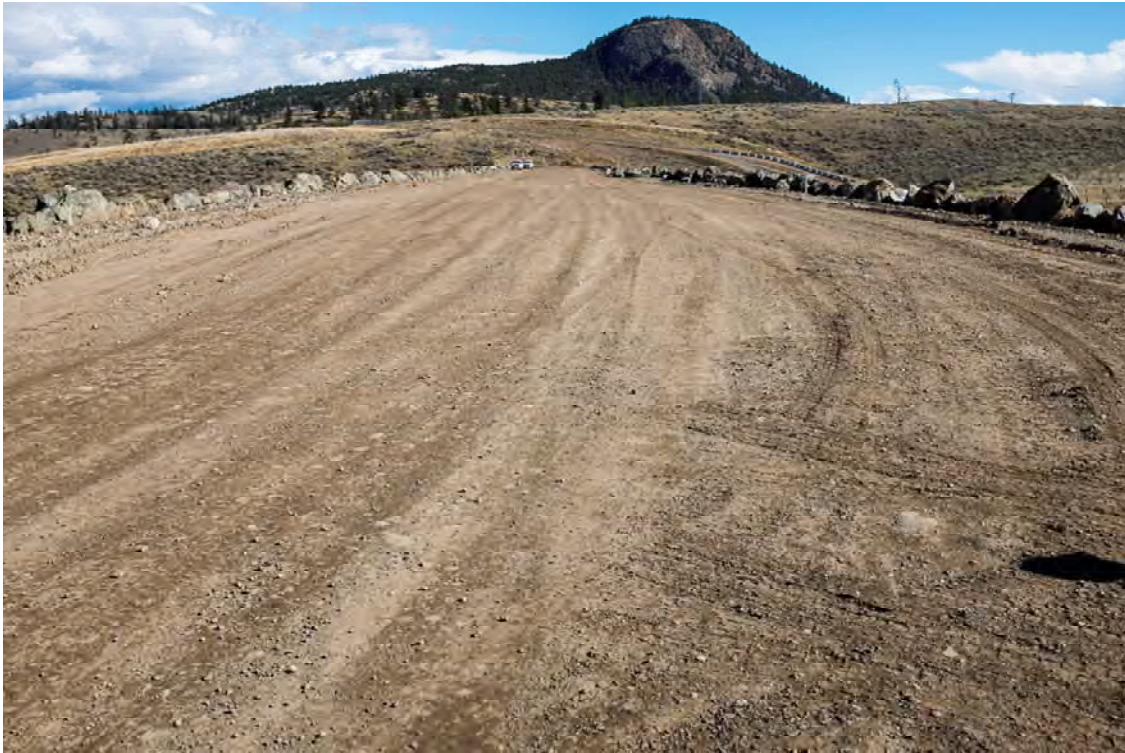
Photo WD16: View of the downstream face and toe of the West Dam from the crest at the right abutment. Note ponding at the downstream toe.

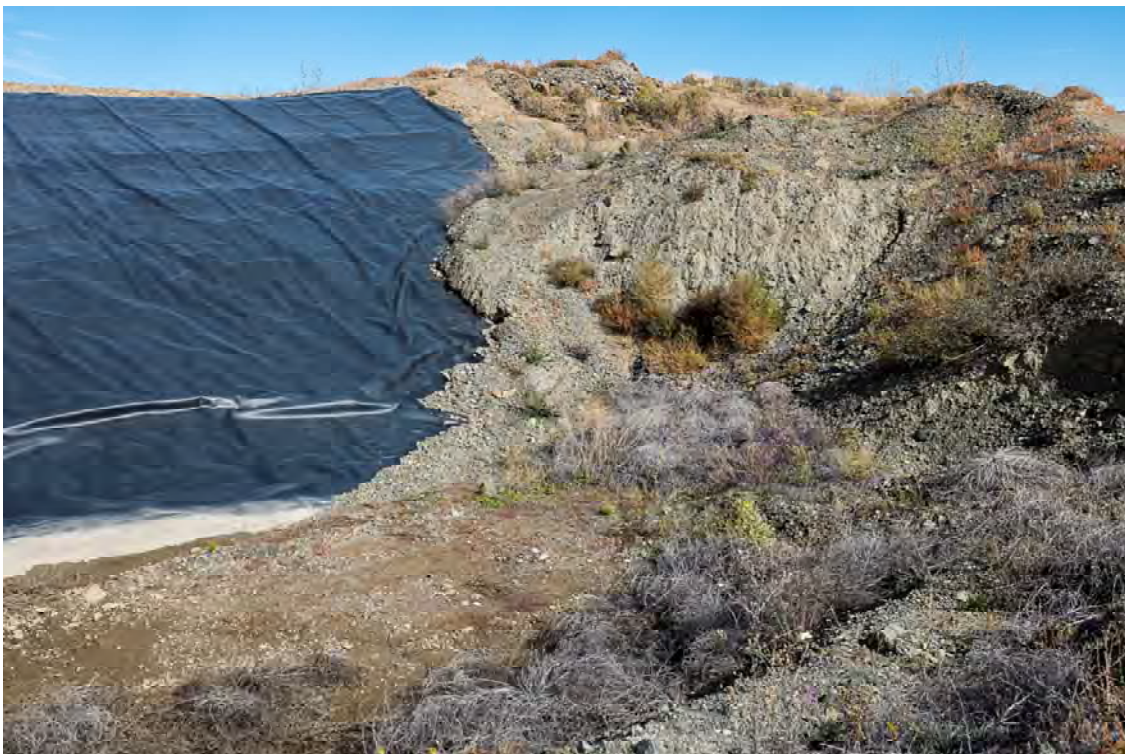
Photo PD03: View of the upstream face and toe of the Pothook Dam at the right abutment. Note pipeline draped down the upstream face of the dam over liner in the background.

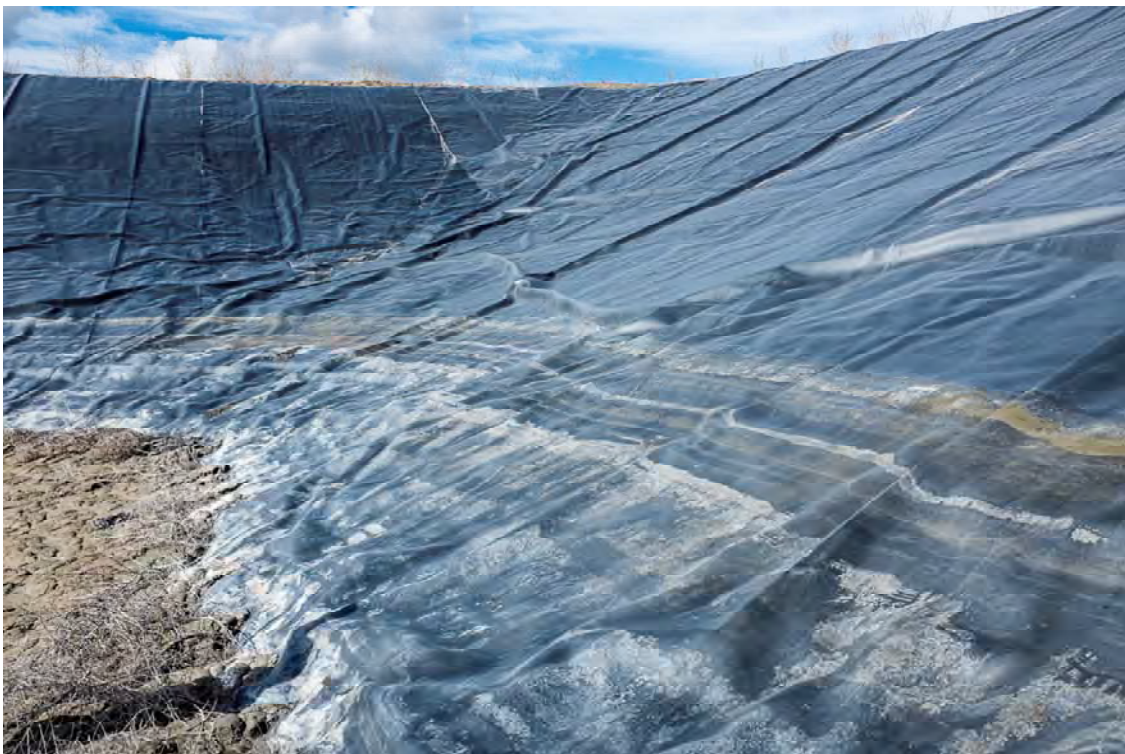
Photo PD05: View of abraision and liner bedding protrusion damage on the liner on Pothook Dam at the downstream toe one third of the way between the right abutment and the first dogleg of the dam.

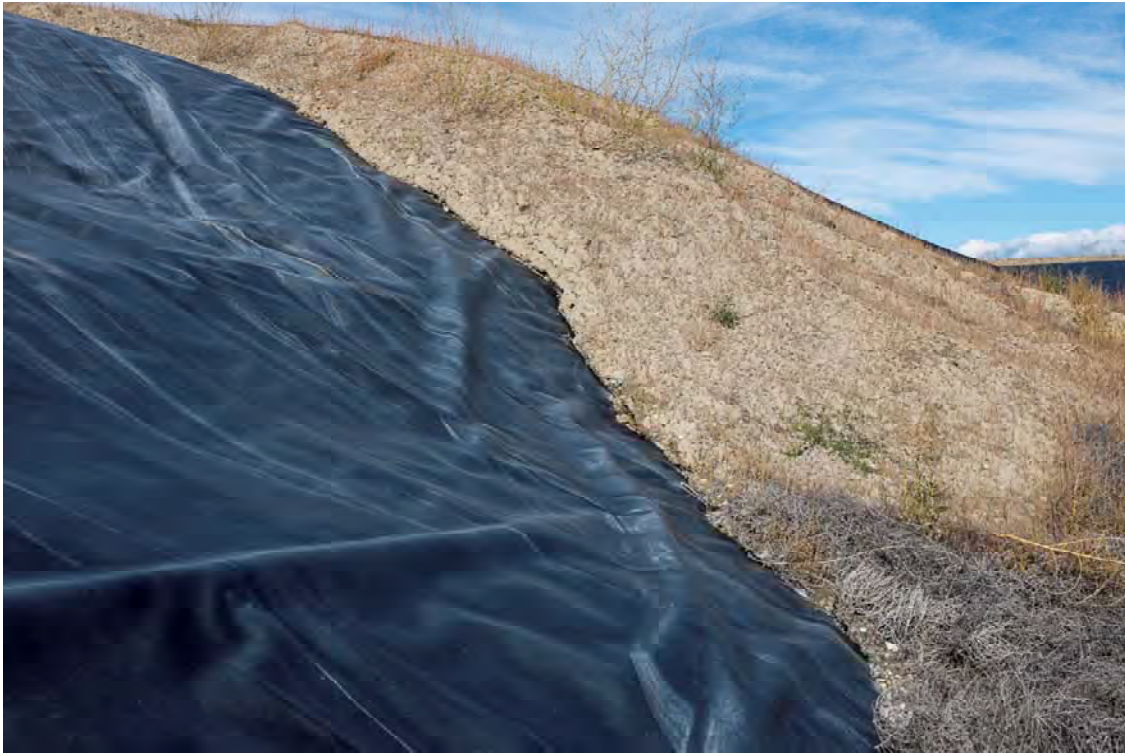
Photo PD08: View of punctures and abrasion damage on the upstream face of the Pothook Dam mid-way between the first dogleg and the tailings pipeline ramp.

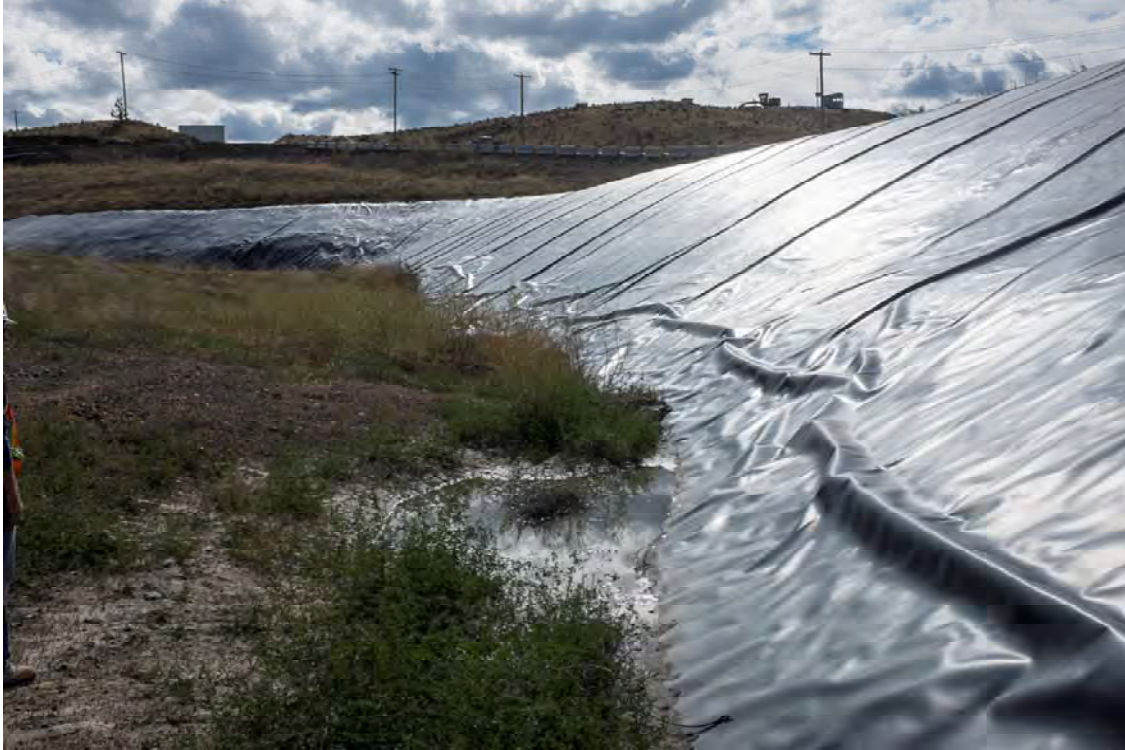
Photo PD10: View of abrasion damage and punctures in liner on upstream face of the Pothook Dam due to a waterline draped over liner south of the tailings pipeline ramp.

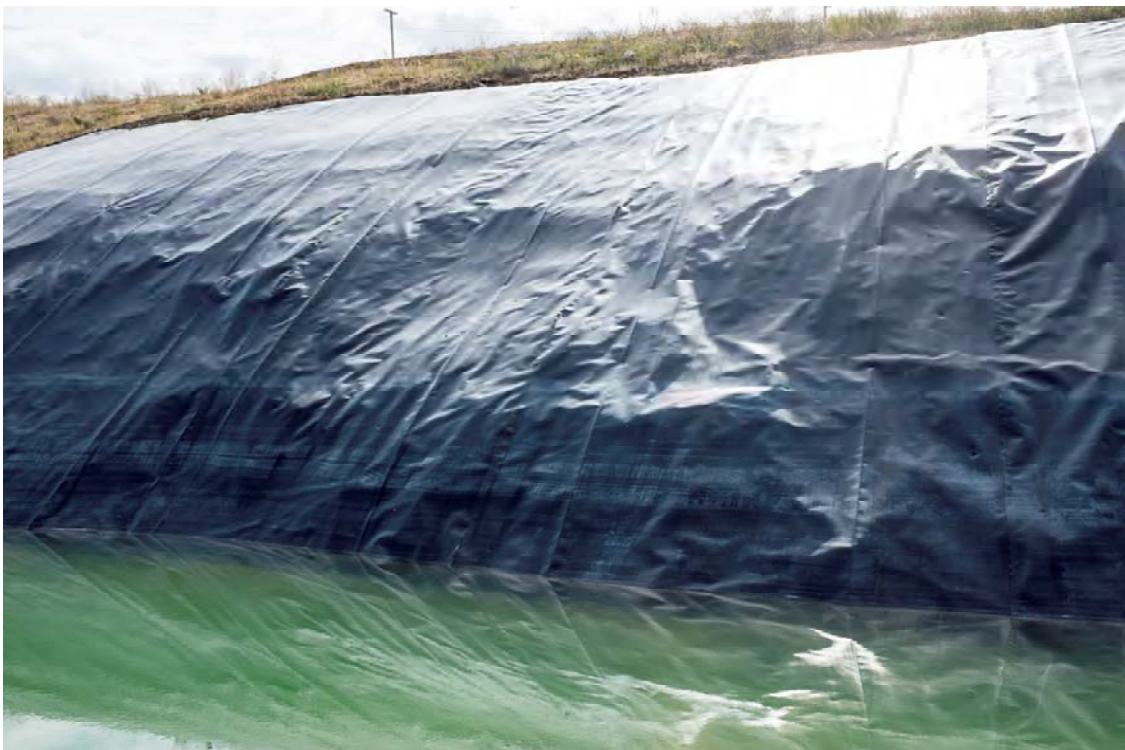
Photo PD13: View of the liner on the upstream face of the Pothook Dam at the left abutment looking south. Note punctures across the entire liner surface.

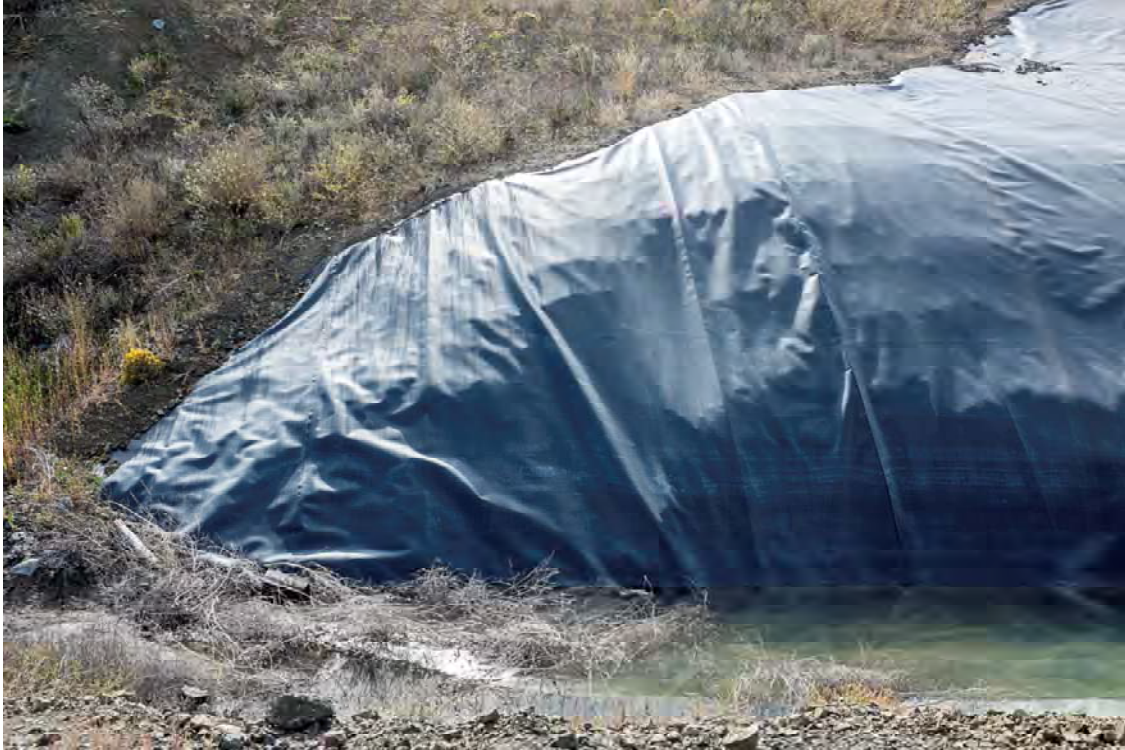
Photo PD14: View of the liner on the upstream face of the Pothook Dam adjacent to the left abutment looking south. Note various punctures across the entire liner.

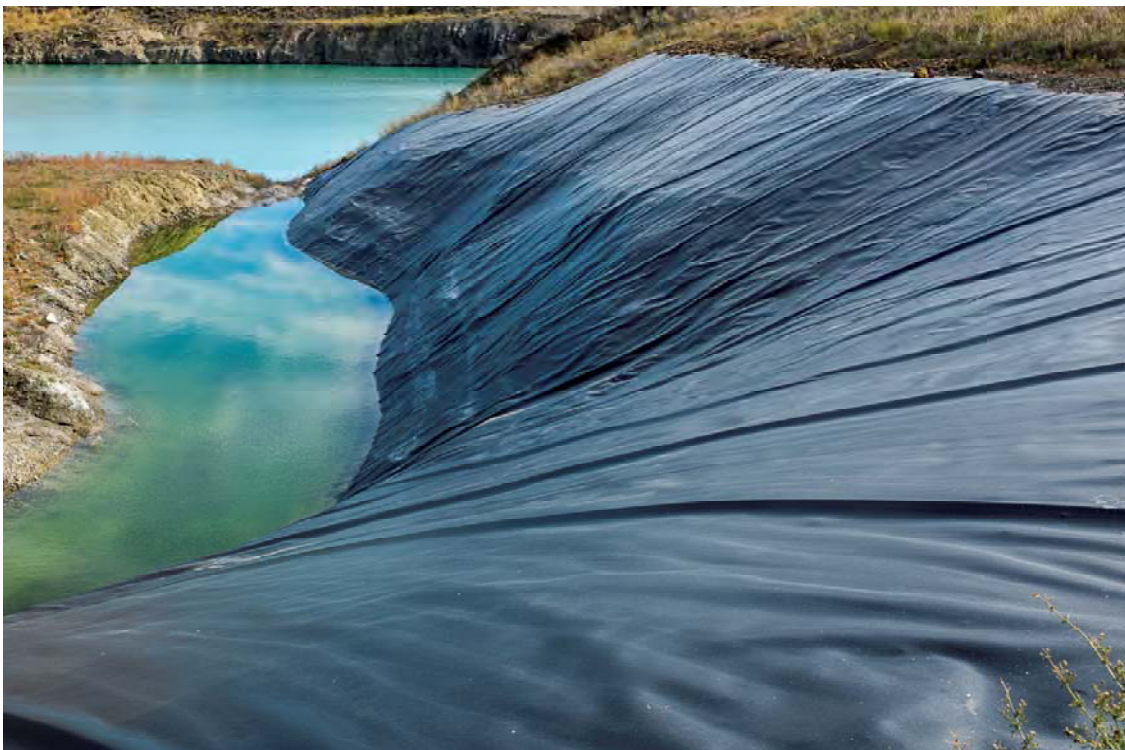
Photo PD17: View of the upstream face of the Pothook Dam from the crest looking west at the second dogleg. Note high water mark on the liner at the upstream toe.

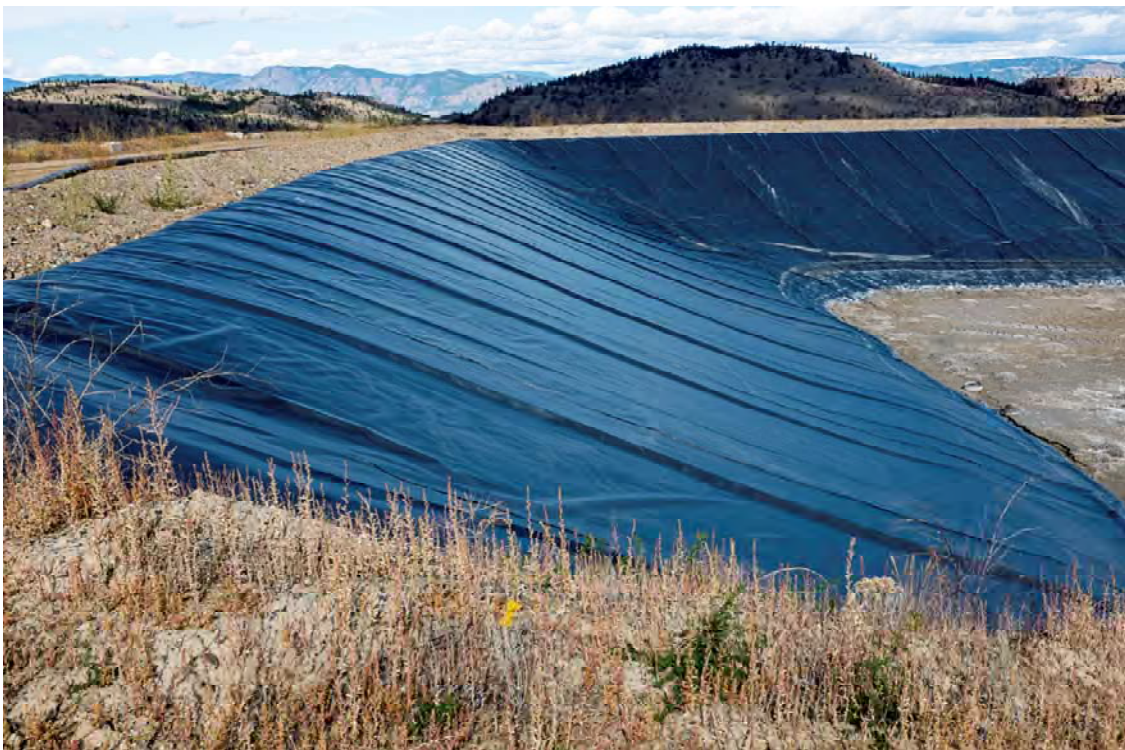
Photo PD22: View of upstream face of Pothook Dam at first dogleg from the tailings pipeline ramp looking north. Note high water mark on liner at upstream toe.

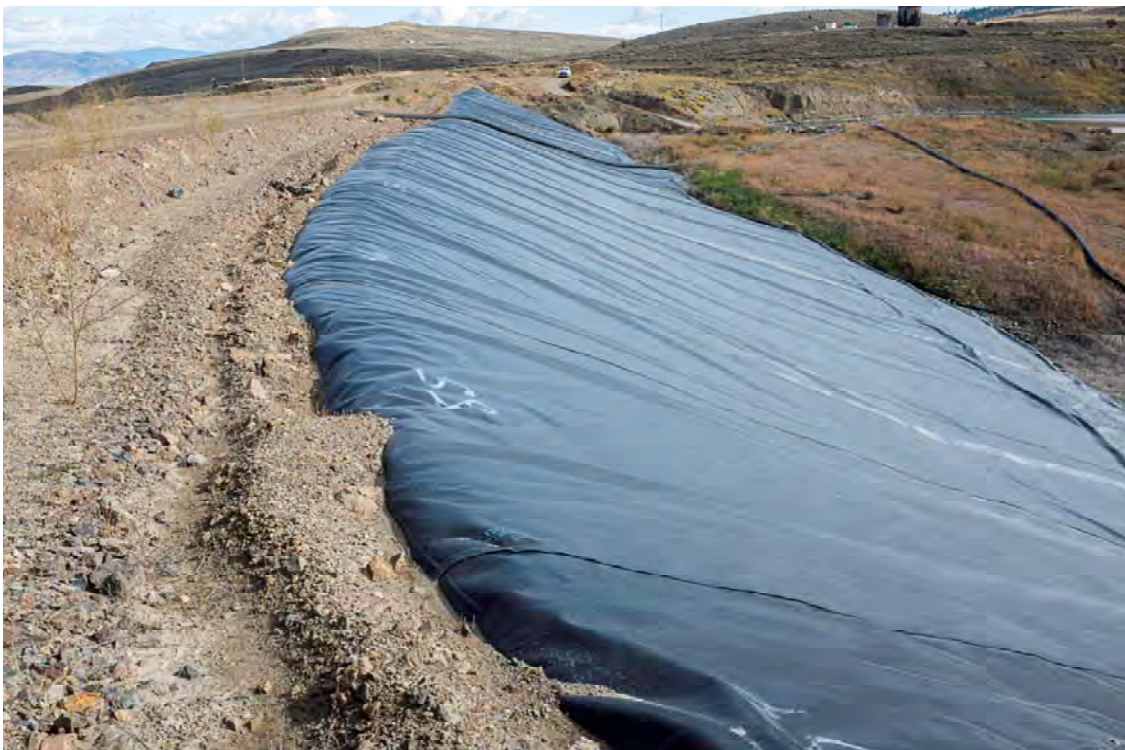
Photo PD23: Note tear in liner at anchor trench just north of the tailings pipeline ramp. Defect identified for repair in 2013 annual inspection report.

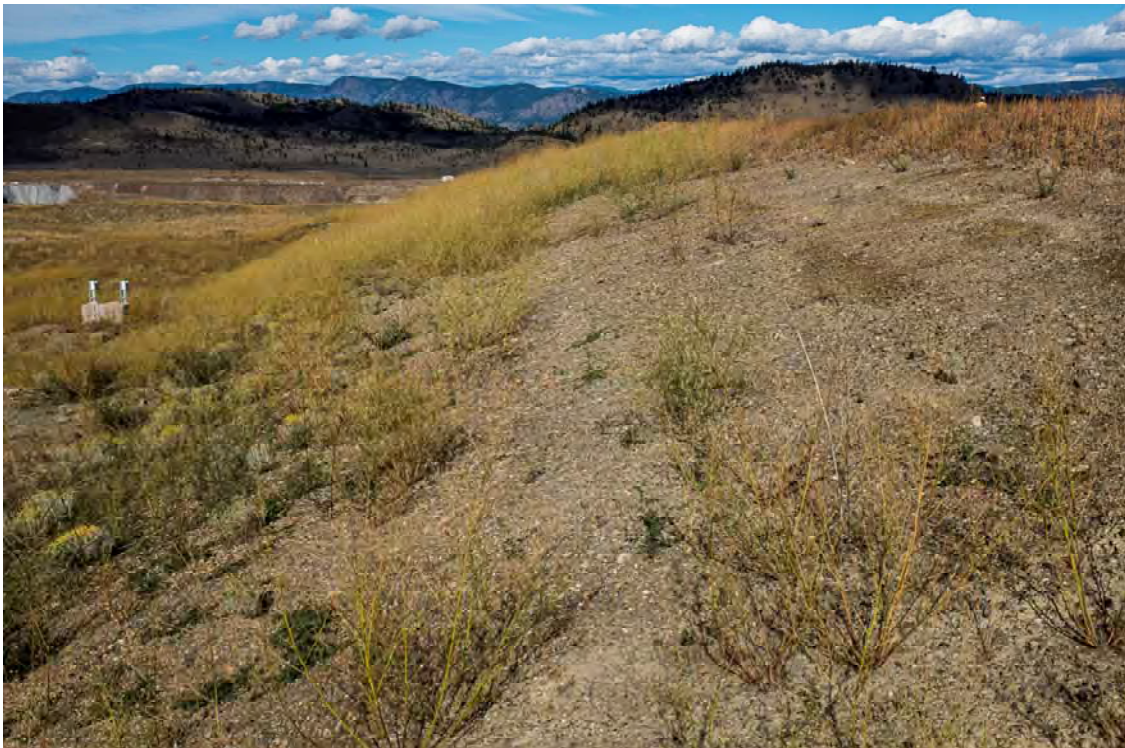
Photo PD25: View of damaged survey prism at the downstream crest of Pothook Dam at the first dogleg.

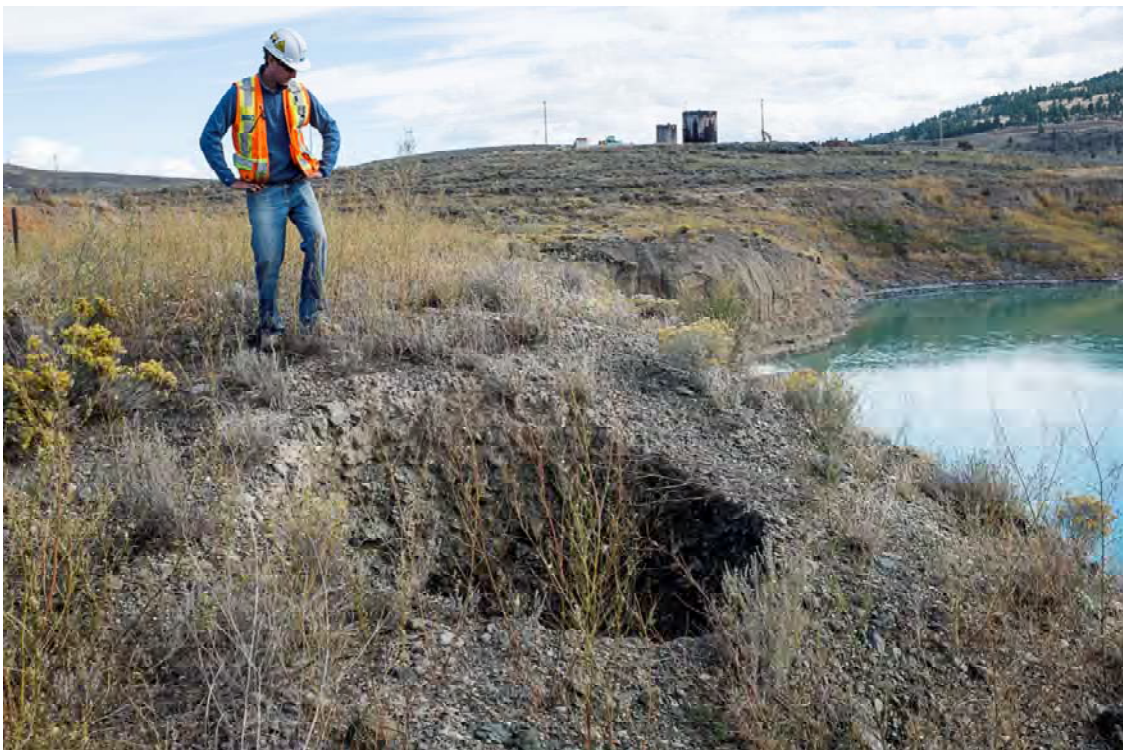
Photo PD34: View looking east at sinkholes in till along the north rim of the Pothook Pit between the Pothook Dam and the Emergency Spillway. Source of water likely pipelines from Afton Pit.

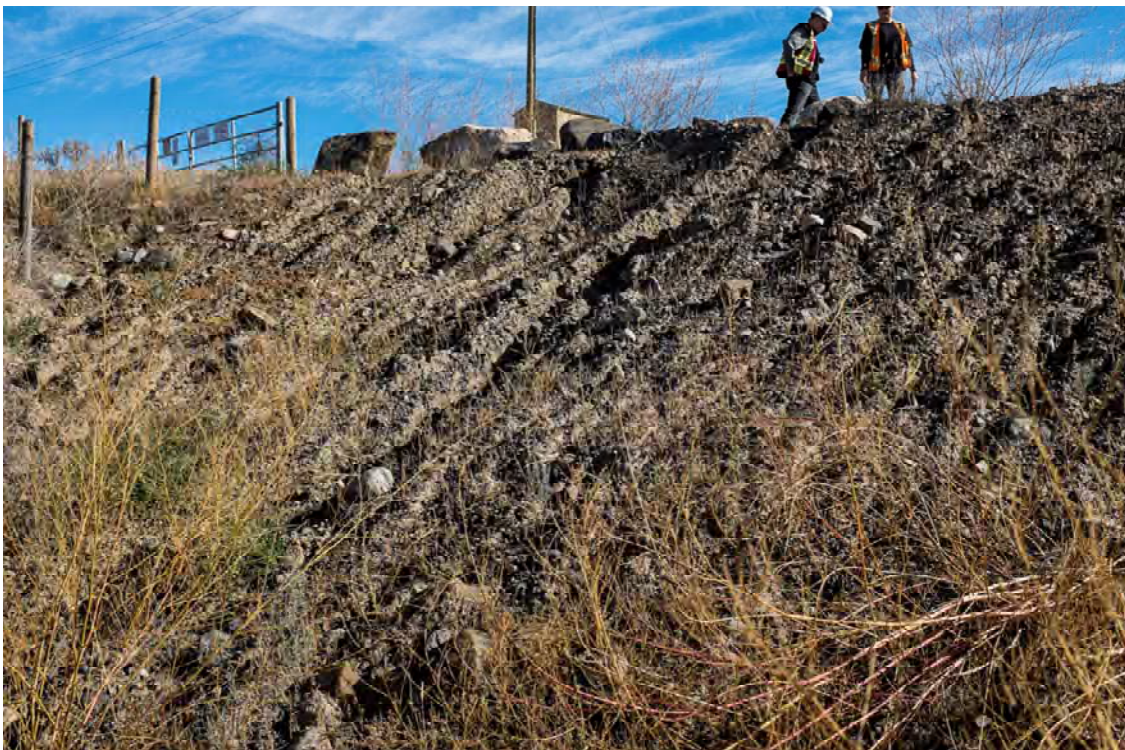
Photo S103: View of Seepage Pond 1 Dam crest and downstream face from right abutment. Note rilling and minor erosion in foreground. Note vegetation on downstream face.

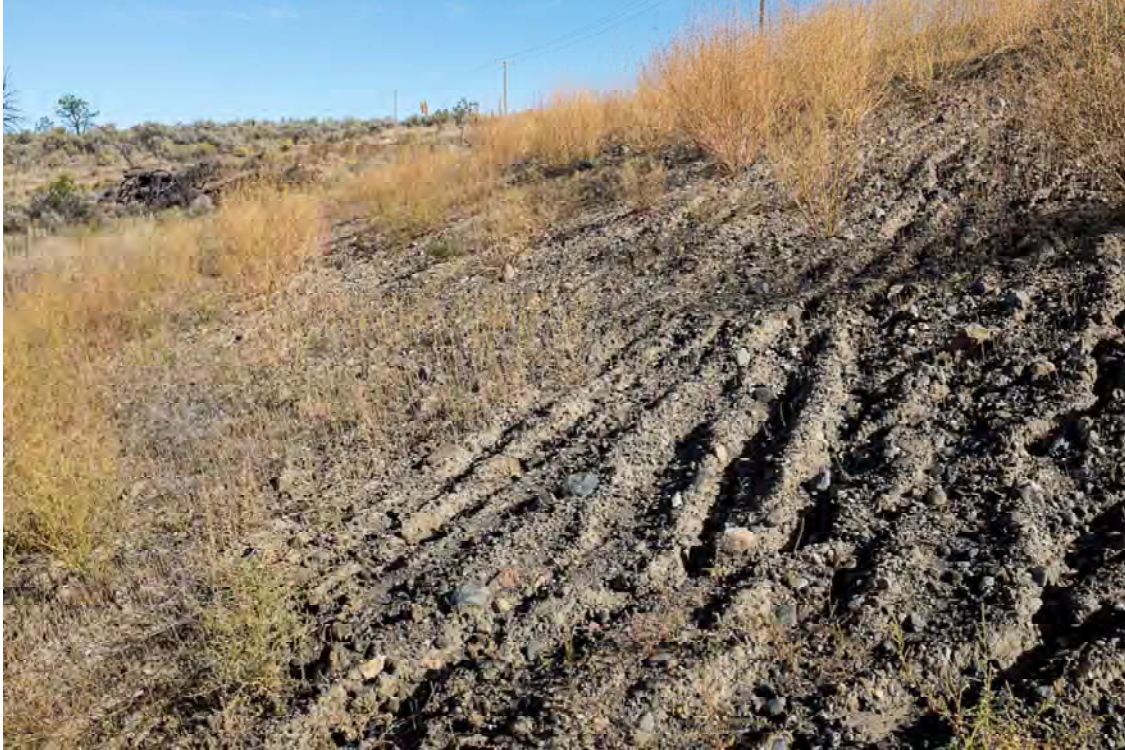
Photo S104: View of downstream face of Seepage Pond 1 Dam at right abutment. Note erosion and rilling of dam face.

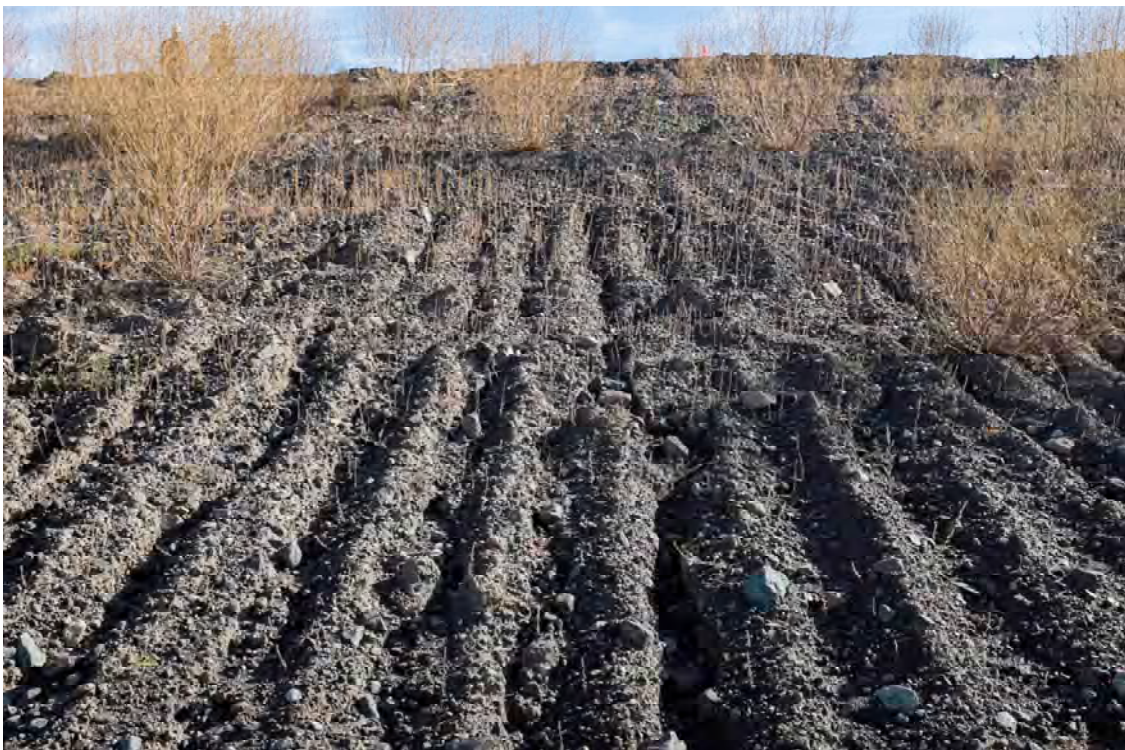
Photo S105: View of downstream face from downstream toe of Seepage Pond 1 Dam looking toward right abutment. Note rilling and vegetation on dam face.

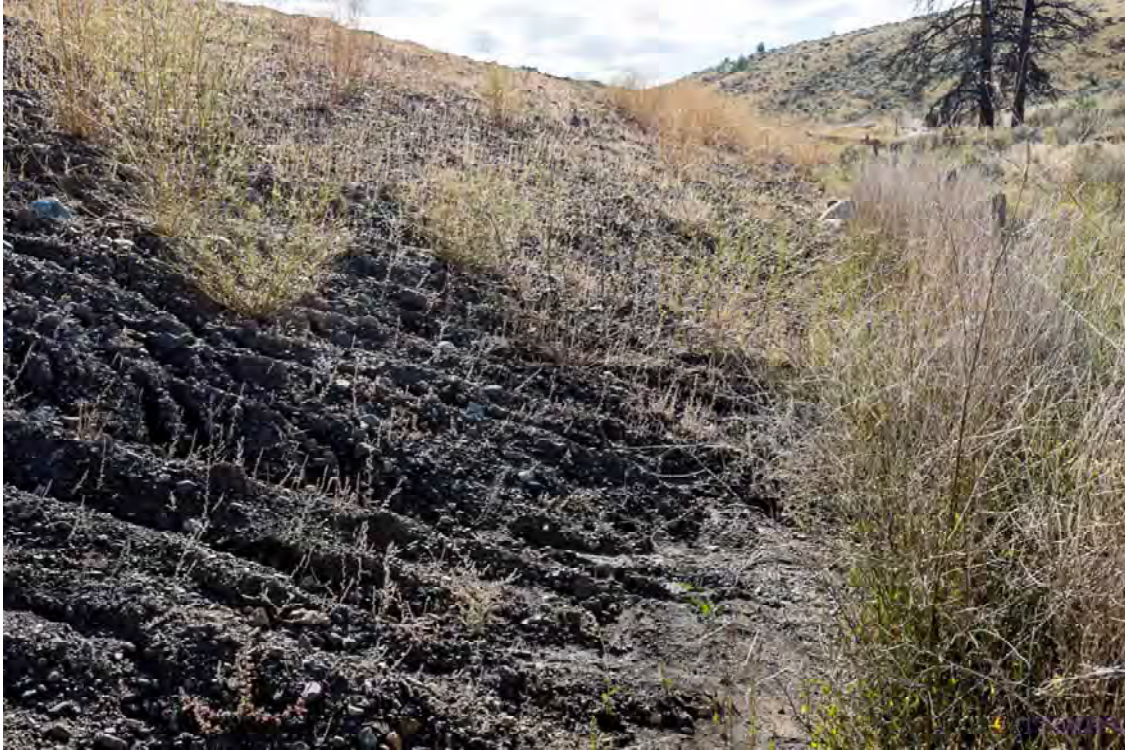
Photo S106: View of downstream face and crest from downstream toe looking east. Note rilling of dam face.

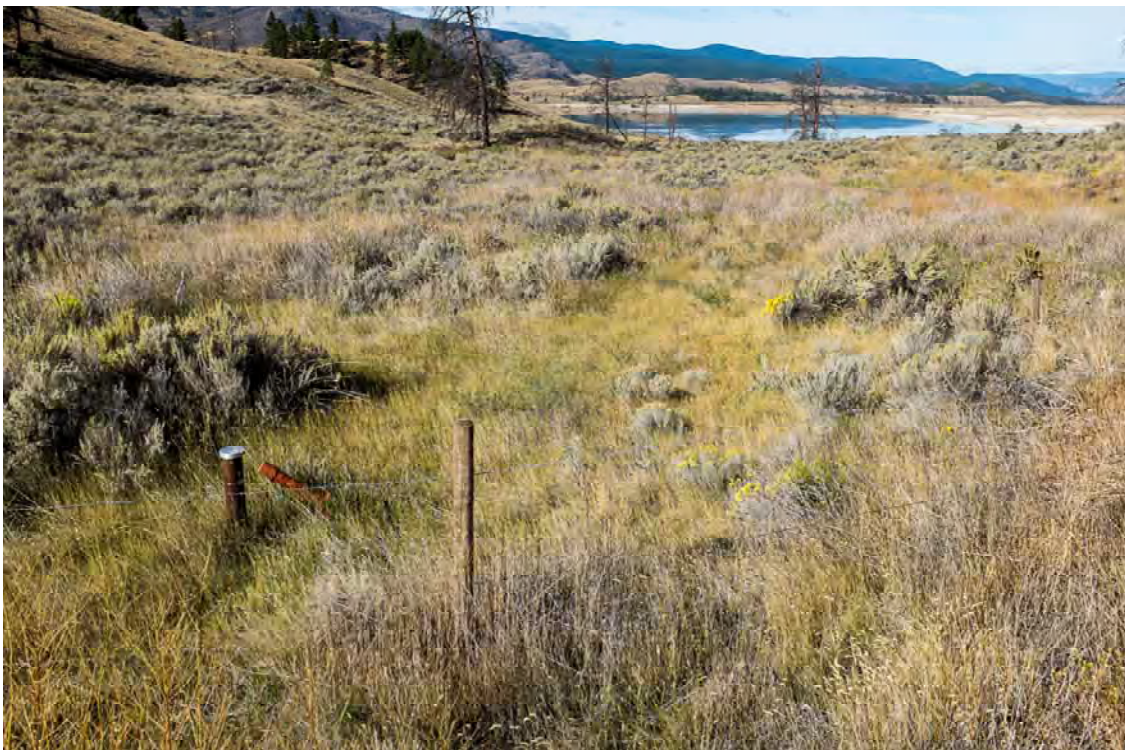
Photo S107: View of downstream face from downstream toe of Seepage Pond 1 Dam looking toward left abutment. Note rilling and vegetation on dam face.
