APPENDIX B SELECT PHOTOGRAPHS

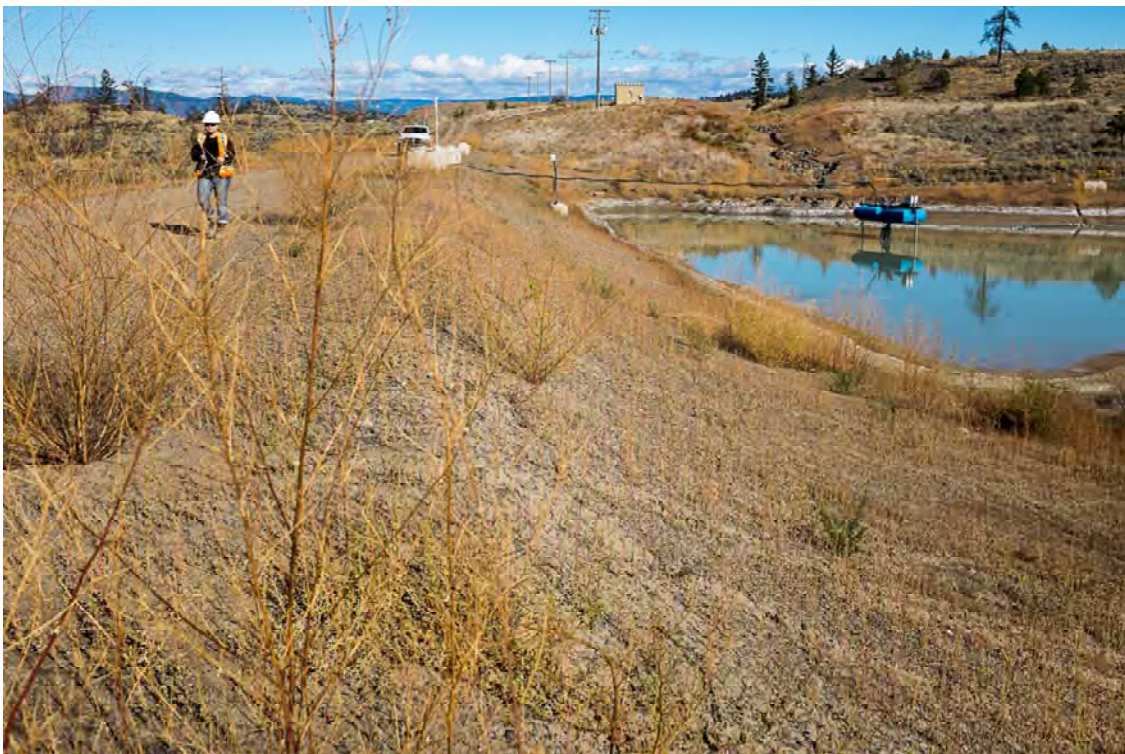
Photo S109: View of downstream face and crest of Seepage Pond 1 Dam from left abutment. Note vegetation on downstream face.

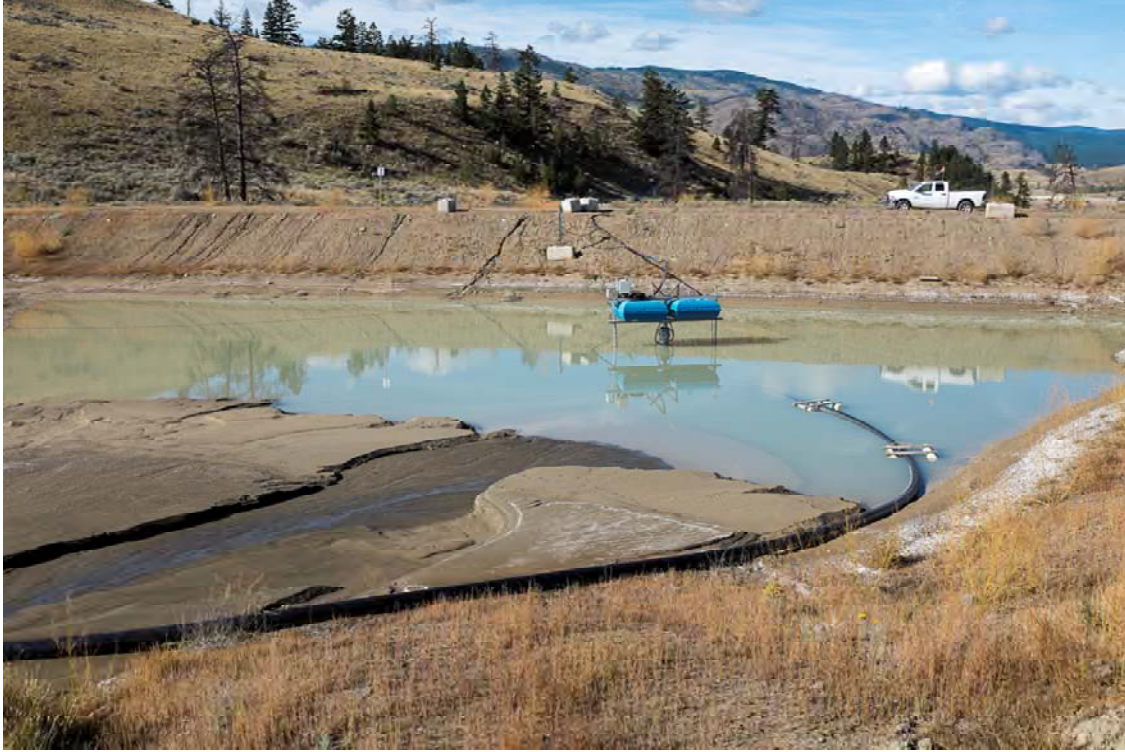
Photo S113: View of Seepage Pond 1 and Dam from upstream end of impoundment. Note minor erosion of dam face and sediment collecting in pond. High water mark visible on face of dam.

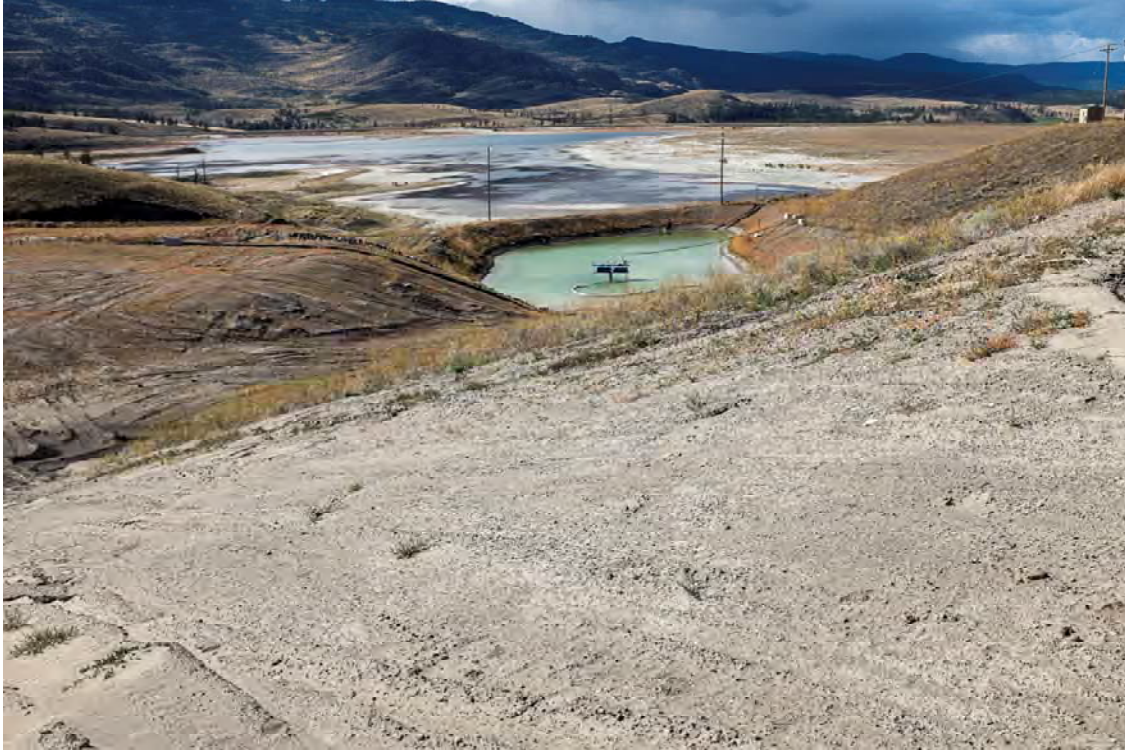
Photo S201: View looking west at Seepage Pond 2 from the downstream face of Dam B. Teck TSF visible in the background.

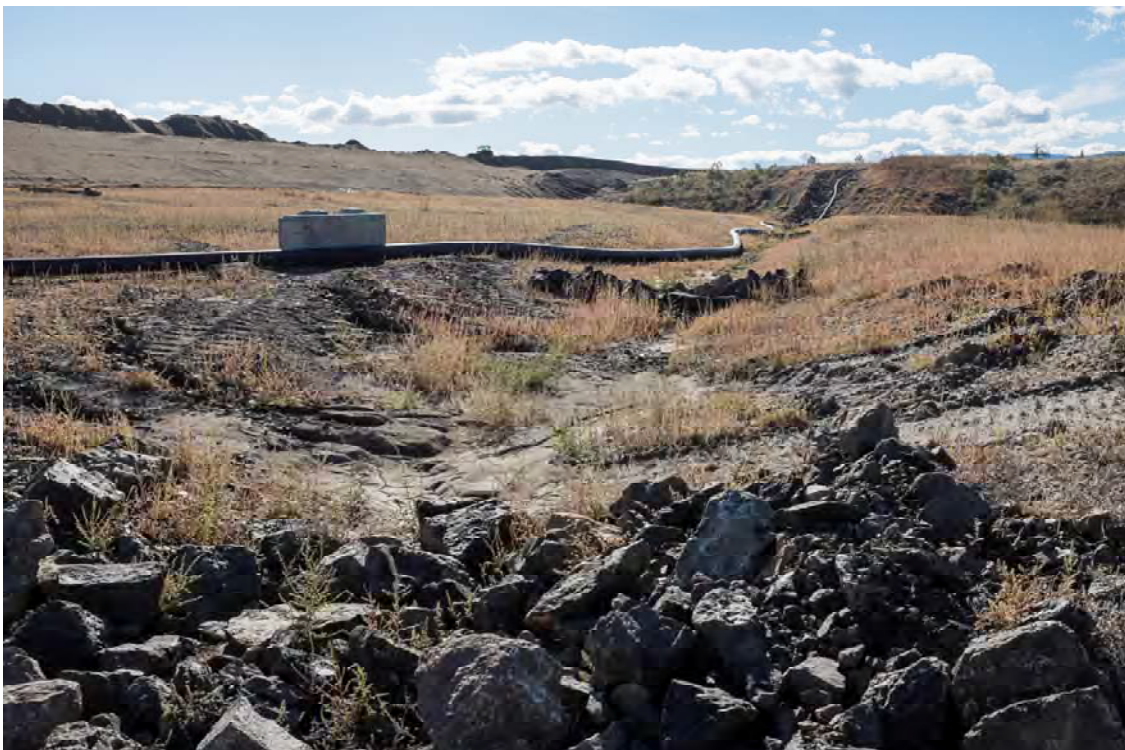
Photo S202: View of the inlet channel and check berms upslope of Seepage Pond 2 looking southwest. Dam B visible in the background.

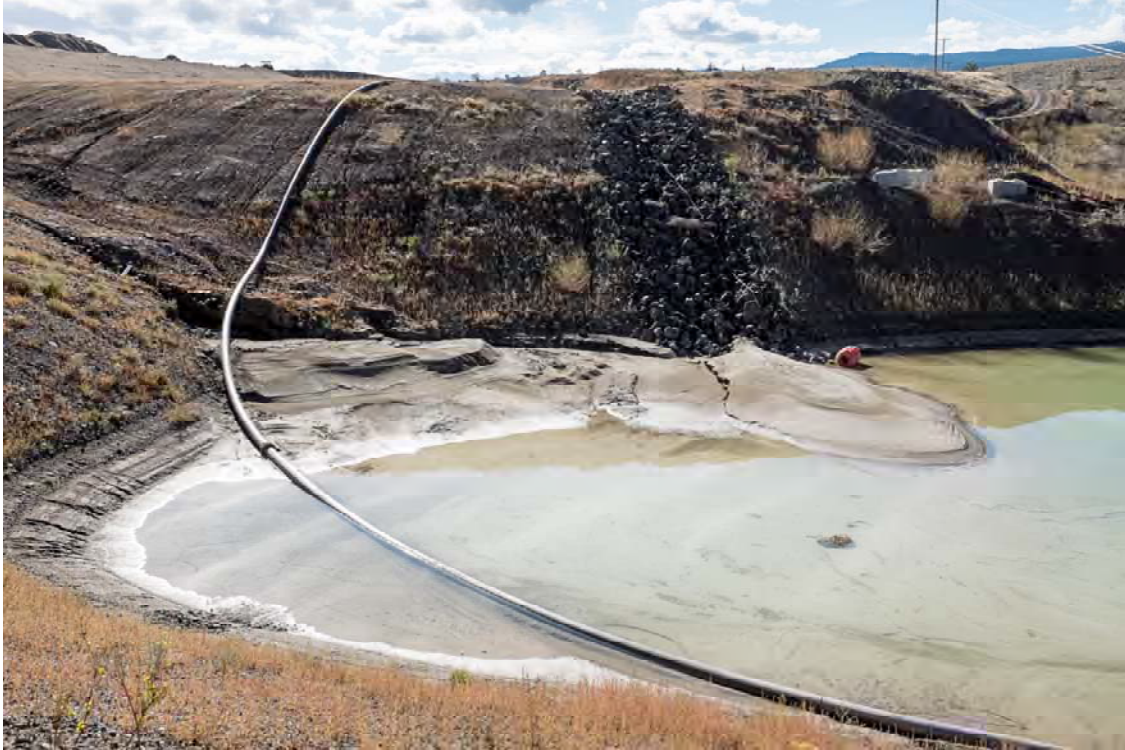
Photo S203: View of the inlet channel and erosion protection looking southwest from the north perimeter of Seepage Pond 2. Note sediment in pond and erosion at inlet from Dam B.

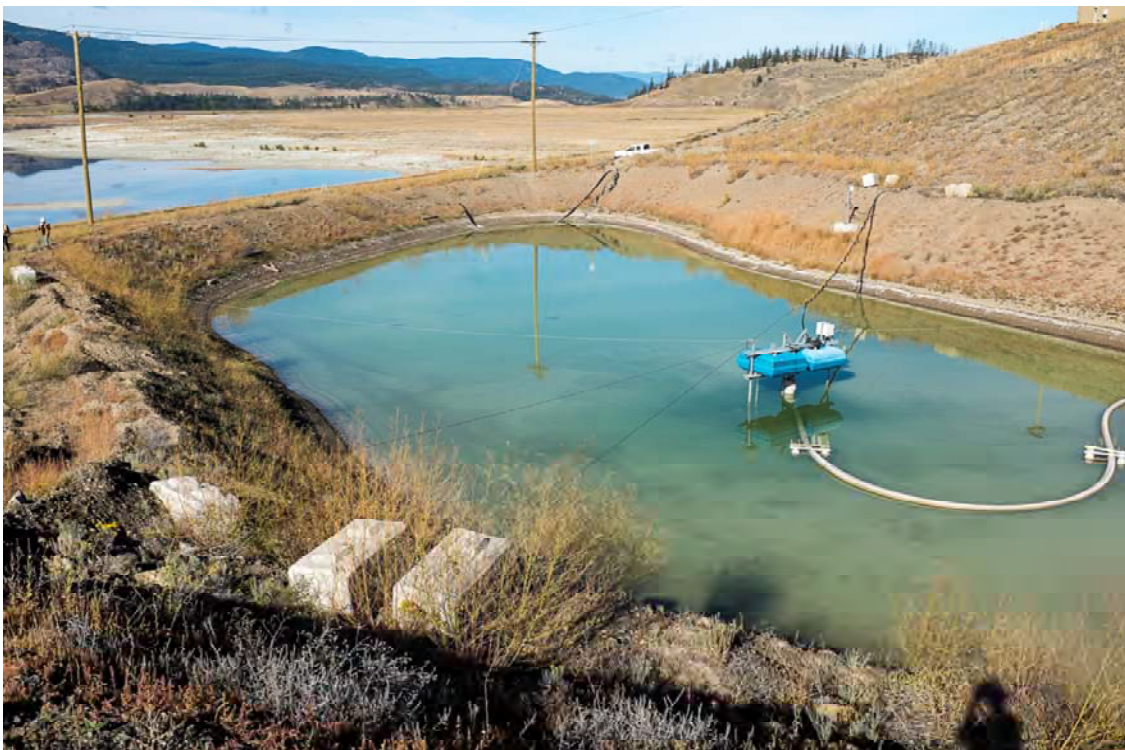
Photo S204: View looking west at Seepage Pond 2 from the inlet channel above impoundment. Teck TSF visible in background. Note erosion on slope between truck and impoundment.

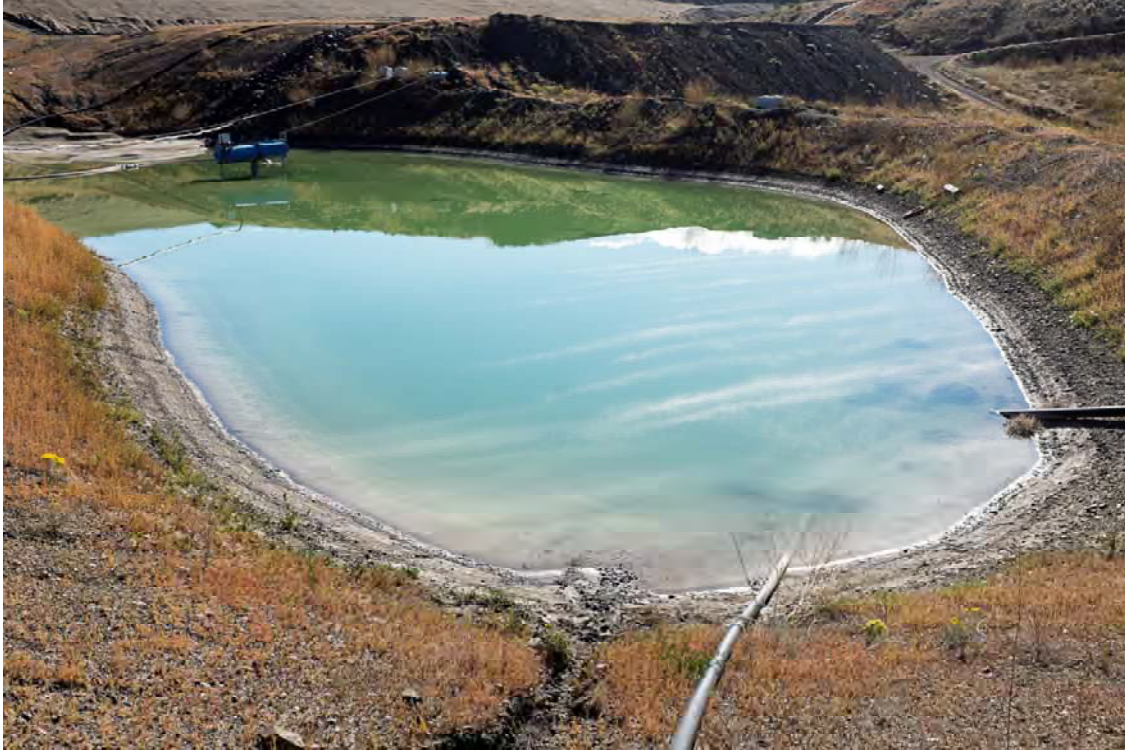
Photo S205: View of Seepage Pond 2 from northwest end of impoundment. Dam B visible in the background. Note erosion on slope in foreground.

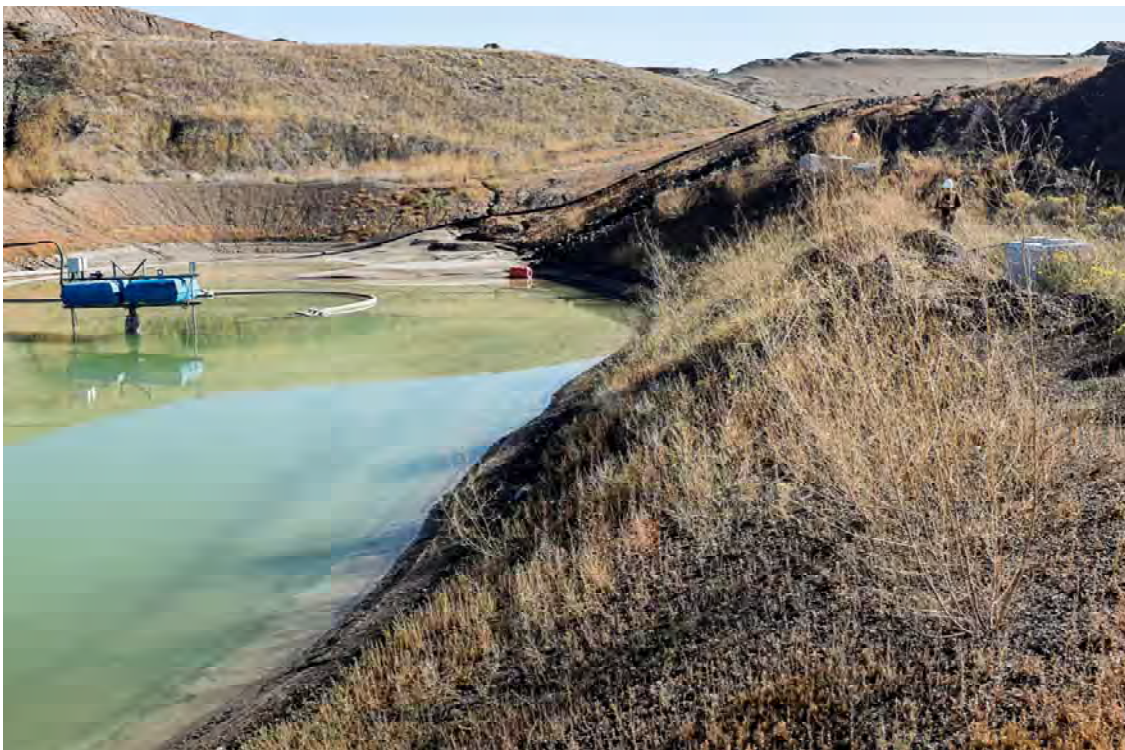
Photo S206: View looking east at inlet of Seepage Pond 2. Note sediment in impoundment. Dam B visible in the background right of the photo.

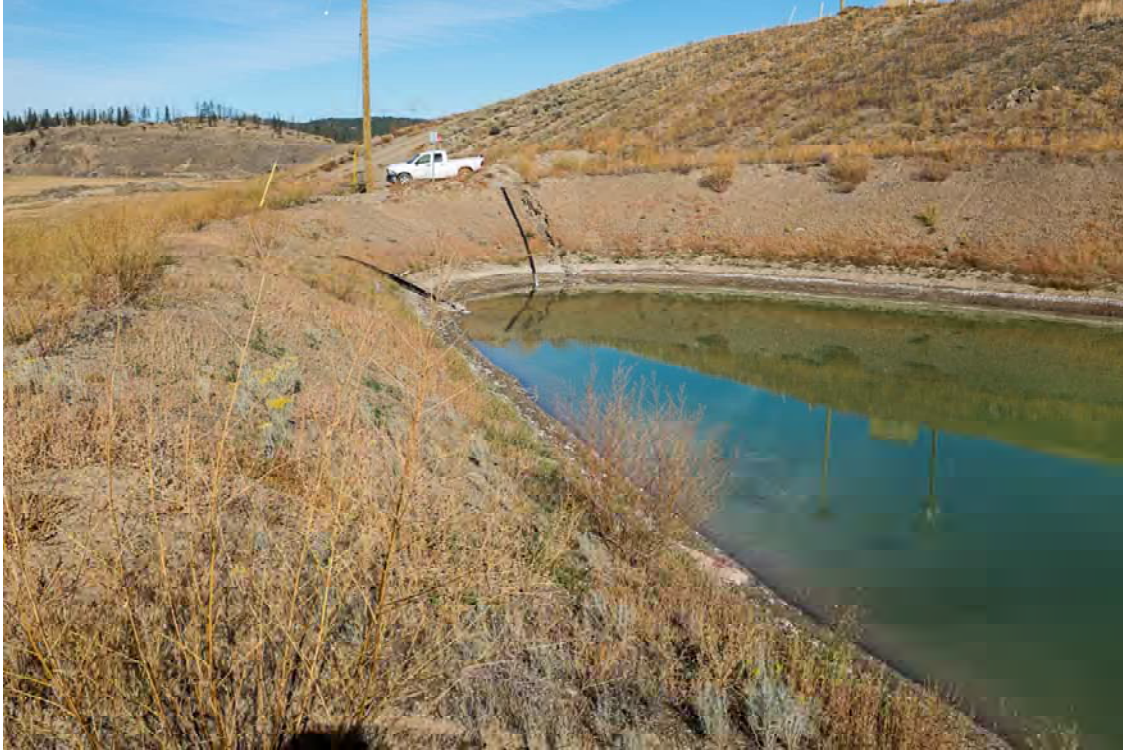
Photo S207: View looking north at northwest end of Seepage Pond 2. Note erosion of slope between truck and impoundment where inlet channel reports to impoundment. Teck TSF visible at top left of photo.

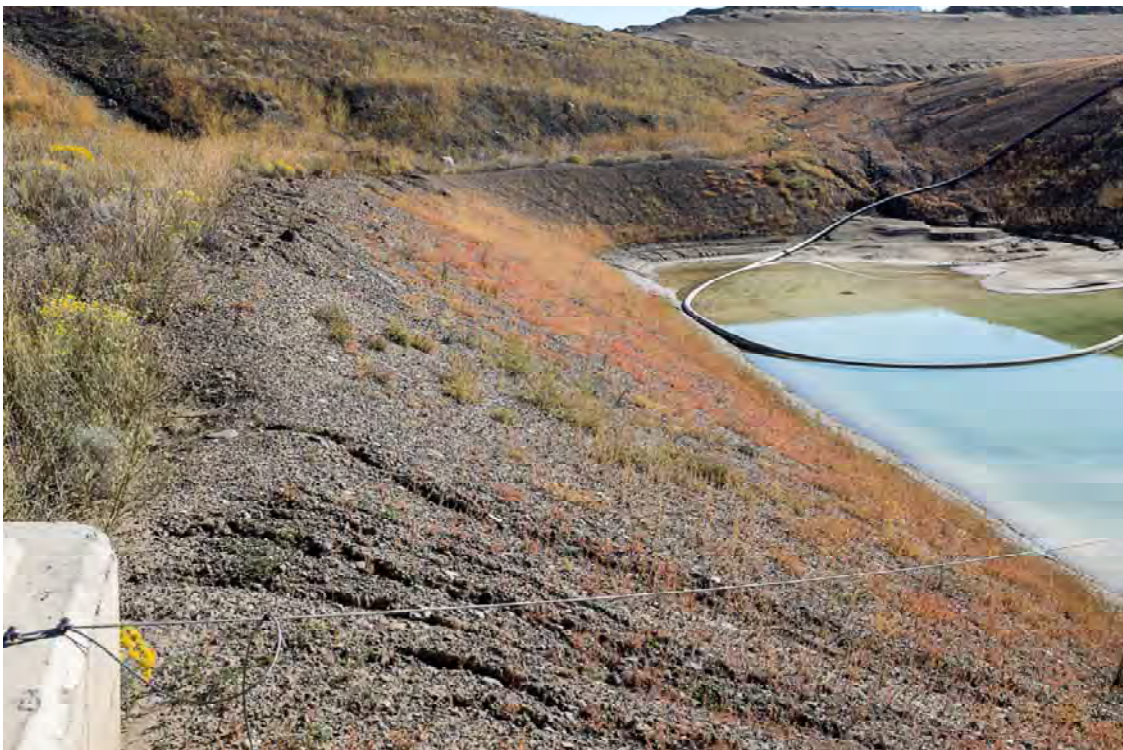
Photo S208: View of north perimeter of impoundment and inlet of Seepage Pond 2. Note minor rilling of impoundment slope in foreground. Dam B visible in background right of photo.

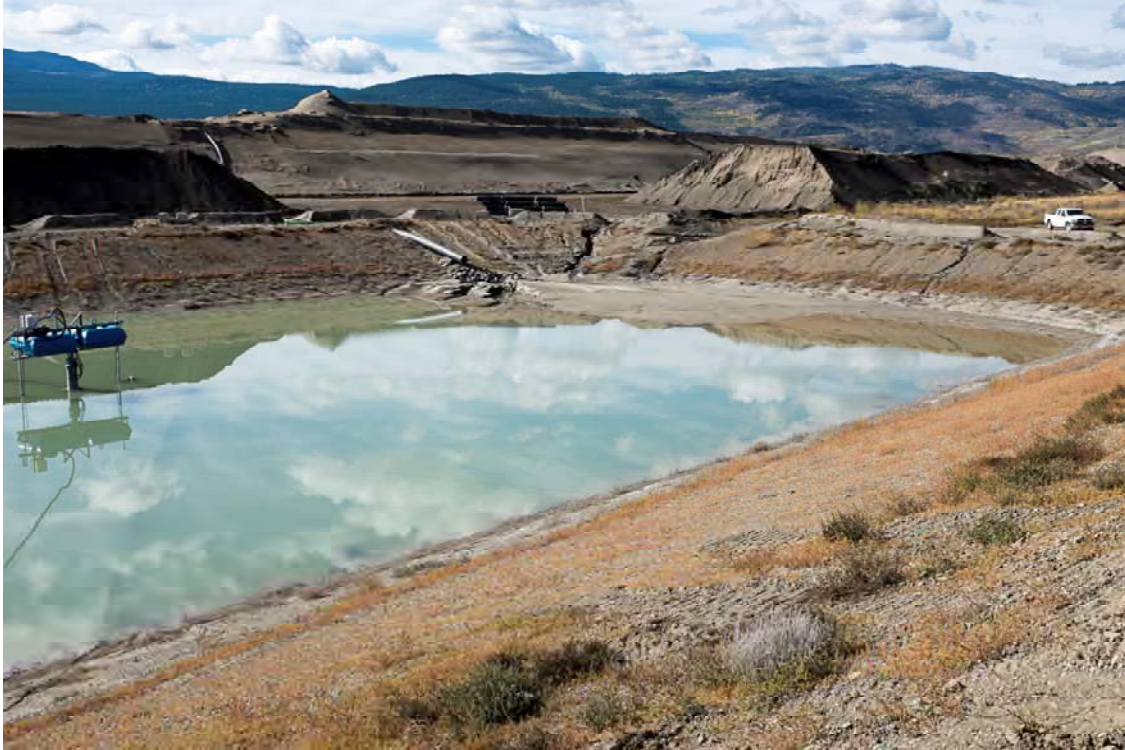
Photo S304: View of the east side of Seepage Pond 3 from the north side looking south. Note sediment accumulated at the decant pipe discharge.

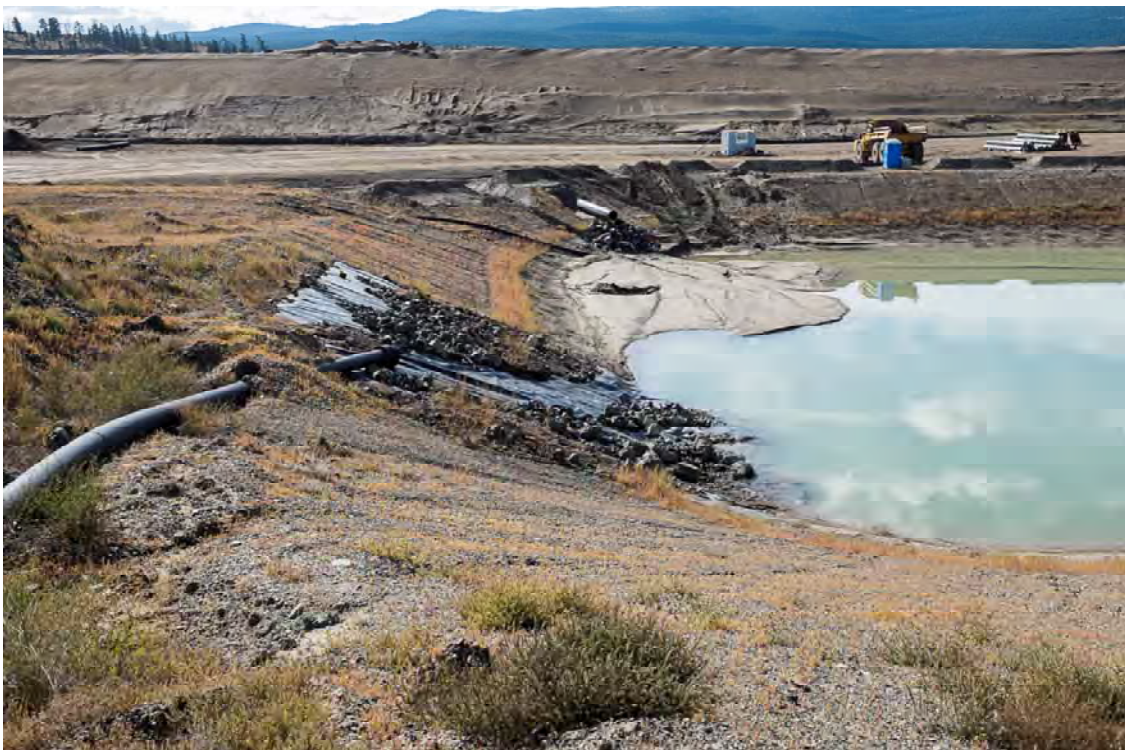
Photo S305: View of the west and north sides of Seepage Pond 3 from the north east corner looking west.

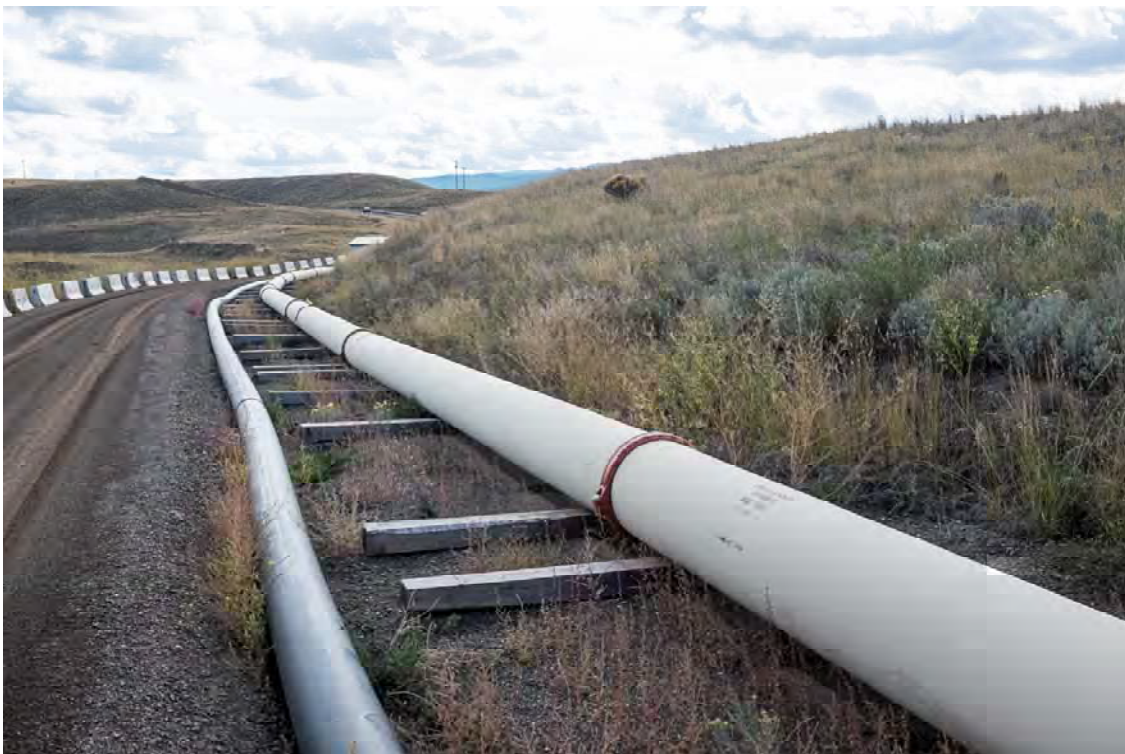
Photo TL06: View looking southeast along steel portion of tailings line from just upslope of mill.

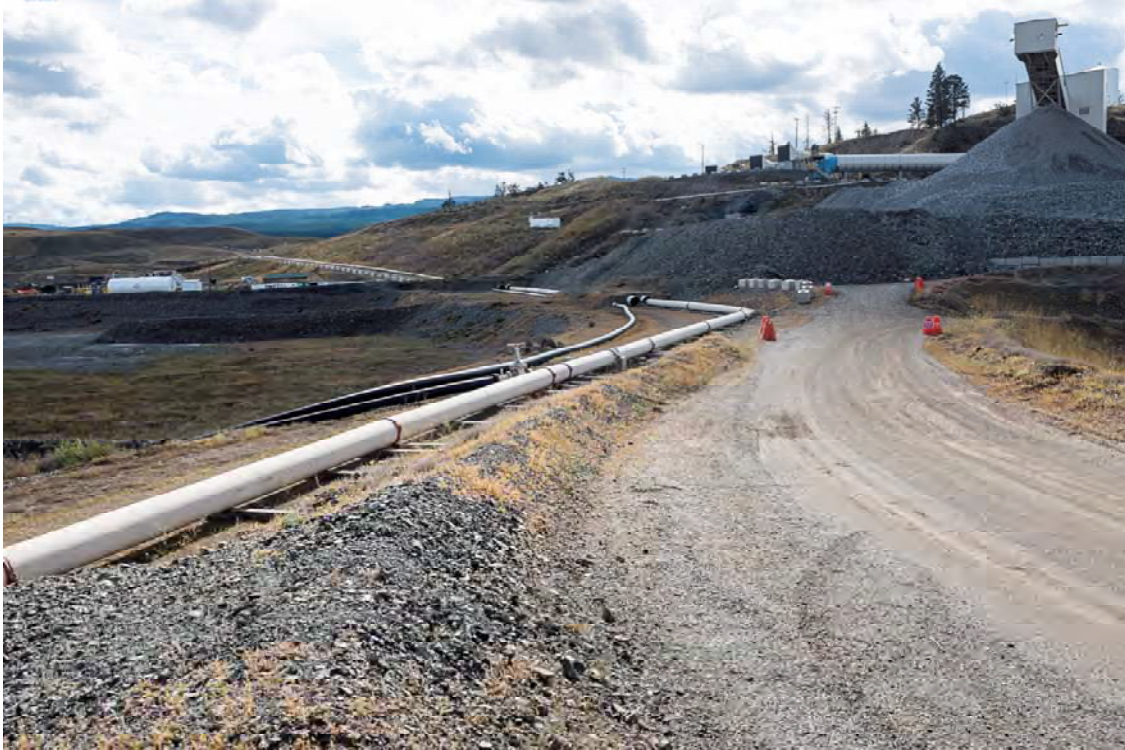
Photo TL07: View looking southwest at steel tailings line adjacent to ore stockpile. Note sections in culverts, and drain line to spillpond.

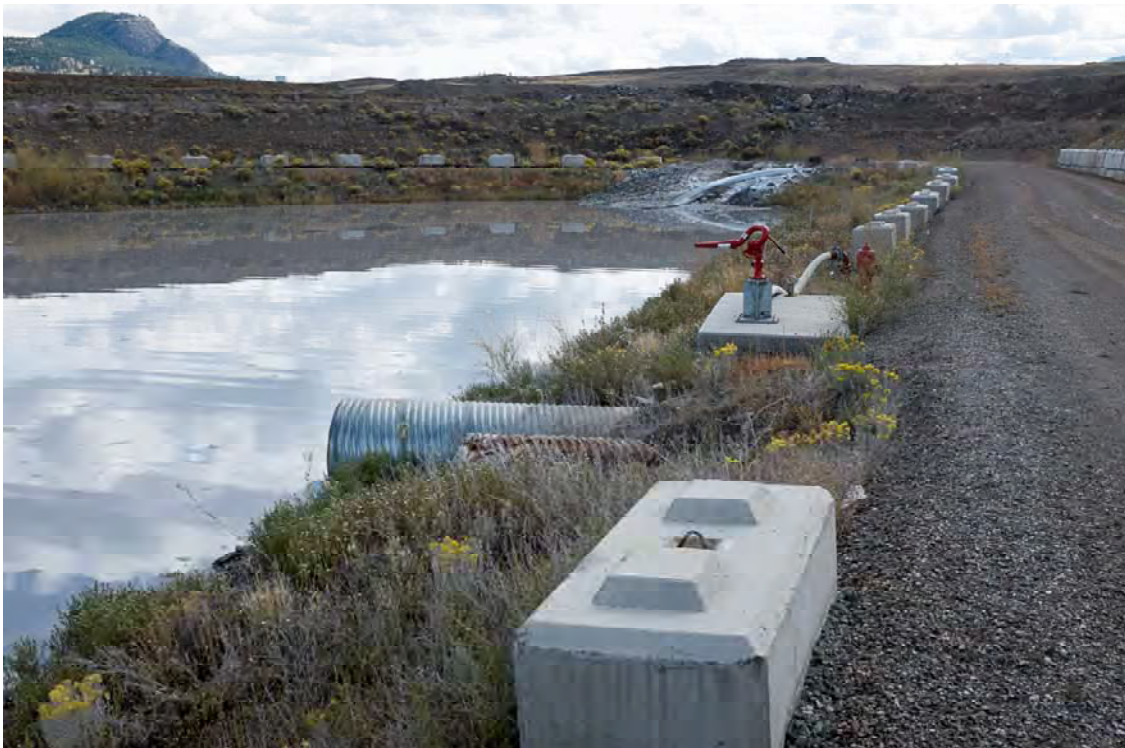
Photo TL10: View looking south at the Spill Pond where the inlet line enters the pond. Note the water level relative to the inlet culvert level.

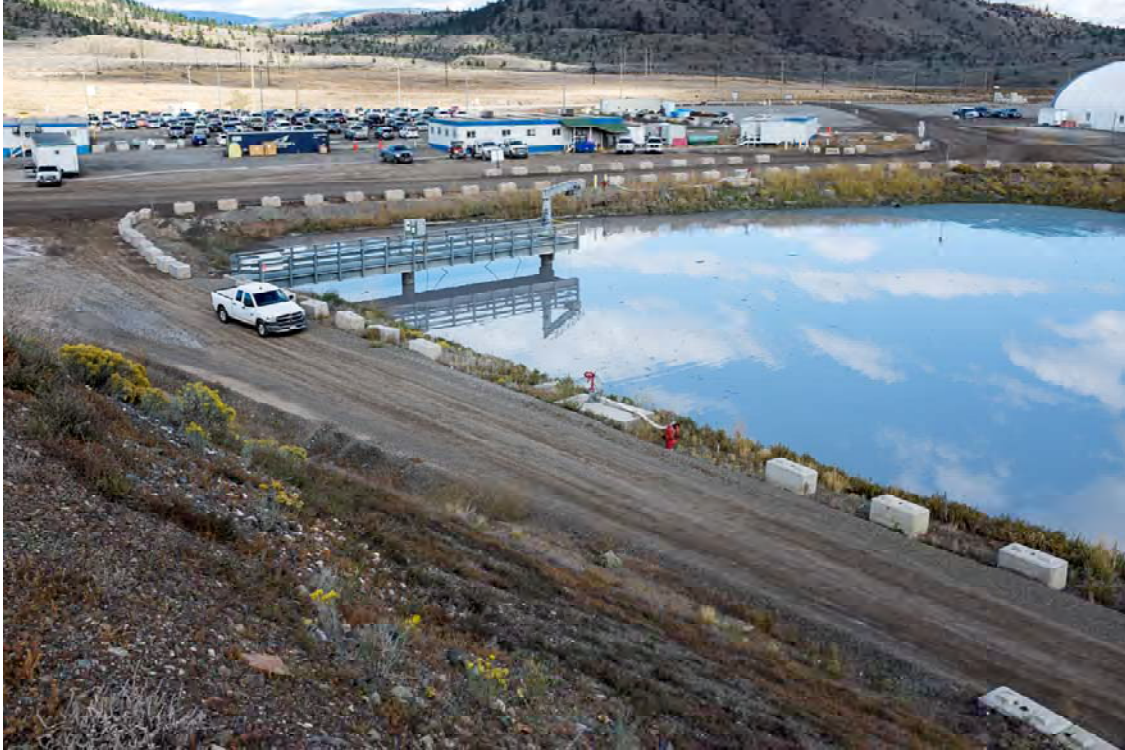
Photo TL11: View of Spill Pond from top of hill adjacent to ore stockpile looking north. Note water level relative to inlet culverts and algae rafts on pond surface at top right of photo.

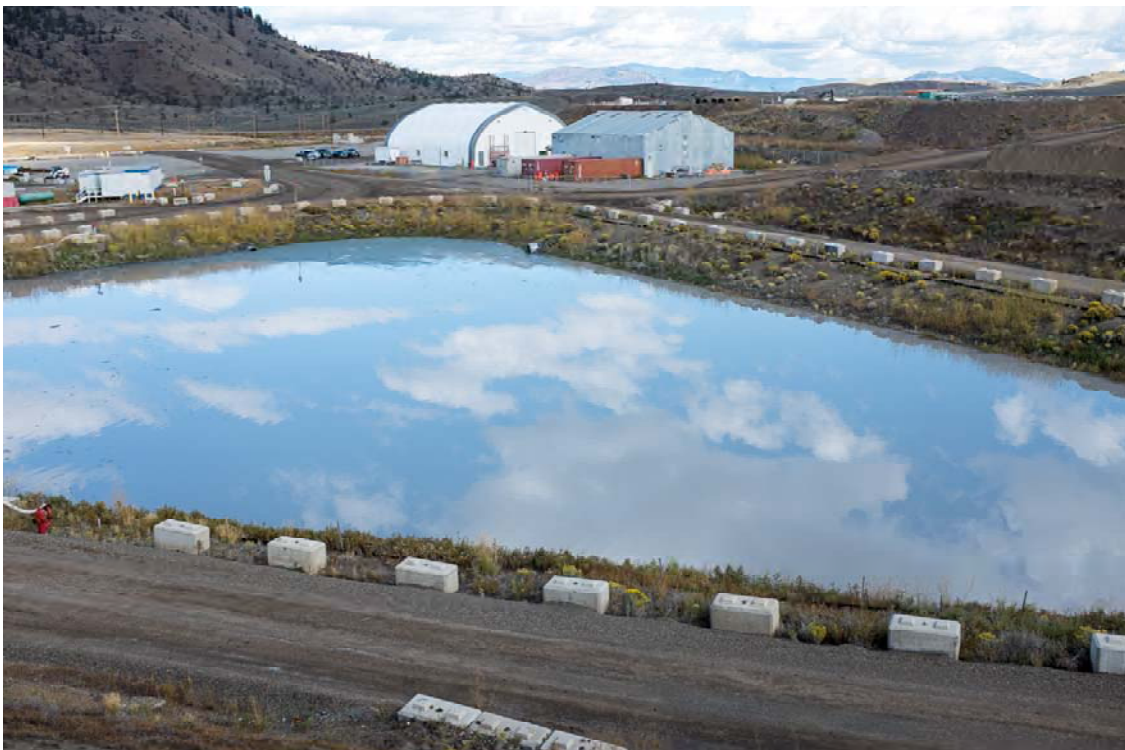
Photo TL12: View of Spill Pond from top of hill adjacent to ore stockpile looking northeast. Note water level relative to inlet culverts and algae rafts on pond surface at top right of photo.

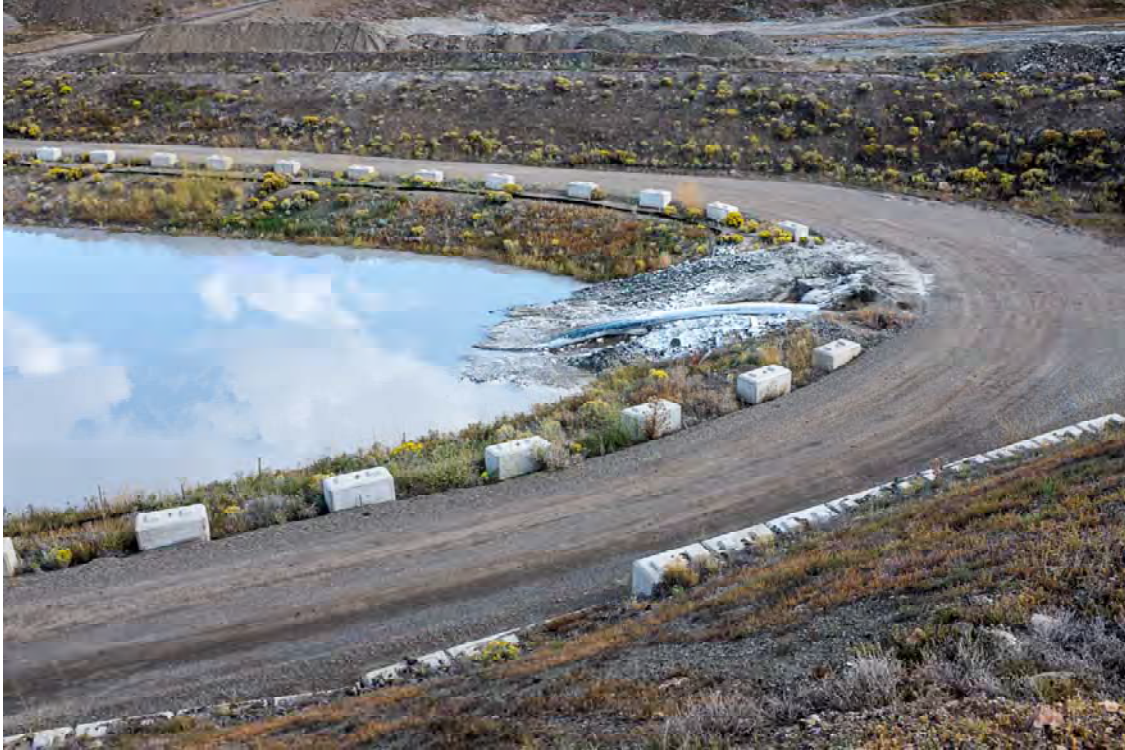
Photo TL13: View of Spill Pond from top of hill adjacent to ore stockpile looking east. Note water level inlet line.
