**BARRICK GOLD INC.
NICKEL PLATE MINE**

2014 TAILINGS FACILITY ANNUAL REPORT

VA101-3/19-1
Rev 0
November 25, 2014

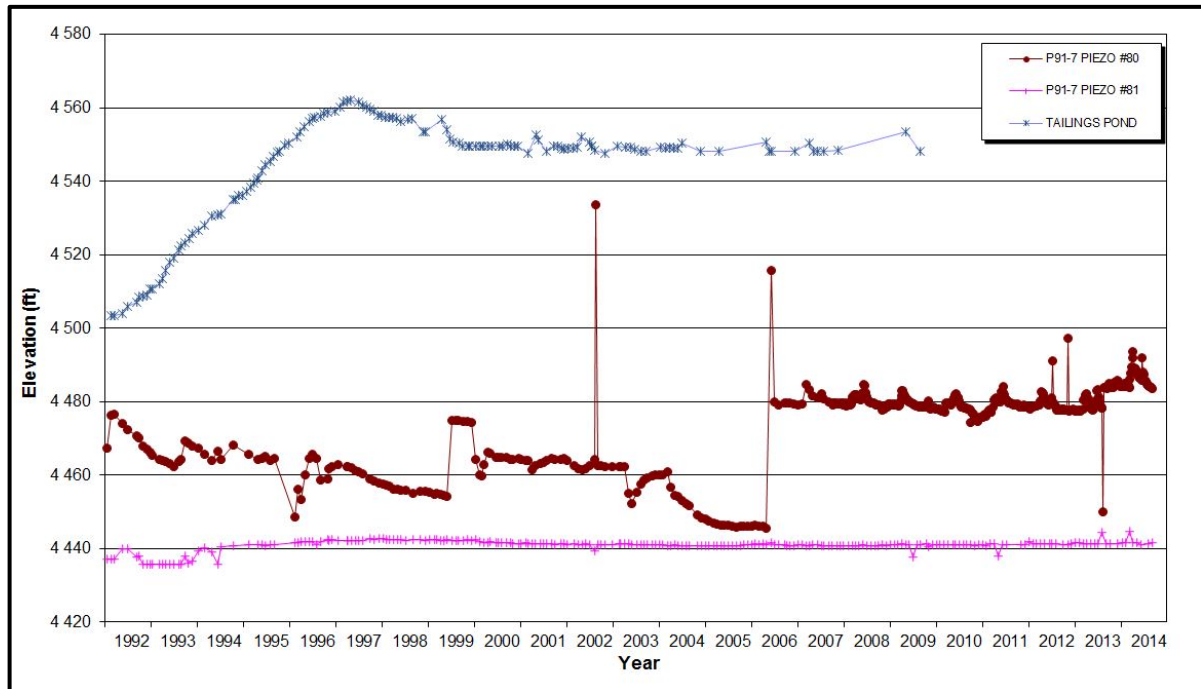
Figure 3.4 Embankment Piezometers P91-7

The recorded water level in P91-7-80 (located within sand and gravel outwash soils) indicated a significant increase of about 70 ft in June 2006, followed by a rapid drop of 37 ft (to about El 4479) where it has generally remained, although larger seasonal fluctuations have been recorded in 2014 (see Figure 3.4). As mentioned in previous inspection reports, it is likely that the high water level readings are due to a blockage in the piezometer pipe. The standpipe likely needs to be flushed and pumped to lower the water level and remove any blockage. The piezometer should continue to be monitored.

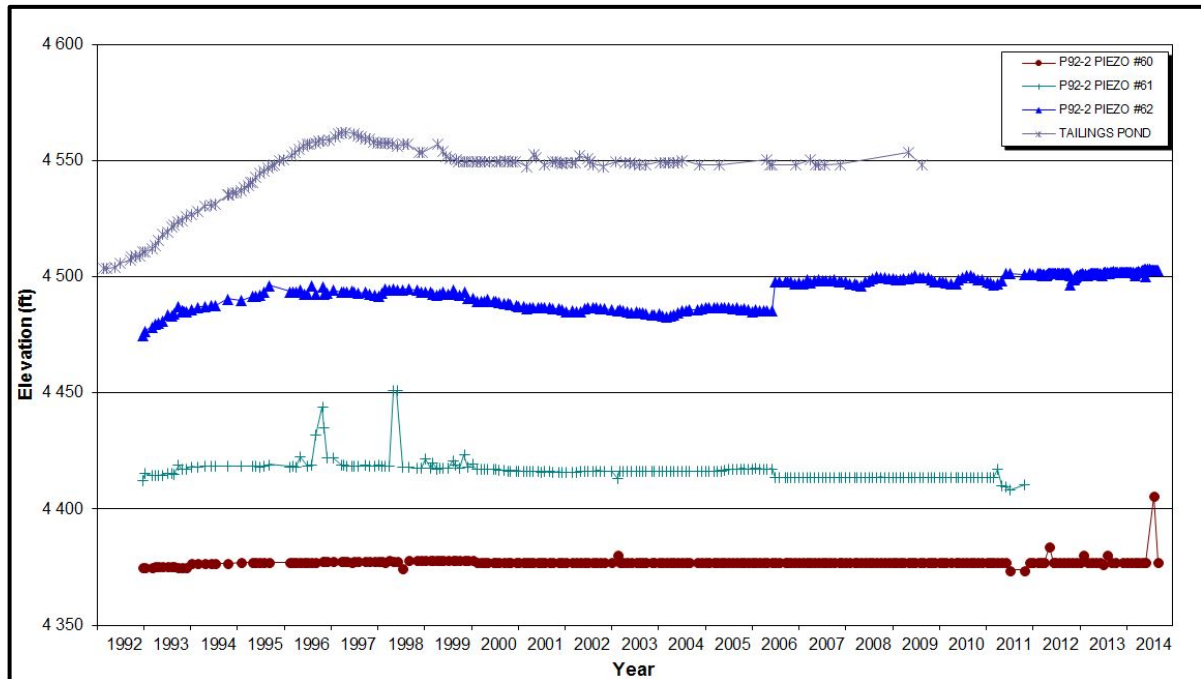
Figure 3.6 Embankment Piezometers P92-2

Standpipe piezometer P92-2-62, located within the embankment at the south-eastern side of the facility, had been stable for several years, but recorded an increase of about 11 ft in July 2006 (see Figure 3.6). This elevated piezometric level remains and has shown either little change or a gradual increase since that time (total increase of about 5 feet since 2006). It is likely that the piezometer pipe has a blockage that is resulting in erroneous water level readings.

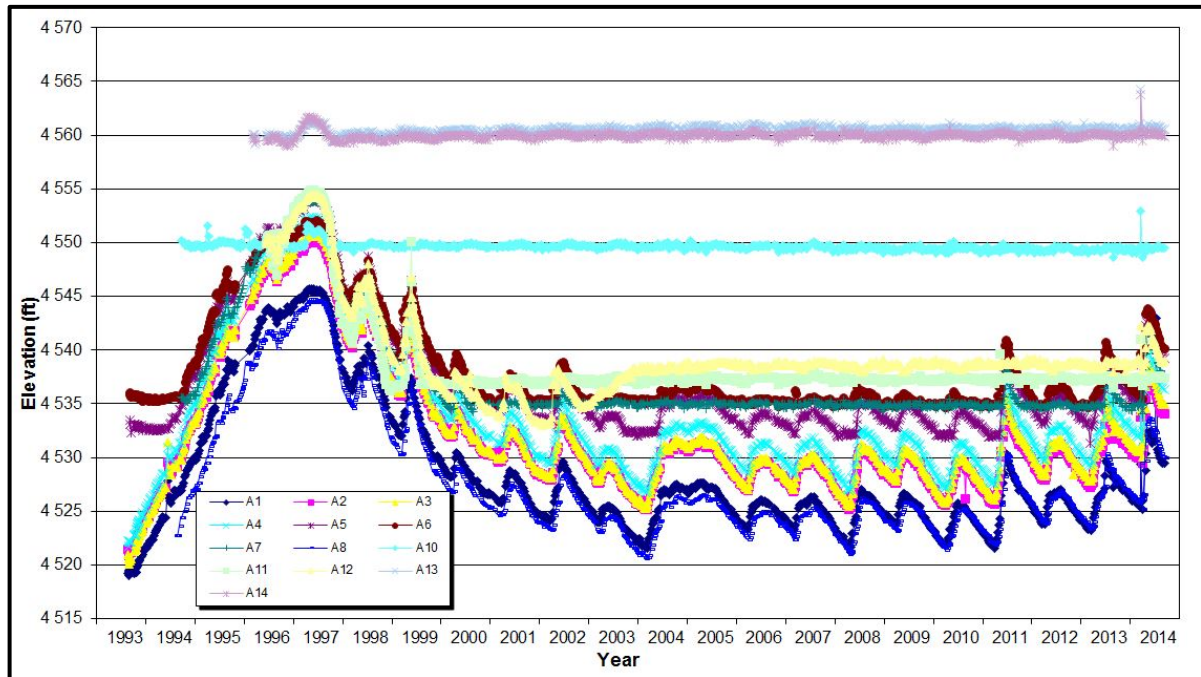
Figure 3.12 Piezometer Plane A

Long-term piezometric levels recorded by the vibrating wire piezometers installed in the tailings embankment have shown a typical seasonal fluctuation each year (increase during freshet followed by a decrease in the winter months). Vibrating wire piezometers A5 and A6 on Instrumentation Plane A (see Figure 3.12) and piezometers B1 and B2 on Instrumentation Plane B (see Figure 3.13) exhibited a larger than normal seasonal fluctuation in early 2014 of about 5 to 8 feet, associated with spring freshet. This is similar to higher than normal spring piezometric levels recorded in 2013 and 2011, attributed to higher than normal precipitation/snowfall conditions. Site staff have indicated that snow levels over the last three years have been higher than normal. It is likely that the higher than normal precipitation and higher snowfall conditions experienced at the site over the last three years has resulted in a general rise in the phreatic surface within the tailings facility.

1. Piezometer A2 has not functioned since Feb. 2003.
2. Piezometer locations provided on Figure 3.1 and Drawings 1812.101 and 1819.201.

The piezometric data recorded during 2007 to early September 2014 indicates that the water table has generally remained stable, with only seasonal fluctuations within the embankment since 2006, as shown by the piezometer data on Figure 3.12. The seasonal fluctuations have been larger in

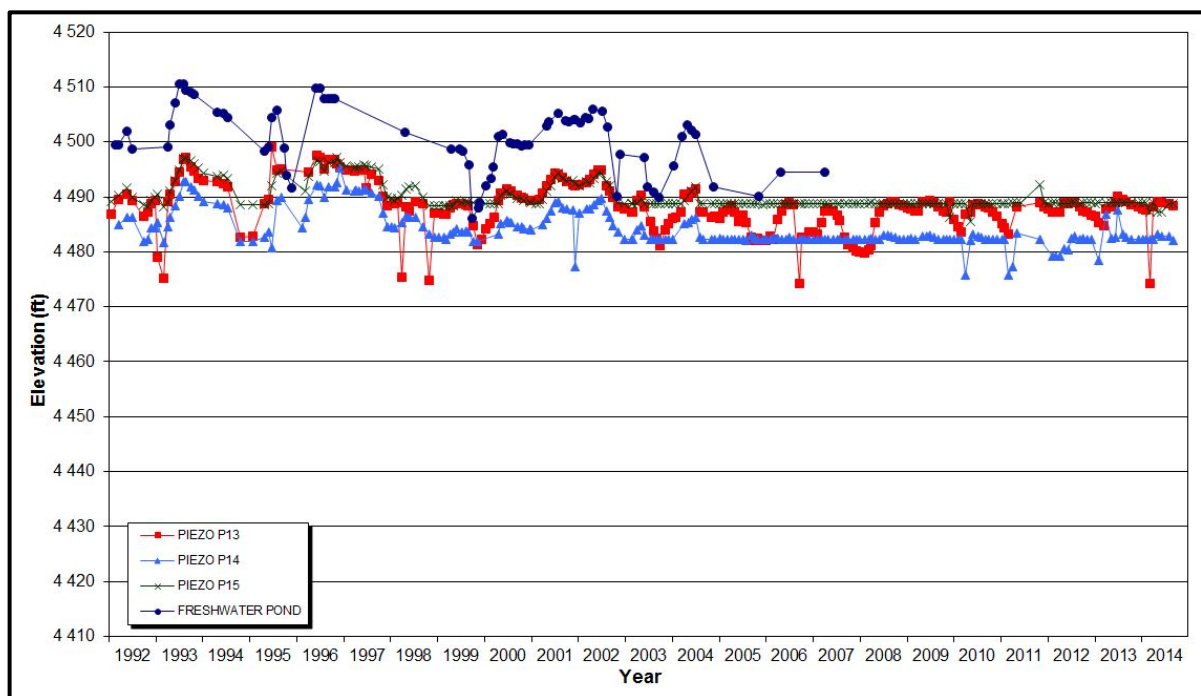
soil. Recorded pore pressure measurements since 2009 suggest relatively stable water levels, with seasonal fluctuations of about 5 to 8 feet (see Figure 3.14). The seasonal fluctuations in water level are consistent with those observed at other piezometers within the tailings deposit and embankment over the same time period. However, it is noted that the recorded piezometric levels in 2013 did not exhibit the typical seasonal decline over the last half of the year. A seasonal increase and ongoing decline in levels has since occurred to date in 2014. The piezometric data is likely indicating that the seasonal increase in water levels within the tailings facility is taking longer to dissipate, due to higher than normal precipitation in 2013 accumulating within the facility. These piezometers need to be monitored closely during and following freshet in 2015.

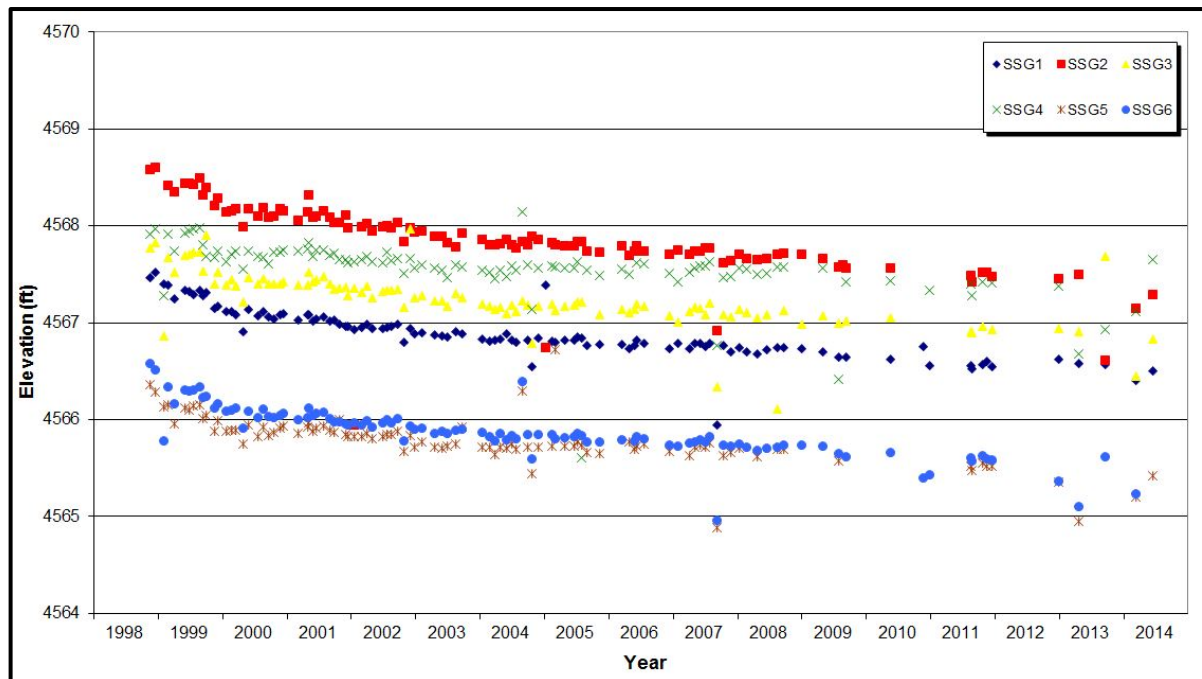
Figure 3.16 Tailings Facility Surface Settlement Gauge Data

There are six surface settlement gauges installed on the completed portion of the tailings cover system. The locations of these settlement gauges are shown on Drawing No. 1812.101 in Appendix A. The survey data collected for these gauges to date is presented on Figure 3.16. Measured settlement of the tailings reclamation cover has been approximately one foot or less since construction was completed and the gauges installed in 1998. There has been no significant change in tailings cover elevation over the last several years (typically less than 0.3 feet). Variations in the recorded elevations in recent years are likely within the measurement accuracy of the survey and influenced by site conditions at the time of the survey.
