Teck Resources Ltd.

Quintette Coal Operations

Plantsite Tailings Dam

2014 Dam Safety Inspection

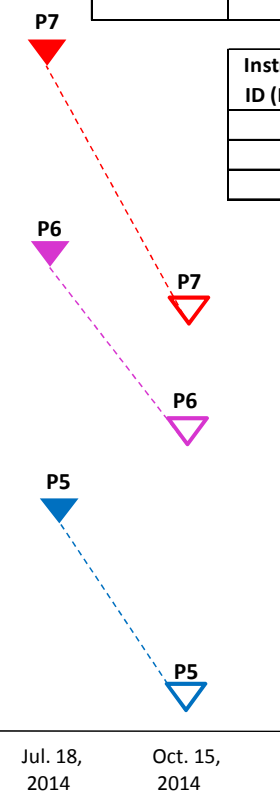
PROJECT:			
Quintette Coal Operations 2014 Dam Safety Inspections			
TITLE:			
Plantsite Tailings Dam Piezometer Readings			
Sta. 0 + 475			
PROJECT NO.	M09684A10	FIGURE	3

Instrument ID (Note 2)	Oct. 15, 2014 Reading (psi)	Pressure		Tip Elevation (m)	Change From Jul. 18 (m)
		Head (m)	Elevation (m)		
P5	0.4	0.3	853.8	853.5	-2.3
P6	5.1	3.6	862.6	859.0	-2.2
P7	7.3	5.1	861.1	856.0	-3.2

1. Instrument section and historic readings chart from Golder(2003). Historic piezometric reading values were unavailable.
2. No labels on piezometer leads. Comparison of past readings and tip location used to infer what readings apply to what instruments. Labels should be added for ongoing comparison purposes.

DSI-PS-09 (New – Priority 3)	Piezometer monitoring data	n/a	Complete minimum 3 piezometer readings in 2015 at Sta. 0+300 and Sta. 0+475 instrumentation lines.	(1) before May 30, 2015 (2) between July and August, 2015 (3) between September and November, 2015.
DSI-PS-10 (New – Priority 3)	Closure spillway IDF	CDA (2007)	KCB recommend Teck complete a design assessment with summary report to confirm the closure spillway is suitable for the IDF.	December, 2015

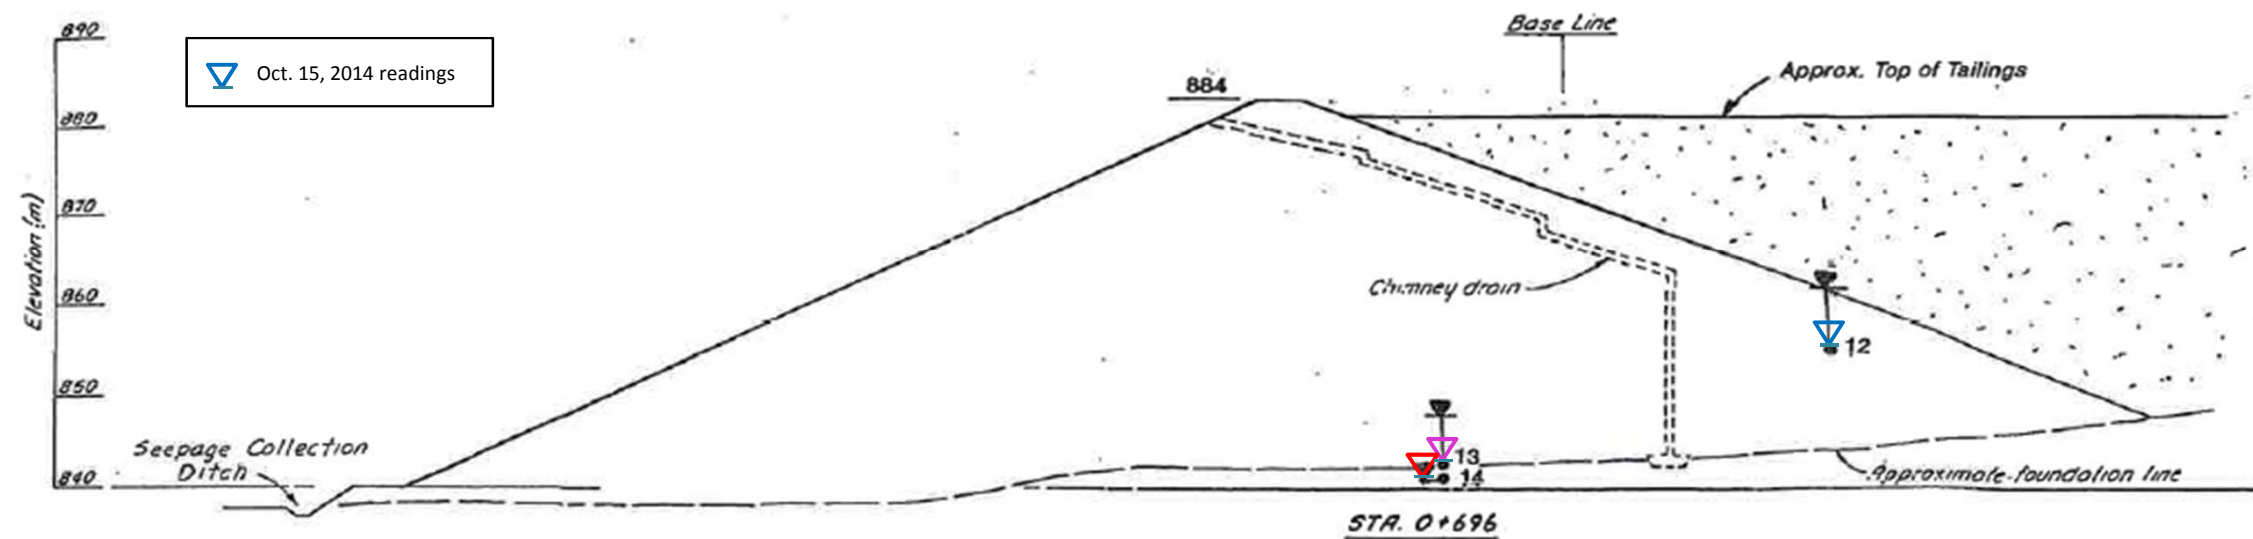
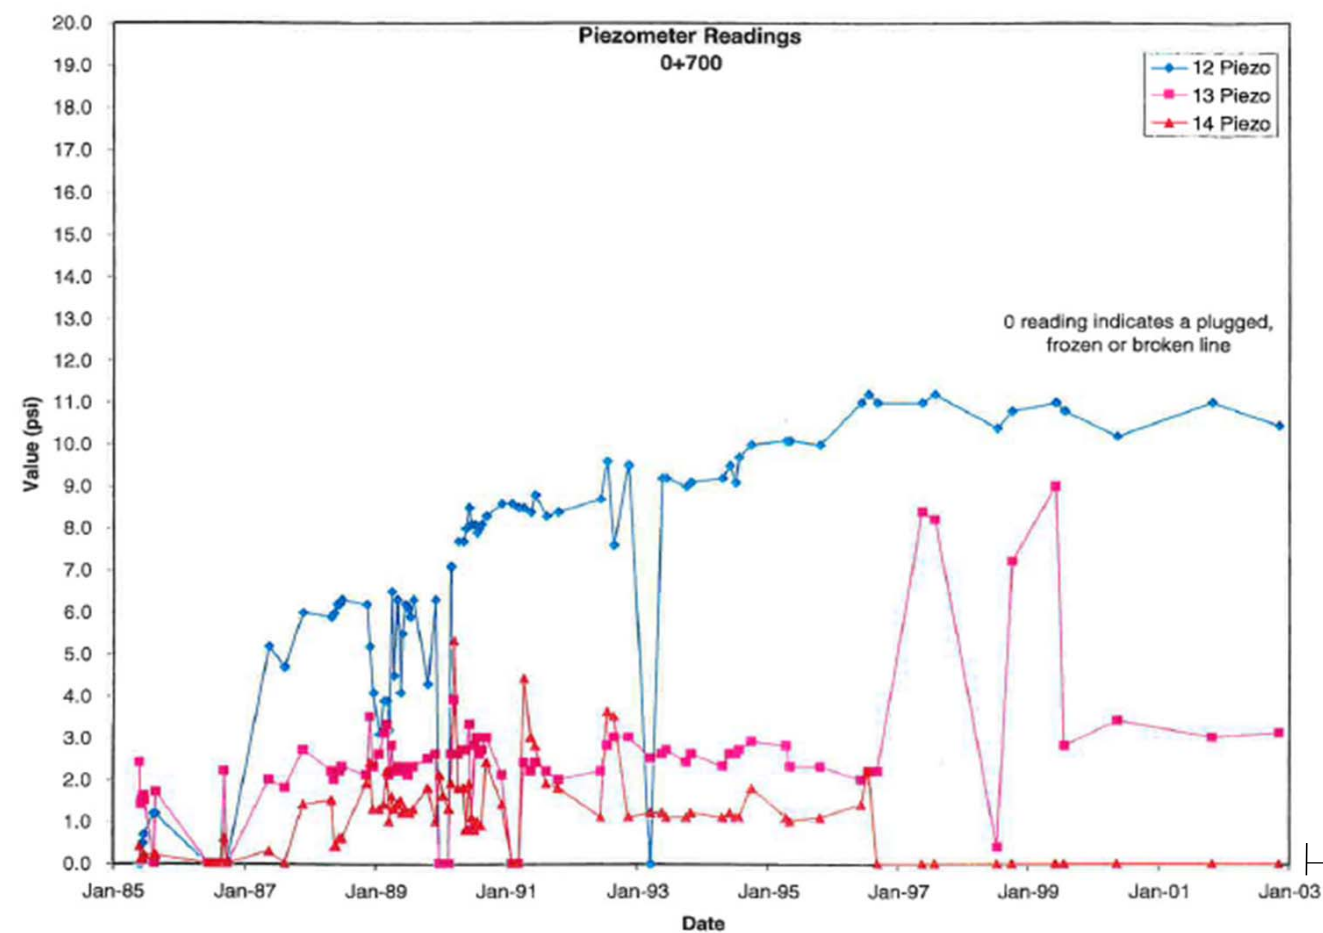
PROJECT:			
Quintette Coal Operations 2014 Dam Safety Inspections			
TITLE:			
Plantsite Tailings Dam Piezometer Readings			
Sta. 0 + 696			
PROJECT NO.	M09684A10	FIGURE	4

Instrument ID (Note 2)	Oct. 15, 2014 Reading (psi)	Pressure		Tip Elevation (m)	Last Reading (Jan '03)		Post Op. Average Reading	
		Head (m)	Elevation (m)		(psi)	Change (m)	(psi)	Change (m)
P12	1.5	1.0	856.0	855.0	10.5	-6.4	10.6	-6.4
P13	0.7	0.5	843.0	842.5	3.2	-1.8	5.3	-3.3
P14	0.6	0.4	841.9	841.5	n/a	n/a	n/a	n/a

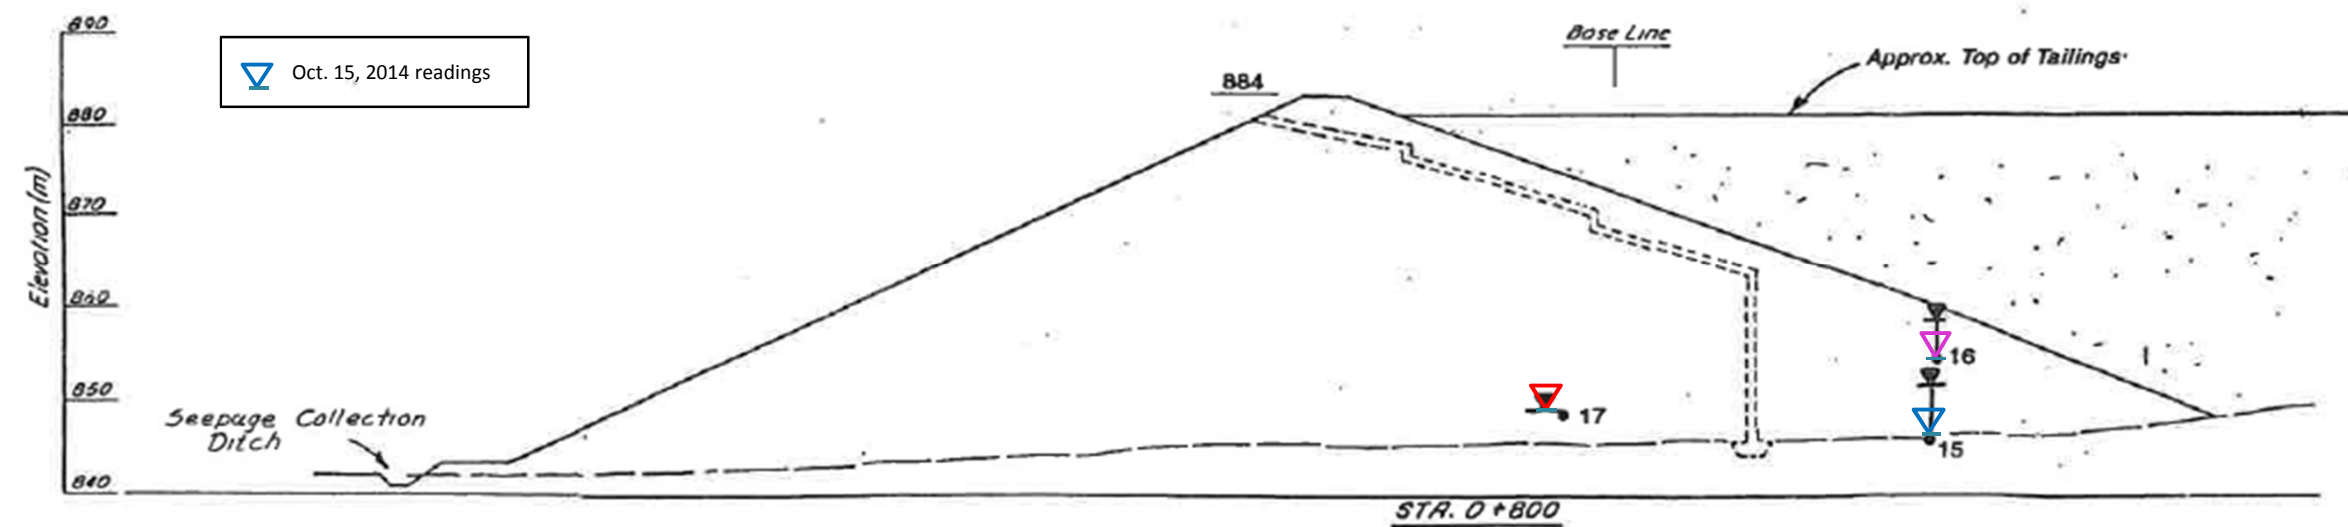
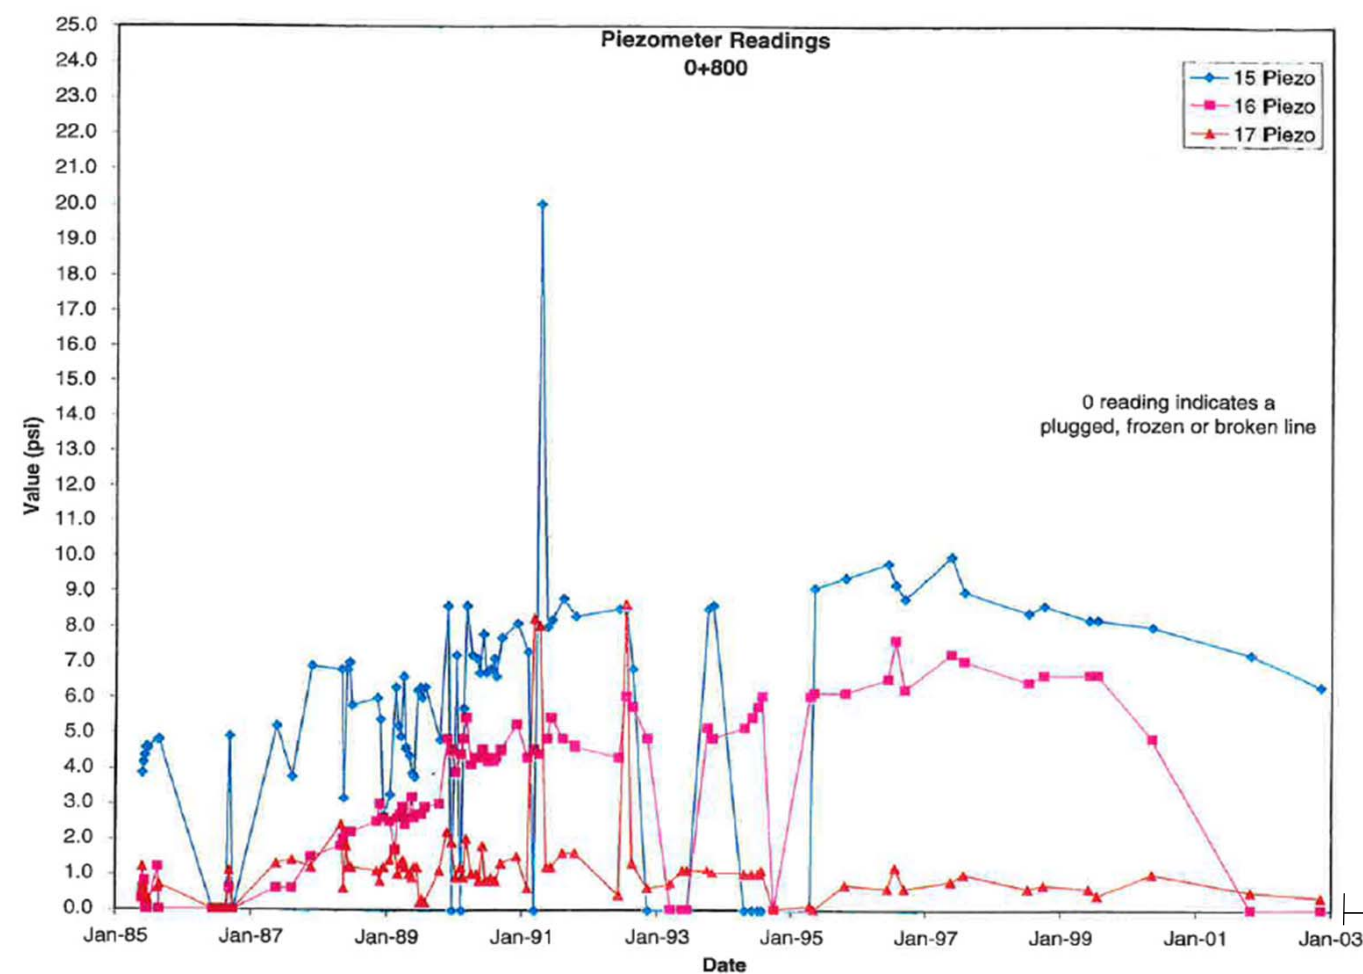
Instrument ID (Note 2)	Oct. 15, 2014 Reading (psi)	Pressure		Tip Elevation (m)	Last Reading (Jan '03)		Post Op. Average Reading	
		Head (m)	Elevation (m)		(psi)	Change (m)	(psi)	Change (m)
P15	1.0	0.7	846.7	846.0	6.2	-3.6	7.5	-4.6
P16	0.4	0.3	854.8	854.5	n/a	n/a	n/a	n/a
P17	0.3	0.2	848.2	848.0	0.3	0.0	0.7	-0.3

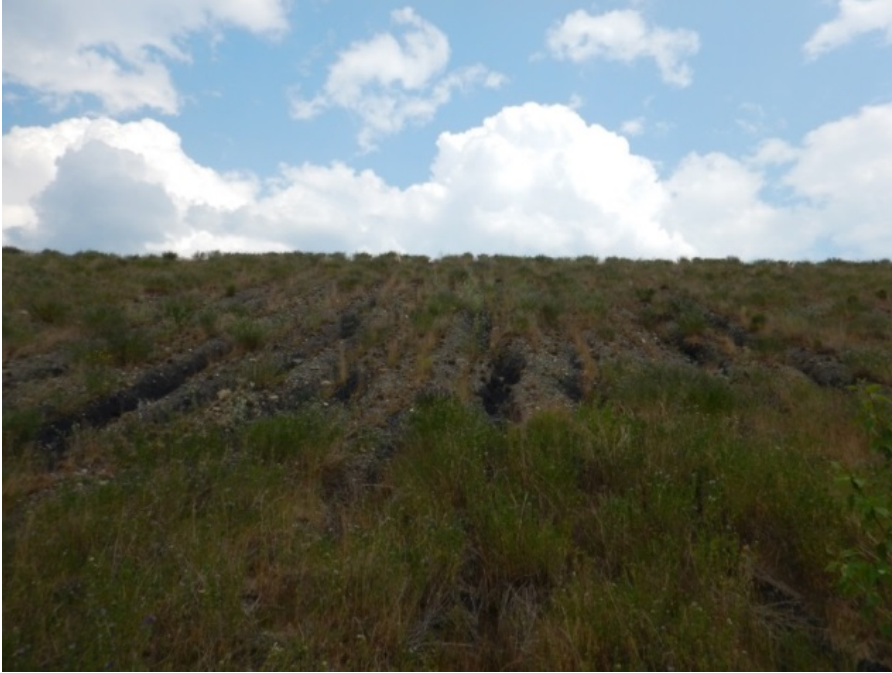
II-1 PS-RILL-01

- **Surface Erosion:** There is significant rilling (erosion gullies) of the downstream slope; refer to discussion in Section 4.2. The rills observed during the DSI do not significantly reduce the structural integrity of the dam and do not extend through the crest towards the impoundment. Recommendations for ongoing monitoring are discussed in Section 4.2.

DSI-PS-05 (2012 – Priority 3)	Downstream slope erosion	n/a	Establish rill monitoring into OMS (DSI-PS-01): photographs of downstream slope from recommended rill monitoring points; and walk crest to confirm rills are not extending through crest.	December, 2014. (proposed rill monitoring should be included in the OMS manual).
DSI-PS-06 (New – Priority 3)	Survey monument monitoring	n/a	Complete minimum 3 survey readings in 2015 after appropriate survey method has been established with appropriate accuracy for this purpose.	(1) before May 30, 2015 (2) 1 month after first 2015 survey. (3) between August and October, 2015
DSI-PS-07 (New – Priority 3)	Monitoring requirements	n/a	Add ID tags to piezometer tips to allow for reliable comparison of future readings.	Prior to July, 2015
DSI-PS-08 (New – Priority 3)	Monitoring requirements	n/a	Establish piezometer threshold values that trigger action or design review. Include these in the OMS document (DS-PS-01).	December, 2015

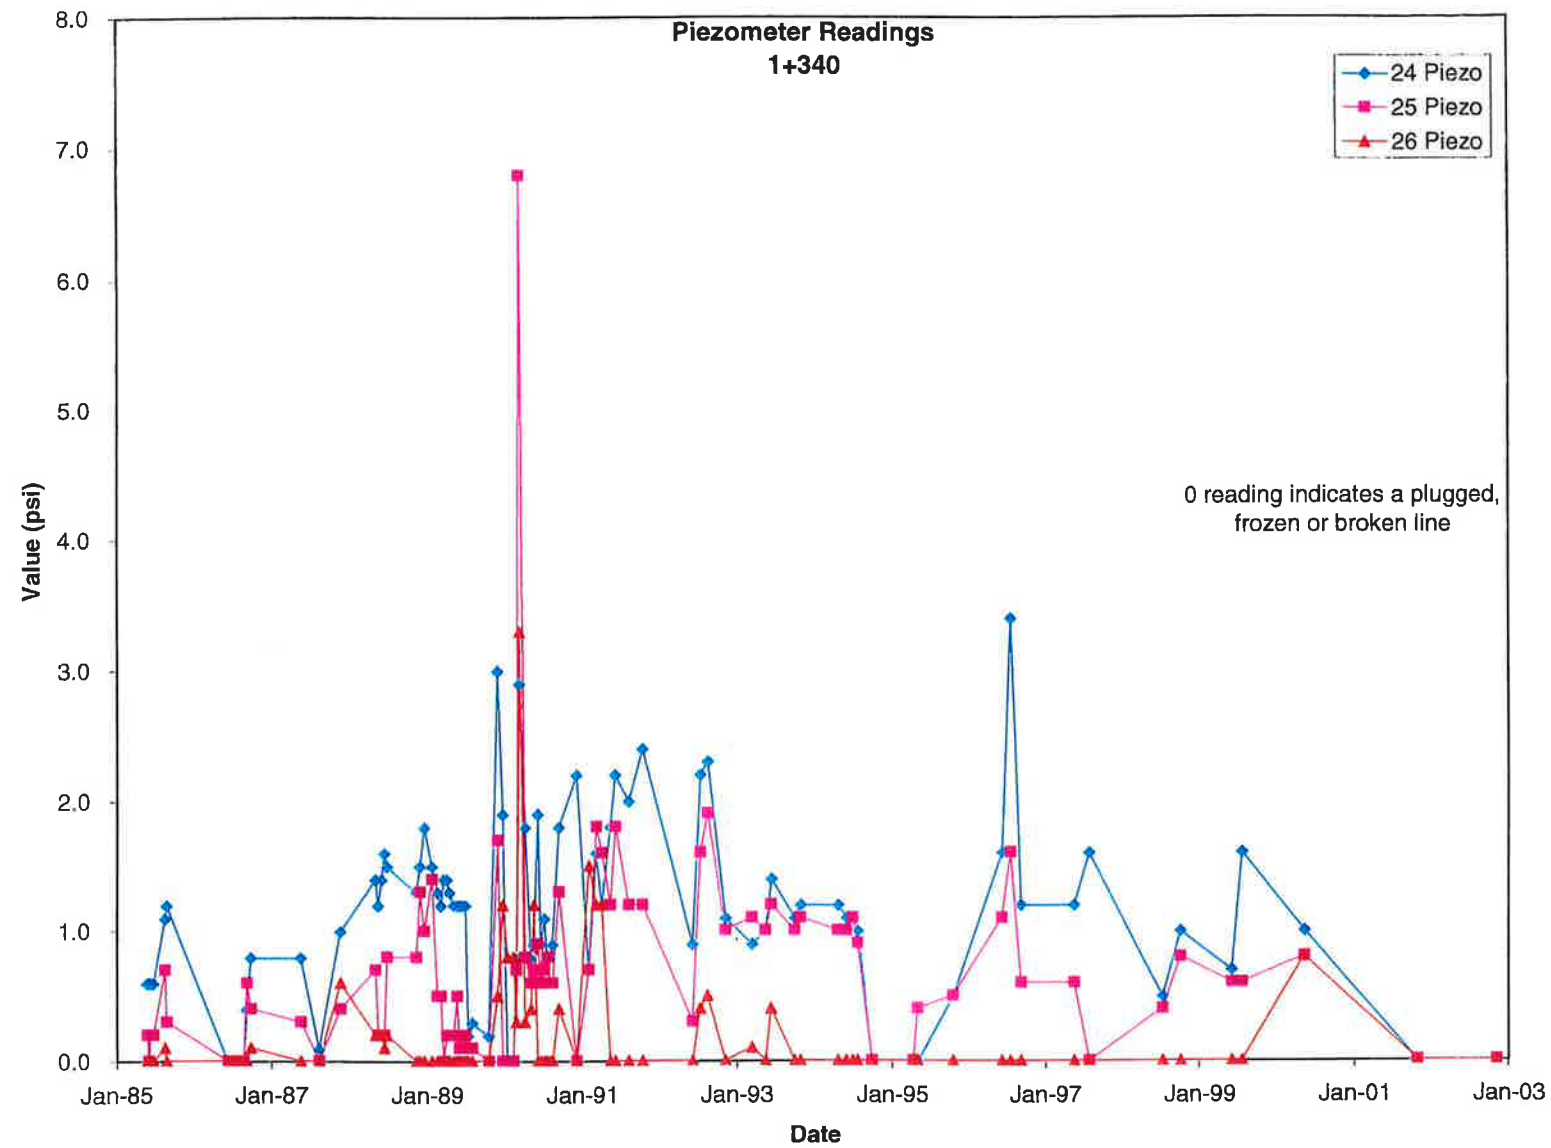
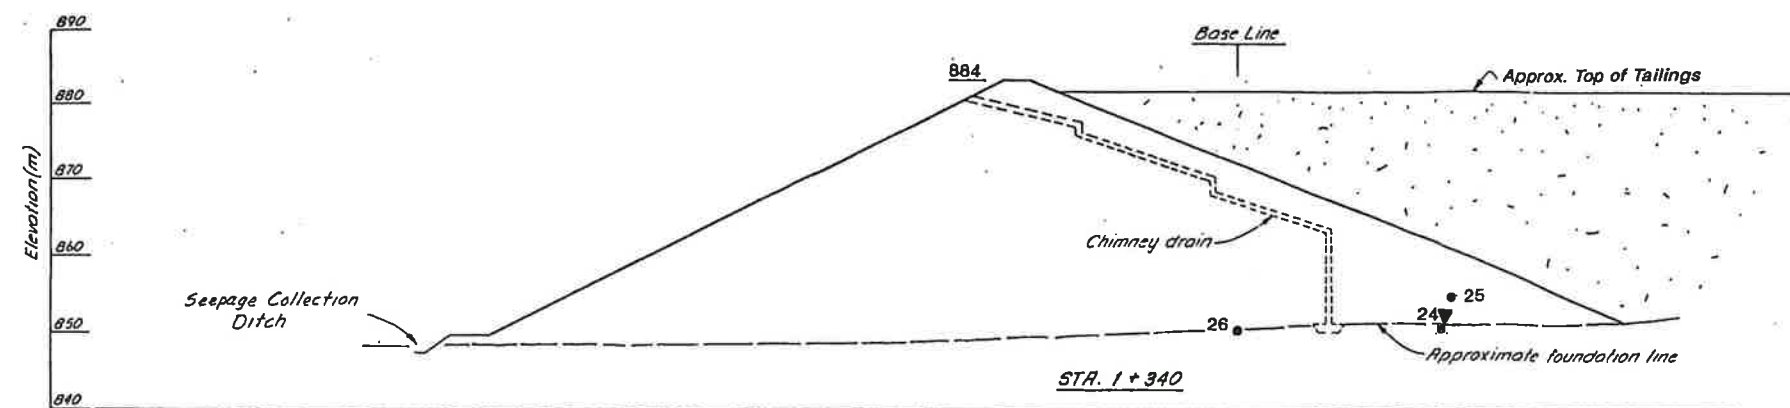
Figure
B-9

Piezometer 26 is located shallow depth below the fill/foundation surface of contact, on the downstream side of the core drain. This piezometer has not been functional for several years.
