## **RED CHRIS DEVELOPMENT COMPANY LTD.**

### **RED CHRIS TAILINGS FACILITY**

## **2014 DAM SAFETY INSPECTION REPORT**

PROJECT NO.: 0866001.14.7  
DATE: November 24, 2014  
DOCUMENT NO.: 0866001.14.002

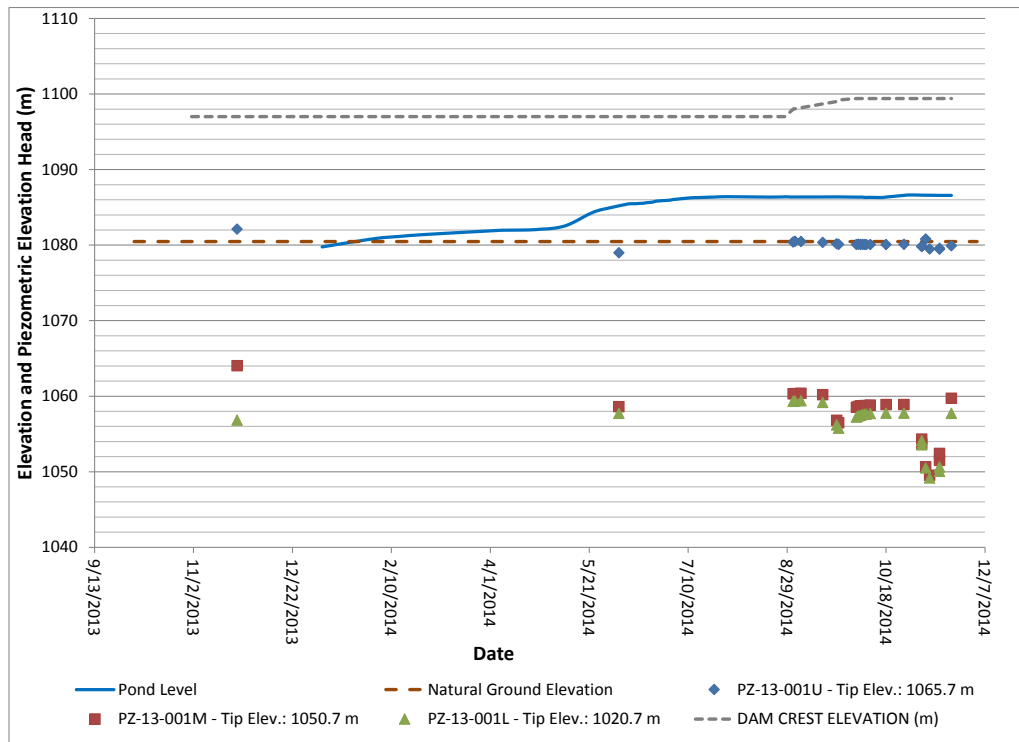
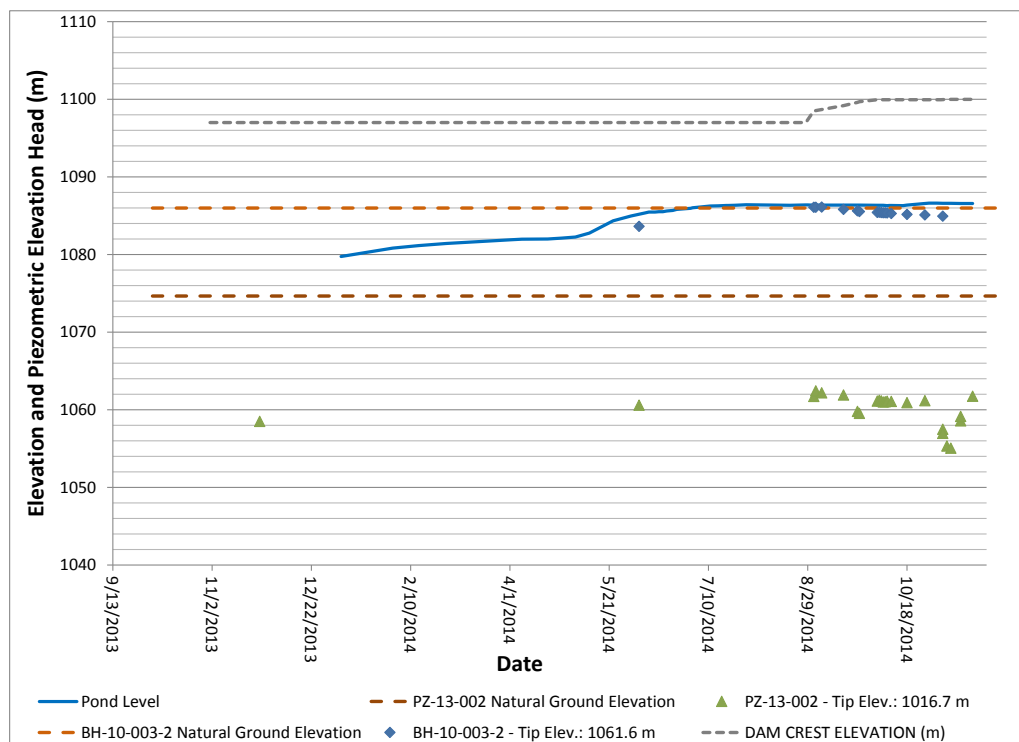
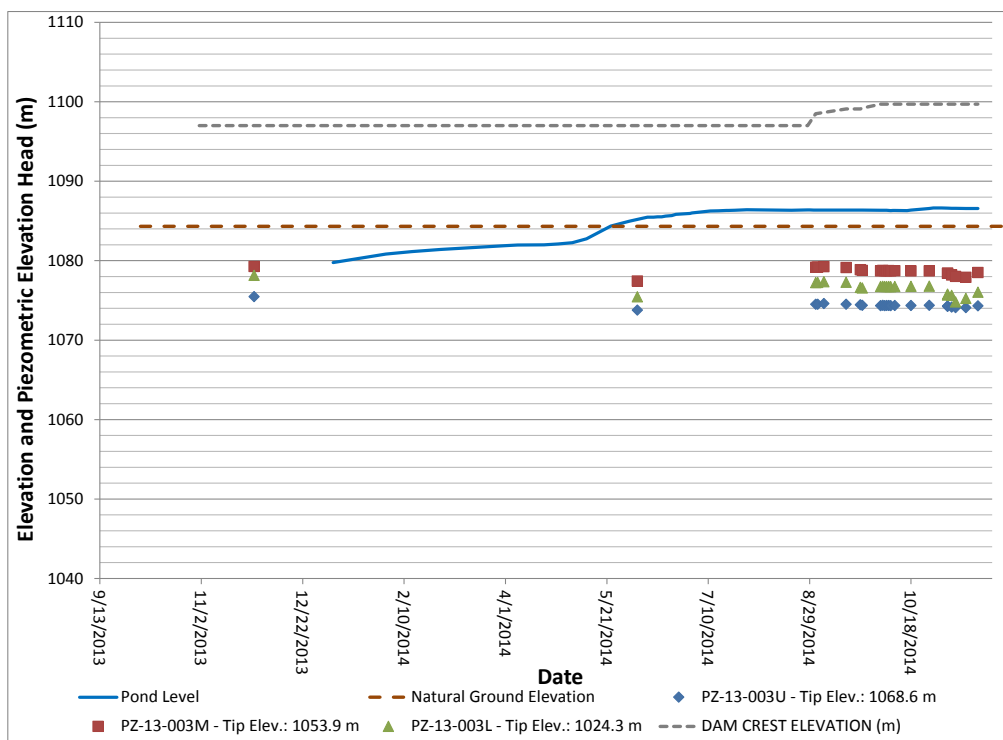
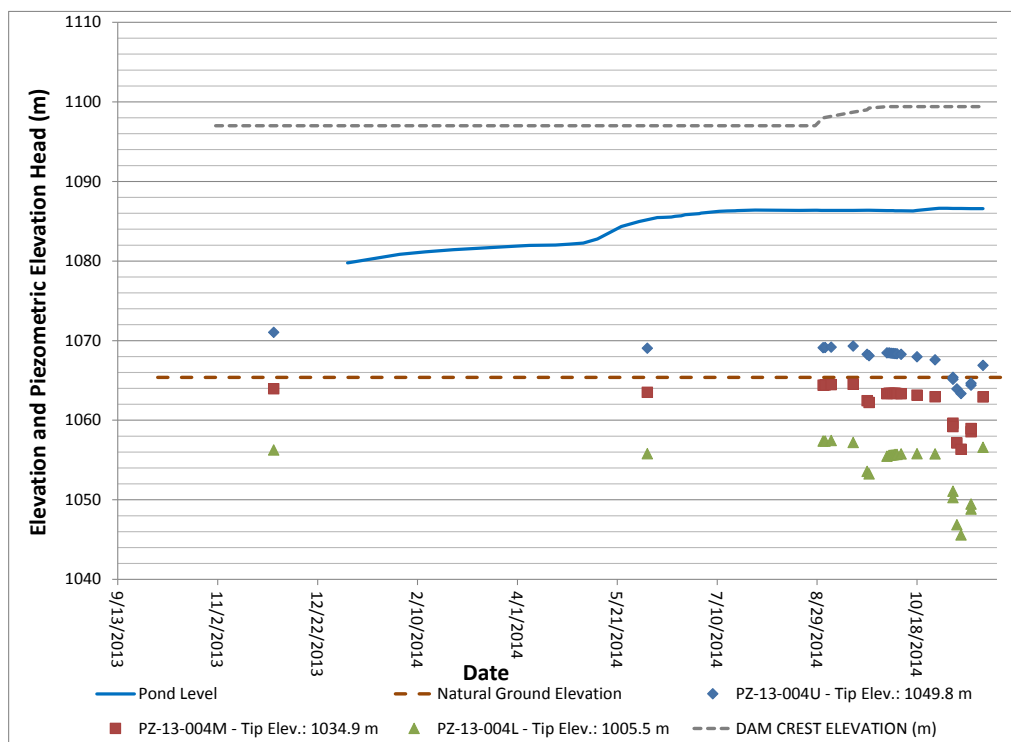
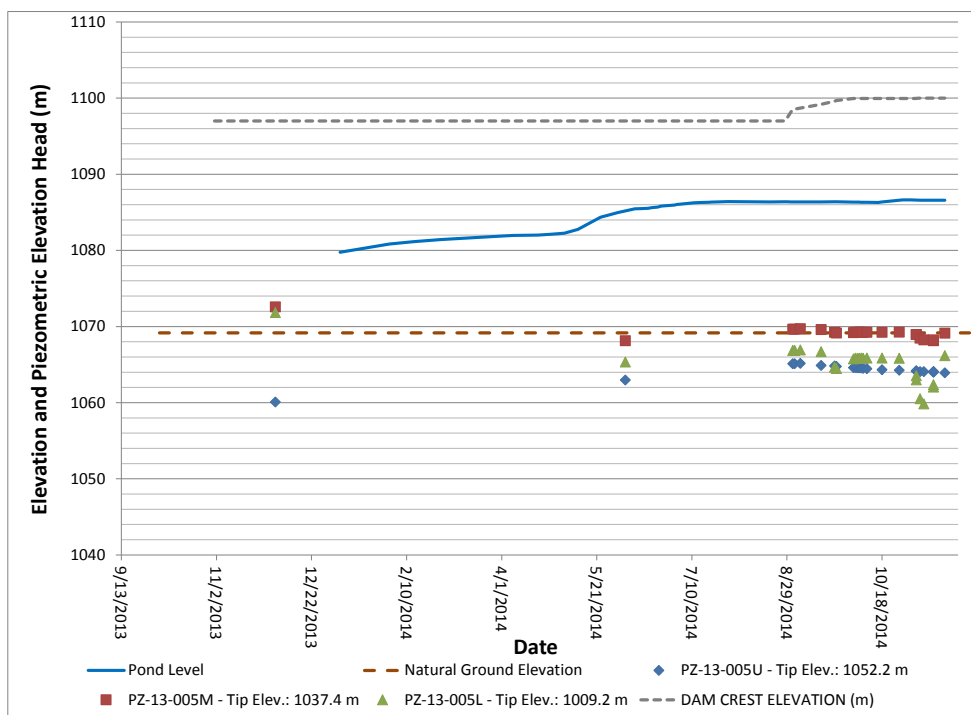
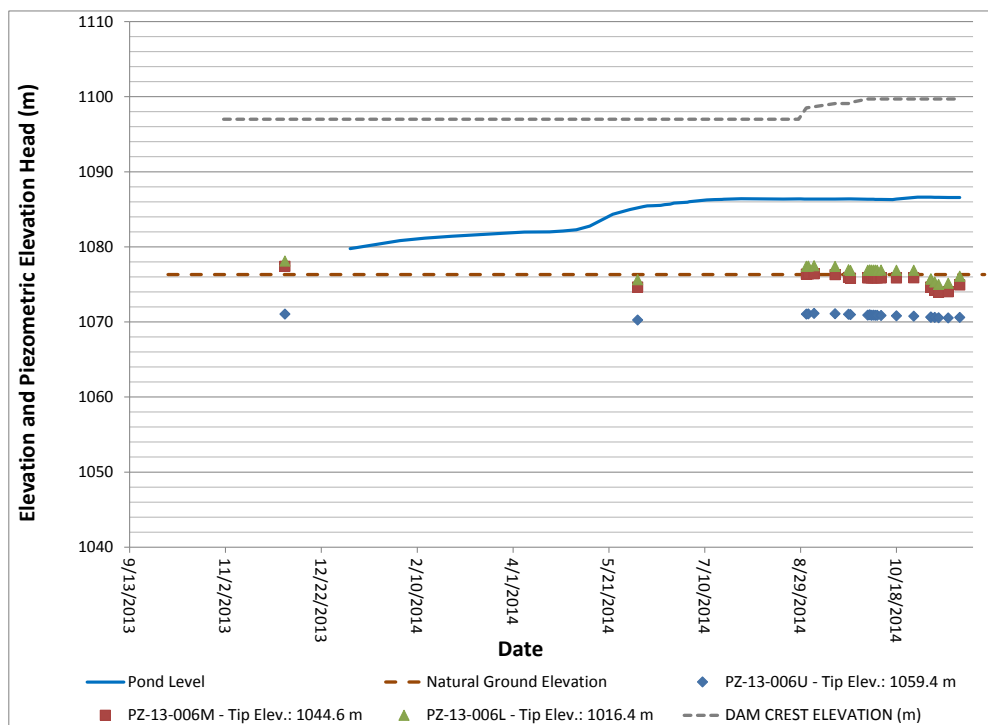
Time history plots for the piezometers are provided in Figure 6-1 through Figure 6-6. These plots also include the North Starter Dam reservoir level, the North Starter Dam crest elevation, and the elevation of original natural ground (i.e. foundation level for the dam) at the piezometers location.

A number of the piezometers, generally those at depth, showed a marked response to pumping from groundwater well 11-NPW2, located downstream of the NRD (see Drawing 03), from November 1 to November 13.

It will be important to read the piezometers at least bi-weekly going forward, so that seasonal effects can be discerned and distinguished from response to the reservoir level and changes once tailings discharge commences.

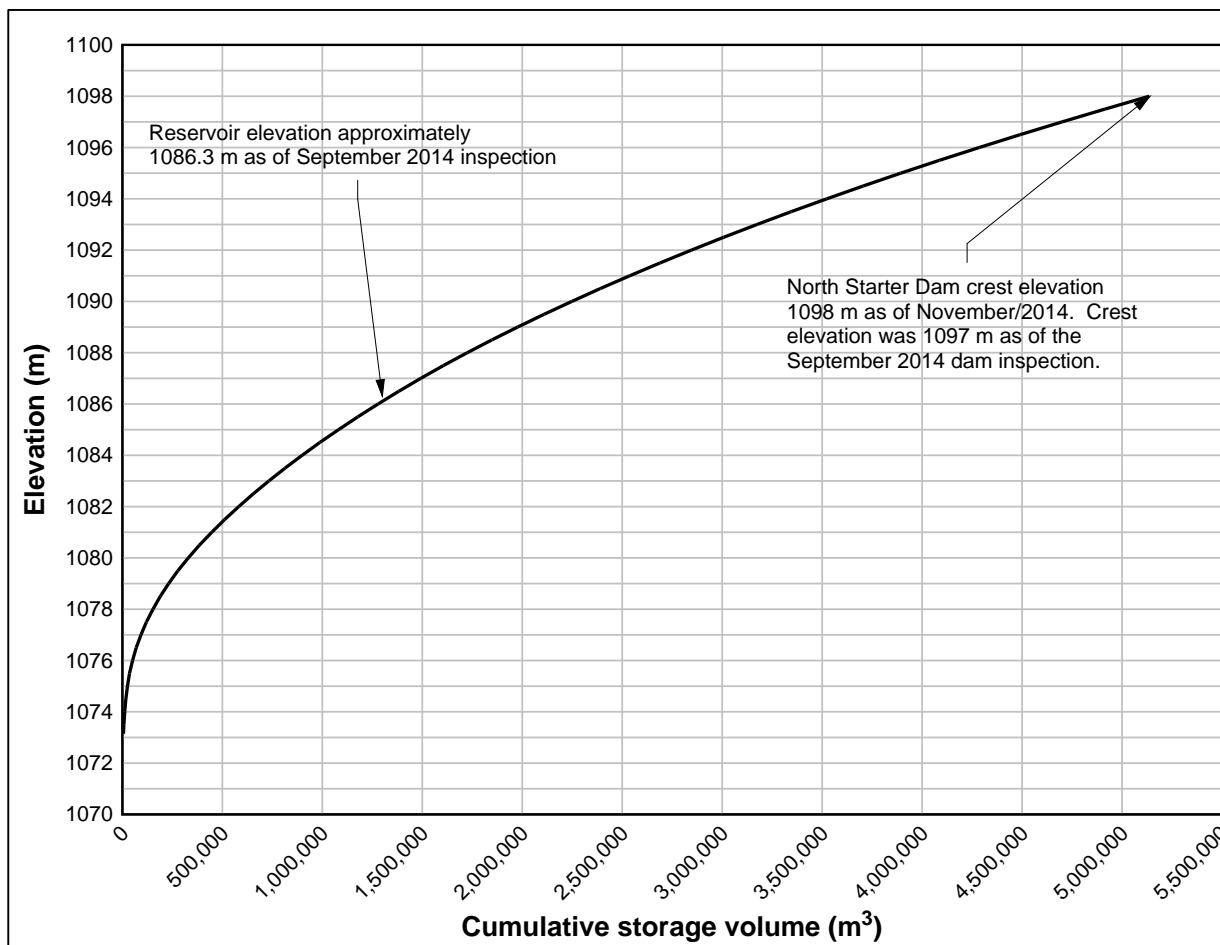
**Figure 8-1. Storage-elevation curve for the North Starter Dam reservoir.**

The storage-elevation curve for the North Starter Dam, to crest El. 1097, is shown in Figure 8-1. Between the crest elevation and September 2014 pond level of 1086.3 m, the reservoir had 3.75 Mm<sup>3</sup> of storage capacity.

For a pond elevation of 1086.3 m as shown above on Figure 8-1, and with no spillway, the North Starter Dam reservoir has the capacity to contain a 24-hour duration Probable Maximum Flood (PMF) with more than 2 m of freeboard, but insufficient capacity to accommodate the 10-day duration PMF.

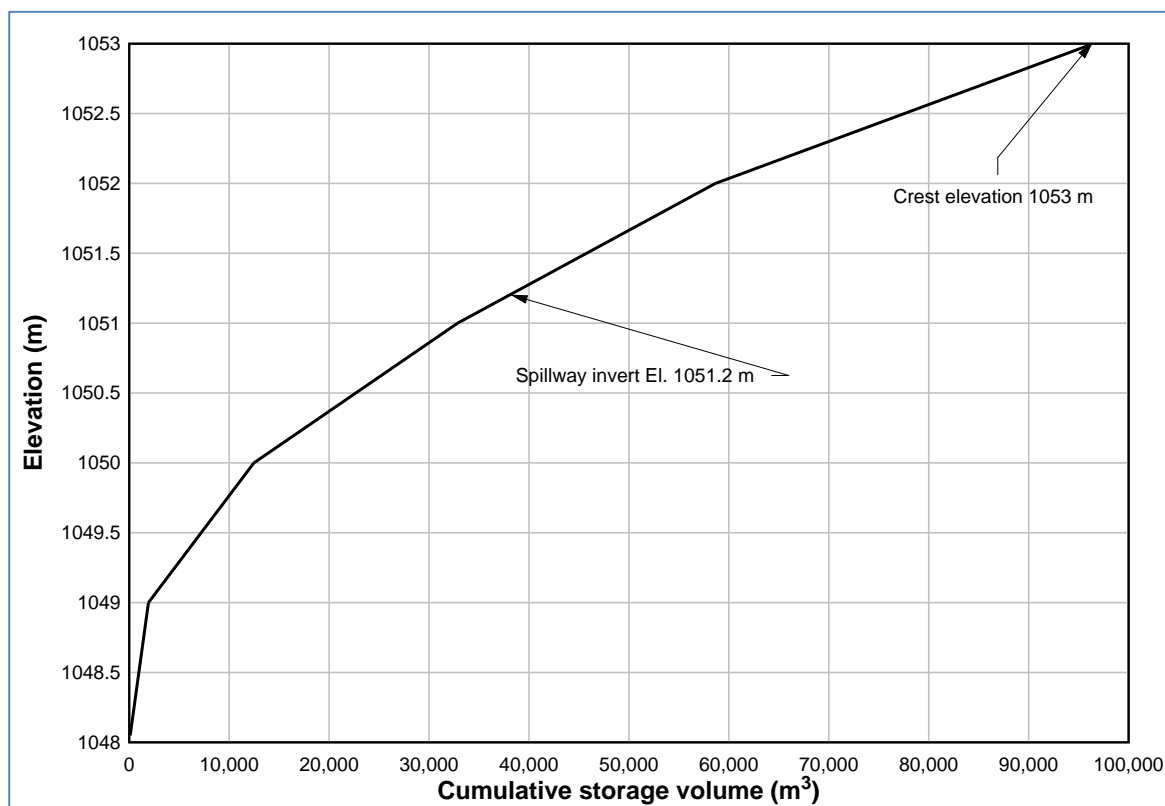
**Figure 8-2. Storage-elevation curve for the North Reclaim Dam reservoir.**

The storage-elevation curve for the North Reclaim Dam reservoir is given in Figure 8-2.

Per AMEC (2011), the North Reclaim Dam and its spillway are designed to accommodate an IDF comprising the 1 in 200-year return period 24-hour duration rainfall event, with minimum freeboard of 0.5 m above the peak routed pond level.

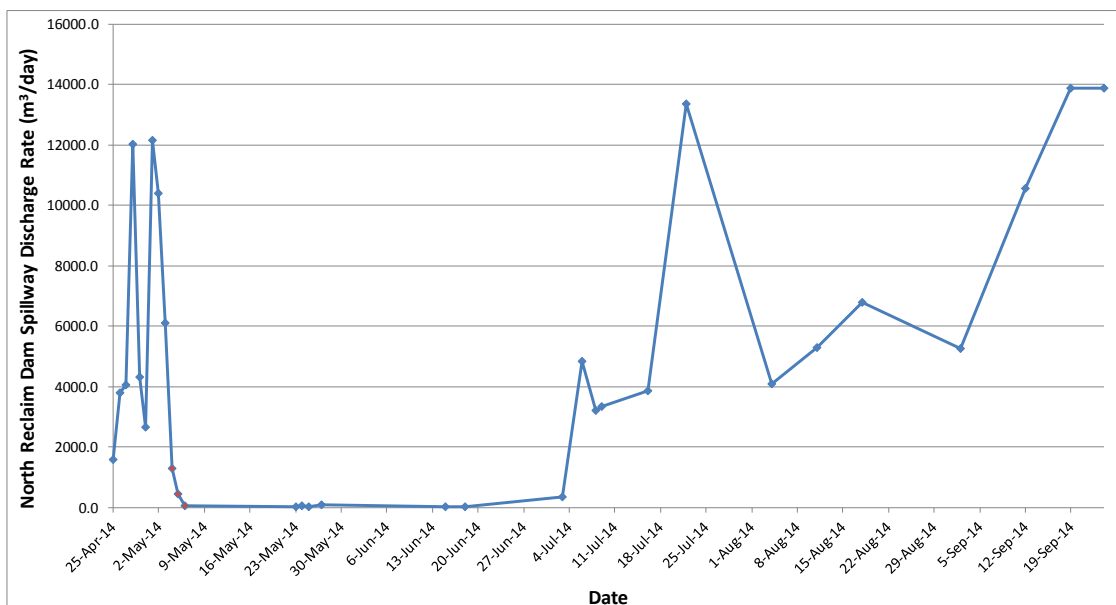
**Figure 9-1. Discharge data for the North Reclaim Dam spillway.**

Flow rates from the North Reclaim Dam spillway are measured by RCDC as part of their monitoring program. Figure 9-1 provides the discharge data gathered by RCDC. The period of zero to near-zero flows represents the period during which pumpback from the North Reclaim Dam reservoir occurred at a rate sufficient to keep up with inflows. The peak in July may be because inflows, largely dominated by natural groundwater discharge as discussed in Section 6.4, increased in a lagged response to increased groundwater recharge during the freshet period.

The depth of flow in the North Reclaim Dam spillway has remained well below the requisite freeboard (0.5 m) level.

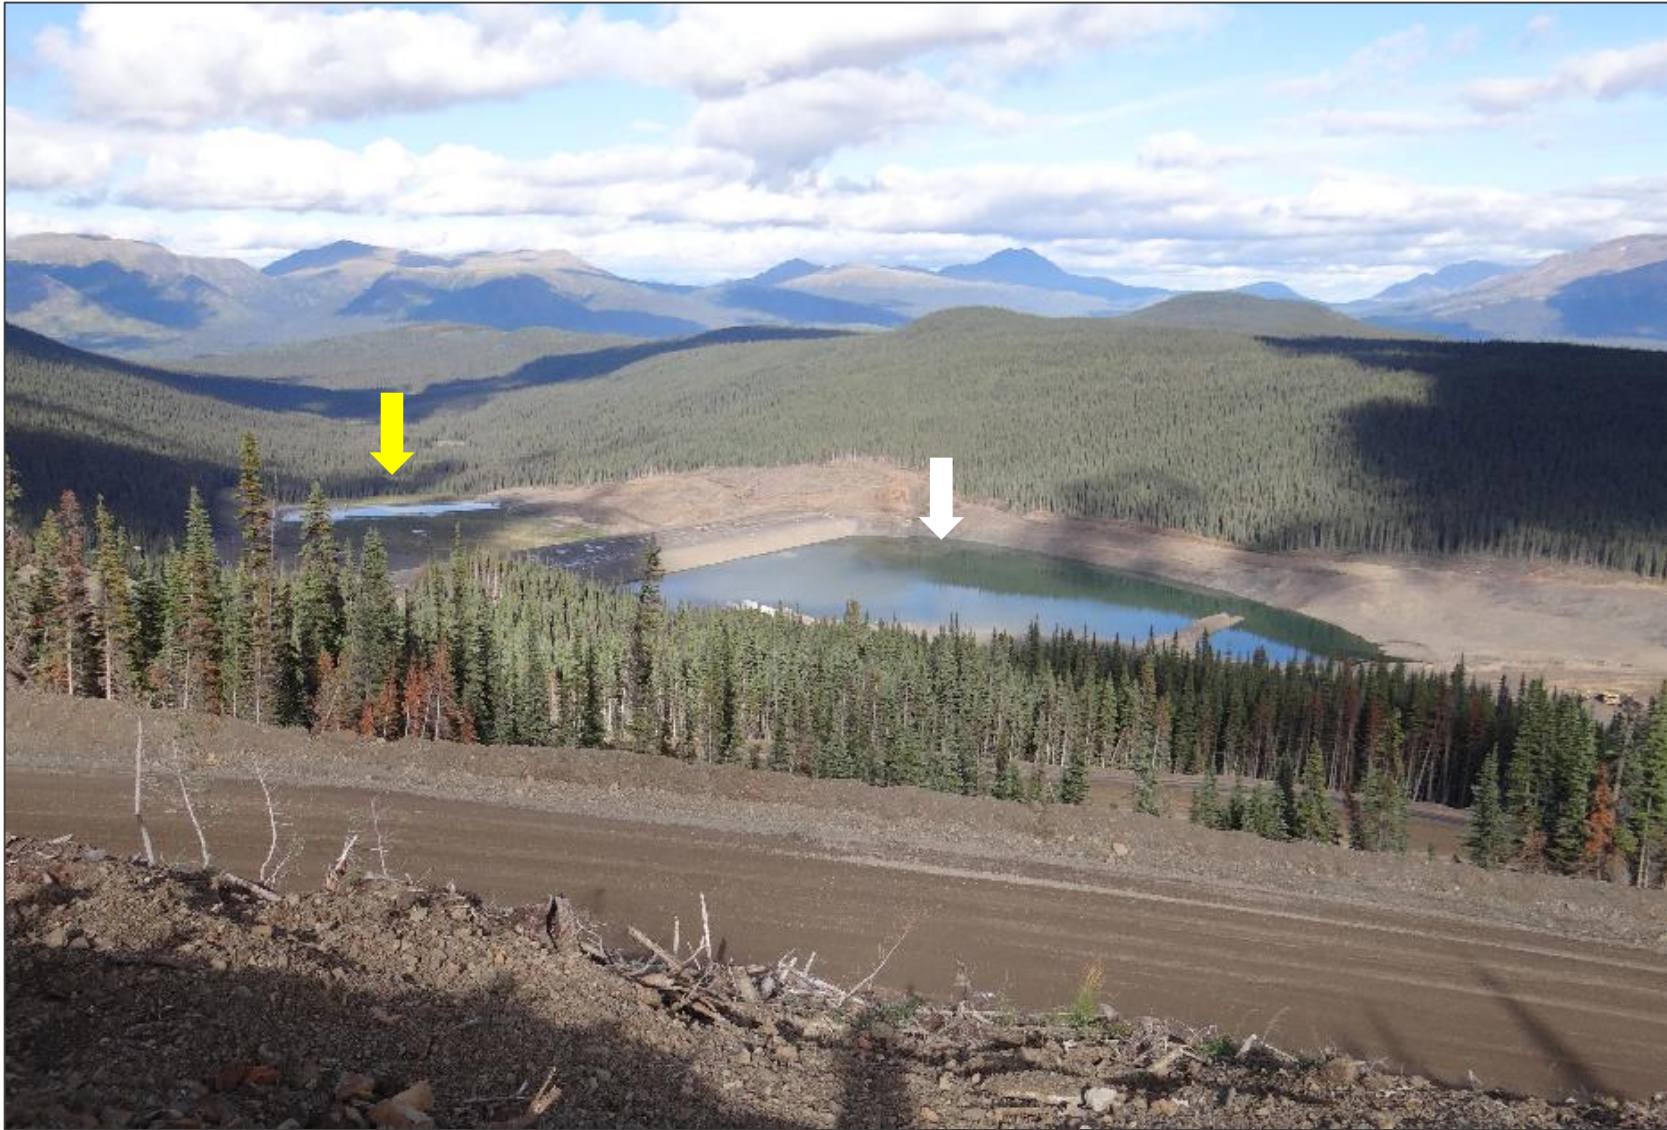
PHOTO 1

View of the NSD reservoir (white arrow) and the NRD reservoir (yellow arrow) from the Red Chris TSF access road.

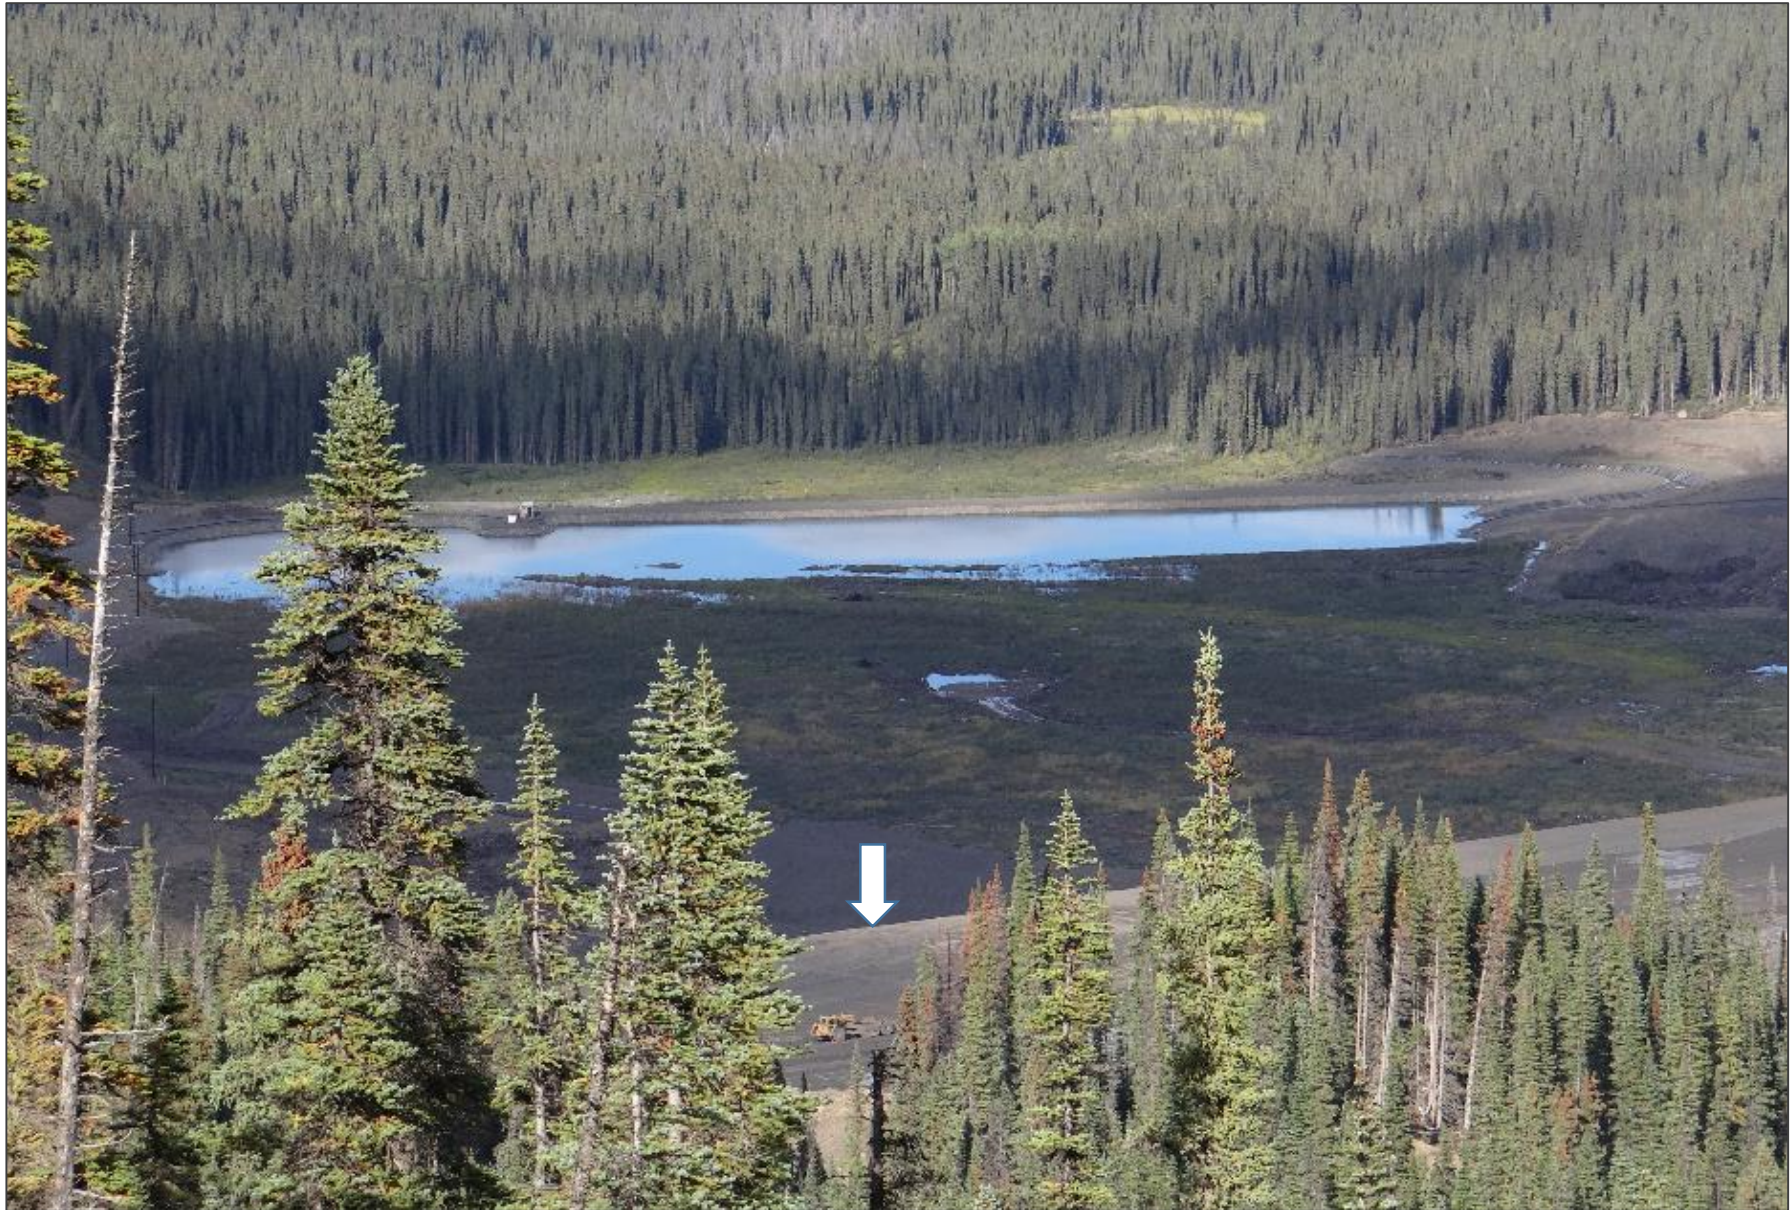
PHOTO 3

Looking north to the NRD and the NRD reservoir. NSD crest in the foreground (white arrow).

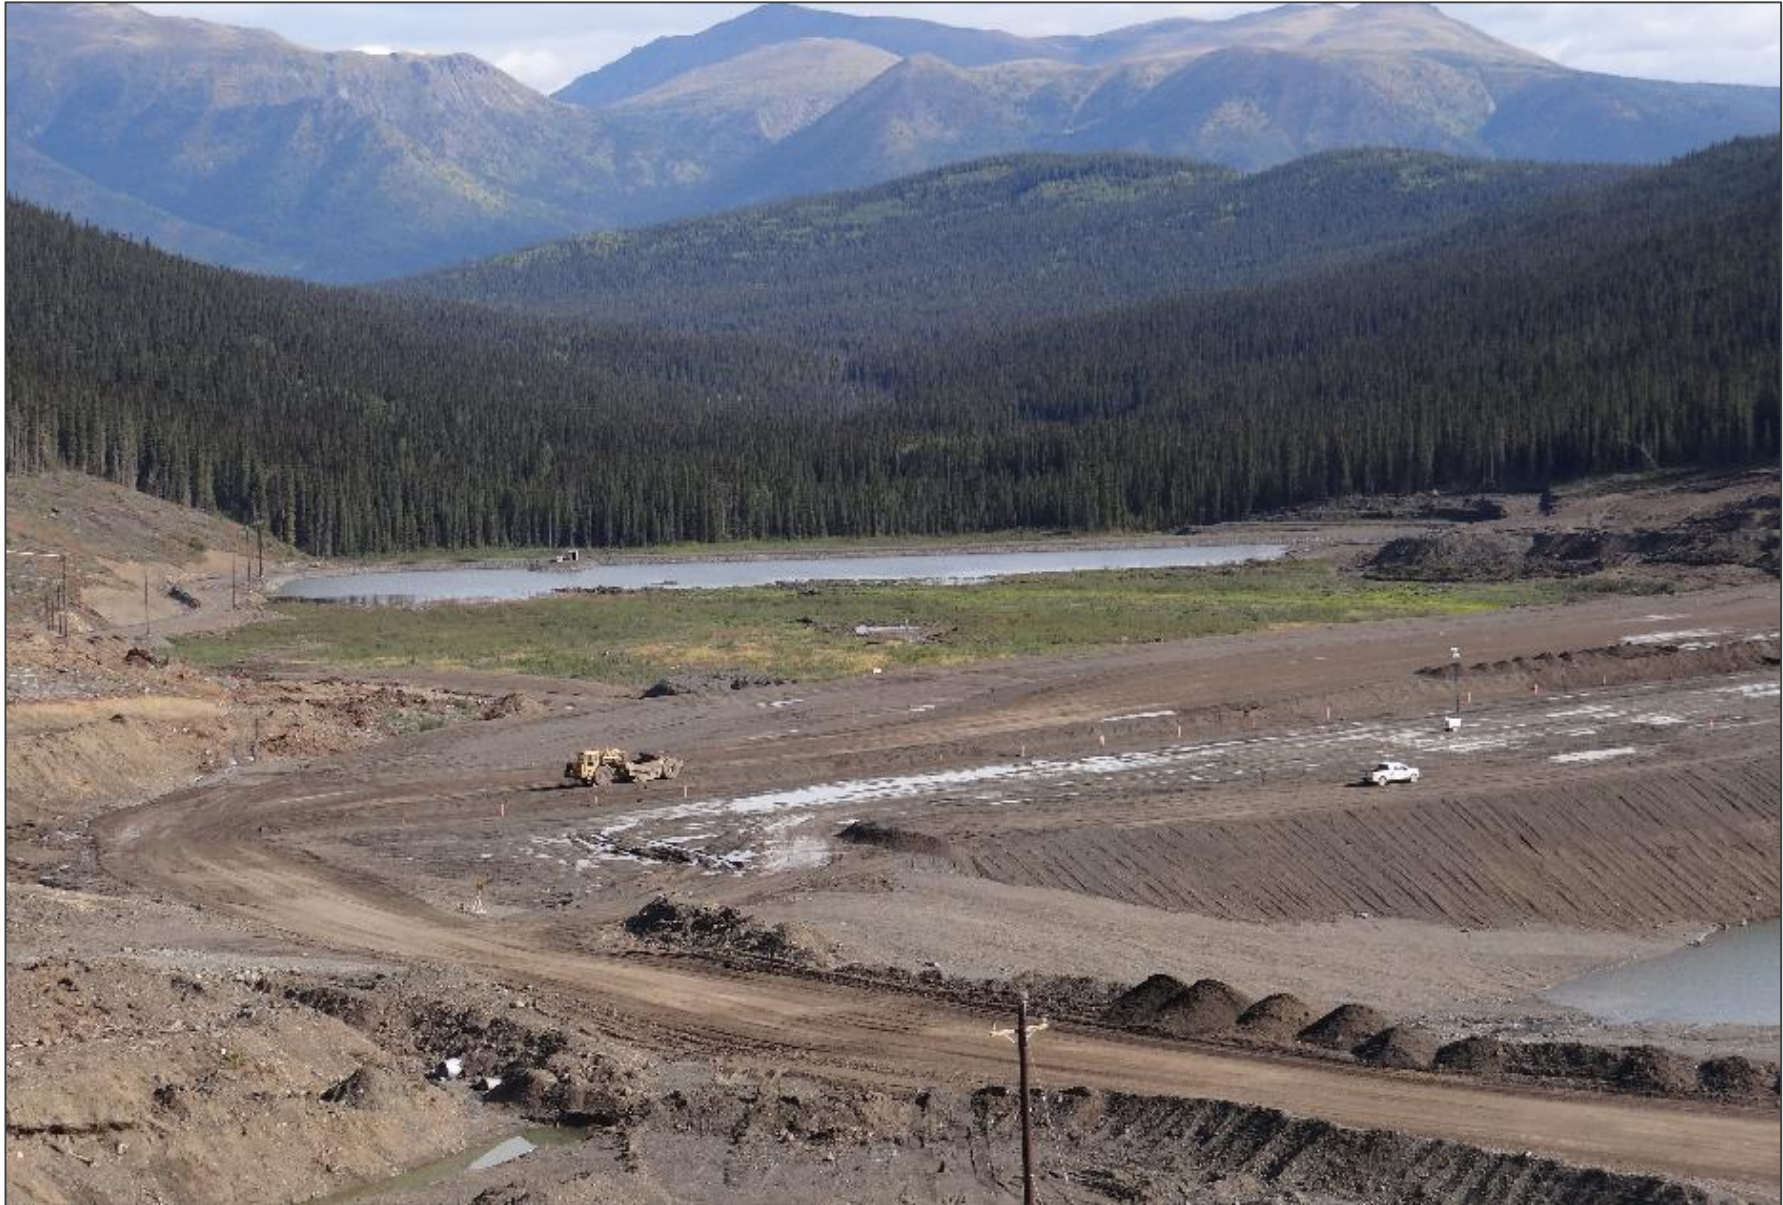
PHOTO 4

Left abutment of the NSD, looking north (towards the NRD). Construction in progress on the NSD at time of inspection visit.

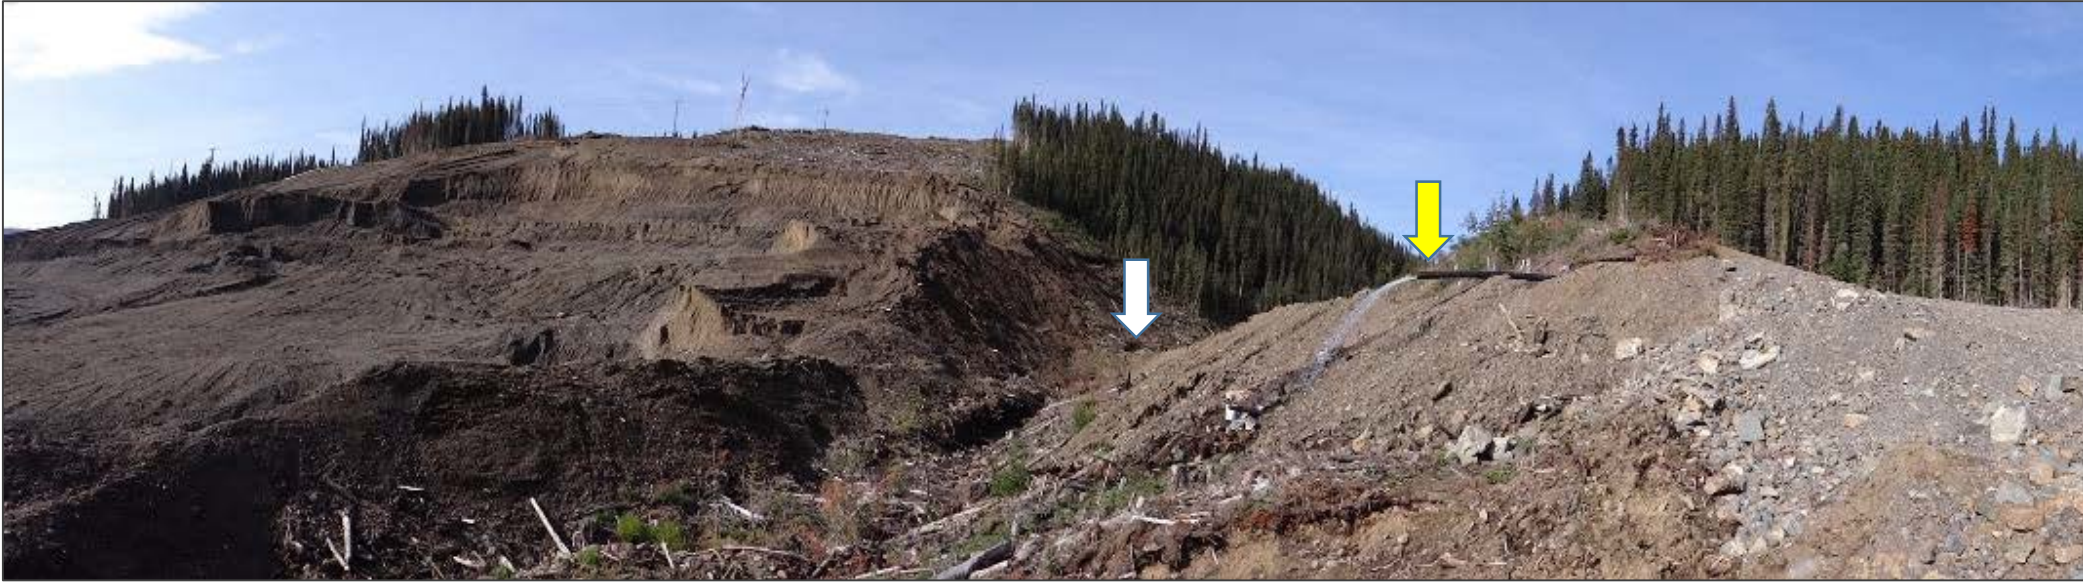
PHOTO 5

- Seepage discharge from the North Starter Dam toe (discussed in Section 6.4)
- Inflows to the North Reclaim Dam reservoir (could be measured via weir, see Photos 33 and 34 in Appendix A)
- Inflows to the North Starter Dam reservoir from Beaver Creek (see Photo 6 in Appendix A) and any other significant inflow streams
- Pumpback flows from the North Reclaim Dam reservoir to the North Starter Dam reservoir (see Photo 5 in Appendix A).

Looking to west side of valley, with Beaver Creek gully (white arrow). Yellow arrow indicates pipeline discharge with pumpback water from the NRD reservoir.

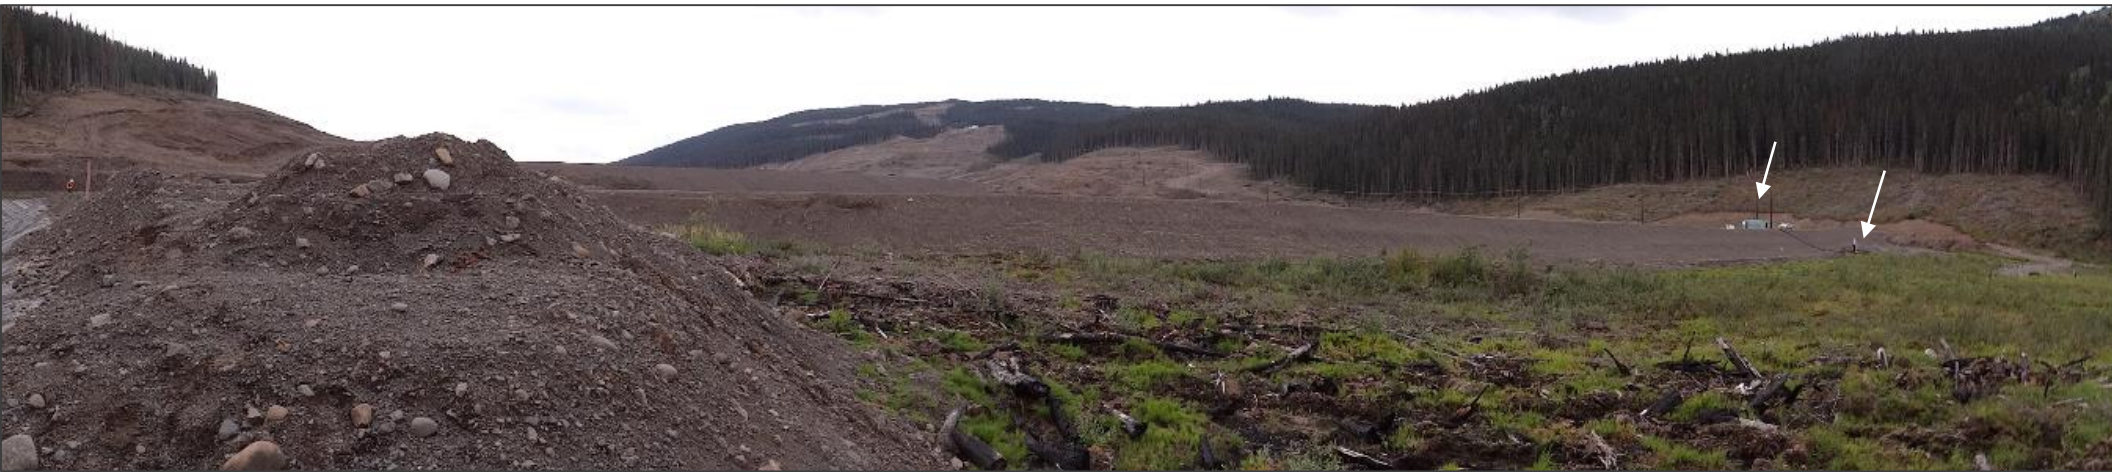
**PHOTO 8**

**Panorama showing the downstream face of the NRD. Artesian well and the pumphouse indicated by the arrows.**

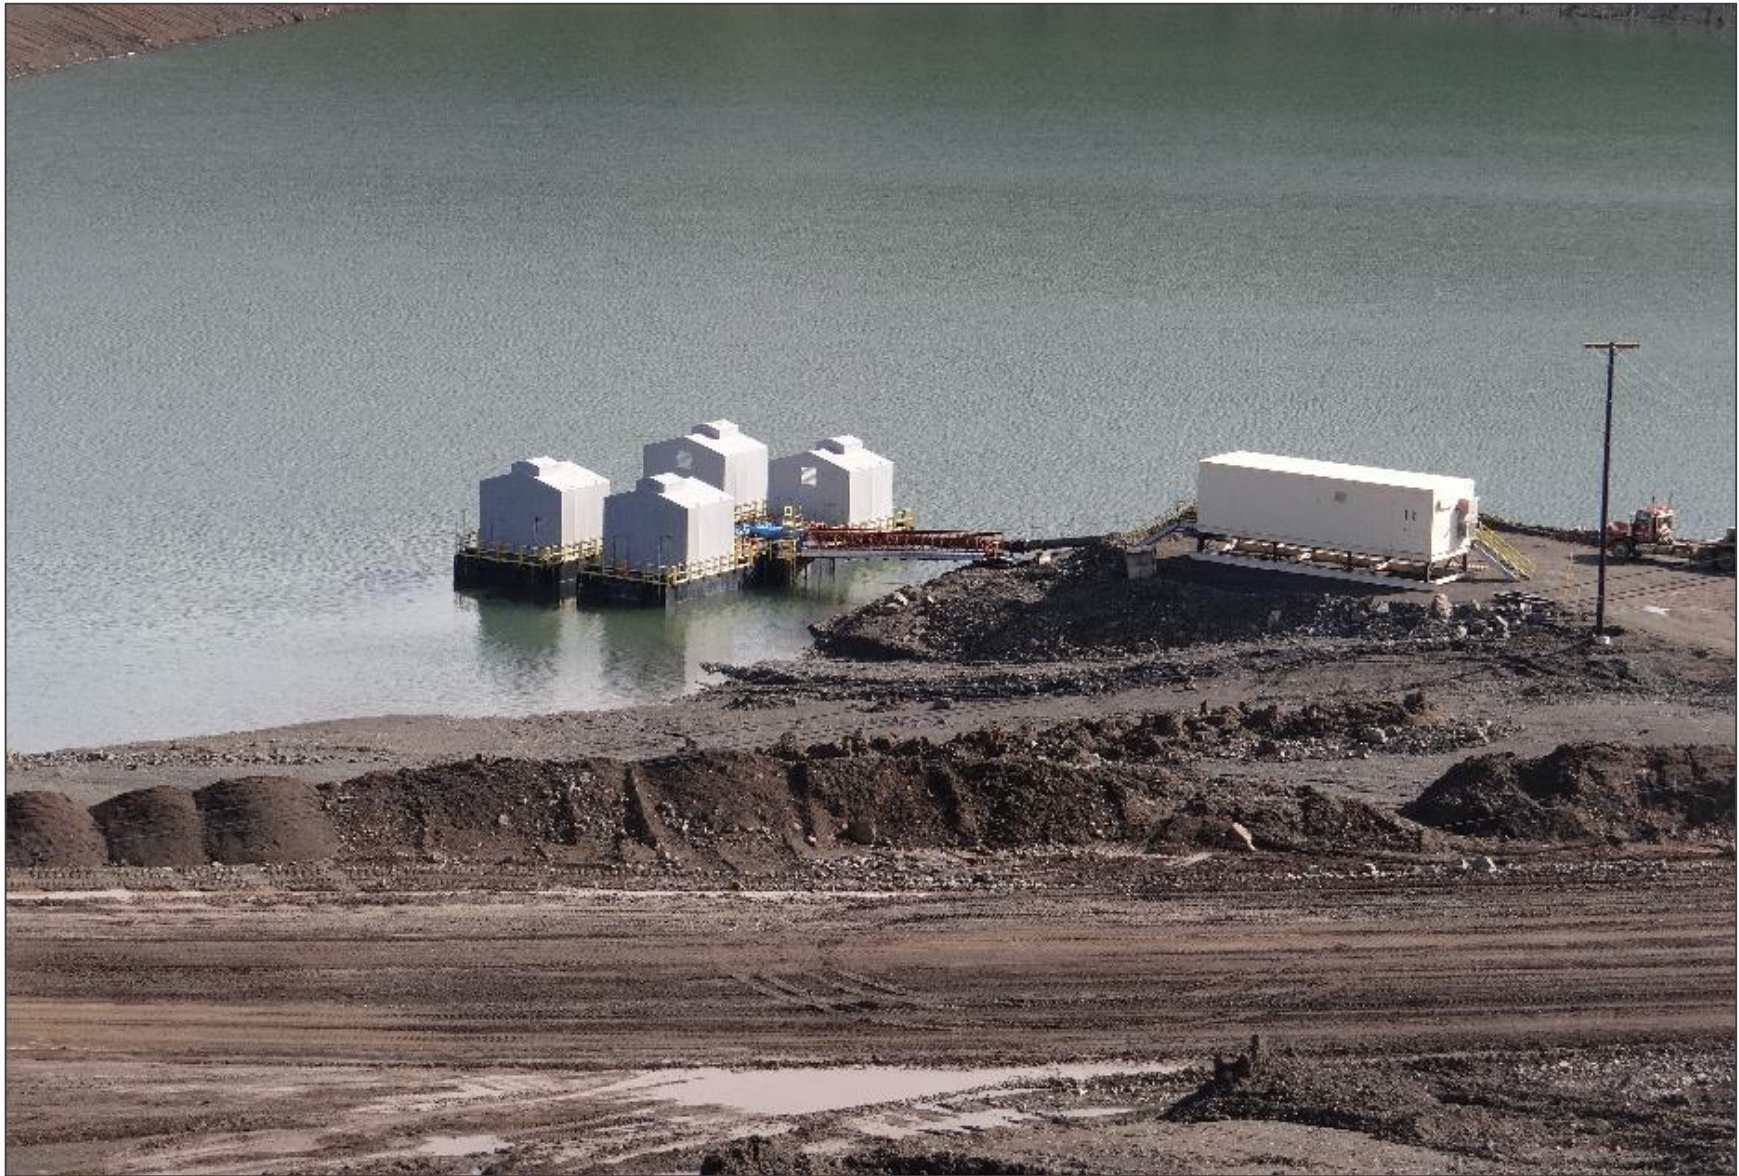
PHOTO 9

NSD reclaim and surplus water discharge pump barges. Not in operation at the time of the dam inspection.

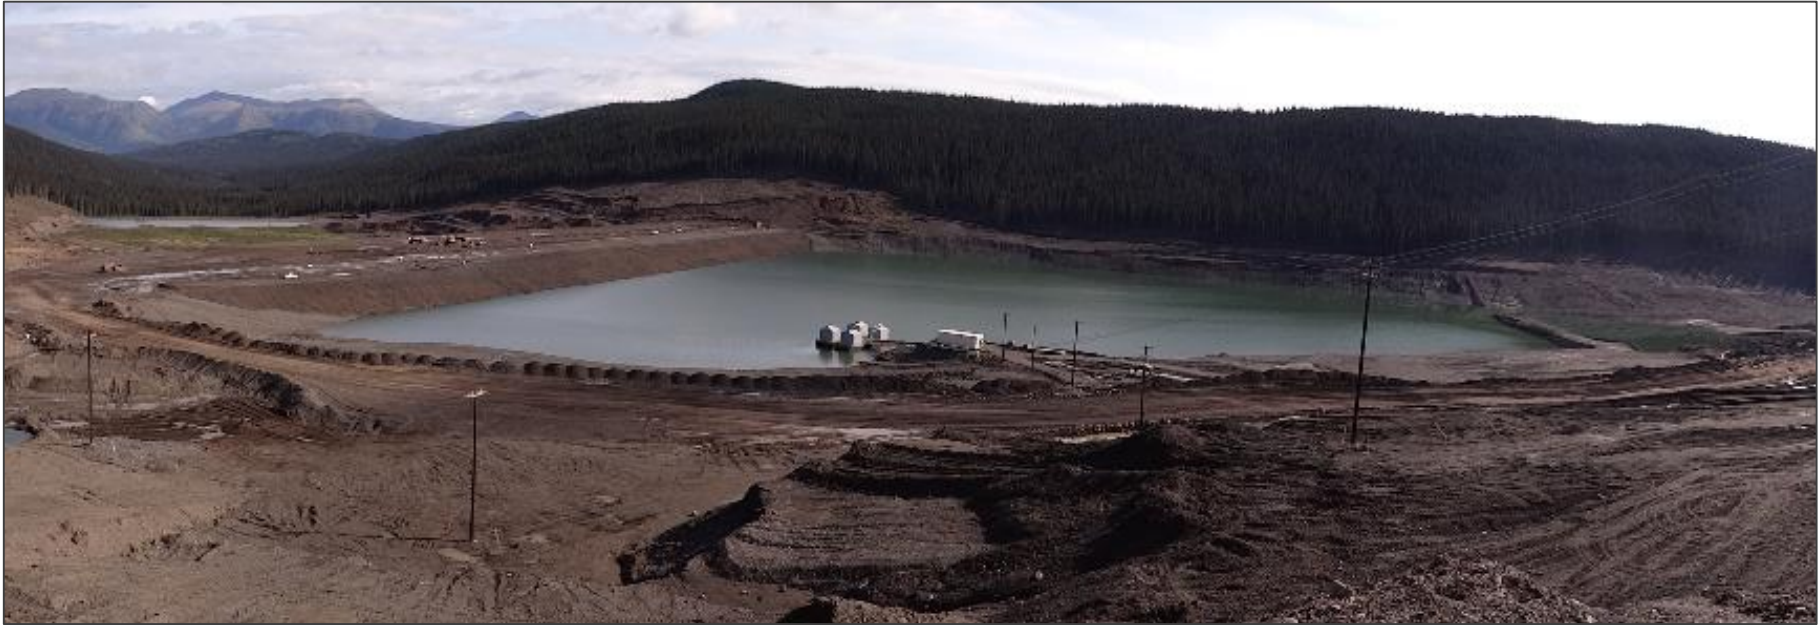
**PHOTO 10**

**Panorama of the NSD reservoir, reclaim/discharge water barges in the center. Reservoir elevation approximately 1086.3 m at the time of the site inspection visit. Looking towards the east side of the valley.**

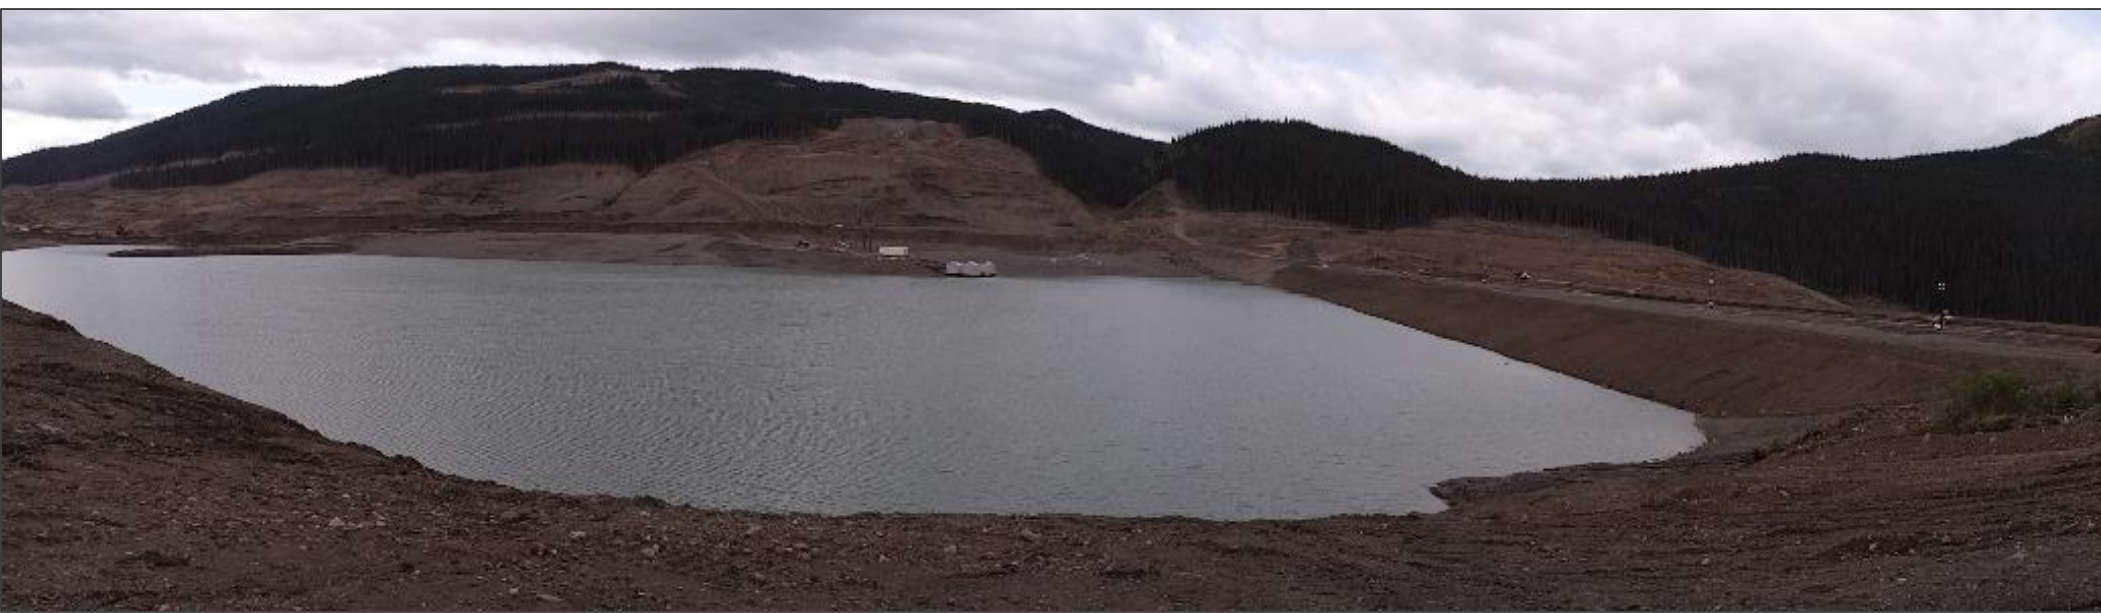
**PHOTO 11**

**Panorama of the NSD reservoir, looking towards the west side of the valley. NSD to the right, reclaim/discharge water barges in the center. Reservoir elevation approximately 1086.3 m at the time of the site inspection visit.**

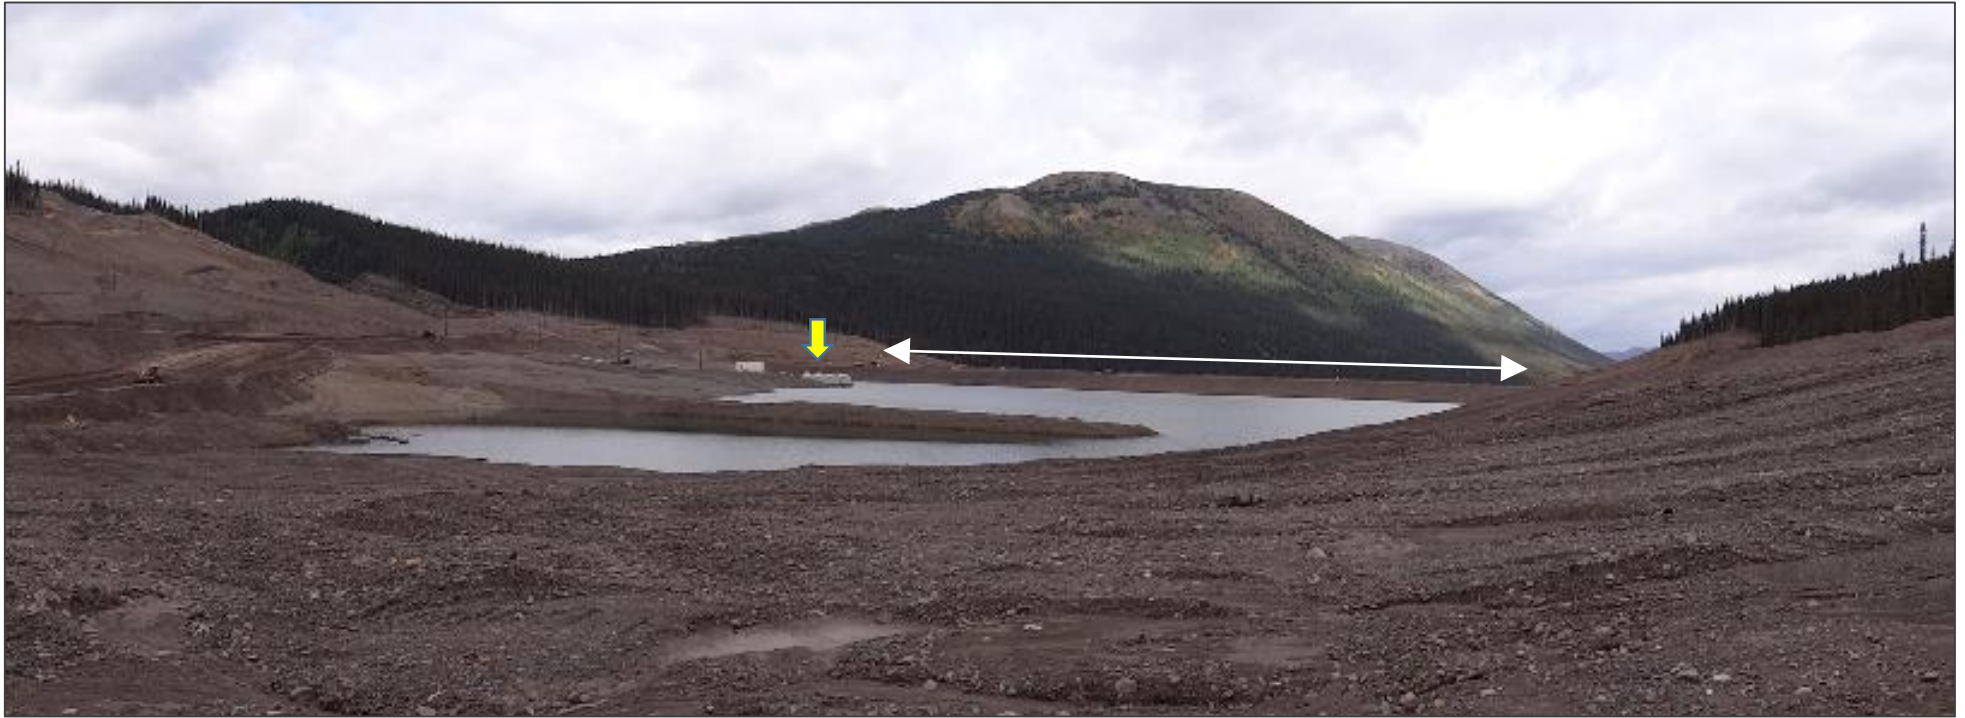
**PHOTO 12**

**NSD reservoir, looking north-northwest. NSD indicated by the white arrow, reclaim/discharge water barges by the yellow arrow. Reservoir elevation approximately 1086.3 m at the time of the site inspection visit.**
