## **RED CHRIS DEVELOPMENT COMPANY LTD.**

### **RED CHRIS TAILINGS FACILITY**

## **2014 DAM SAFETY INSPECTION REPORT**

PROJECT NO.: 0866001.14.7  
DATE: November 24, 2014  
DOCUMENT NO.: 0866001.14.002

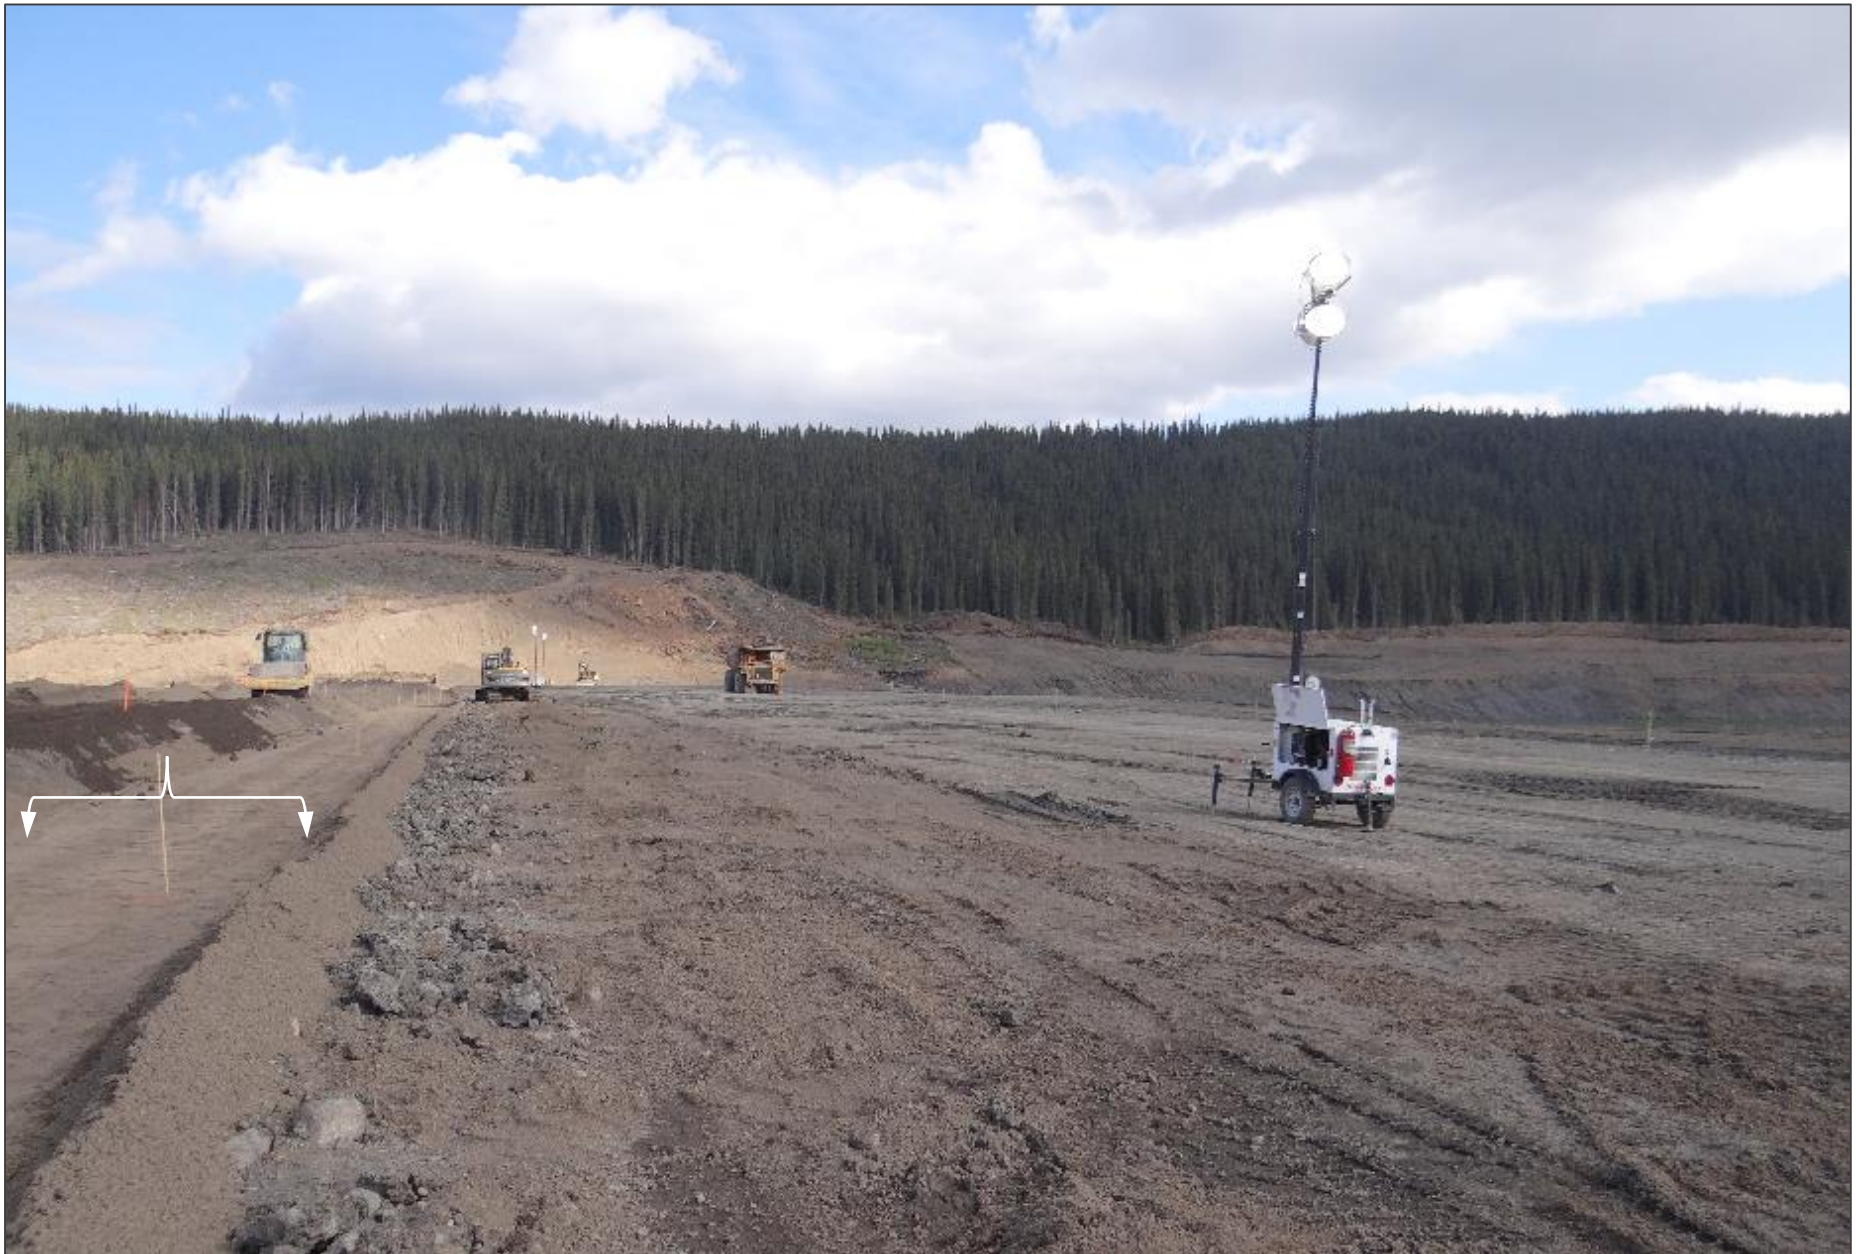
**PHOTO 13**

**Crest of the NSD. Smooth drum vibratory roller working on Zone 3 b chimney. Bracket indicates Zone 3A chimney filter. Light plant situated on Zone 1 till core.**

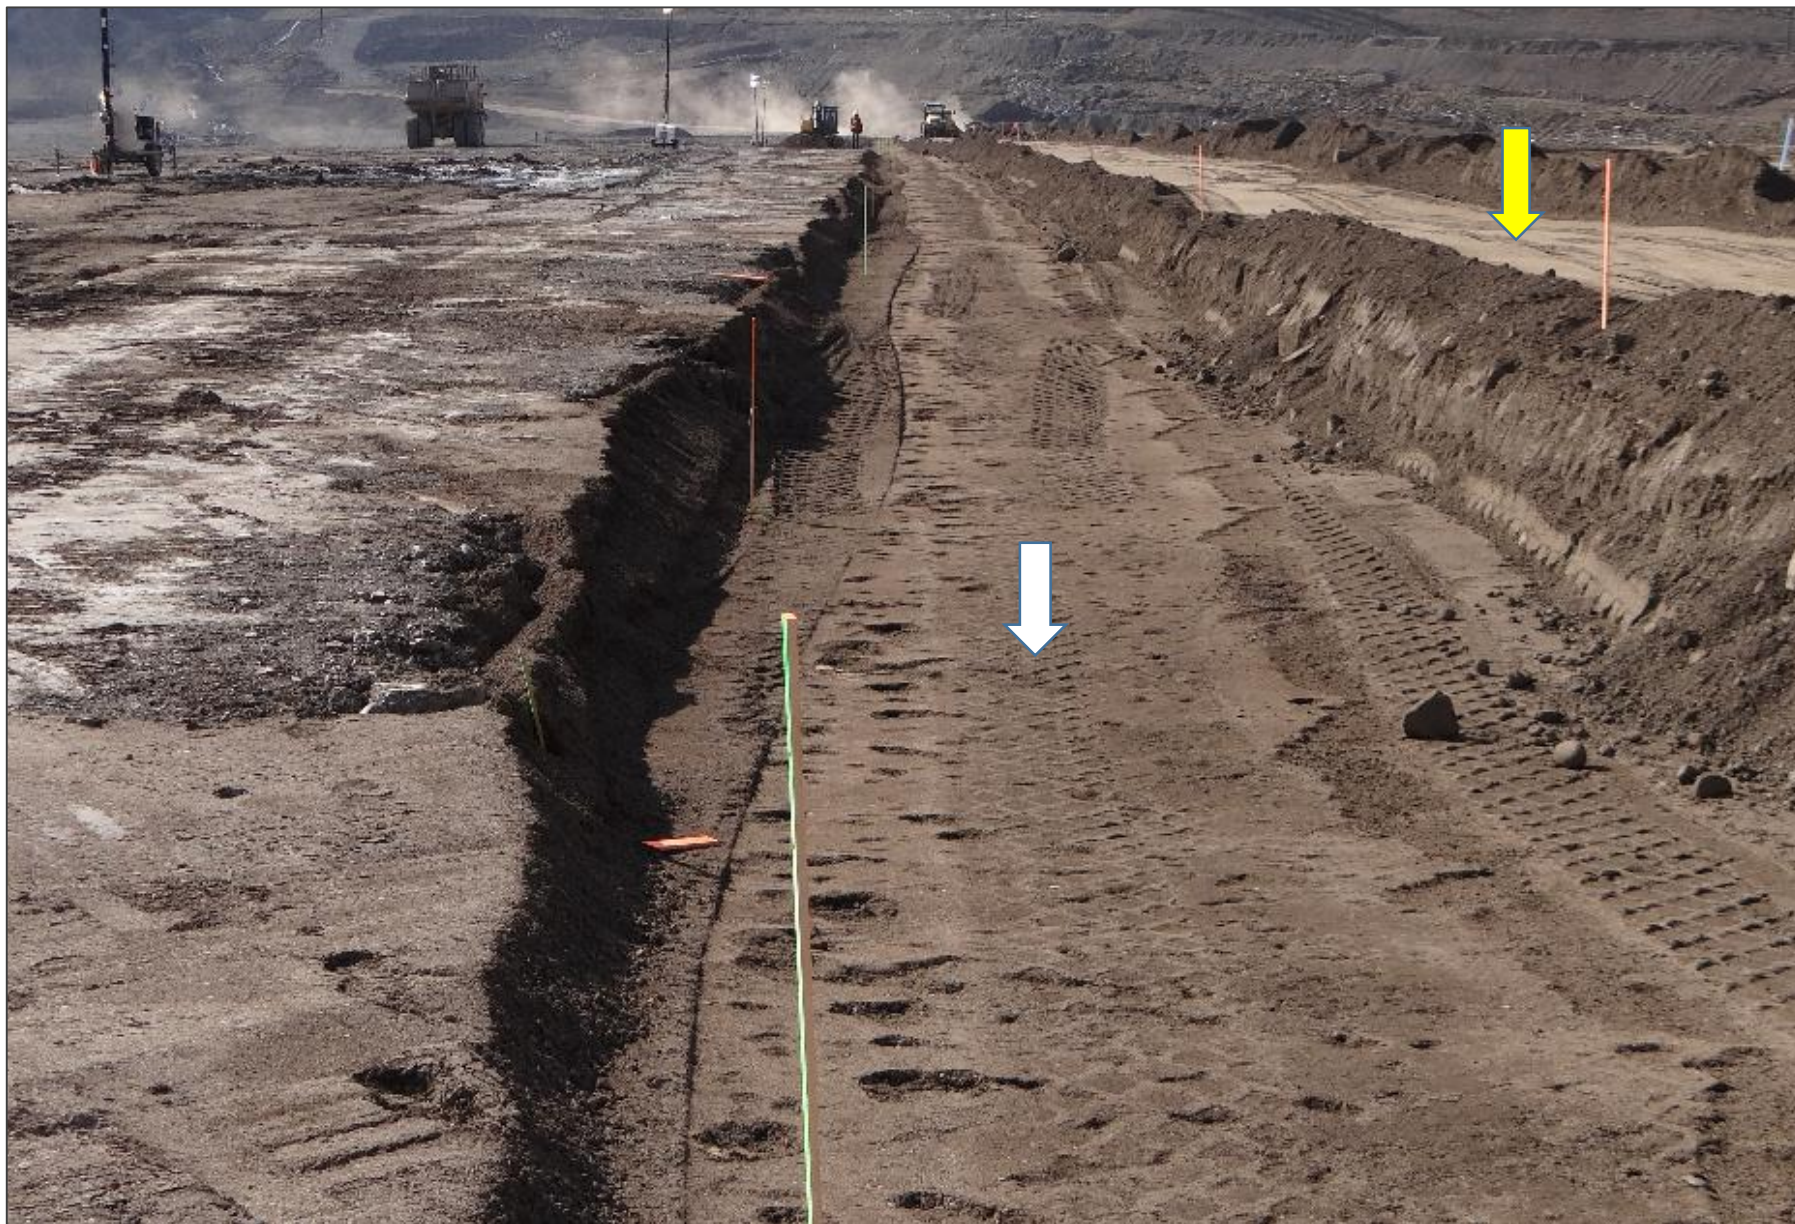
PHOTO 14

Crest of the NSD. Zone 3A chimney filter (white arrow) and Zone 3B chimney filter (yellow arrow) under construction. Survey stakes in place to control the construction. Zone 1 till core (no 2014 construction on the core prior to the inspection visit) to the left of Zone 3A.

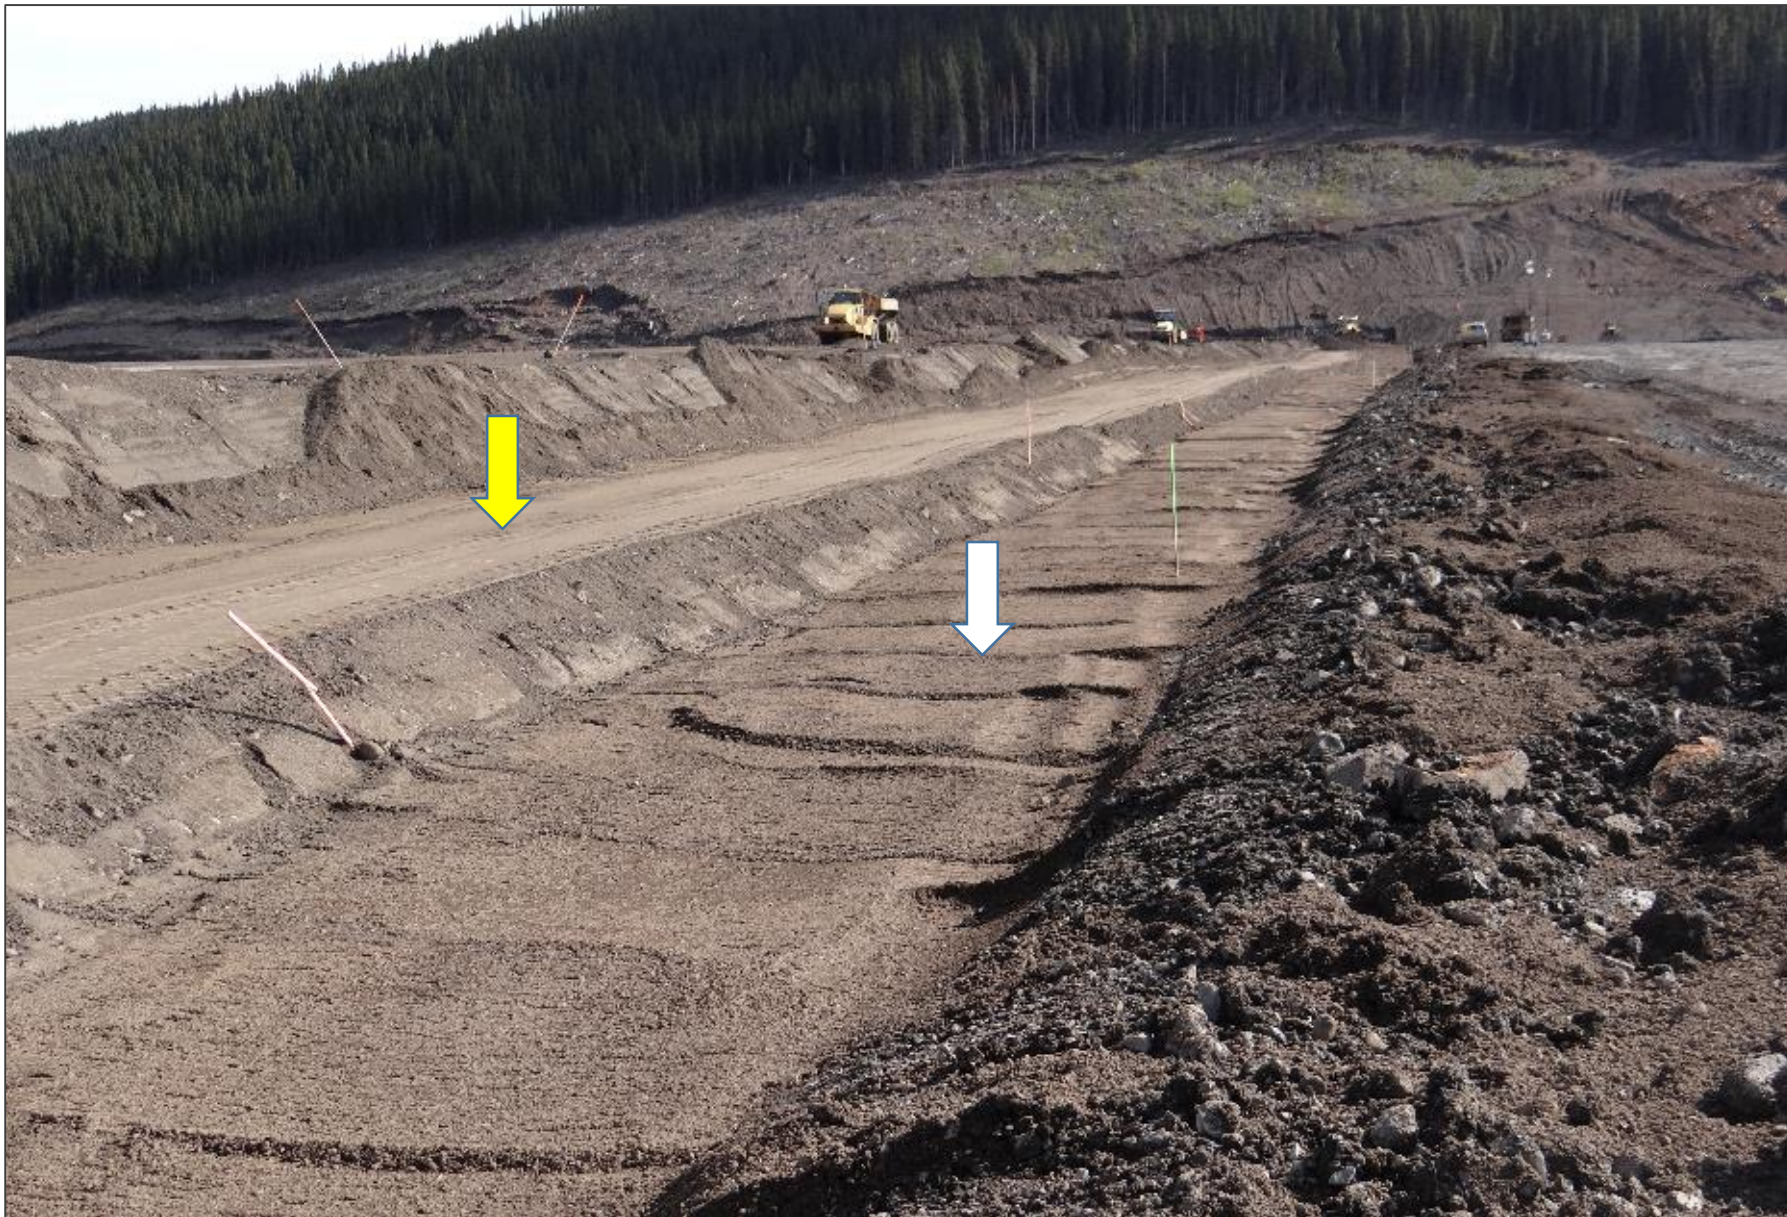
PHOTO 15

Crest of the NSD, looking east towards the right abutment. Zones 3A and 3B indicated by white and yellow arrows respectively. Waste/spoil on the core (to the right of 3A) will require removal prior to core preparation for additional till placement.

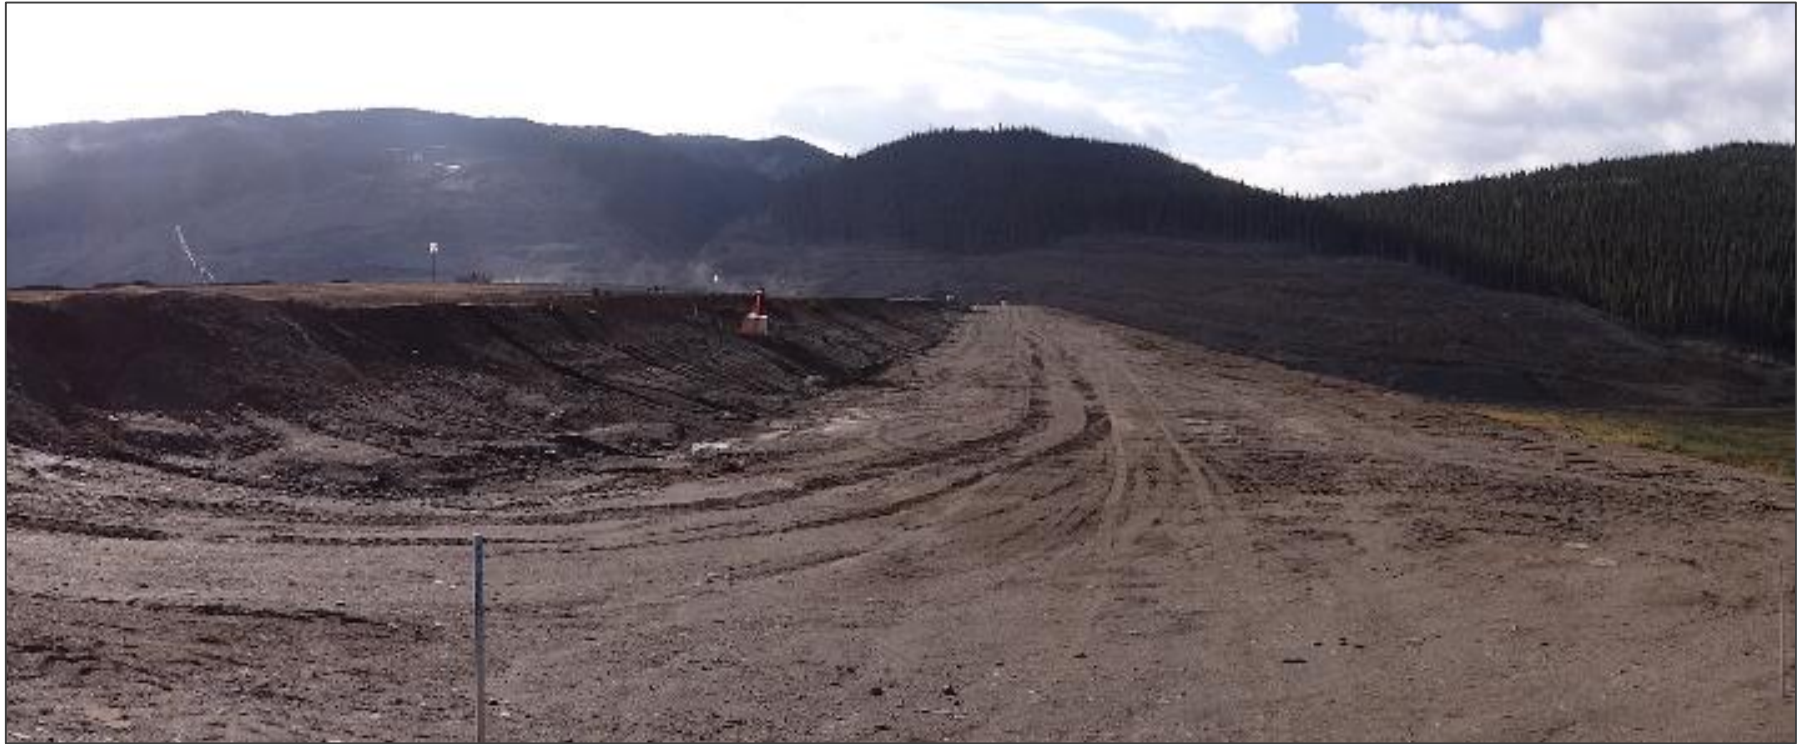
**PHOTO 16**

**NSD crest, looking towards the west (left) abutment.**

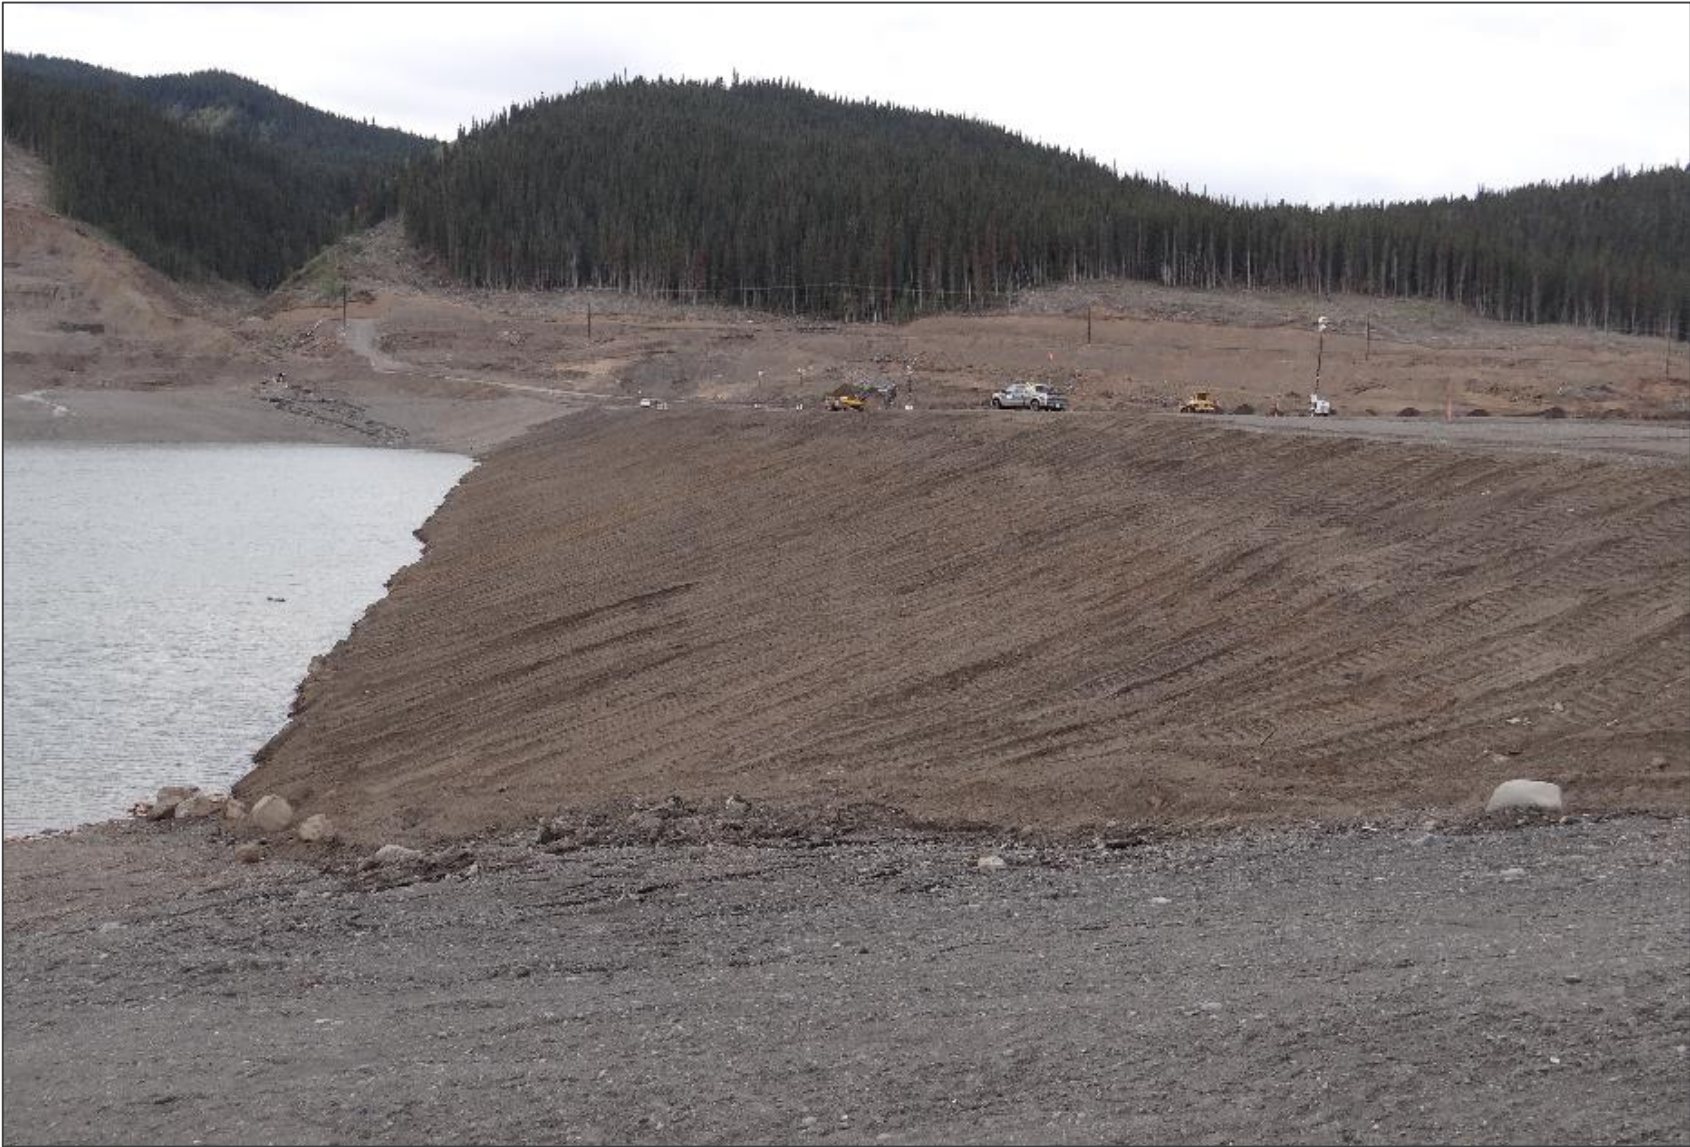
**PHOTO 17**

**NSD upstream facing, looking west towards the left abutment. No indications of erosion or slope instability.**

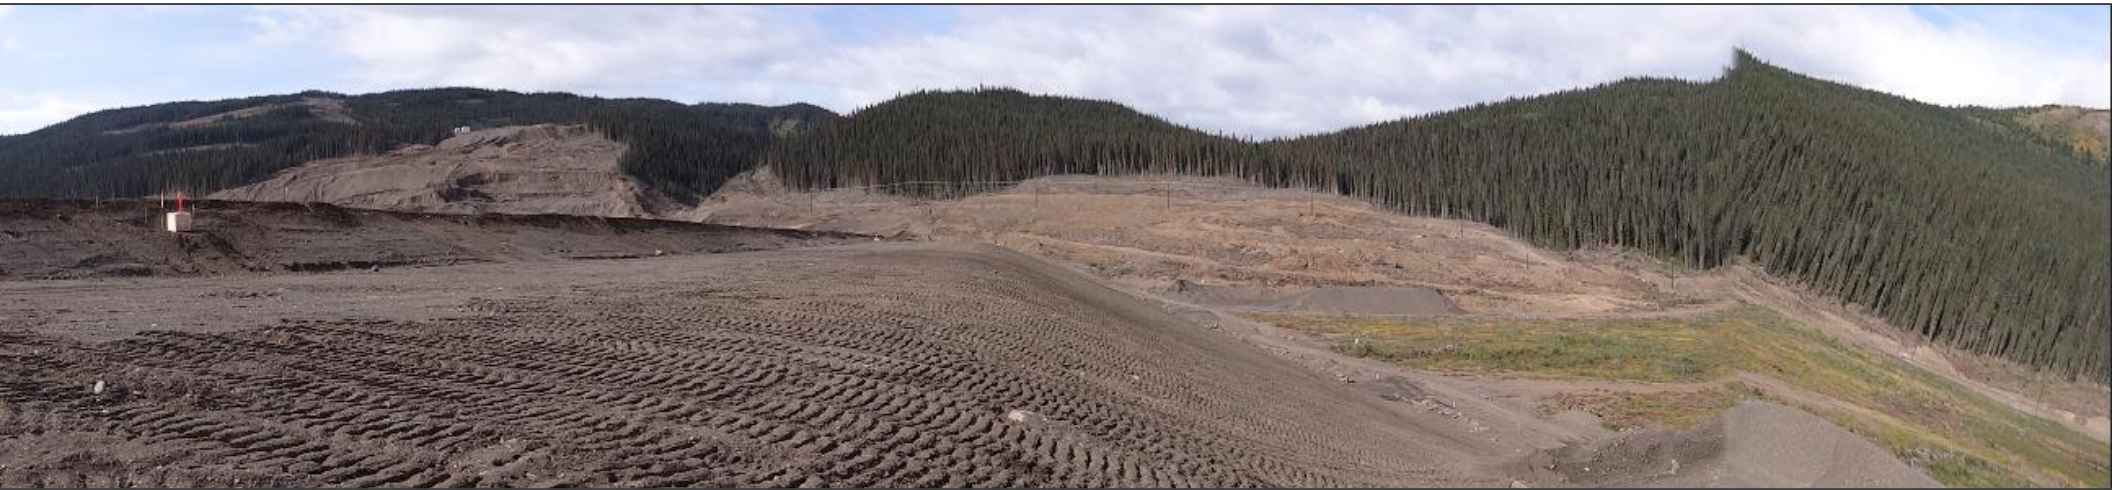
**PHOTO 19**

**NSD crest and downstream slope (2.5H:1V), looking west towards the left abutment. No indications on slope of instability, erosion, seepage break-out.**

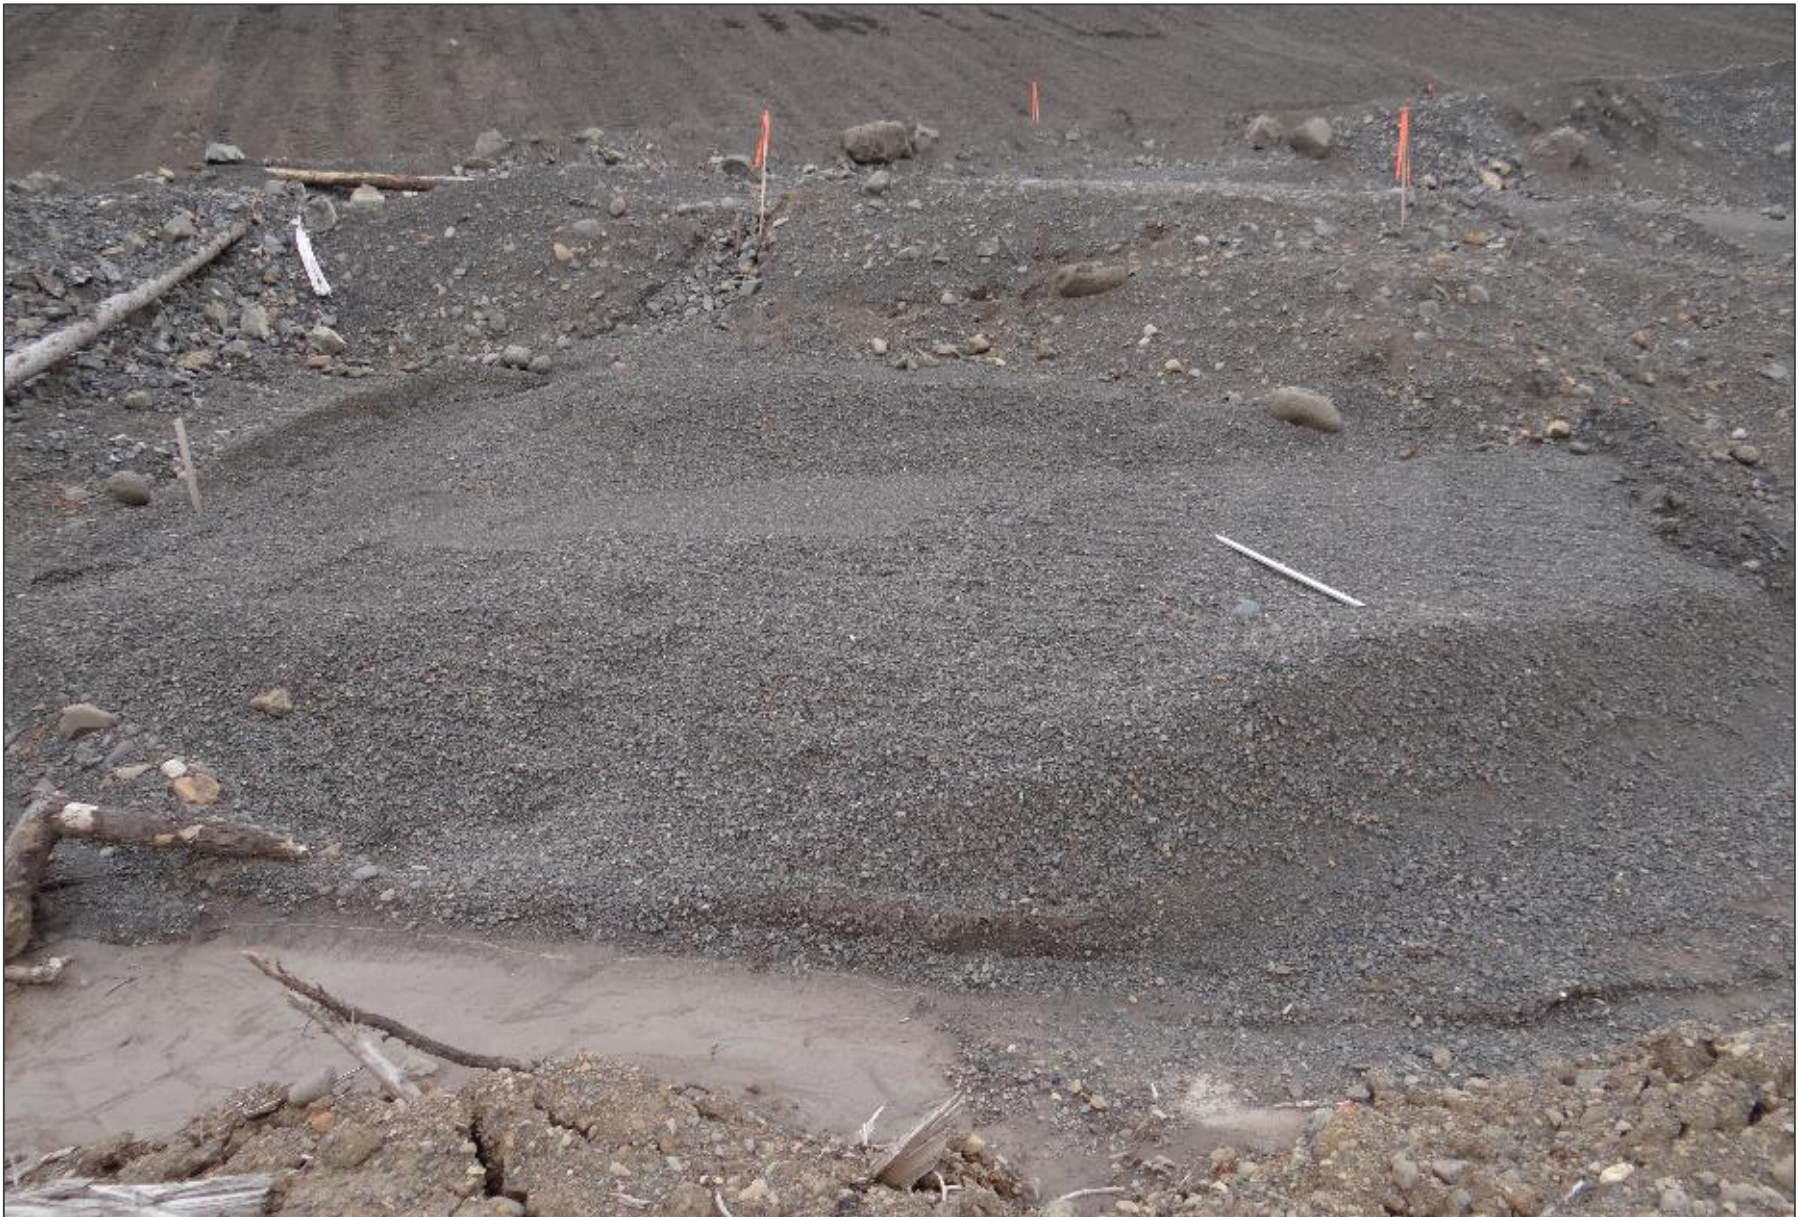
PHOTO 22

Finger drain 0+500 at toe of NSD near the left abutment.

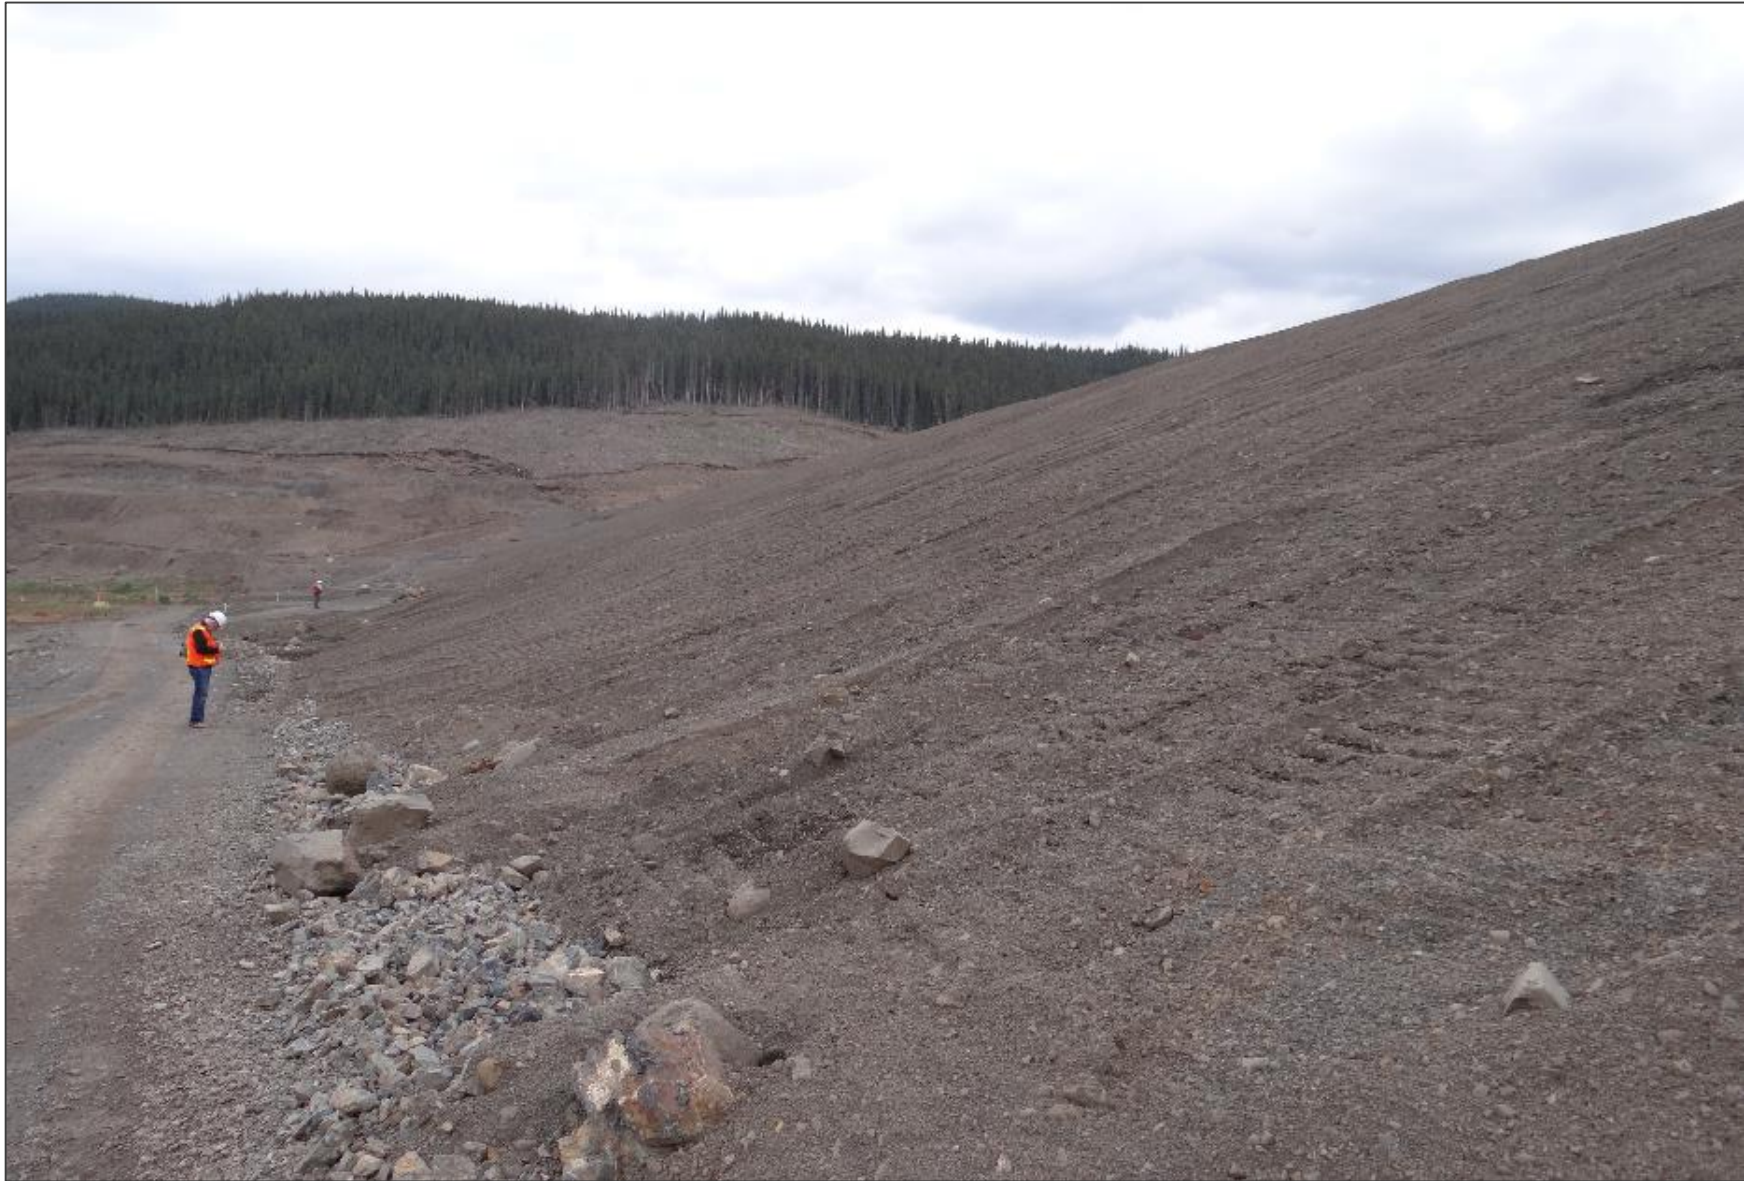
**PHOTO 23**

**Toe of NSD looking east towards the right abutment. No indications of erosion or instability of the downstream slope of the dam. No indications of elevated seepage discharges on the dam face.**

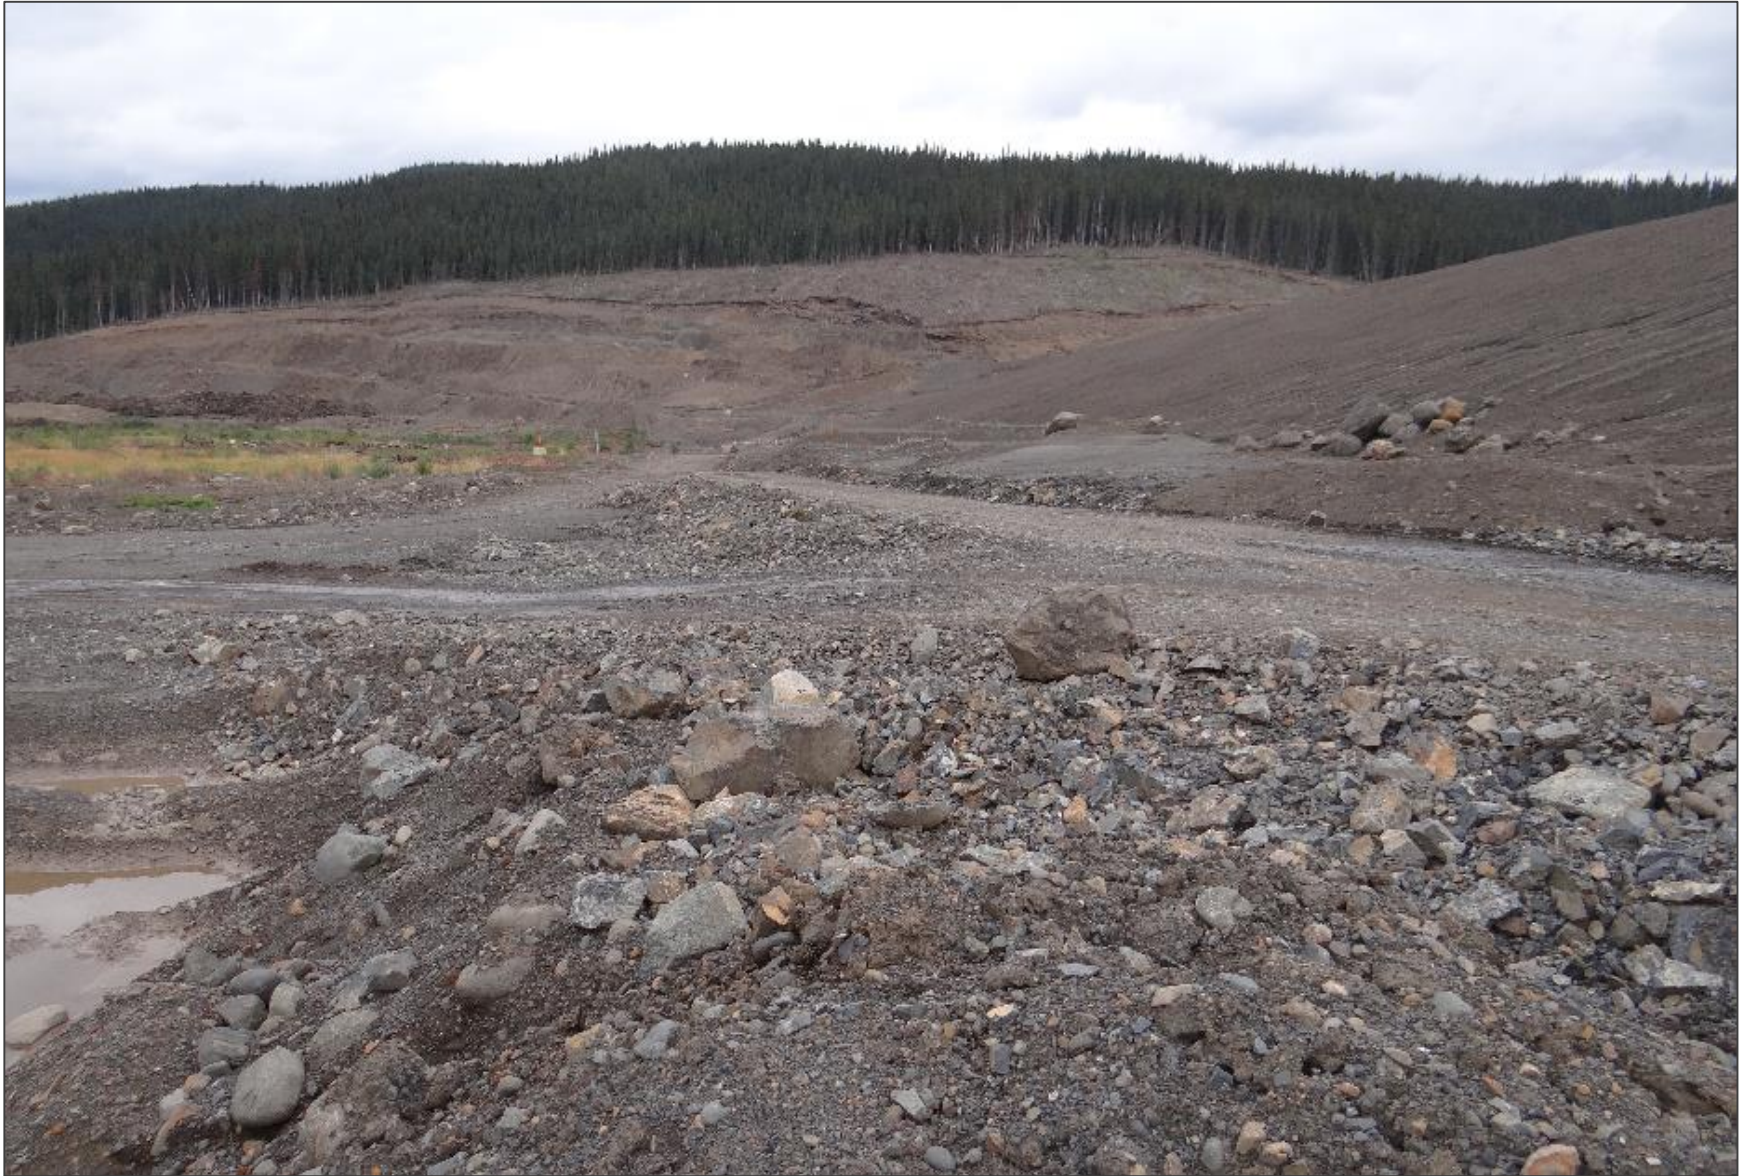
PHOTO 24

Toe of NSD looking towards the right abutment.

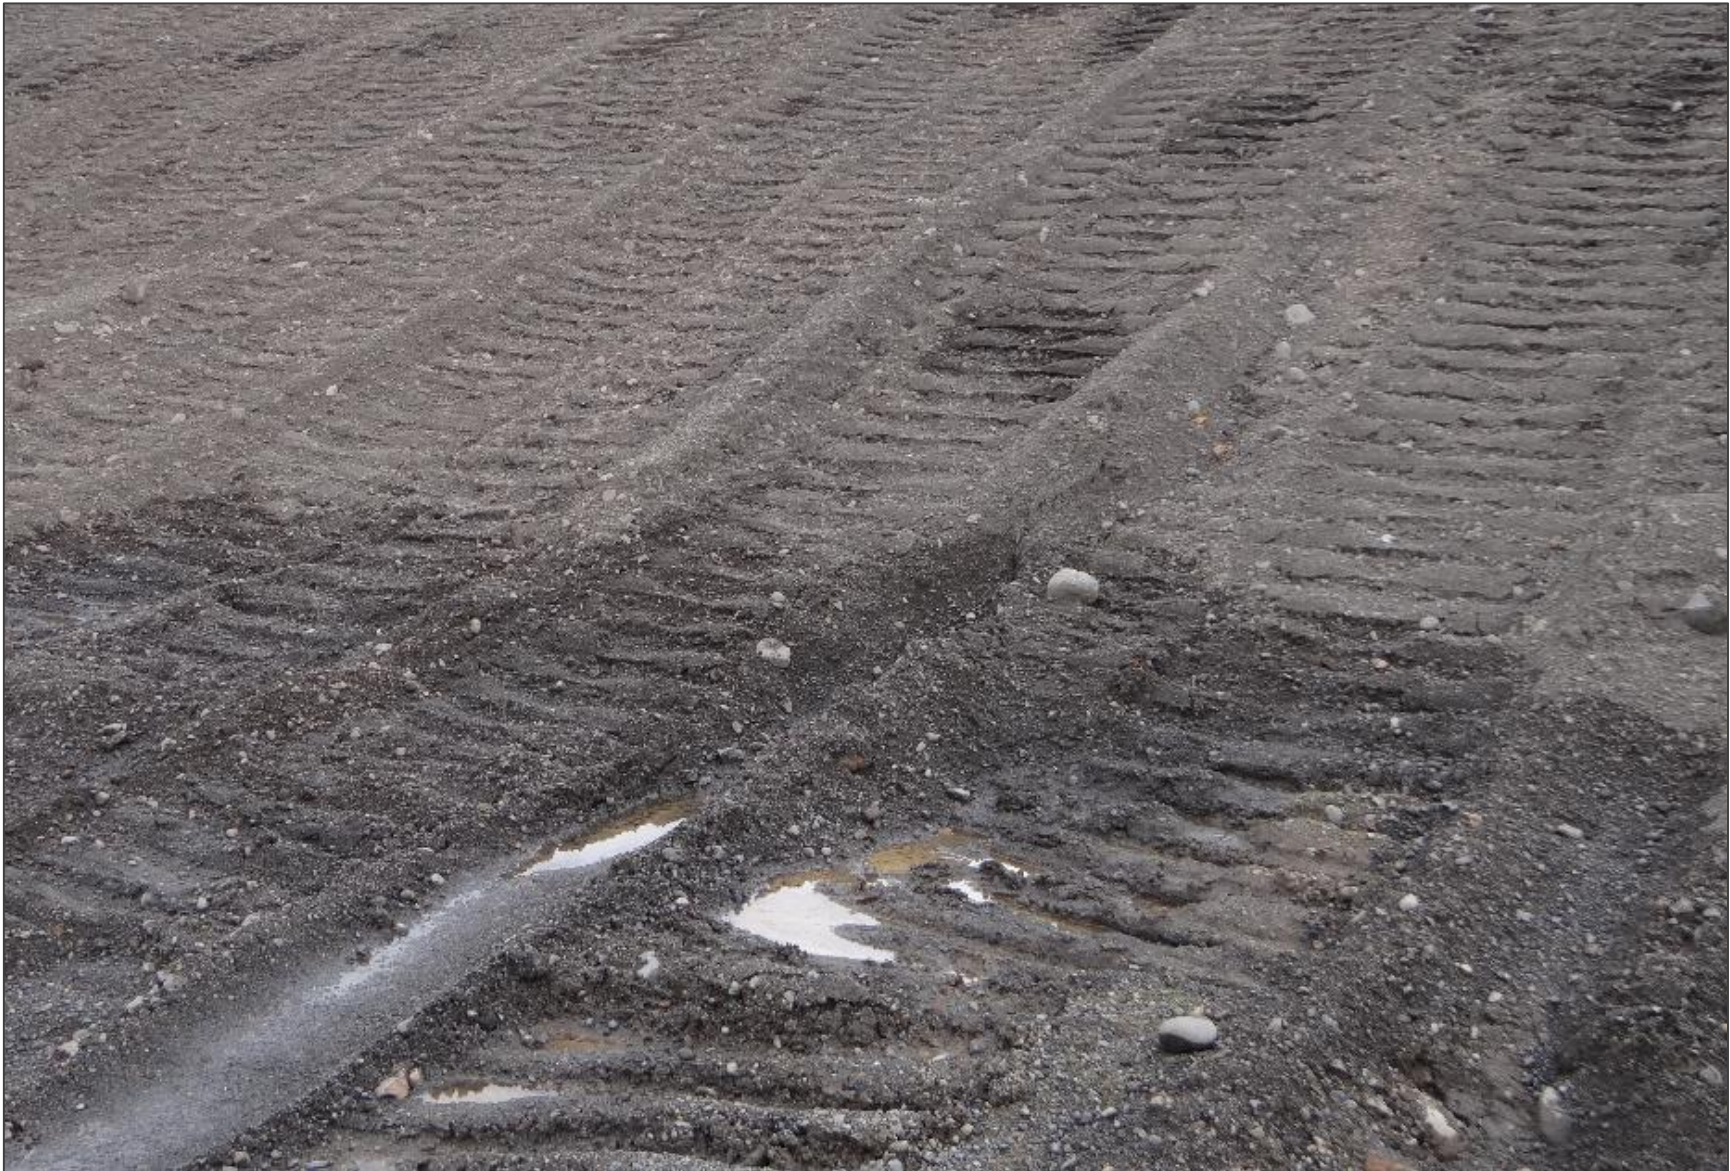
PHOTO 27

Seepage at toe of NSD, at about Sta. 0+250 m, where slope of the dam meets the drainage blanket. No flow rate discernible. No indications of fines in seepage discharge.

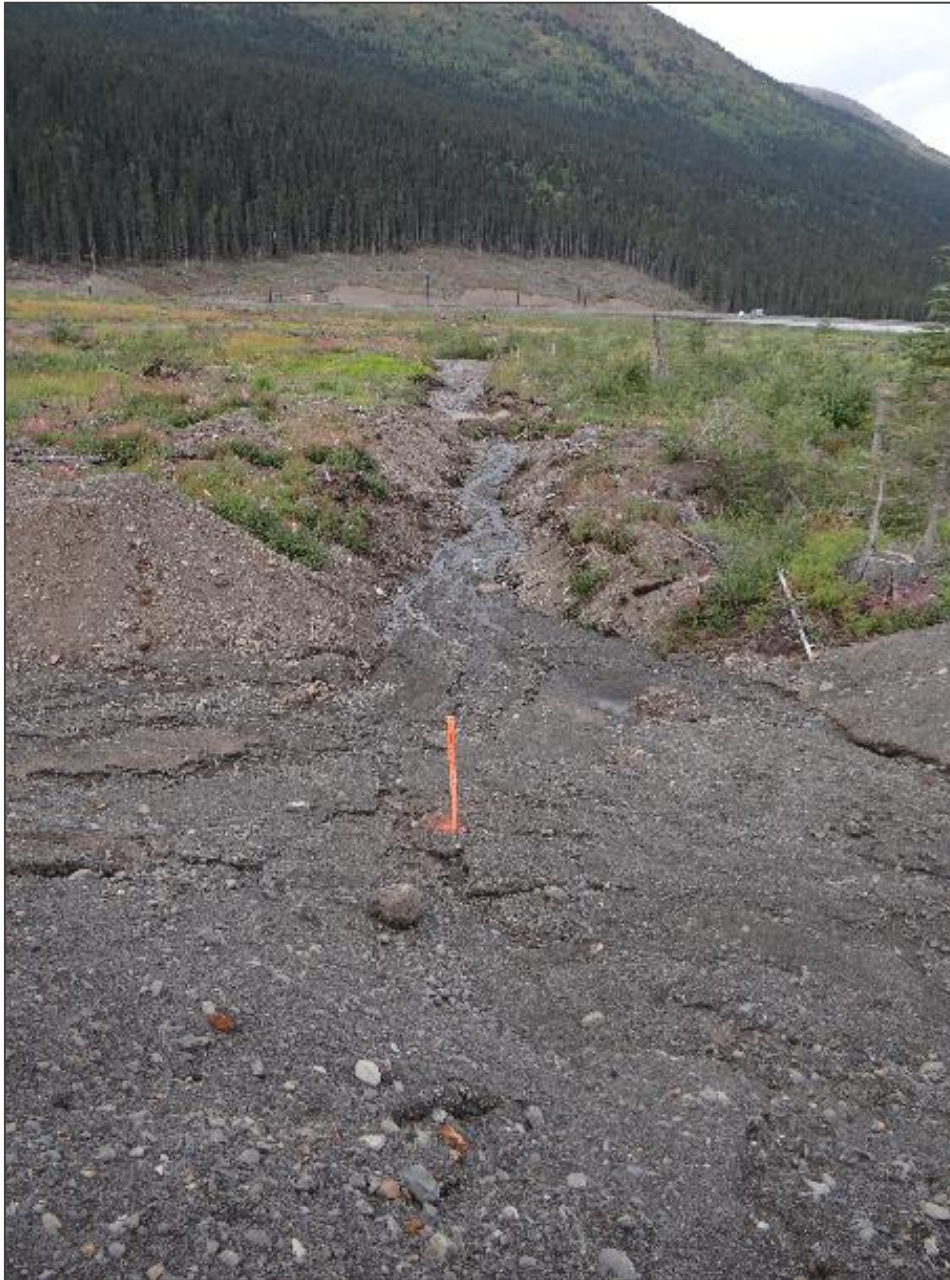
**PHOTO 29**

On September 15, 2014, AMEC personnel undertook a survey of groundwater discharge and surface flows between the North Starter Dam and the North Reclaim Dam. This survey also included temperature measurements. Seepage discharge from the 0+200 toe drain at the toe of the North Starter Dam (see Photo 29 in Appendix A) was measured at a temperature of

**Toe of NSD, finger drain 0+200, looking downstream towards the NRD. Finger drain discharge visually estimated at 0.2 litres/sec. Flow in the channel increases progressively moving downstream, indicating the area between the NSD and the NRD to represent a groundwater discharge area.**

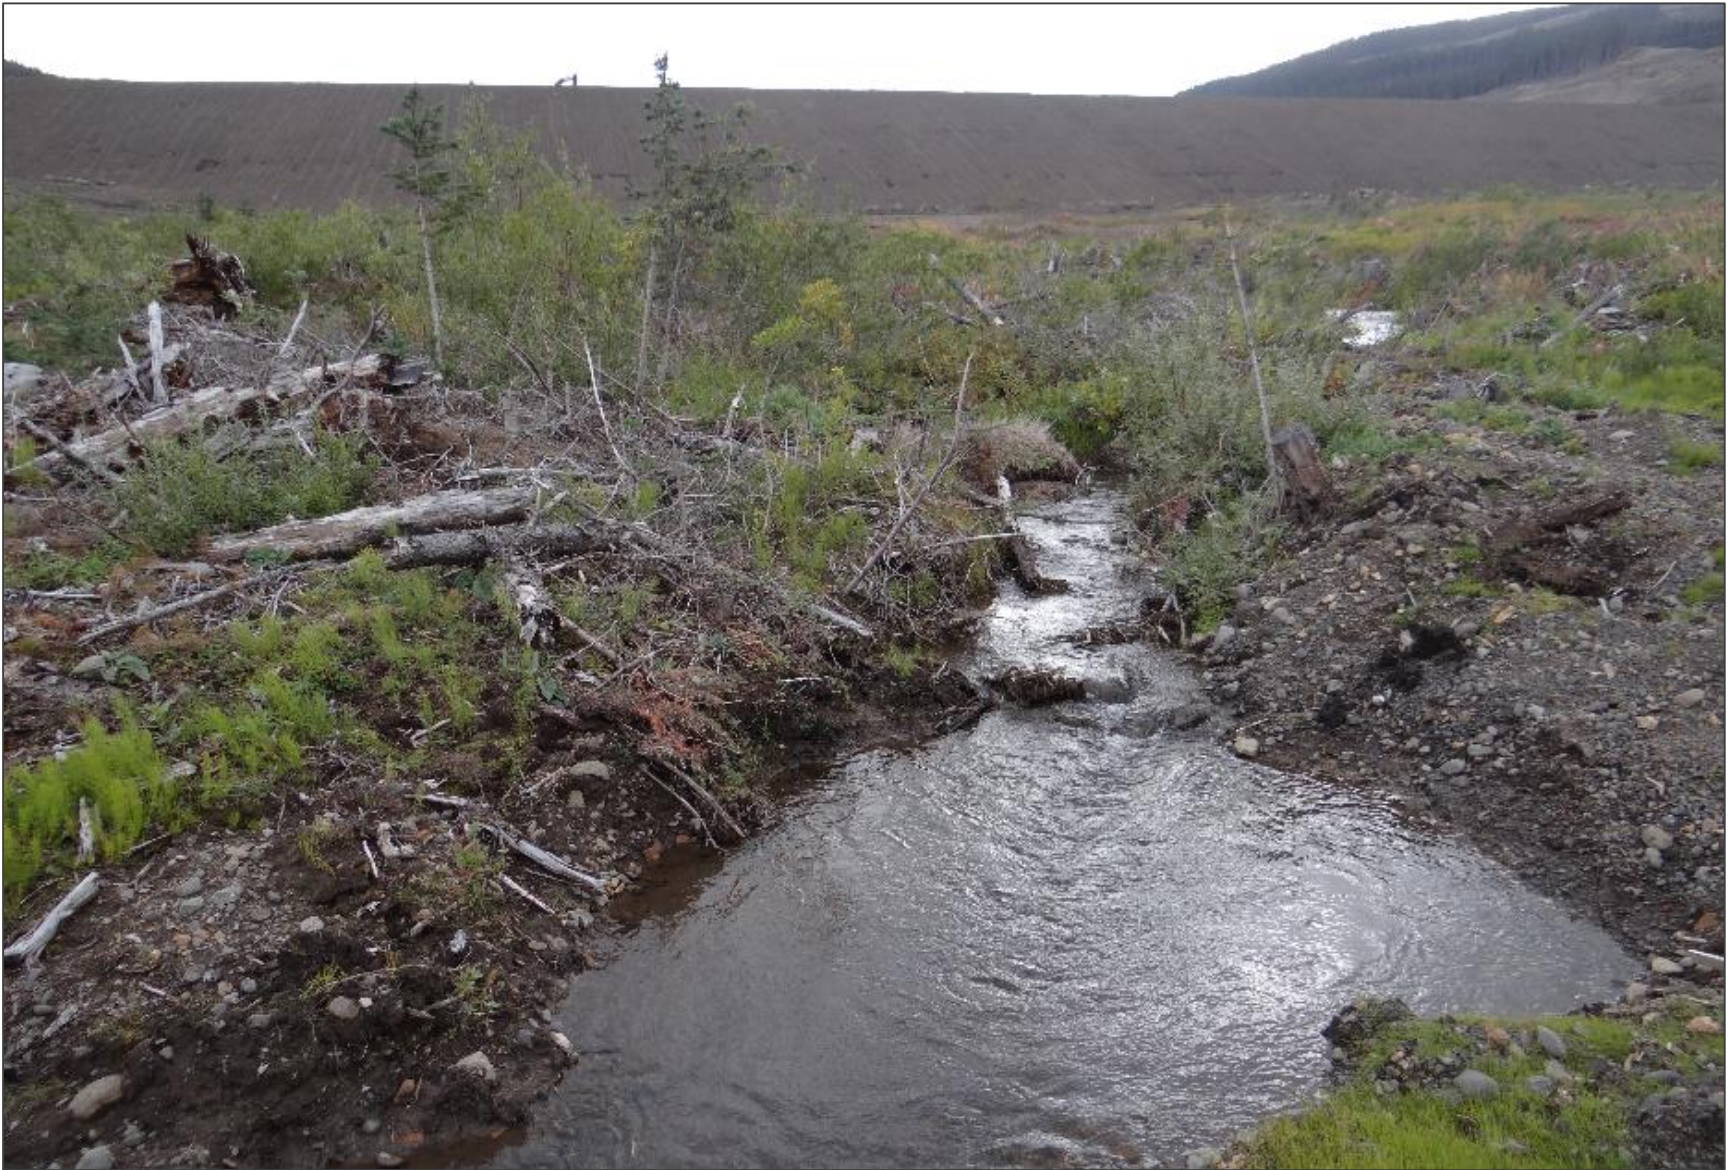
PHOTO 32

Looking south towards downstream slope of the NSD, again noting increased flows due to groundwater discharge in the area between the NSD and the NRD.
