## **RED CHRIS DEVELOPMENT COMPANY LTD.**

### **RED CHRIS TAILINGS FACILITY**

## **2014 DAM SAFETY INSPECTION REPORT**

PROJECT NO.: 0866001.14.7  
DATE: November 24, 2014  
DOCUMENT NO.: 0866001.14.002

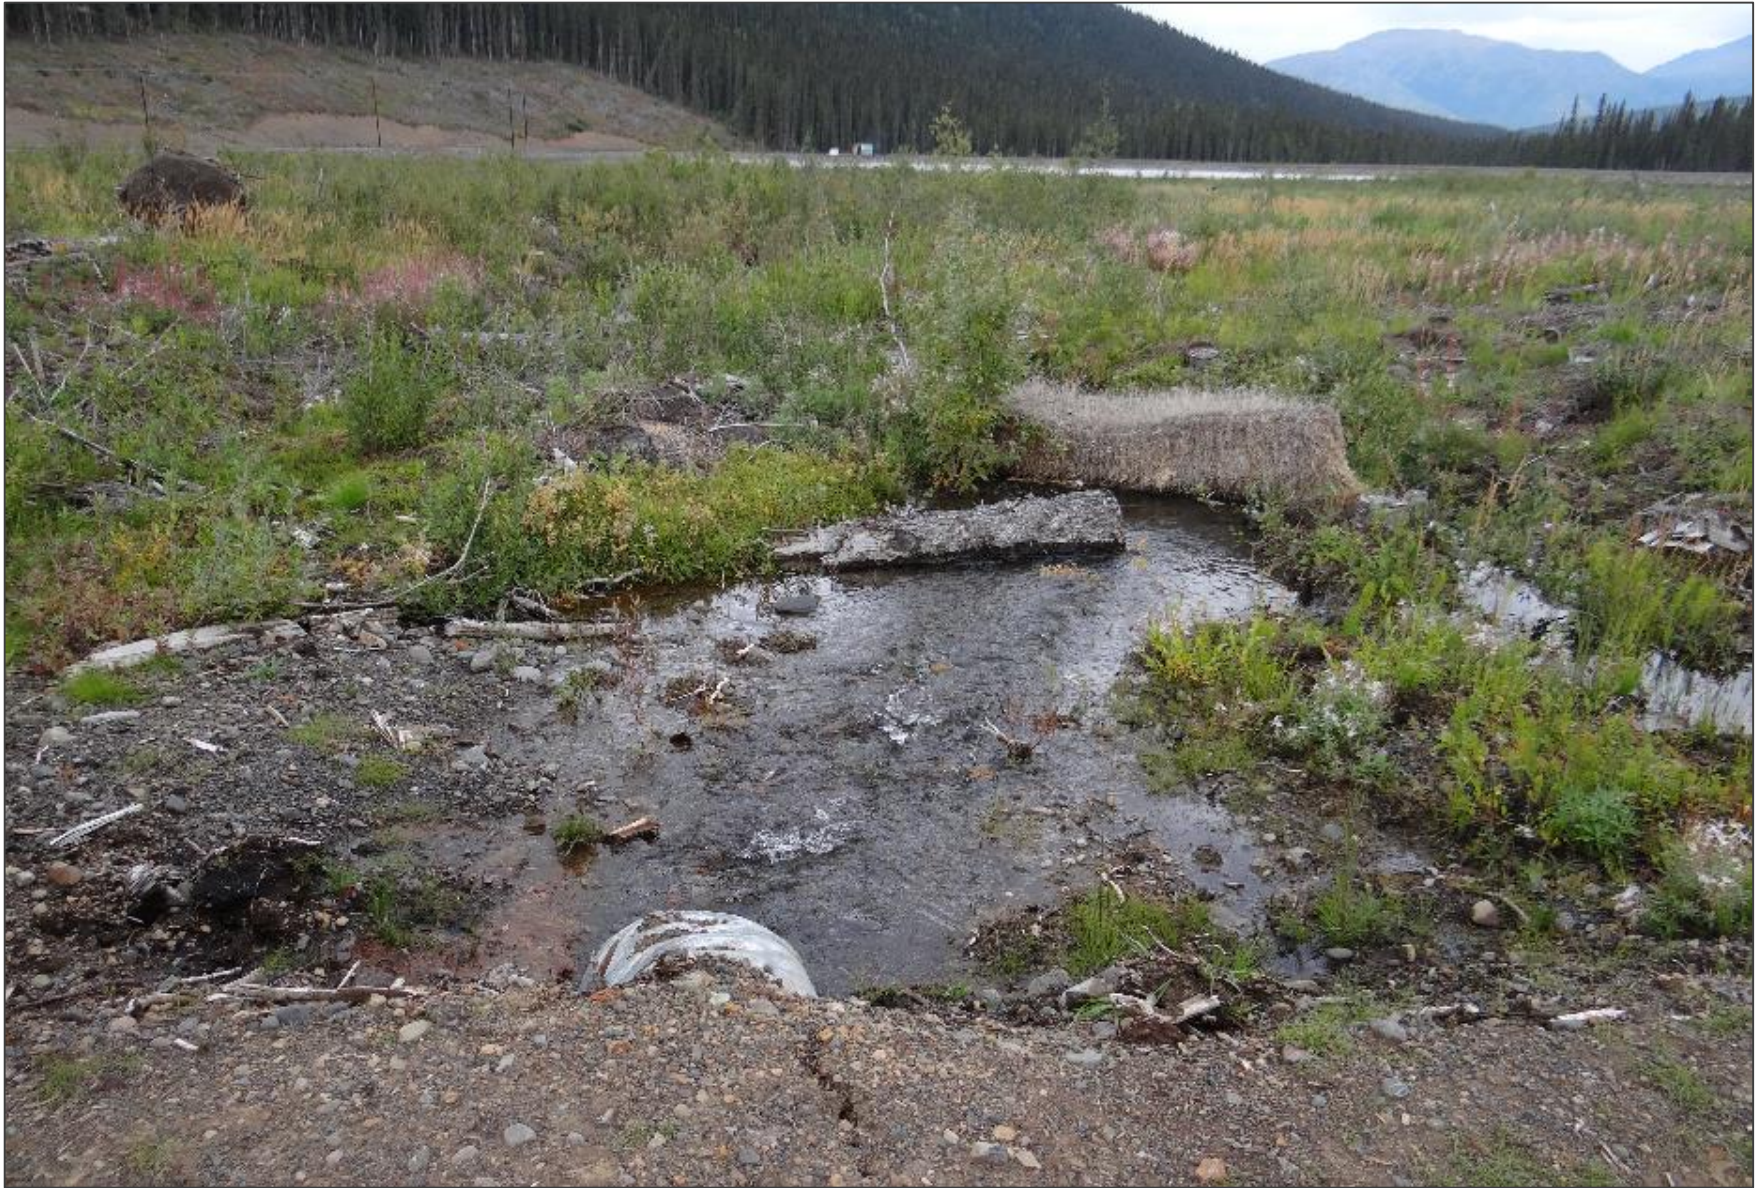
PHOTO 33

- Seepage discharge from the North Starter Dam toe (discussed in Section 6.4)
- Inflows to the North Reclaim Dam reservoir (could be measured via weir, see Photos 33 and 34 in Appendix A)
- Inflows to the North Starter Dam reservoir from Beaver Creek (see Photo 6 in Appendix A) and any other significant inflow streams
- Pumpback flows from the North Reclaim Dam reservoir to the North Starter Dam reservoir (see Photo 5 in Appendix A).

Looking north towards the NRD. Flow rates continuing to increase moving towards the NRD reservoir from the NSD toe.

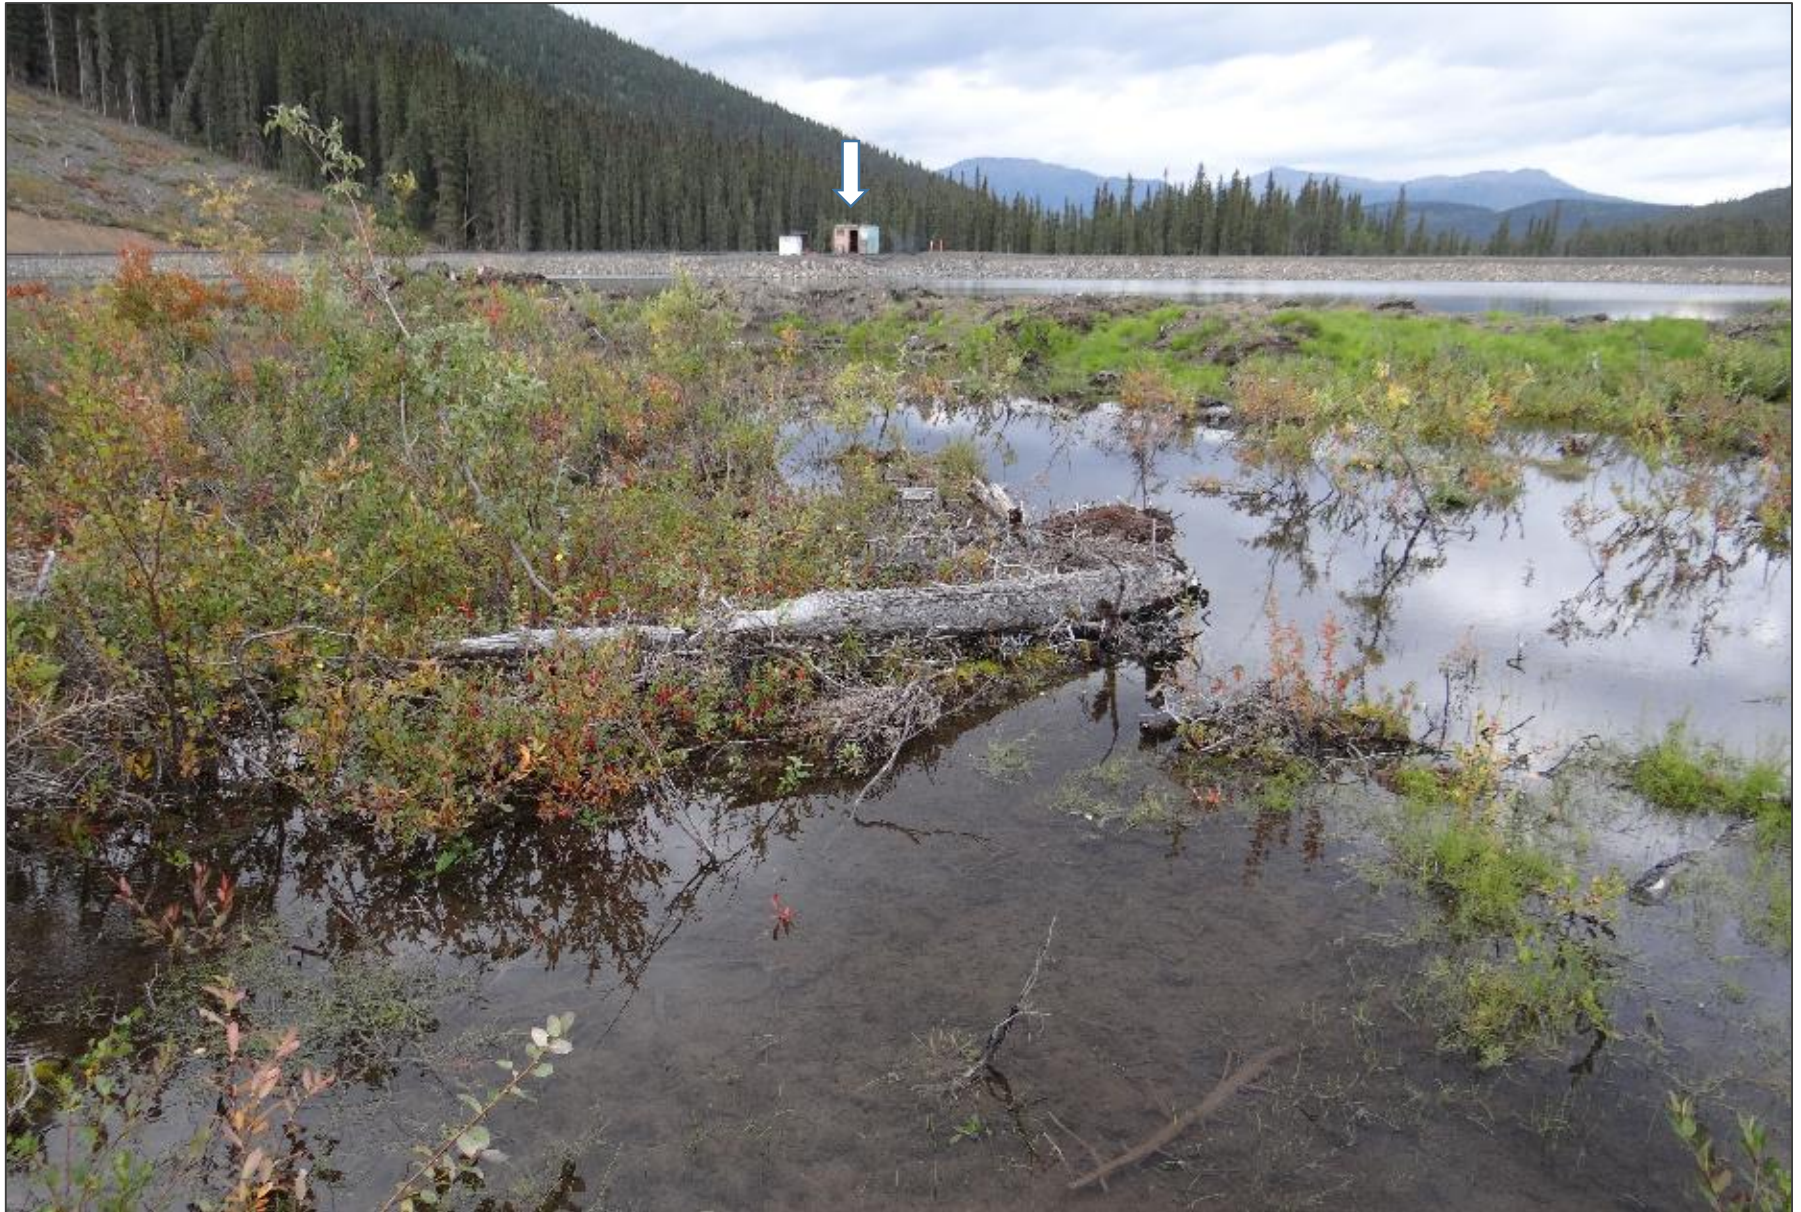
PHOTO 34

Inlet to the NRD reservoir. NRD in the background, pumphouse indicated by the arrow.

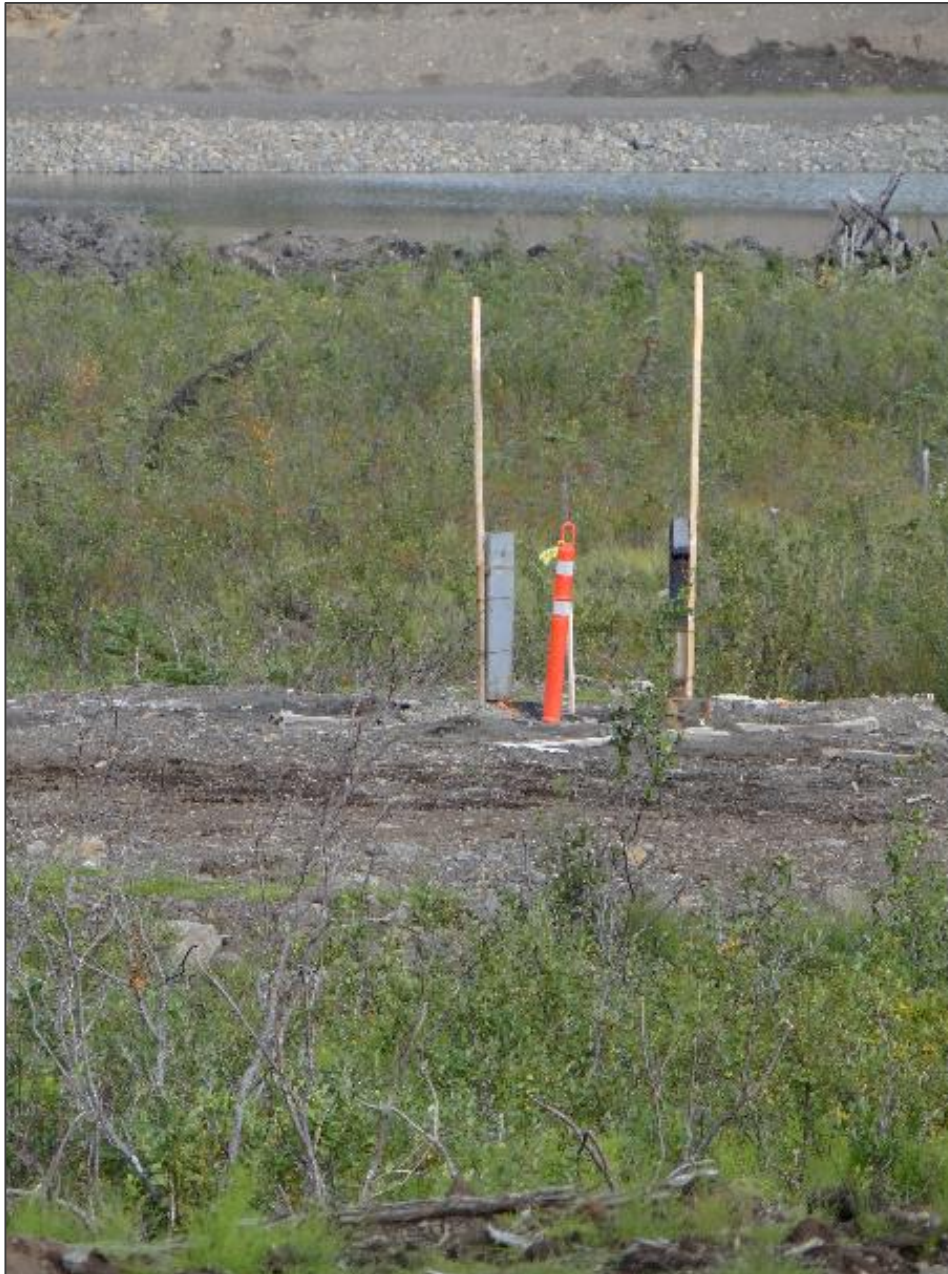
**PHOTO 35**

**Looking north towards the NRD and associated reservoir. Groundwater monitoring wells 13-21D and 13-21S. Both wells indicate slightly artesian groundwater levels.**

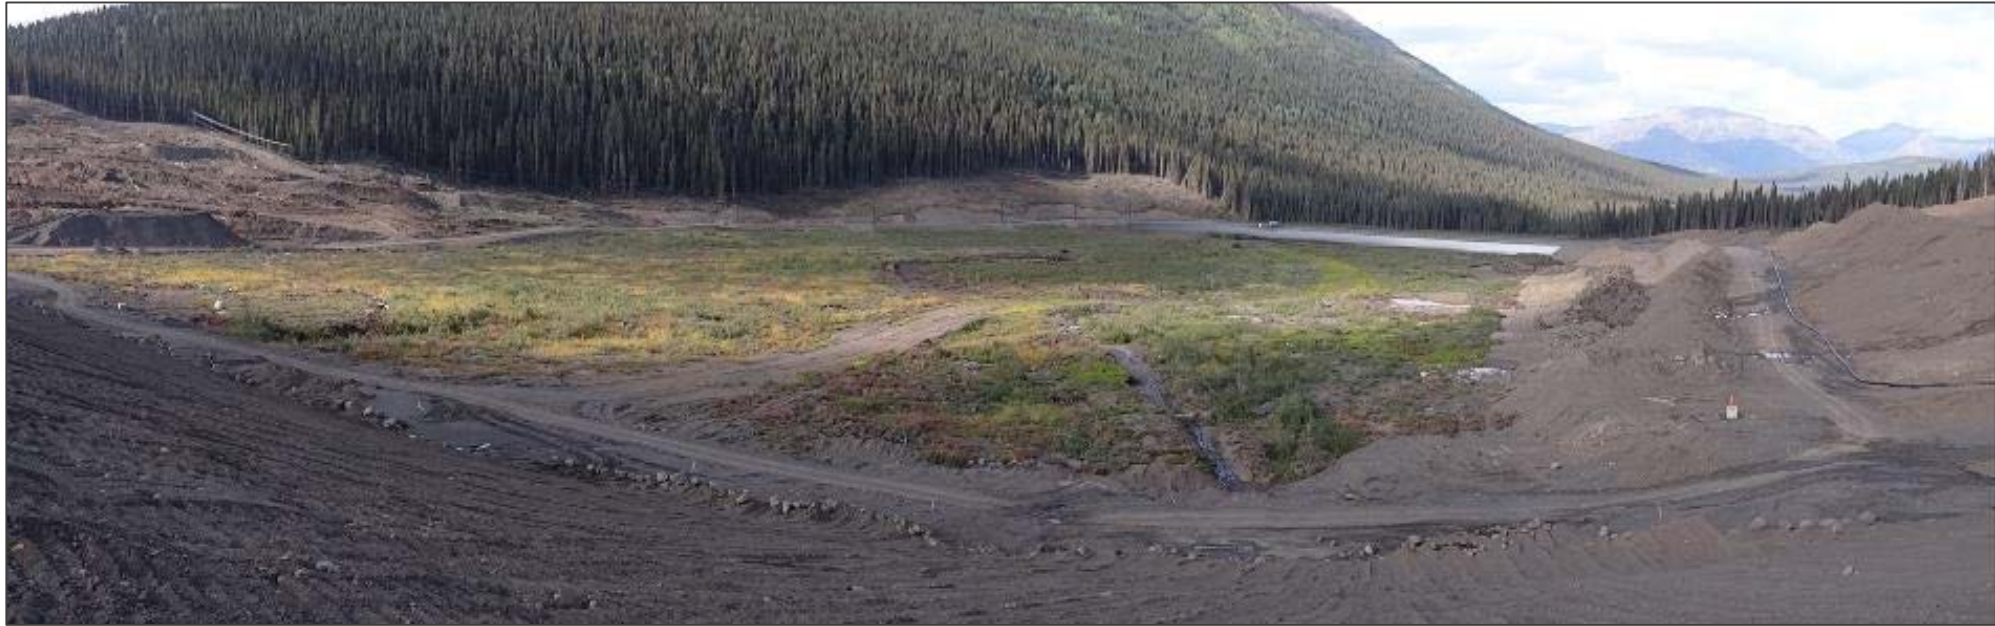
**PHOTO 36**

**Panorama from crest of NSD near the right abutment, looking downstream towards the toe of the NSD (left), the area of groundwater discharge between the NSD toe and the NRD, and the NRD reservoir.**

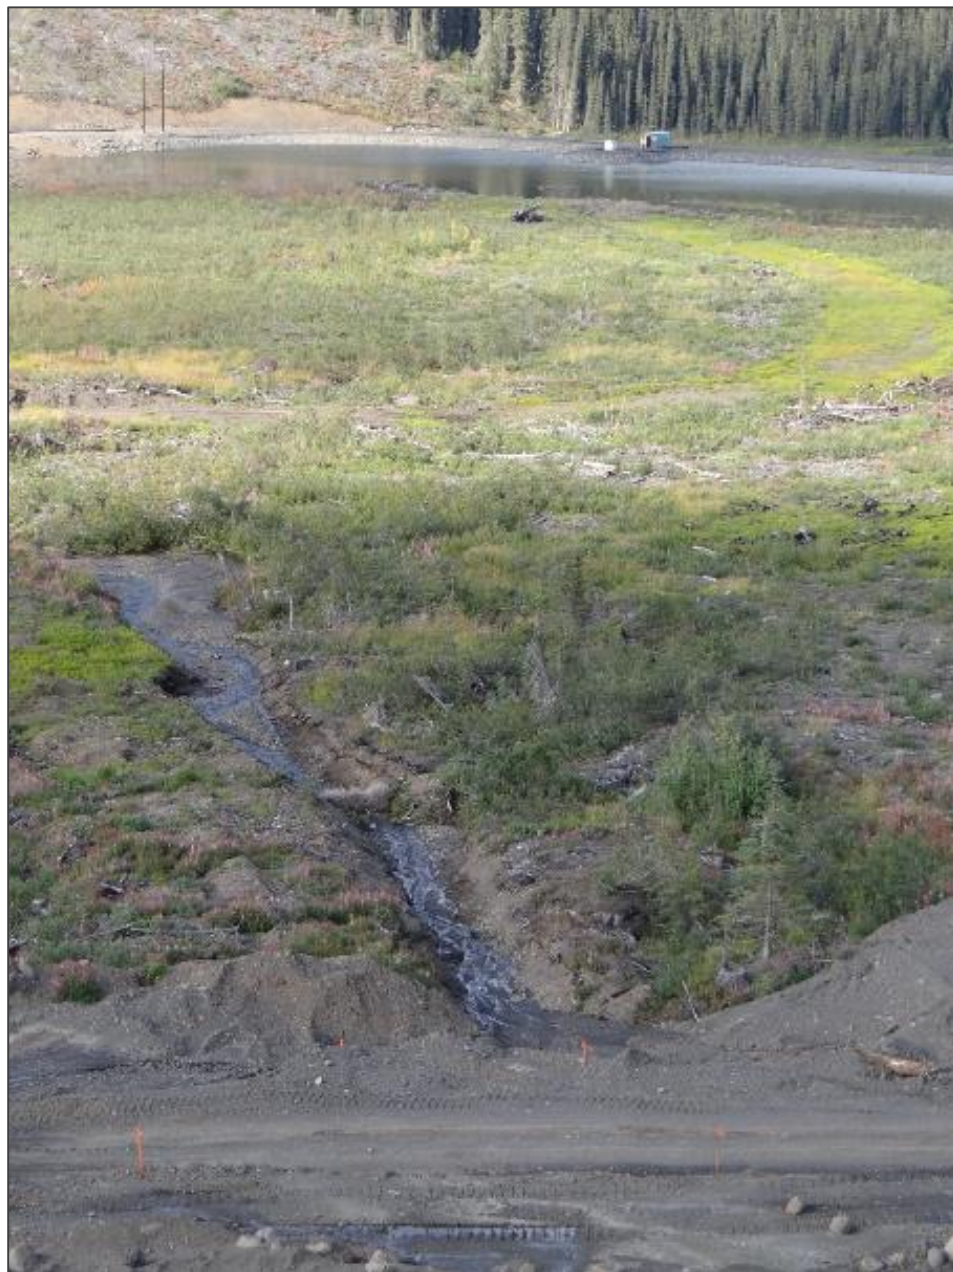
**PHOTO 37**

**Looking west towards the left abutment of the NRD. Note surface flow to the groundwater discharge area – source is groundwater discharge from the west-facing slope. There are numerous such creeks/springs along the valley slopes in the area between the NSD toe and the NRD reservoir.**

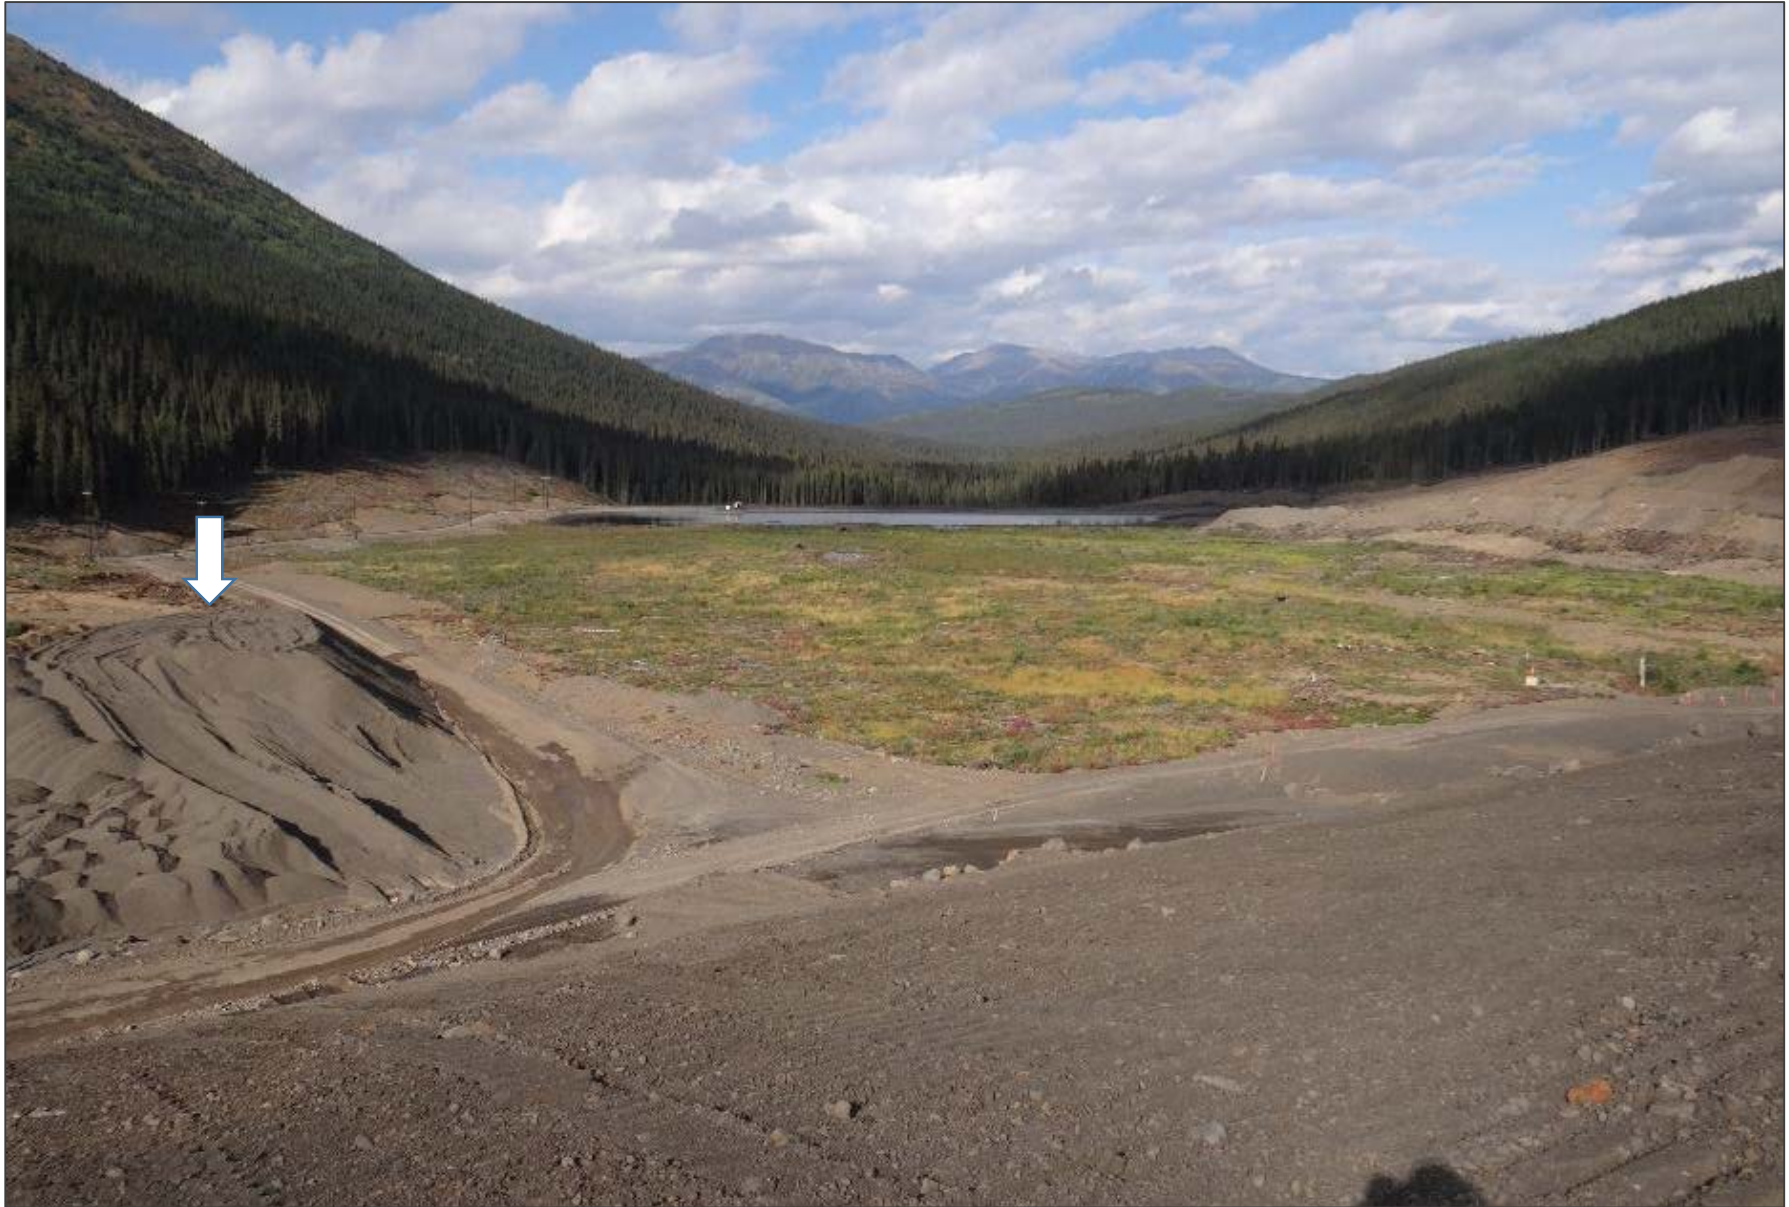
PHOTO 38

Looking north from crest of the NSD, near the left abutment. 3A filter stockpile to the left (white arrow). NRD reservoir in the background.

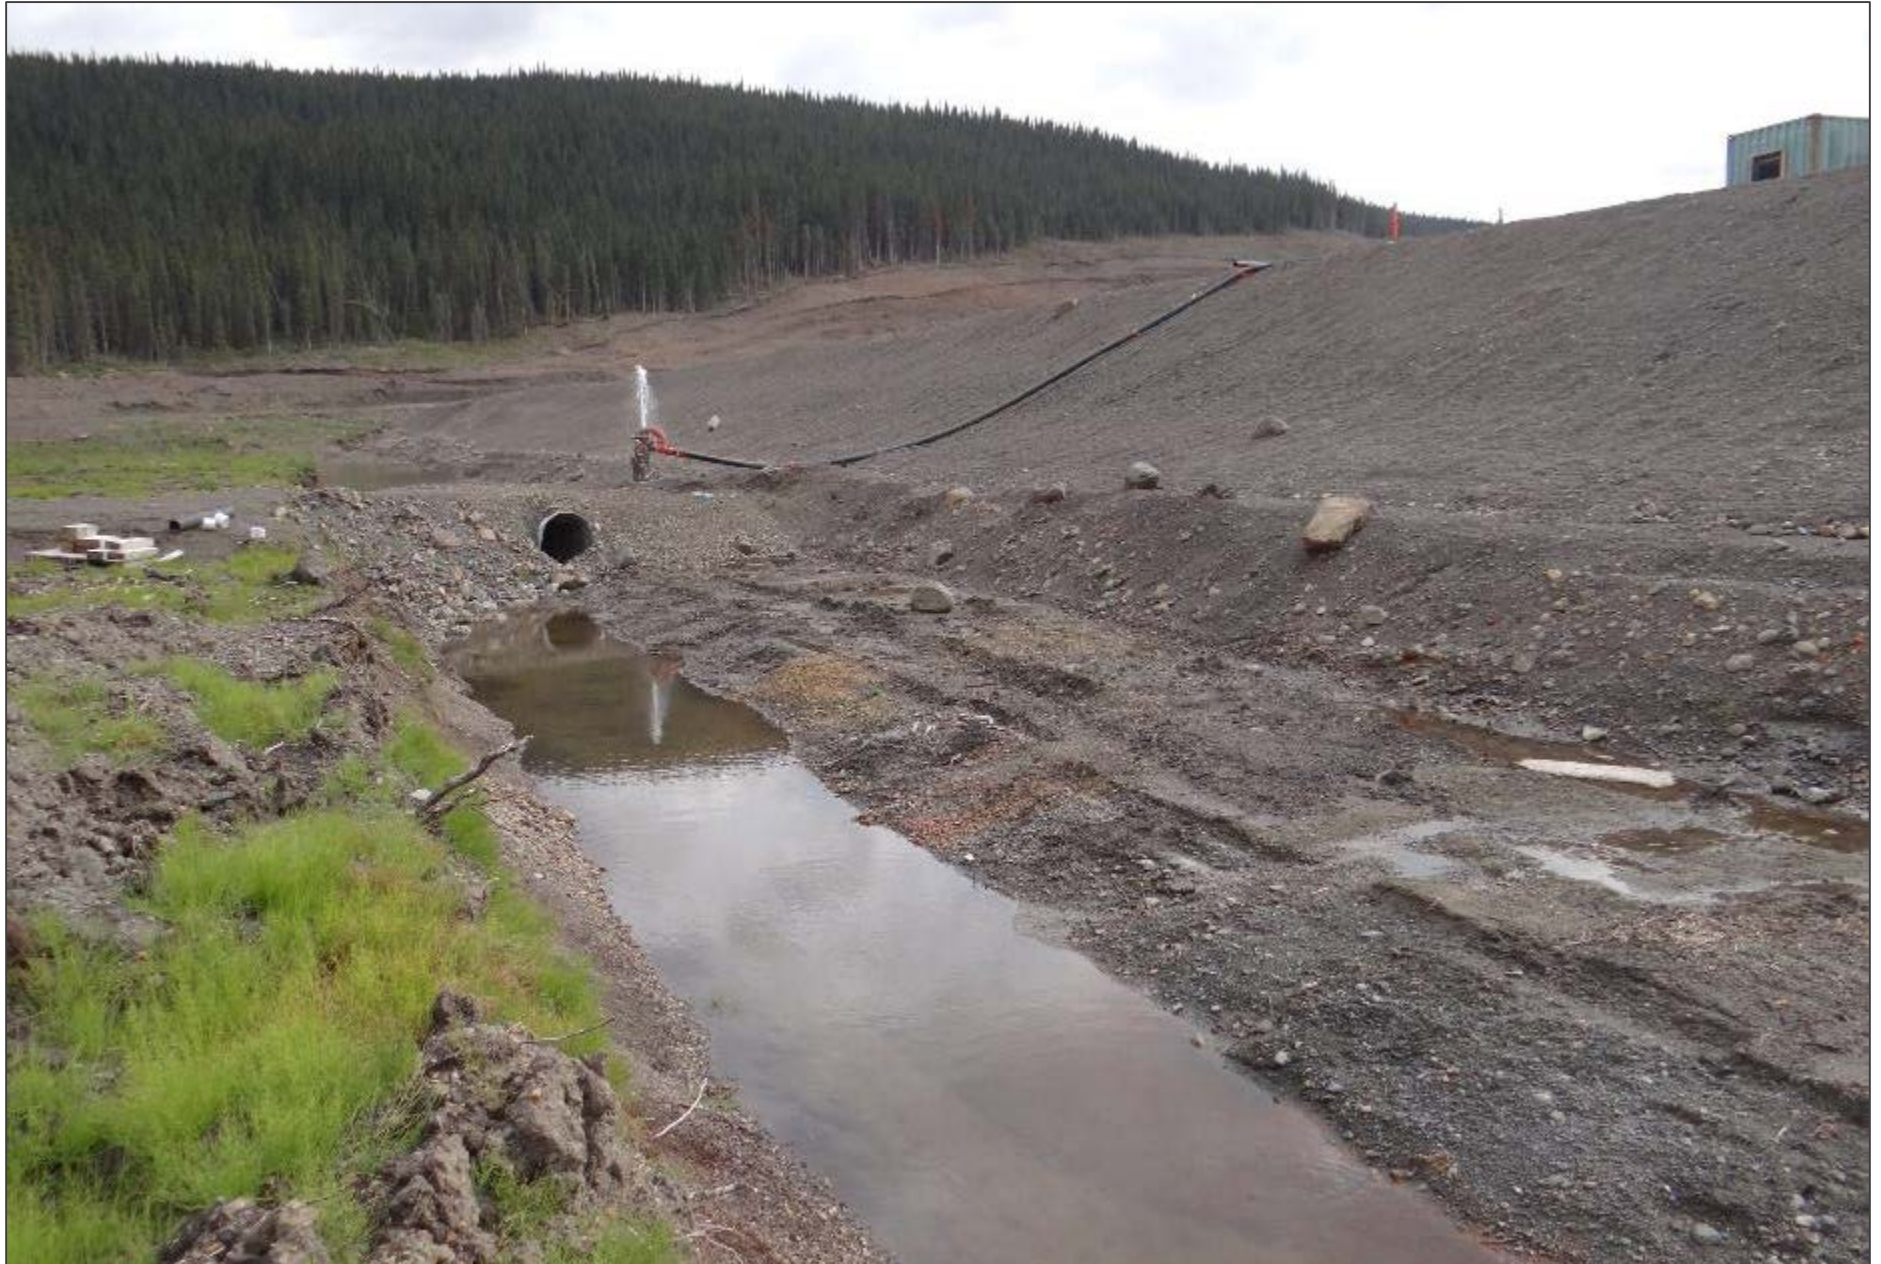
PHOTO 48

Downstream face of the NRD, looking east towards the right dam abutment.

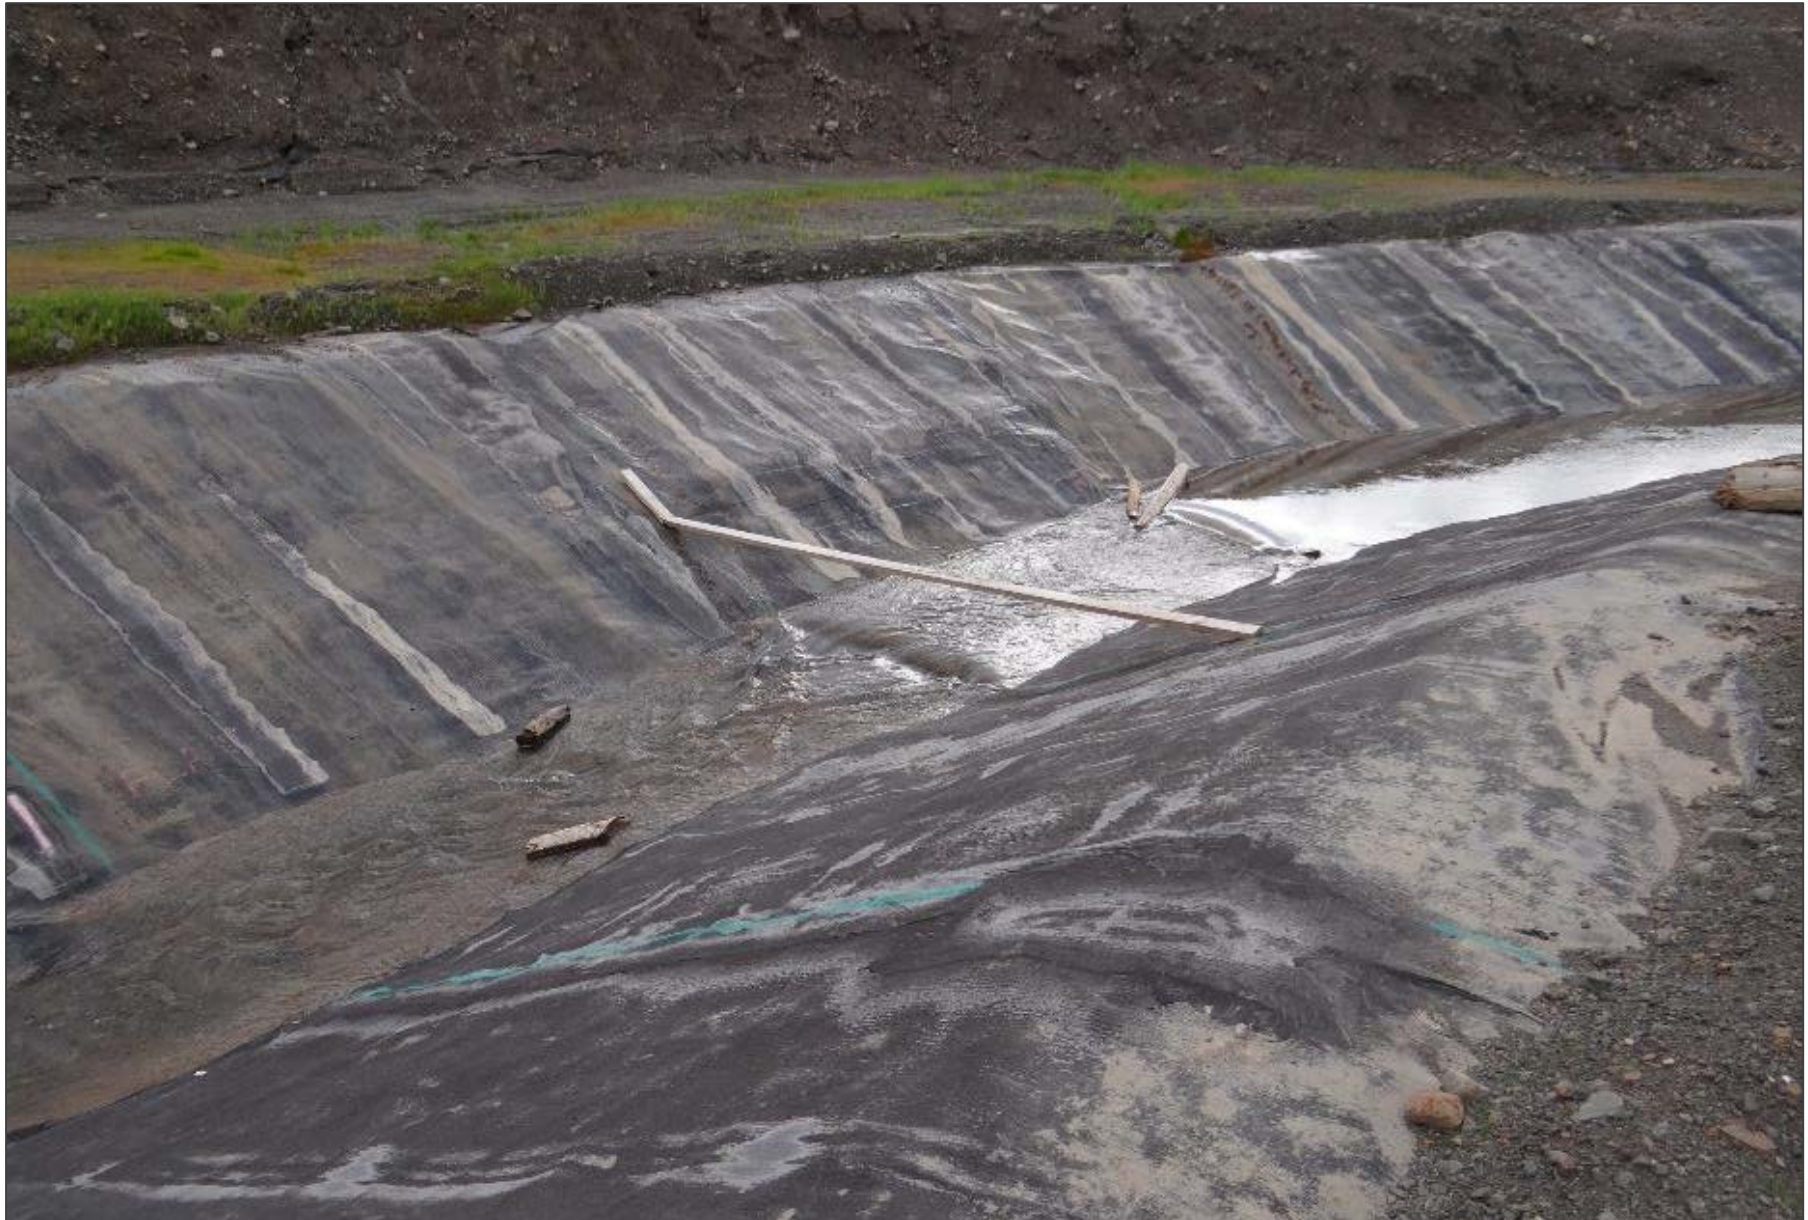
PHOTO 50

The North Reclaim Dam spillway was flowing at the time of the inspection. The spillway is shown in Photos 49 through 54; a record of the spillway flows is on Figure 9-1. The following were noted during the inspection:

Open channel spillway from the NRD reservoir. Flow rate from the NRD reservoir is monitored continually by RCDC using a datalogger.

2014-4	Floating debris should be removed from the North Reclaim Dam reservoir, and the spillway channel cleared of accumulated debris.	3	See Photos 49 and 50, and Section 5.4.	By end of Q4, 2014
2014-5	Cobbles near the crest of the North Reclaim Dam spillway slopes, which could fall into and damage the geomembrane, should be removed.	3	See Photo 52, and Section 5.4.	By end of Q3, 2015
2014-6	Construct armored outfall structure at North Reclaim Dam Spillway outlet, and repair scour that has occurred to date.	2	See Photos 53 and 54, and Section 5.4.	By end of Q4, 2014
2014-7	Read North Starter Dam piezometers at least bi-weekly going forward.	3	See Section 6.2. Data-loggers could be considered, to facilitate data gathering over the winter months.	Complete: bi-weekly readings implemented.

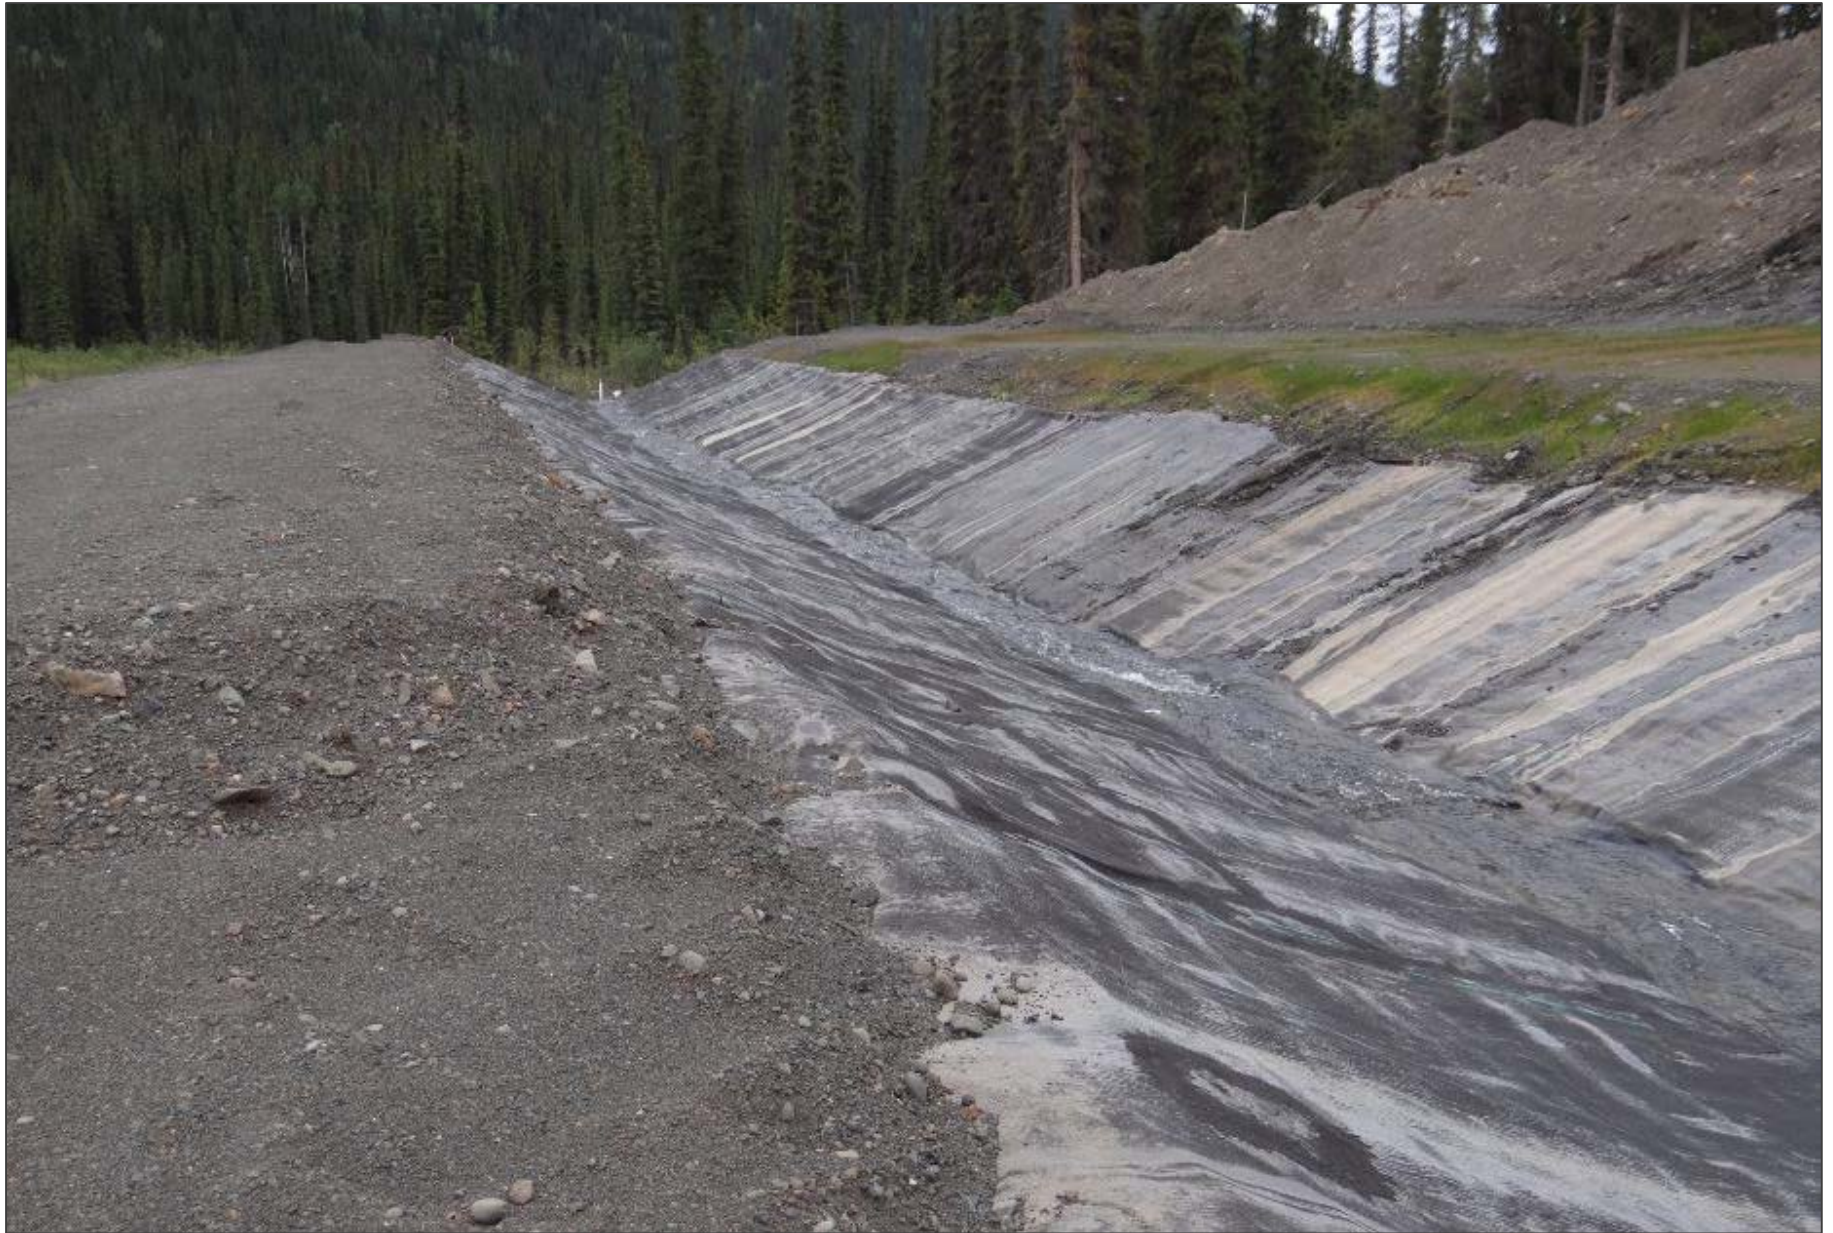
PHOTO 51

Open channel spillway from the NRD reservoir, looking downstream towards the outlet.

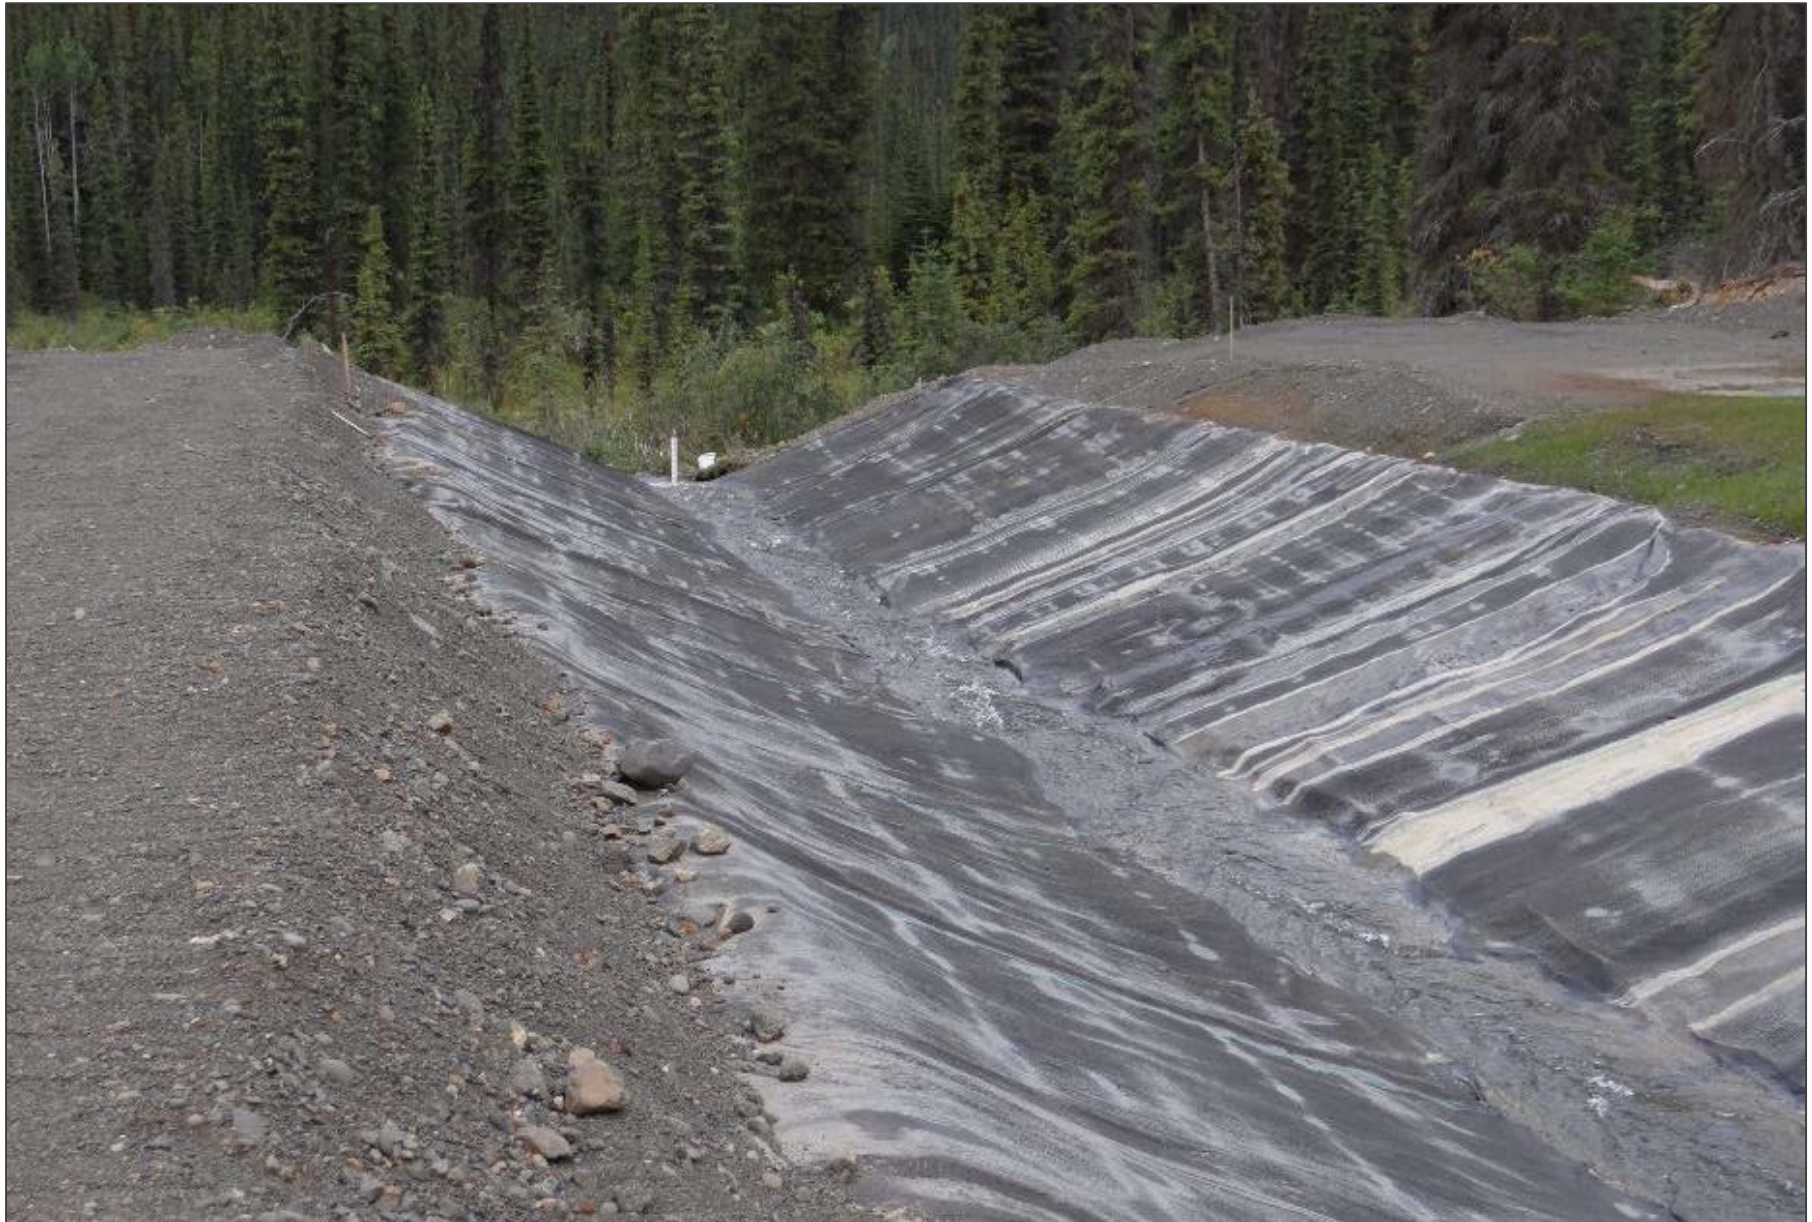
PHOTO 52

Open channel spillway from the NRD reservoir, looking downstream towards the outlet.

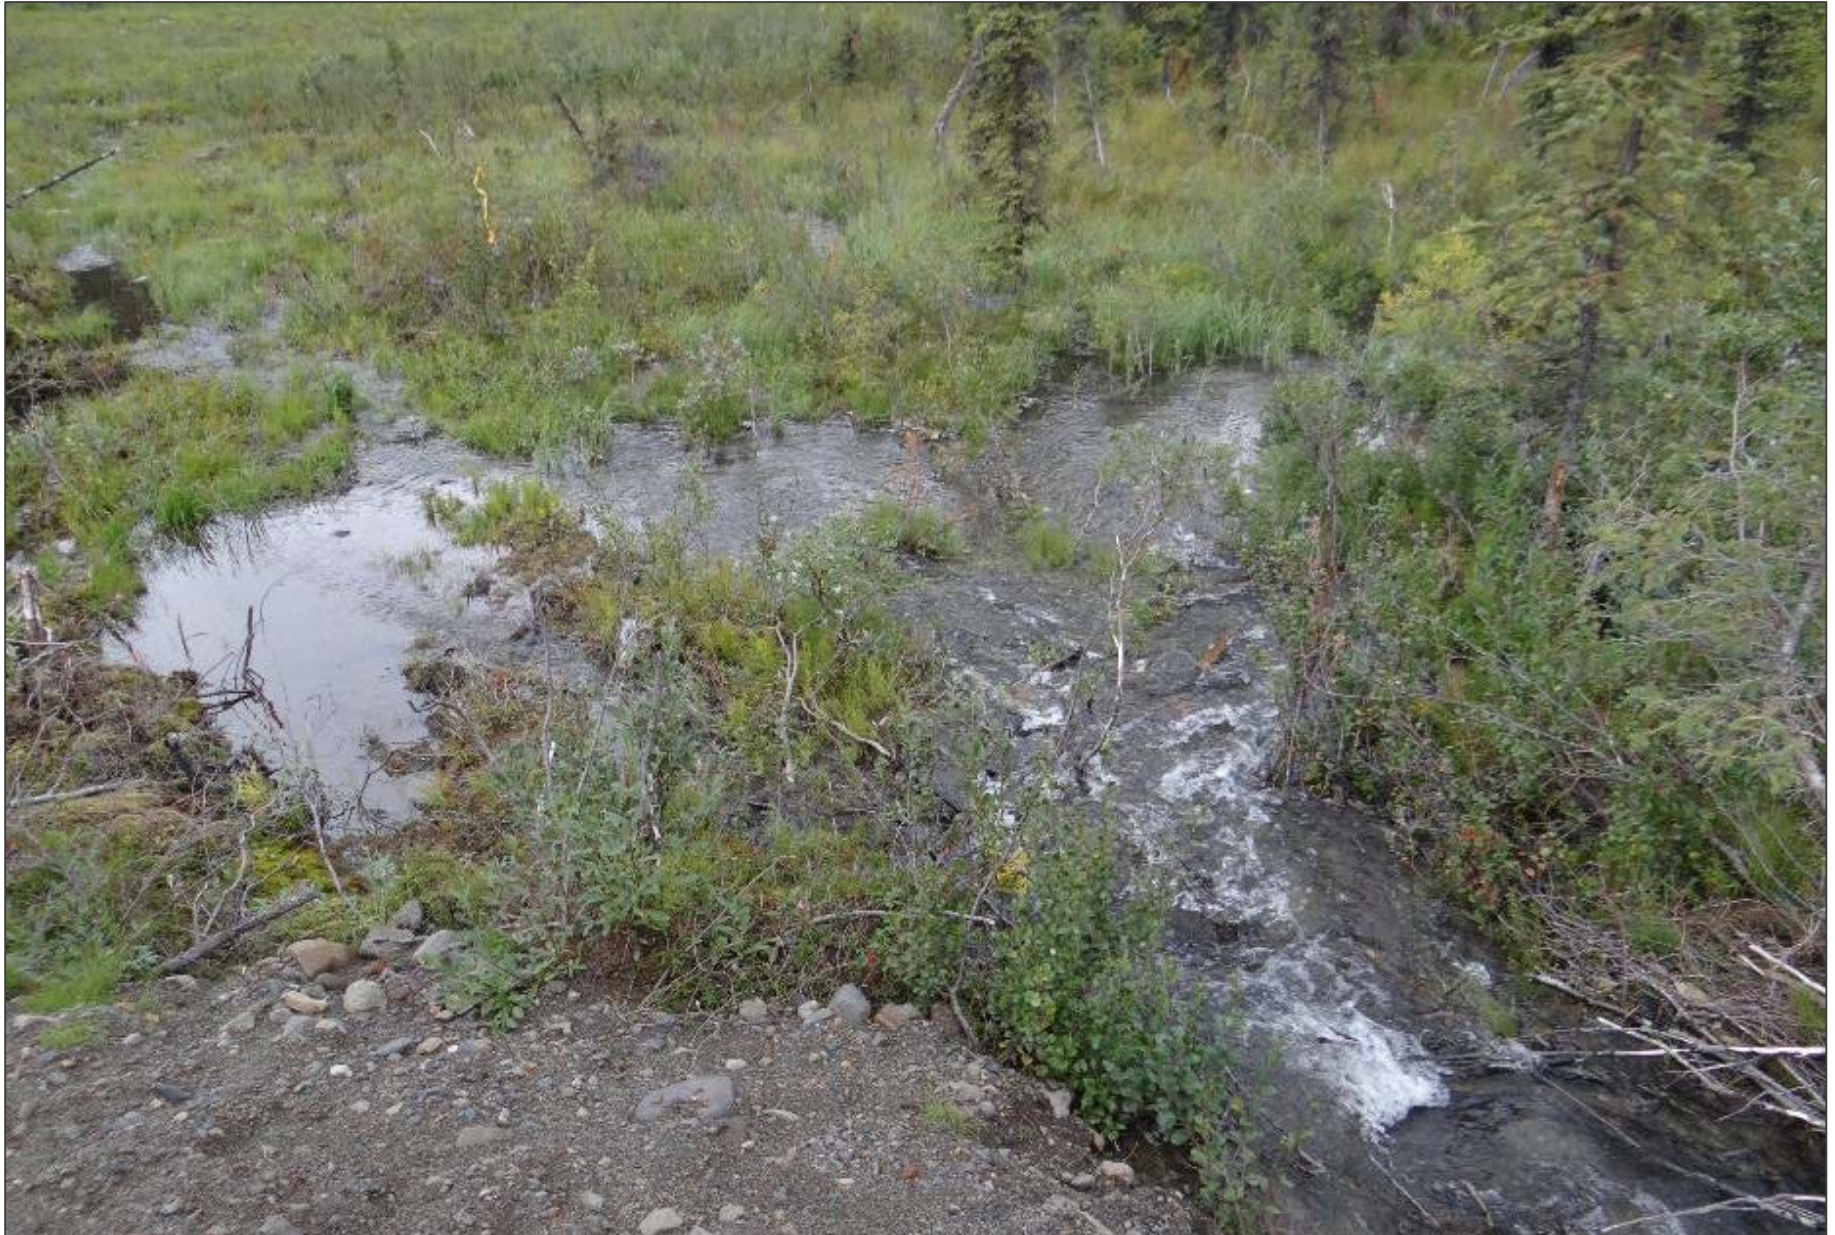
**PHOTO 54**

**Spillway discharge into meadow downstream of the NRD.**
