## **RED CHRIS DEVELOPMENT COMPANY LTD.**

### **RED CHRIS TAILINGS FACILITY**

## **2014 DAM SAFETY INSPECTION REPORT**

PROJECT NO.: 0866001.14.7  
DATE: November 24, 2014  
DOCUMENT NO.: 0866001.14.002

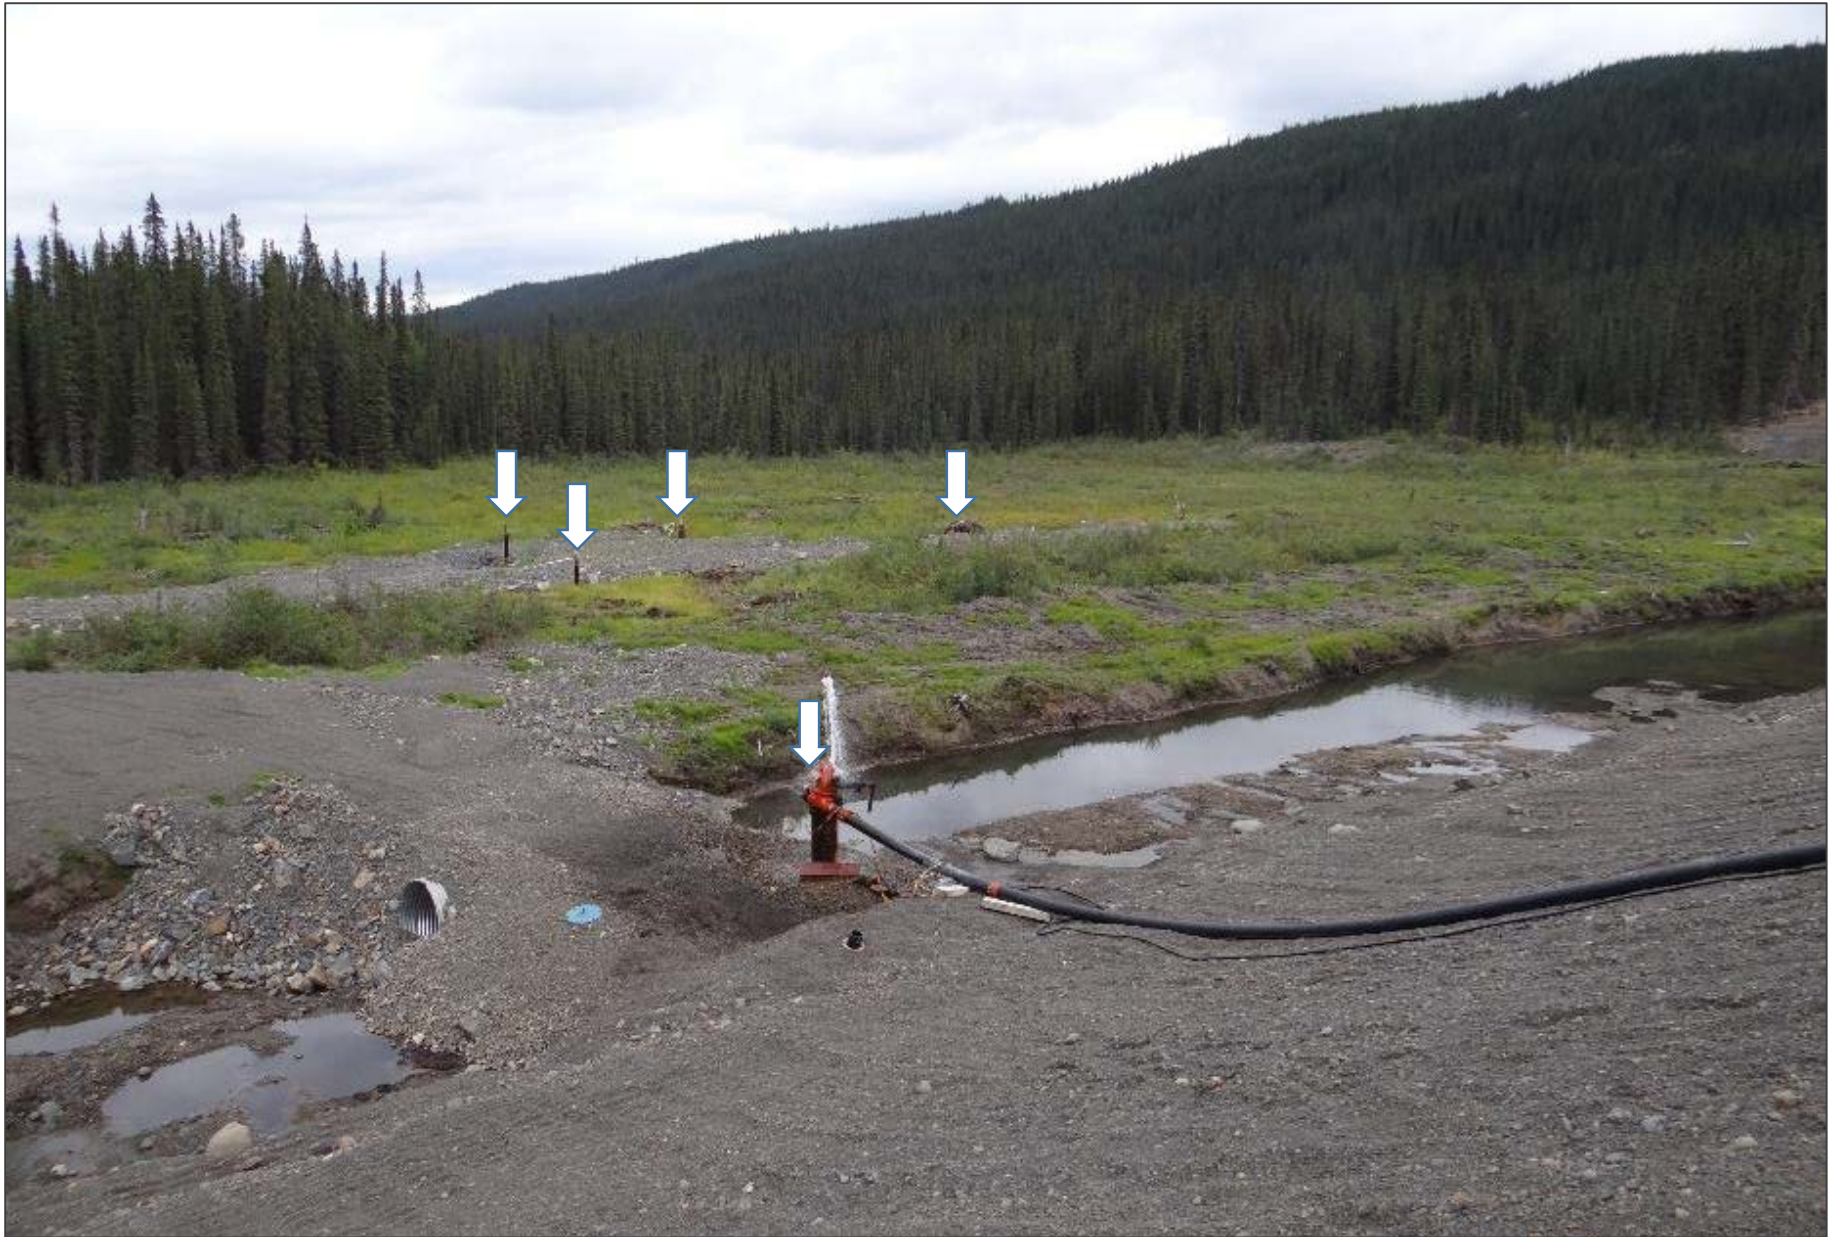
PHOTO 55

Area downstream of the NRD. Arrows indicate groundwater monitoring wells.

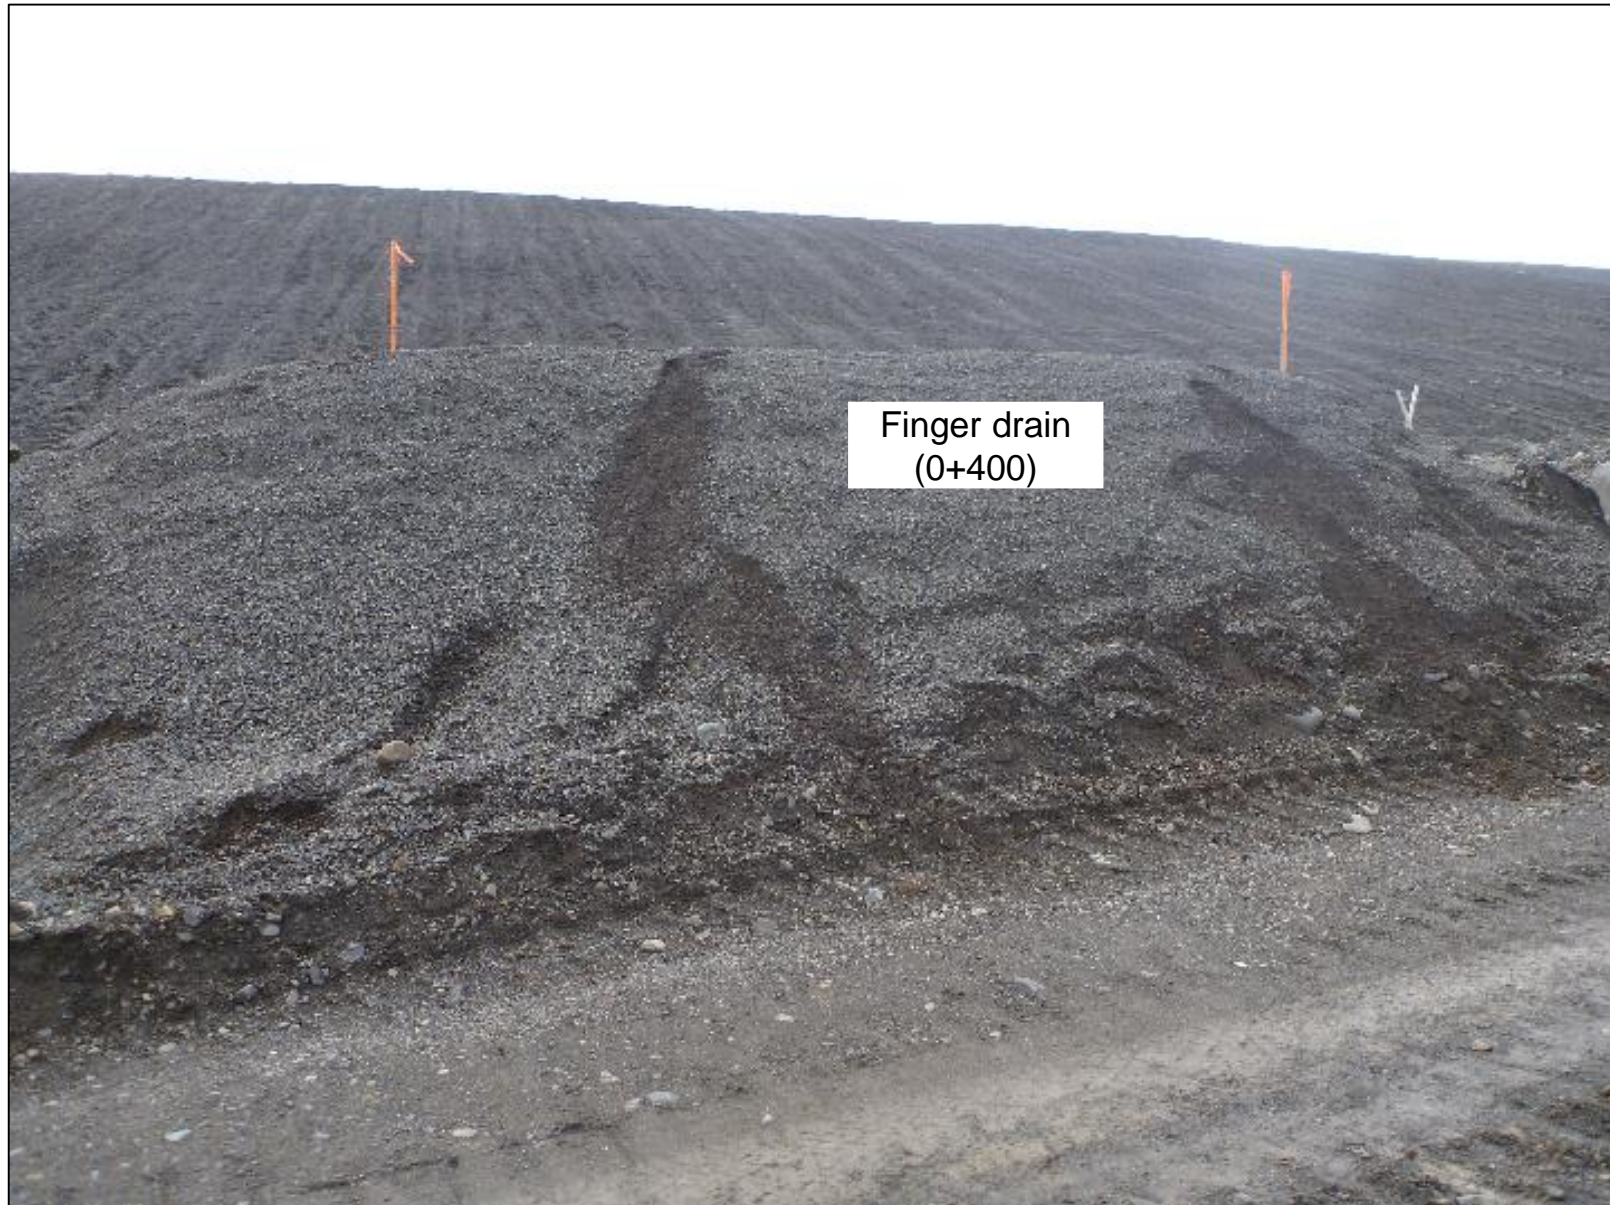
**PHOTO 5**

**Chainage 0+400: Finger drain with no visible seepage or ponding water. Looking south from access road below NSD toe.**

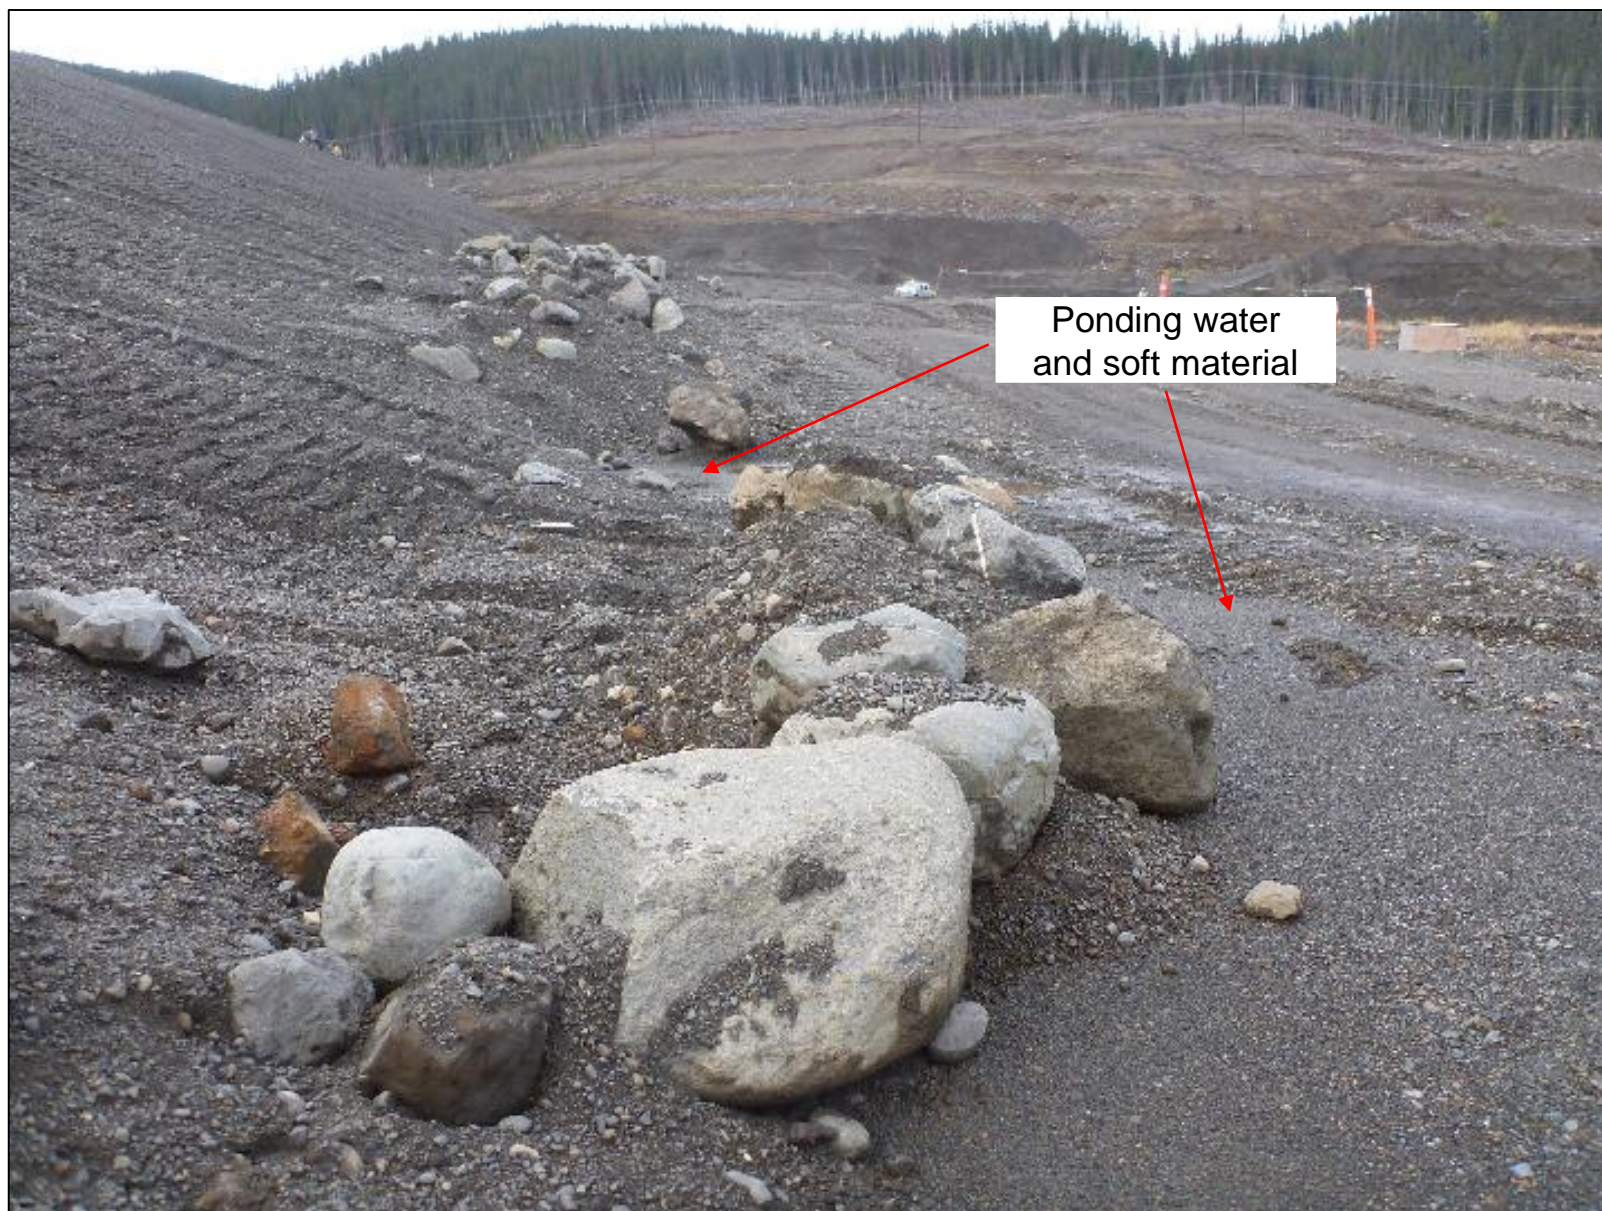
**PHOTO 7**

**Chainage 0+325: Ponding water and saturated material at toe of dam, not visibly flowing. Appears wet for ~5 m where downstream toe meets blanket drain. Footsteps appear wet once stepped on. Looking west.**

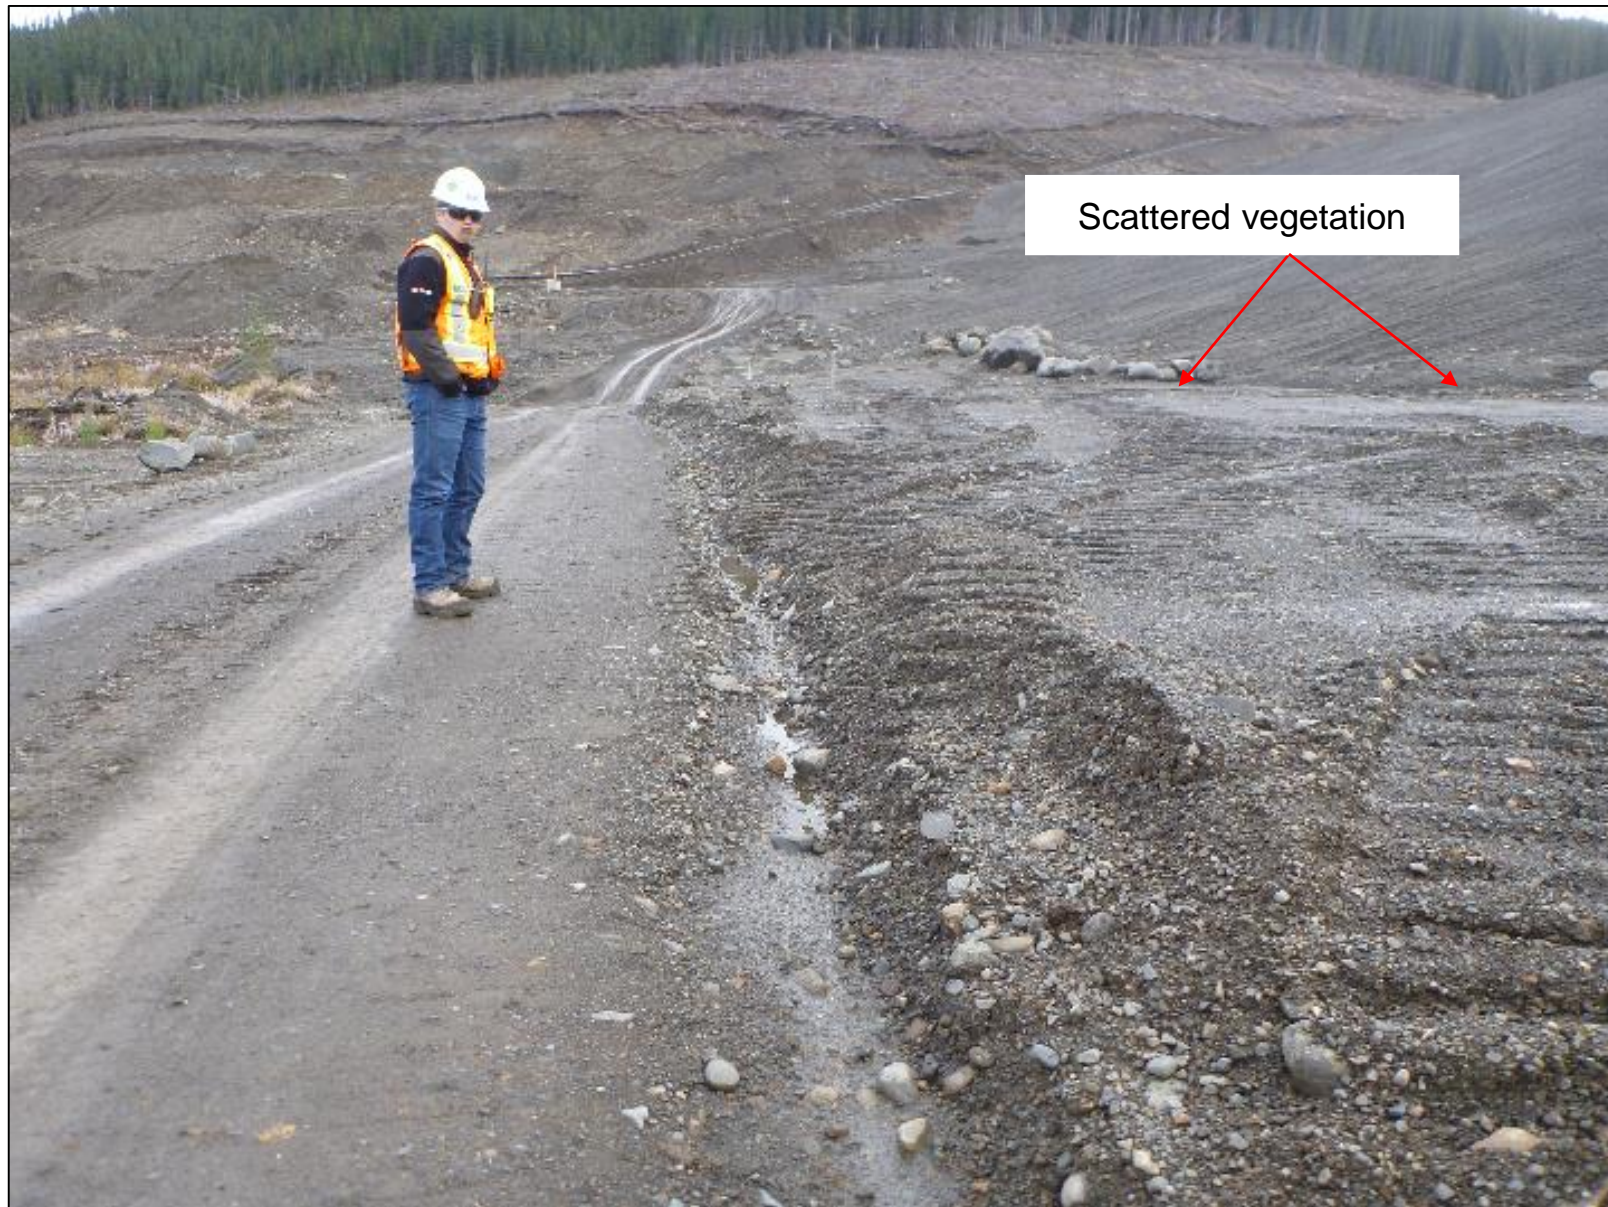
PHOTO 8

Chainage 0+270: Blanket drain appears wet at surface with scattered vegetation. Drainage ditch along toe. Looking east.

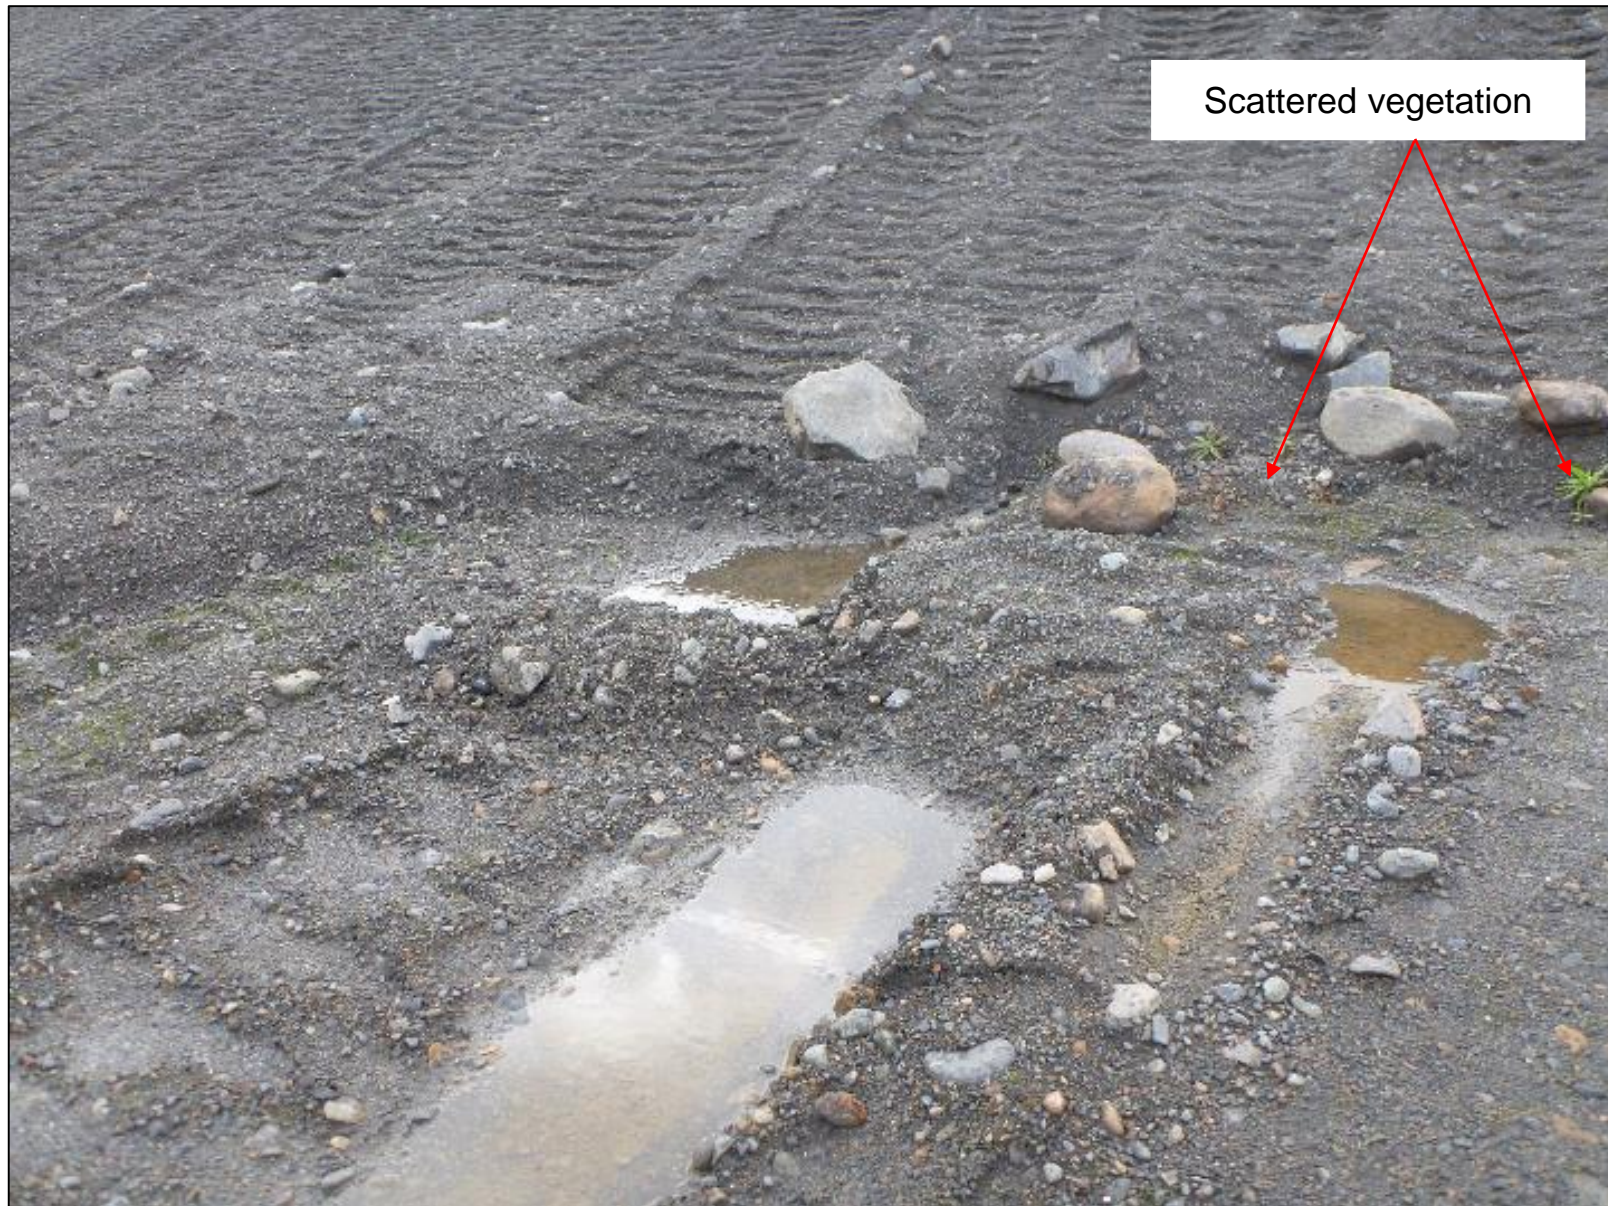
**PHOTO 9**

**Chainage 0+250: Ponded water where downstream slope meets blanket drain. Footsteps appear wet once stepped on. Looking south toward the downstream toe from blanket drain.**

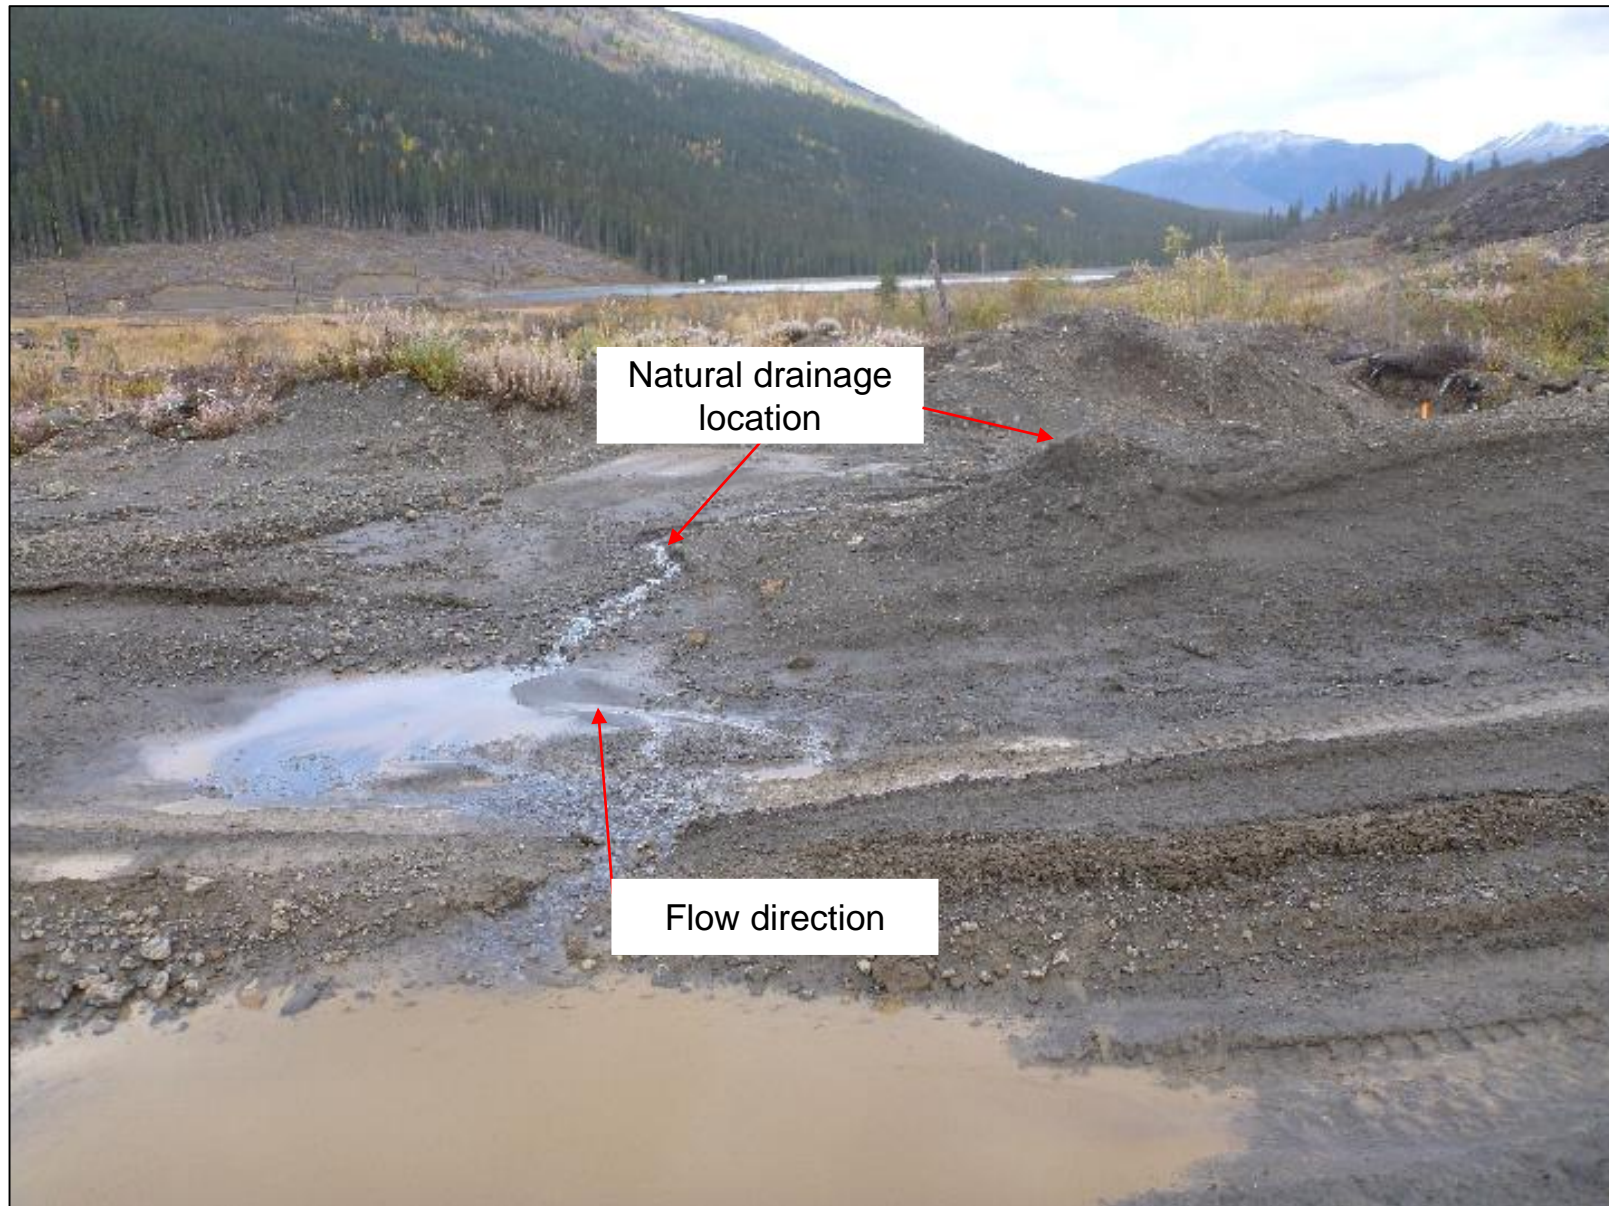
**PHOTO 11**

**Chainage 0+215: Trickling water on access road below NSD; this location is a low point on the downstream toe and blanket drain near where a natural creek flowed before dam construction. Looking north from NSD toe.**
