**BARRICK GOLD INC.
SNIP TAILINGS STORAGE FACILITY**

2014 DAM SAFETY INSPECTION

VA101-2/17-1
Rev 0
November 28, 2014

**2014 DAM SAFETY INSPECTION
VA101-2/17-1**

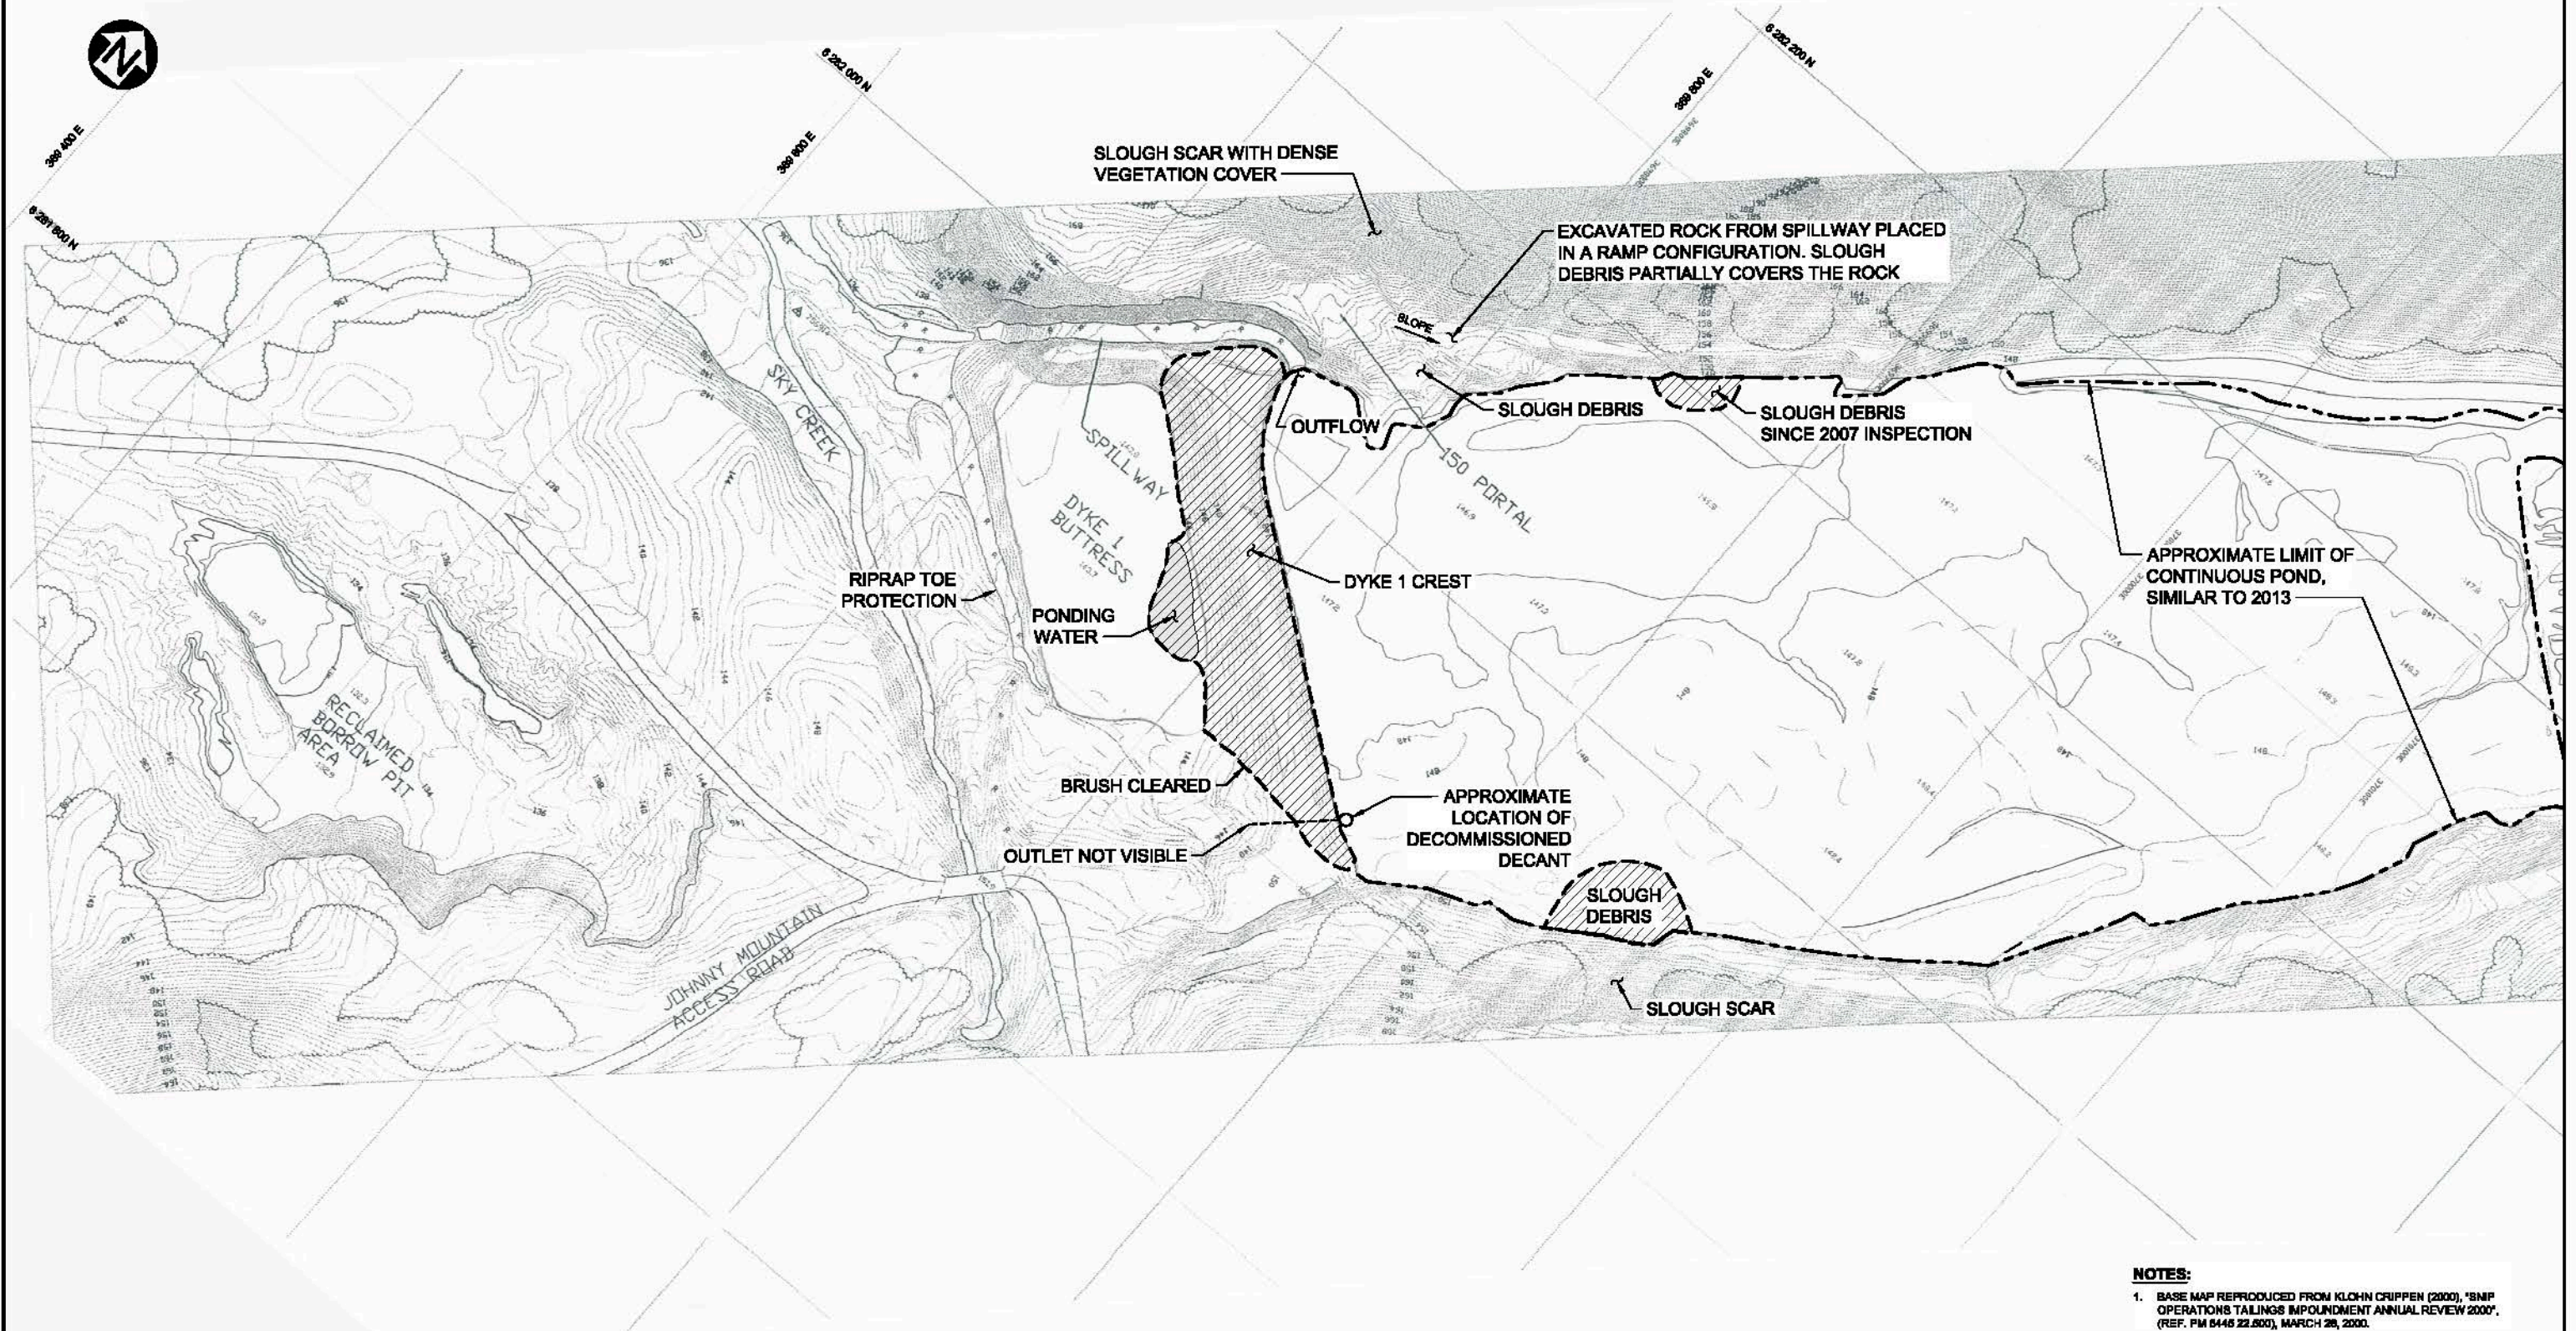
FIG. NO. VA101-2/17	REF. NO. 1
FIGURE 2.1	
REV 0

The general arrangement of the Snip TSF, annotated with conditions and observations during the 2014 inspection, is provided as Figures 2.1 and 2.2. Photographs from the site visit are provided in Appendix B and an inspection checklist of the major features of the TSF, including condition assessments and recommendations, is provided in Appendix C. Observations of major features are summarized in the following sections.

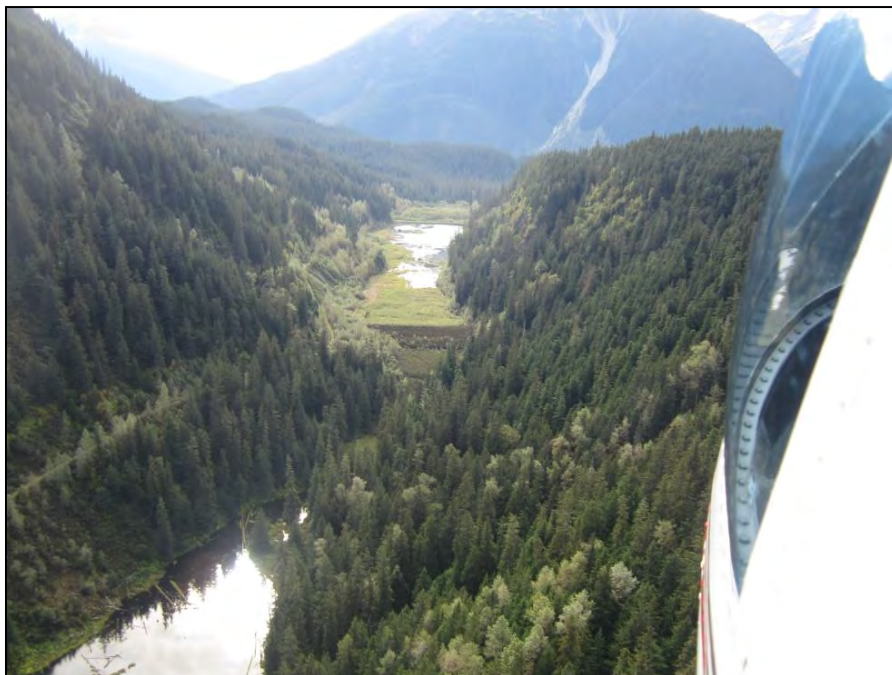
PHOTO 2 – Dyke 3 Overview from downstream.

- The vegetation on the crest, upstream slope, downstream slope and stability berm of Dyke 3 is very thick and well established. There is very limited visibility of the Dyke 3 ground surface from air (Photo 2).

- No surface water was ponded against the upstream face of Dyke 3 (Photos 22 to 24).
- Very thick vegetation growth, approximately 3 m high, was present on Dyke 3, including the dyke crest, downstream slope, closure stability berm. The vegetation growth made progress difficult and limited visibility to a few meters (Photos 28 and 29). A thorough visual inspection of Dyke 3 was not possible. The clearing of this vegetation from the upstream rip rap to the crest of the stability berm is recommended.

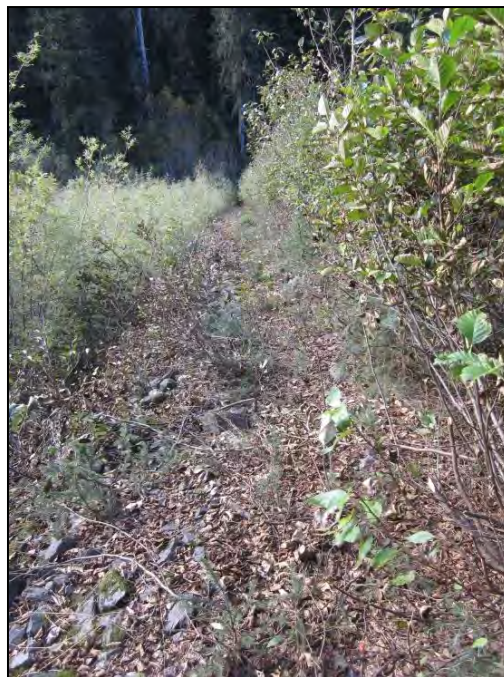
PHOTO 26 – Dyke 3 – Clear upstream crest of dyke at intersection with the downstream face of Dyke 3.

- An assessment of the upstream face of the dyke crest and the riprap was completed (Photos 26 and 27).
- Inspection of the dyke crest and downstream face was not possible due to the dense vegetation cover (Photos 28 and 29).

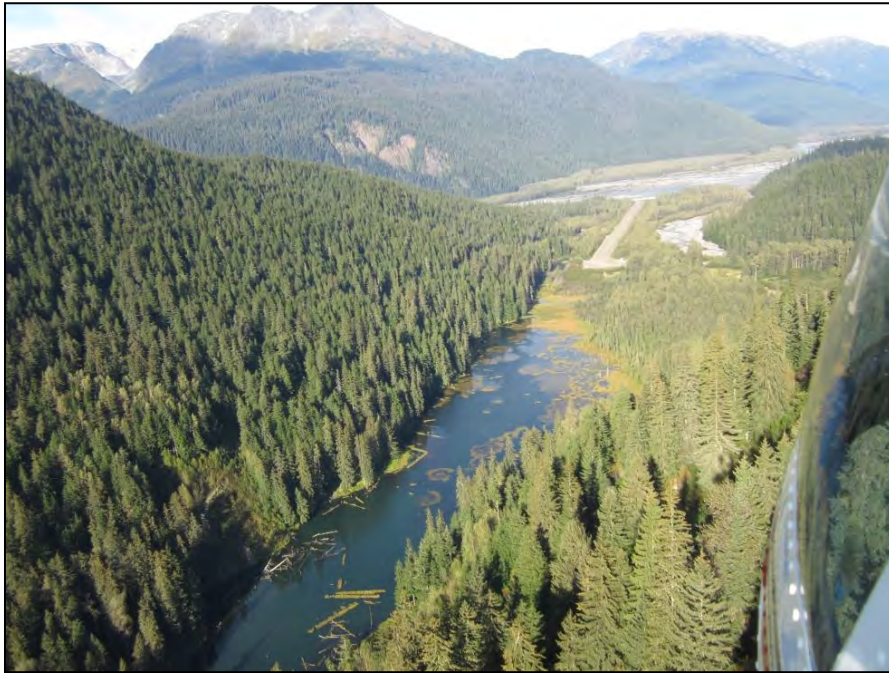
- There is potential for a temporary population or a seasonal workplace below Dyke 3 at the closed Bronson Creek Airstrip located between 1,250 m and 2,500 m downstream of Dyke 3 and at a historical fishing camp comprised of several structures located at the far end of the airstrip 2,500 m downstream of Dyke 3 as shown on Figure 3.1 and Photos 31 & 32. Both of these facilities are located below Monsoon Lake a narrow 900 m long lake and are currently unused and unoccupied. Based on a desktop assessment it is unlikely a dam breach would impact these facilities. However, as a dam breach analysis has not been completed for the site and is beyond the scope of this report. A dam breach analysis is not required for a SIGNIFICANT class dam. Therefore, the population is assessed by conservatively considering Dyke 3 to have 'a temporary population at risk'.

PHOTO 31 – Downstream of Dyke 3 – Bronson Lake Airstrip in the background.

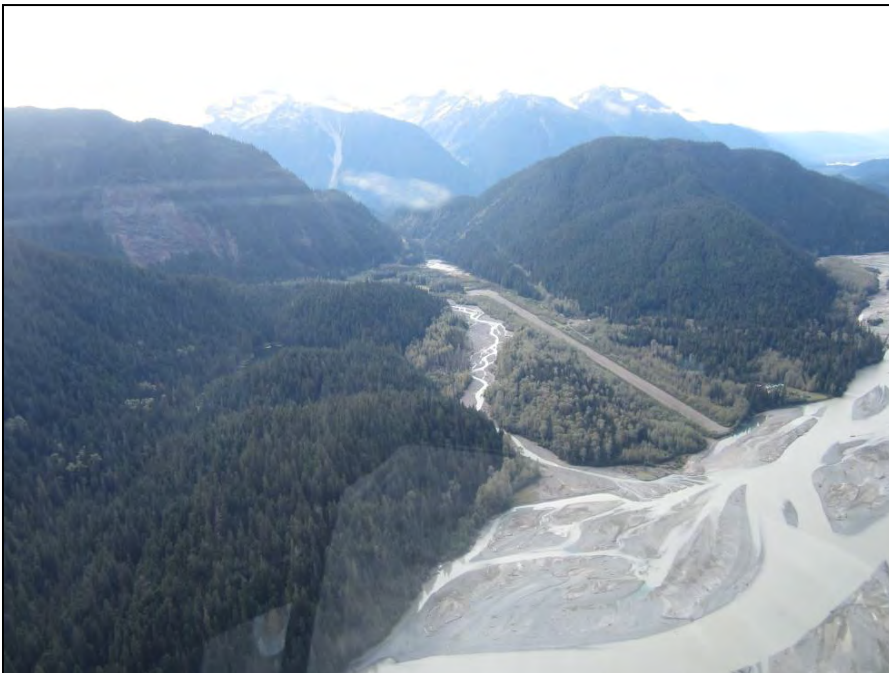
PHOTO 32 – Bronson Lake Airstrip and historic fishing camp cabins downstream of Dyke 3.
