November 21, 2014

CONFIDENTIAL
FILE: V15103110-01Cassiar Gold Corporation
China Minerals Mining Corporation
Suite 1100 – 1111 Melville Street
Vancouver, BC V6E 3V6**ISSUED FOR USE**

Subject: Report on Dam Safety Inspection
Tailings Storage Facility – Cassiar Gold Mine
near Jade City, BC

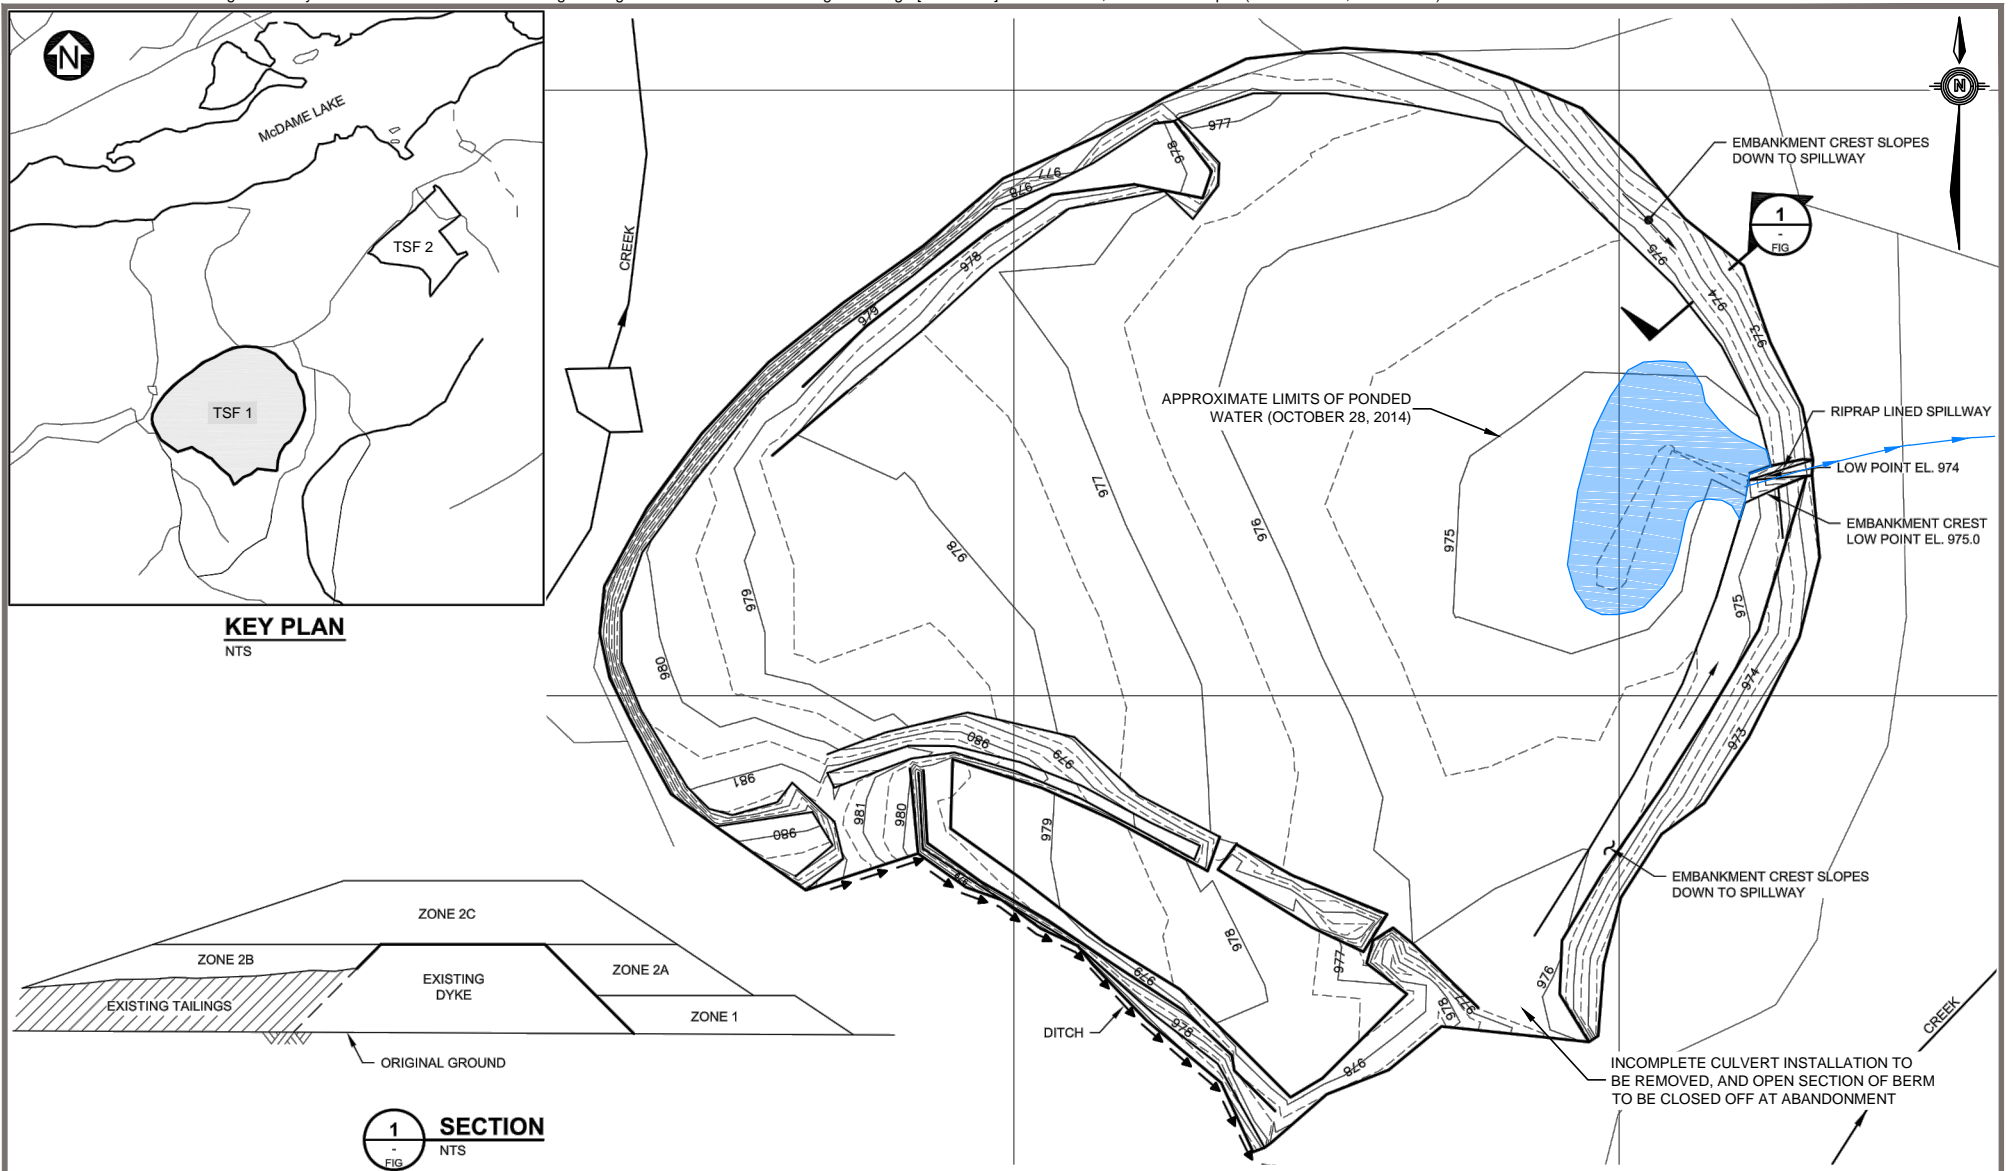
The south end of TSF 1 contained an incomplete culvert installation (see Figure 2 and Photo 3) probably for water management purposes. As this end of the pond is a couple metres higher than the existing spillway, it will likely never convey water. It is recommended that this partially installed culvert be removed and the embankment closed off and repaired at abandonment.
