KGHM AJAX MINING INC. AFTON TAILINGS STORAGE FACILITY

REPORT ON 2014 ANNUAL INSPECTION

VA101-246/39-1
Rev 0
October 1, 2014

AFTON TAILINGS STORAGE FACILITY REPORT ON 2014 ANNUAL INSPECTION VA101-246/39-1

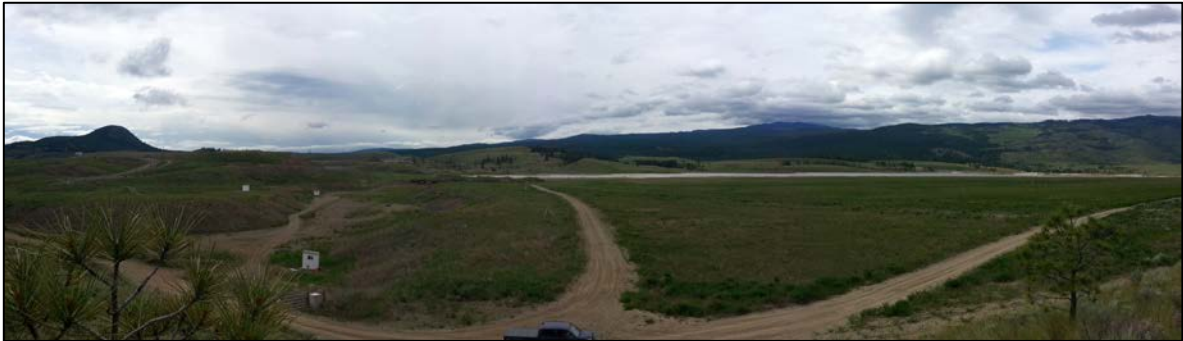
Figure 1.3 Panoramic View of Afton TSF from the Northeast Corner

Figure 1.3 shows a panoramic view across the Afton TSF taken during the inspection.

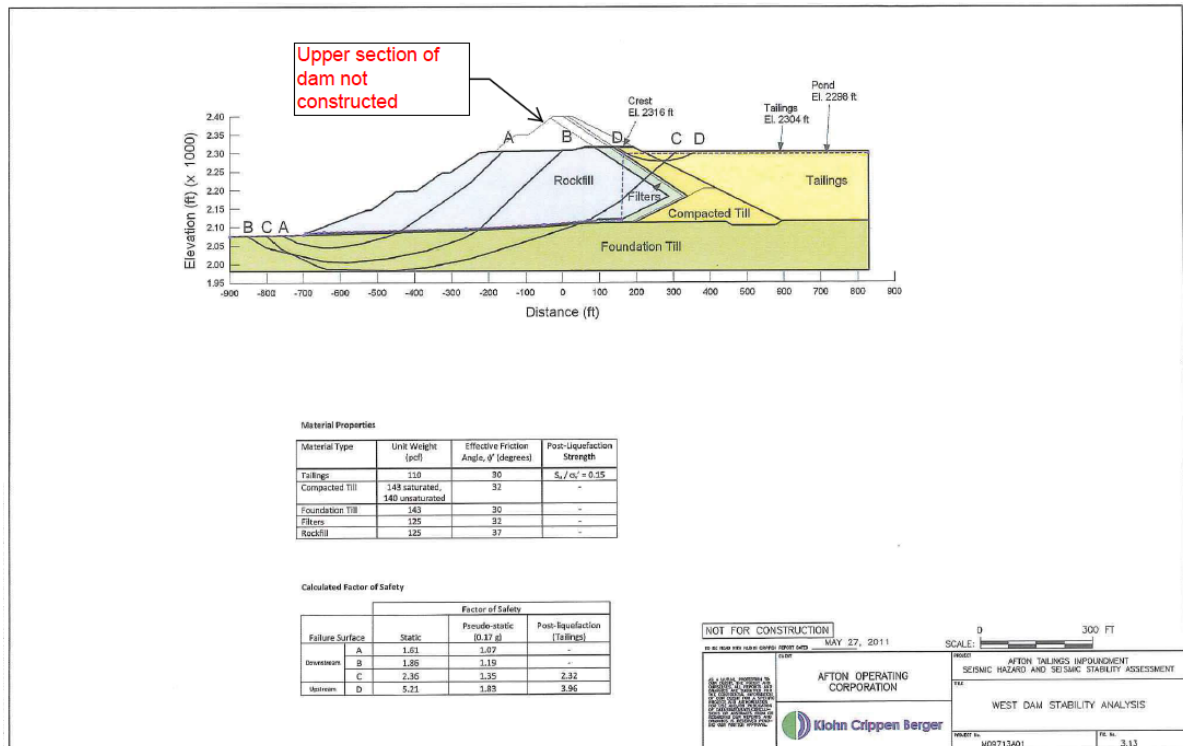
Figure 2.1 Dam Cross Section from 2011 KCB Stability Assessment

The tailings dams were initially constructed in 1976 and 1977 and were progressively raised using the downstream construction method during the mine operating period. The dams are comprised of an upstream till zone, filters, and a downstream rockfill zone as shown on the KCB cross section for the West Dam that was used in the 2011 stability assessment (Figure 2.1).

The assessment considered the embankment section shown on Figure 2.1 and used the 1 in 10,000 year peak ground acceleration (PGA) value of 0.34g and a corresponding earthquake magnitude of 7.3. The conclusions from the stability assessment were:

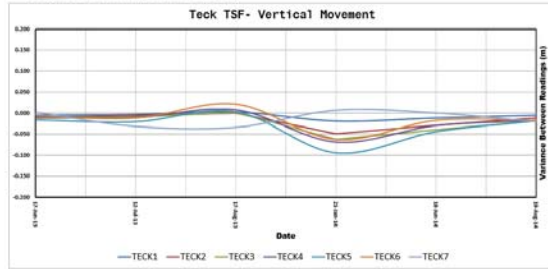
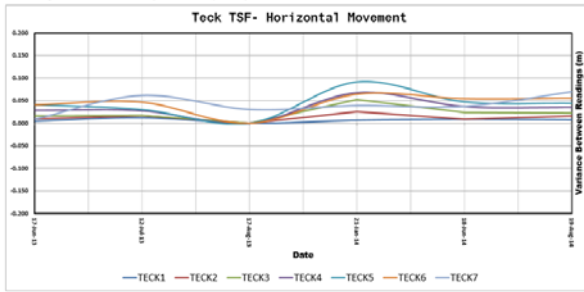
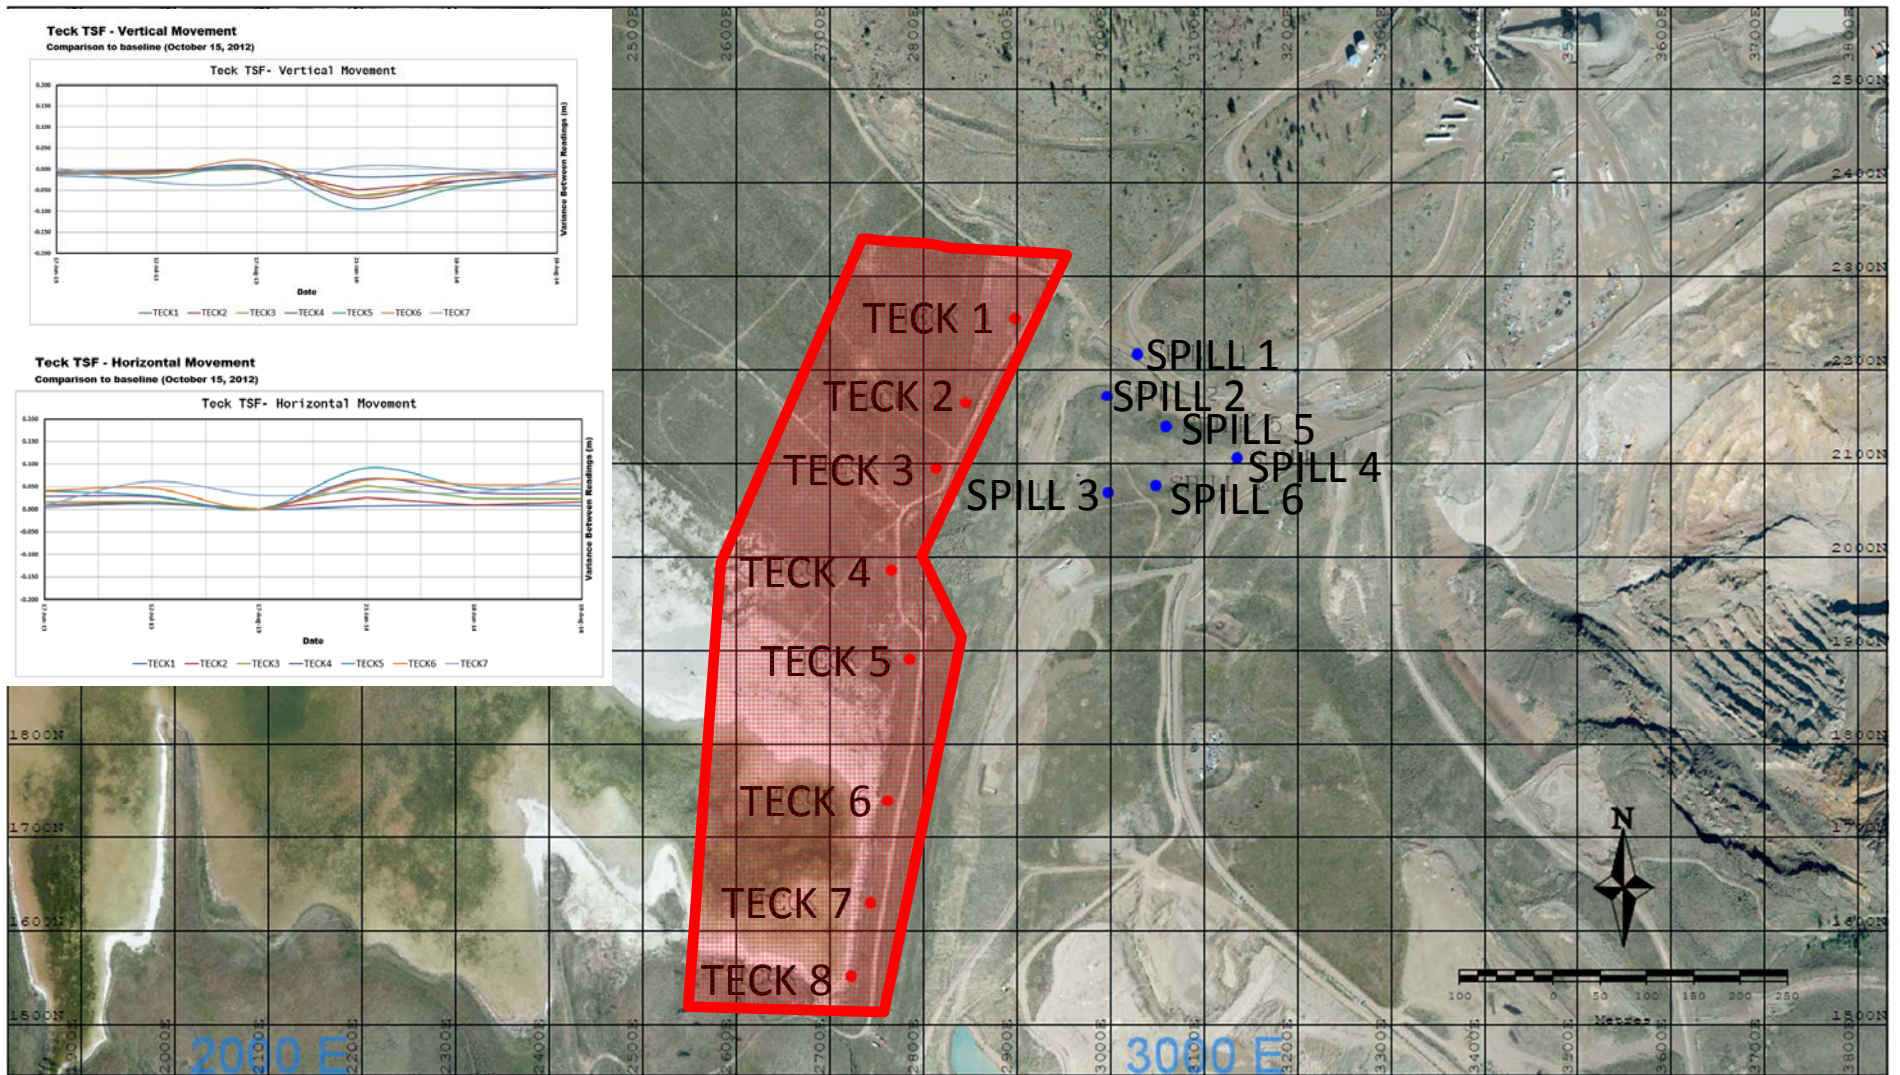
TECK TSF PRISMS
PLAN VIEW

Teck TSF - Vertical Movement
Comparison to baseline (October 15, 2012)

Teck TSF - Horizontal Movement
Comparison to baseline (October 15, 2012)

Negligible movement can be attributed to environmental differences from day to day.

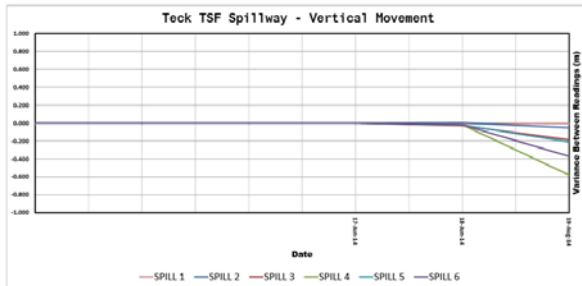
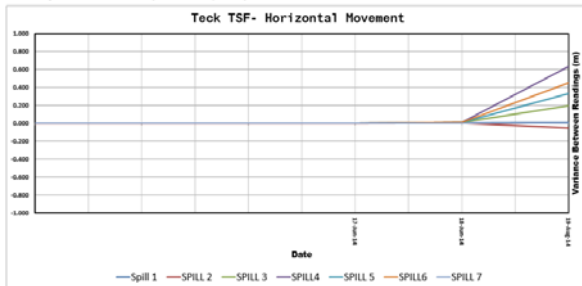
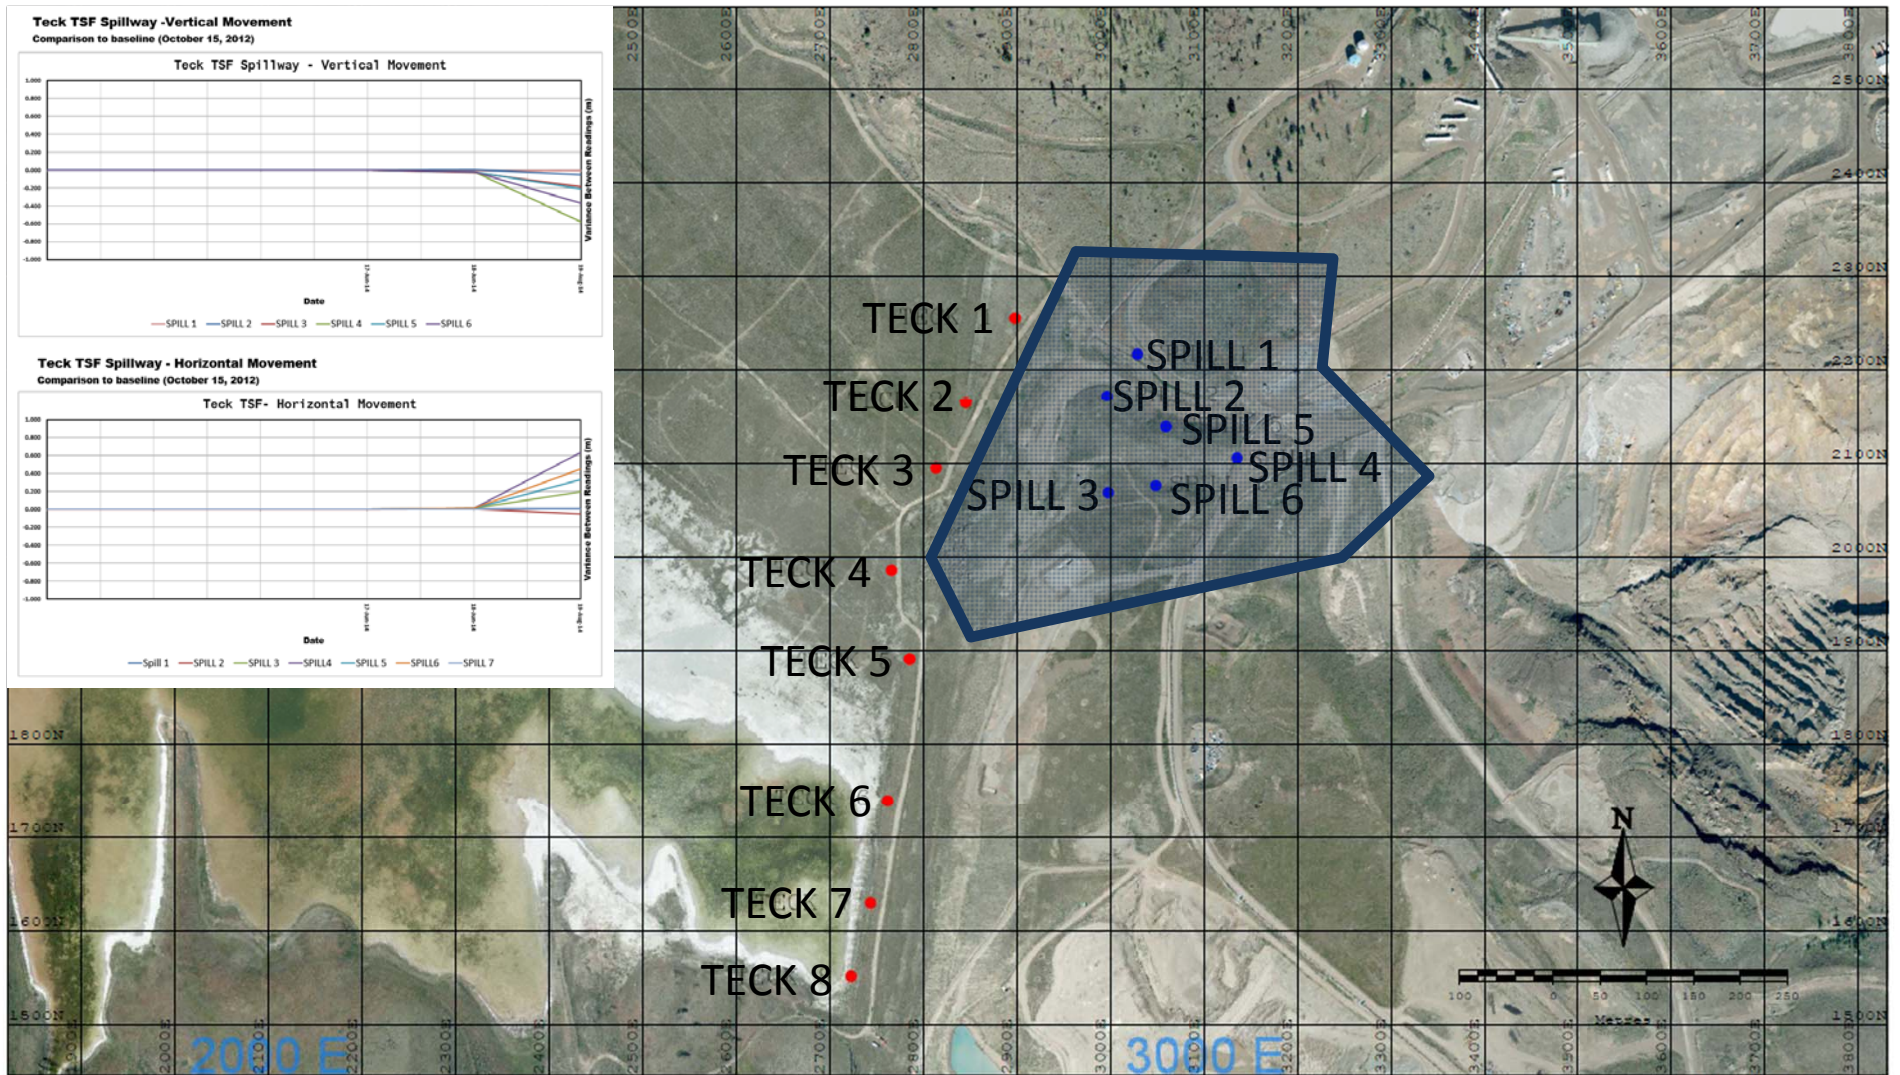
TECK TSF PRISMS
PLAN VIEW

Teck TSF Spillway - Vertical Movement
Comparison to baseline (October 15, 2012)

Teck TSF Spillway - Horizontal Movement
Comparison to baseline (October 15, 2012)
