**MOUNT POLLEY MINING CORPORATION
MOUNT POLLEY PROJECT
TAILINGS STORAGE FACILITY**

**OPERATION, MAINTENANCE
AND SURVEILLANCE MANUAL
FOR STAGE 1b EMBANKMENT (El. 934m)
(REF. NO. 10162/7-3)**

NOVEMBER 24, 1997

Knight Piésold
CONSULTING ENGINEERS

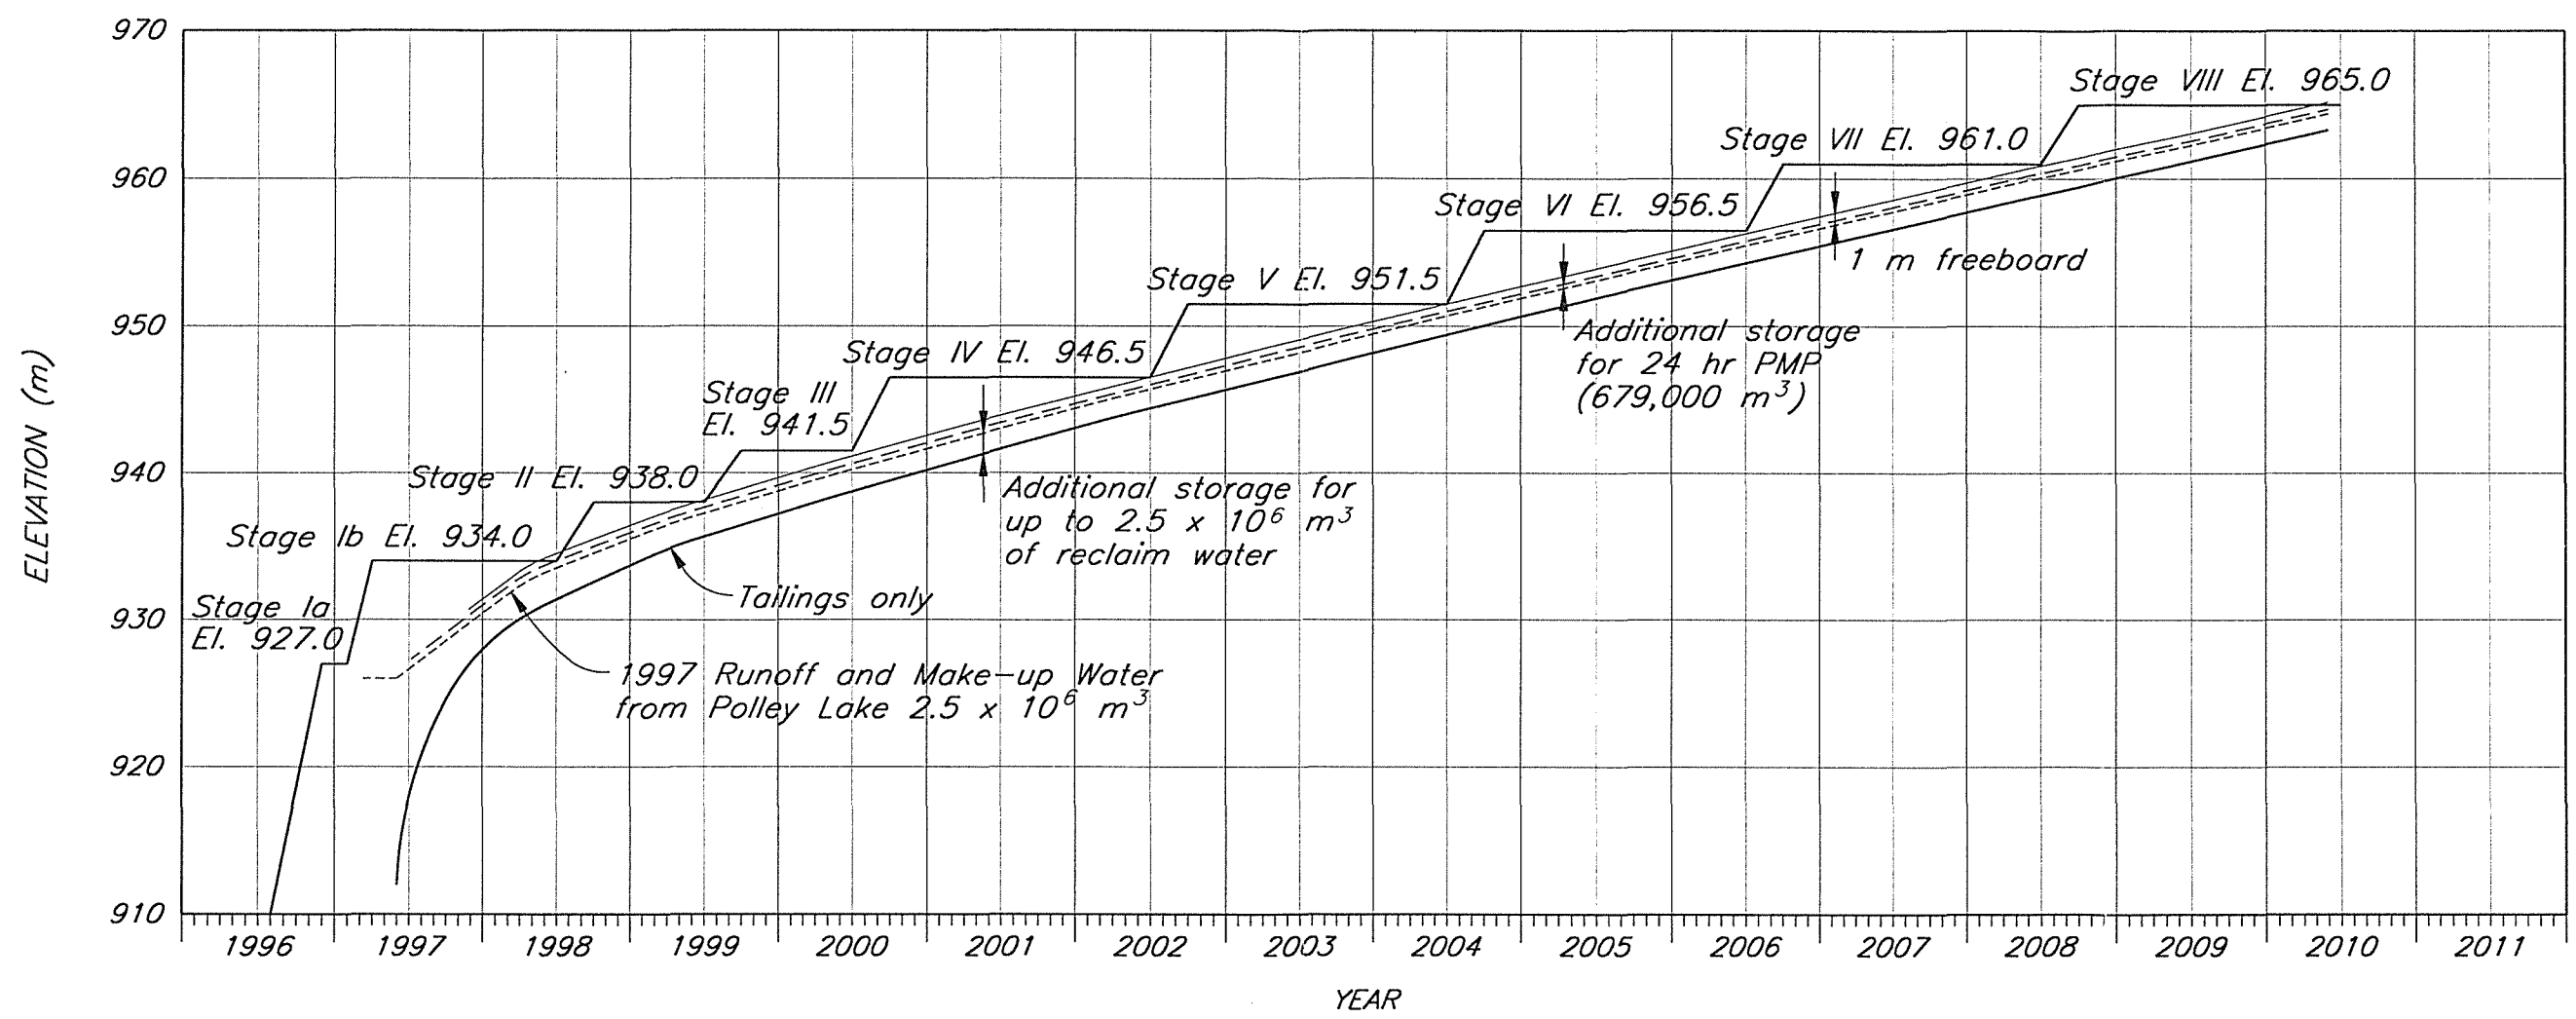
MOUNT POLLEY MINING CORPORATION
MOUNT POLLEY PROJECT
TAILINGS AREA FILLING SCHEDULE AND STAGED CONSTRUCTION
FOR 6,500,000 tpy THROUGHPUT

1. All construction periods shown are for July through September, except Stage Ib, which is February through March.
2. Filling schedule based on tailings dry density of 1.1 t/m³ in Year 1, 1.2 t/m³ in Year 2 and 1.3 t/m³ for remainder.
3. Embankment crest elevations for each of the staged expansions will be determined annually based on tailings production, in-situ density and water management requirements.

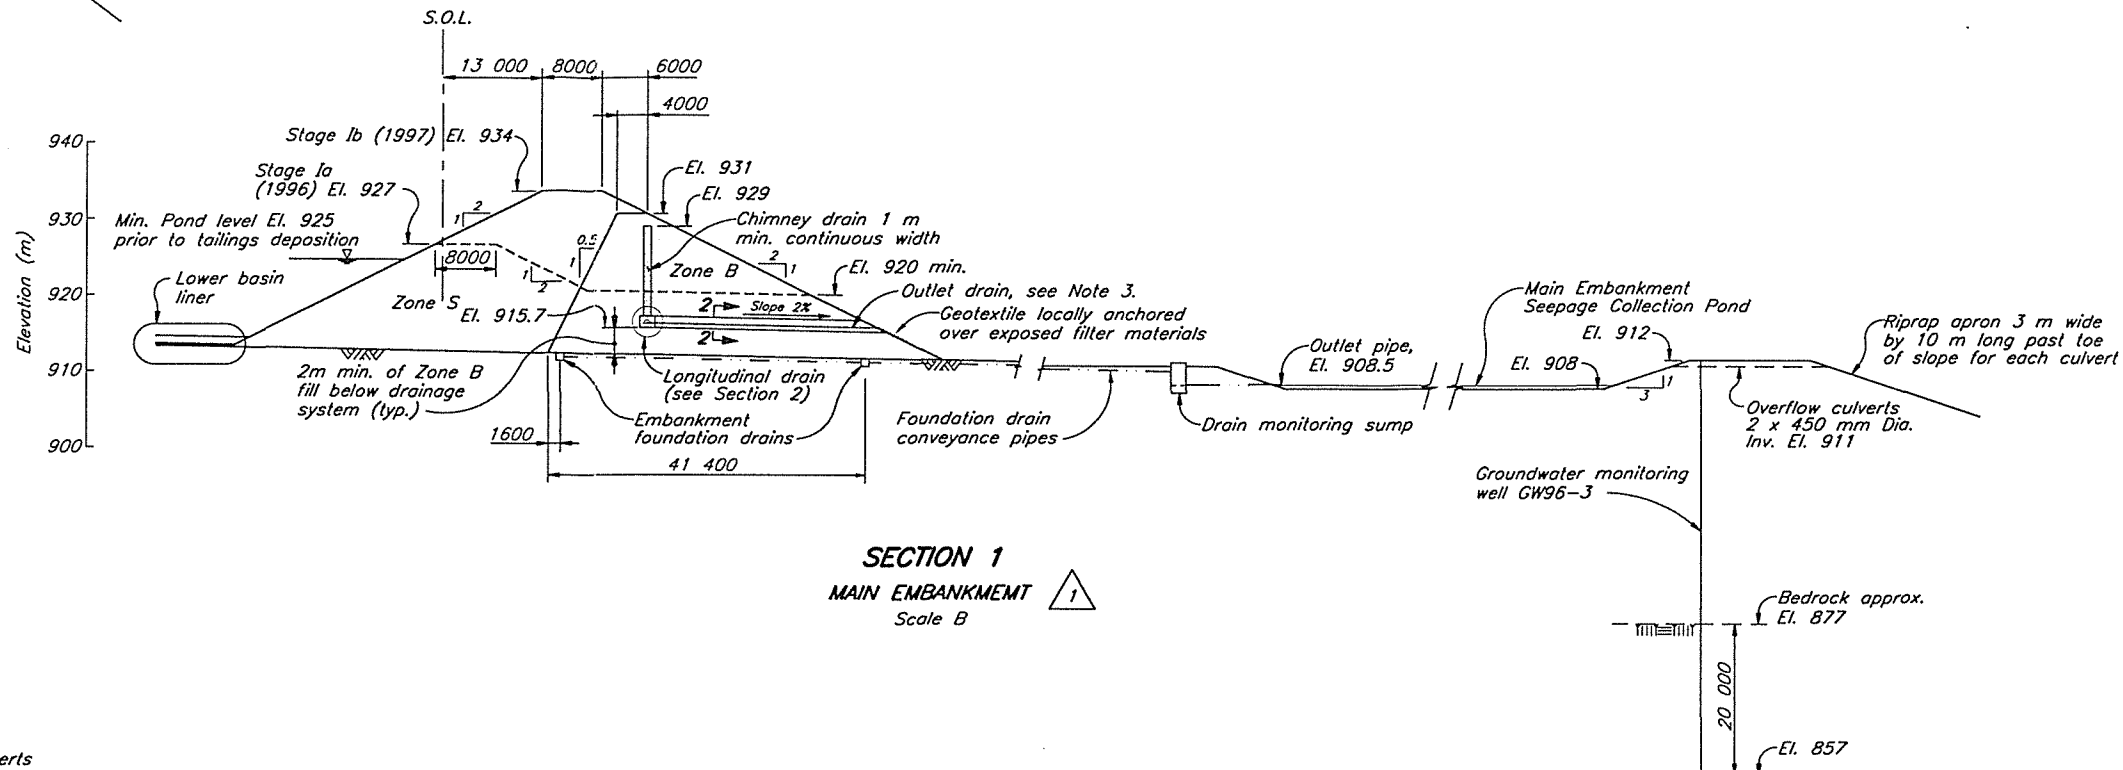
SECTION 1
MAIN EMBANKMENT
Scale B

- NOTES**
1. Longitudinal drain installed with invert El. 915.7 m approx. Ch. 18+50 to 23+00. On the right abutment, (Ch. 16+00 to 18+50) it was installed to invert El. 929 m in placed and compacted Zone B fill. On the left abutment (Ch. 23+00 to 25+25) it was installed in original ground, following the prepared ground surface.
 2. HDPE toe drain conveyance pipe to be installed at later date. To be bedded with concrete as shown on Drg. No. 1625.202.
 3. Outlet drains to be extended to Drain Monitoring Sumps during Stage II construction.
 4. As-built information provided by Mount Polley Mining Corporation.
 5. Topography has not been updated for 1997 Flyover.

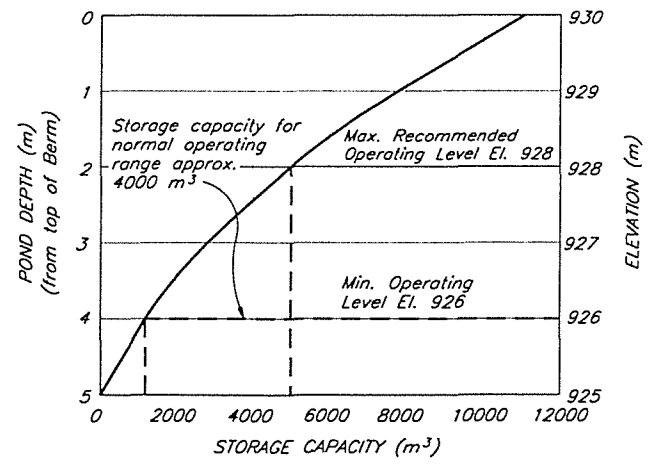
PERIMETER EMBANKMENT SEEPAGE COLLECTION POND
DEPTH/CAPACITY RELATIONSHIP

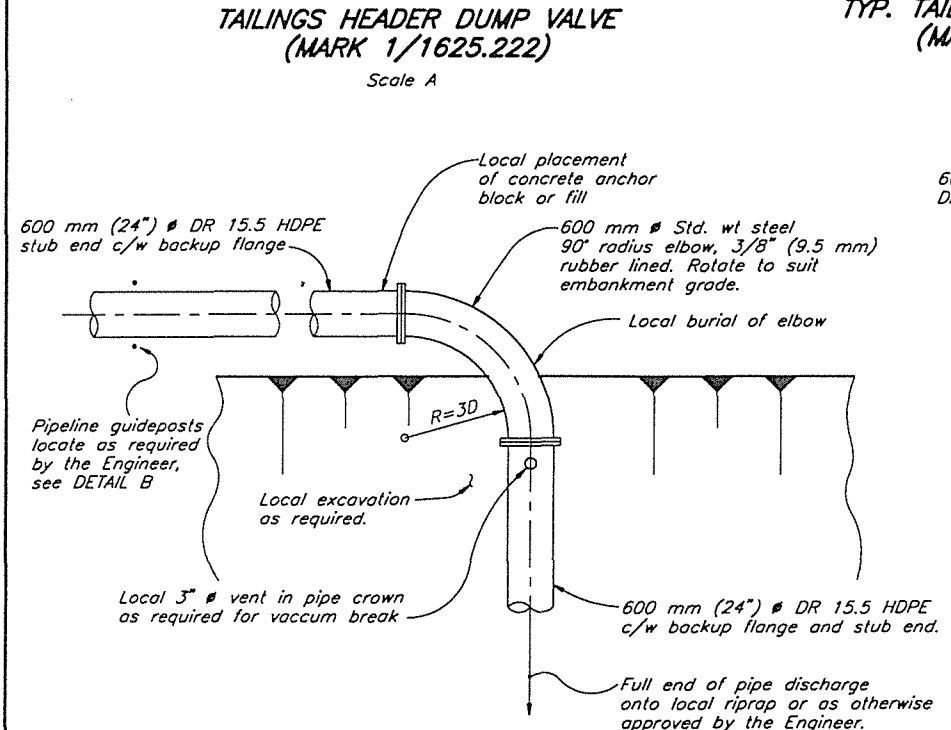
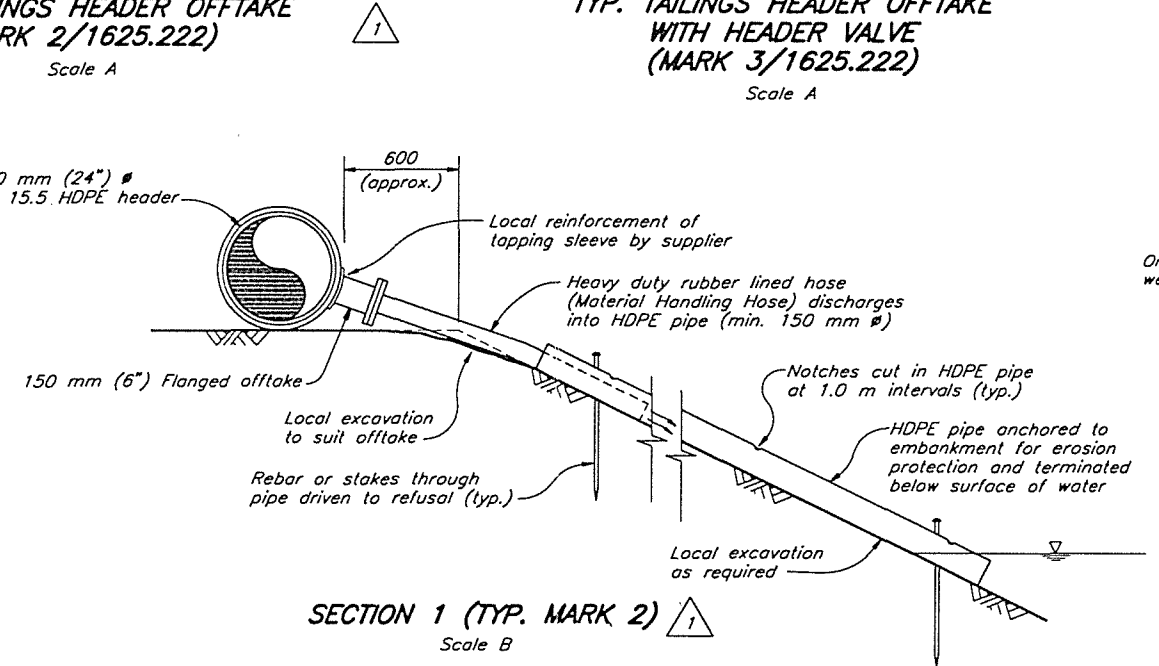
DATE: JULY 15, 1996
SCALE AS SHOWN
DRG. NO. 1625.224
REV. 1

- NOTES**
- Rubber lining to be Linatex PGR or approved equivalent.
 - Pipe restraint by local burial of pipeline or as otherwise required by the Engineer to control movement due to thermal and hydraulic forces.
 - Robar 6626 c/w 1/4" rubber lining of offtake and external reinforcement of offtake to sleeve joint.
 - HDPE Pipe ID exceeds that of knife gate valve and is to be field bevelled to match.
 - HDPE pipelines to be connected under cool conditions with snaking allowance made for additional thermal contraction of empty pipeline.
 - Mark 2 and 3 offtakes to be added as required.

**TAILINGS STORAGE FACILITY
TAILINGS DISTRIBUTION SYSTEM
DETAILS**

3. Mark 2 and 4 offtakes have been revised and are included on the movable discharge section, as shown on Drg. No. 1625.224.
4. All bends in tailings and reclaim HDPE pipelines are made using natural flexibility of pipe unless otherwise noted. Minimum bend radius to be 25 pipe diameter.

- Butt fusion joining of lower DR pipe to higher DR pipe requires end of lower DR pipe to be bevelled to same inside diameter as higher DR pipe.
 - Tailings offtakes (Mark 1 to 4) are shown on Drg. No. 1625.224.
