ELKVIEW OPERATIONS Inactive Tailings Facilities

Emergency Preparedness Plan (EPP)
&
Emergency Response Plan (ERP)

For Lagoon Breach Emergencies

Prepared and Administered by Teck Coal Elkview Operations
November, 2014

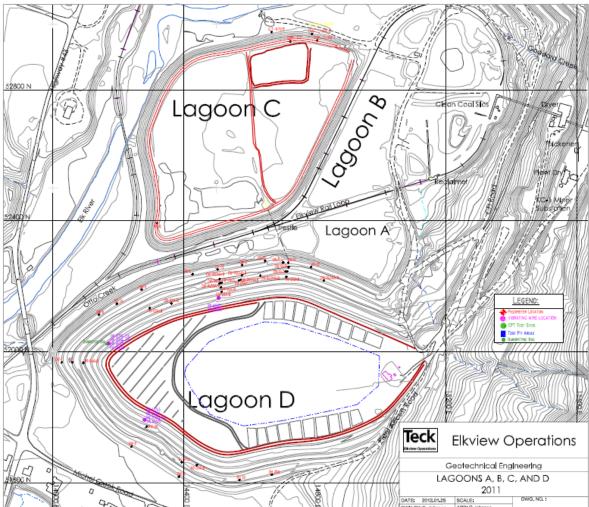
Figure 2: Inactive Tailings Facilities and Surrounding Infrastructure

The inactive tailings facilities are located near the Elk River, approximately 0.8km from Sparwood Heights and 0.4km from the Spardell Trailer Park. Access to the site from Sparwood is via the Main Gate on Michelle Creek Rd, off Highway 3.

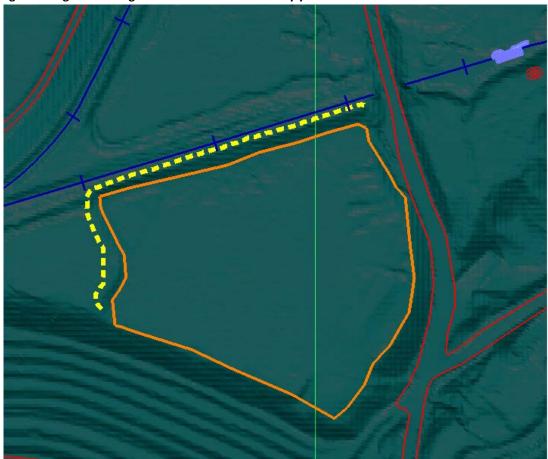
Figure 3: Lagoon A Sludge Inundation Area- shown by yellow dashed line

A tailing inundation zone assuming a 10 percent sludge run out zone is shown in Figure 3. This number is consistent with historic failures of similar material. The major effect will be exceedence of total suspended solids (TSS) specifications for a short time.

Little information is known of the construction and deposition history of Lagoon A. Lagoon A is bordered on the East by Harmer Ridge and on the South by Lagoon D. To the north, a ditch separates the lagoon embankment from the railroad embankment, and on the West (downstream), the embankment lies above Otto Creek (see **Figure 3.**). A small ephemeral pond is present near the downstream embankment.

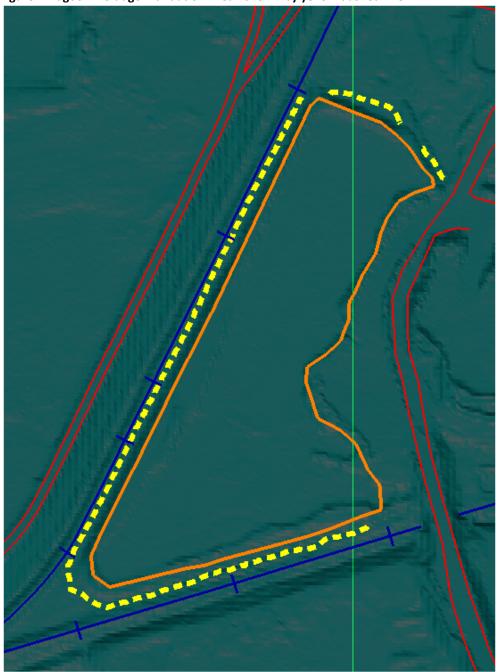
Figure 4: Lagoon B Sludge Inundation Area - shown by yellow dashed line

Since there is generally no water ponded in Lagoon B, the major impact from embankment failure will come from sludge. As with the other lagoons, a 10% shadow for sludge inundation is used and shown in Figure 4. Effects are expected to be contained by ditching and existing sedimentation structures; therefore are not expected to migrate off site. However, the railroad loop may be inundated resulting in closure and inability to load coal onto rail cars.

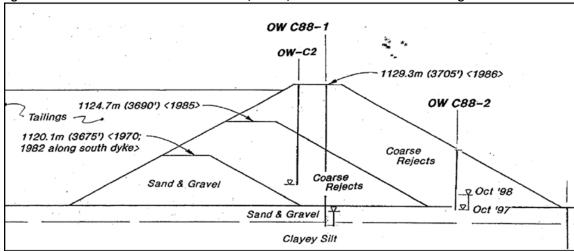
The North, West, and South embankments of Lagoon C were built in lifts using "downstream" construction, where successive lifts expand the starter dike over natural ground (see Figure 5). This is a robust and stable construction method since each lift is founded on well prepared material.

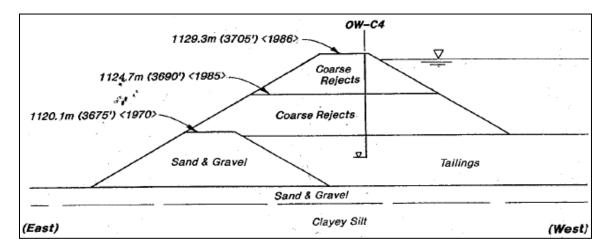
Figure 6: Upstream Lift Construction on Lagoon C

The East embankment was constructed using "upstream" construction where successive lifts are built over the previously-deposited tailing (see Figure 6). This type of construction is not as robust but was required due to the proximity of the railroad embankment. As a consequence of being founded on tailings, this embankment is considered potentially liable to failure through liquefaction.

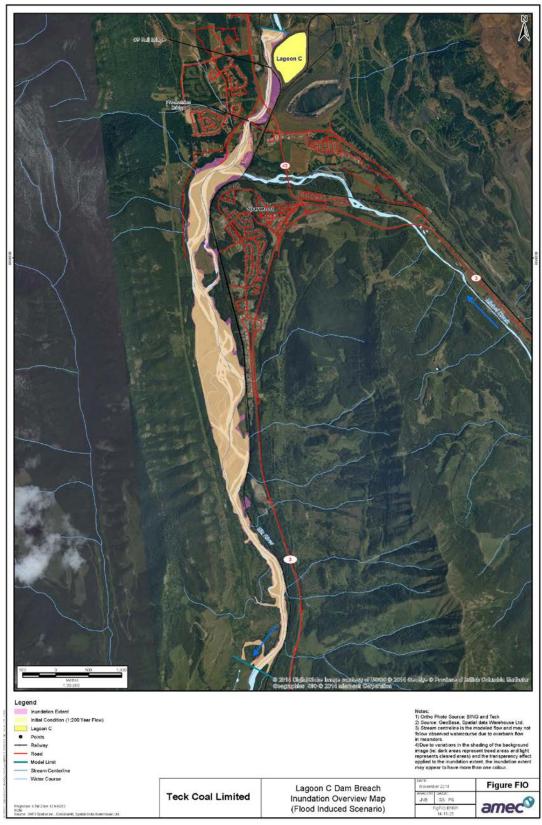
Figure 7: Lagoon C Flood Scenario Inundation Map

Failure of the South or East embankments will likely result in consequences limited to the Elkview mine site. On-site effects will likely be blockage of the rail loop and interruption of coal rail haulage until the debris is cleaned up. Workers would be at risk of engulfment with potential fatal results. Although it is possible for a breach to occur along these embankments the Inundation study focused on the North and West embankments. This focues was due to the higher consequence of failure to public infrastructure and property located in close proximity to the Elk River. Please refer to Figure 7 in regards to maxium affected inundation area.

- A potential breach coud result in the release of between 0.24M m3 to 1.8 M m3 of tailings.
- Assuming the breach outflow entered the Elk River, the flooding effects could travel approximately 10.5km downstream.
- Peak outflow at the breach is estimated to be between 1,122 m3/s under fair weather conditions and 1,102 m3/s under flood condtions.
- The increase in water level 10.5 km downstream would be approximately 1.54m under fair weather conditions or 0.61m under flooding conditions with consideration for attenuation effects.
